## Rehabilitation of a traditional house.

### *Traditional architecture to accommodate today's comfort.*

**Site** Askas, Nicosia district, Cyprus

**Objectives** Conservation- restoration & addition to a listed building in Askas village.

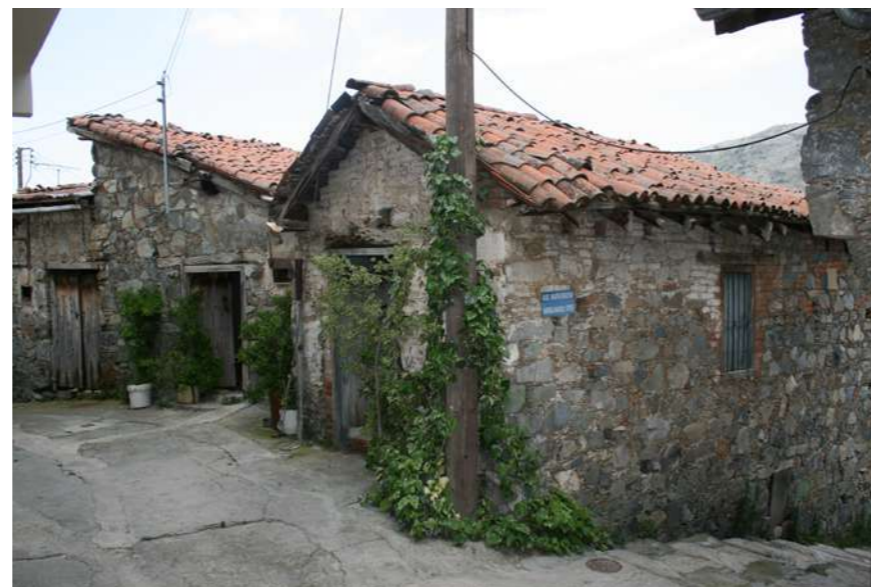
Fig.1: The house from the SW (upper level) before the renovation works. © Agisilaou & Kalavas

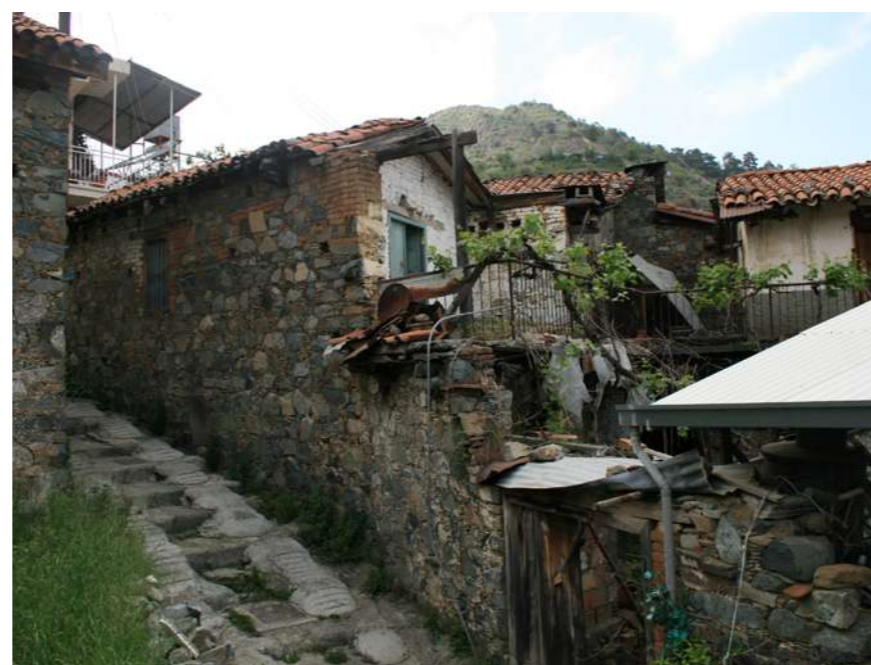
Fig.2: The house from the SE before the renovation works. © Agisilaou & Kalavas

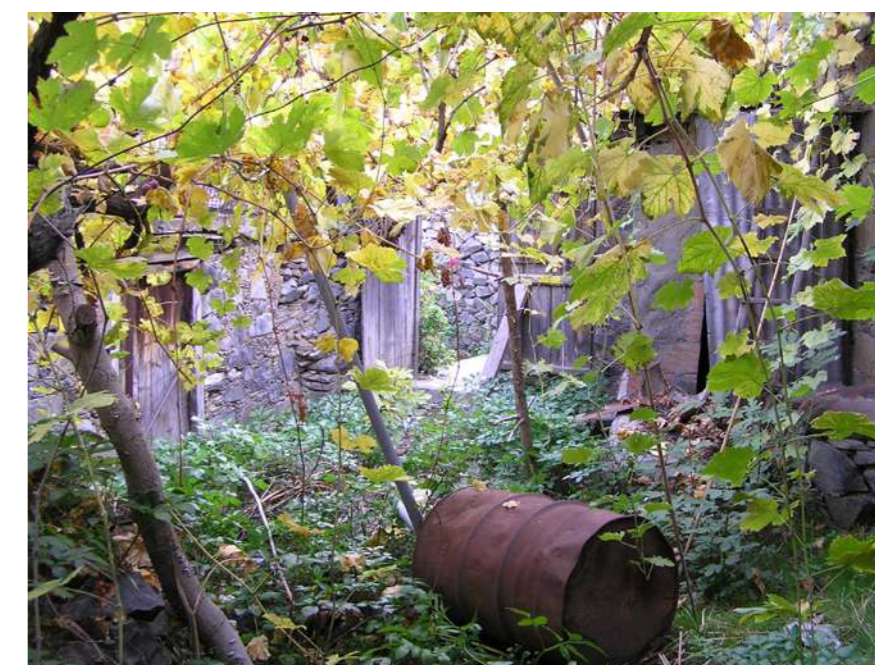
Fig.4: The courtyard with the front door (lower level) before the renovation works. © Agisilaou & Kalavas

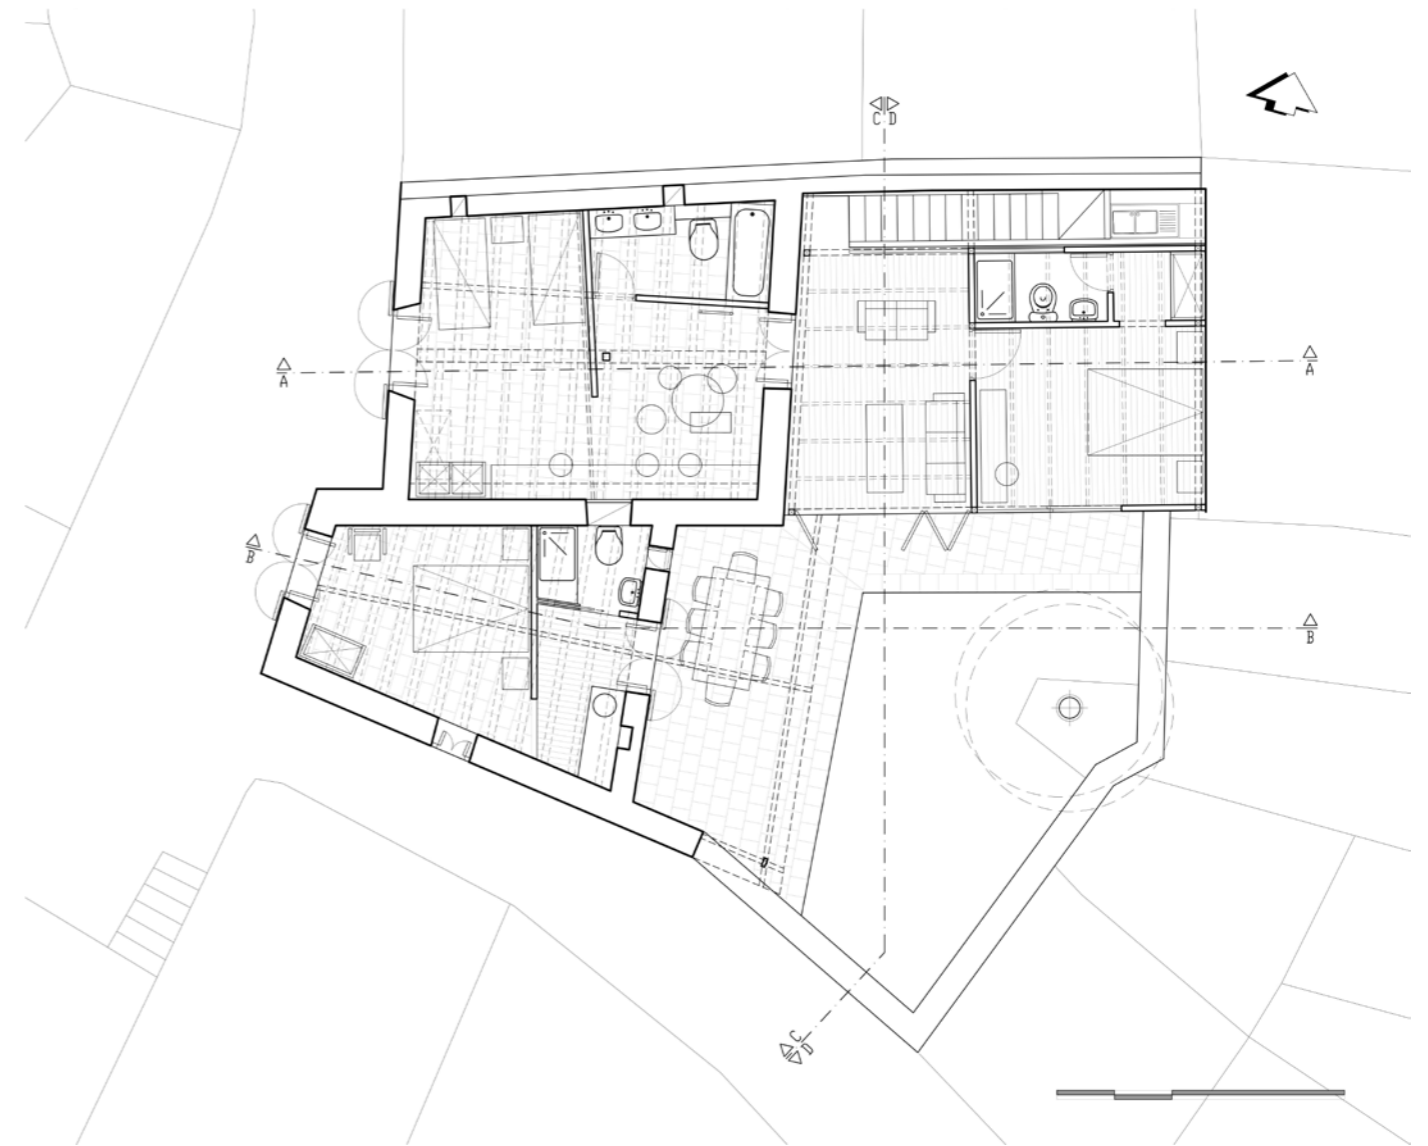
Fig.12: Upper level plan - proposal. © Agisilaou & Kalavas

The house was restored and conserved with the use of traditional material and techniques. A new structure replaced one of the rooms of the upper level, which was demolished. The connection of the two levels of the house was achieved by adding a new light staircase.

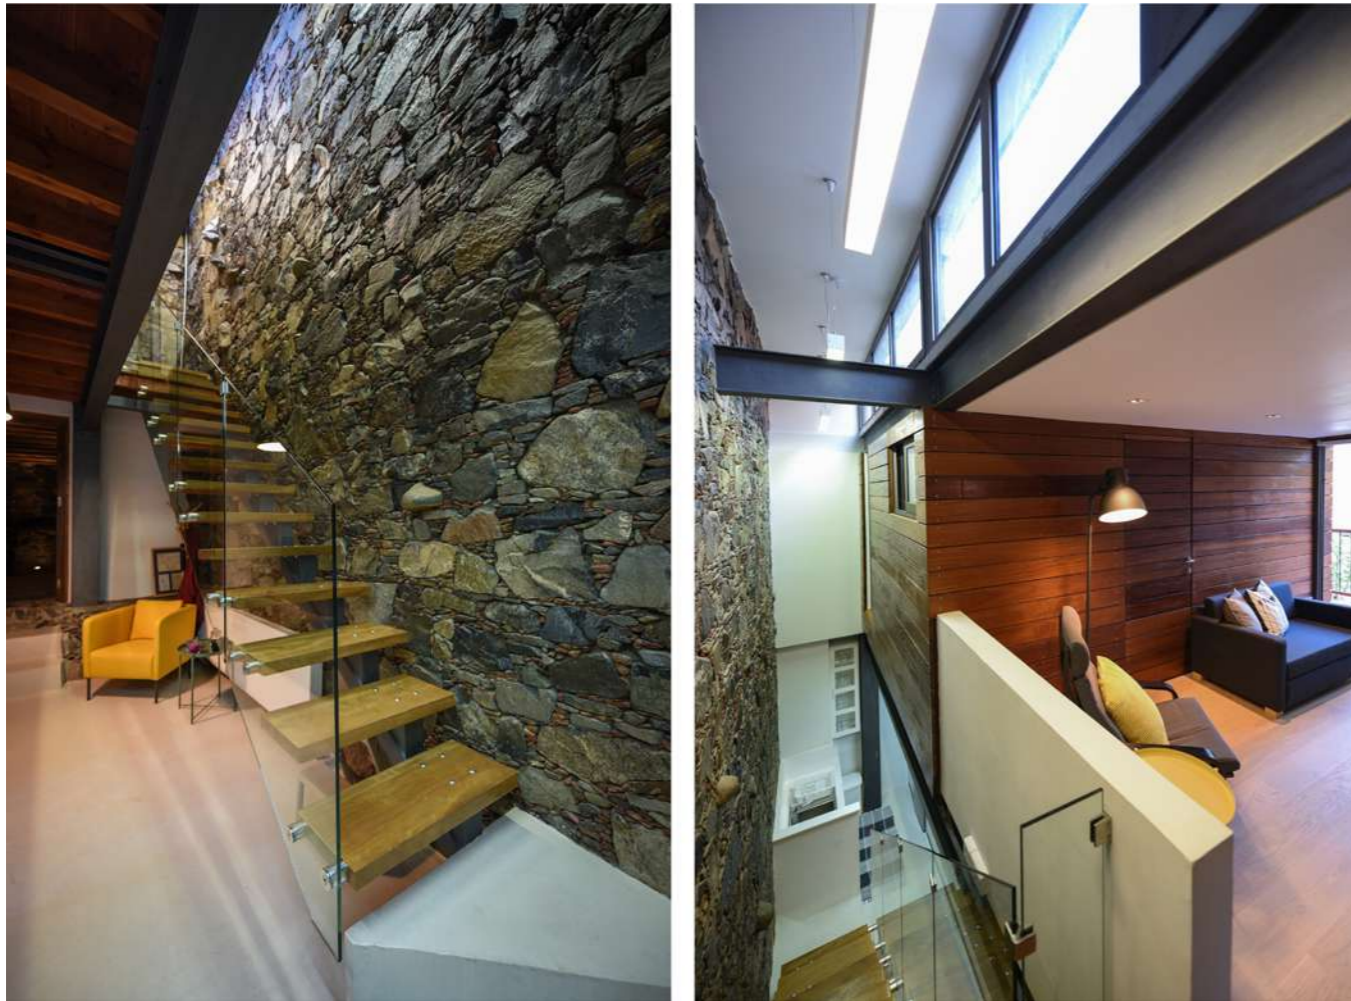
Fig.25-26: The staircase for the vertical internal connection. © Agisilaou & Kalavas
