Rehabilitation of a residential building in the old city of Barcelona.

Site Carrer de Montcada 22, Barcelona, Catalunya, Spain

Designer AGORA Arquitectura: Archs. Joan Casals Pañella & Jose Luis Cisneros Bardolet

Date Project date : 2014
Works: 2015-29
Phase 1 (2015): Building envelopes, prototype floor
Phase 2 (2016-19): Rest of dwellings, accesses

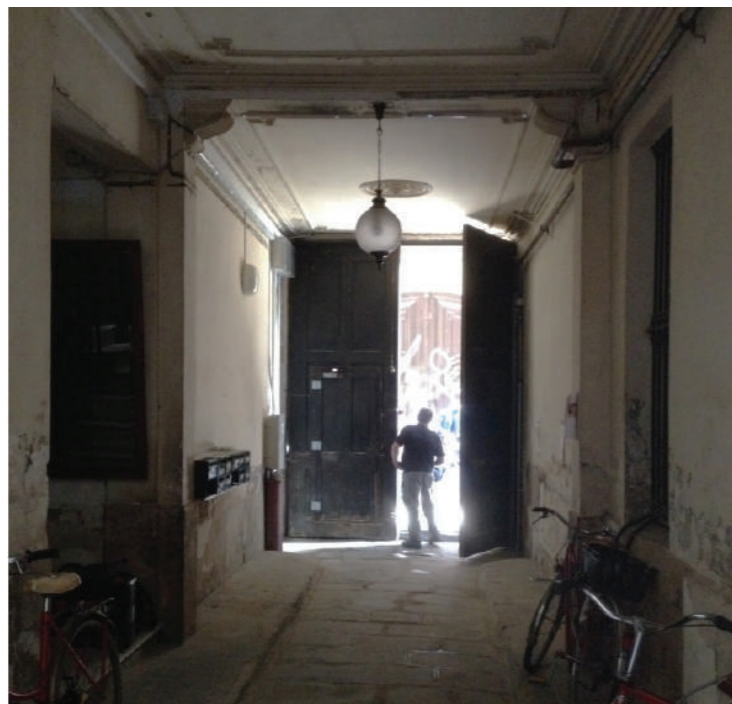
Fig.1: View of the entrance from the inside of the building, before the intervention.

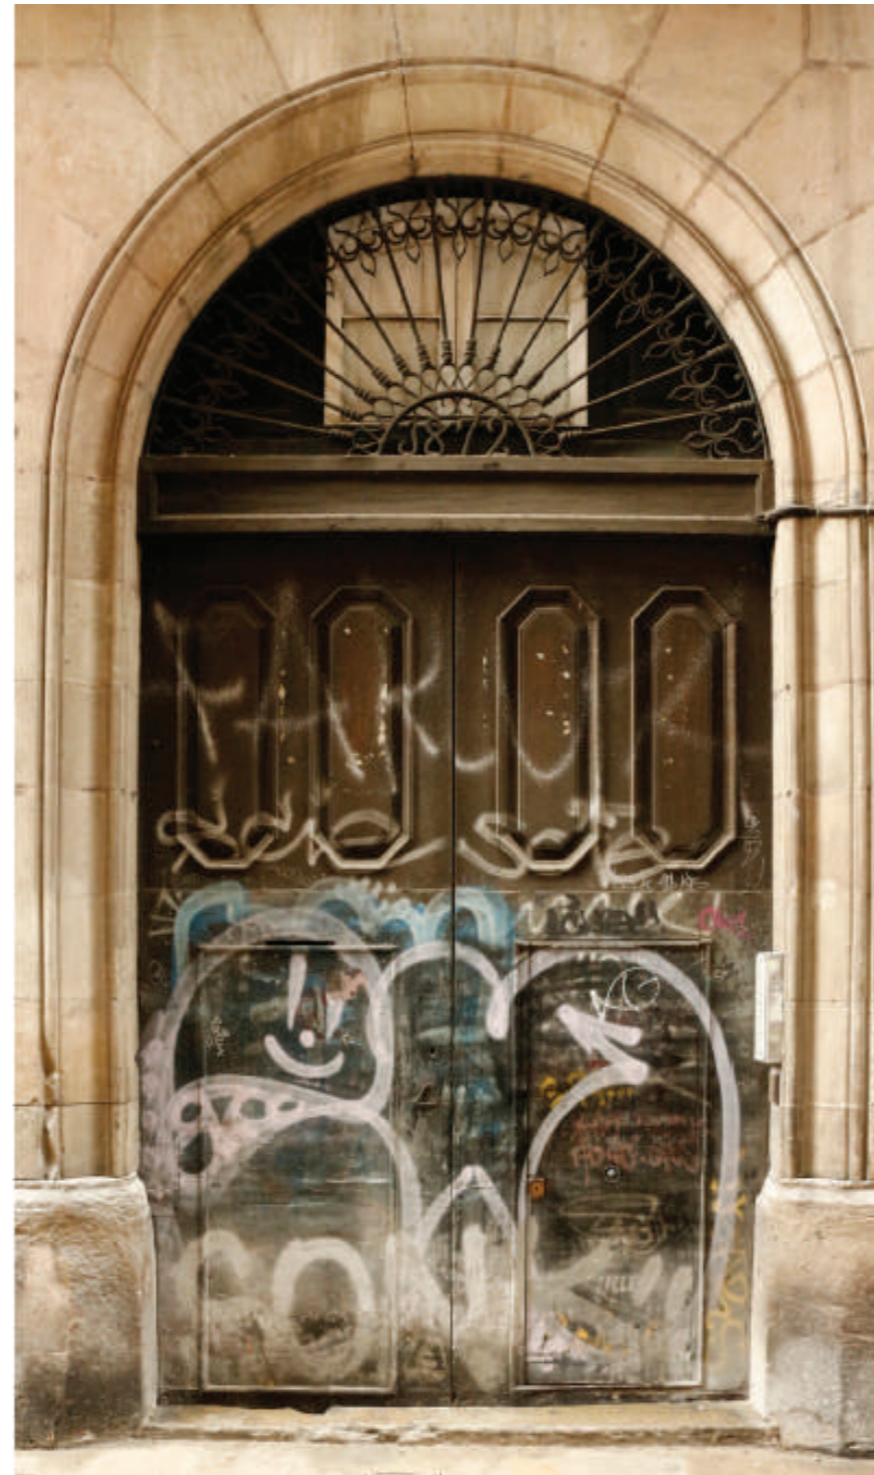
Fig.2: View of the main entrance door, before the intervention.

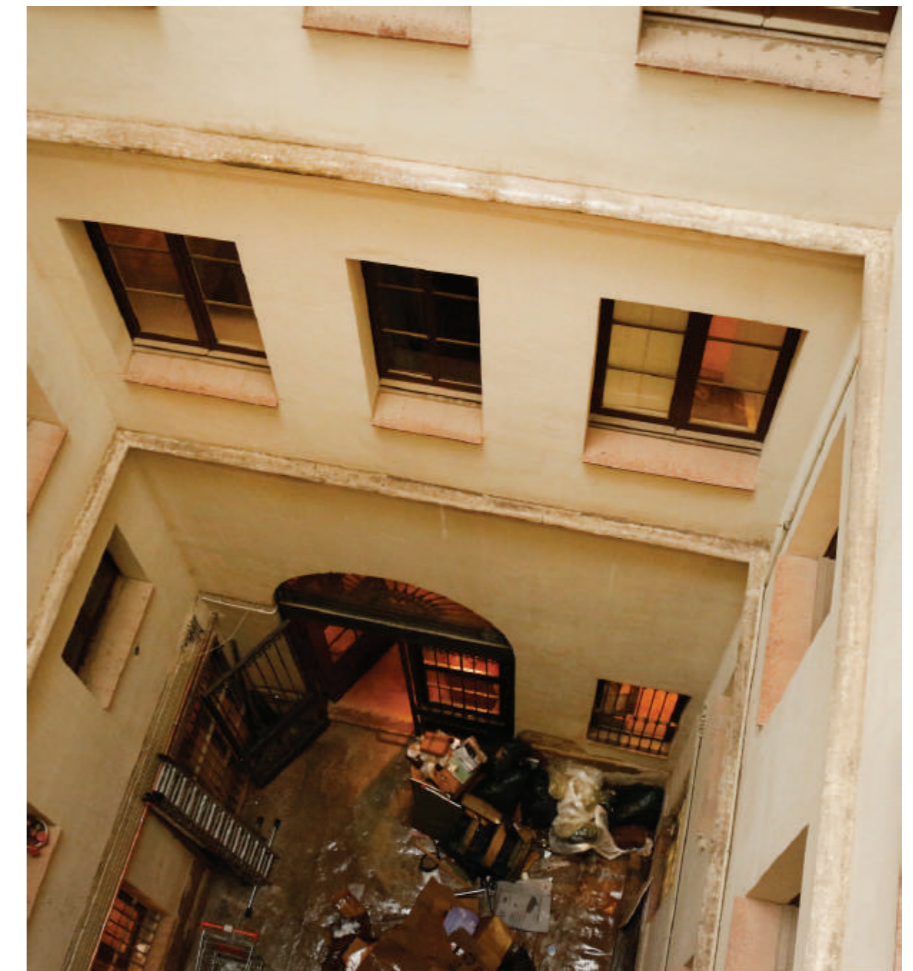
Fig.3: View of courtyard, before the intervention.

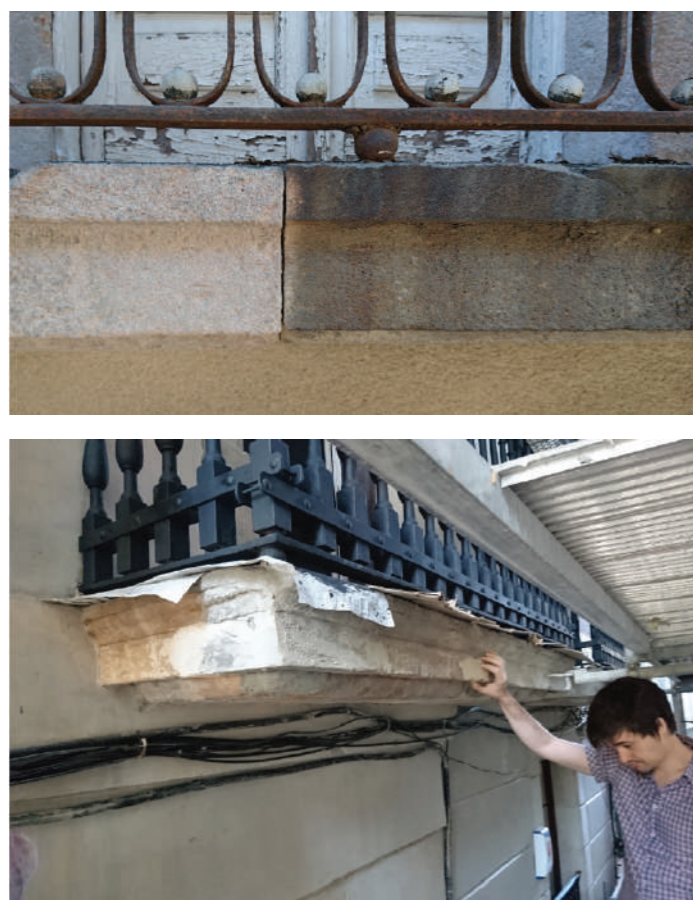
Fig.4-5: Process of the restoration and cleaning of the balconies.

In general, a non-aggressive cleaning of the vertical facing of the façades is carried out by means of manual soft brushing and cold water jet at pressure of up to 2 bar, mechanical removal of efflorescence on stone facing by application of cellulose dressings with successive applications of inert cellulose dressings and subsequent brushing with non-aggressive

manual means and elimination of black crusts by applying deconsolidating potassium silicate AB57 and when it is not possible to conserve the vertical support, it is proposed to repoint and remove the existing coating to leave it completely clean and then apply a lime mortar coating, applied manually according to the traditional three-layer system, applying mass pigments in the last layer to recover the original color of the façade. Regarding the exterior carpentry, it was decided to restore the sections and adjust the opening mechanisms damaged by the passage of time and replace the single glazing with a double glazing with chamber through a new glazing bead fixed on the front of the windowpane that allows the new section to be incorporated.

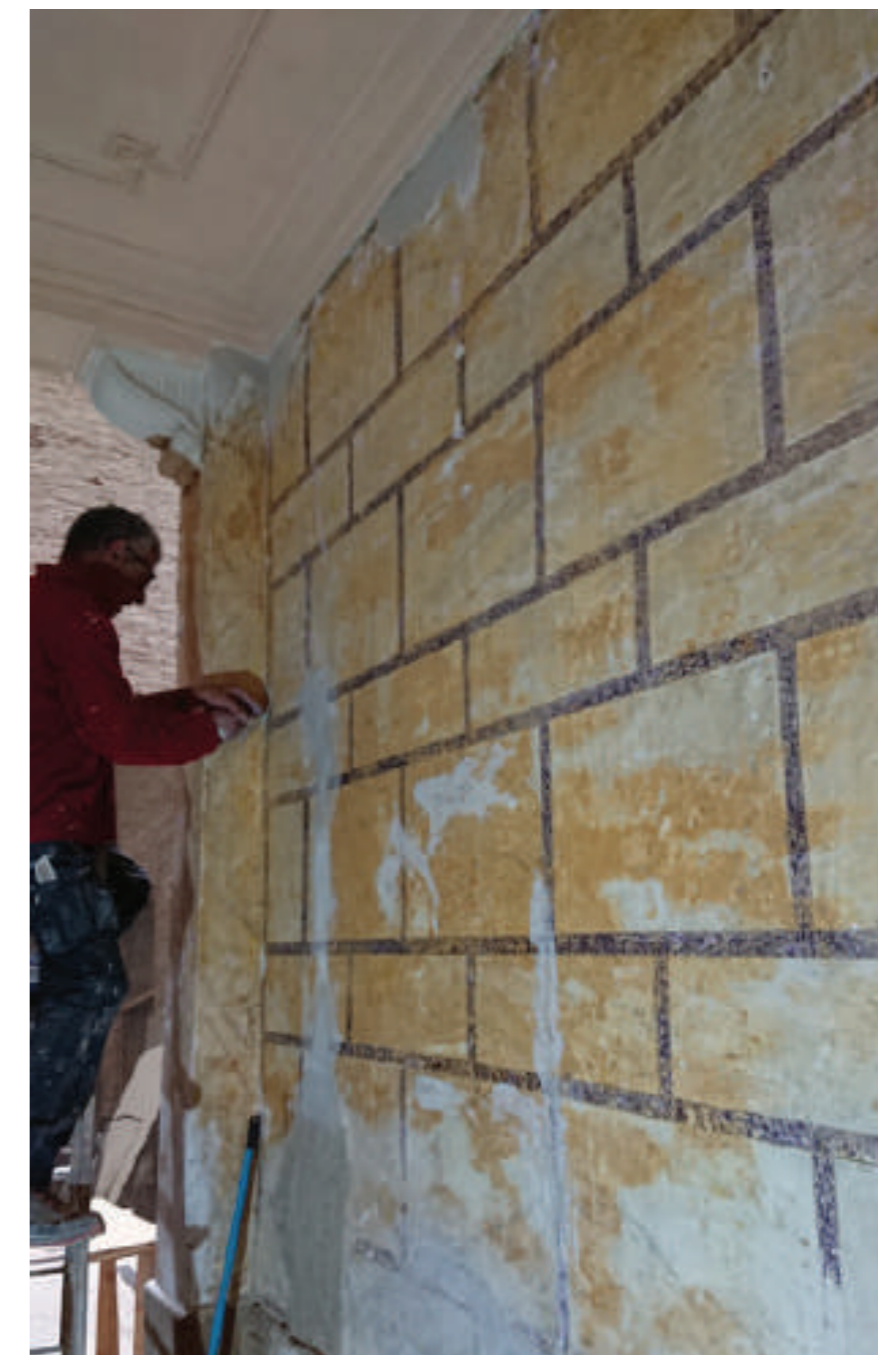
Fig.6: Restoration of the stuccoes of the interior passage.

In the interior passage all the existing paintings are stripped, all the areas where the fire stuccoes have been destroyed by the passage of time are reconstructed and the ceiling is cleaned by means of spatulas and steam strippers to try to discover the existing drawings and pieces to later proceed to repair and paint all the ceiling moldings and to wax all the vertical surfaces. Also here the main access door to the property is restored by removing an iron plate adhered to it and stripping the paints superimposed on the wood. In the same action, the intervention is used to create a crack in a small access door that allows the neighbors to enter in a more comfortable way when, for example, the big doors are closed at night. The fissure involves adding a new frame to the system, which is solved by hiding the panel in it. Finally, and given that it is planned to leave the doors open to the city during the day, it is proposed to place a new door in front of the old neighborhood access staircase, forcing even more the idea of reproducing inside the idea of street or passage of the environment. The door is resolved by means of a 15mm thick iron perimeter frame and industrial pivots that allow a span of 160cm to be bridged. The 10+10 glass and the gaps/joints on the perimeter allow this fragile element to act as a load-bearing element. Thus, for example, any deformation in the system is avoided.

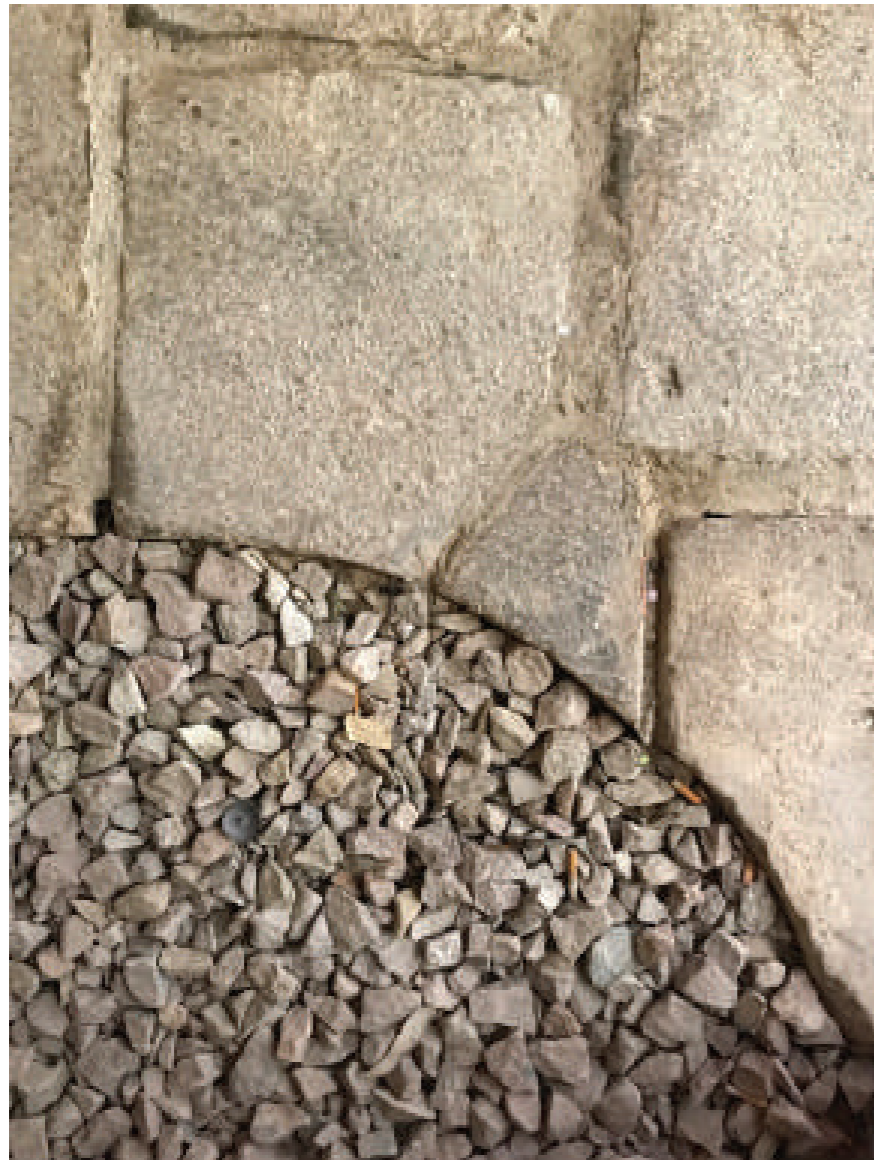
Fig.7: New sidewalks with some parts restored and others recycled to be used as gravel for the new installations channel.

On the other hand, an old vestige of what was the old sidewalk is preserved as part of the memory of what we find in this place. It also helps to bridge the existing gap between the first floor level and the staircase reception area. In fact, it was decided to eliminate some interior stone sidewalks in order to channel under them all the installations superimposed on the walls of the lobby (water, electricity and gas). Once the sidewalks had been re-routed, they were crushed and the gravel generated was used to cover their tracks. This achieves several goals: that the installations do not invade the noble space of the entrance, that the entrance hall is all flat and that the meeting of the stucco

with the floor is protected from capillarity, taking advantage of the resources of the work itself.

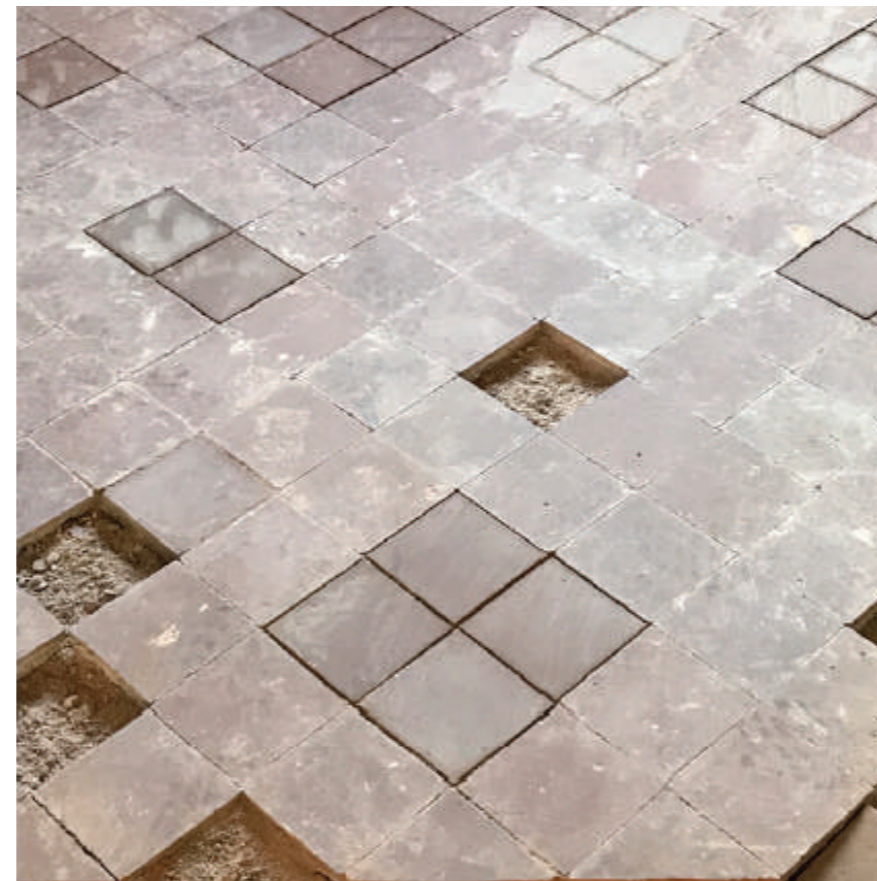
Fig.8: Recovery process of the original interior pavement.

In the interior of the floors and after eliminating all the added false floors, we proceed to restore the uncovered pavements that we decide to preserve by cleaning, polishing and brightening. In this matter, in some cases it is necessary to add some deteriorated pieces, in others it is necessary to remove all the paving to later level the floor and in some cases it is decided

to store the paving found to relocate it in some place of the work that due to the preserved surface and the new program foreseen could better fit. Thus, for example, the old installations are also removed and replaced by simple new conduits. The horizontal electricity conduits were almost entirely exposed by means of galvanized pipes painted white. The water pipes, also practically in their entirety, are traced on the floor, taking advantage, to a large extent, of the perimeters of the carpets formed by hydraulic floors or the old traces of the eliminated partitions. On these traces, monochromatic hydraulic pieces that have been recovered from the demolition of other nearby works through a local company are added. Practically all of the interior woodwork has been restored, requiring only minor adjustments, sanding and subsequent applications of paint.

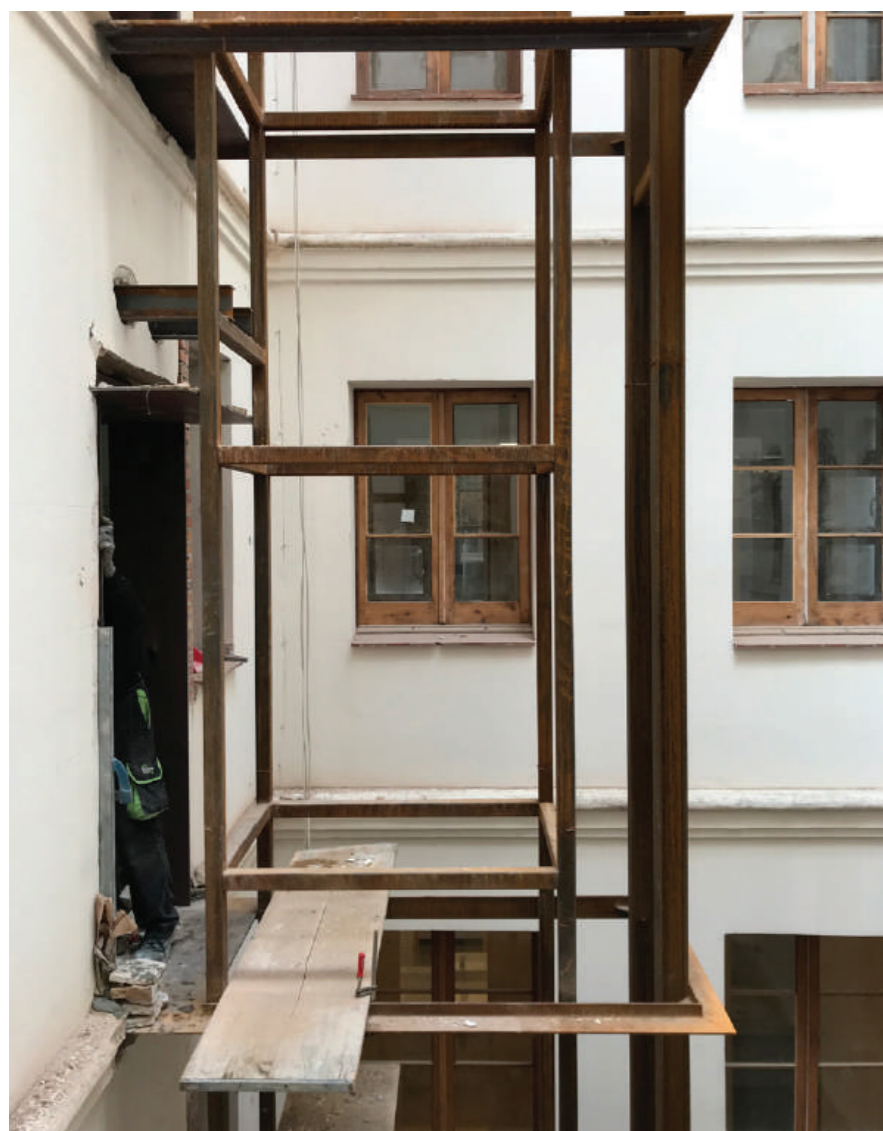
Fig.9: Installation of the elevator's steel frame, and enlargement and reinforcement of the openings to improve accessibility.

For the installation of the elevator, it is first necessary to redirect the manhole that is installed in the courtyard, lift all the stone slabs to also redirect the slopes of the courtyard and build the pit. It was decided to build the pit by means of concrete walls crowned with an embedded steel plate. On this plate the only two pillars that support the weight of the elevator are welded; 2 HEB 100 that are located away from the entrance and free the corners. On these columns, concentric rings formed by a T 100 profile brace the system on each slab, coinciding with the cornices of the courtyard. The structure is clad with 4+4 laminated glass on the ground floor and mezzanine. The rest with 4+4 laminated mirror. The idea is that on the first floor the system disappears, giving depth to the courtyard, and that on the upper floors the elevator blends in with its immediate surroundings. To access each landing it is necessary to make some shoring in the courtyard wall. This is done by means of a 10mm thick steel perimeter frame that hides a T-profile to reinforce the lintel. The rings are welded to the floor of this frame. The frame is screwed transversely to the façade wall. An internal tubular structure temporarily serves as scaffolding during the installation work. Once the elevator structure is anchored to the load-bearing walls, the tubular structure is removed and used for the installation of other elevators.

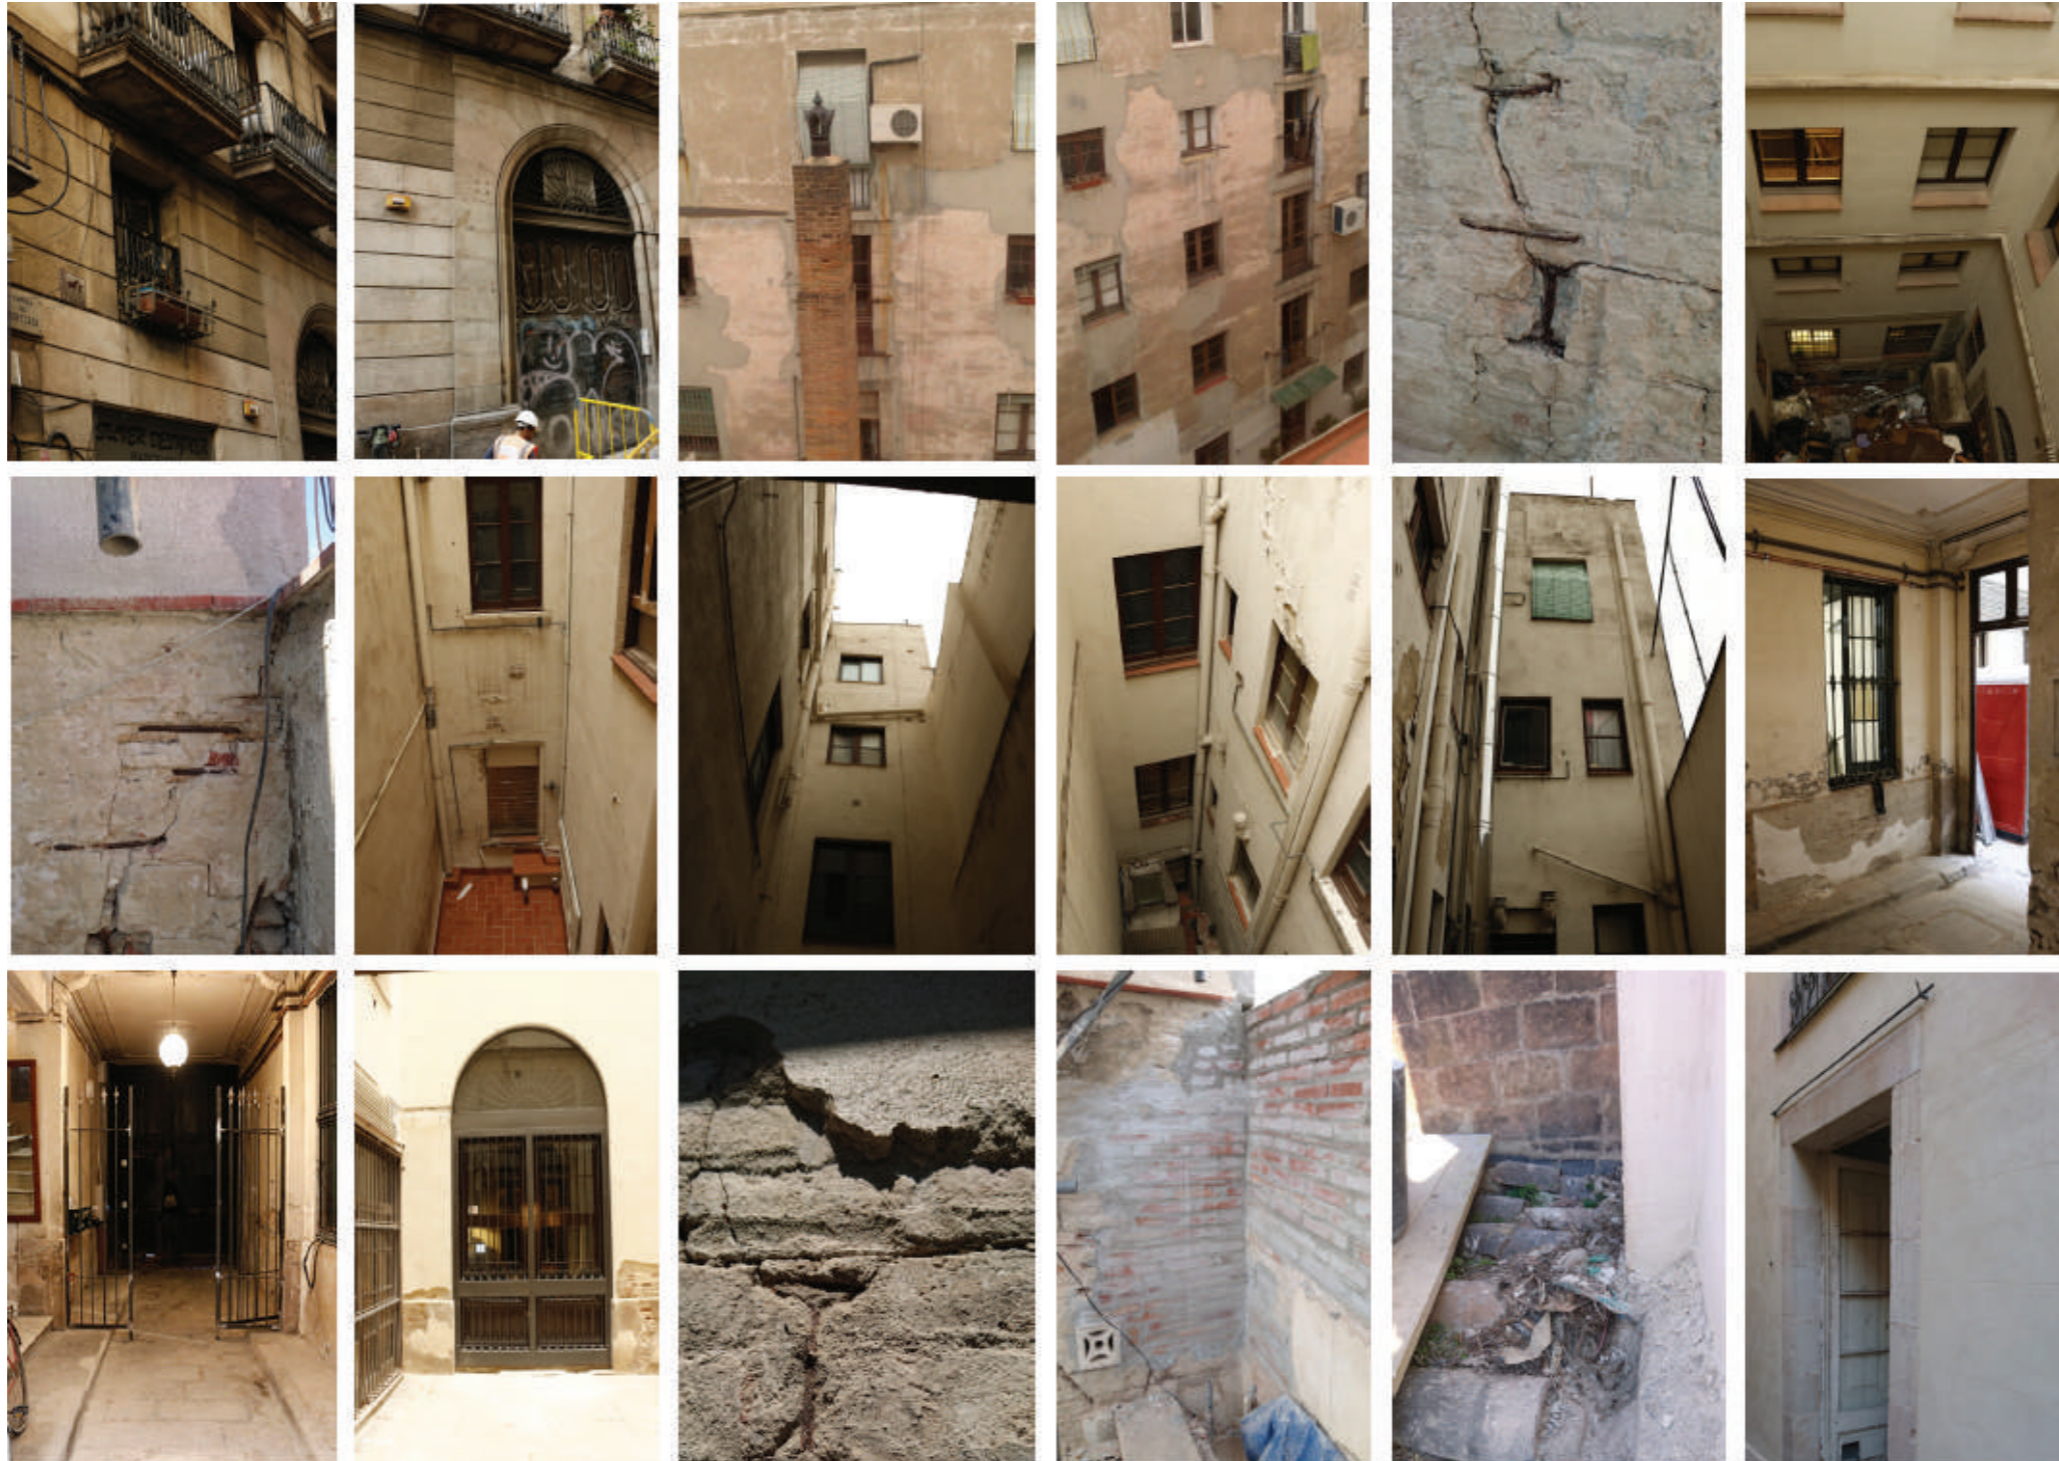
Fig.9: Existing conditions of the building envelopes.

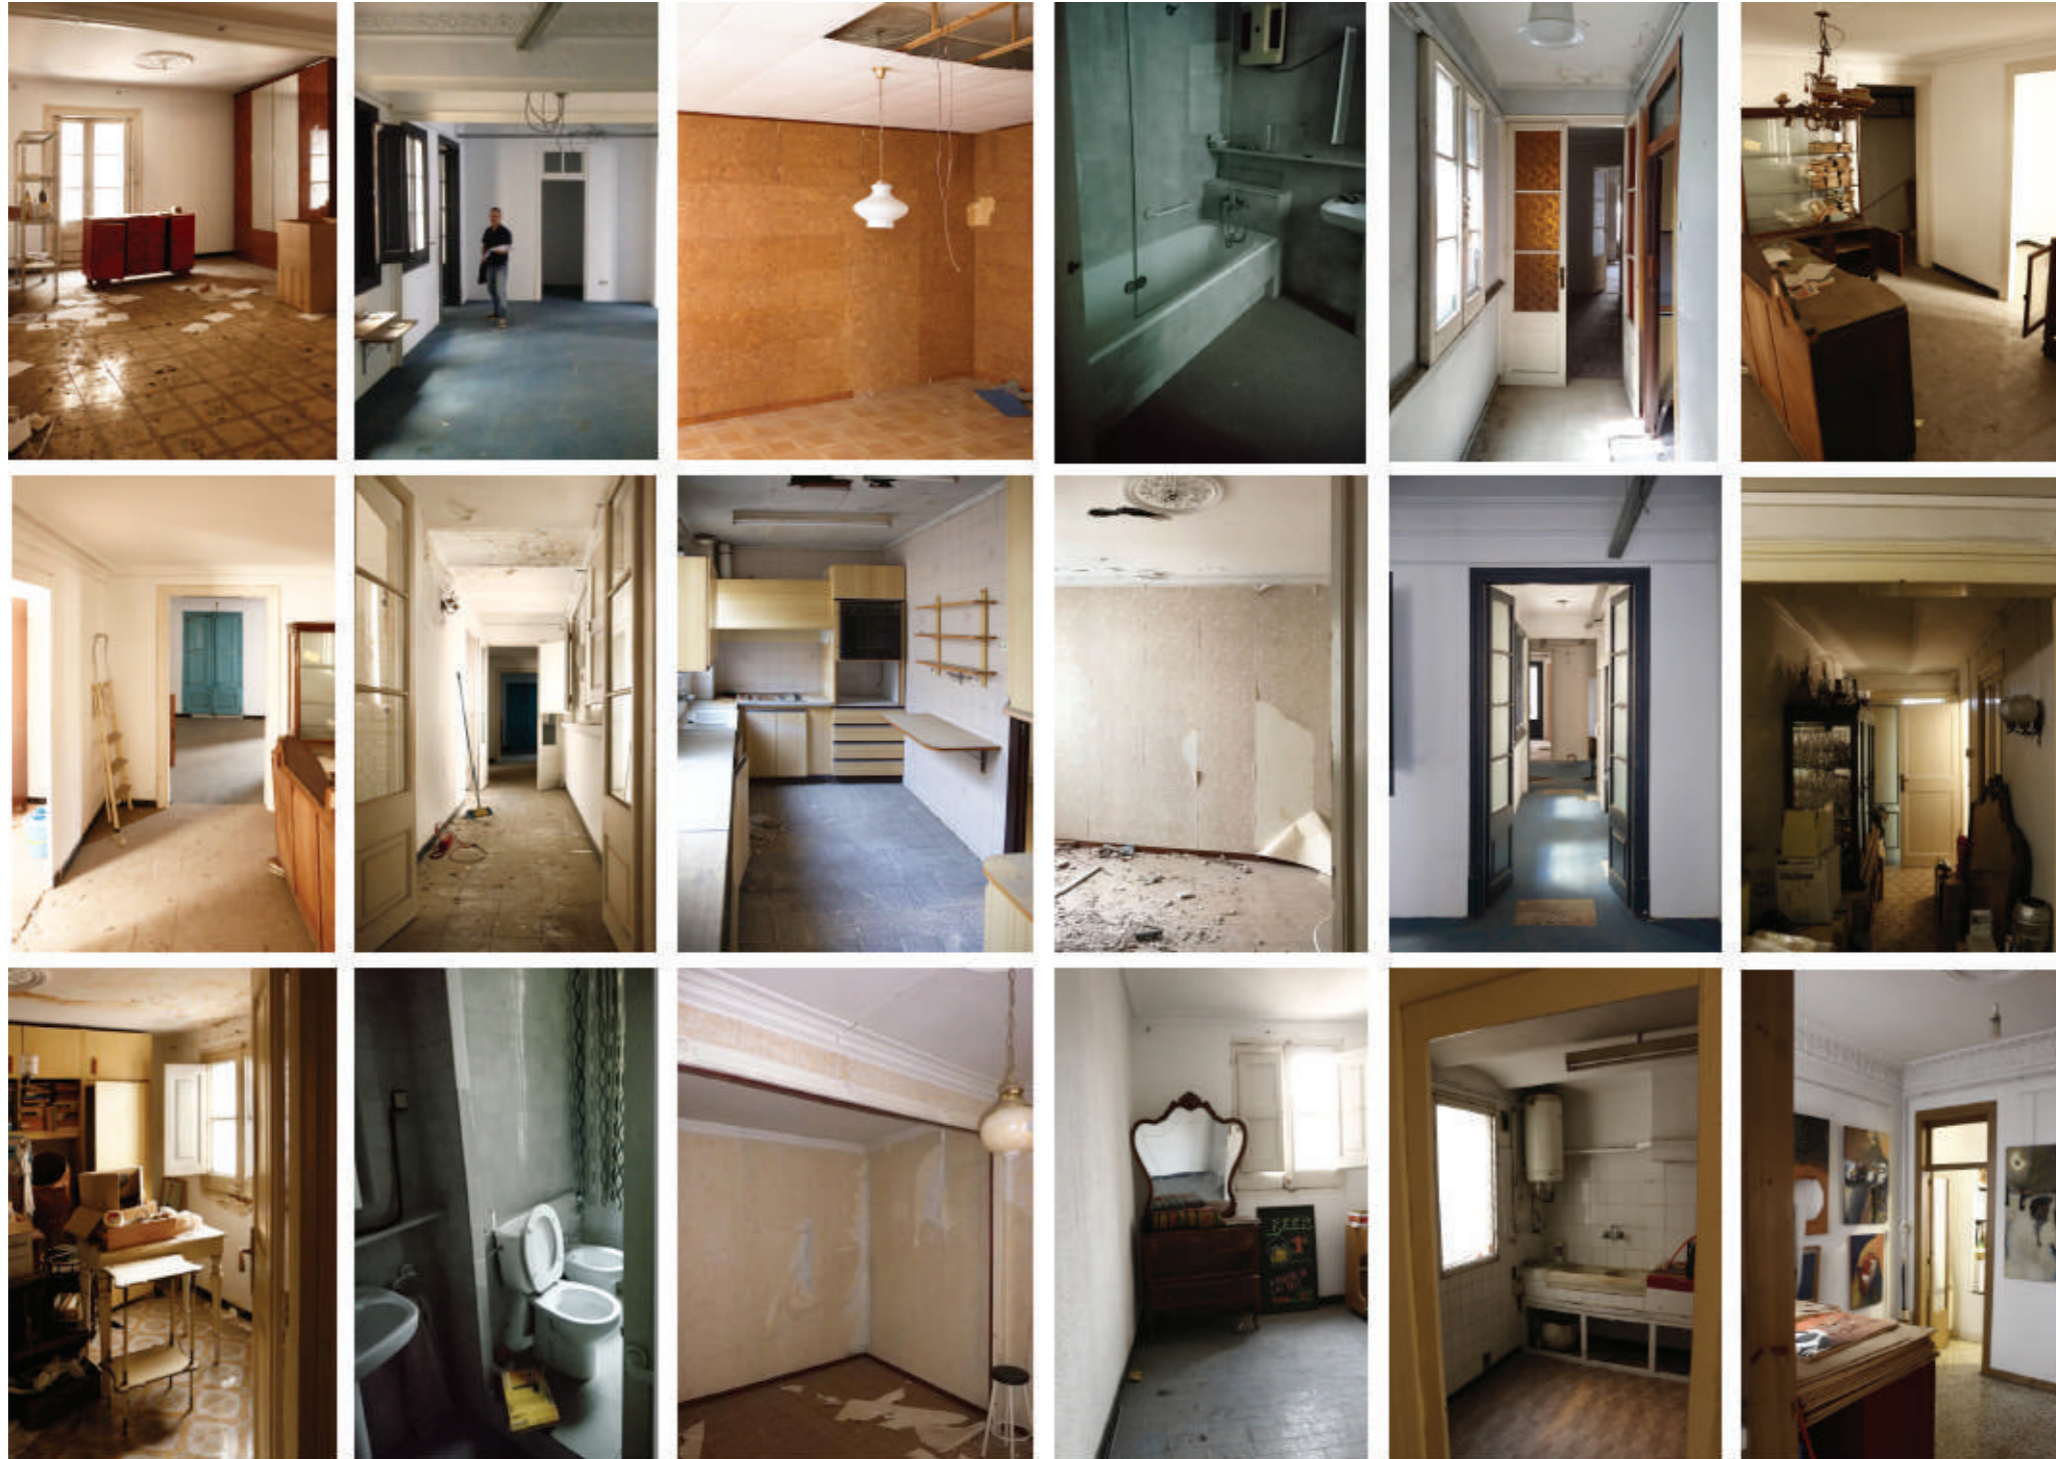
Fig.10: Existing conditions of the dwellings.

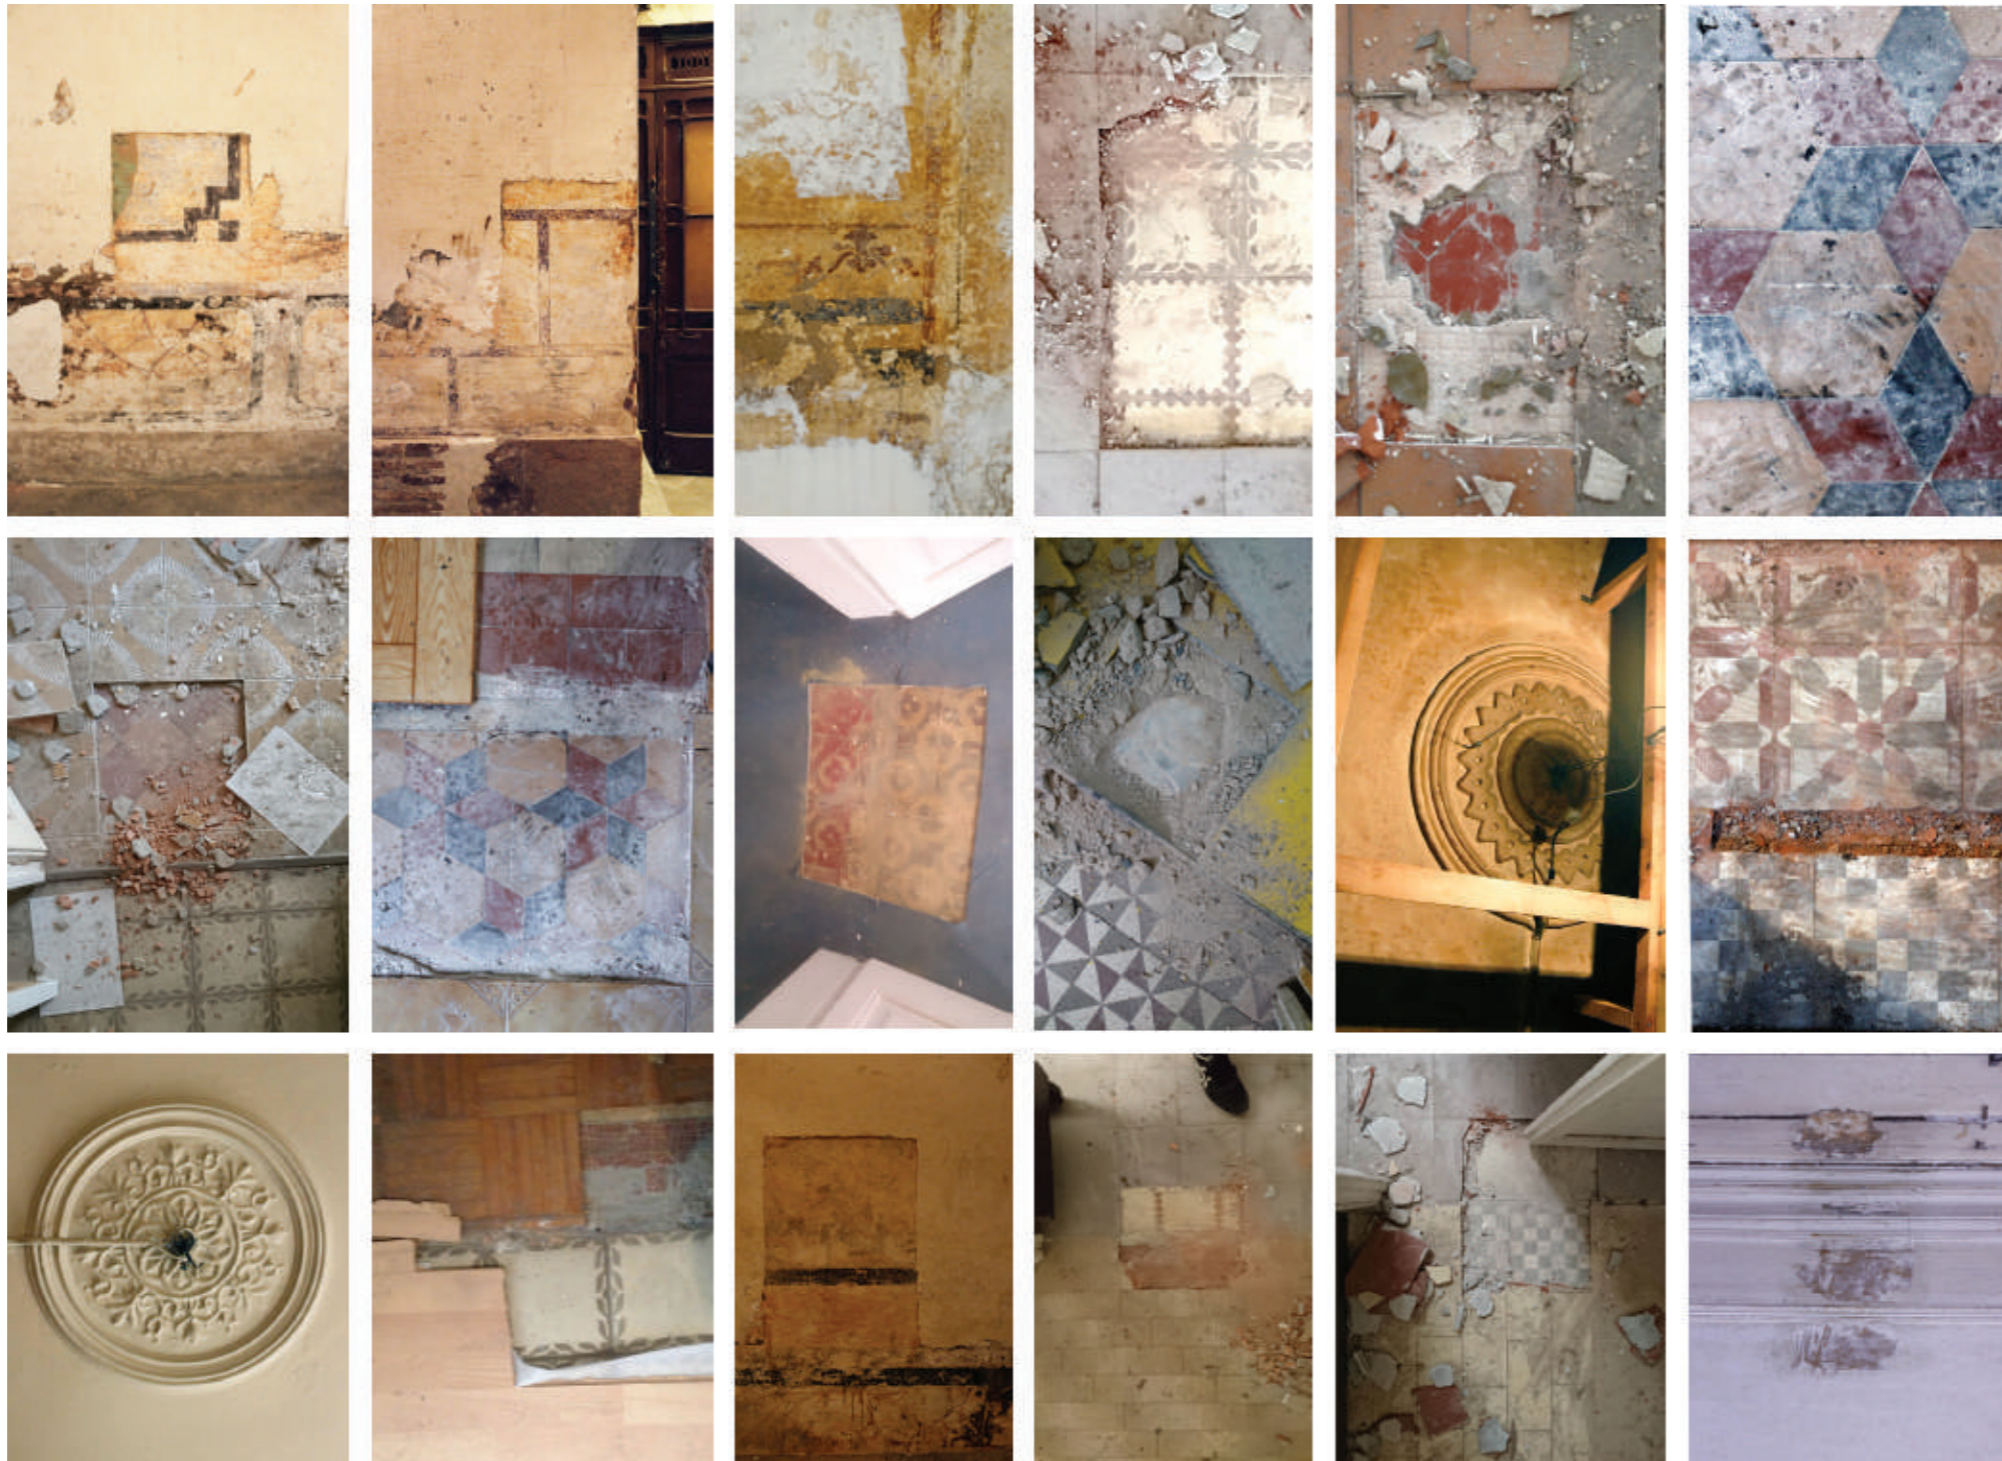
Fig.11: Exploratory test-holes to discover the original elements hidden underneath later interventions.

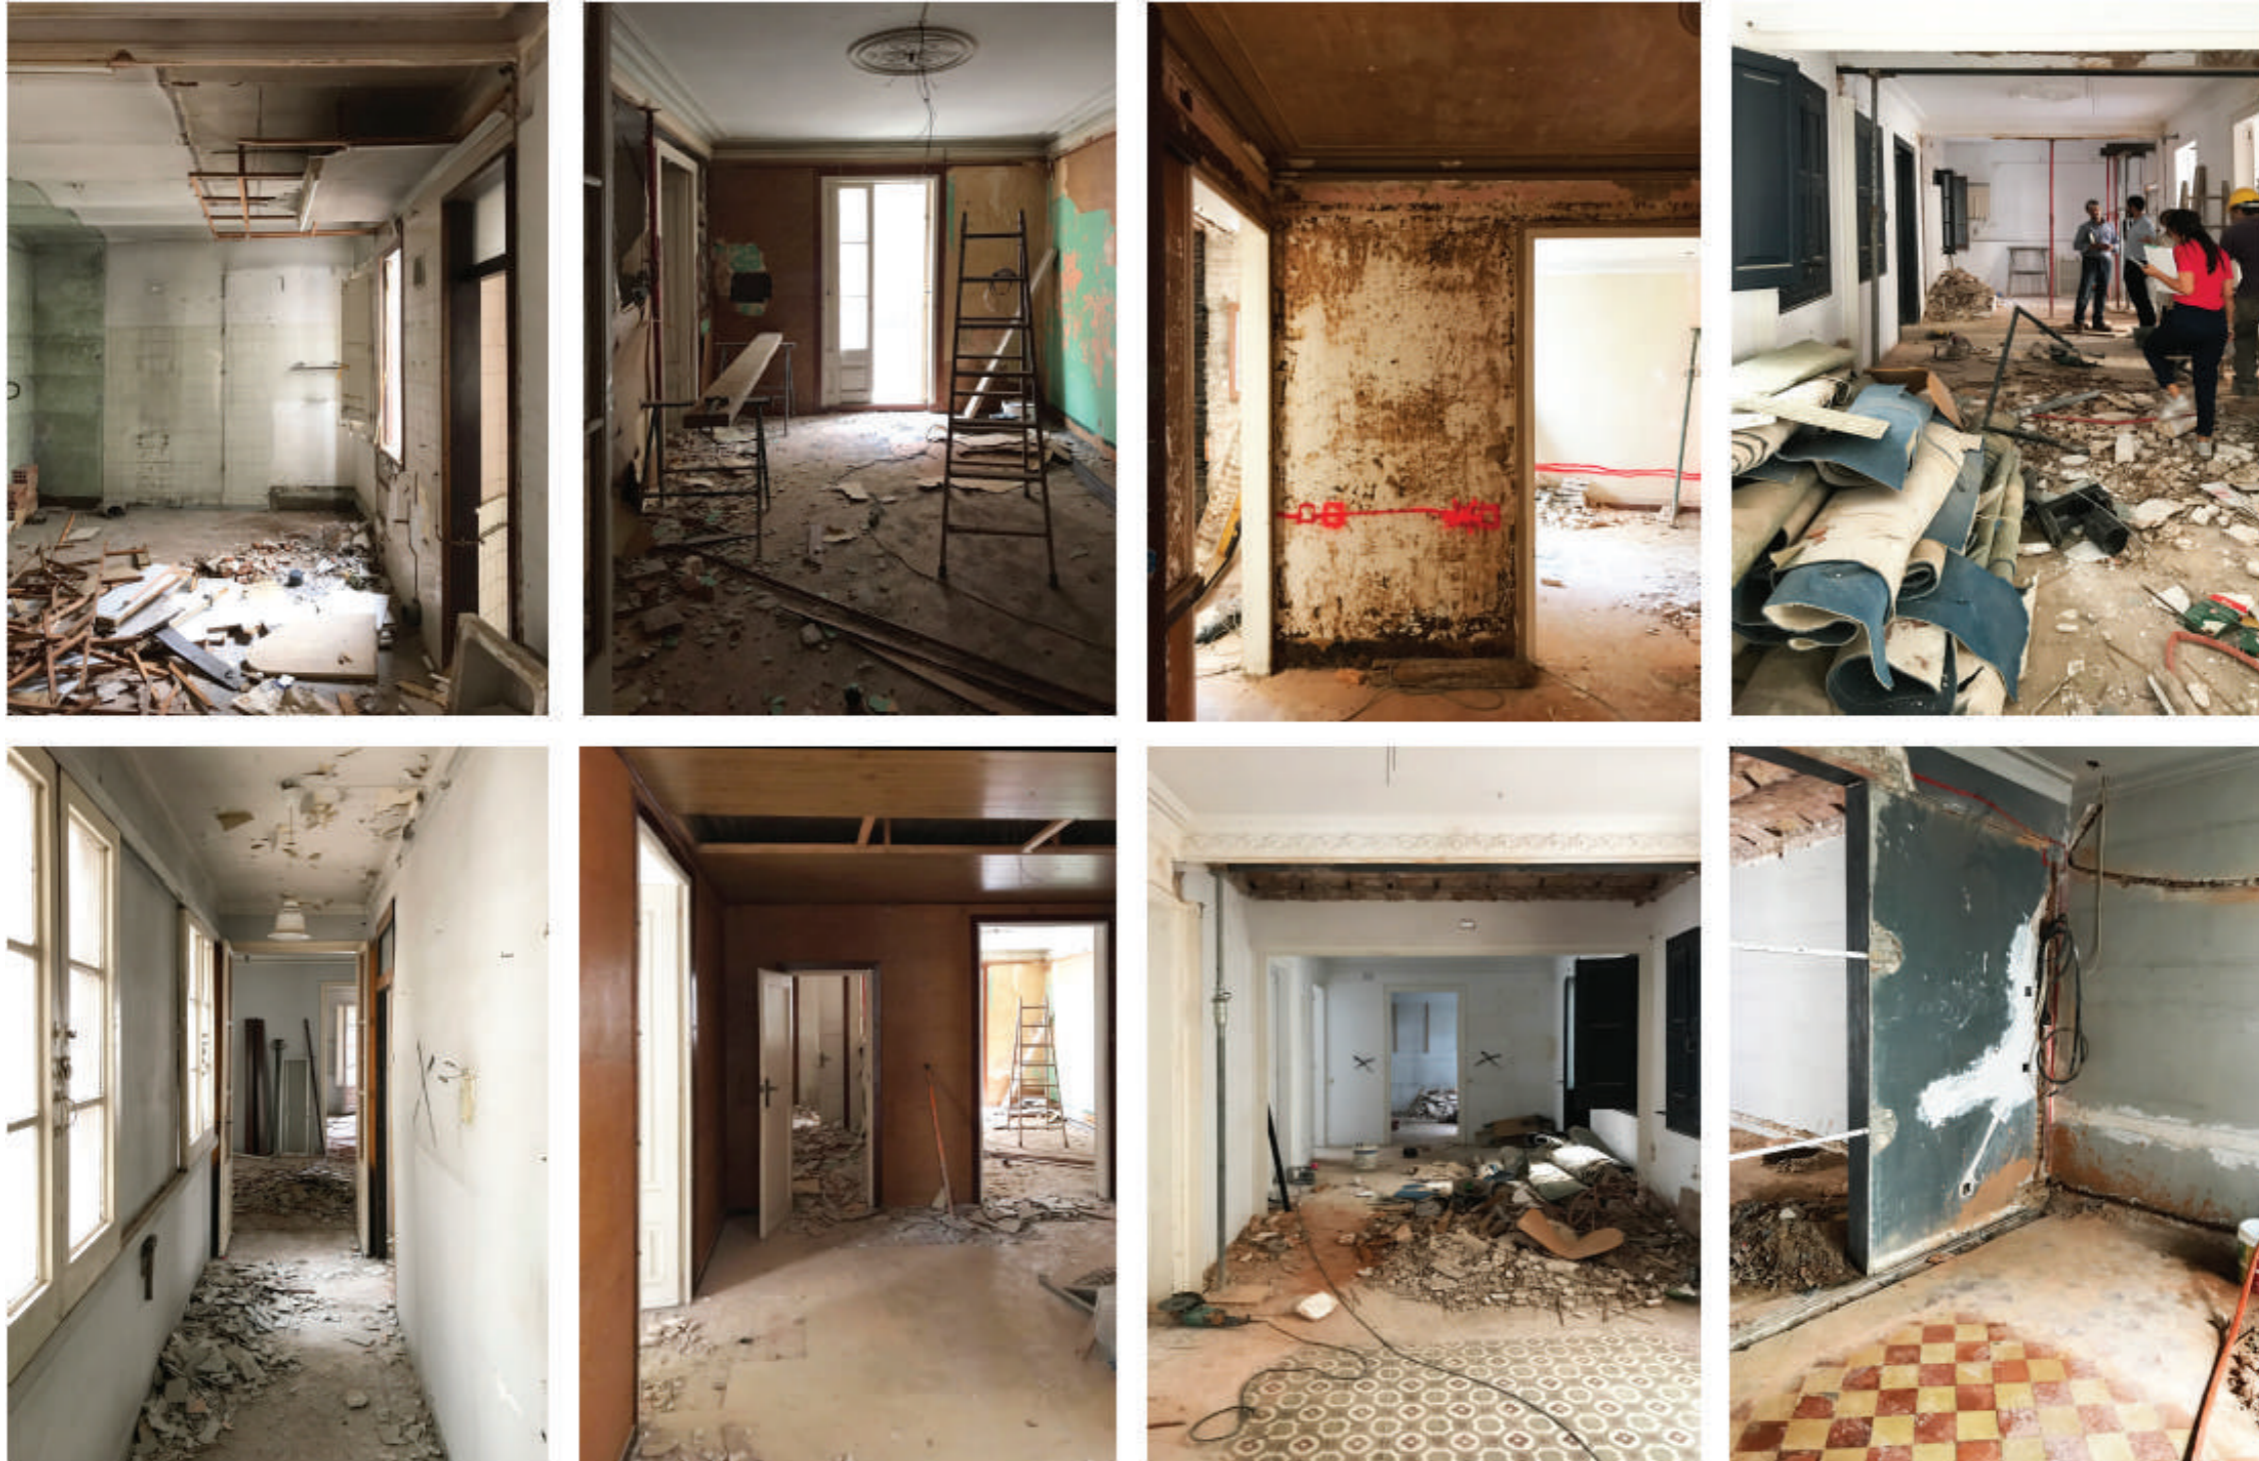
Fig.12: Removal of the modern interventions that cover the historical elements.

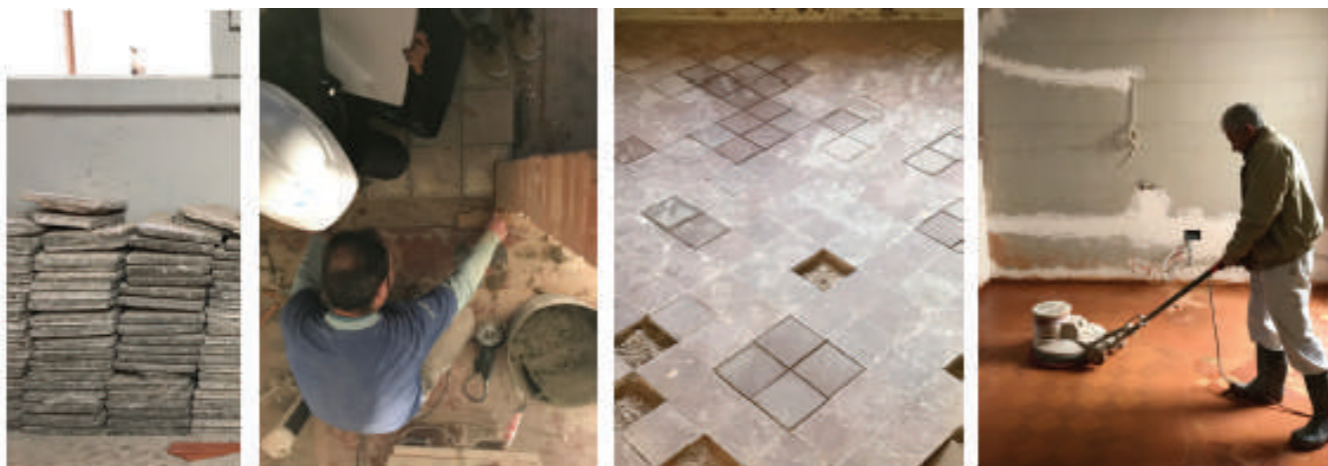
Fig.13: Restoration / recovering of the pavements.

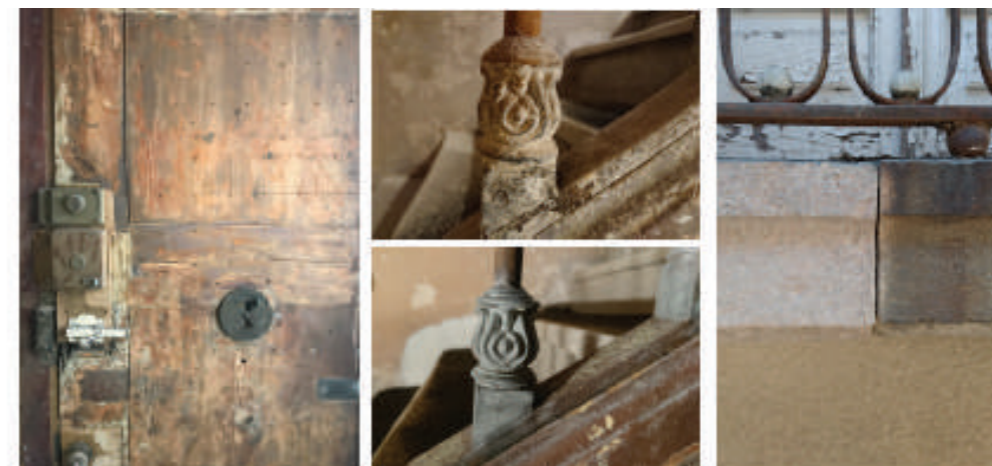
Fig.14: Stripping and pickling of surfaces.
