Rehabilitation of a residential building in the old city of Barcelona.

Site Carrer de Montcada 22, Barcelona, Catalunya, Spain

Designer AGORA Arquitectura: Archs. Joan Casals Pañella & Jose Luis Cisneros Bardolet

Date Project date : 2014
Works: 2015-29
Phase 1 (2015): Building envelopes, prototype floor
Phase 2 (2016-19): Rest of dwellings, accesses

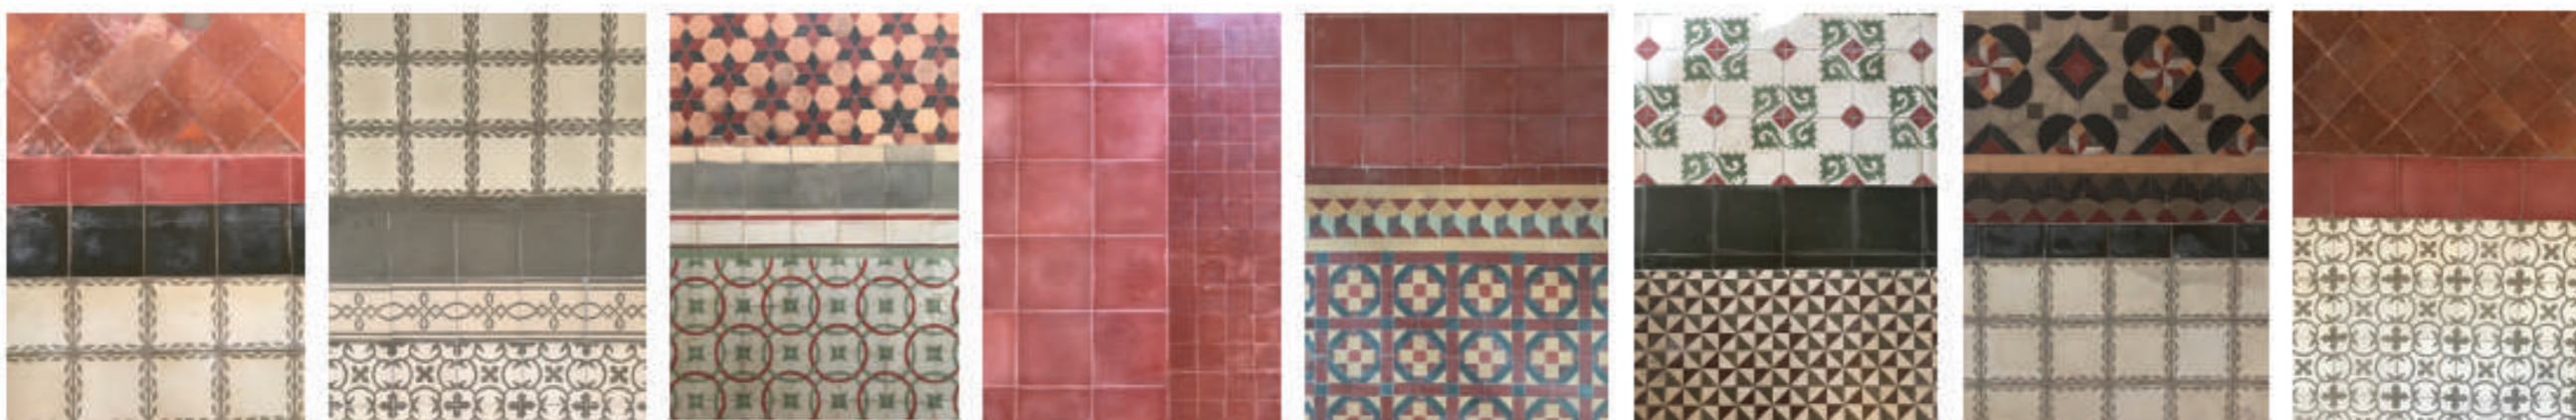
Fig.15: Joints between pavement.

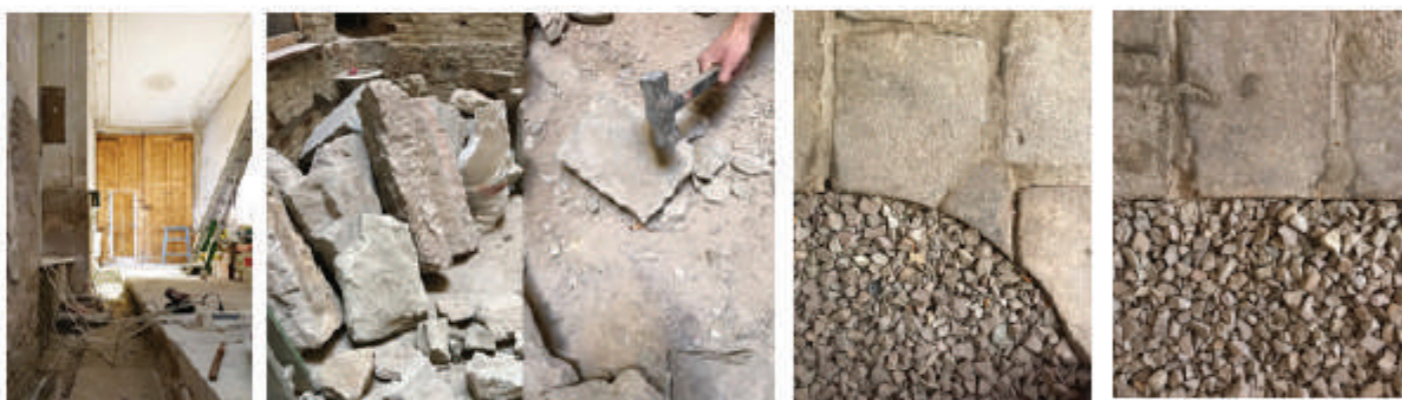
Fig.16: Sidewalks transformation.

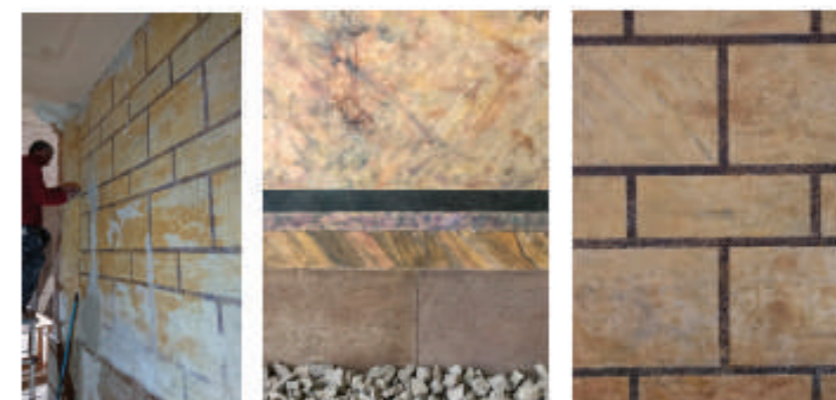
Fig.17: Recovery of stuccoes.

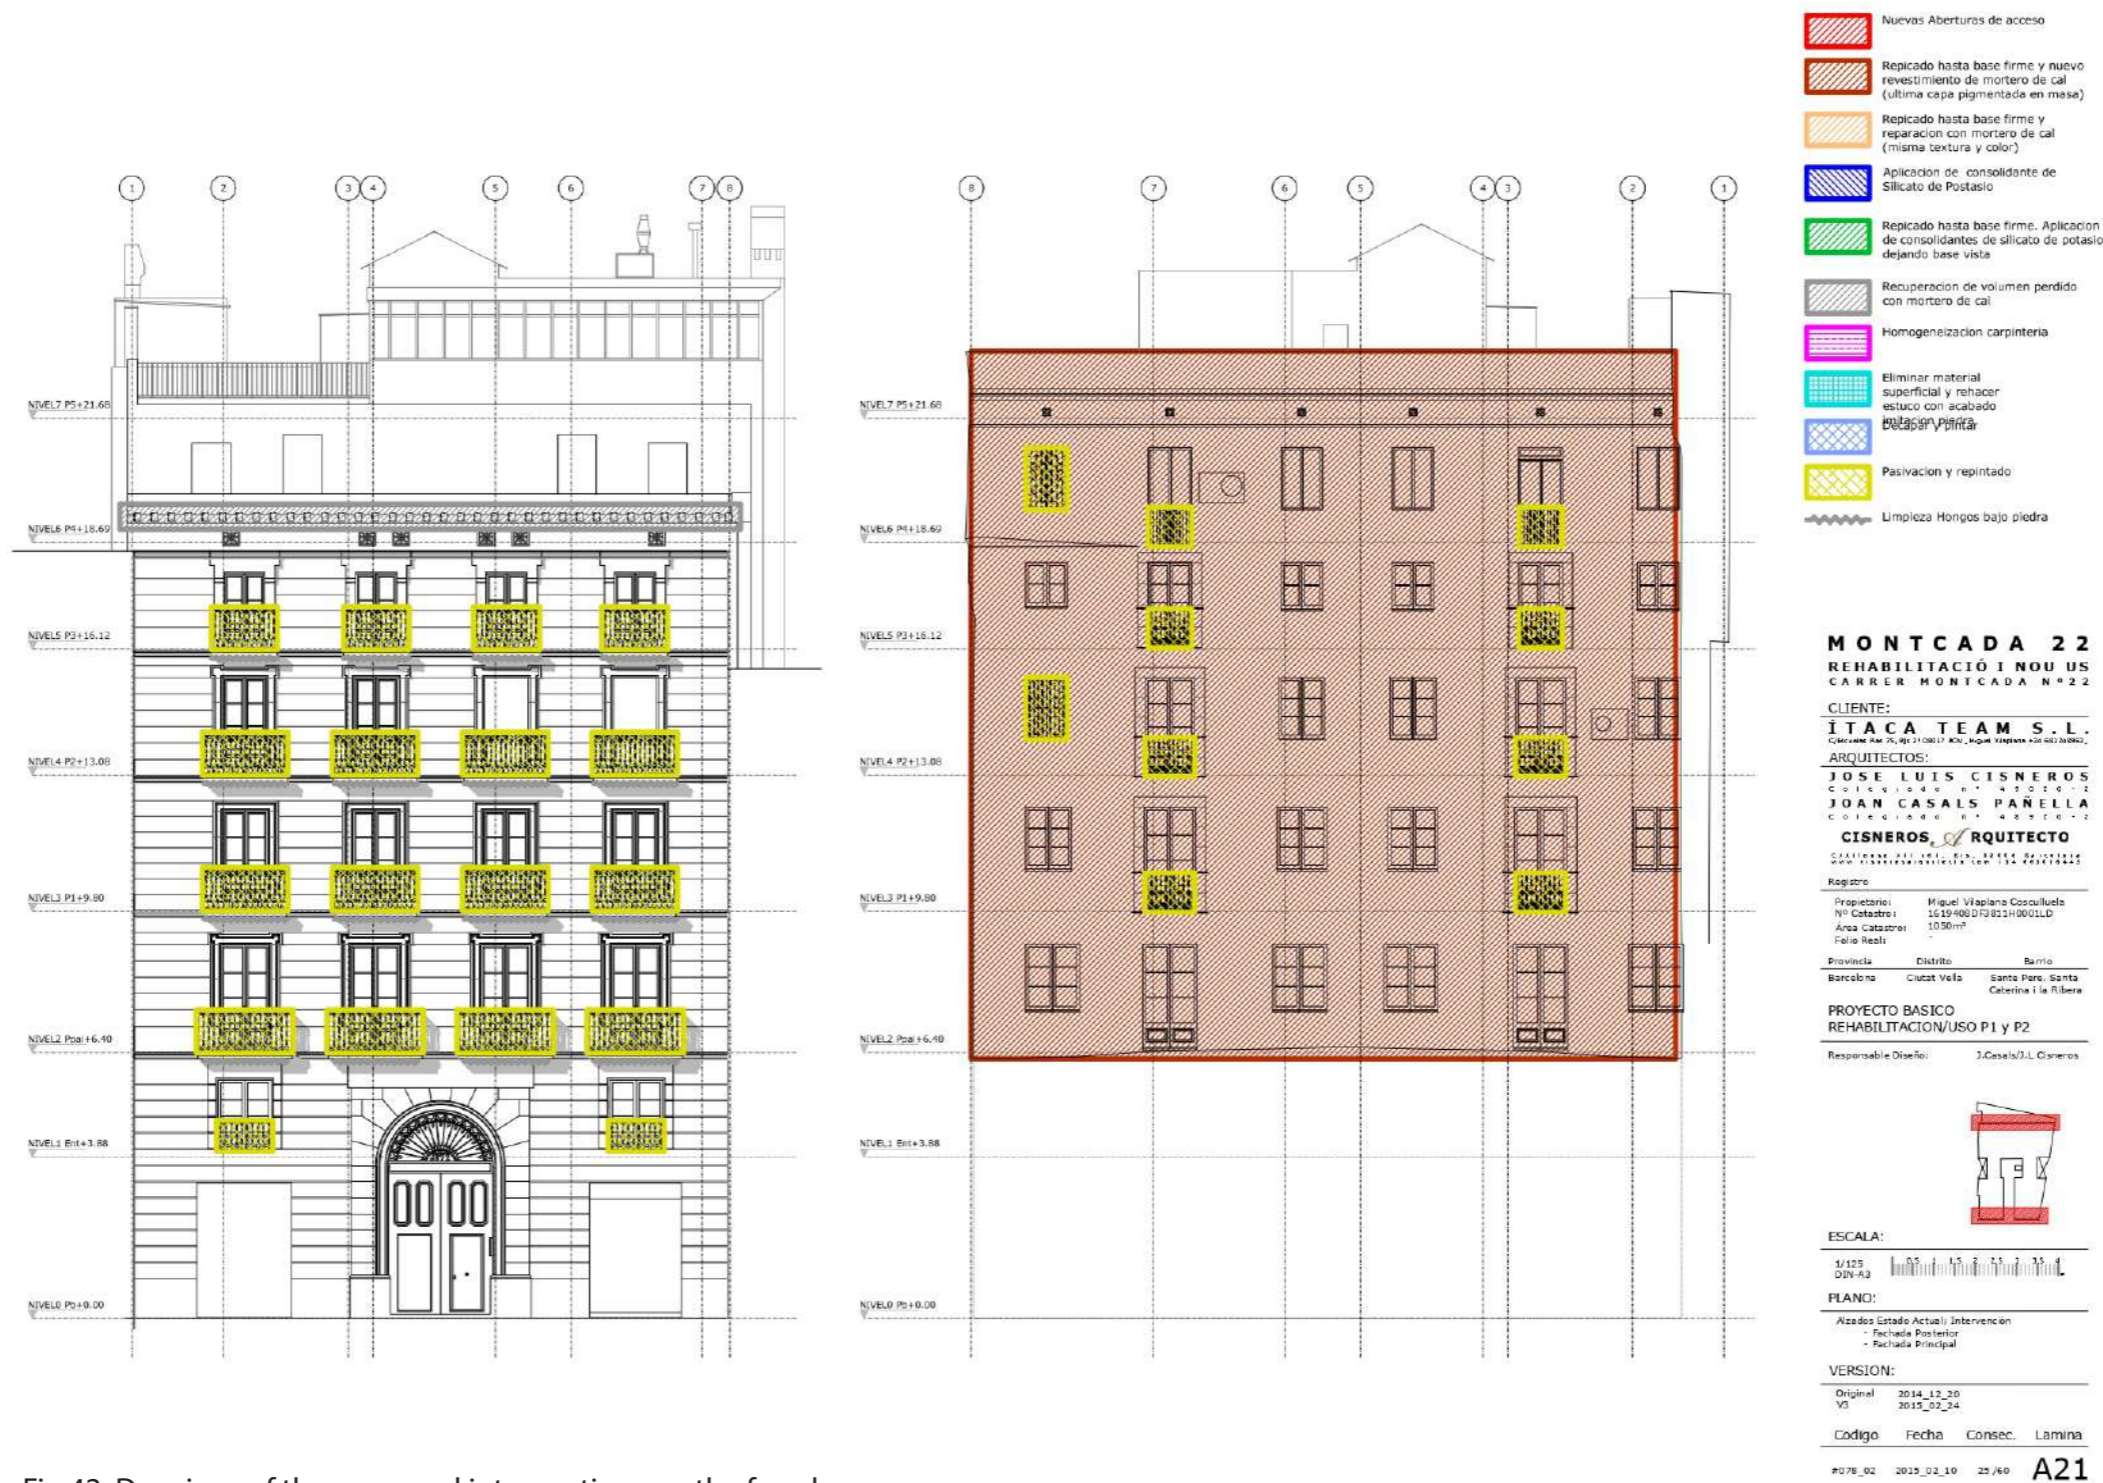
Fig.42: Drawings of the proposed interventions on the façades.

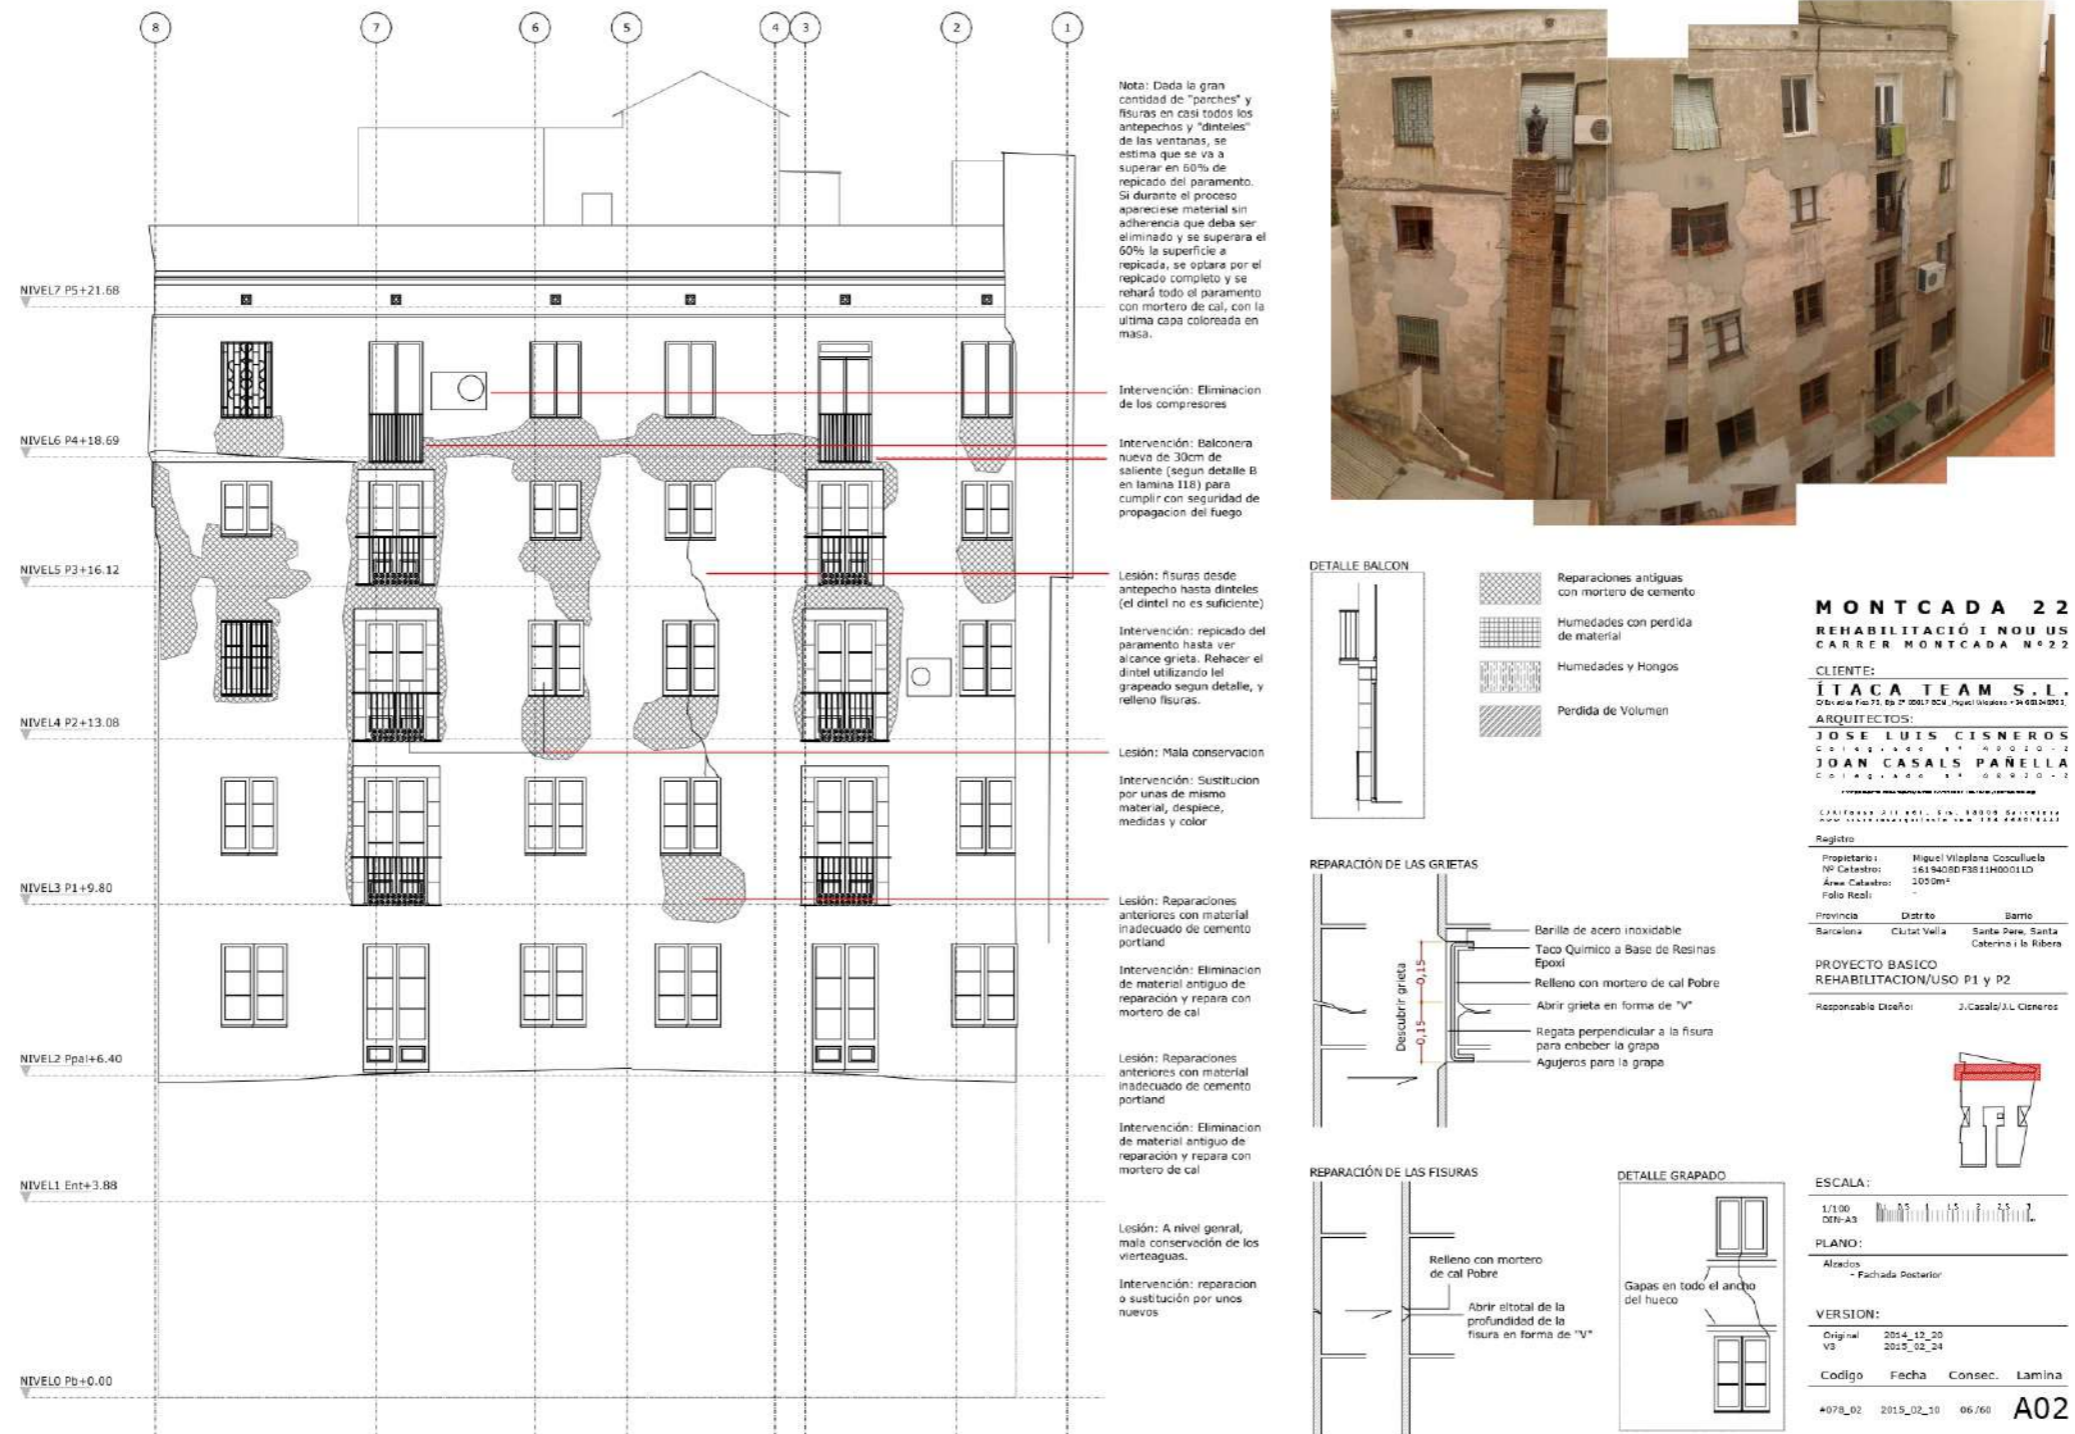
Fig.43: Drawing of the repairs to be made on the rear façade.

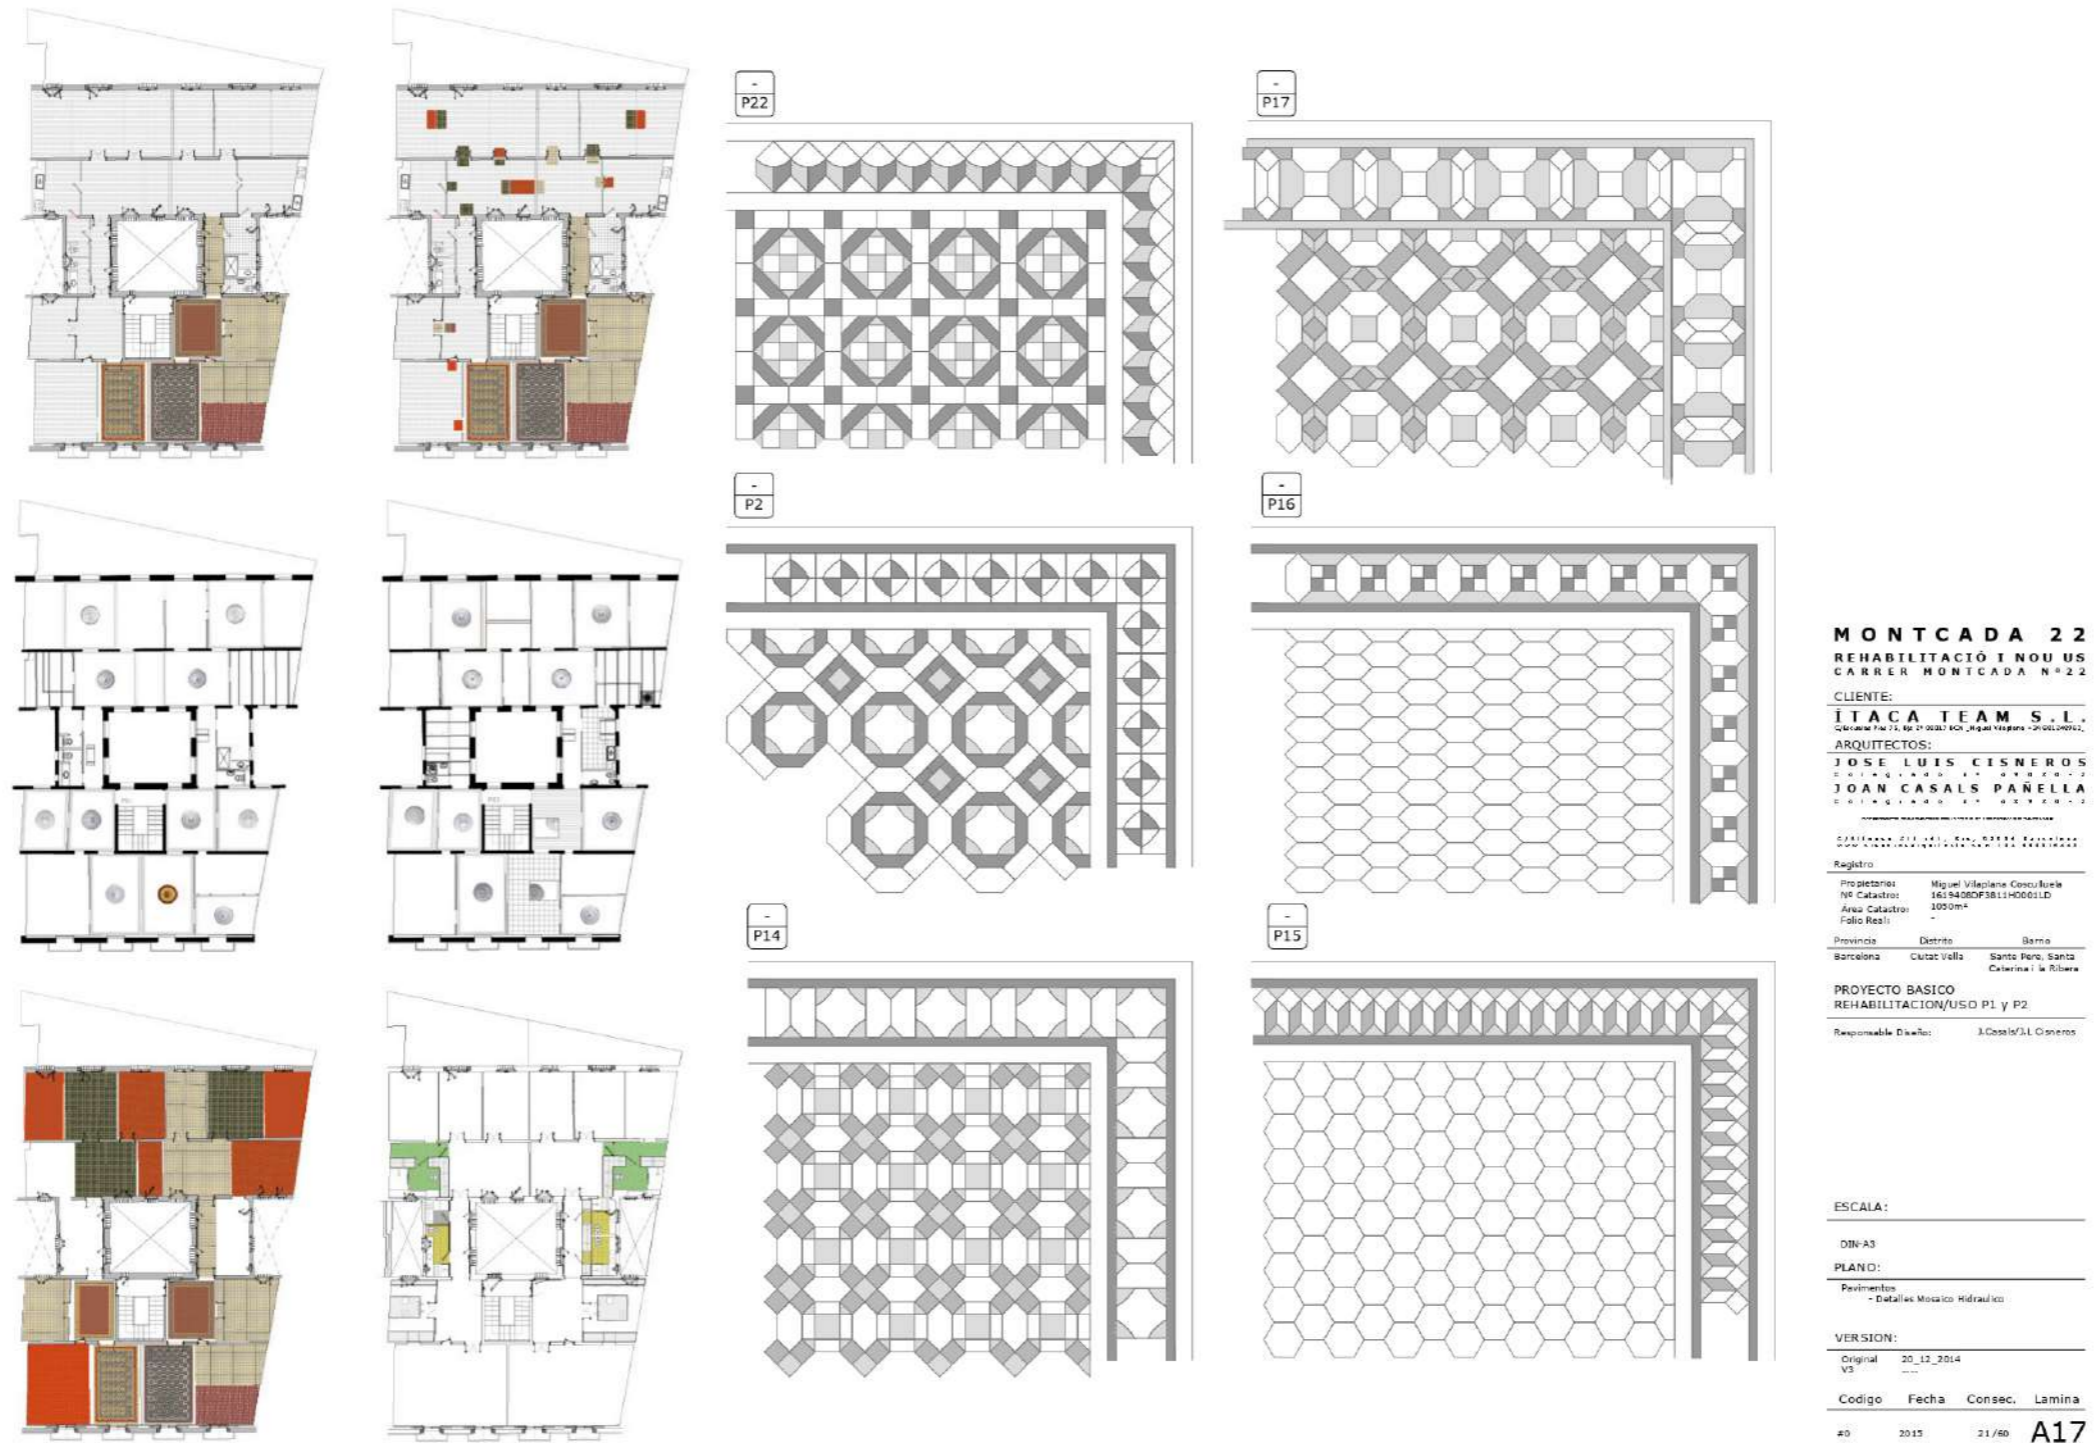
Fig.45: Drawing of the original ceramic tiles pavements to be restored and their respective location inside the building.
