Rehabilitation of a colonial building.

Institutional use for a British period building.

Site Omirou Street 38, Nicosia, Cyprus

Date Project Development 2019,
Works 2019

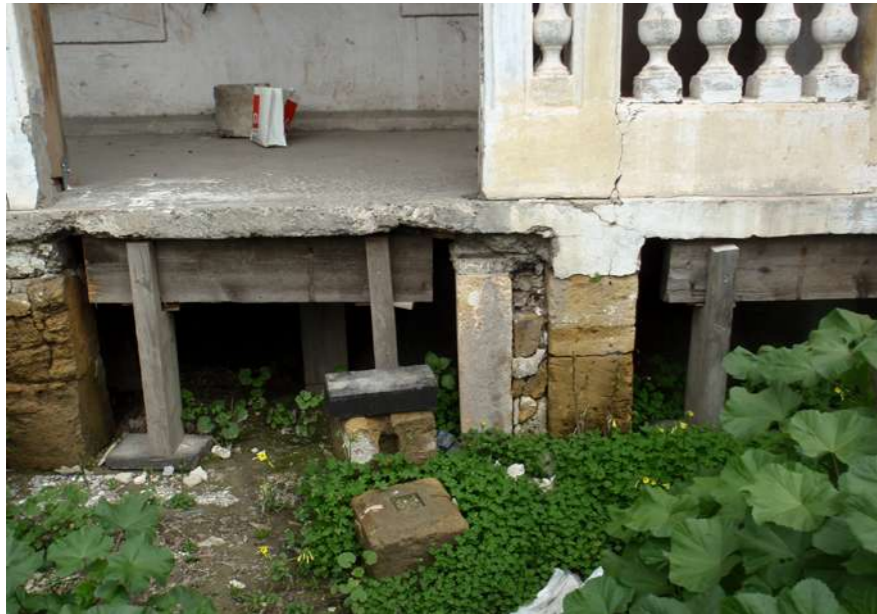
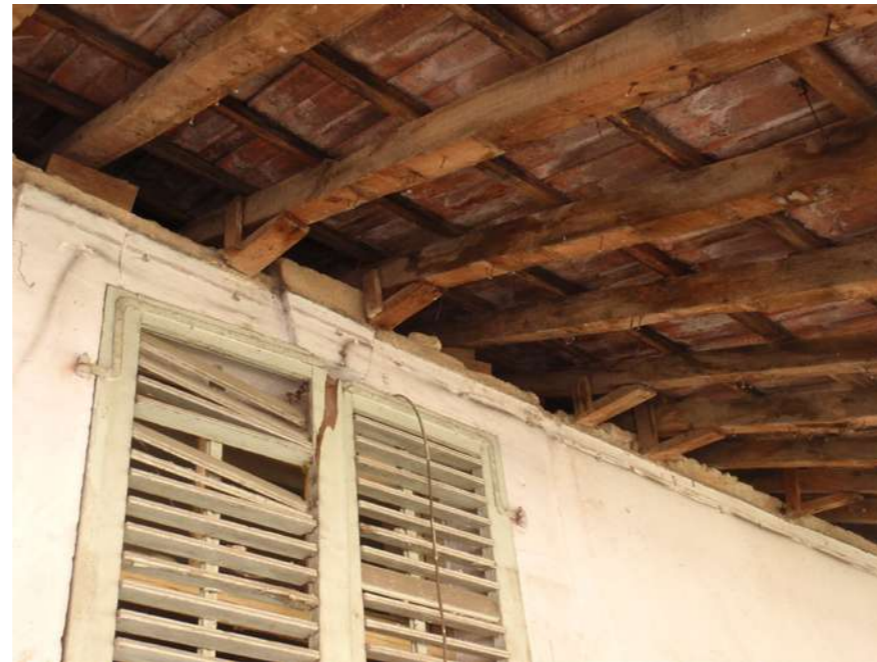
The building was in a very bad condition. Part of the surrounding balcony has collapsed. The roof of the building had major problems. The wooden floor of the ground floor was damaged. Some of the masonry walls of the semi-basement floor were rotted as a result of trapped moisture. The doors and the windows were damaged, as well. As for the auxiliary buildings, part of the roof and the walls have collapsed.

Fig.8-9: Surrounding balcony. © C. Marathovouniotis

- The existing surrounding balcony was entirely removed and it was replaced with a new one that was constructed with the exact design and typology with the initial.

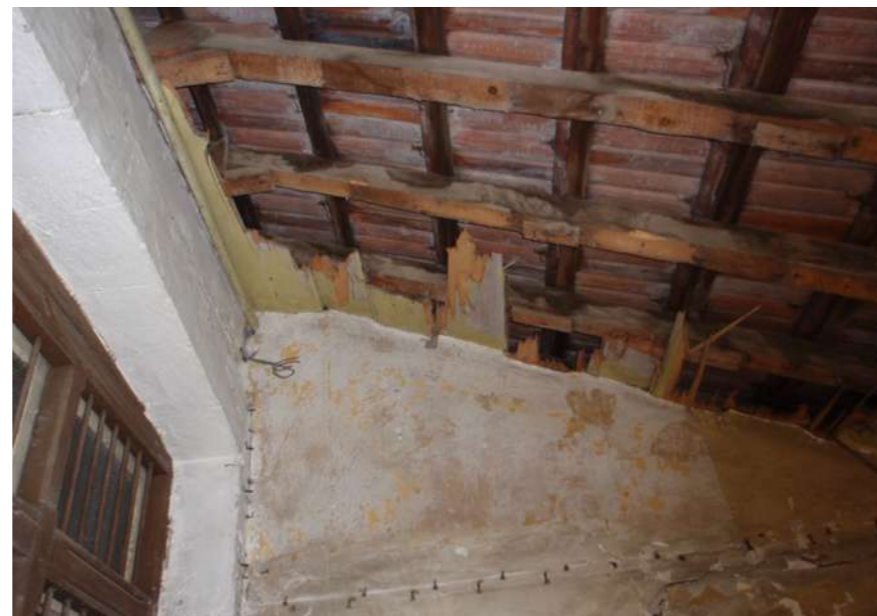
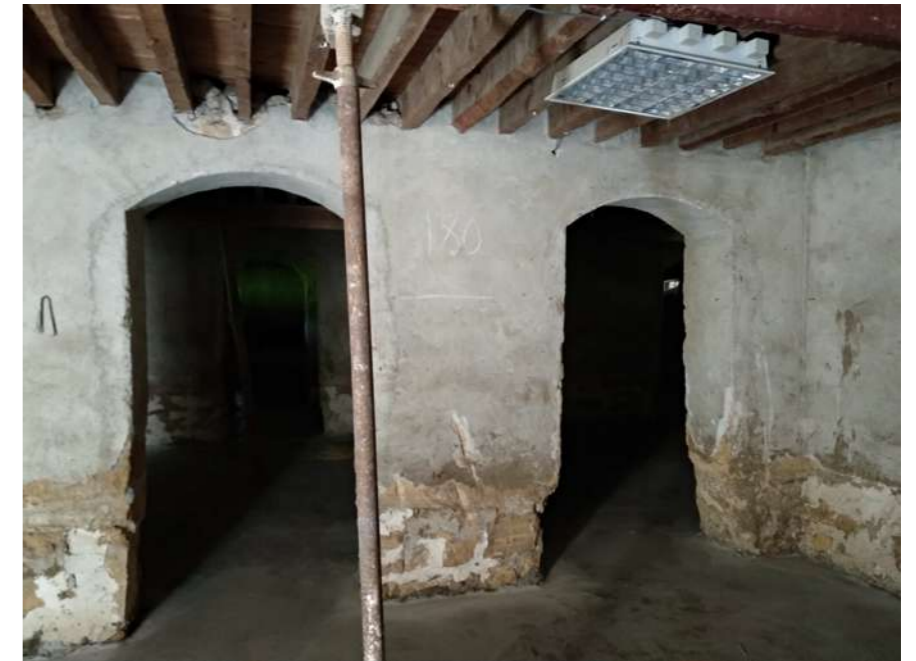
Fig.12-13: Semi-basement floor. © C. Marathovouniotis

- Insulation and Drainage channels were installed around the foundation.
- In the semi-basement floor, a new concrete floor was constructed.
- The masonry walls, of the semi – basement floor, were reinforced and restored.

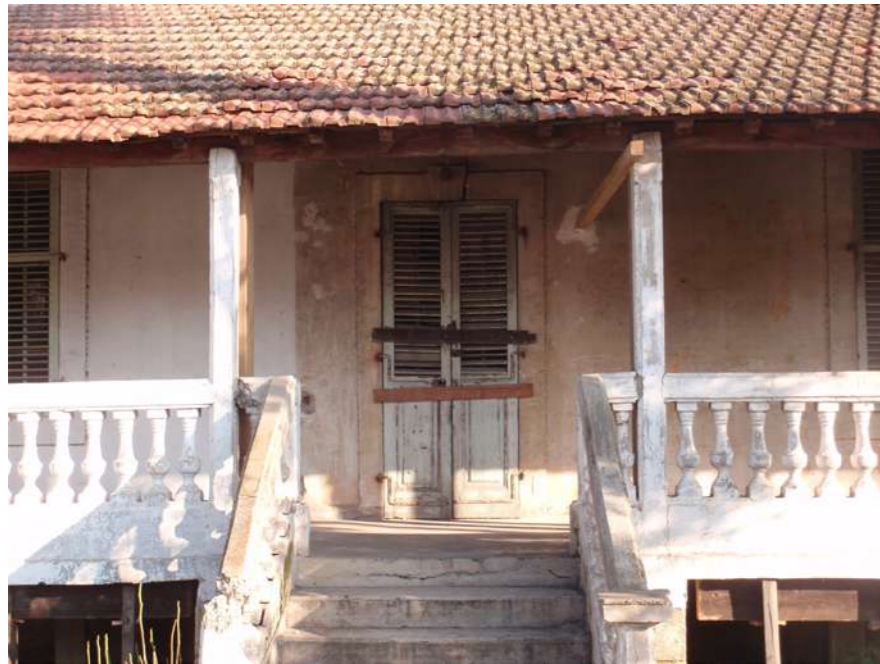
Fig.14-15: Windows and doors. © C. Marathovouniotis

- All the wall plasters (both inside and outside walls) were removed and they were replaced with lime plaster that is vapour-permeable.
- All of the existing doors and the windows were maintained and restored. The windows and doors glass panes were replaced with thermal insulated glass panes.

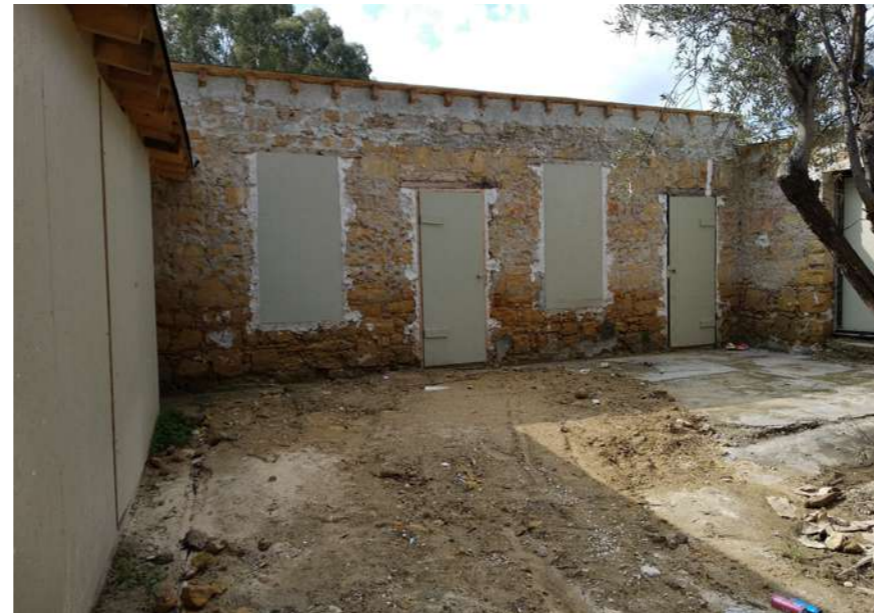
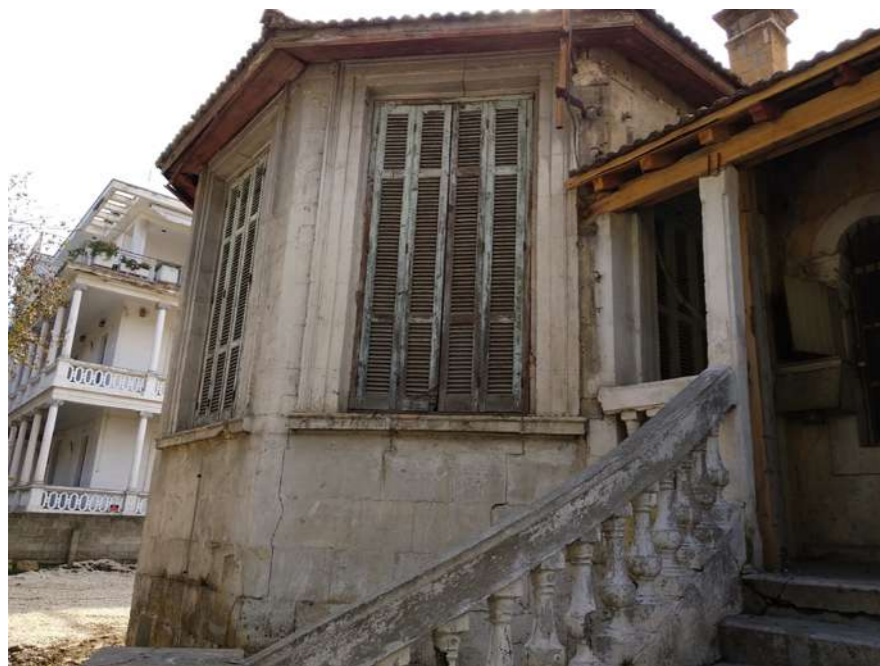
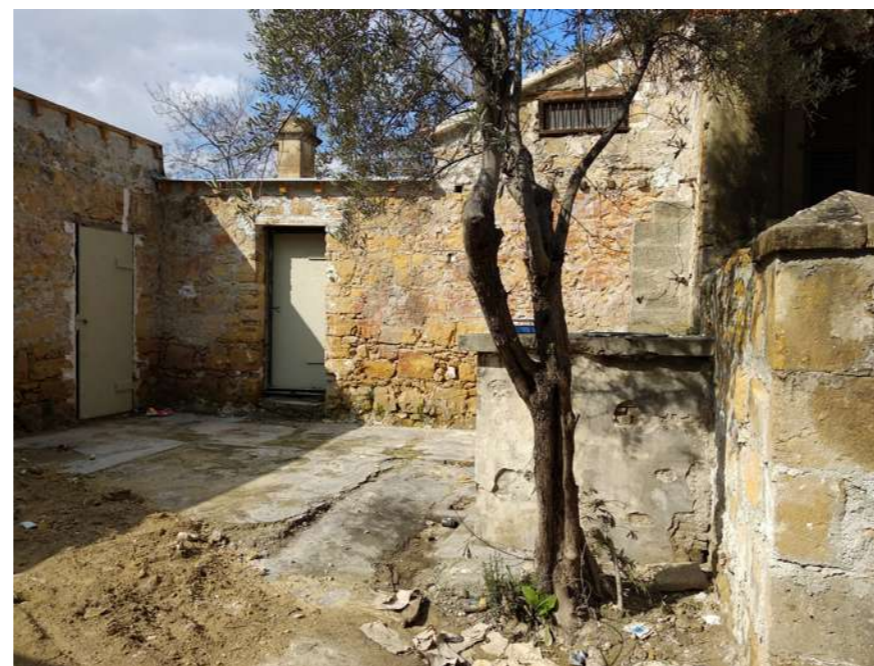
Fig.16-17: Auxiliary buildings. © C. Marathovouniotis

- Constructions, made of wood and metal, were done to ensure that people with disabilities have access to both inside and outside spaces.
- Low energy consumption air conditioning systems were installed.
- Low energy lighting systems were installed.
- Part of the auxiliary buildings was demolished and the rest of the remaining buildings were entirely restored and renovated.
- A metal-shade structure was constructed, in the front area of the auxiliary buildings, covered with polycarbonate sheets.
- On the east side, in the courtyard, a square was designed for gathering and events to run.
- In the garden of the courtyard, Cypriot trees and bushy plants were planted.

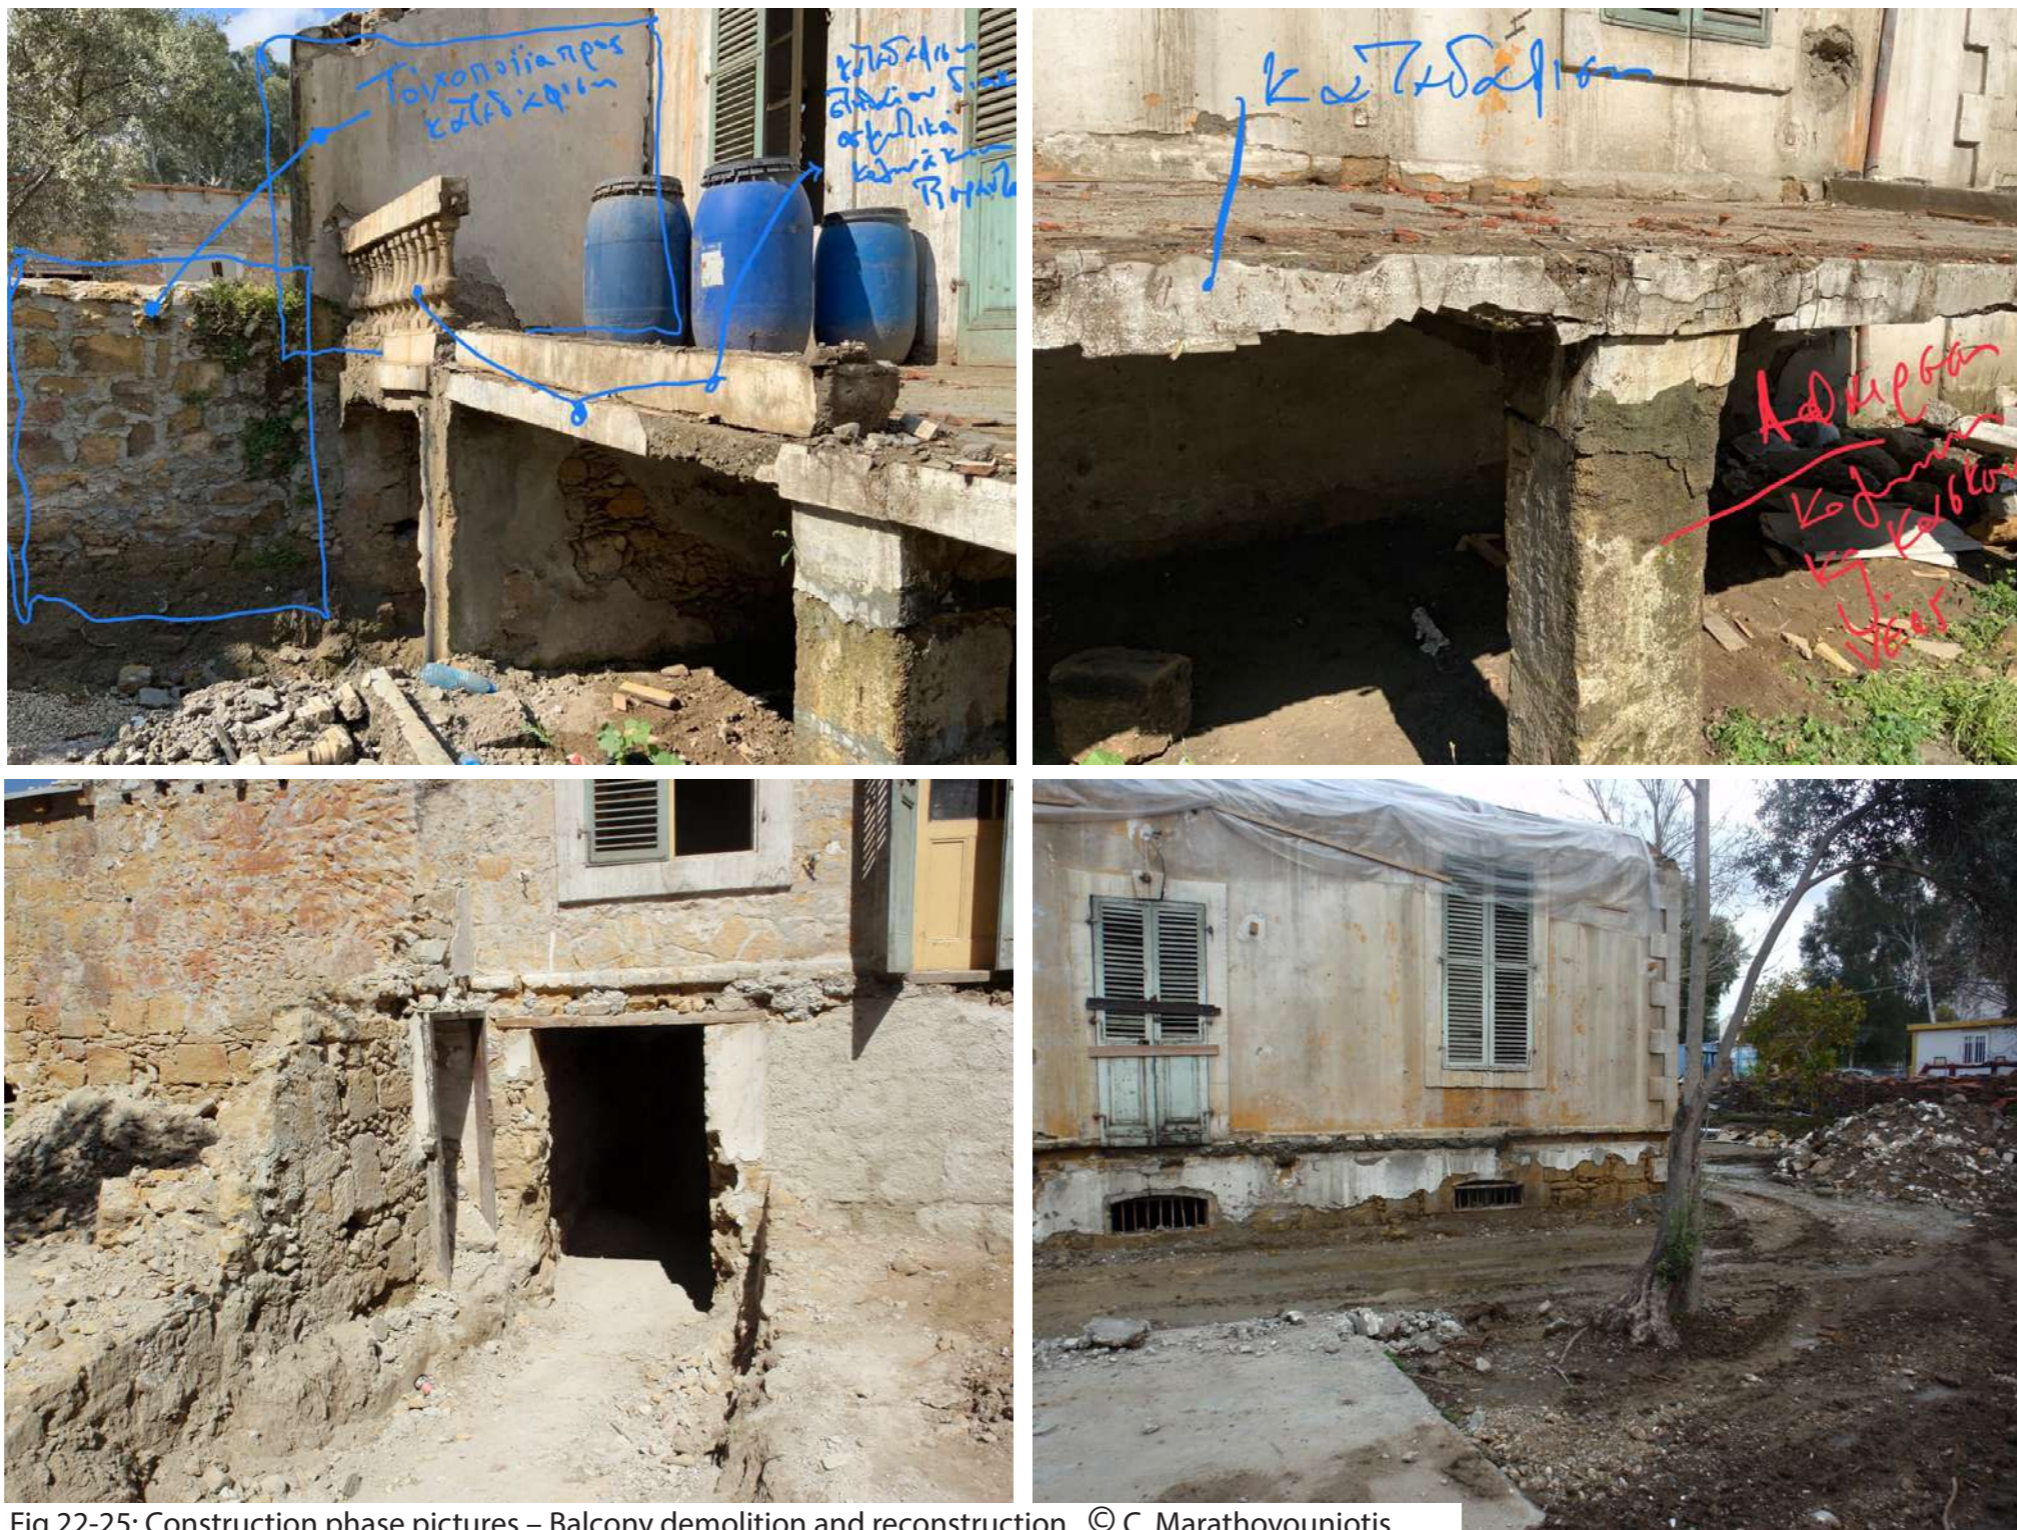
Fig.22-25: Construction phase pictures – Balcony demolition and reconstruction. © C. Marathovouniotis

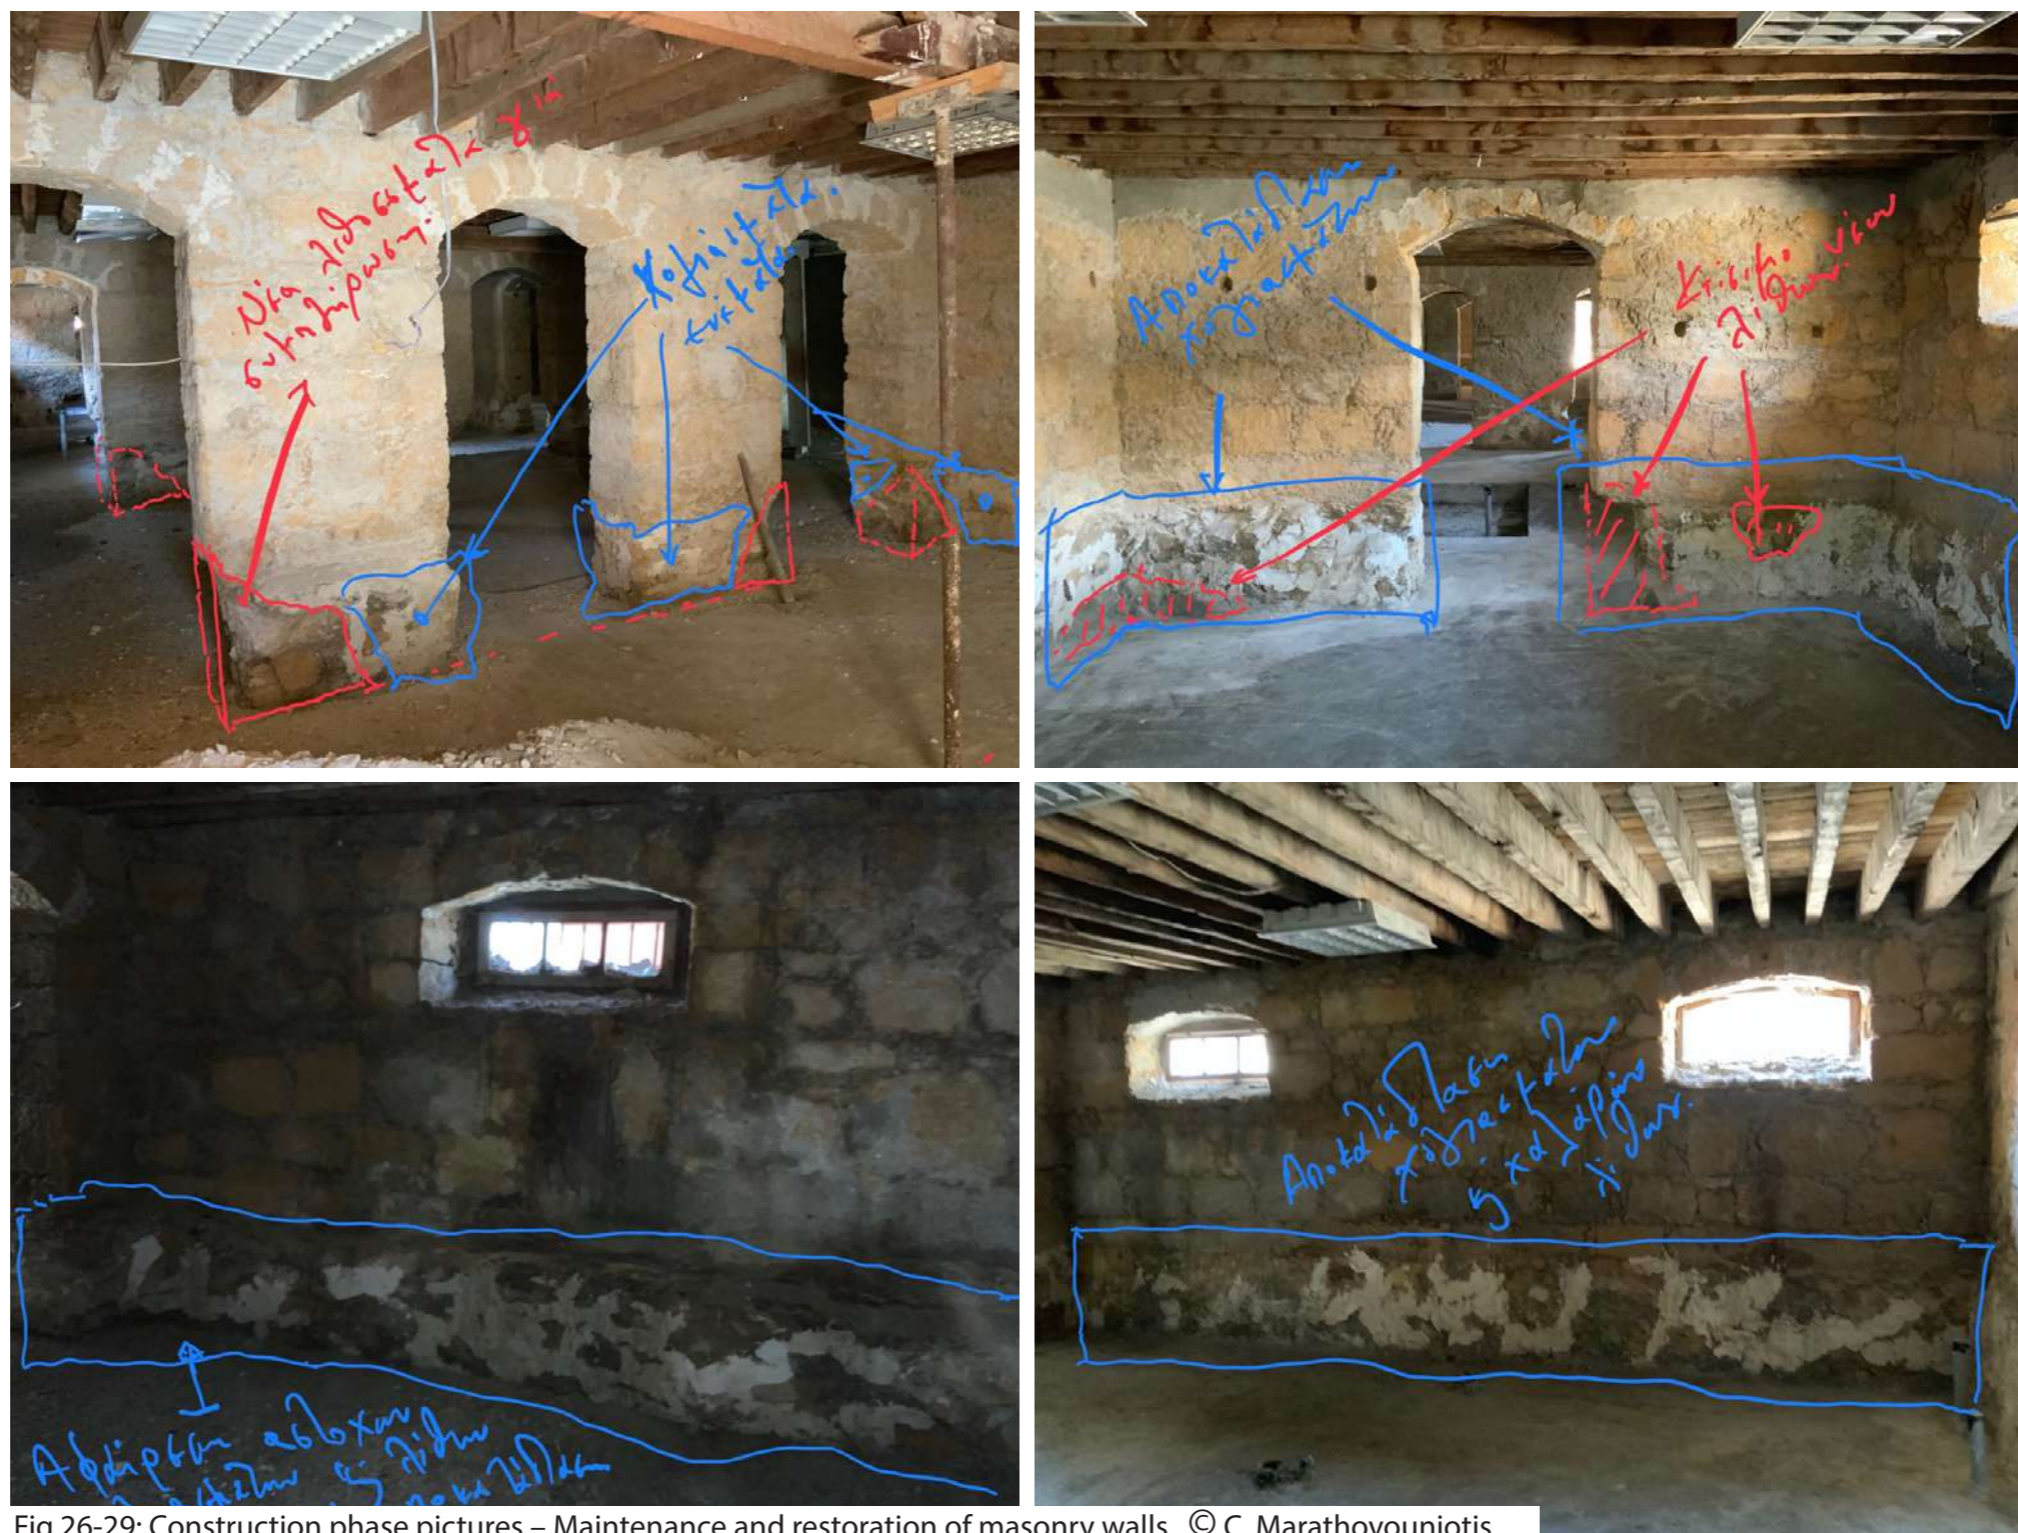
Fig.26-29: Construction phase pictures – Maintenance and restoration of masonry walls. © C. Marathovouniotis

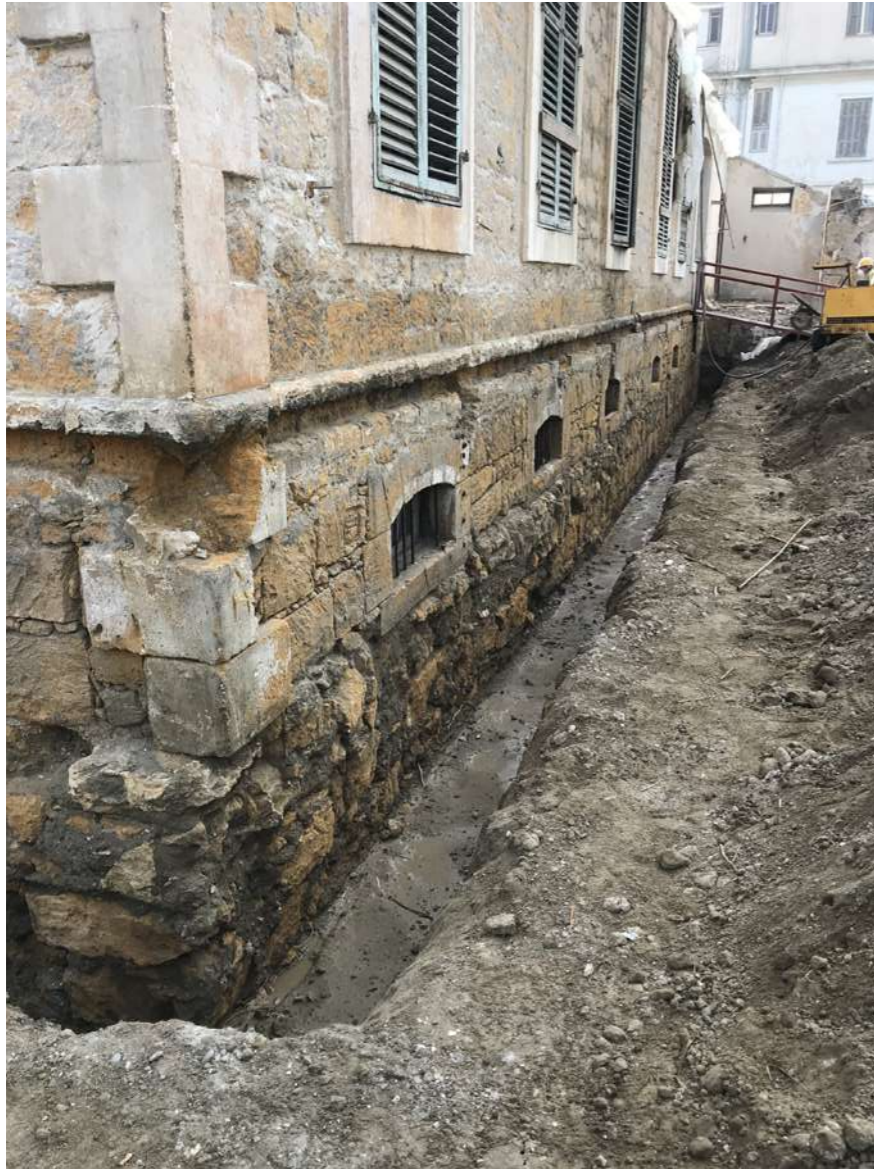
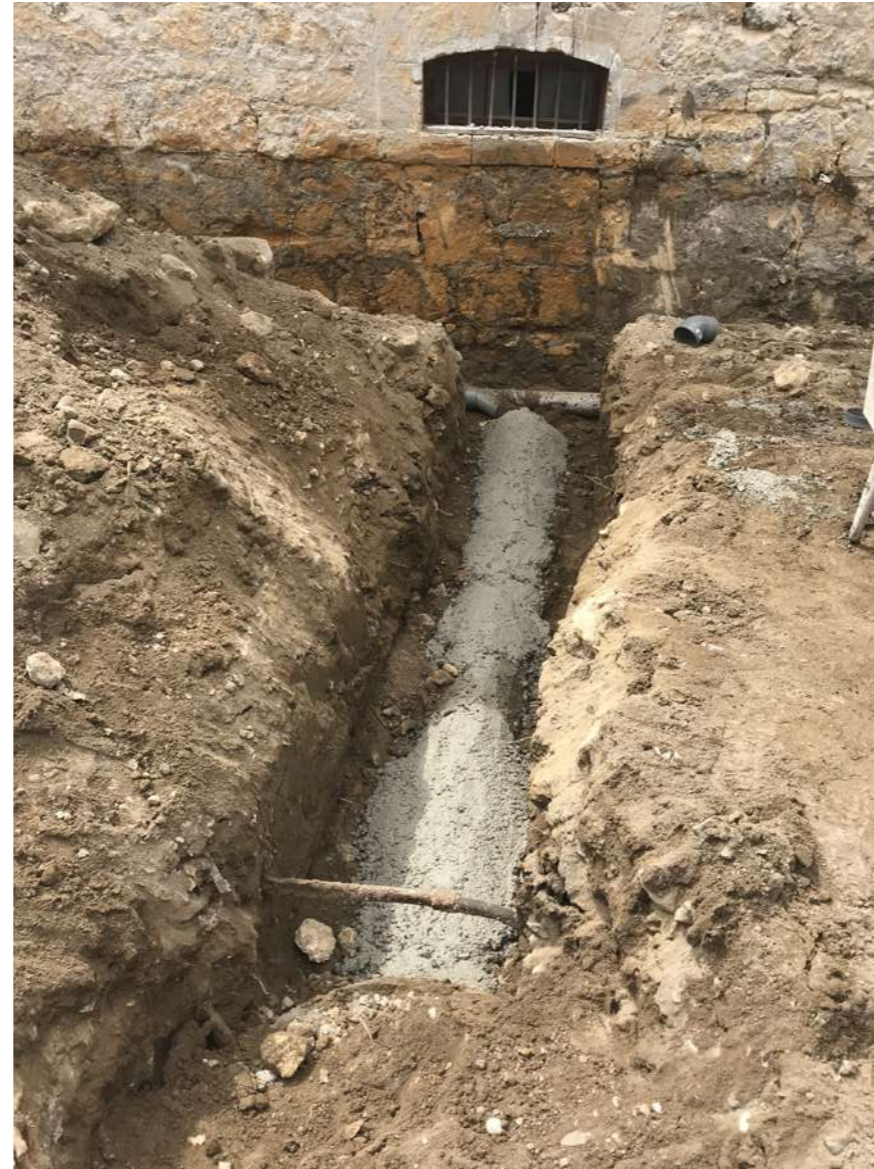
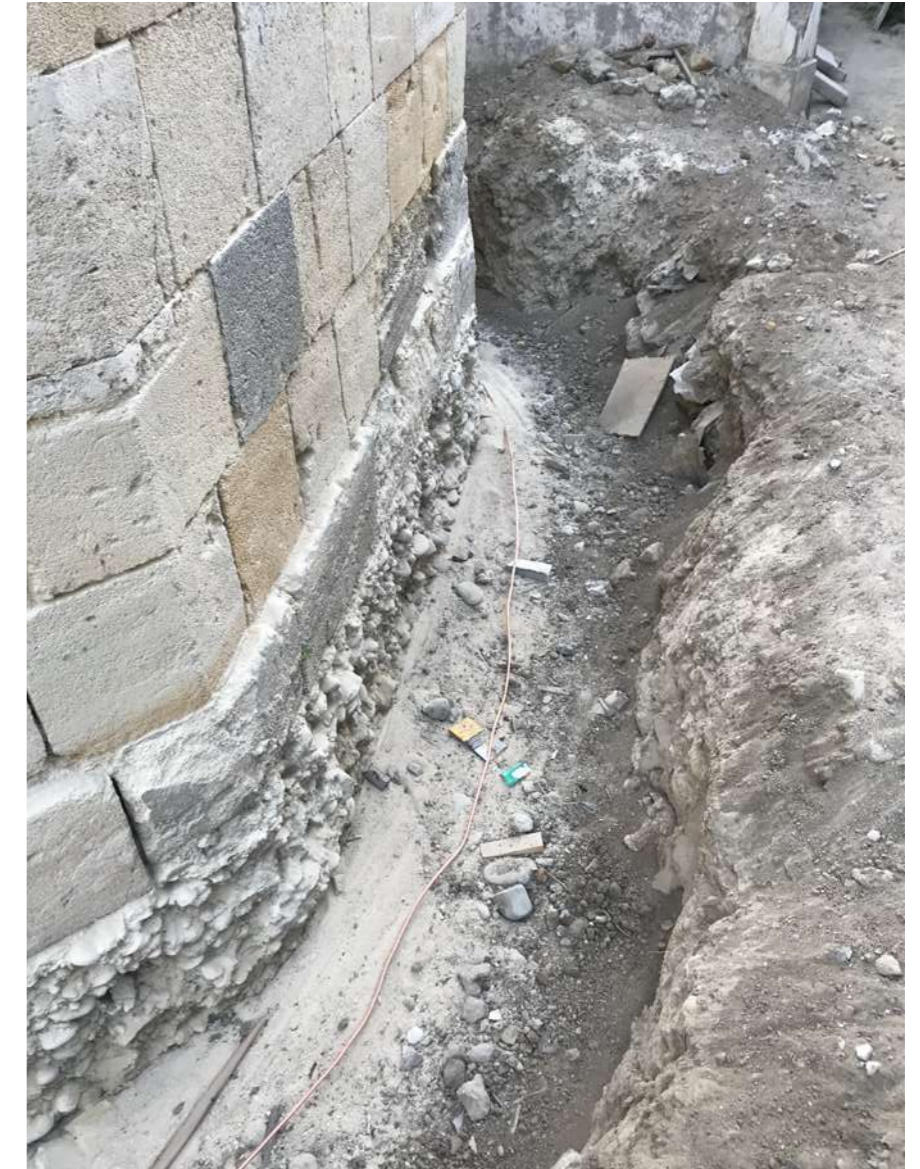
Fig.30-32: Construction phase pictures and details – Drainage system and insulation installation. © C. Marathovouniotis

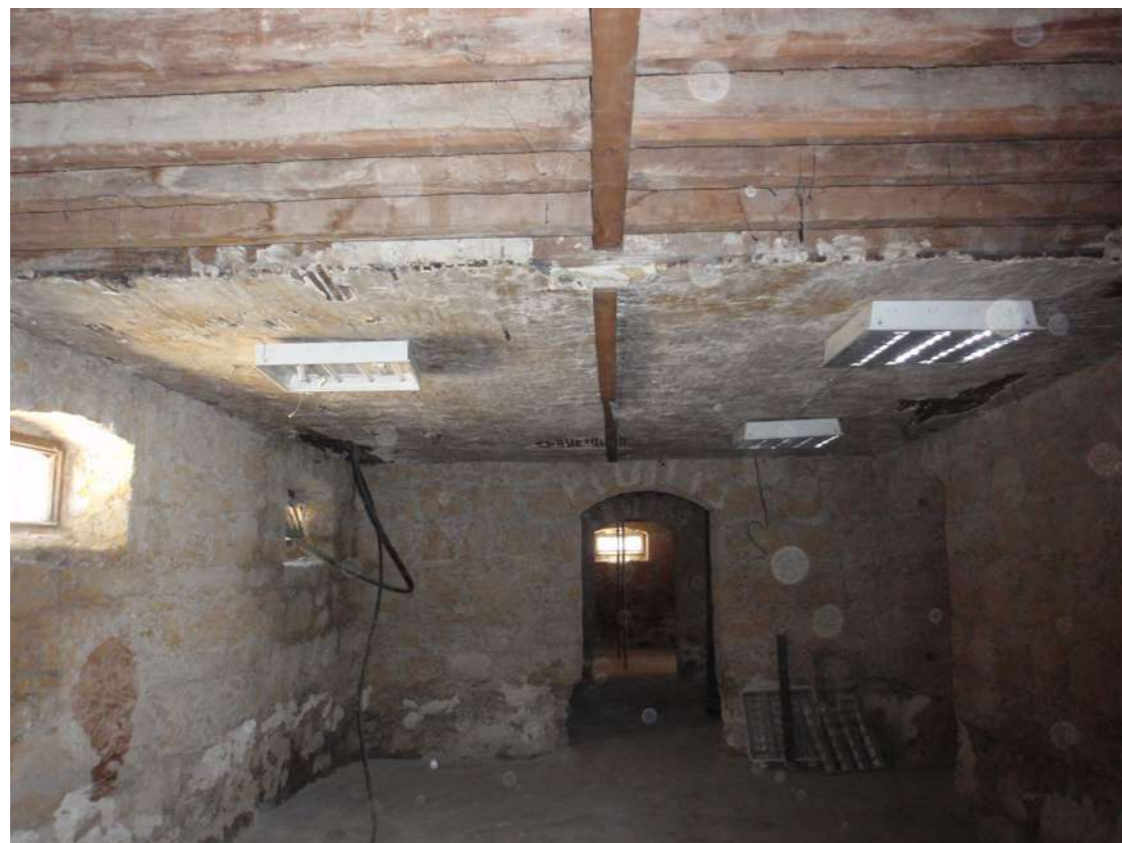
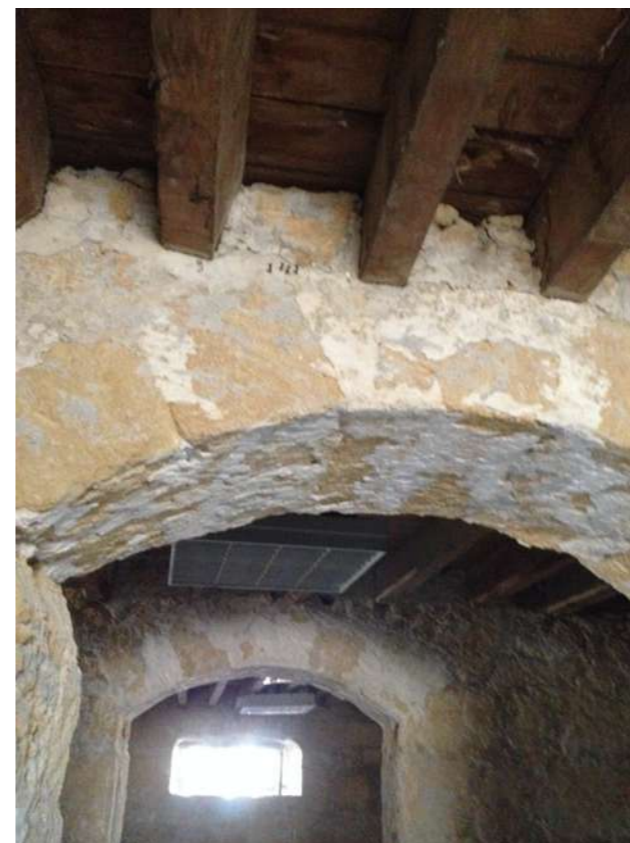
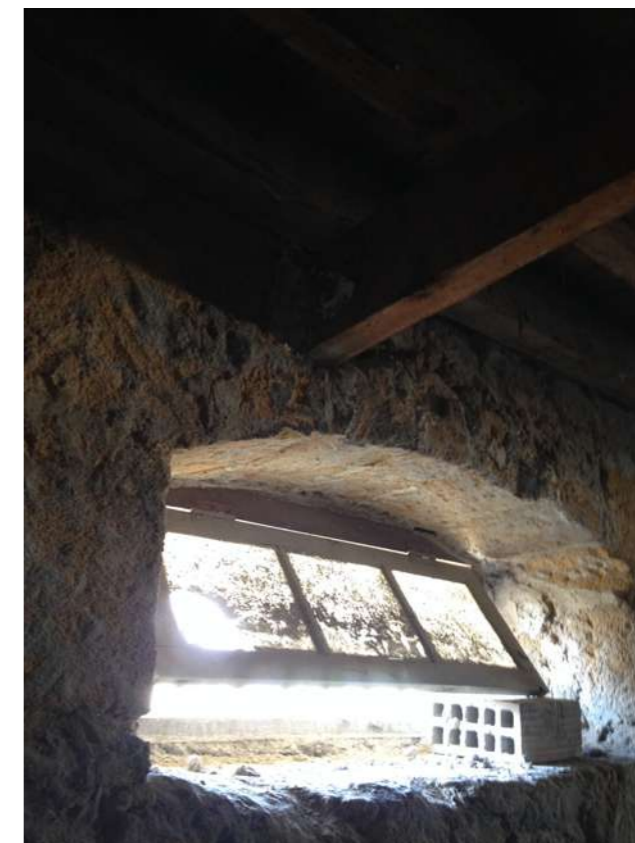
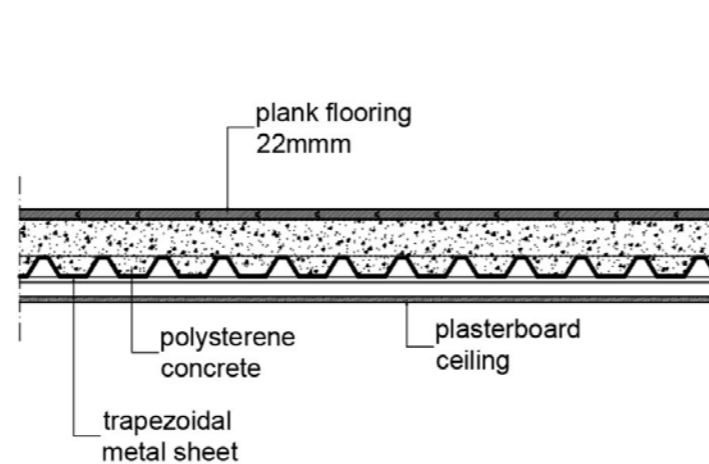
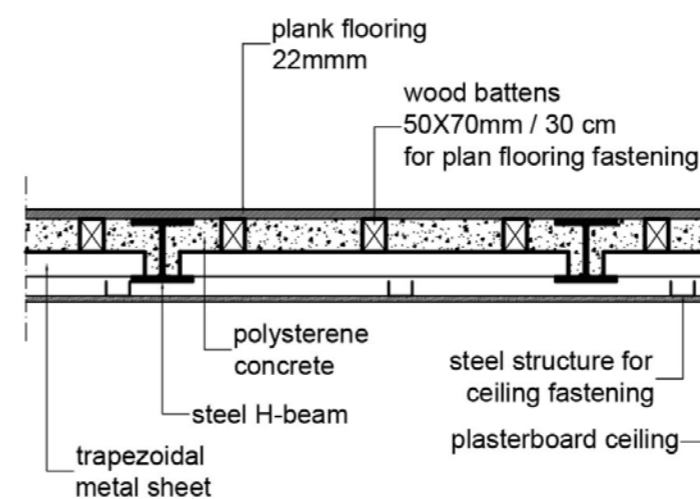
Fig.34-37: Construction phase pictures and details – Semi -basement ceiling / ground floor floor construction. © C. Marathovouniotis

- A new ceiling / floor in the semi – basement / ground floor was constructed. Part of it was made of wooden beams and wooden floor while some other parts were made of steel beam and concrete floor.

- Soundproof insulation was installed between the ceiling and the floor.
- The roof was reconstructed with new wooden elements.
- Thermal proof insulation was installed under the new roof.
