Rehabilitation of a colonial building.

Institutional use for a British period building.

Site Omirou Street 38, Nicosia, Cyprus

Date Project Development 2019,
Works 2019

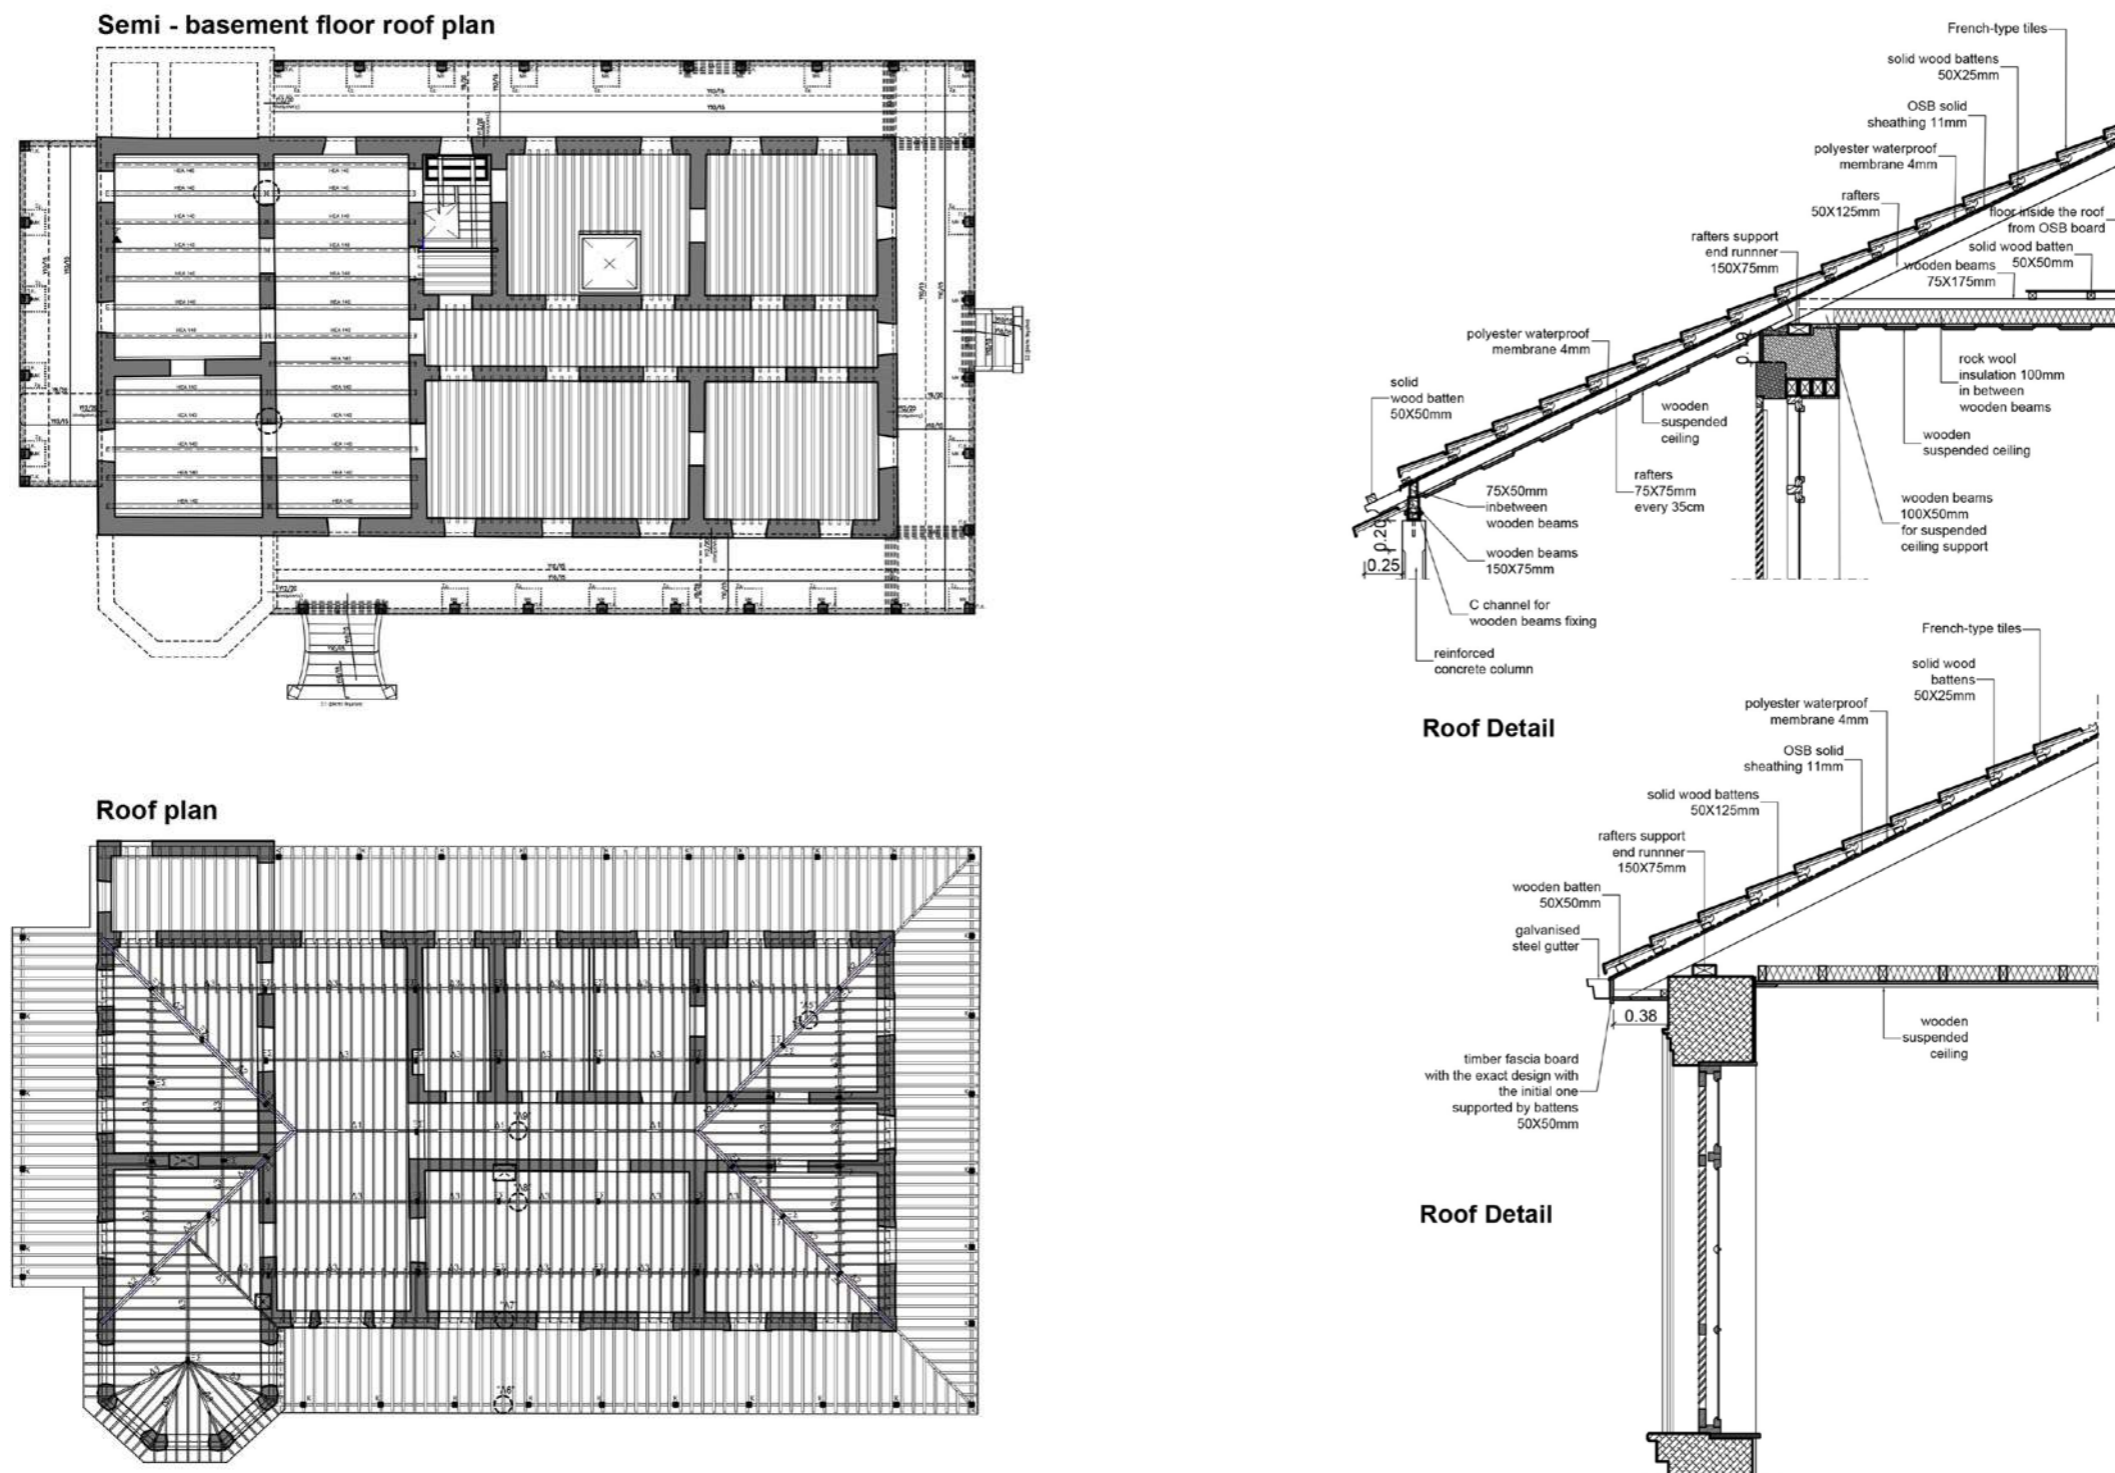
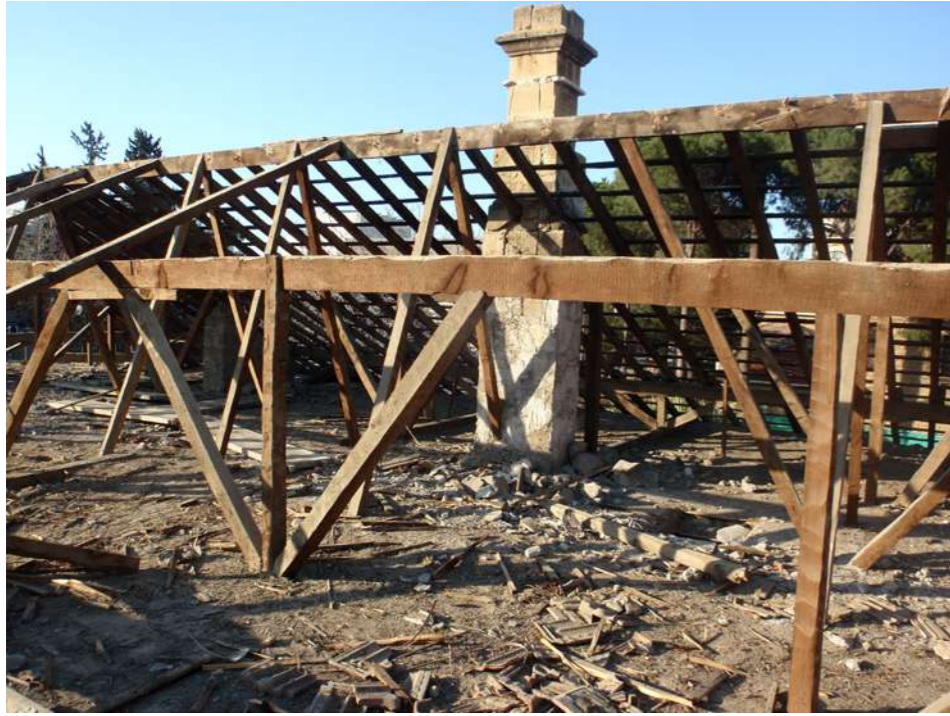
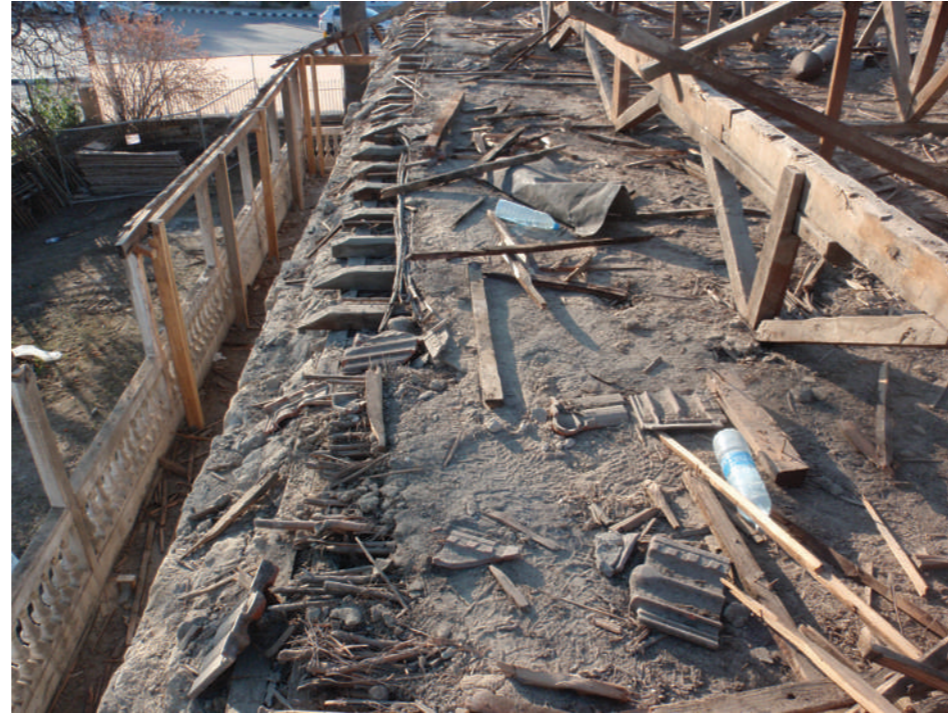
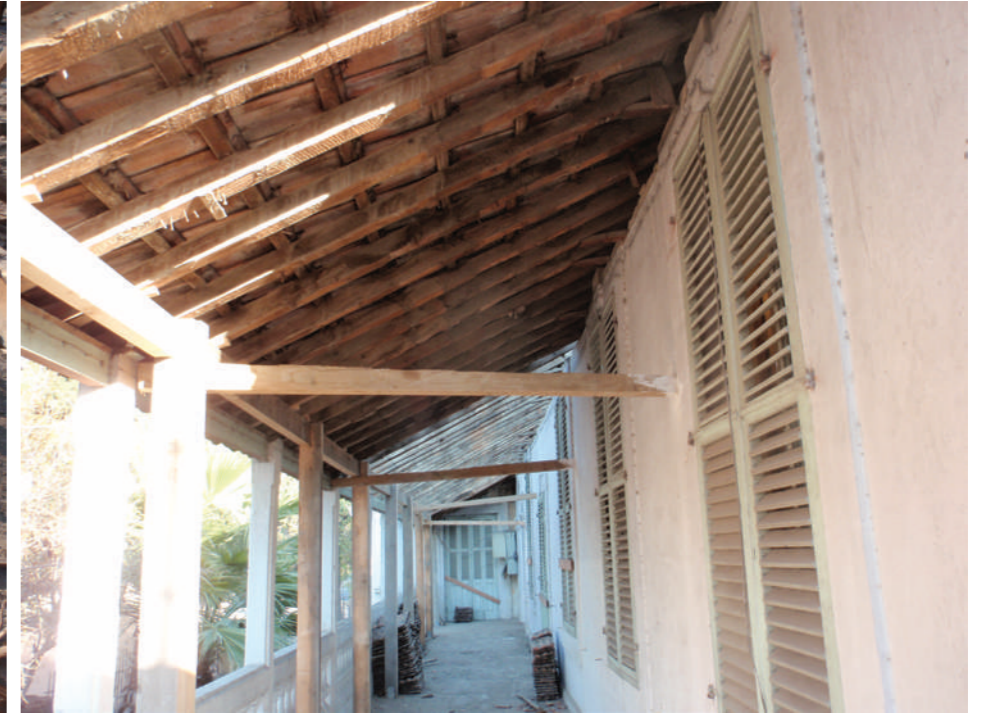
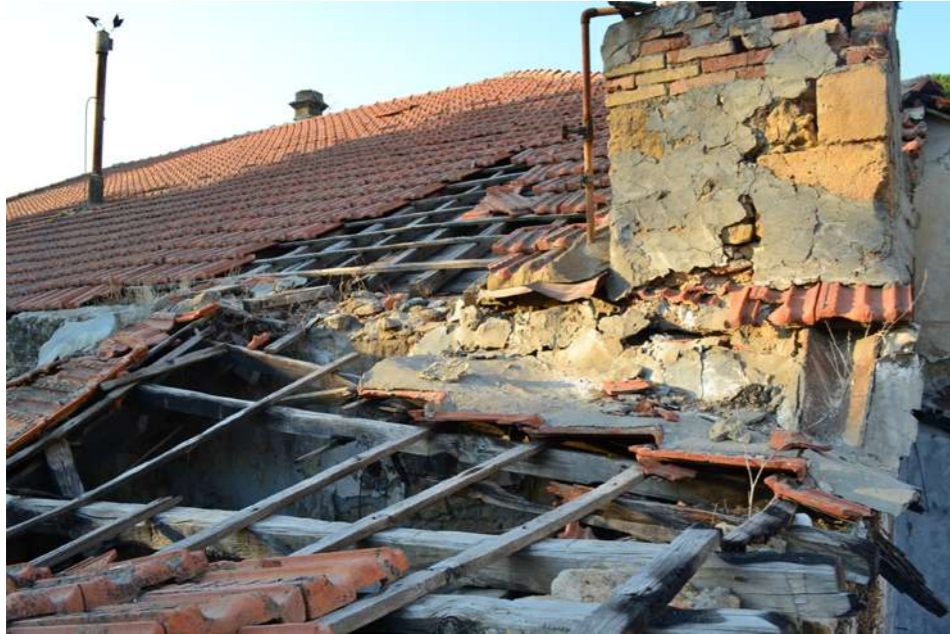
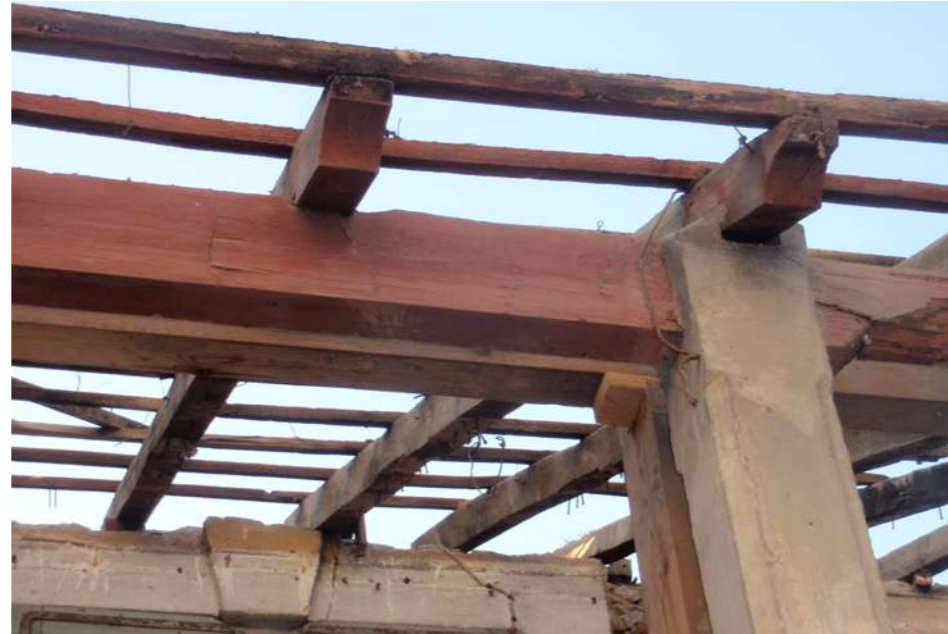
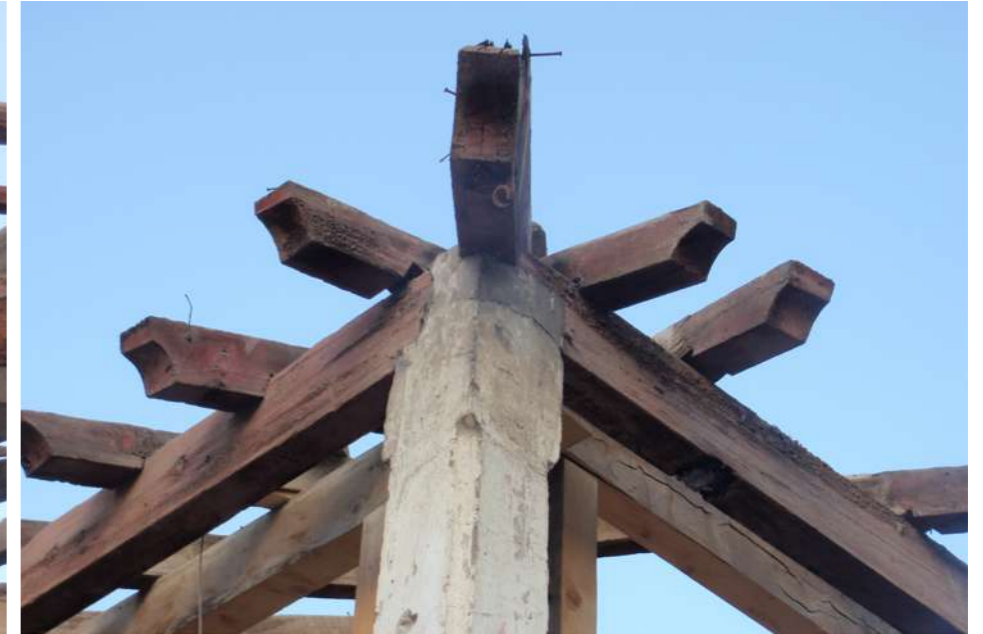
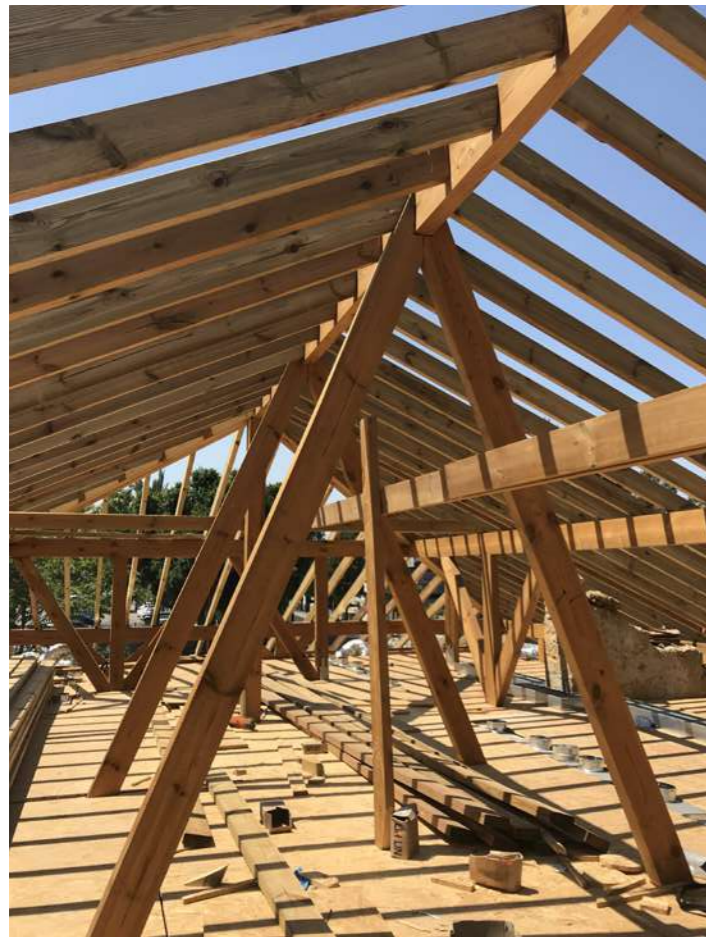
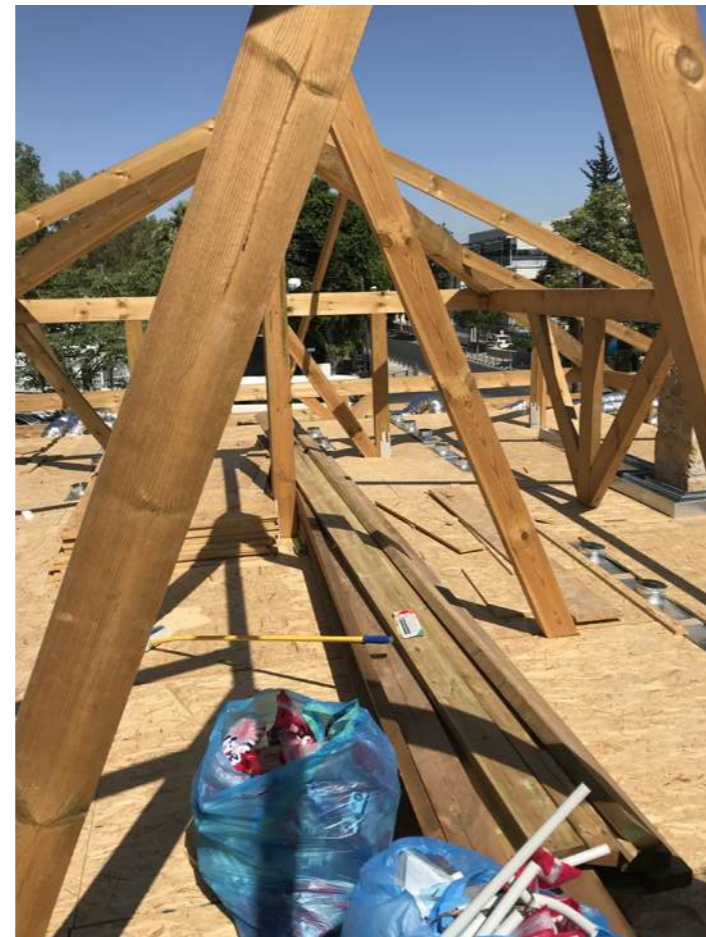
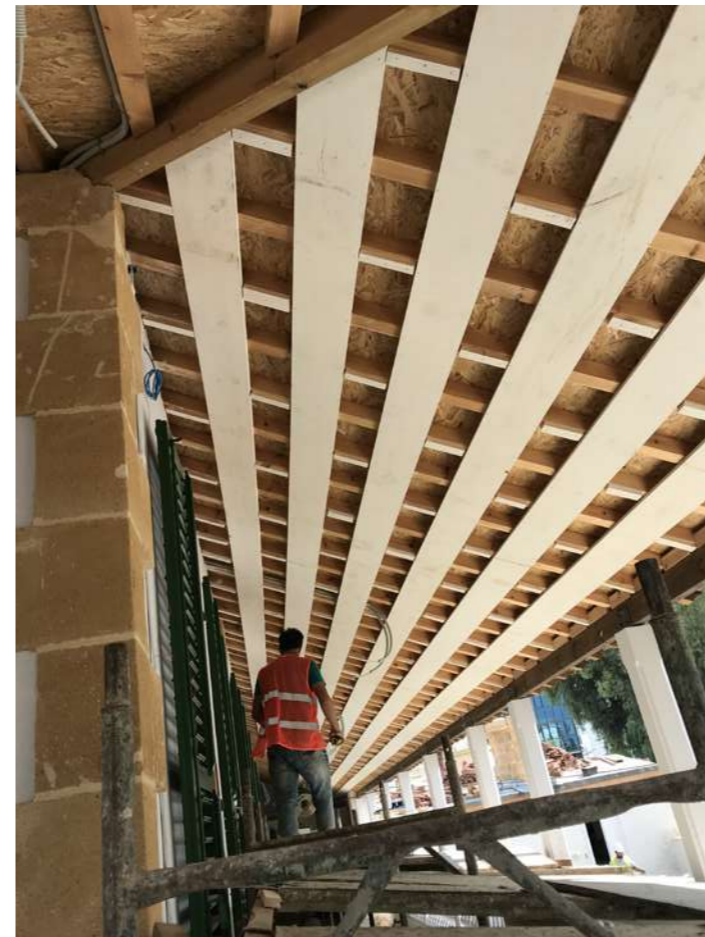
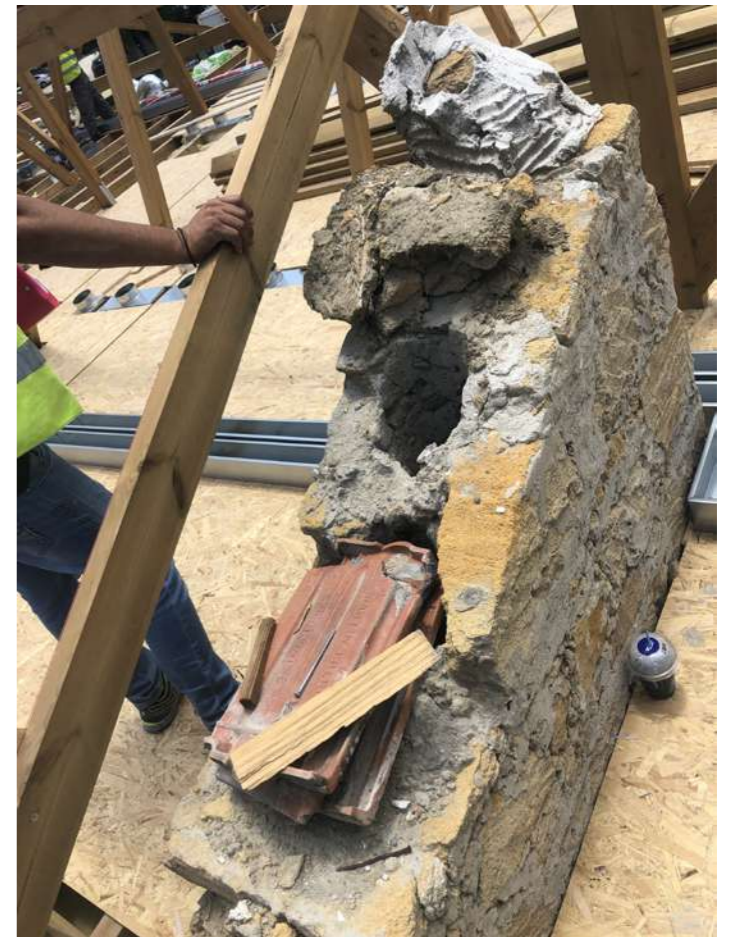
Fig.38-39: Construction phase pictures and details - Roof. © C. Marathovouniotis

Fig.40-45: Construction phase pictures - Roof. © C. Marathovouniotis

Fig.46-49: Construction phase pictures - Roof. © C. Marathovouniotis

- Soundproof insulation was installed between the ceiling and the floor.
- The roof was reconstructed with new wooden elements.
- Thermal proof insulation was installed under the new roof.

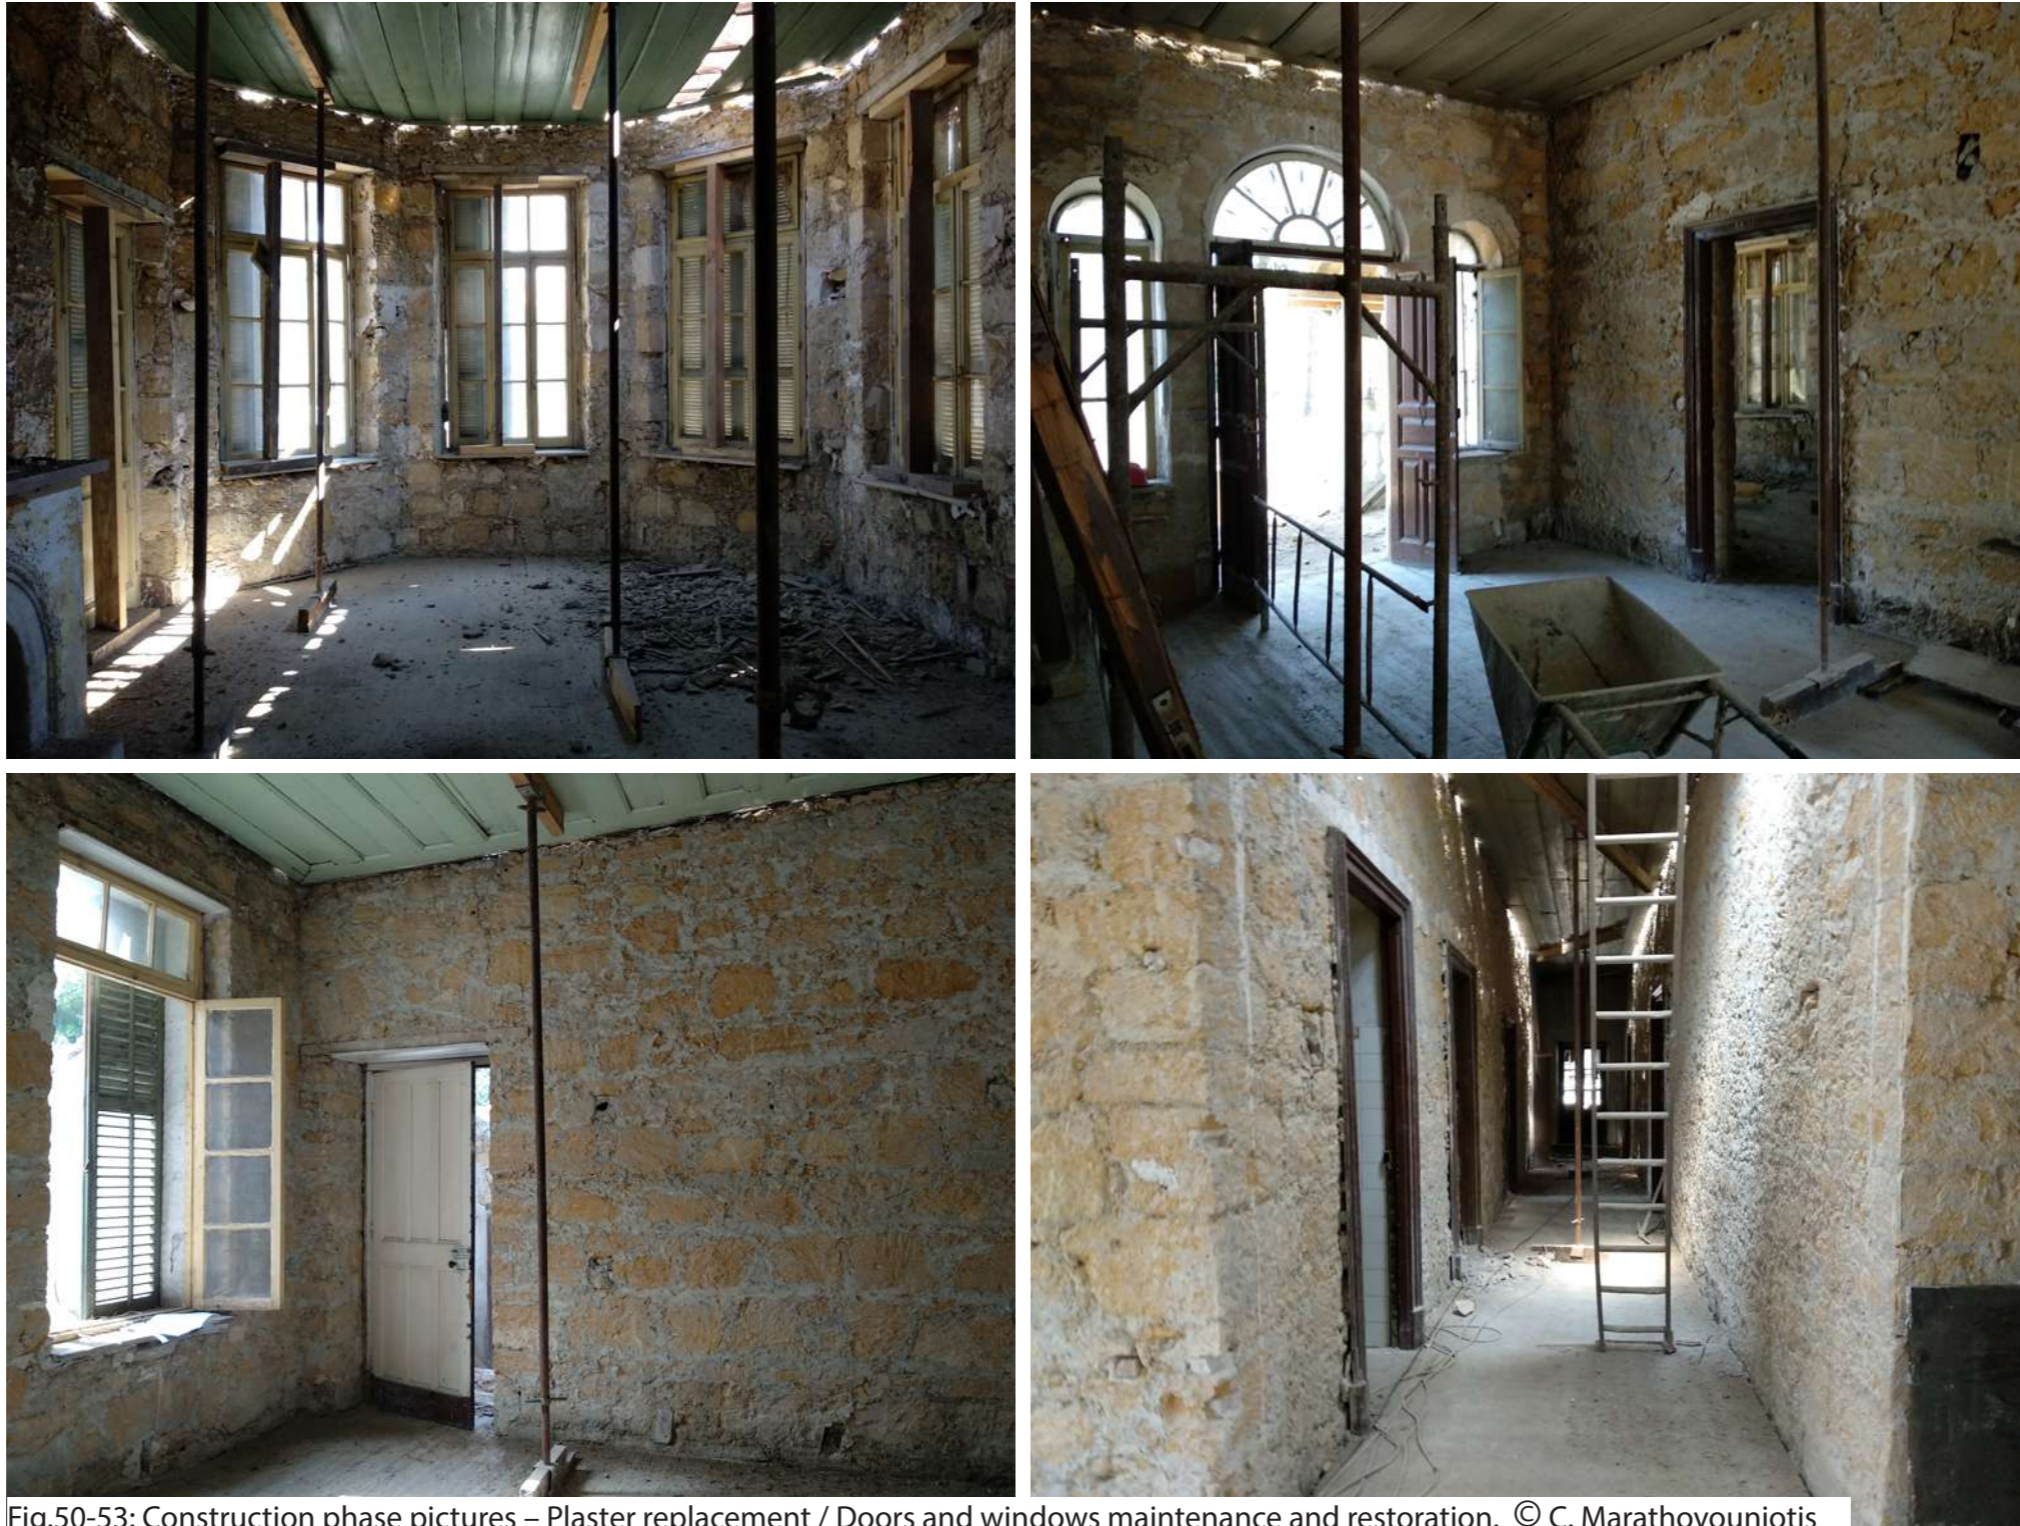
Fig.50-53: Construction phase pictures – Plaster replacement / Doors and windows maintenance and restoration. © C. Marathovouniotis

- All the wall plasters (both inside and outside walls) were removed and they were replaced with lime plaster that is vapour-permeable.
- All of the existing doors and the windows were maintained and restored. The windows and doors glass panes were replaced with thermal insulated glass panes.

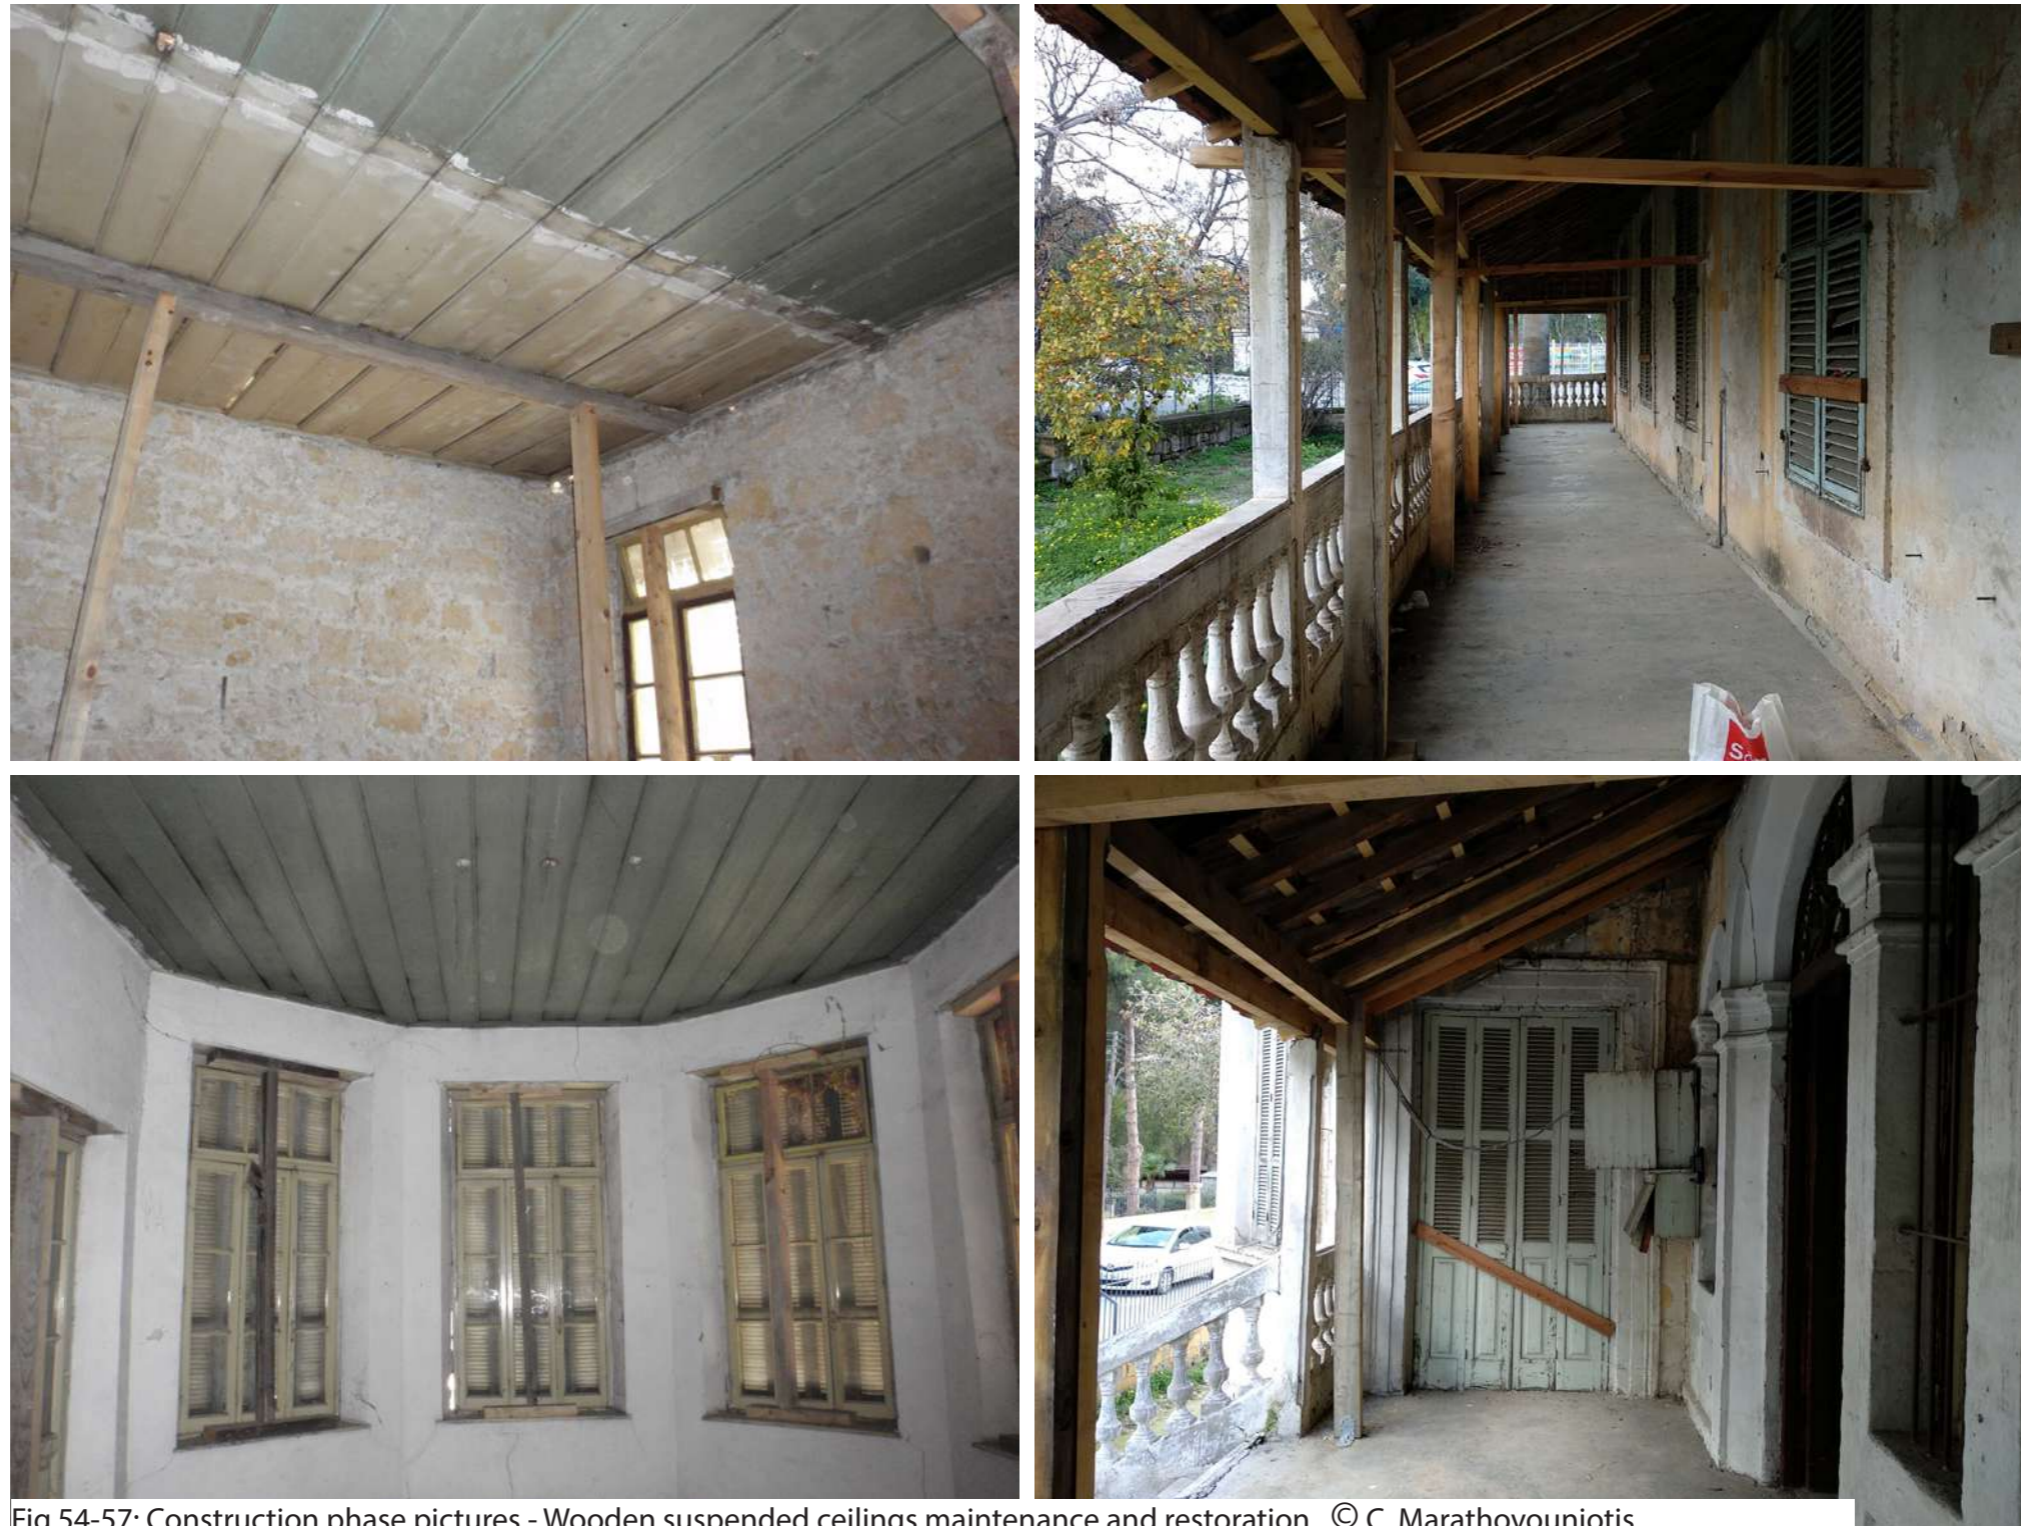
Fig.54-57: Construction phase pictures - Wooden suspended ceilings maintenance and restoration. © C. Marathovouniotis

- All the existing wooden suspended ceilings were maintained and restored.

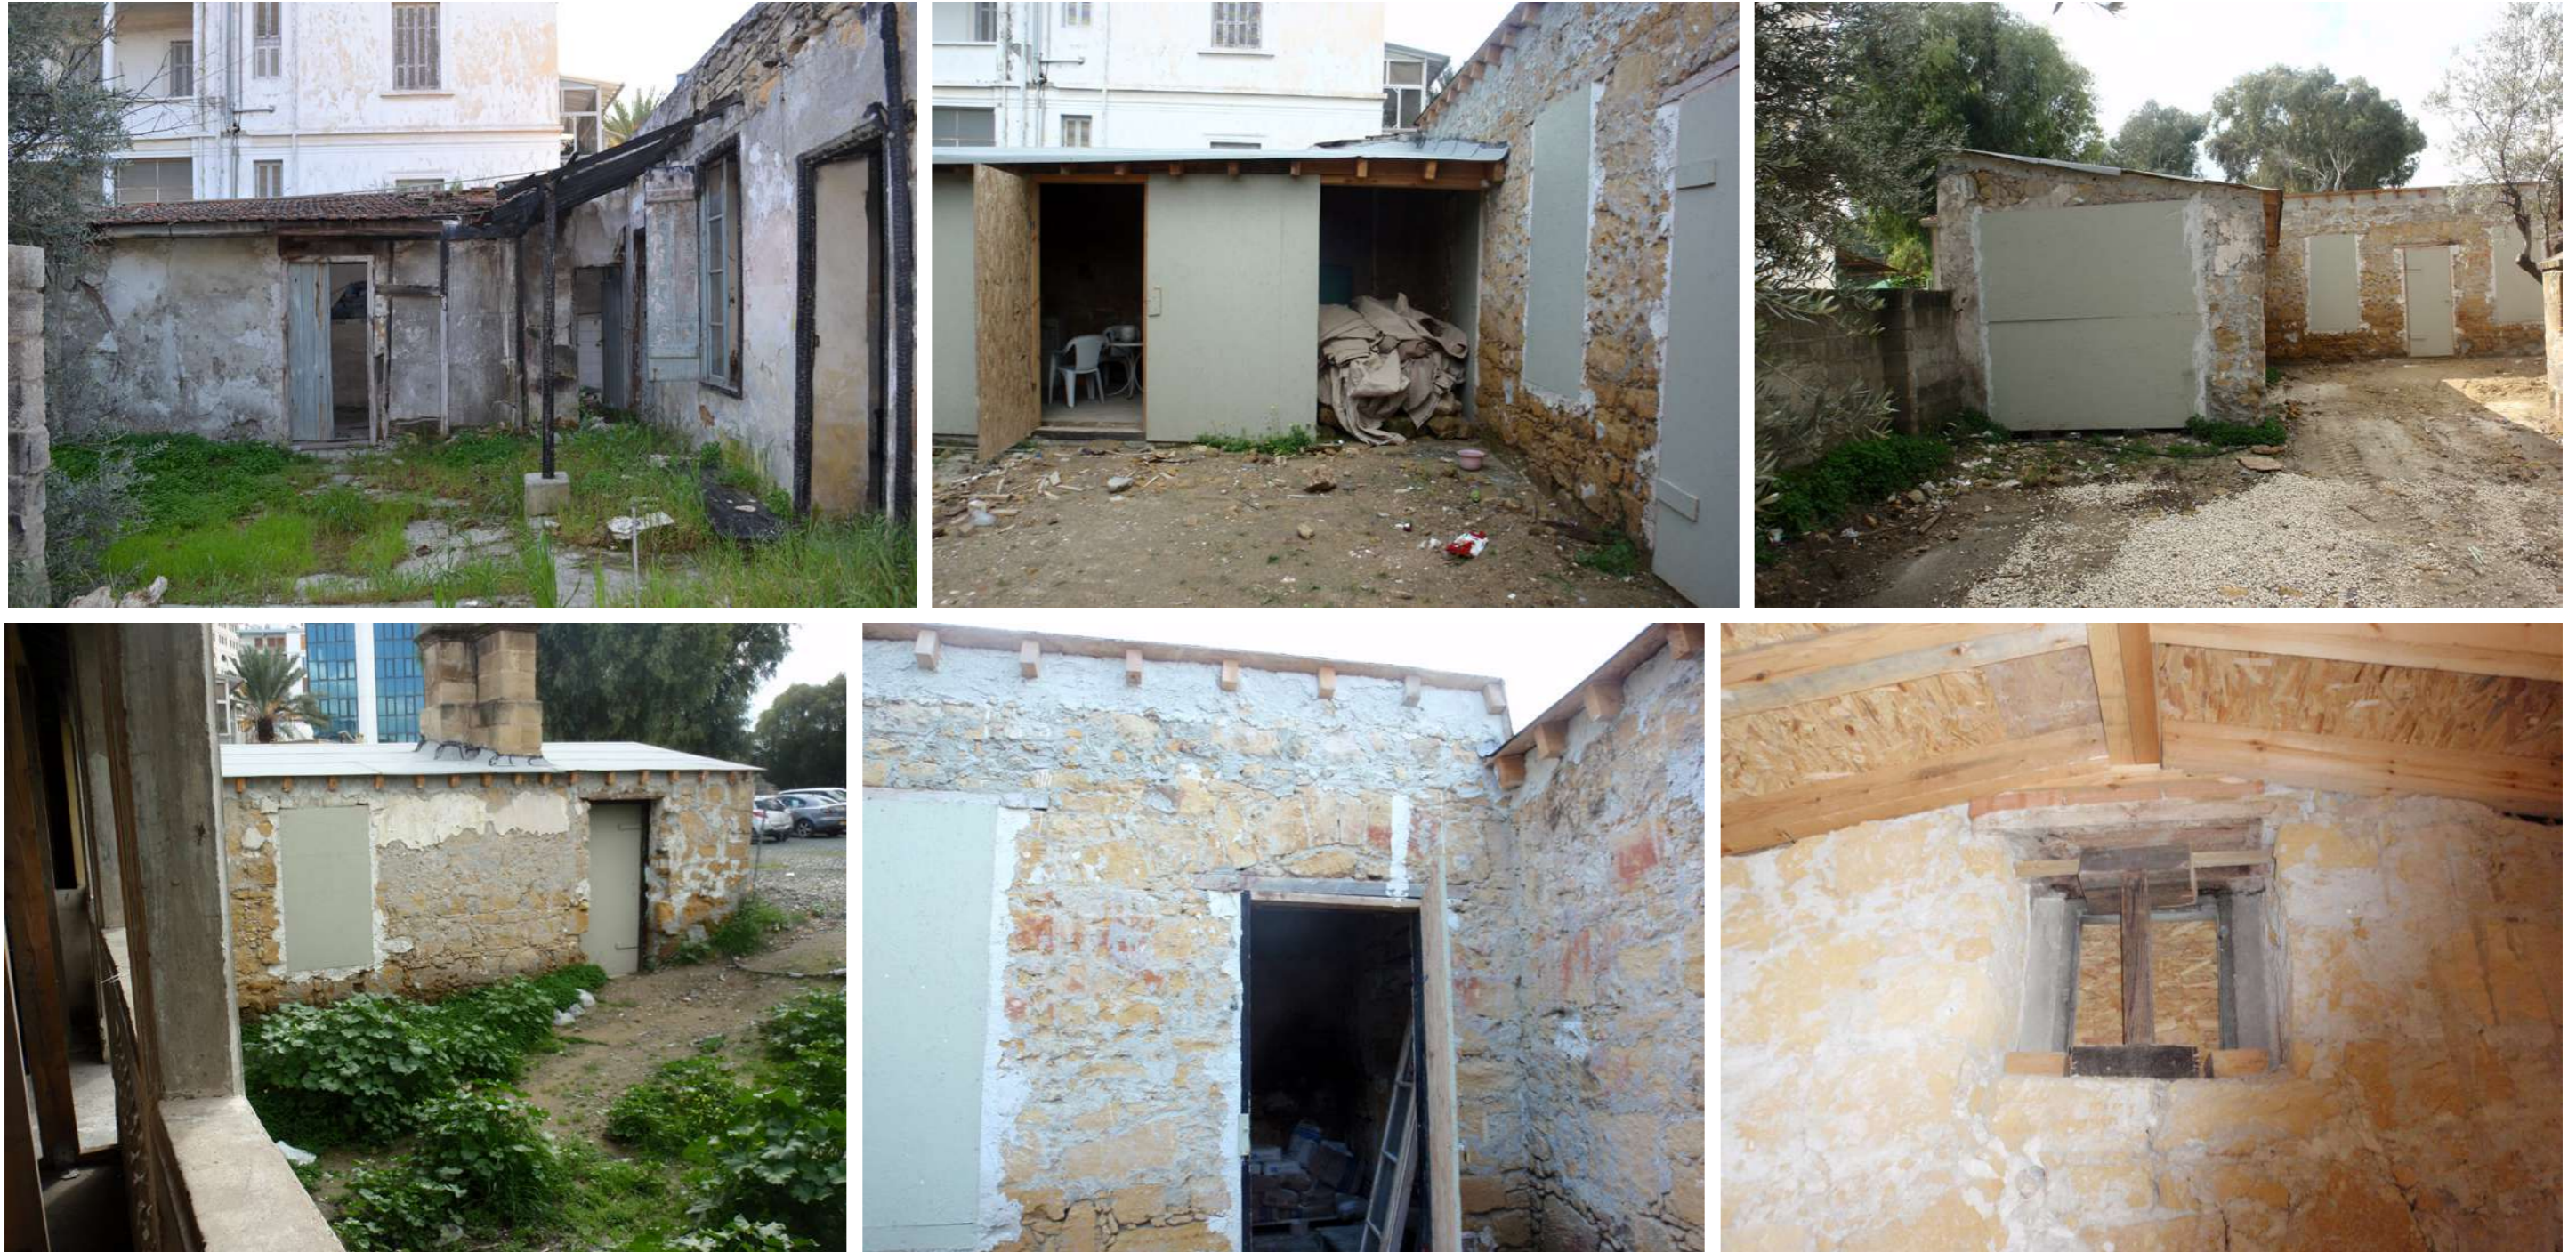
Fig.58-63: Construction phase pictures – Auxiliary buildings restoration and renovation. © C. Marathovouniotis

- Constructions, made of wood and metal, were done to ensure that people with disabilities have access to both inside and outside spaces.
- Low energy consumption air conditioning systems were installed.
- Low energy lighting systems were installed.
- Part of the auxiliary buildings was demolished and the rest of the remaining buildings were entirely restored and renovated.
- A metal-shade structure was constructed, in the front area of the auxiliary buildings, covered with polycarbonate sheets.
- On the east side, in the courtyard, a square was designed for gathering and events to run.
- In the garden of the courtyard, Cypriot trees and bushy plants were planted.
