EcoLiving 1802.

Site EcoLiving 1802, Carrer de la Riereta 35, Barcelona, Catalonia, Spain.

Designer Juli Pérez-Catalá Arquitectura

Date 2021

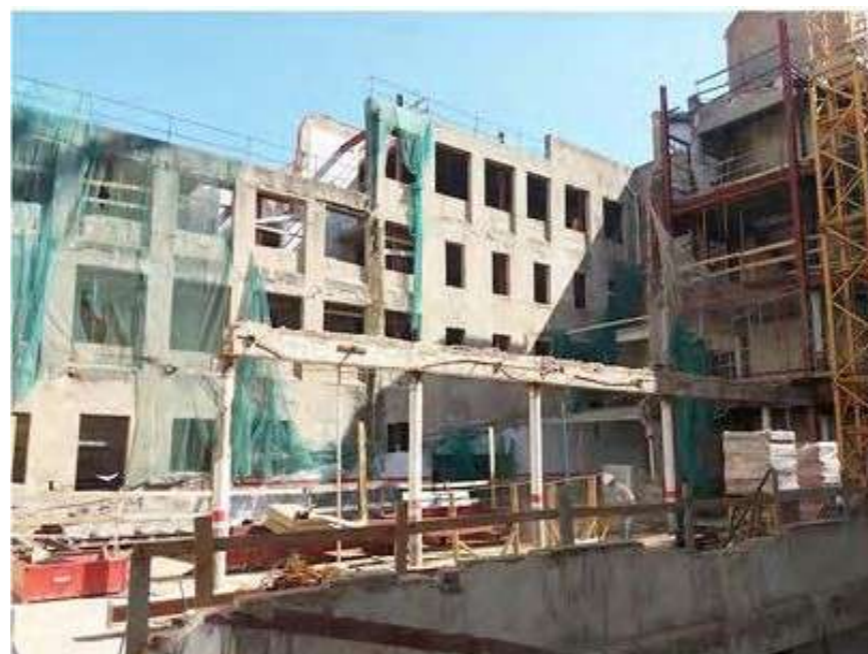
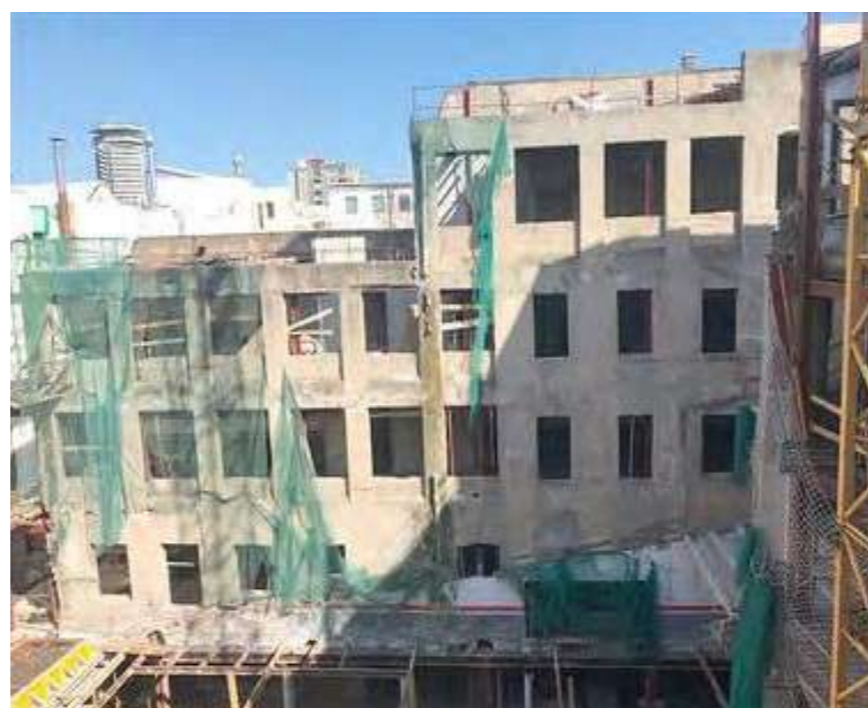
Fig.1-2: Views of the existing conditions of the courtyards façades. © Juli Pérez-Catalá Arquitectura

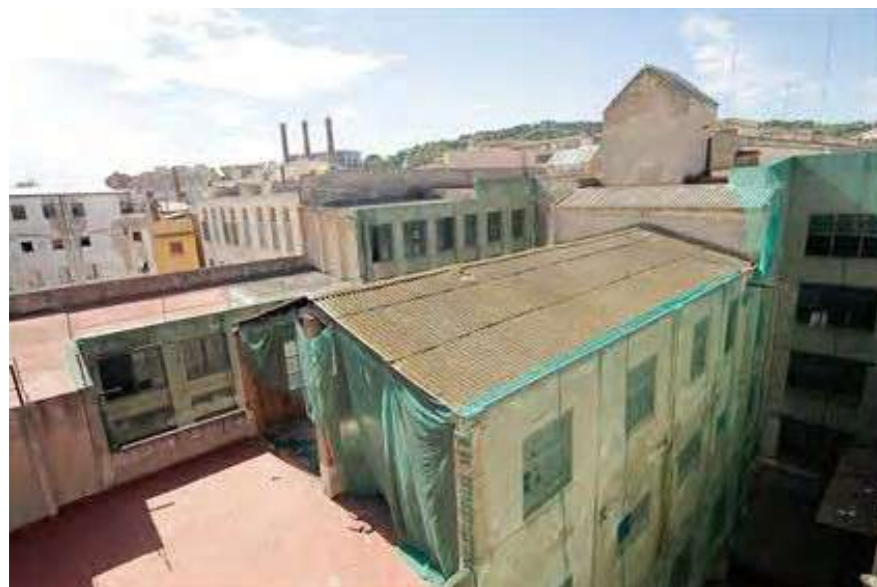
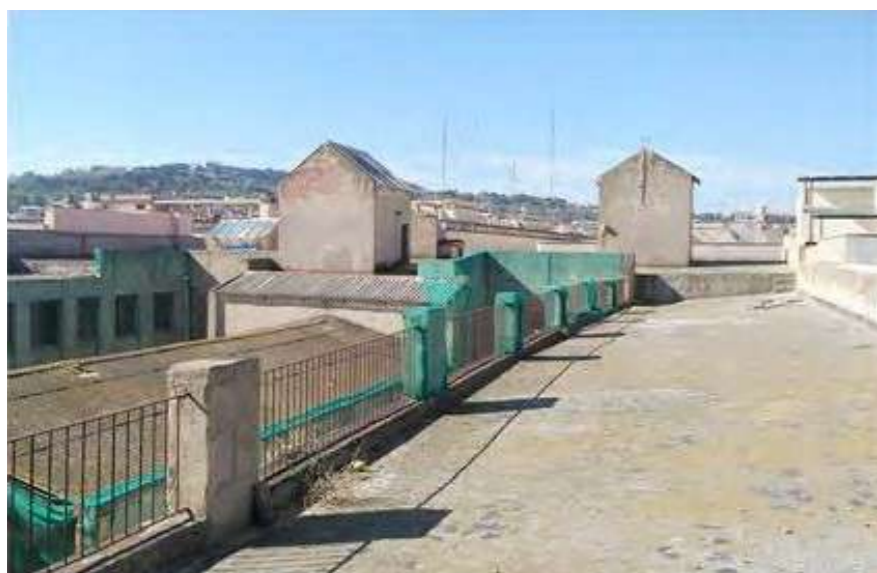
Fig.5-6: Views of the existing conditions of both roof systems.
© Juli Pérez-Catalá Arquitectura

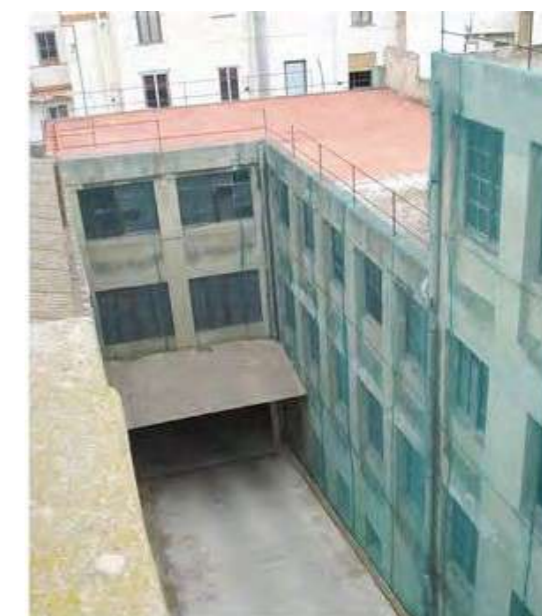
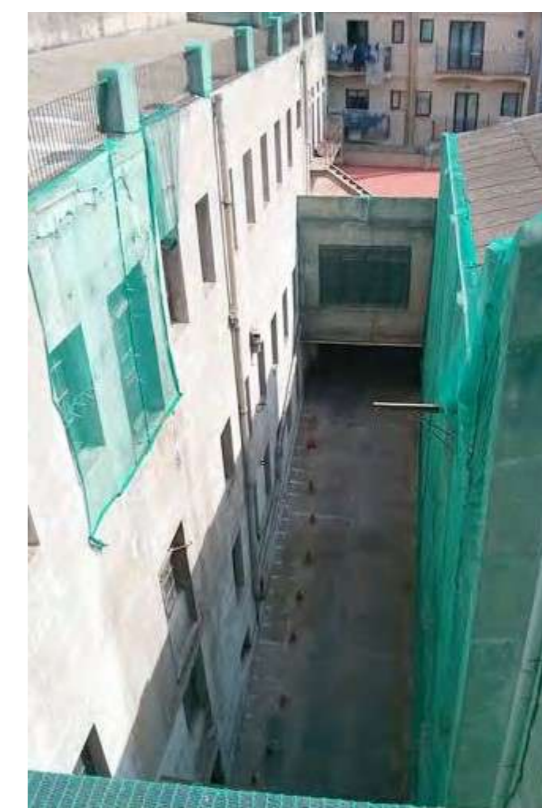
The complex shows signs of subsequent alterations to the original structure, such as changes in the composition and/or direction of the beams of the same floor in different areas, the overlapping or bending of profiles, the presence of mullioned beams or tubular metal reinforcements in the recesses of the wooden beams of the roof.

Fig.7-8: Views of the existing conditions in the courtyards.
© Juli Pérez-Catalá Arquitectura

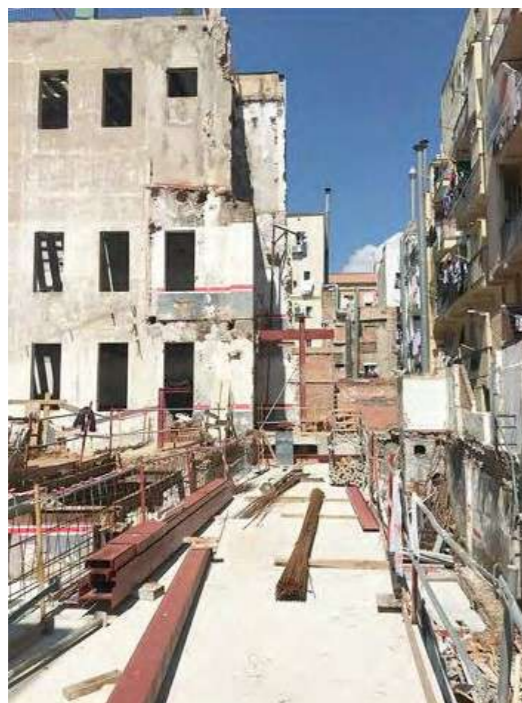
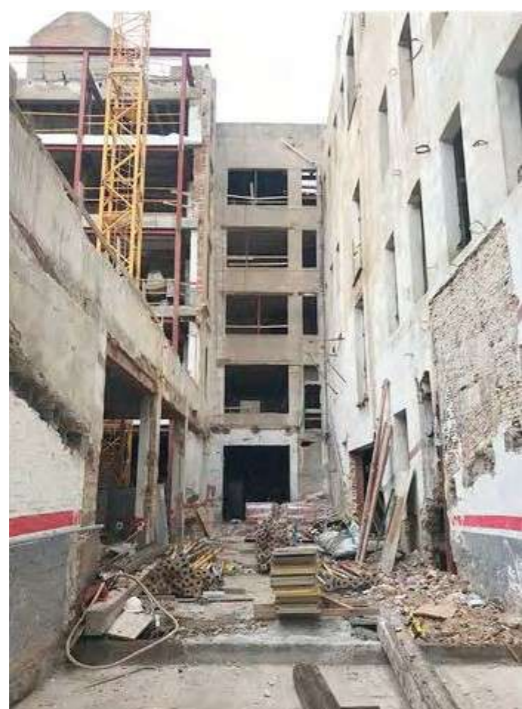
Fig.9-10: Views of the existing conditions in the courtyards.
© Juli Pérez-Catalá Arquitectura
