Rehabilitation of a historic Masía to a new multifunctional building.

Rehabilitation of *El Malloí*.

Site	"El Malloí" building, in Sant Hipòlit de Voltregà, Osona, Barcelona.
Objectives	Complete rehabilitation and change of use: "El Malloí" Building a new multifunctional equipment.
Property	Sant Hipòlit de Voltregà City Council
Designer	Carles Crosas, architect and Gemma Domingo, architect at SOG design; Josep Baquer, technical architect & structure consultant Architecture collaboration: Oriol Ribas, Lorena Hernández, Marta Medina, architects at SOG design; Laia Vilaubí, Heman Lleida, architects. Other Agents: Miquel Autet, technical architect; Clusells & Roca, MEP engineers Building Contractor: Calam Tapias Construccions SL
Date	Project: 2014; Works Phase 1, 2: 2017-2018; Works Phase 3, 4, 5: 2018-2019

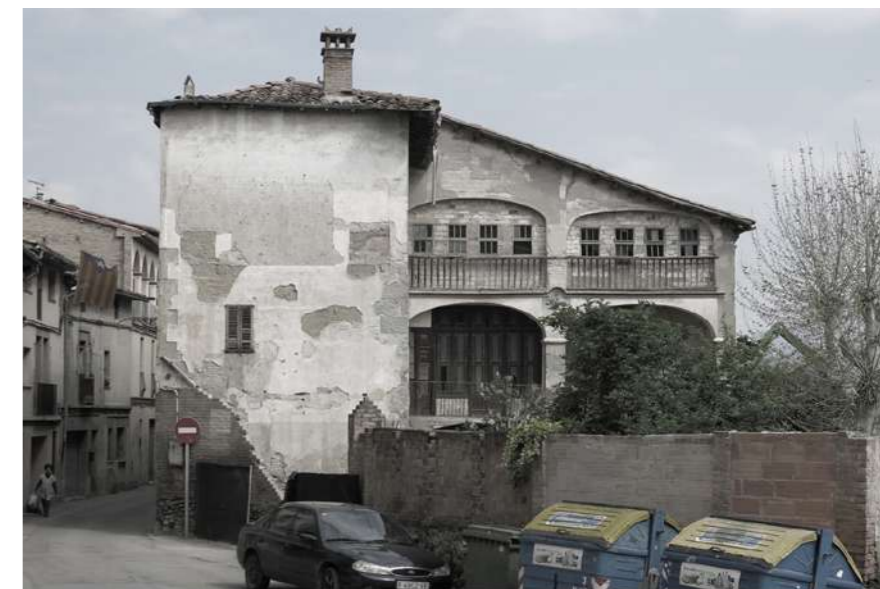
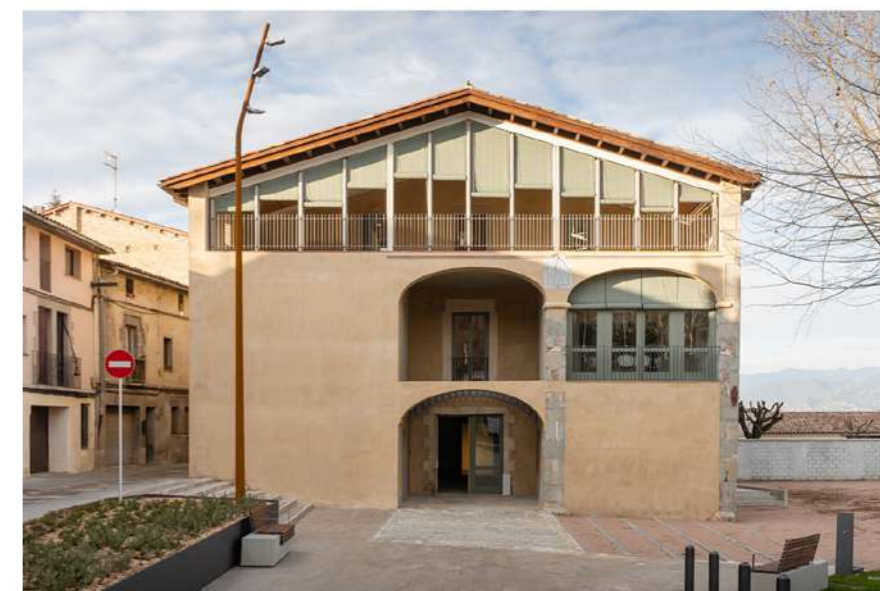
Fig.3: Before and after of the main façade.

On the one hand, the non-reconstruction of some of the slabs damaged by water filtration allowed introducing air and light into the interior. On the other hand, the demolition of the volume attached to the main façade implied recovering the original volume of the building: a symmetrical body with a gabled roof, substantially improving the conditions of the surrounding public space.

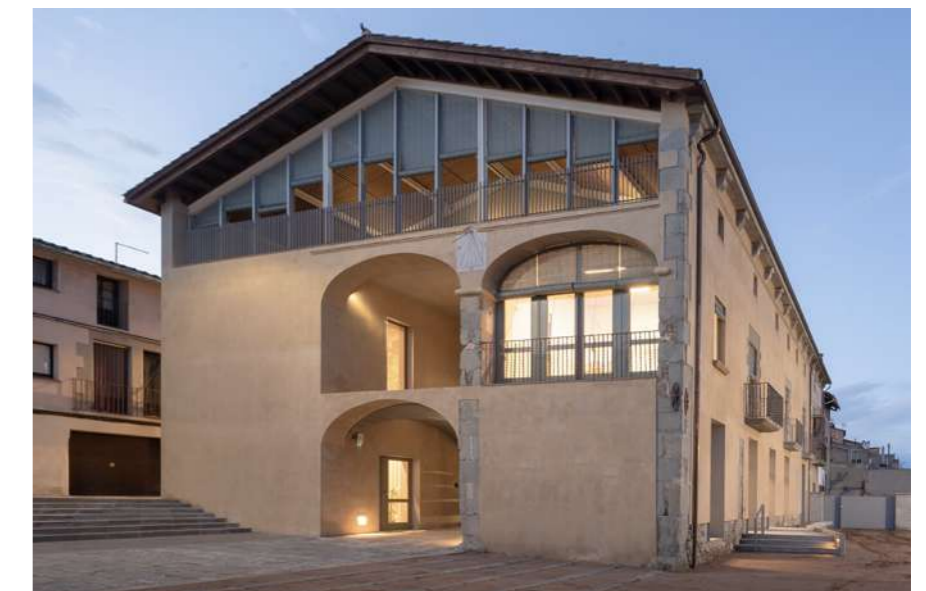
Fig.5: Rehabilitated south façade.

To the south, the demolition of the old annexed volume, as well as the open lobby on the ground floor and the porticoed space on the second floor shows the double façade that the building has had at different times. Precisely the “double façade” with two separate 4m planes is an optimal solution regarding sun protection and makes the building more energy efficient.

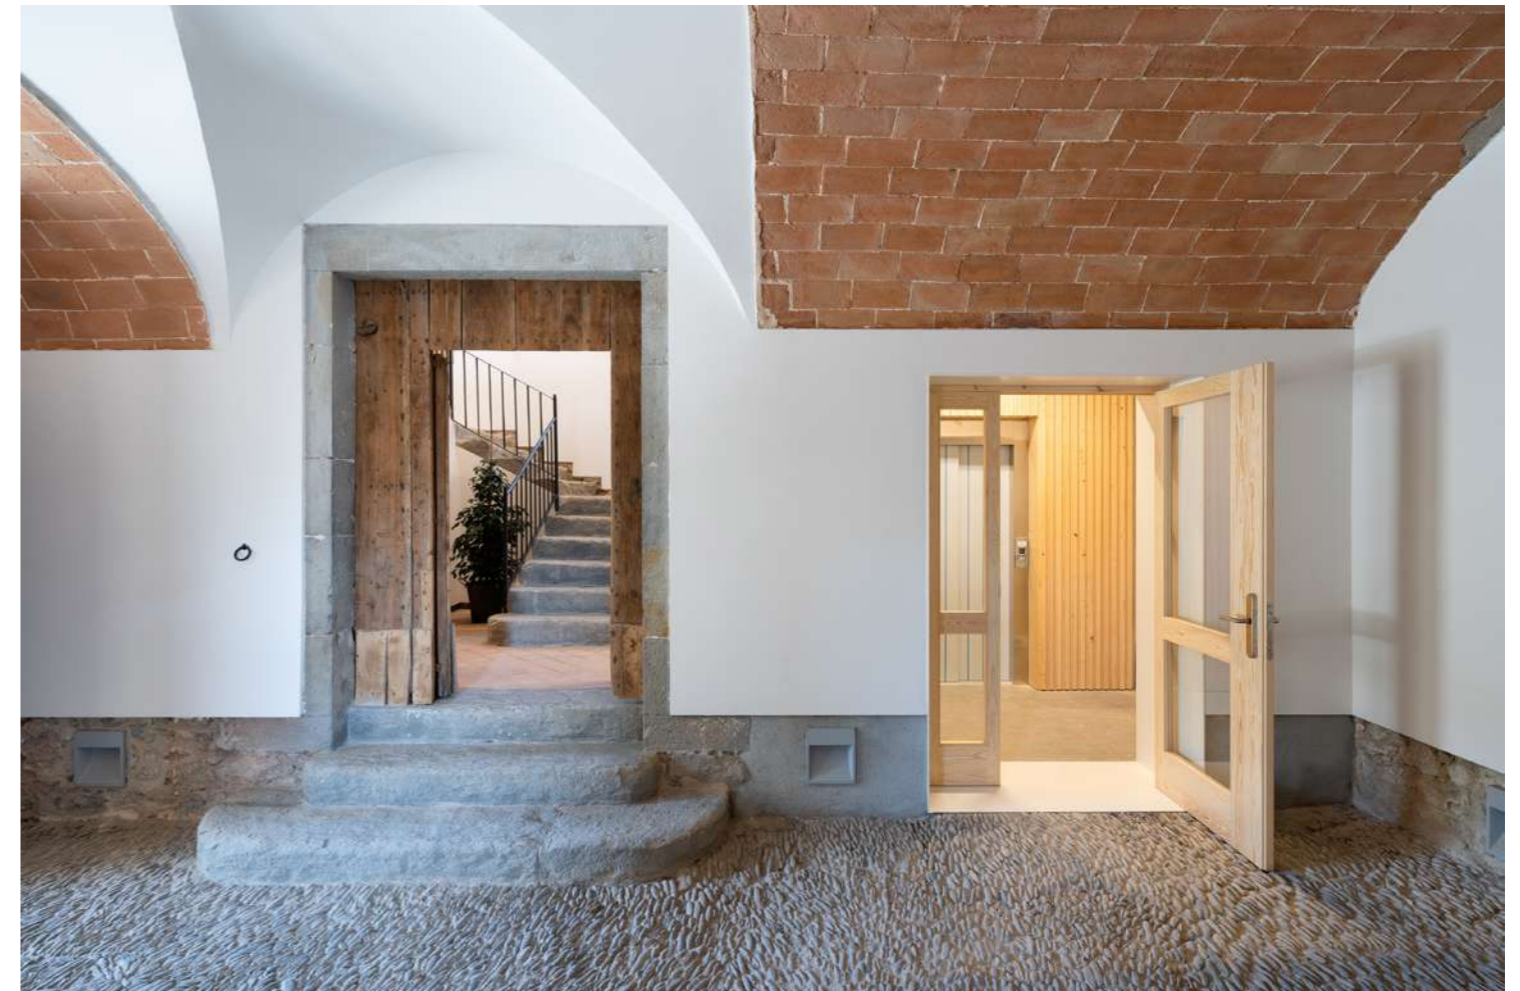
Fig.12: Interior entrance: Lobby closed on the ground floor, with double access and restored original construction elements (round pebble paving and ceramic vault).

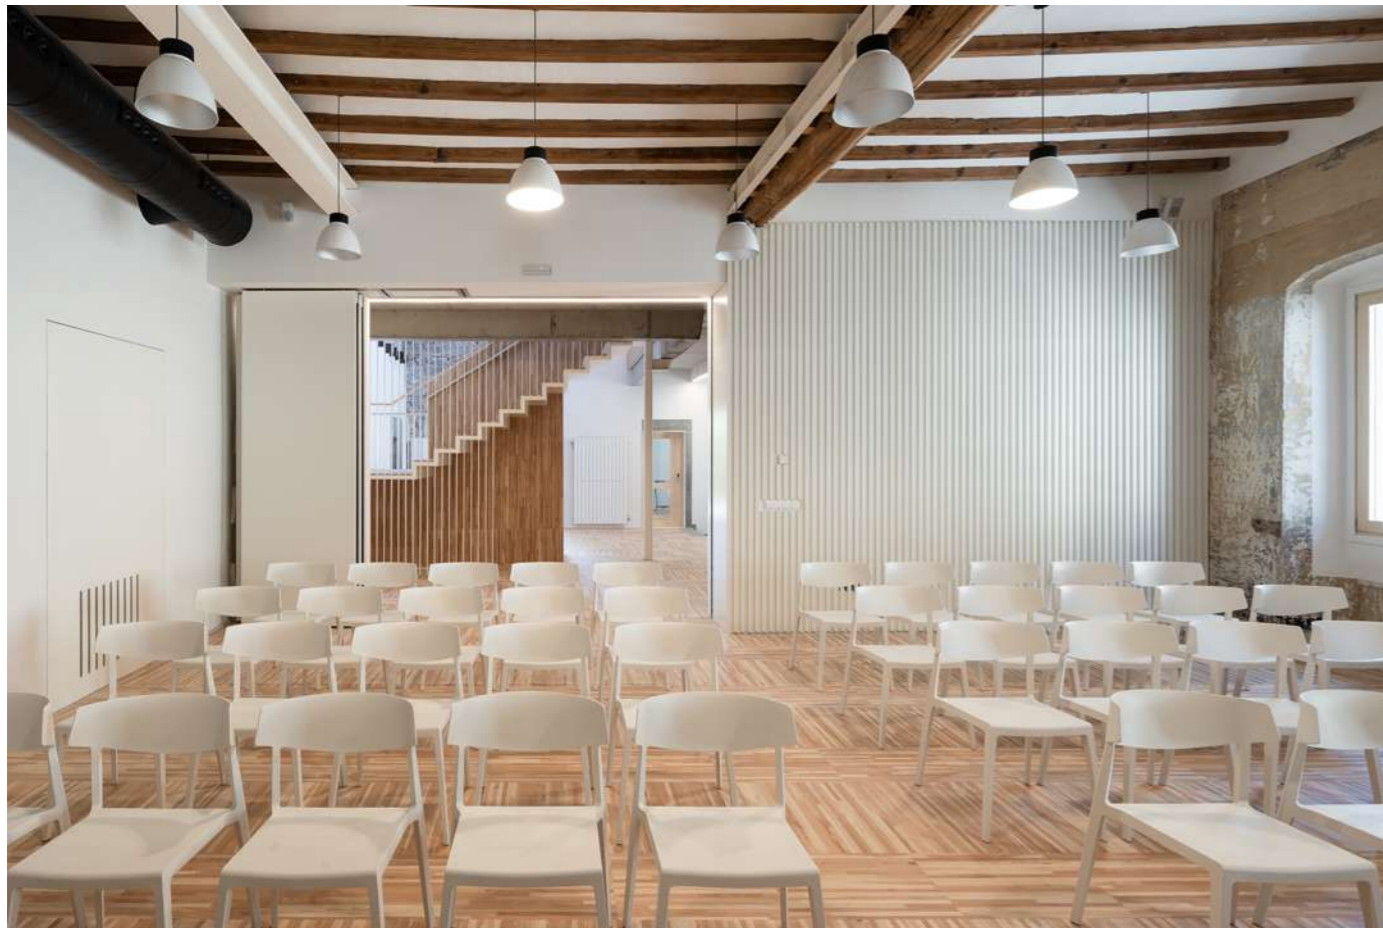
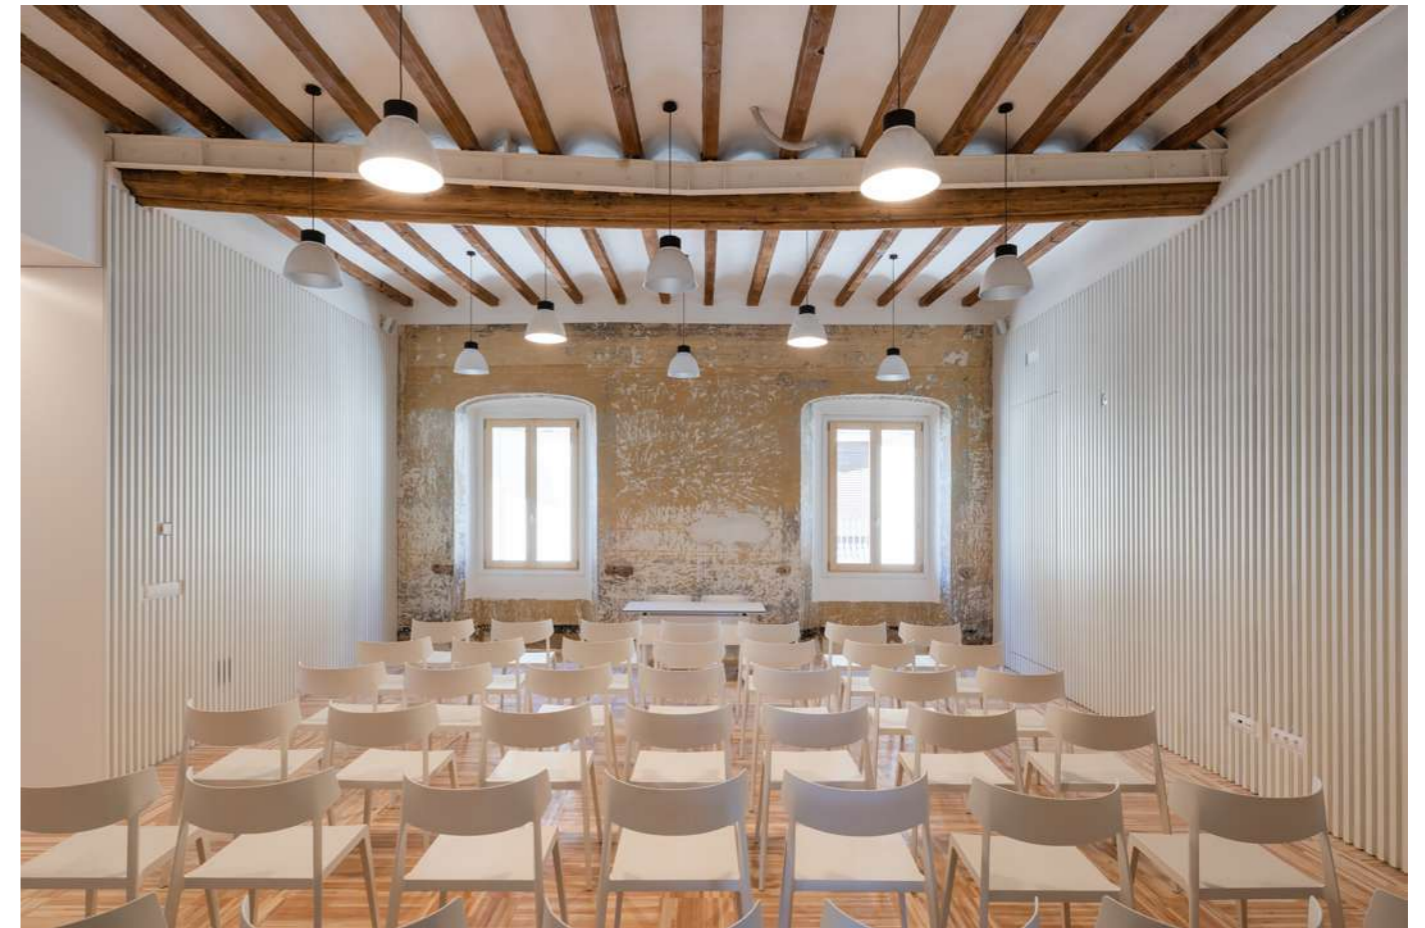
Fig.14-15: Multipurpose room: Noble room on the first floor with preserved and reinforced slab of wooden joists and interior facing of the original facade.

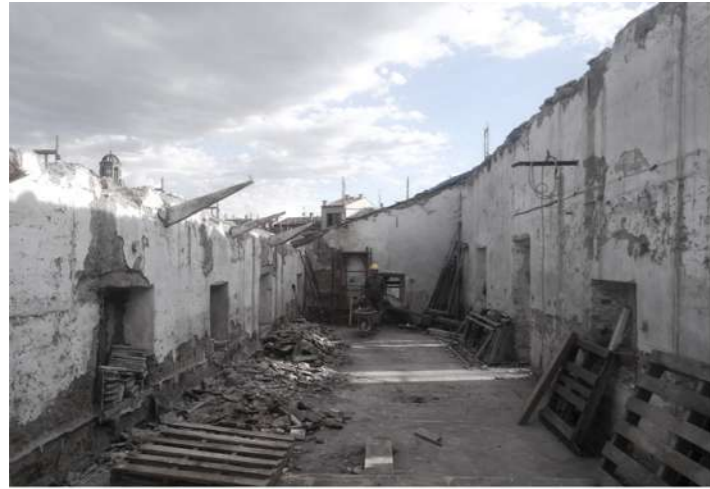
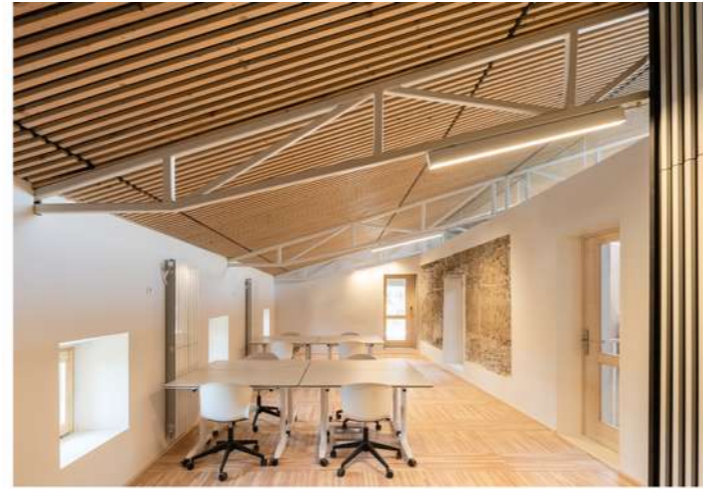
A) Second floor: Co-working space with a wood batten acoustic ceiling.

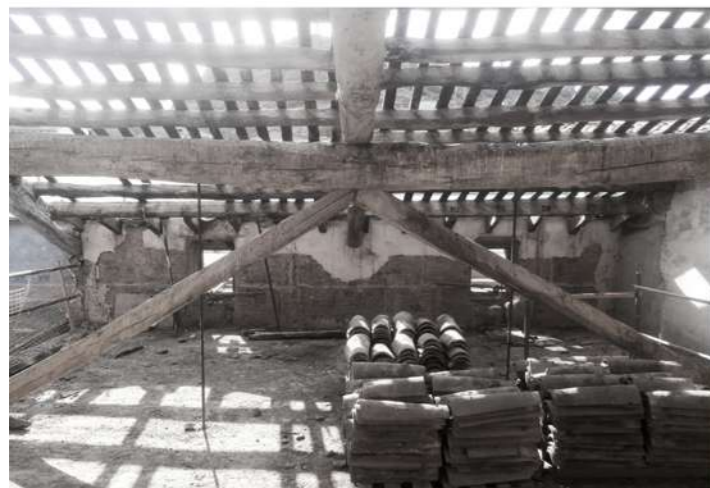
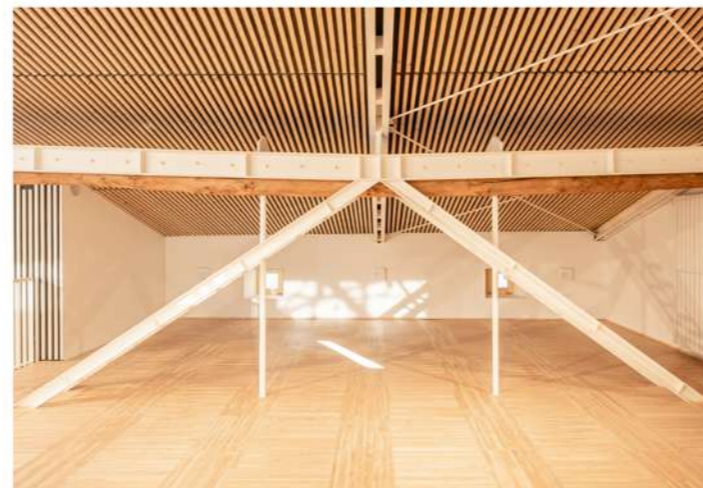
B) Floor below deck: Recreational space: reconstruction and reinforcement of unique planar wood truss that supports the roof and the lower floor.

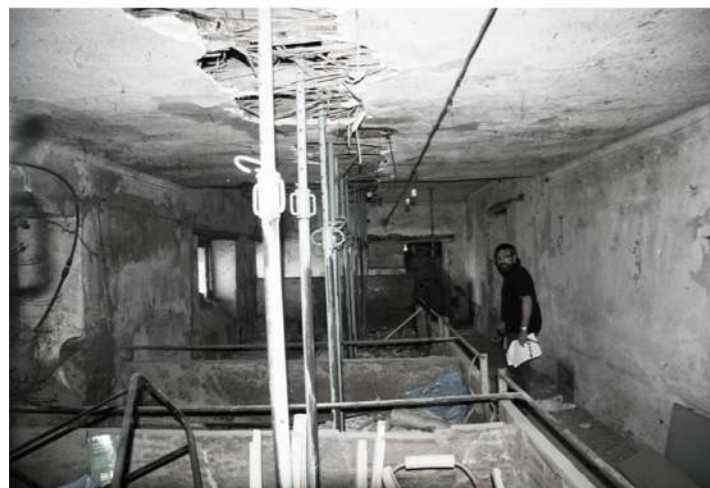
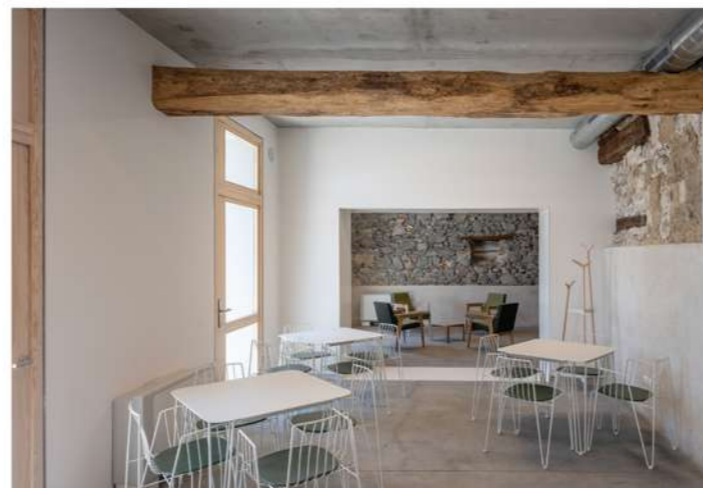
C) Ground floor: Social space: bar with exposed concrete slab and new openings to the landscaped public space.

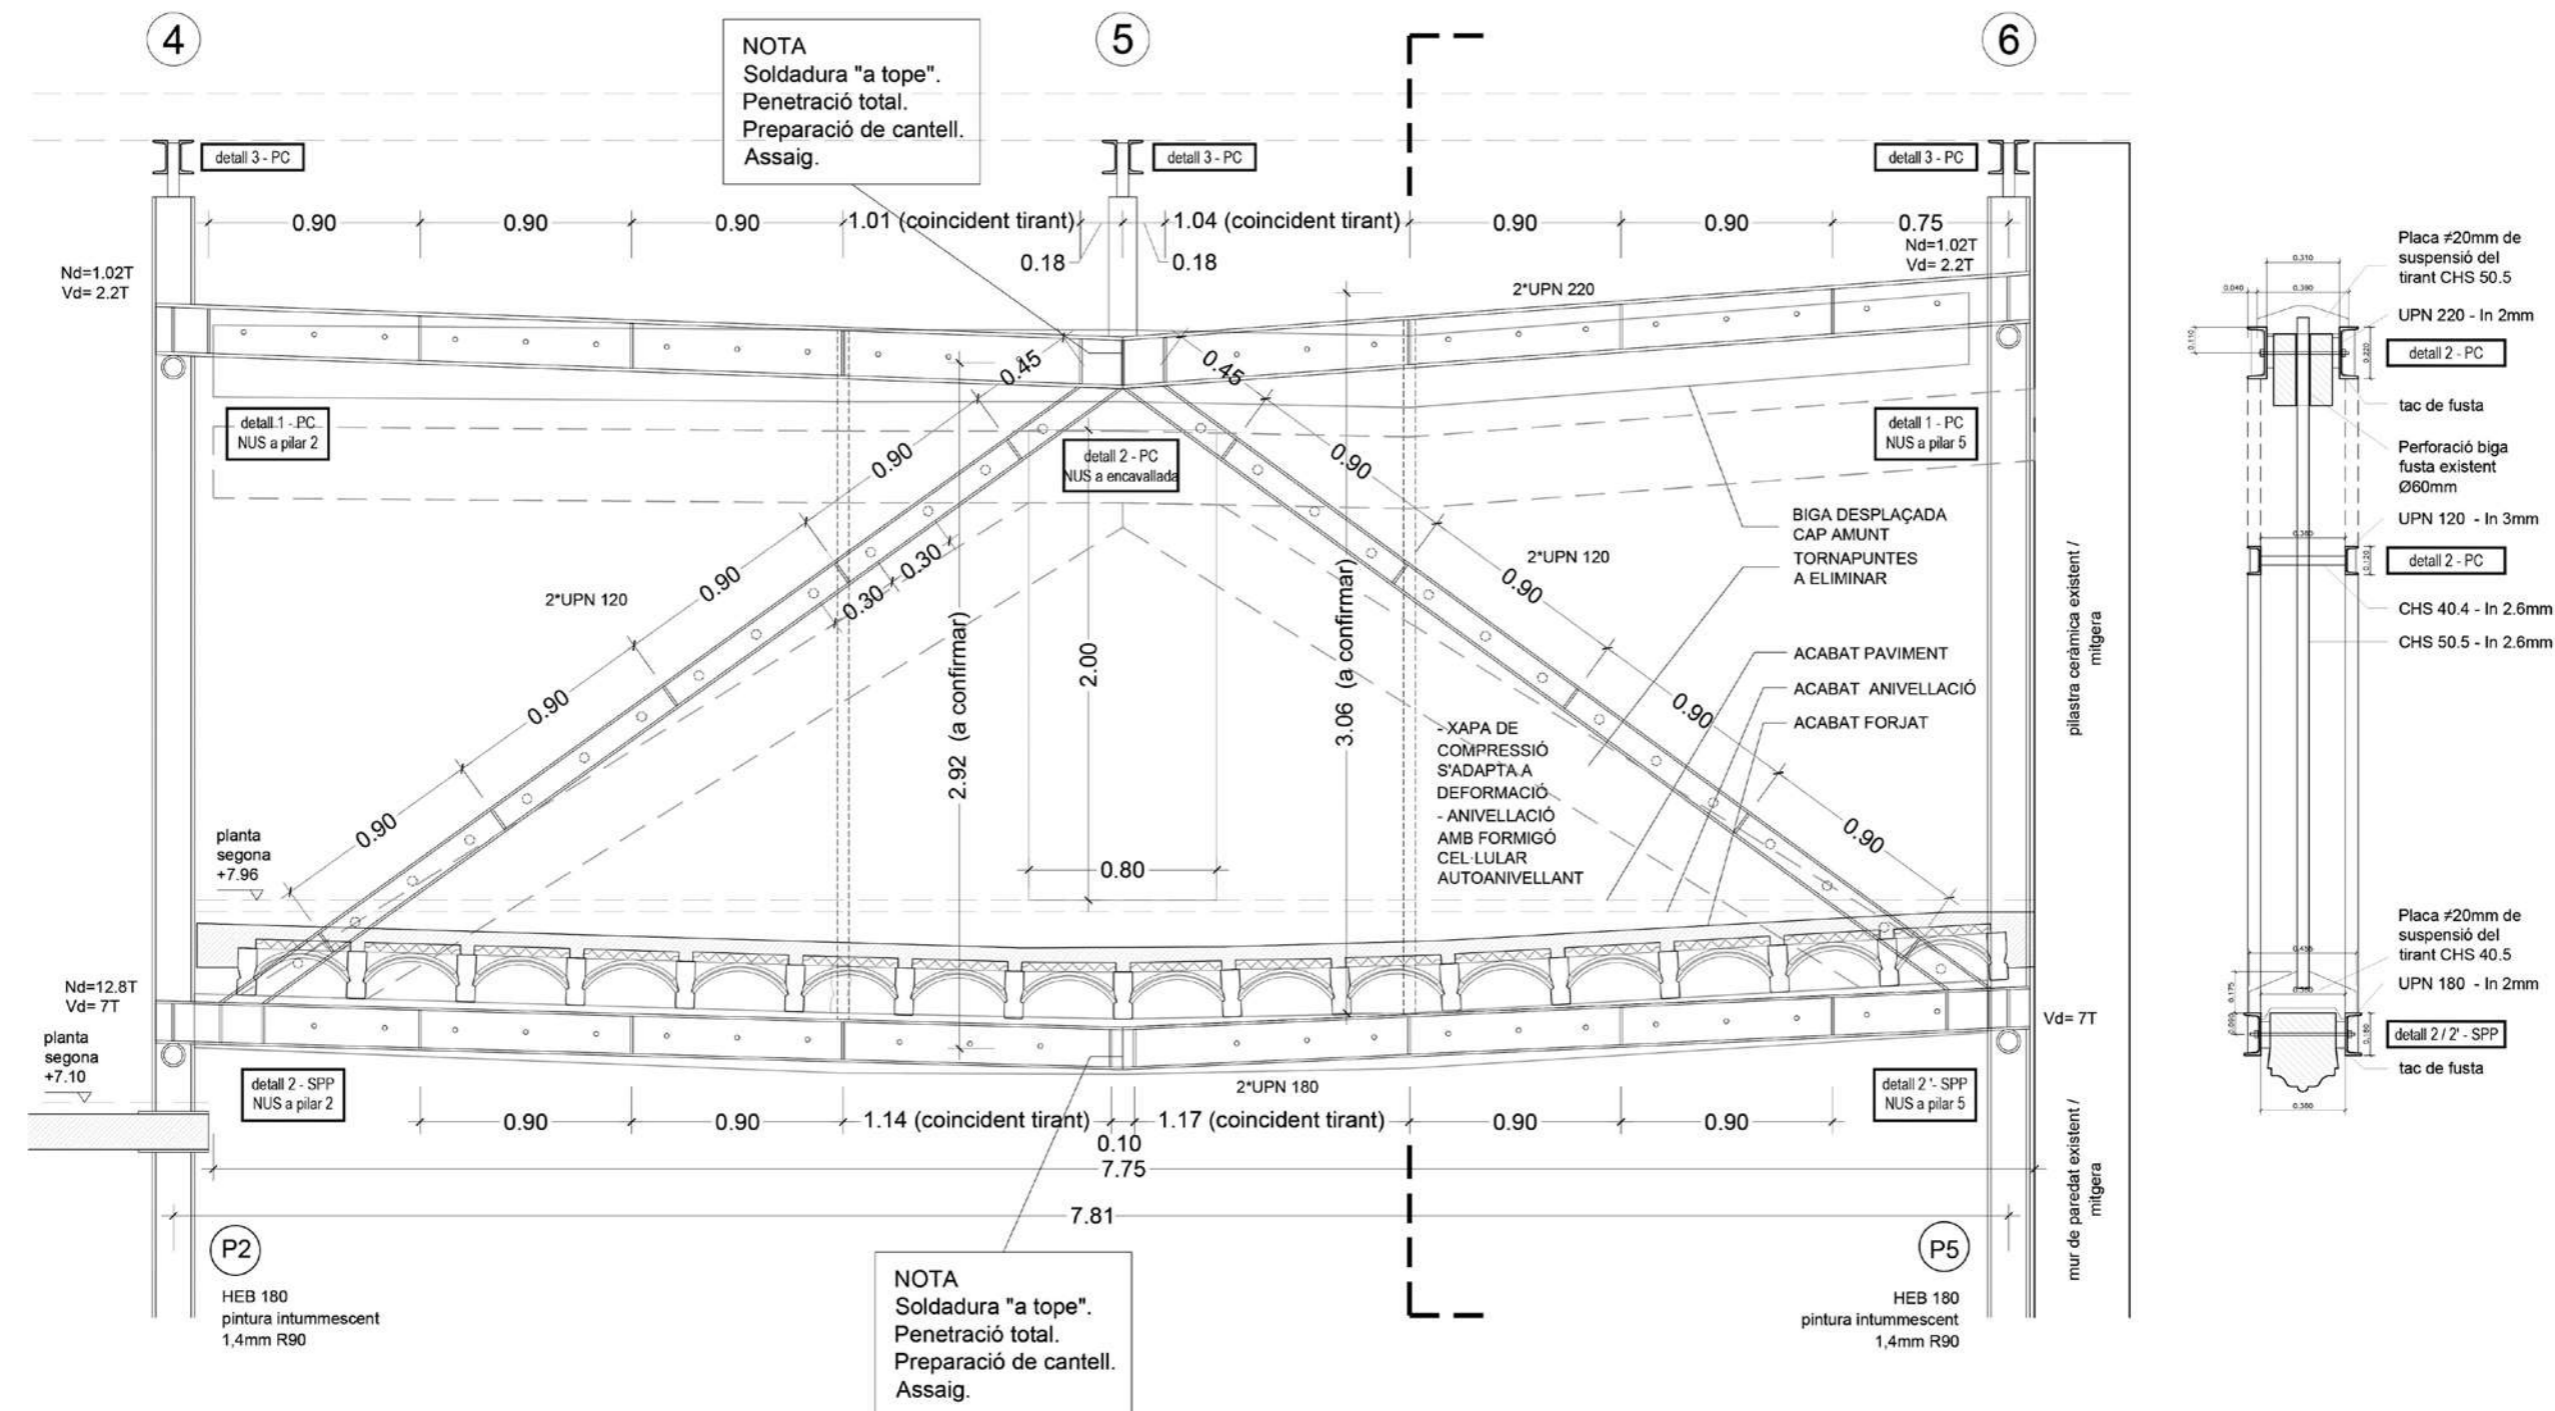
Fig.25: Detailed drawing of the wood truss.
