## A monumental palace, city walls and a gate in Palermo, involved in a fascinating restoration.

*After years of neglect and forgetfulness, the rebirth of a Mediterranean city waterfront piece.*

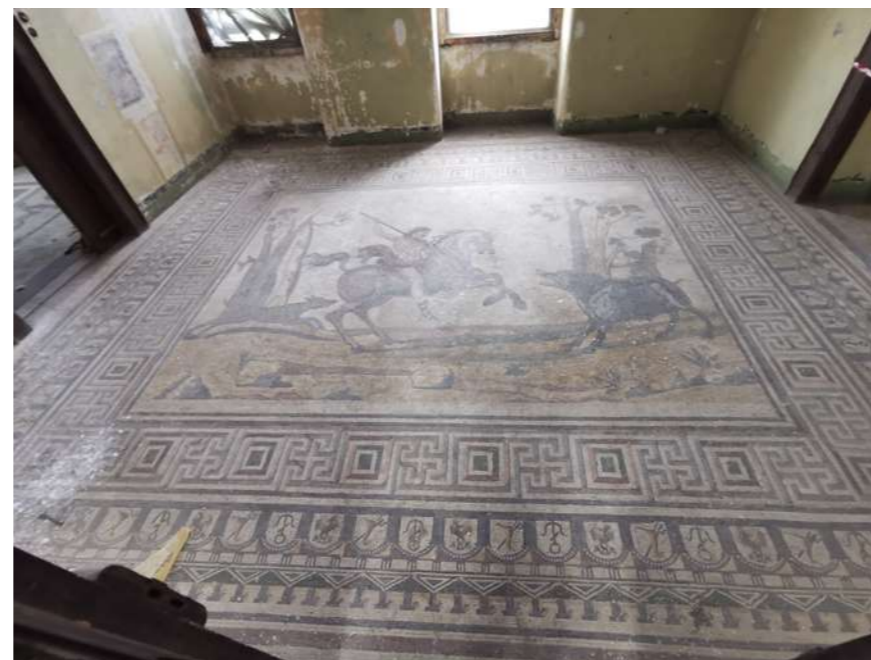
Fig.7: Mosaic with a hunting scene, taken from the *Hippolytus* Greek tragedy of Euripides. © Manfredi Saeli

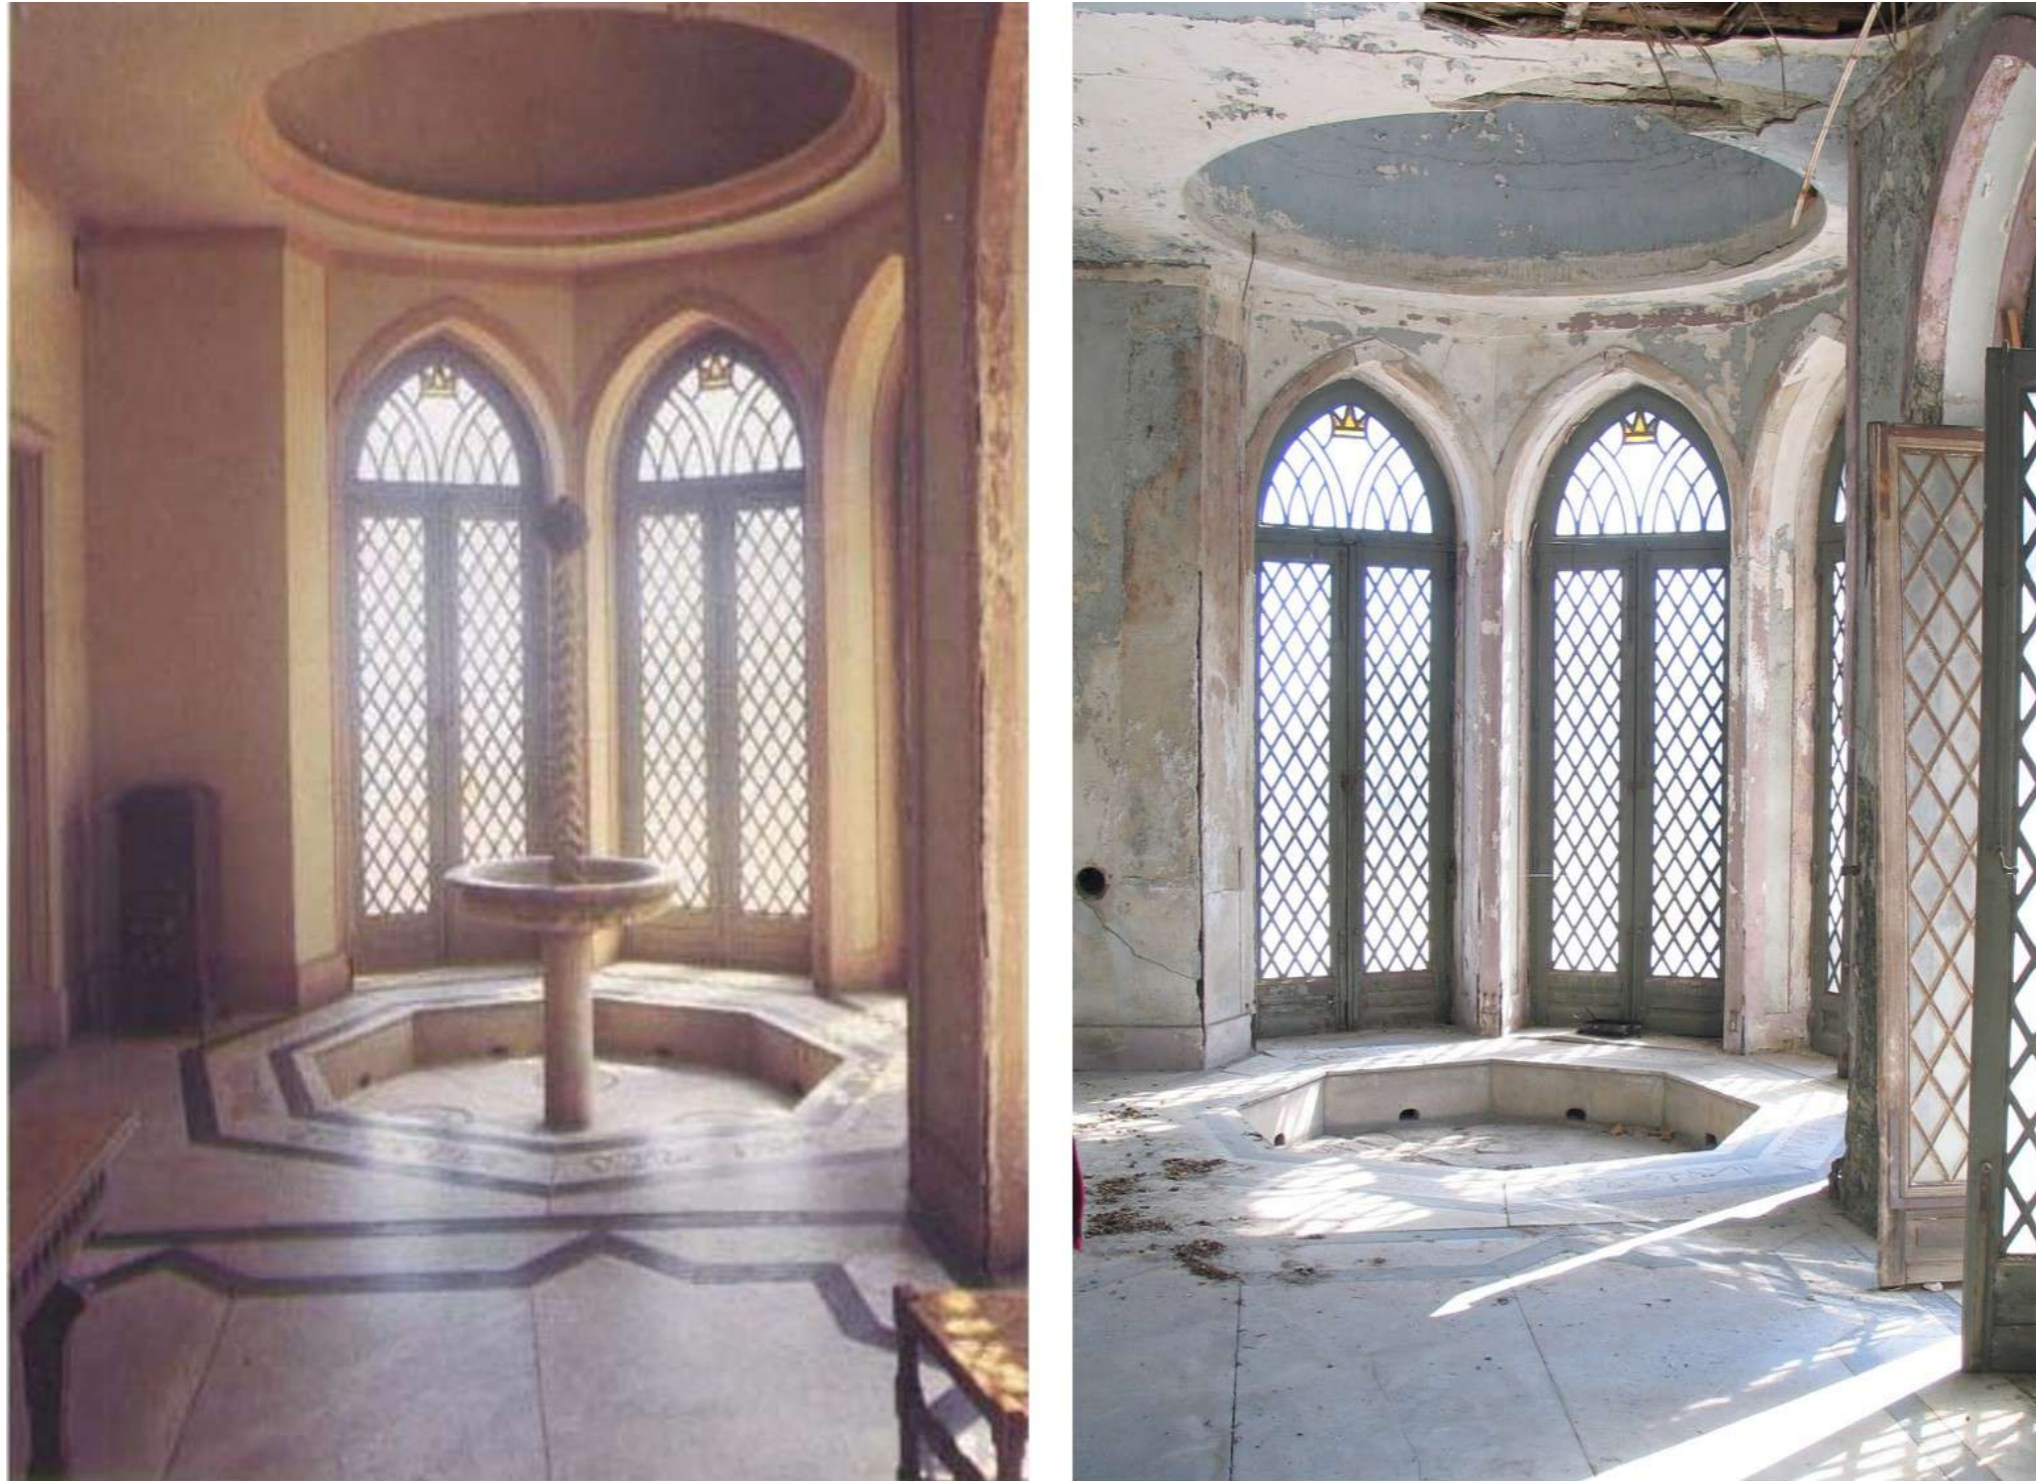
Fig.8a-b: Octagonal room with fountain in the 1950s of XX century (left) and as it appears today (right). © Private Archive & Project Designers

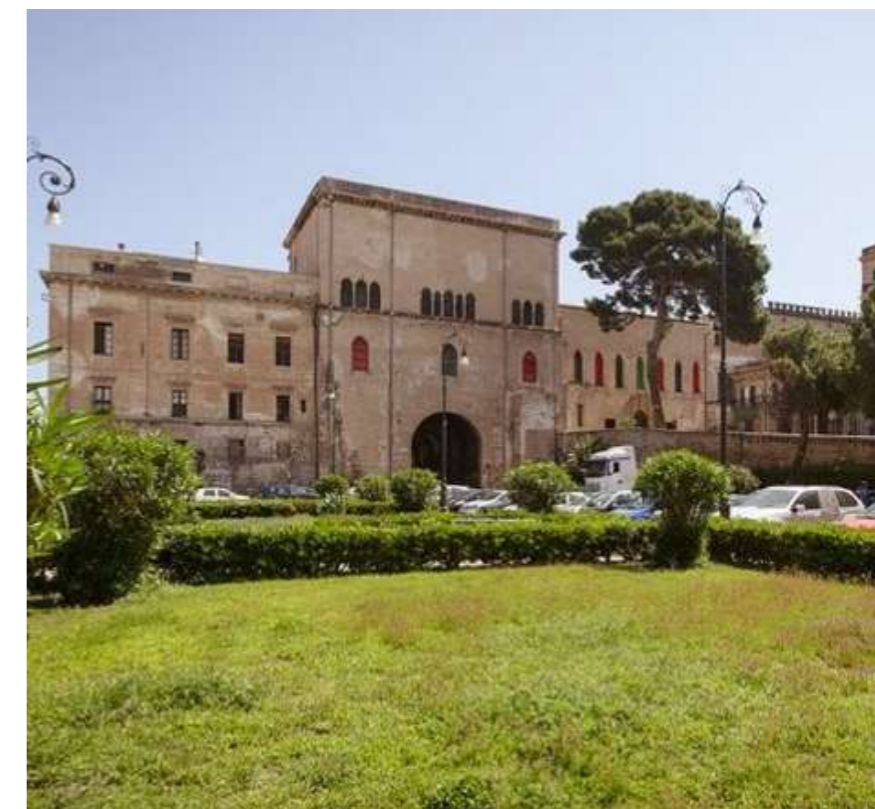
Fig.12: Detail of the façade along the *Kalsa* square, which also includes the *Carini* city gate. © Project Designers

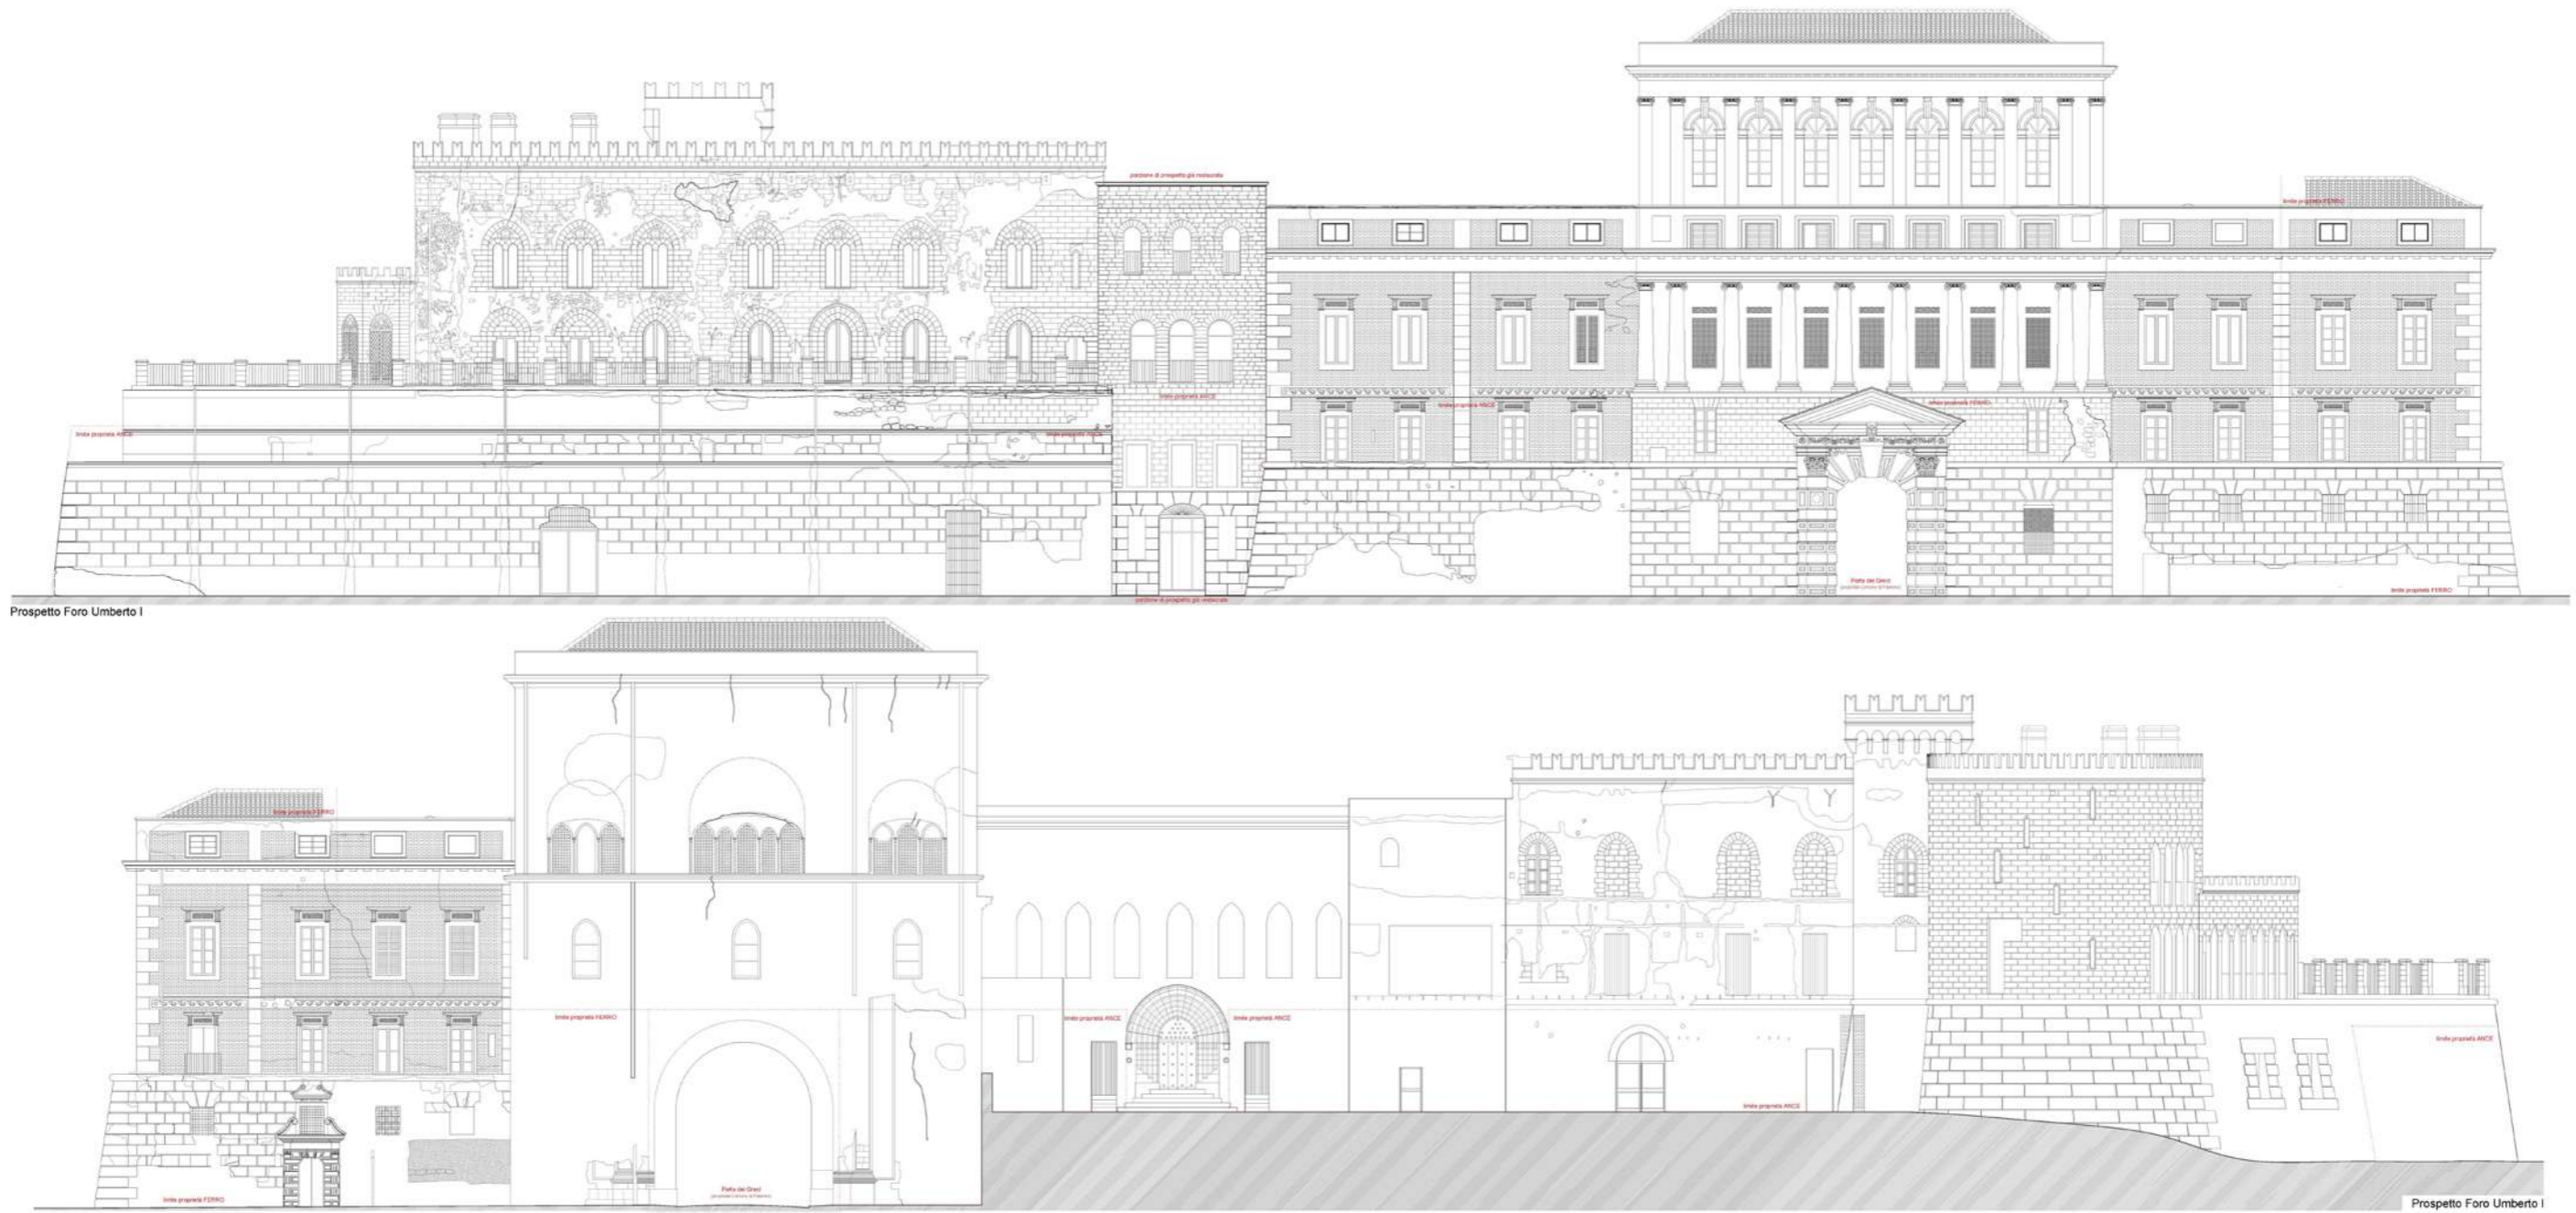
Fig.13: Survey of actual condition of the façades. © Project Designers

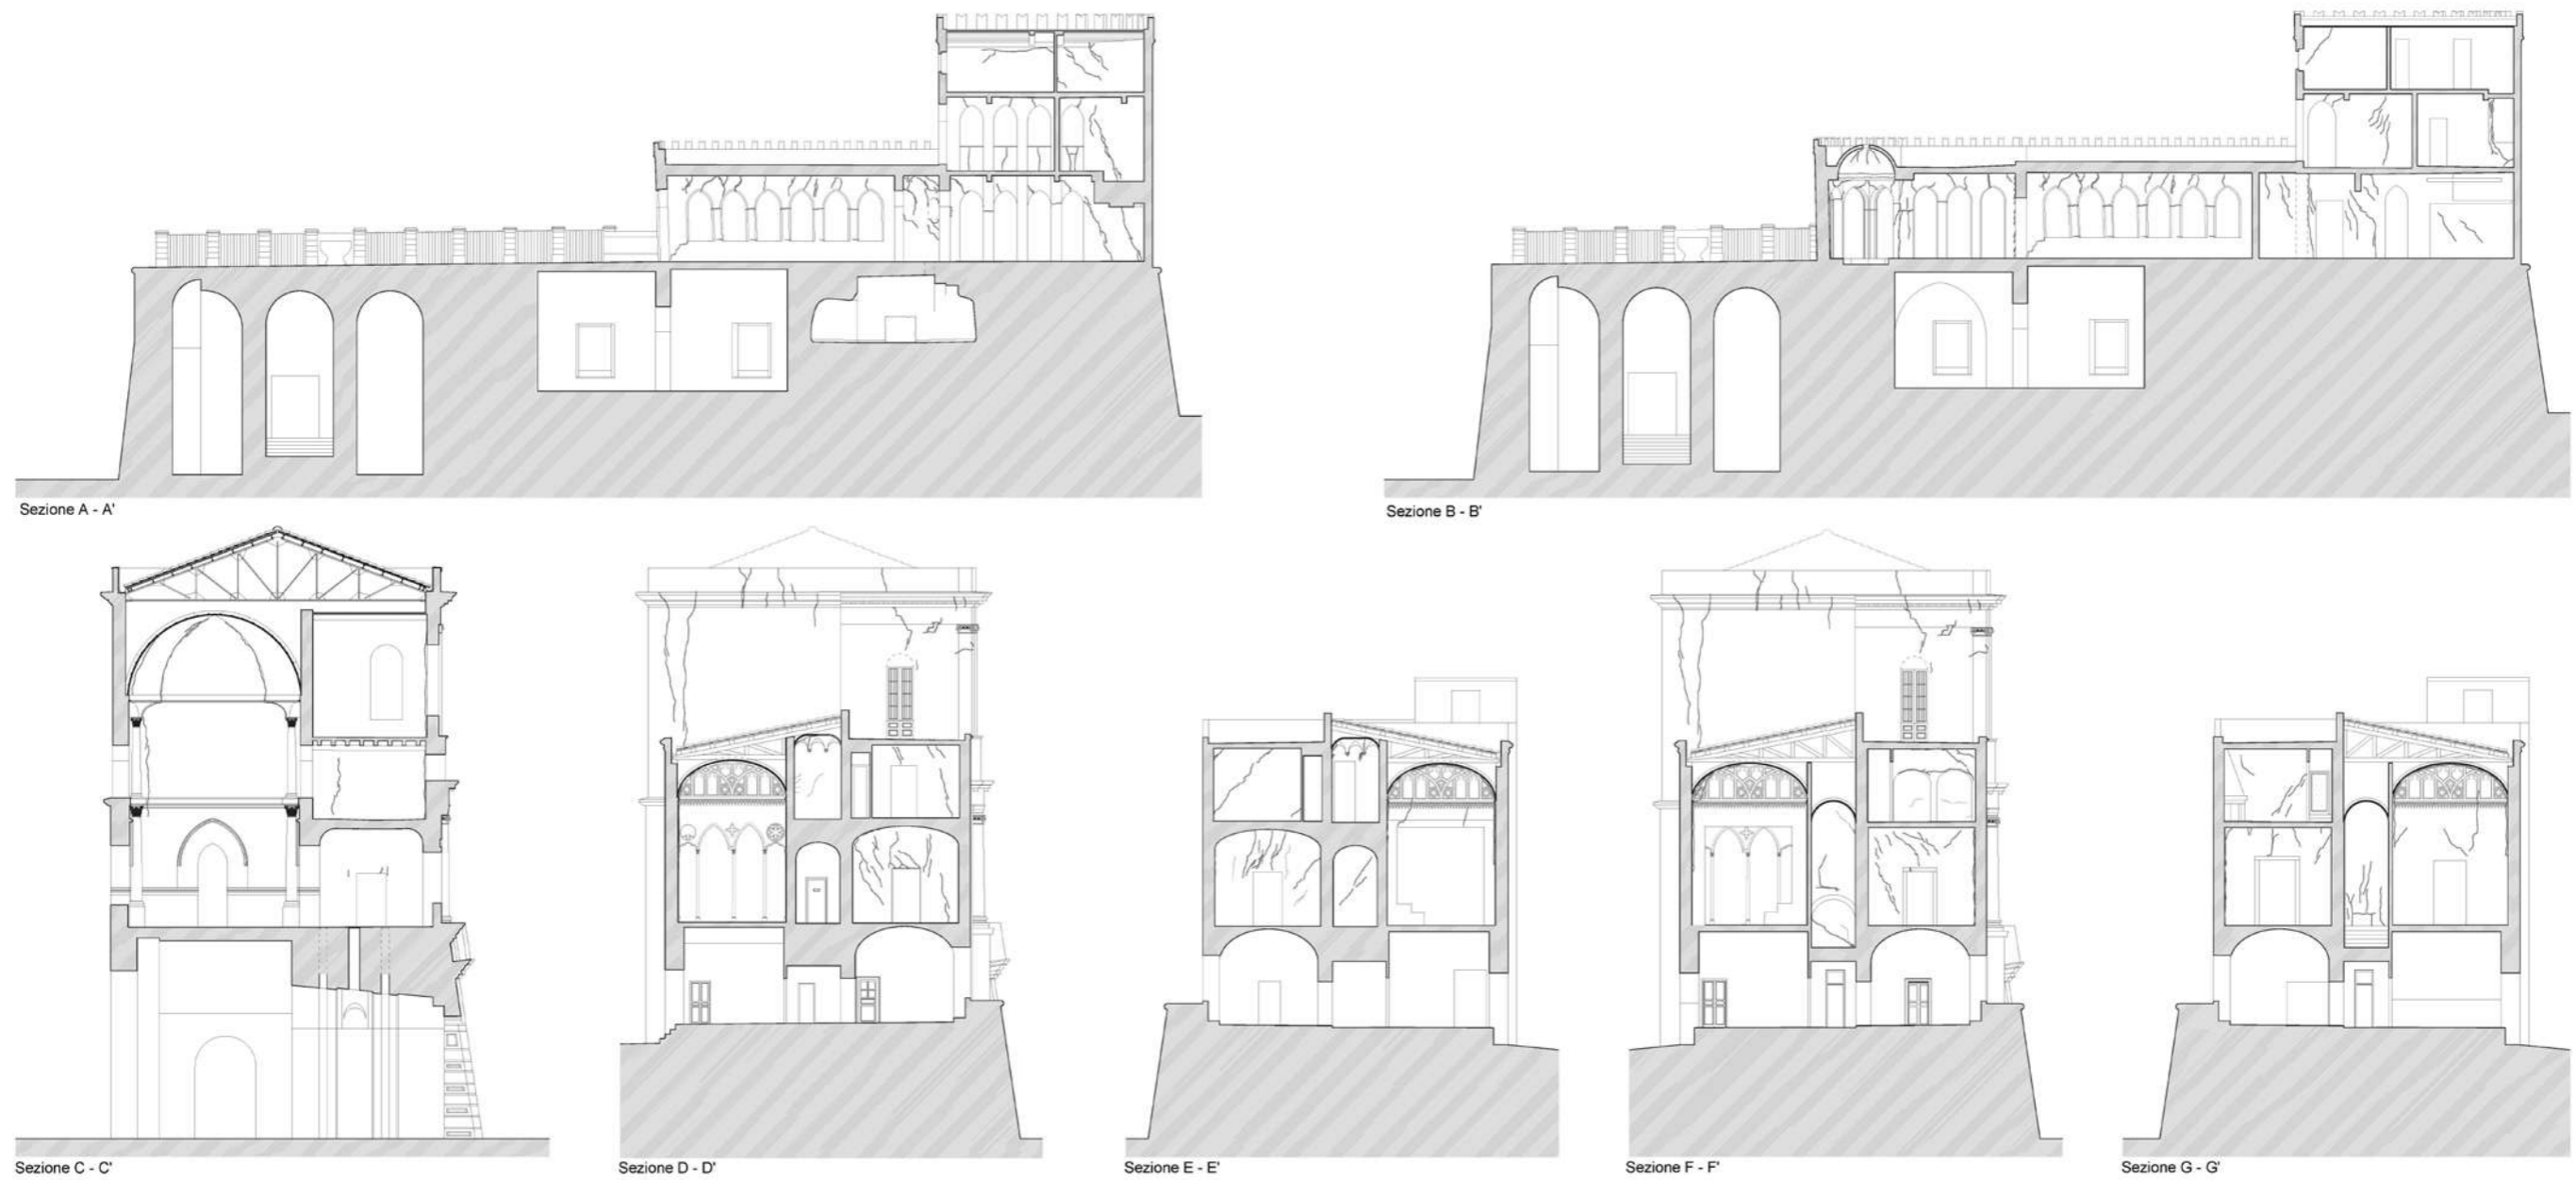
Fig.14: Architectural sections, actual condition of the palace before restoration. © Project Designers

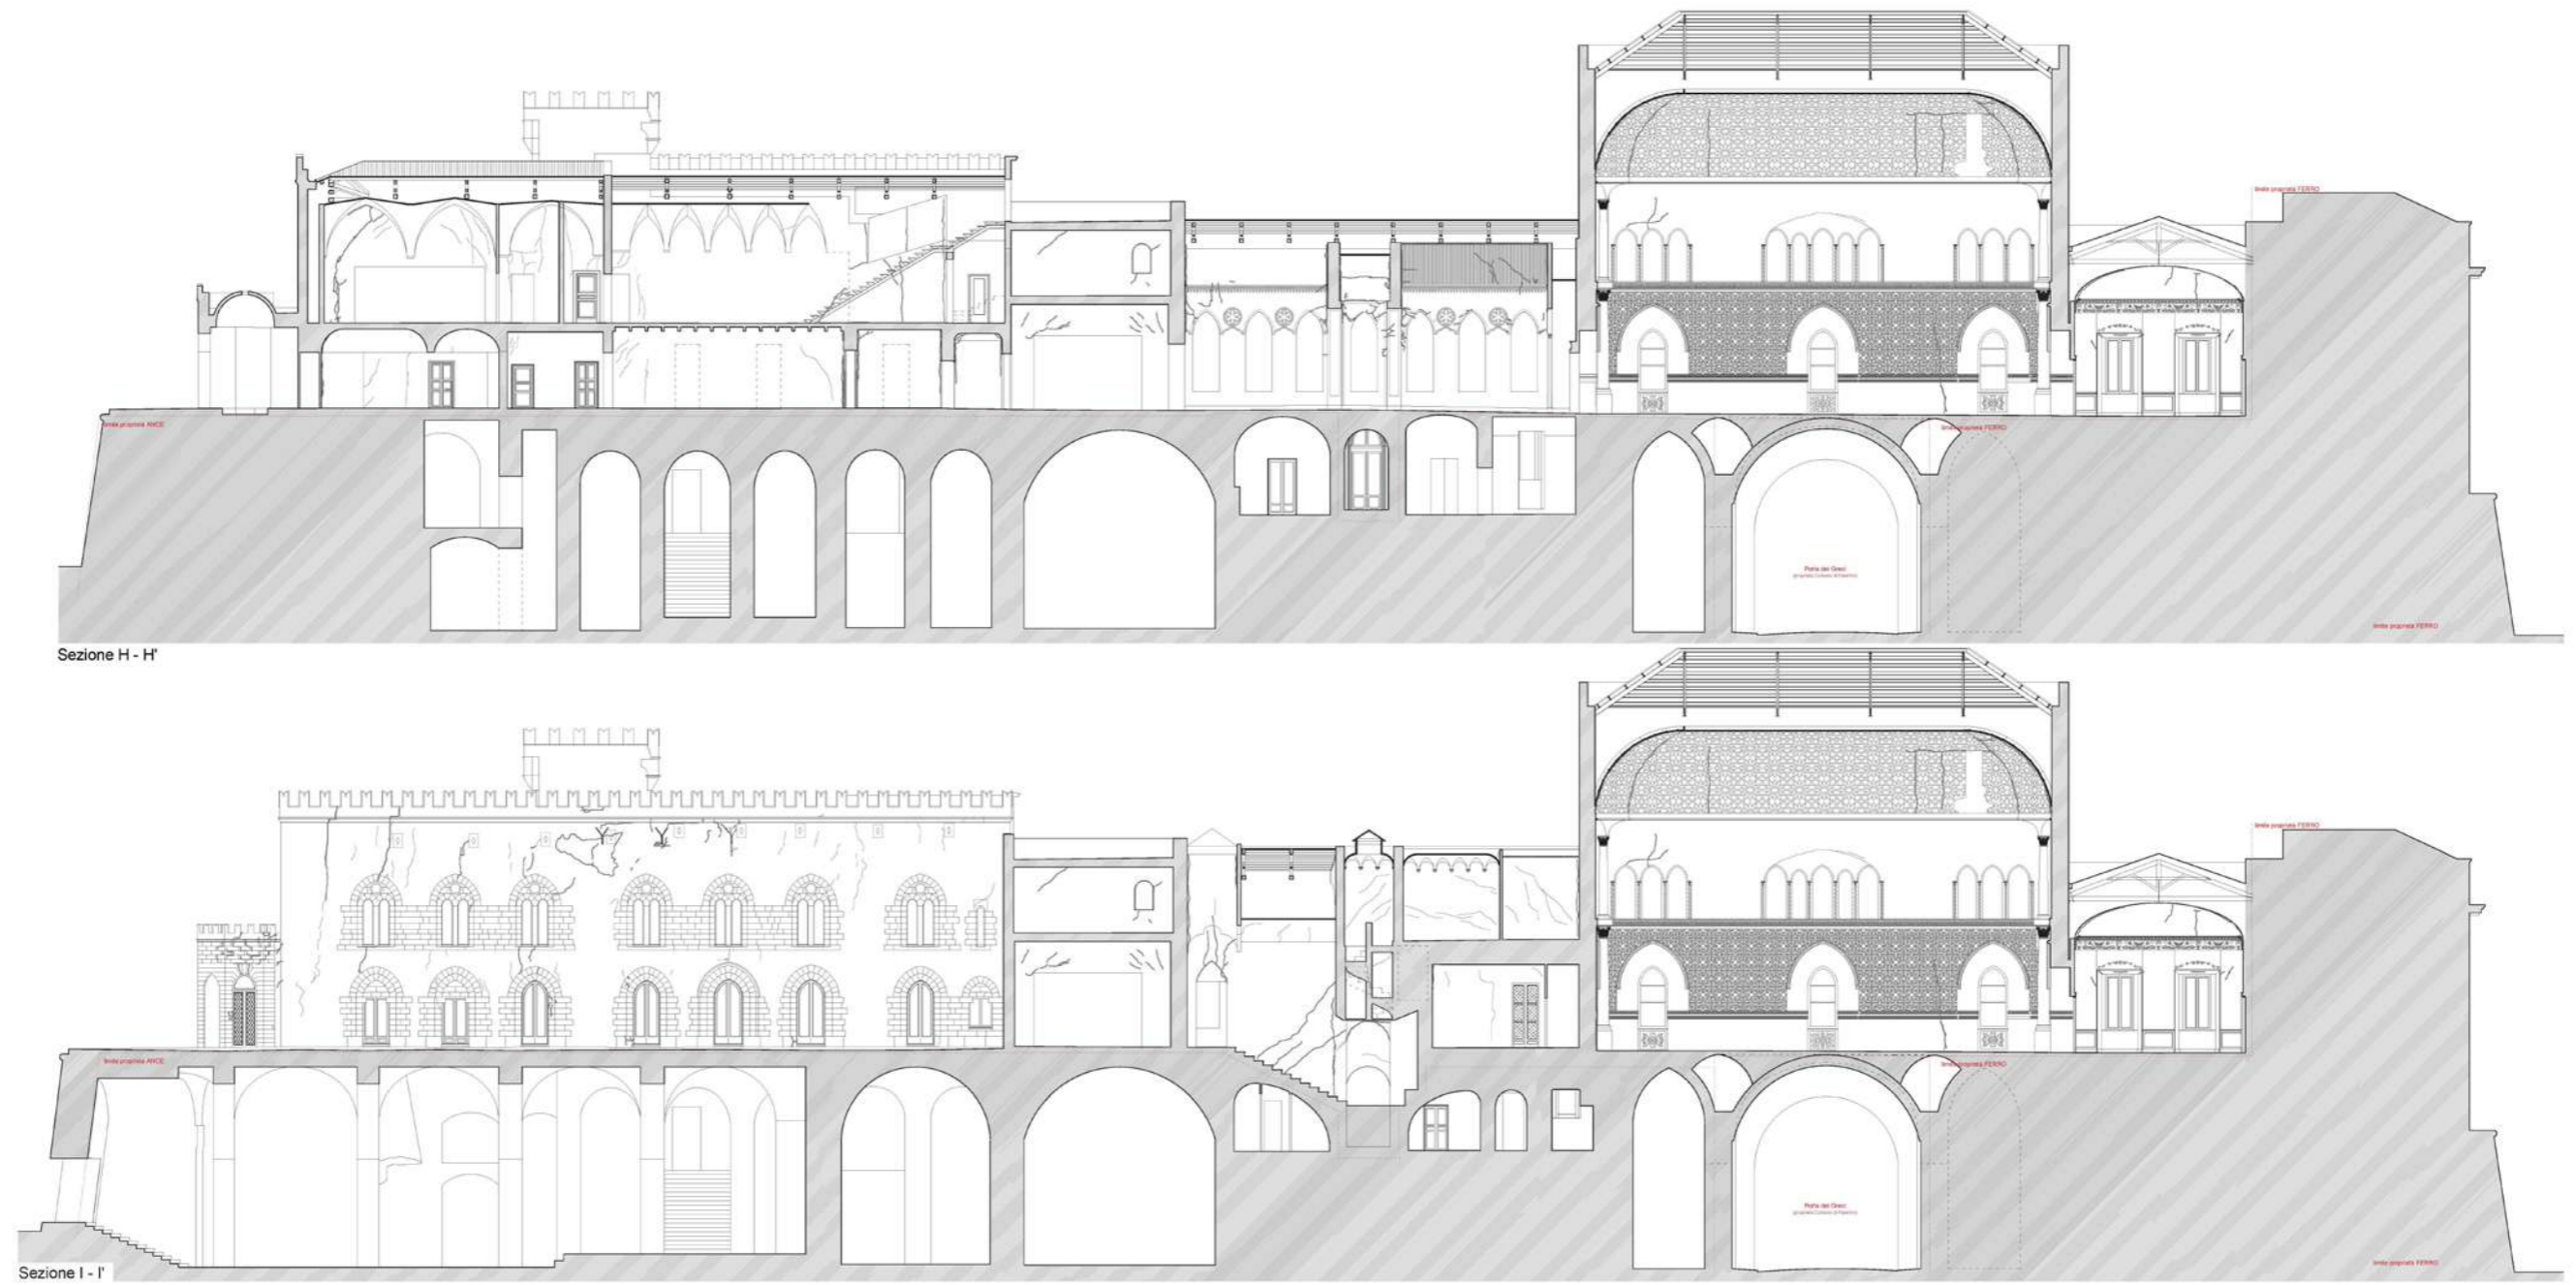
Fig.15: Architectural sections, actual condition of the palace before restoration. © Project Designers

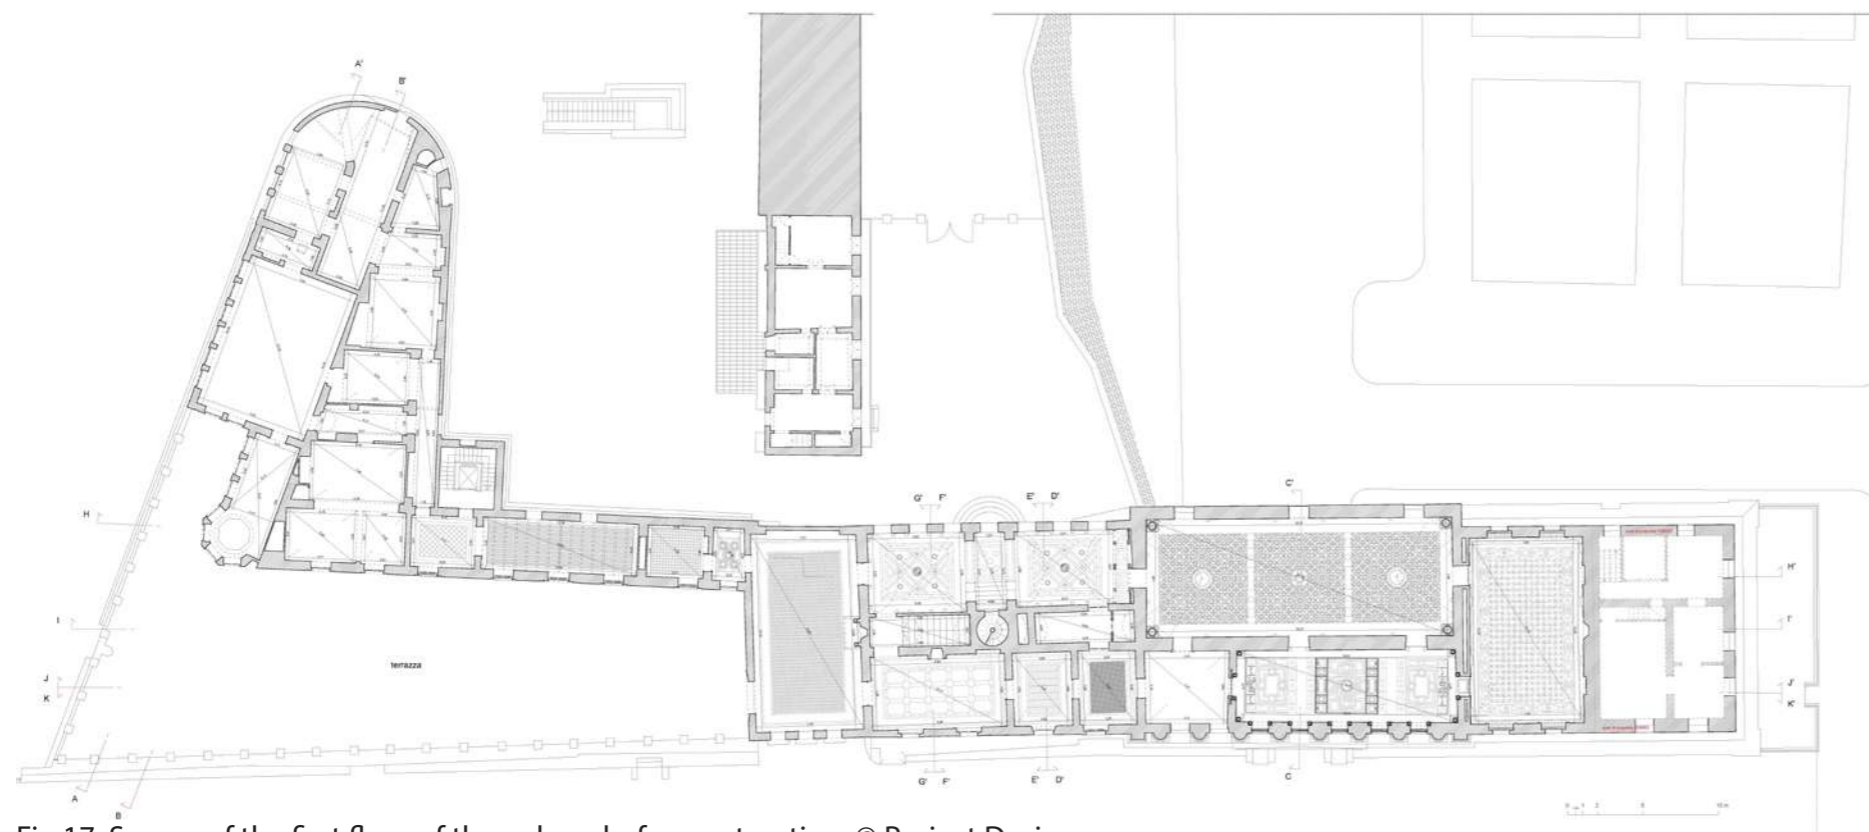
Fig.17: Survey of the first floor of the palace, before restoration. © Project Designers

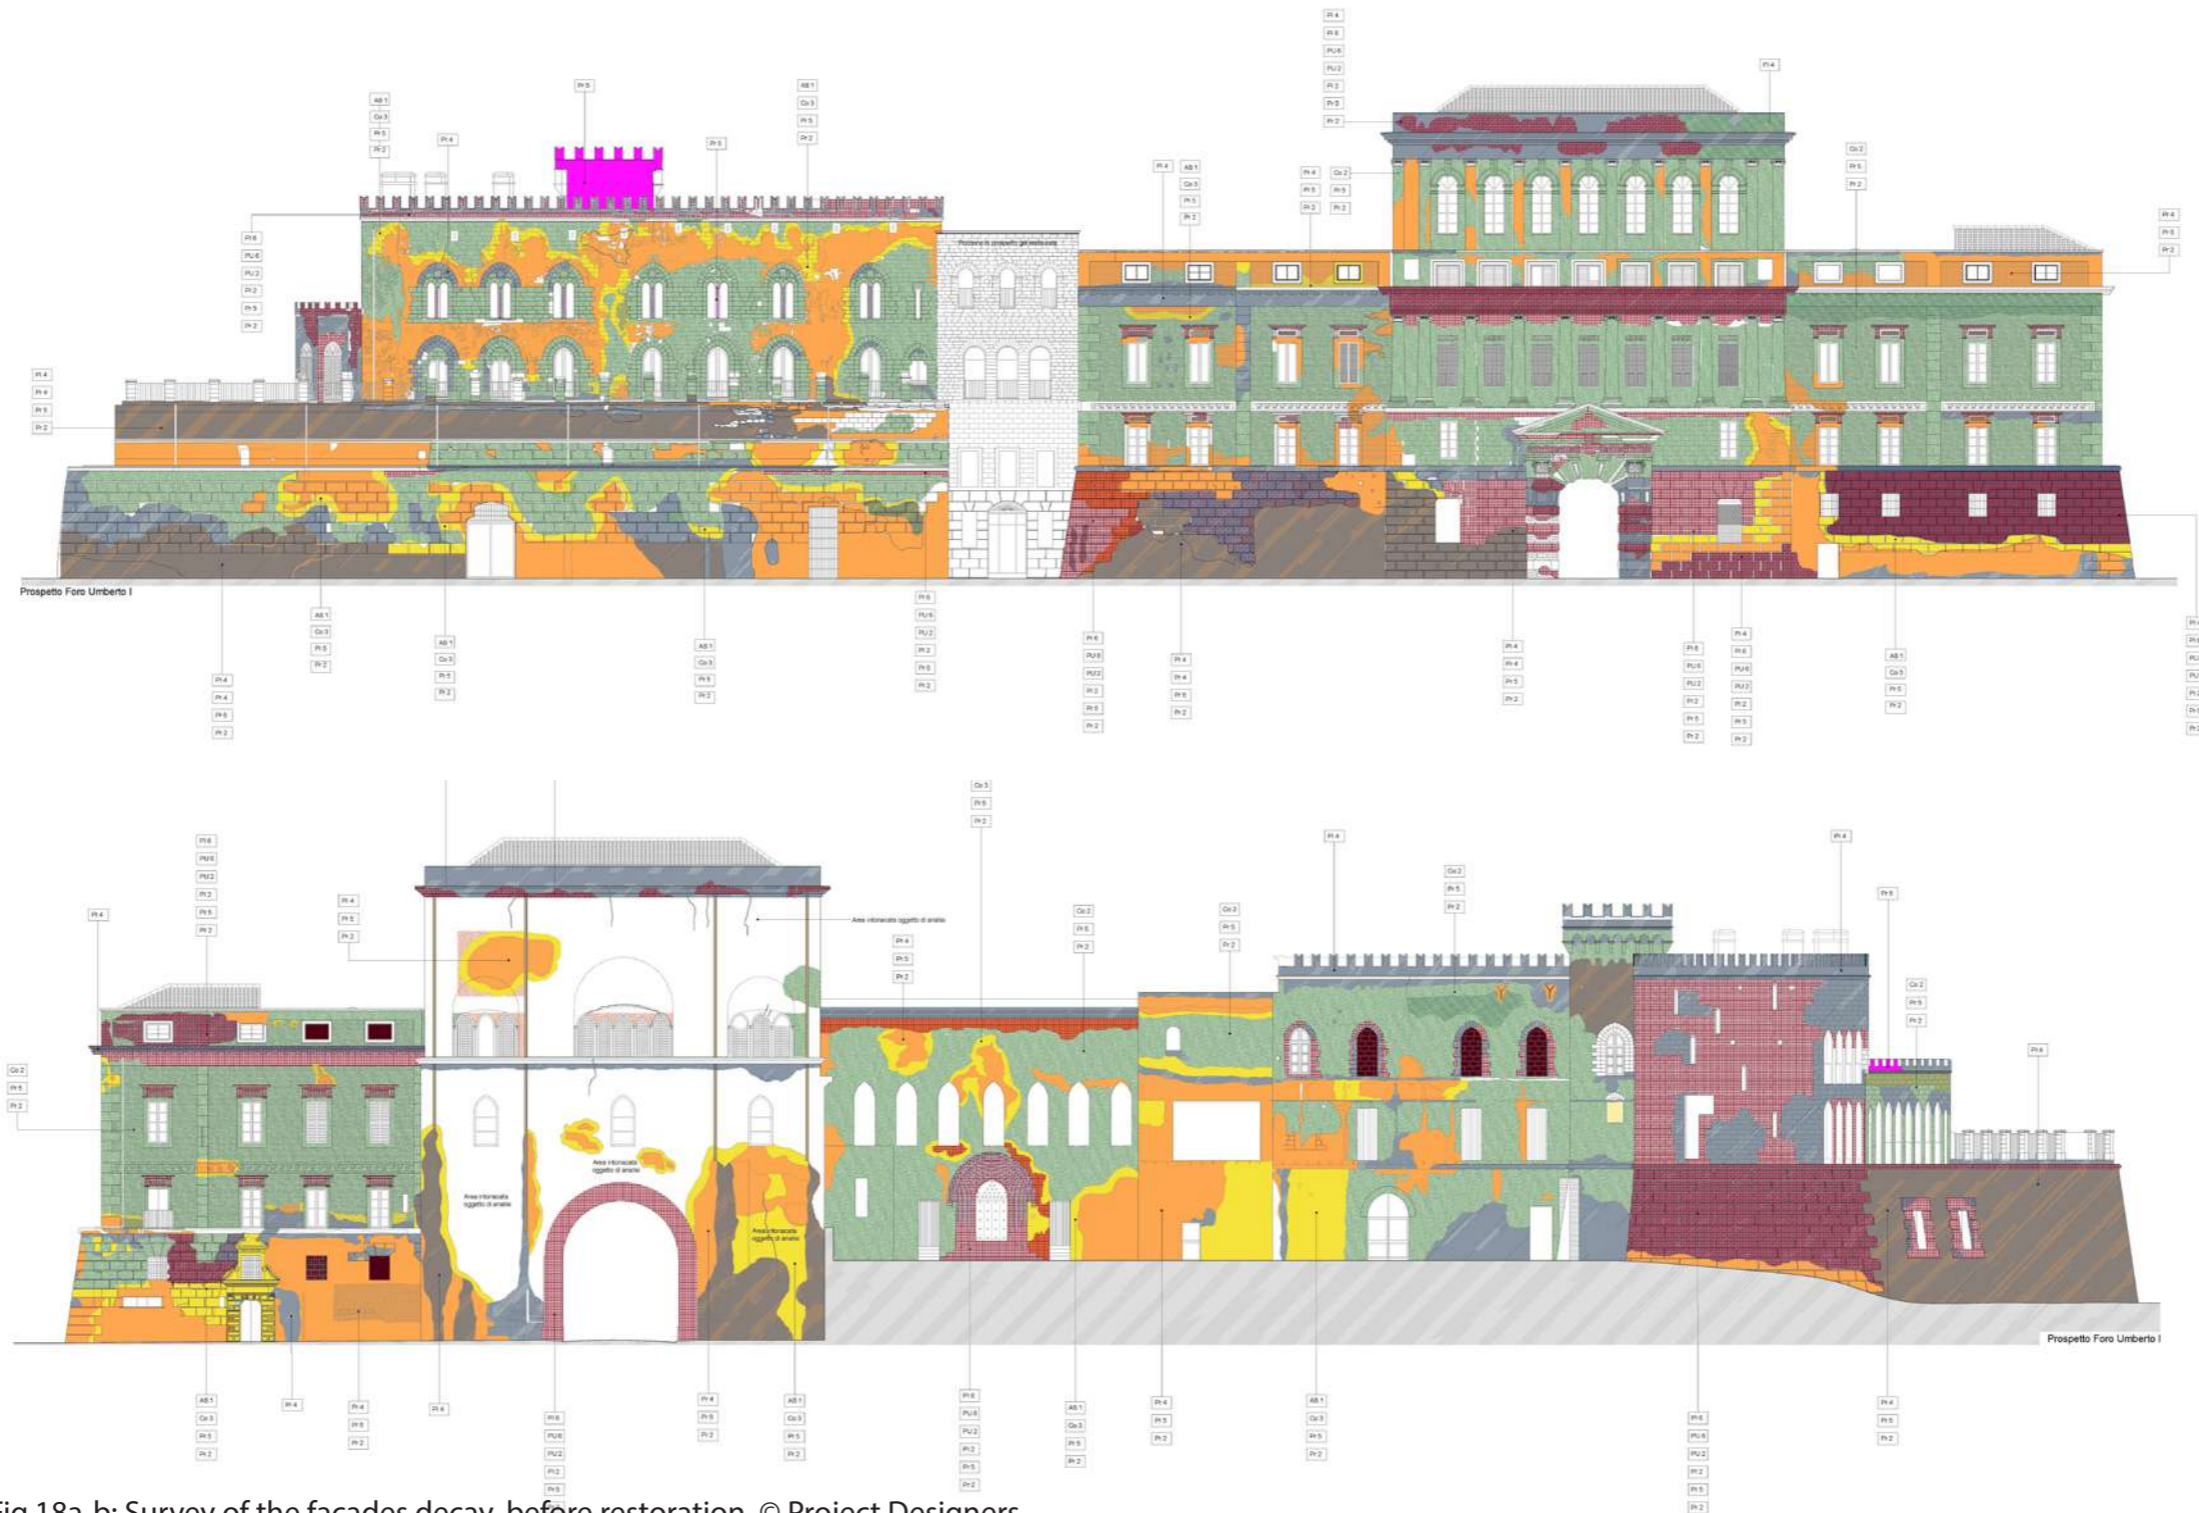
Fig.18a-b: Survey of the façades decay, before restoration. © Project Designers

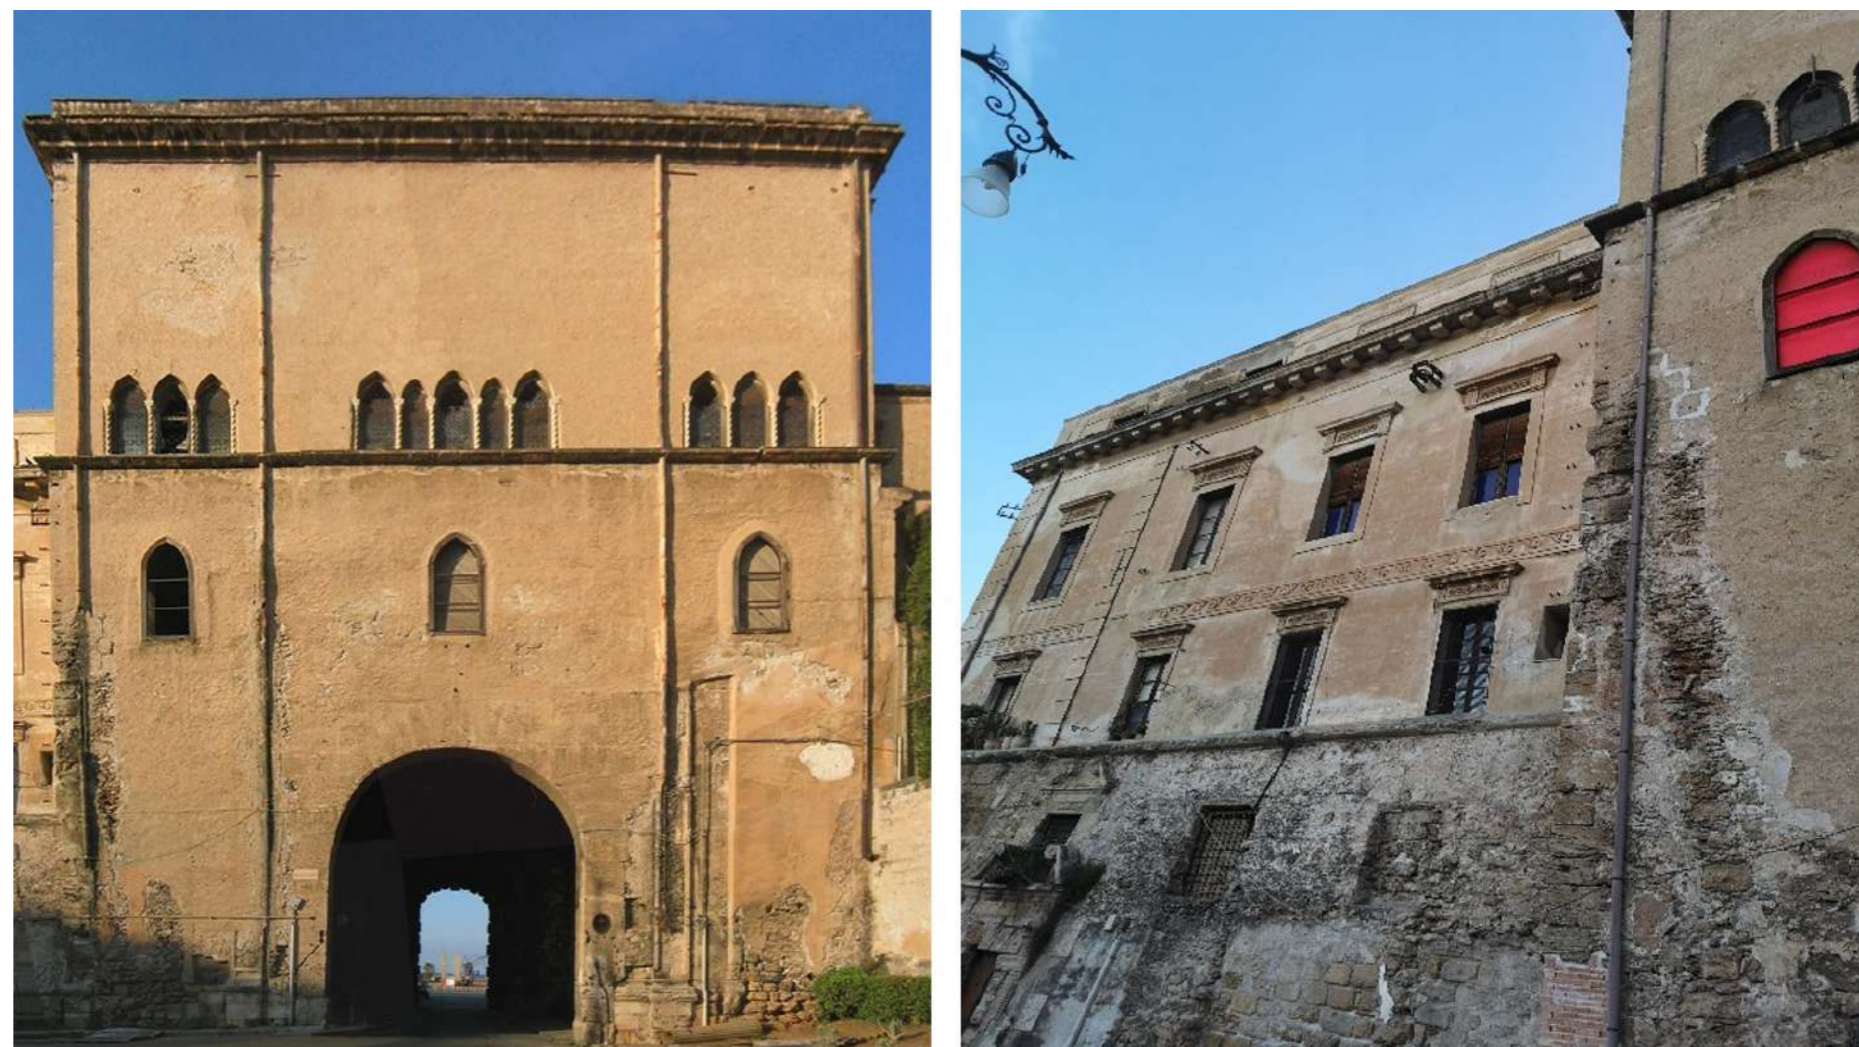
Fig.19a: Façade along Kalsa square: material-construction decay. © Project Designers

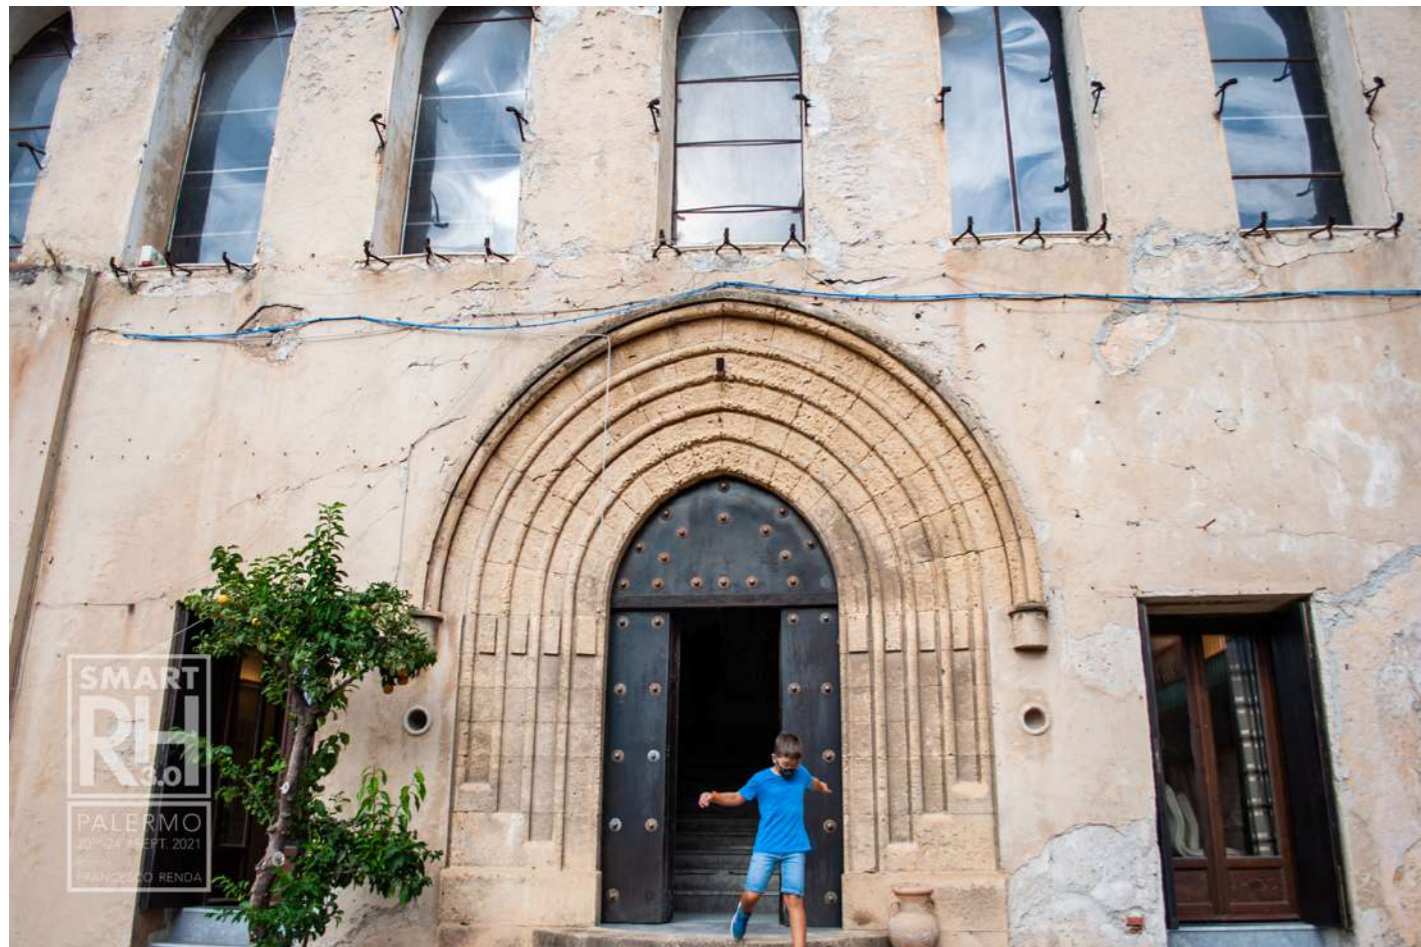
Fig.19b: Façade along Kalsa square: material-construction decay of plasters and stony portal. © Francesco Renda
