## A monumental palace, city walls and a gate in Palermo, involved in a fascinating restoration.

*After years of neglect and forgetfulness, the rebirth of a Mediterranean city waterfront piece.*

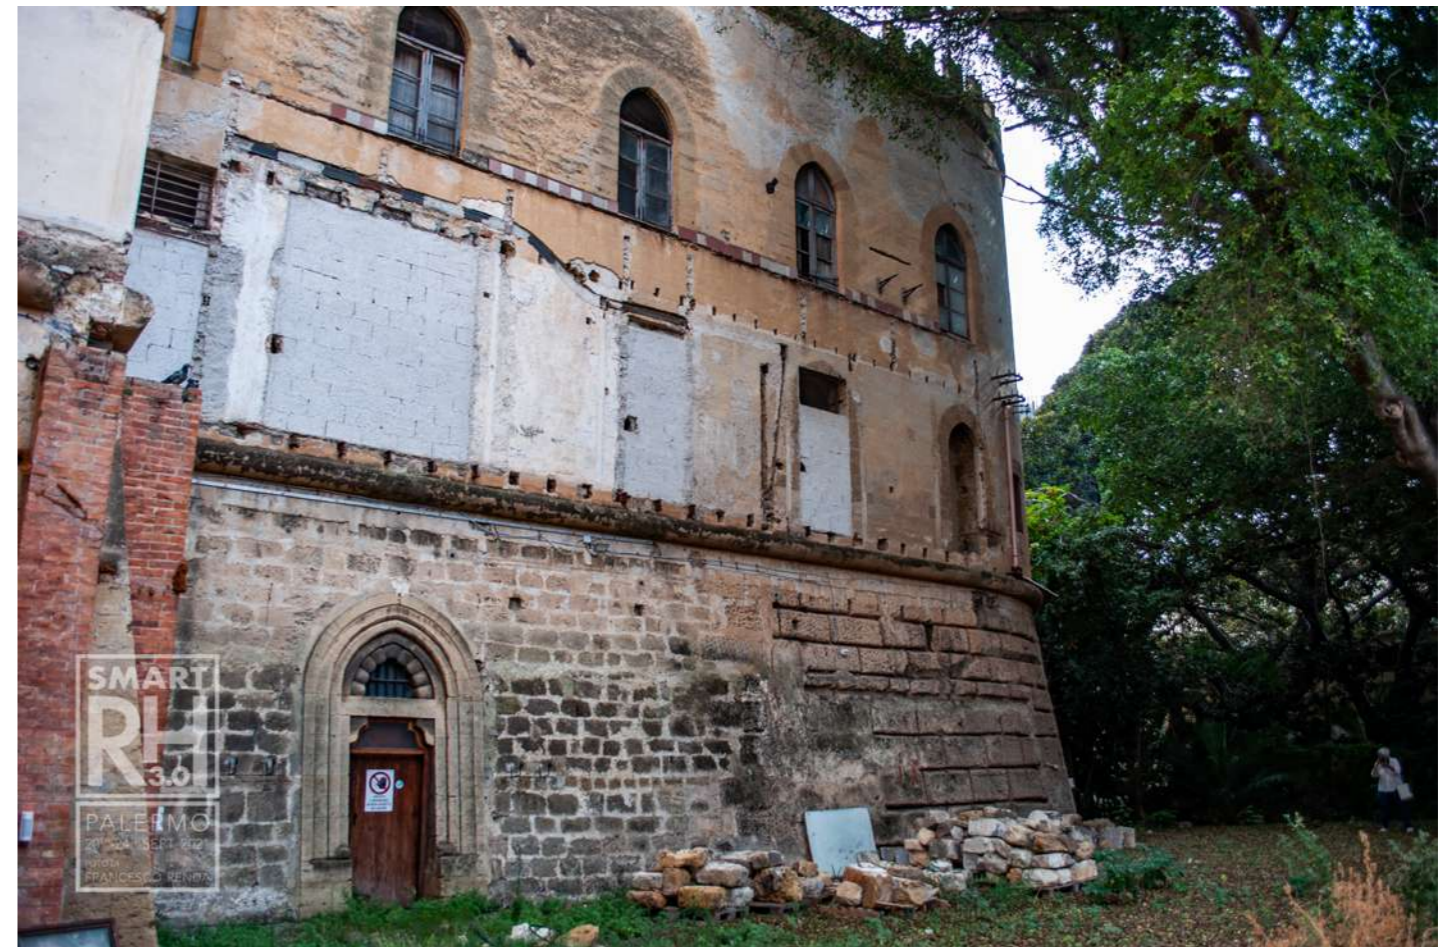
Fig.19c: Façade facing the inner garden: material-construction decay. © Francesco Renda

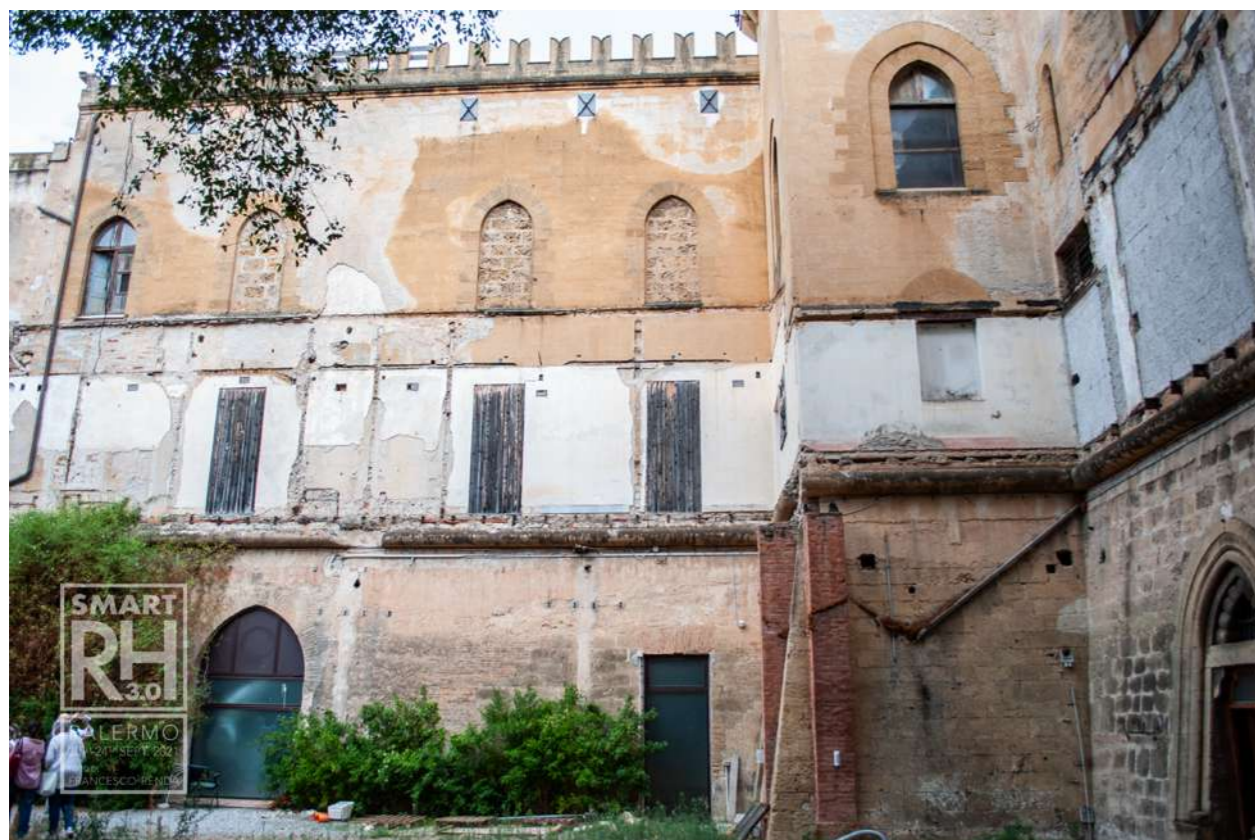
Fig.19d: Façade facing the inner garden: material-construction decay. © Francesco Renda

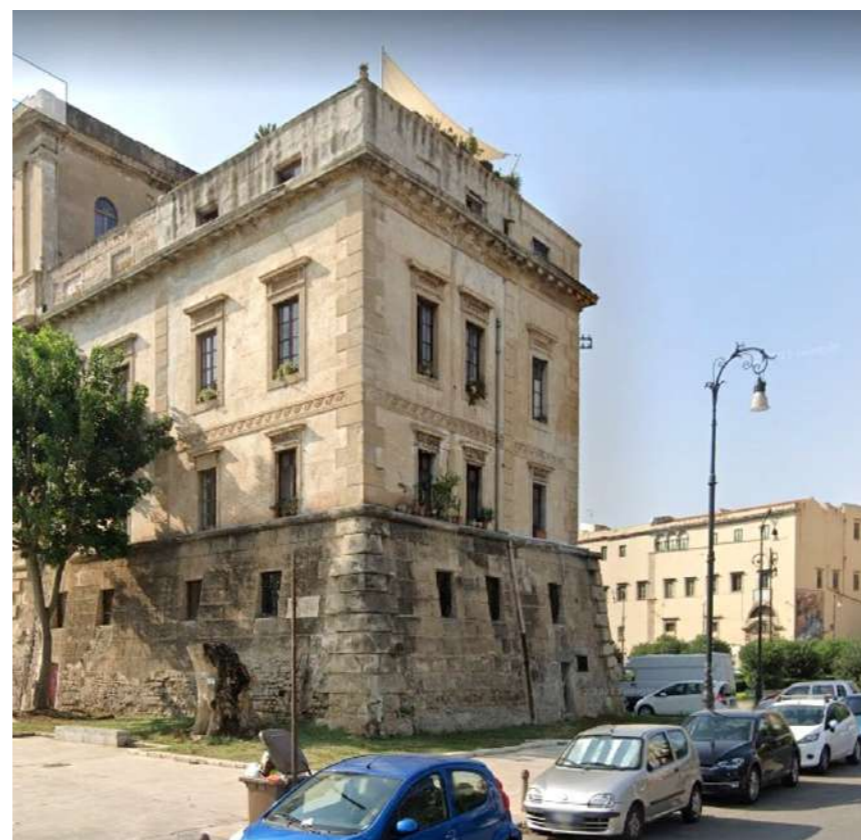
Fig.20a-b: Façade of neoclassical part of the palace: material-construction decay. © Francesco Renda

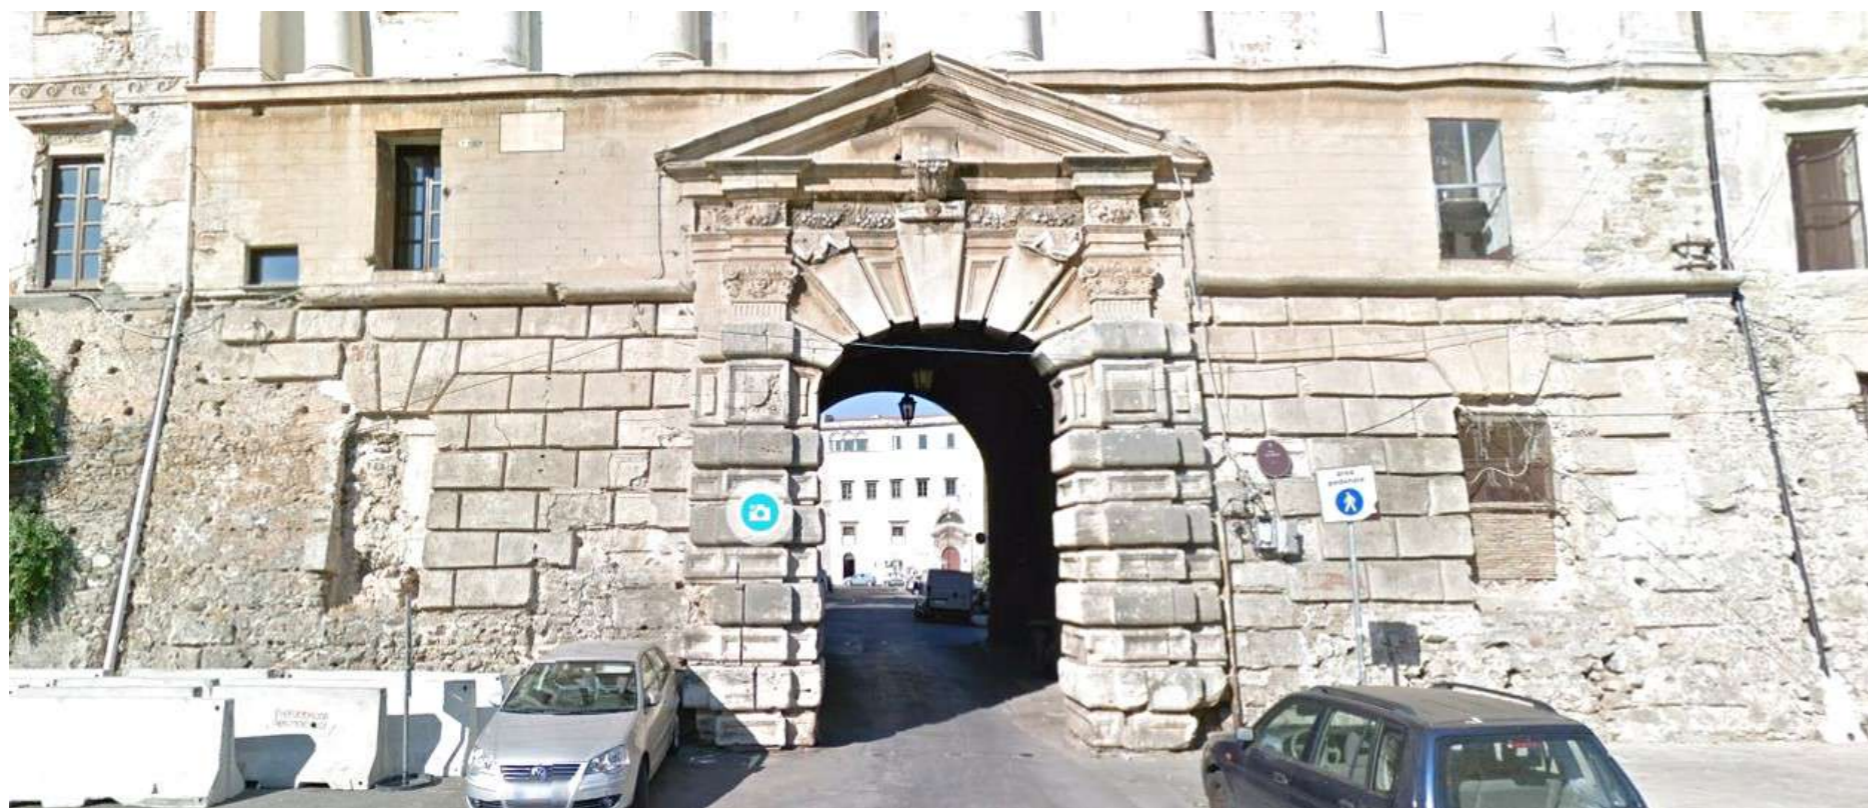
Fig.21: Detail of Façade along the waterfront: material-construction decay. © Francesco Renda

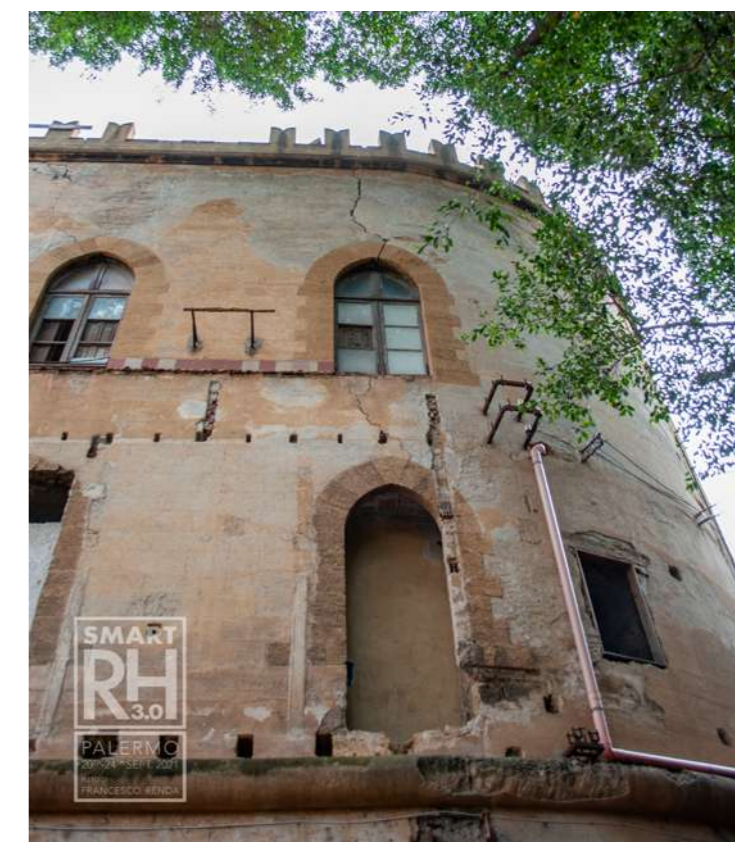
Fig.22: Detail of cracks in the façade of palace tower. © Francesco Renda

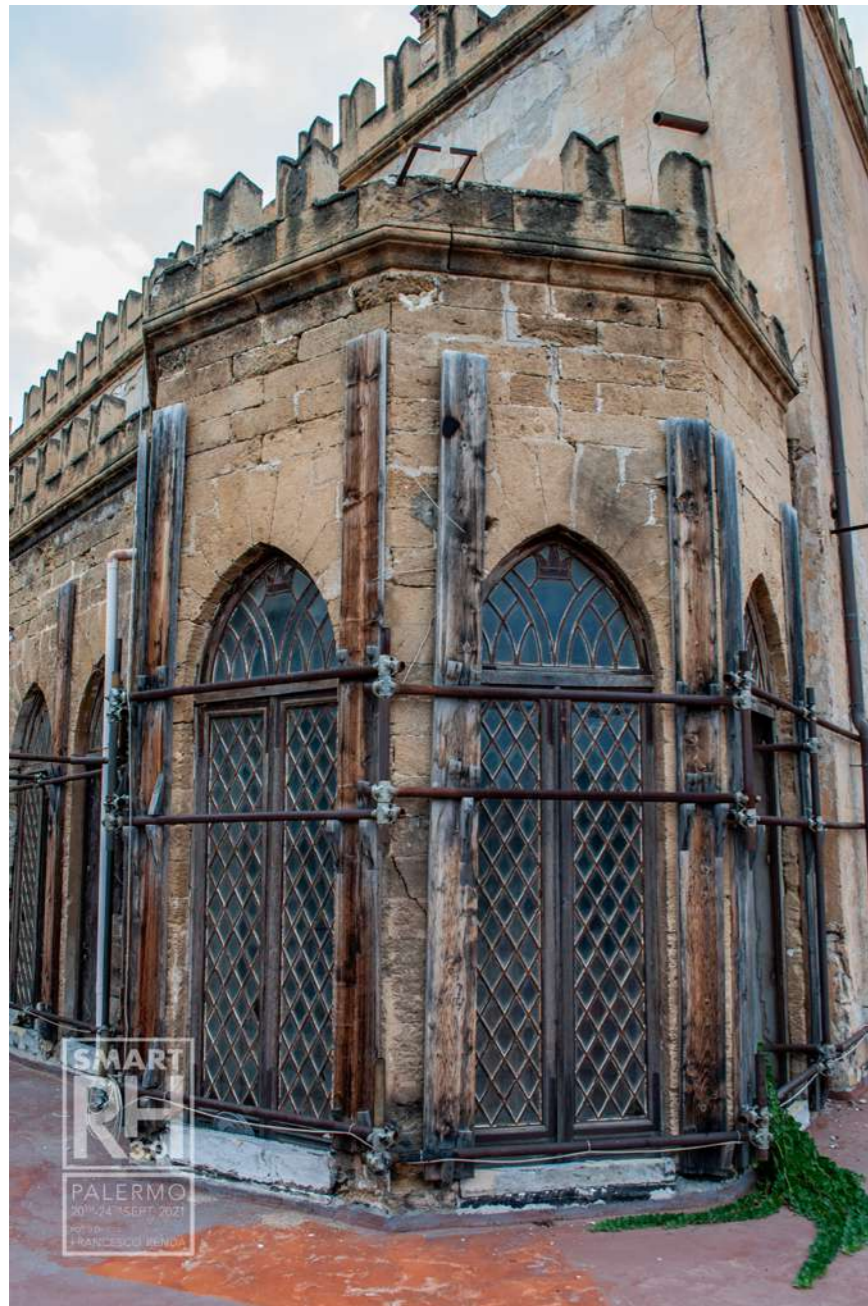
Fig.23: Consolidation and reinforcement systems in the façade of palace tower. © Francesco Renda

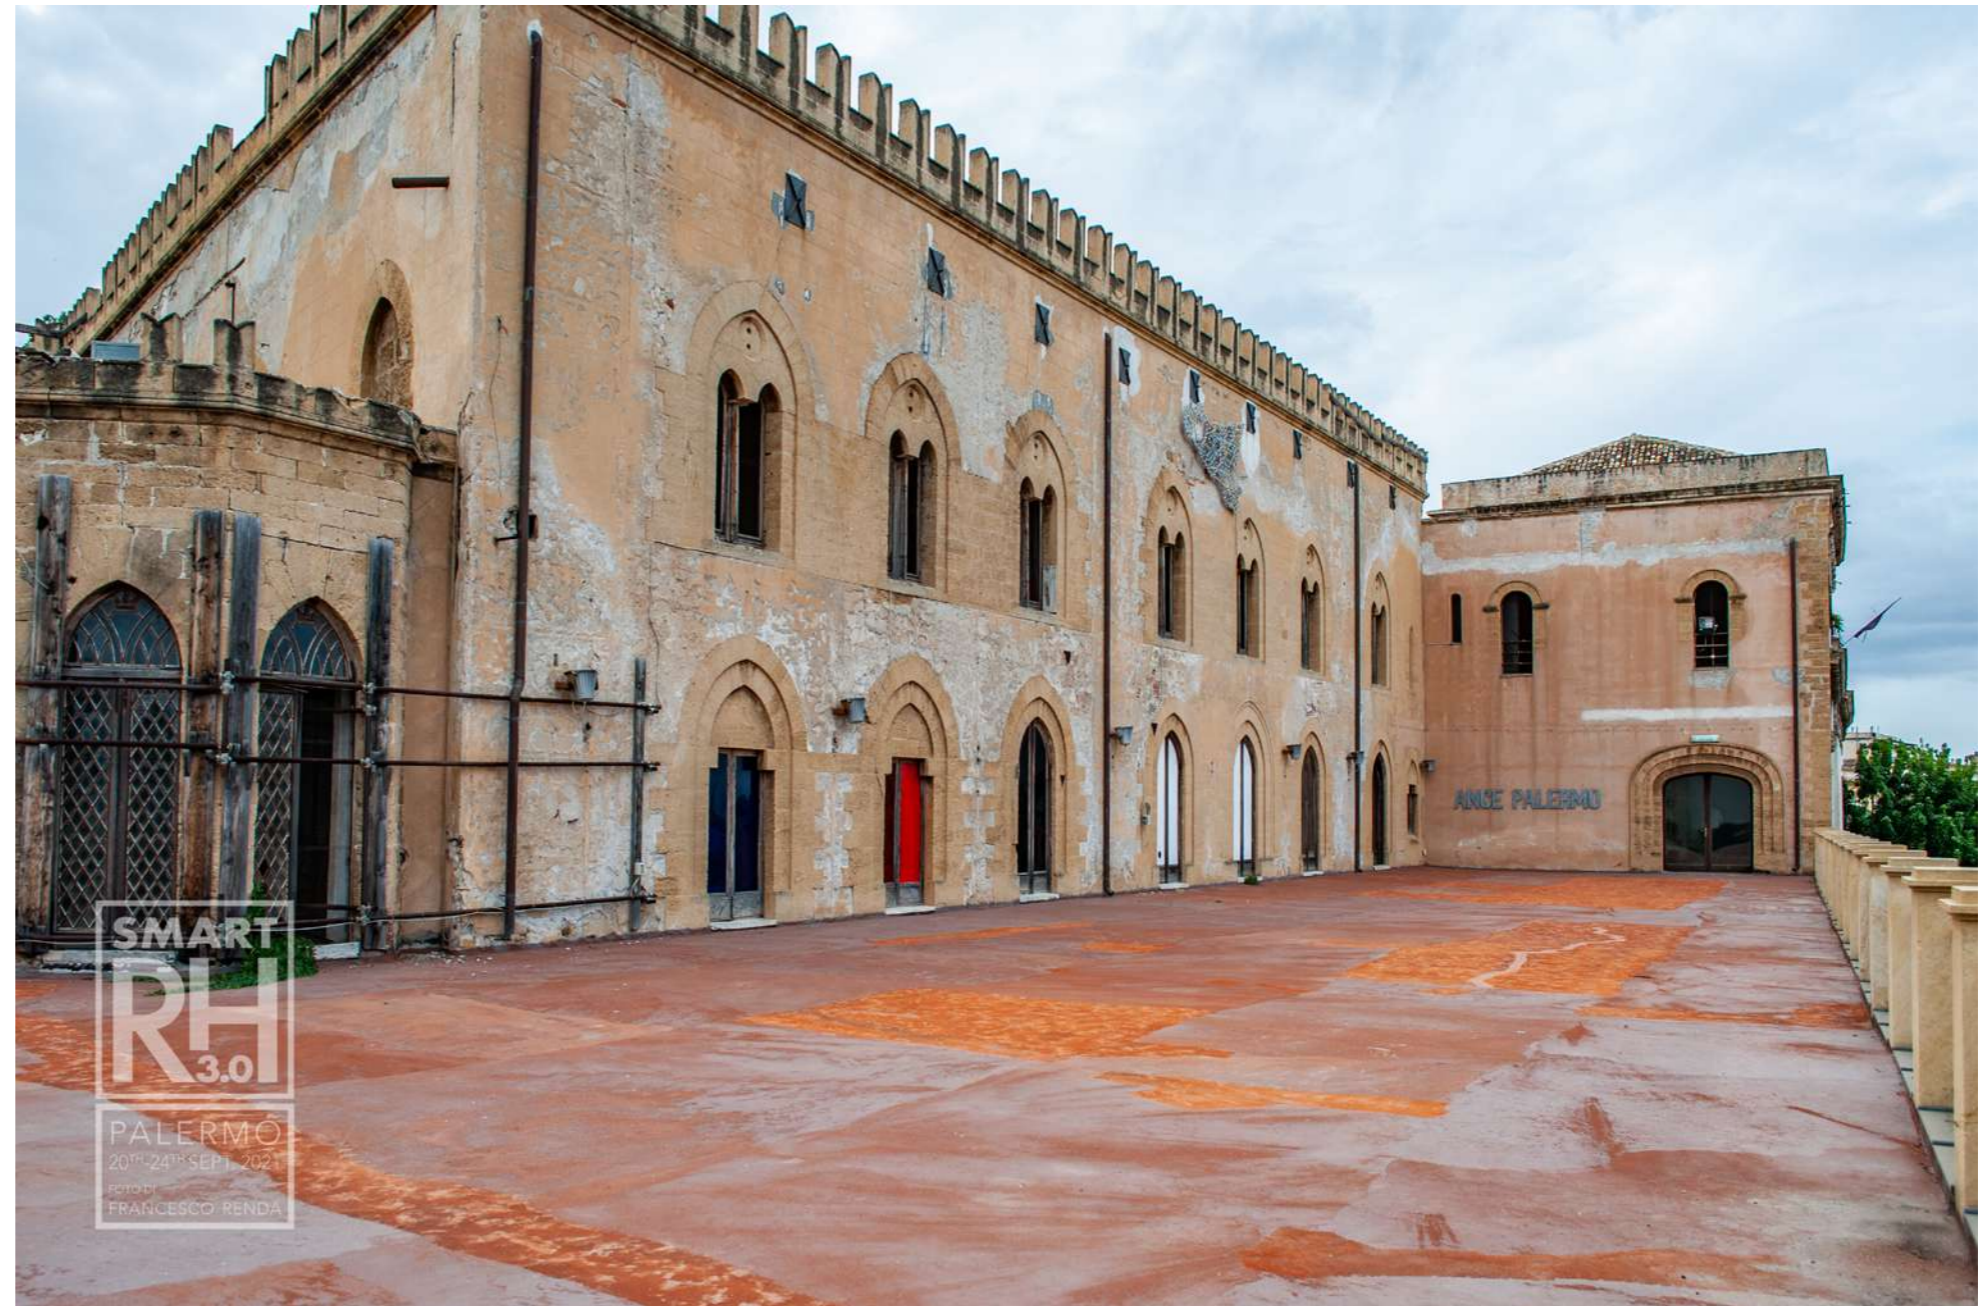
Fig.24: Detail of façade along the waterfront (first floor and terrace): material-construction decay. © Francesco Renda

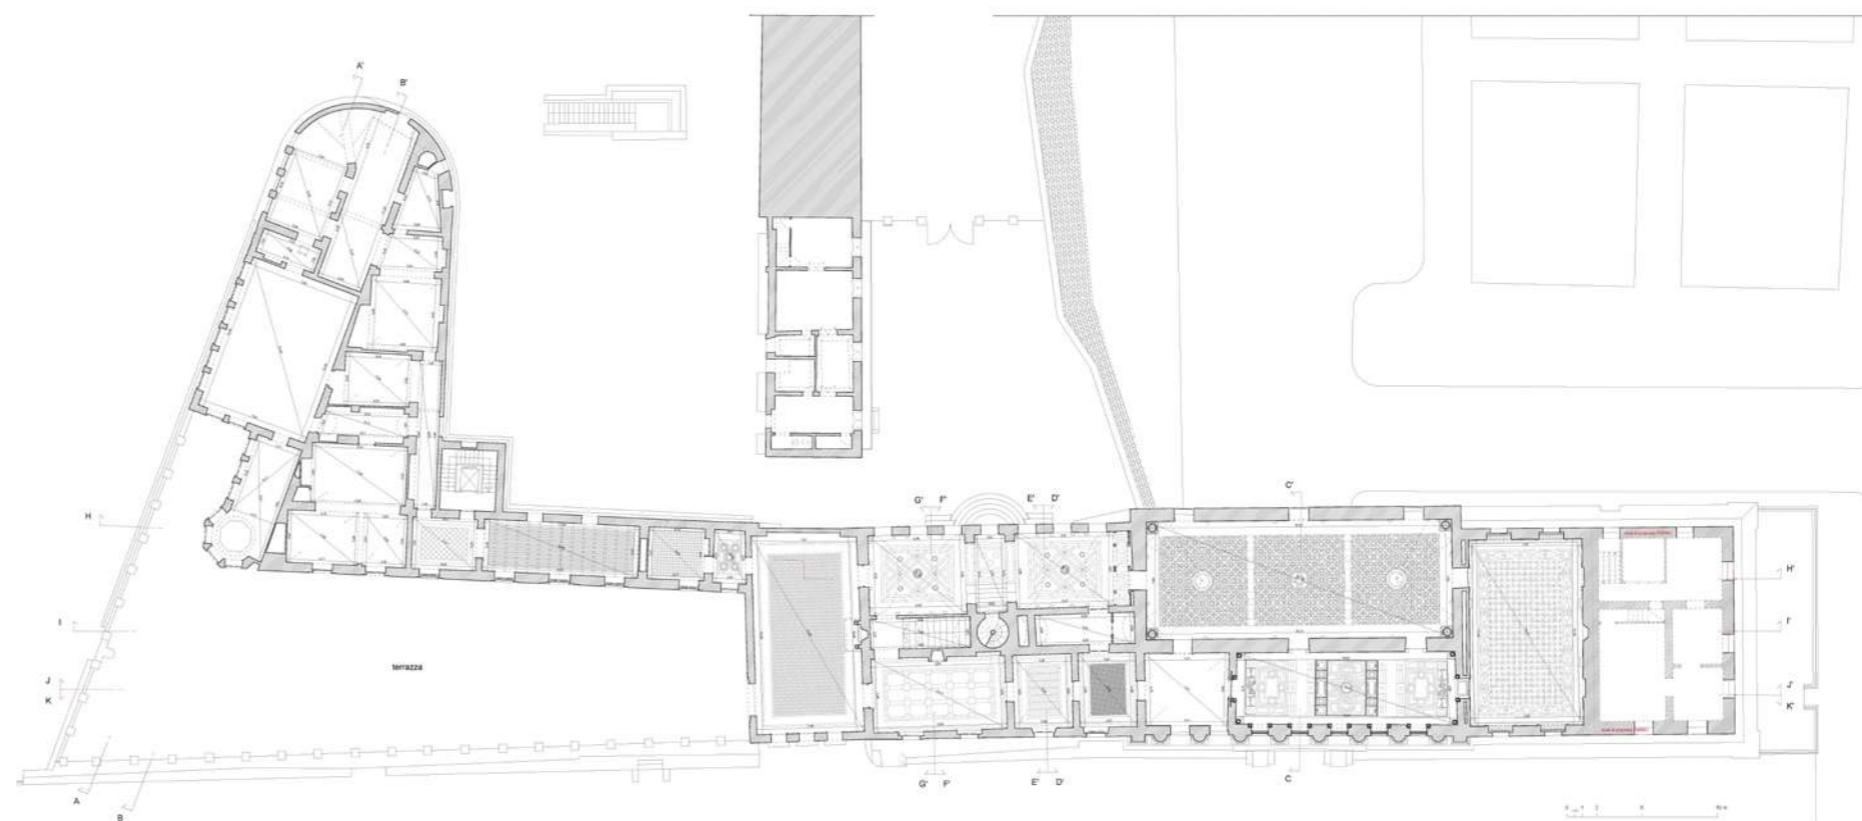
Fig.27: First-floor plan: project. © Project Designers
