Rehabilitation of two tanneries for urban revitalization.

Rehabilitation of the Bella and Bernades tanneries, Igualada, Barcelona, Spain.

Designer Taller 9s Arquitectes:
Oriol Cusidó and Irene Marzo

Date June 2013 - October 2013
April 2014 - March 2015

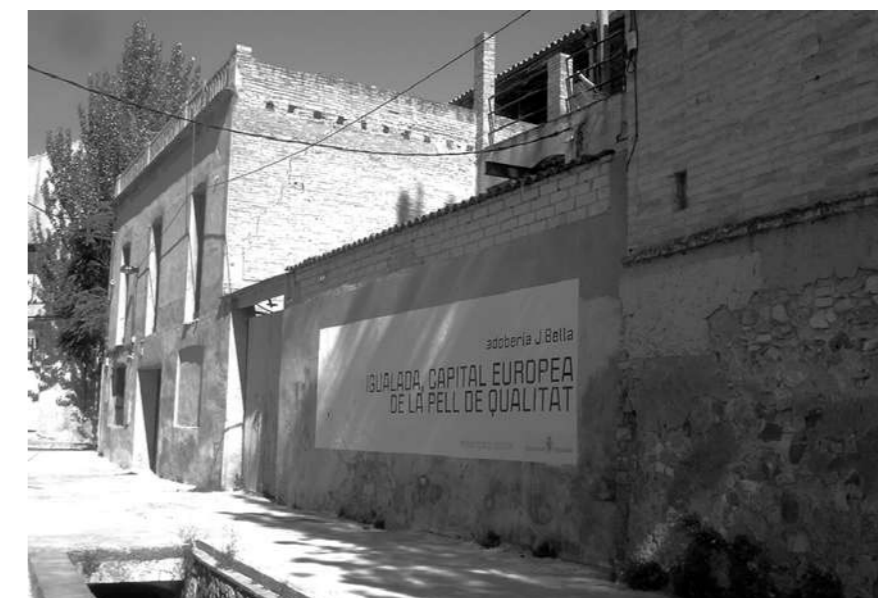
Fig.1: View of the existing conditions of the buildings' exteriors.
© Taller 9s Arquitectes

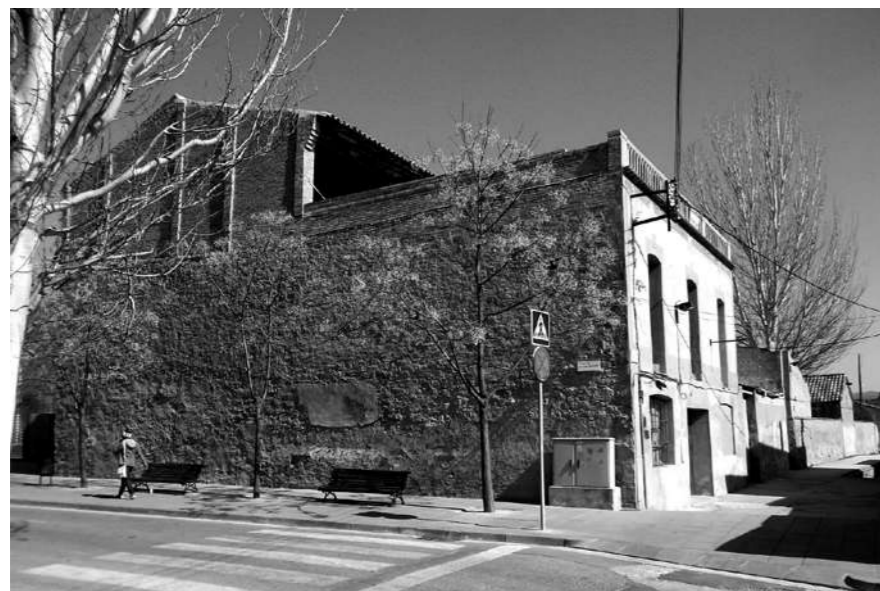
Fig.2: View of the existing conditions of the buildings' exteriors from the main street. © Taller 9s Arquitectes

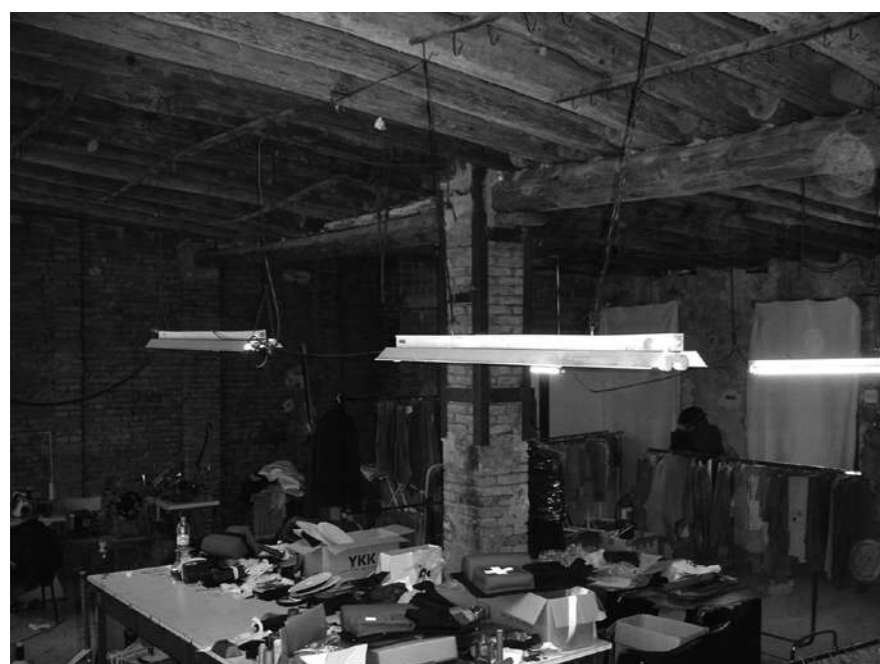
Fig.3: View of the existing conditions in the interiors of the buildings. © Taller 9s Arquitectes

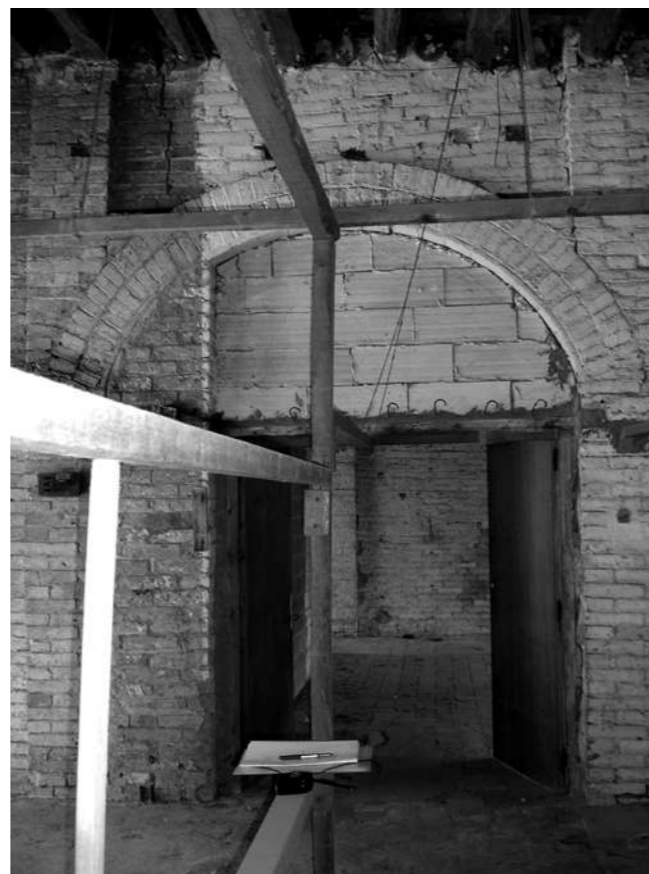
Fig.4: View of the existing conditions of wall surfaces in the interiors of the buildings. © Taller 9s Arquitectes

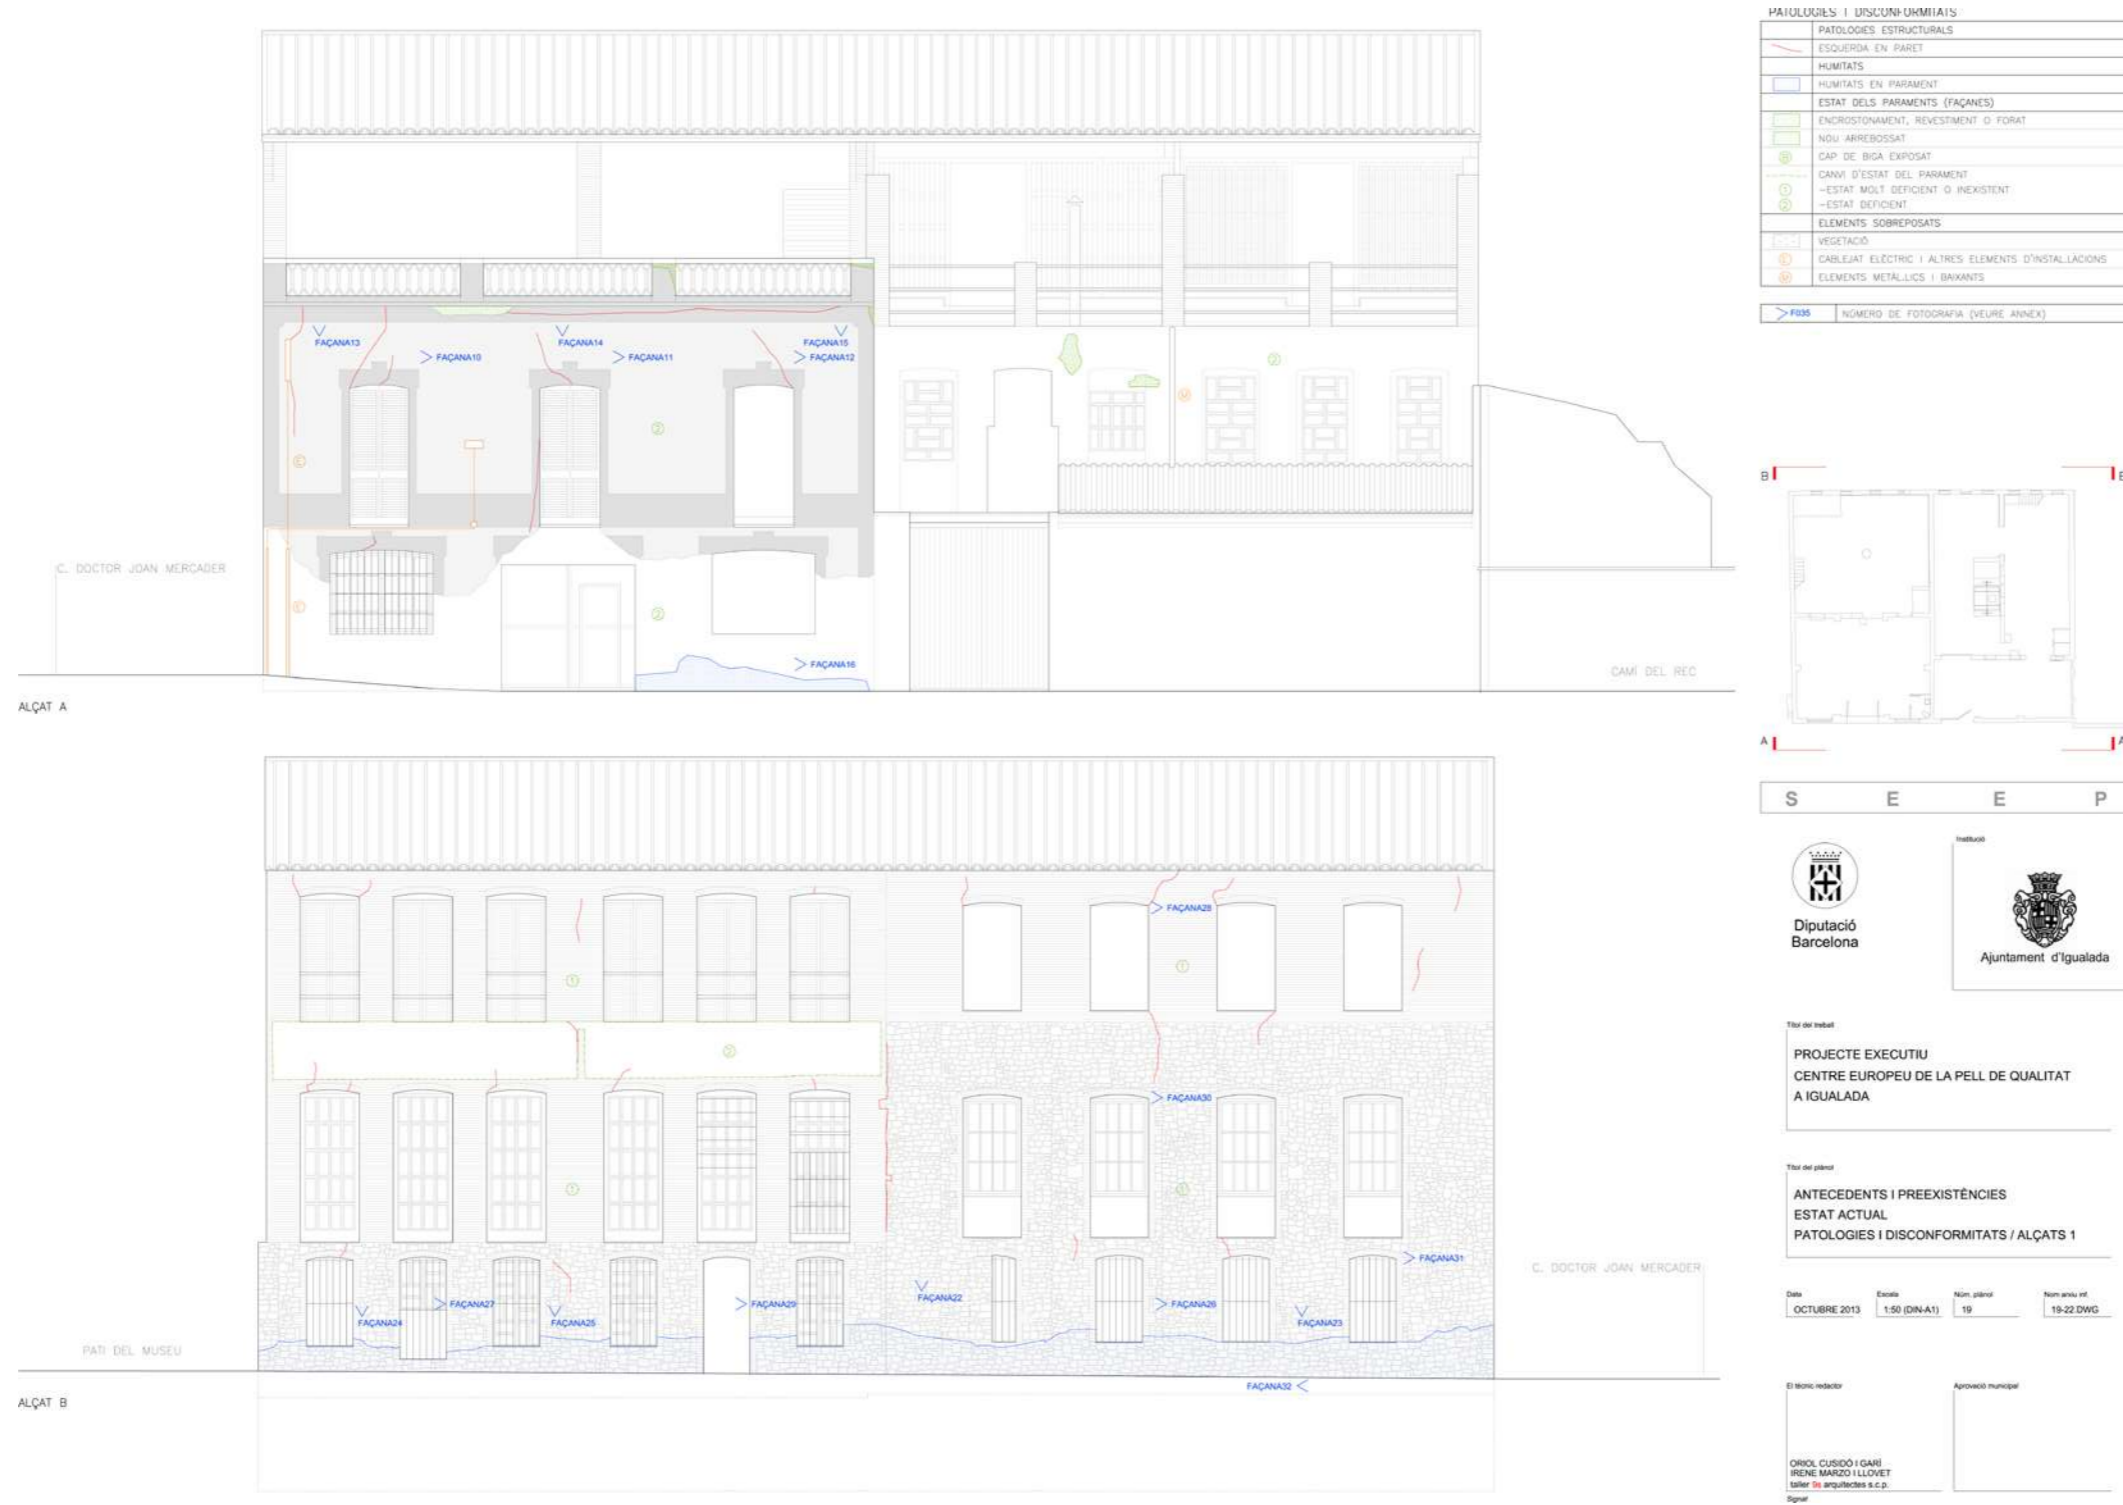
Fig.18: Study of the current state of the façades. Pathologies and facings.. © Taller 9s Arquitectes

The main innovative contribution was the application on the exterior of the façade of an ecological coating based on hydraulic lime and cork (TERMOCAL V) with high thermal performance ($U = 0.044 \text{ W / m}^2\text{k}$) that allows to leave the interior walls visible. The product preserves the properties of traditional lime mortar (breathability) and is easy to apply when sprayed.

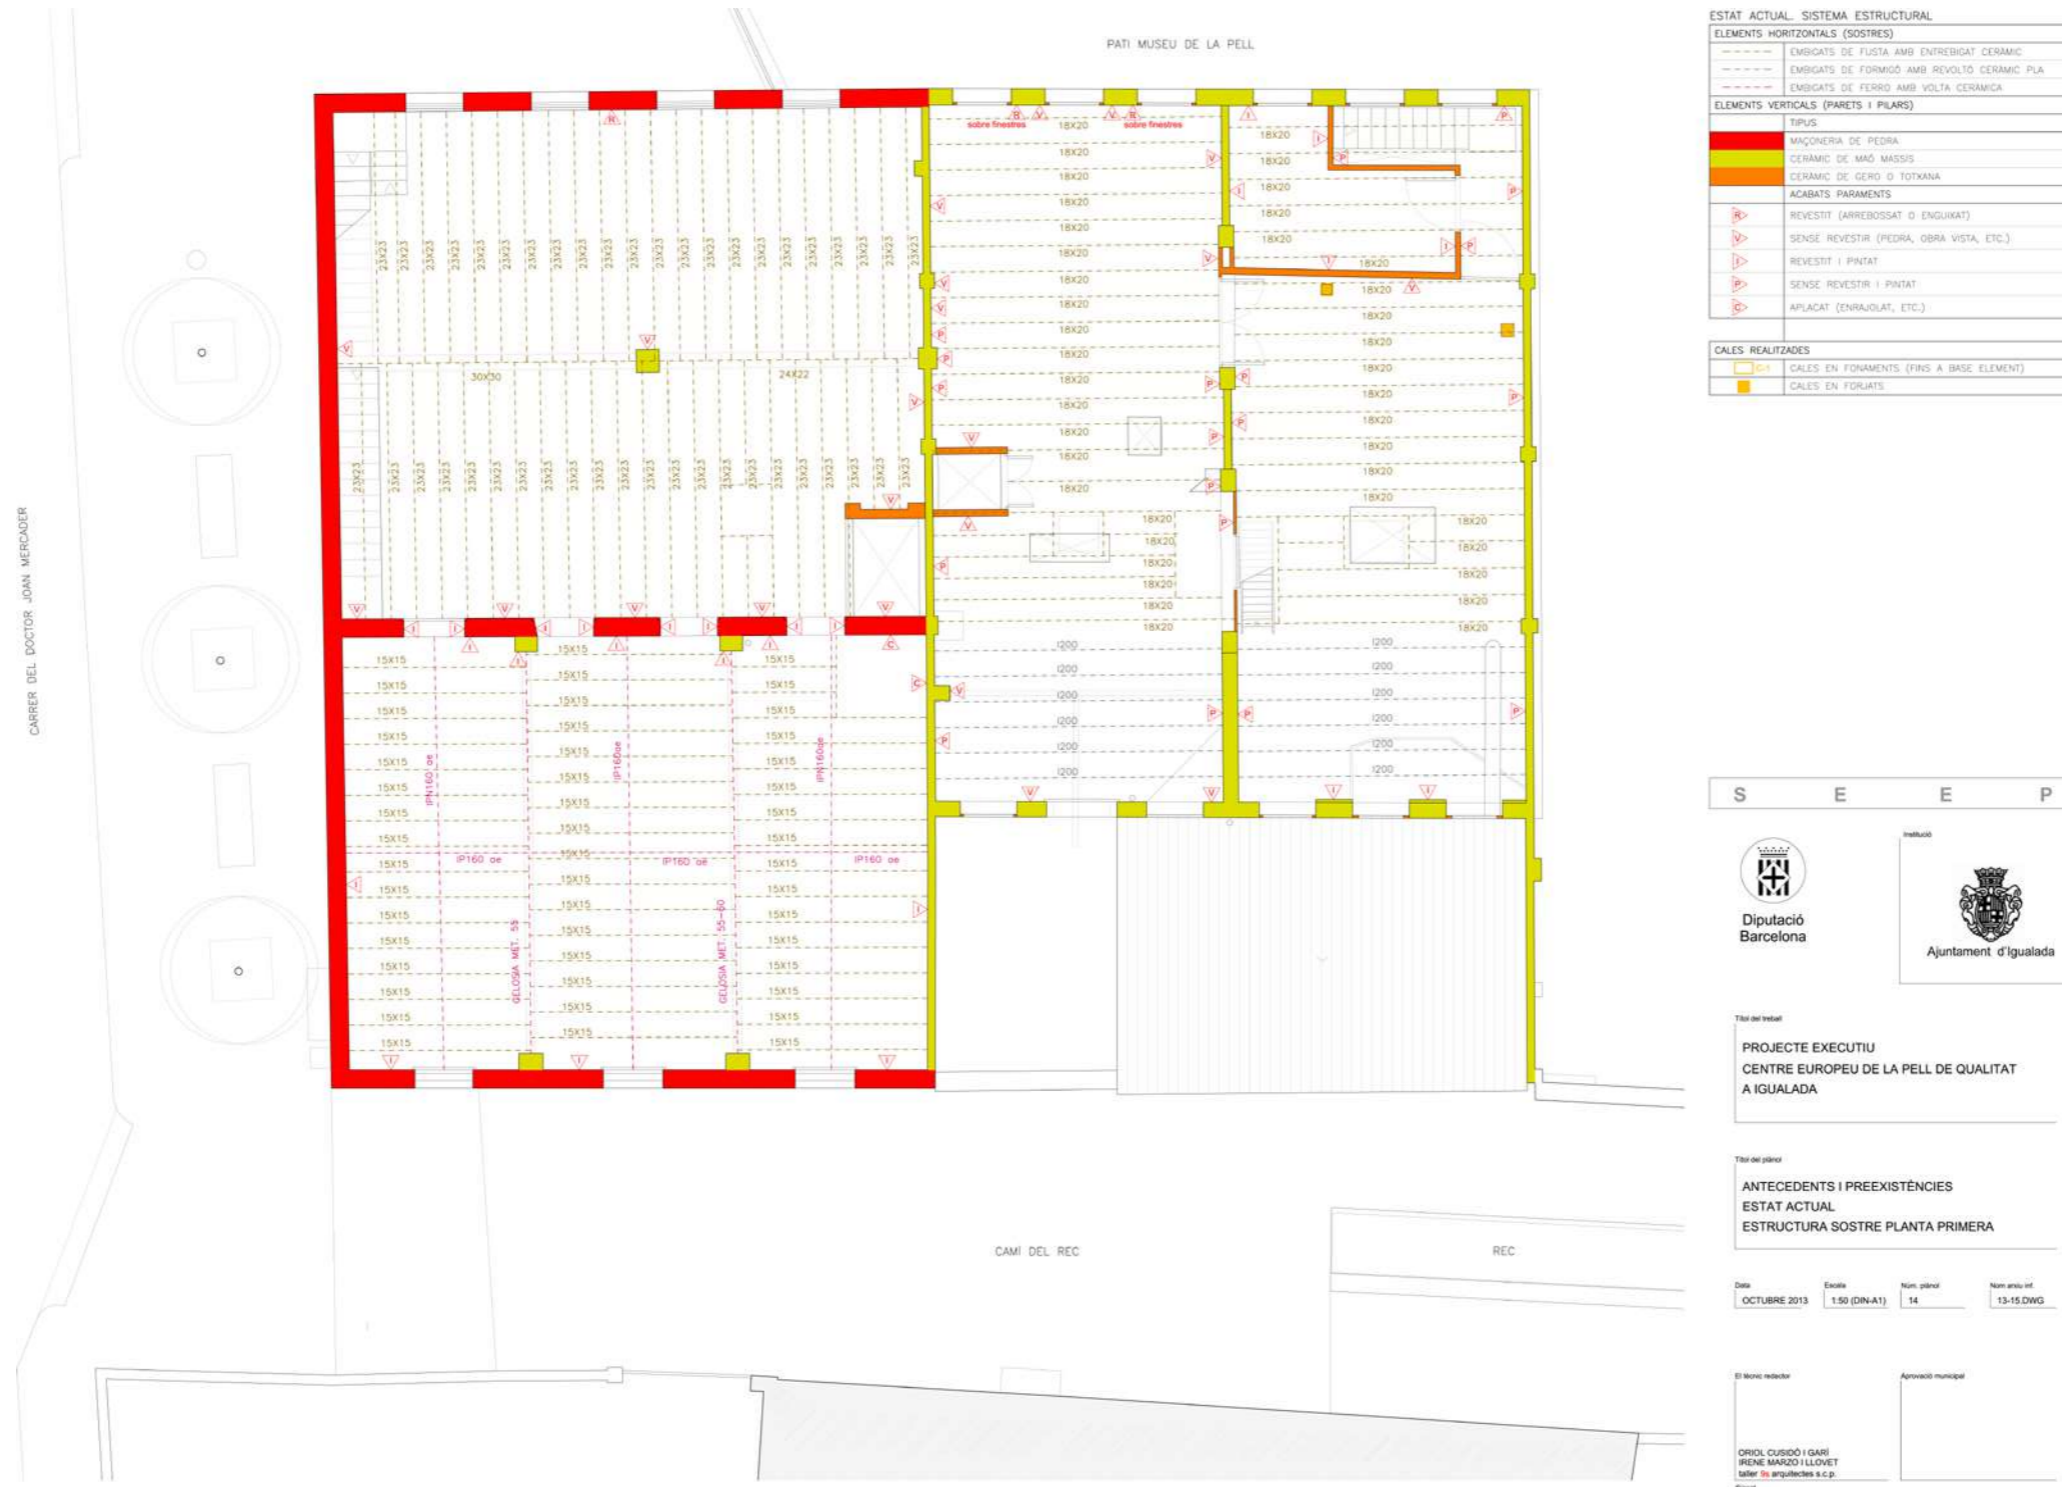
Fig.19: Study of constructive and structural elements. Ground floor.. © Taller 9s Arquitectes

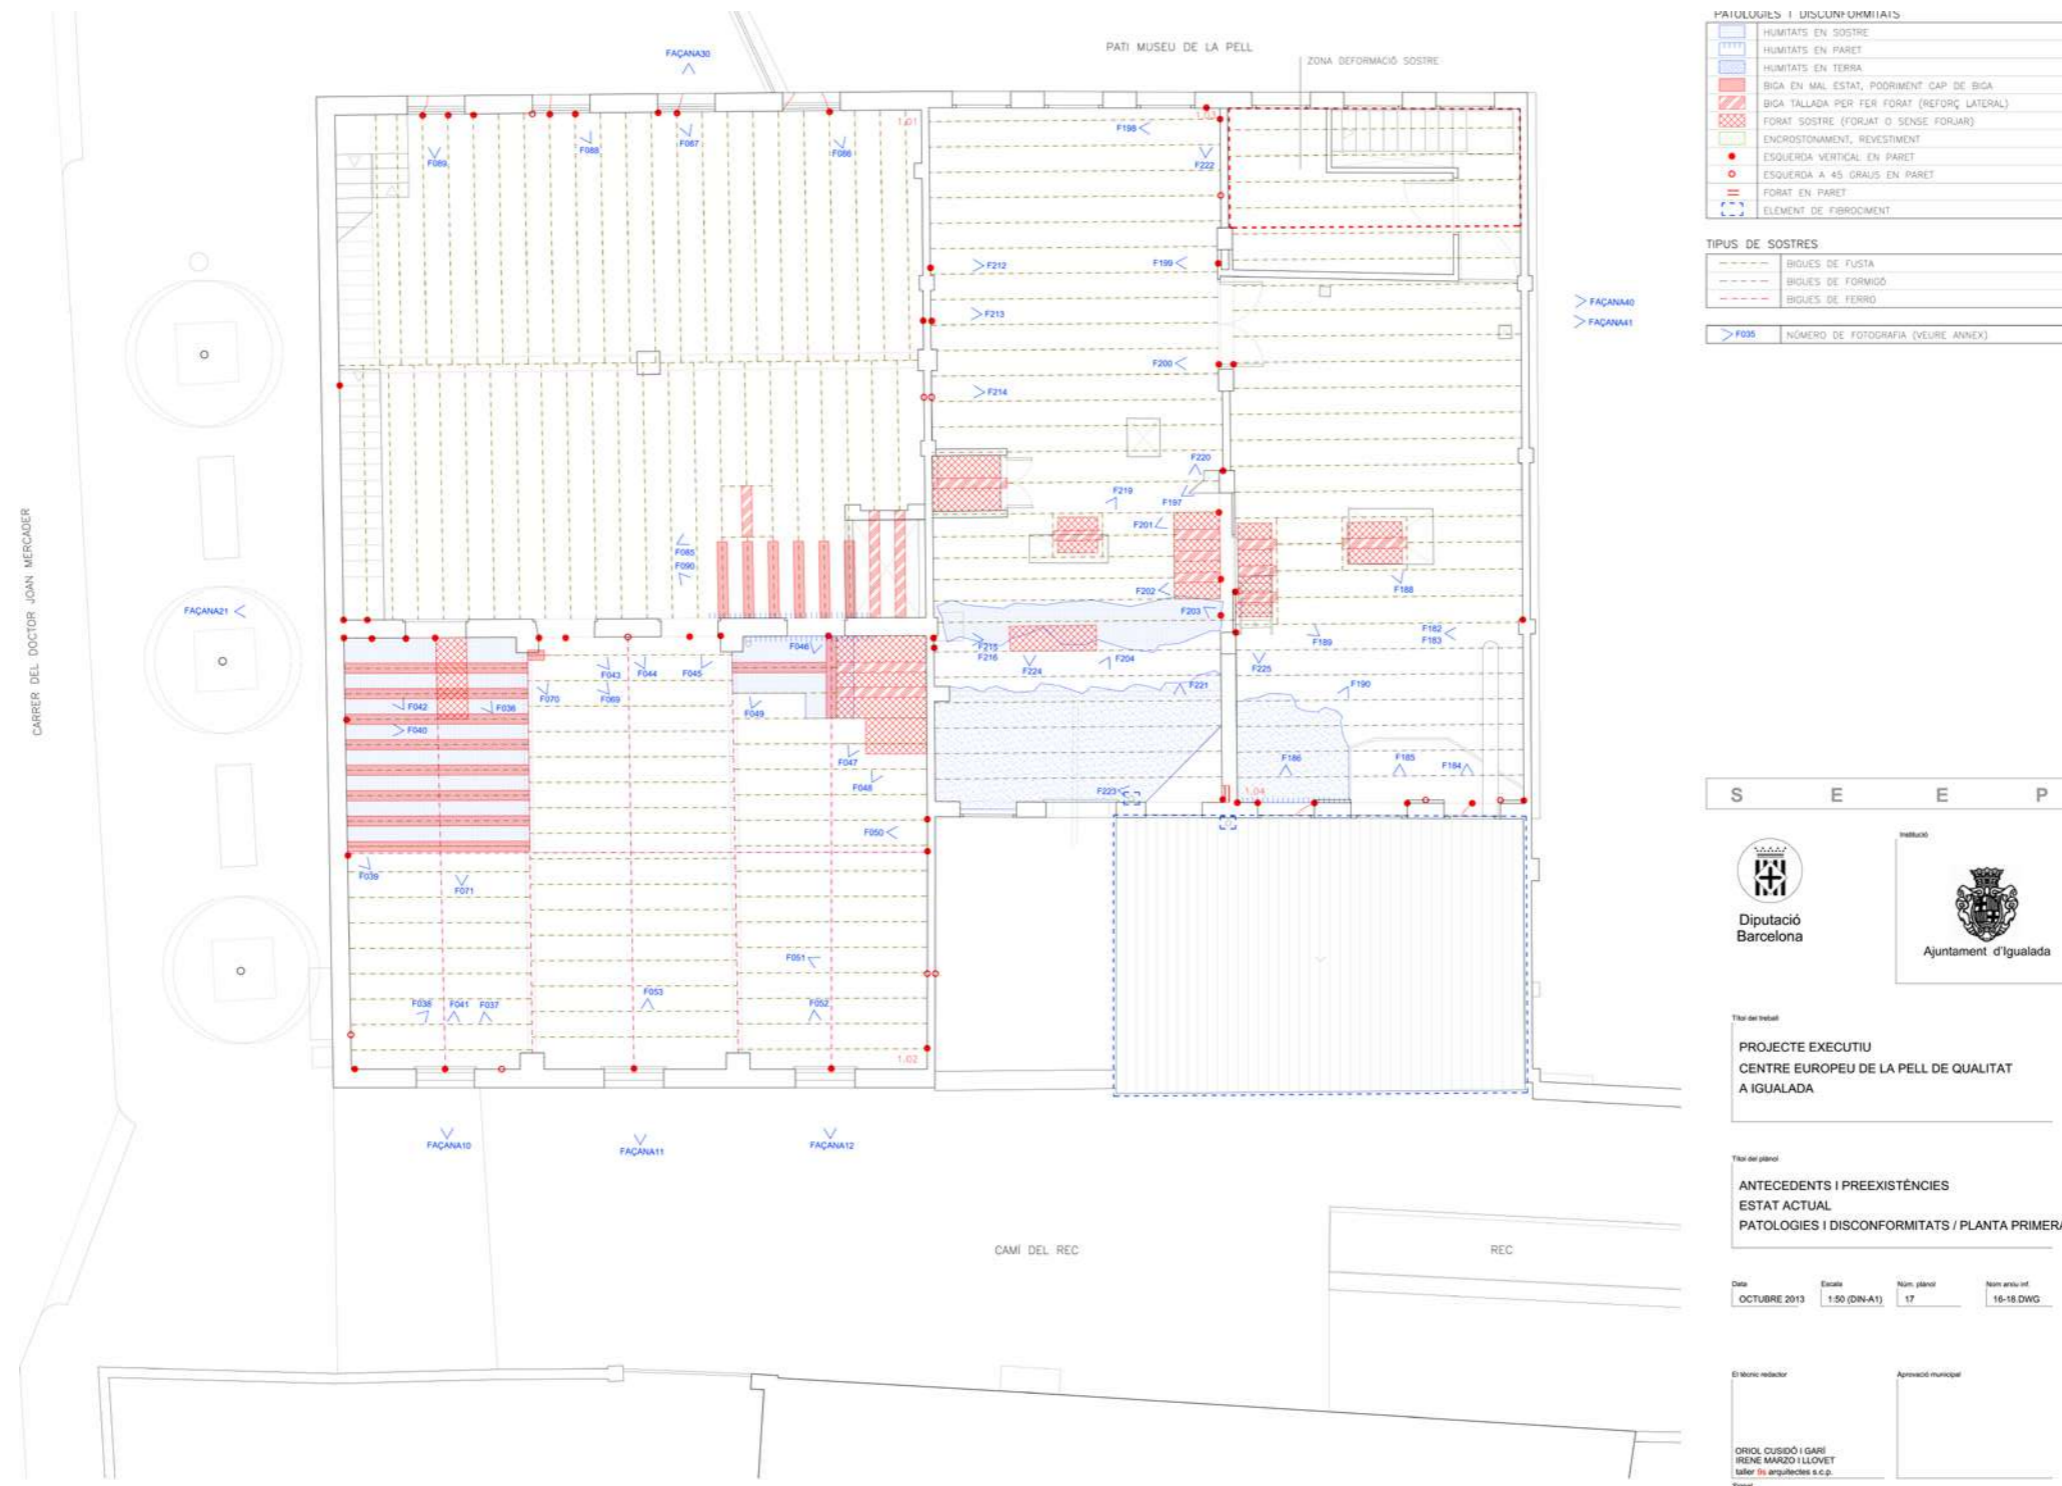
Fig.20: Pathologies and disconformities. First floor ceiling.. © Taller 9s Arquitectes
