Functional and energetic rehabilitation in Kapedes.

Appreciation of vernacular architecture.

Site Vernacular dwelling, 1st of April 12, Kapedes, Nicosia, Cyprus

Date 2010-2011

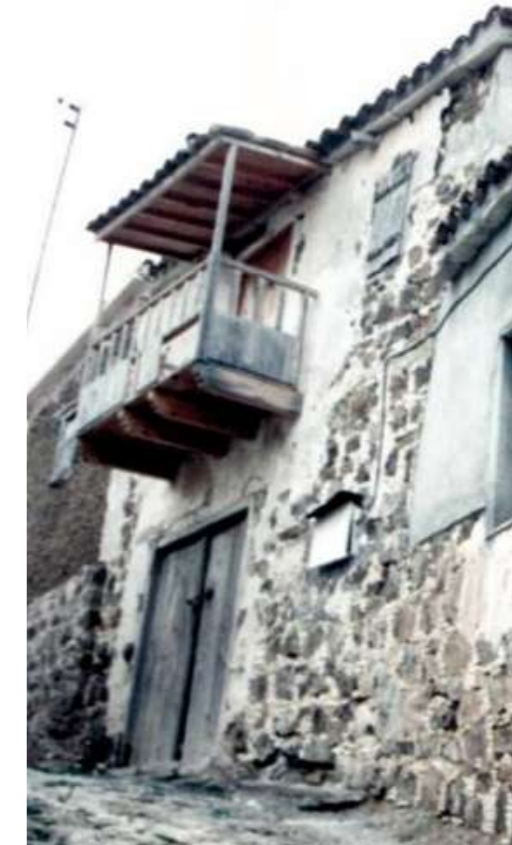
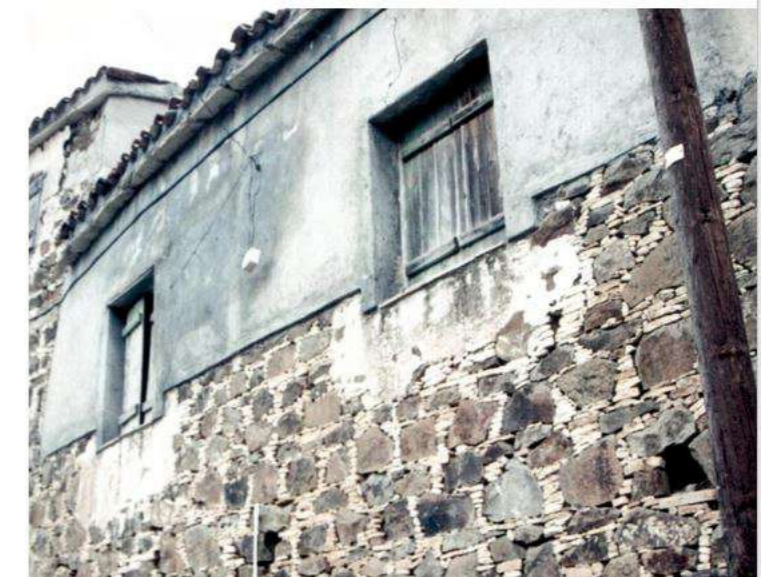
Fig.3-4: Views of the exterior facade of the dwelling towards the road before restoration. © M. Philokyprou

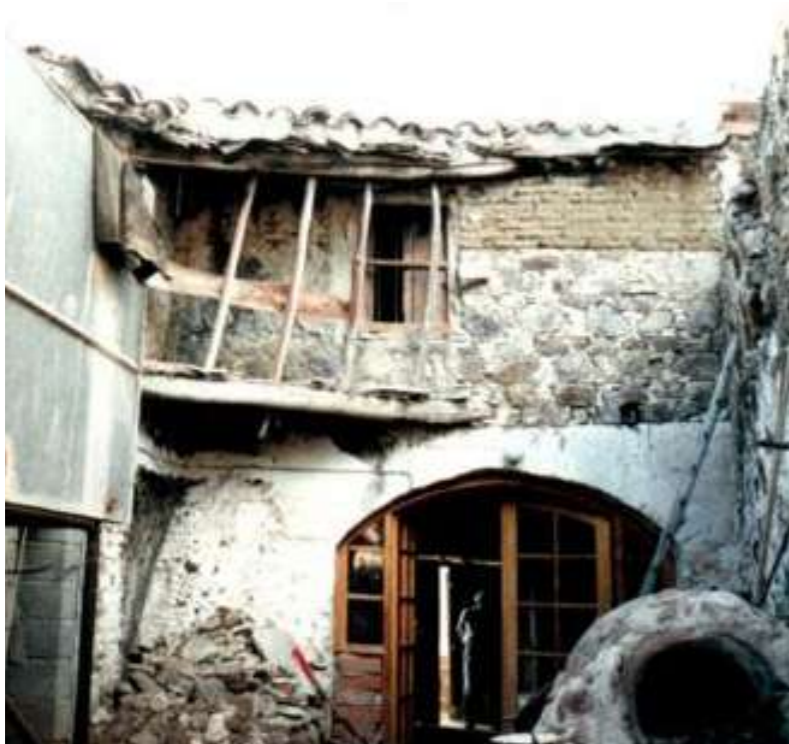
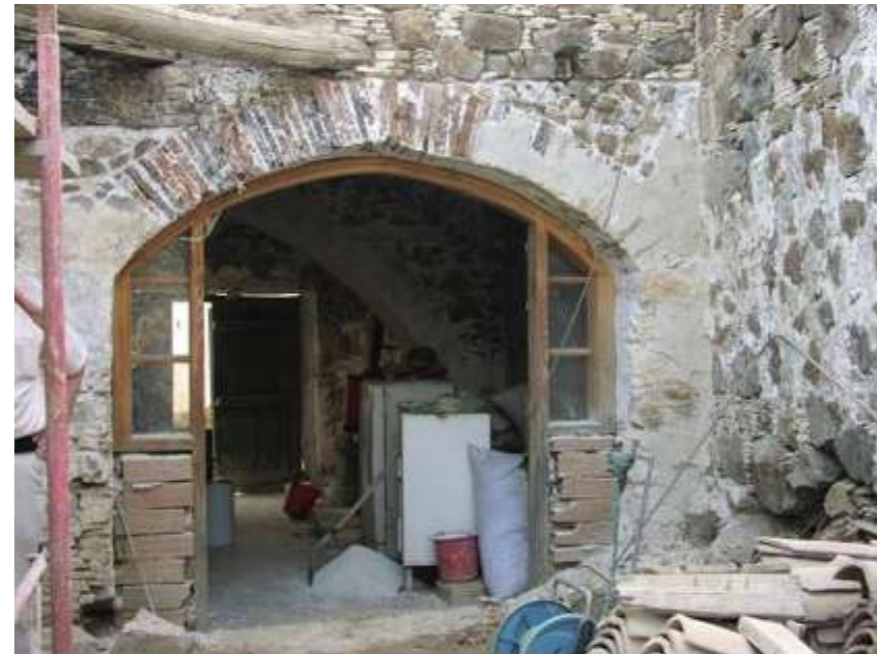
Fig.5-6: The dwelling before restoration work. Views from the courtyard. © M. Philokyprou

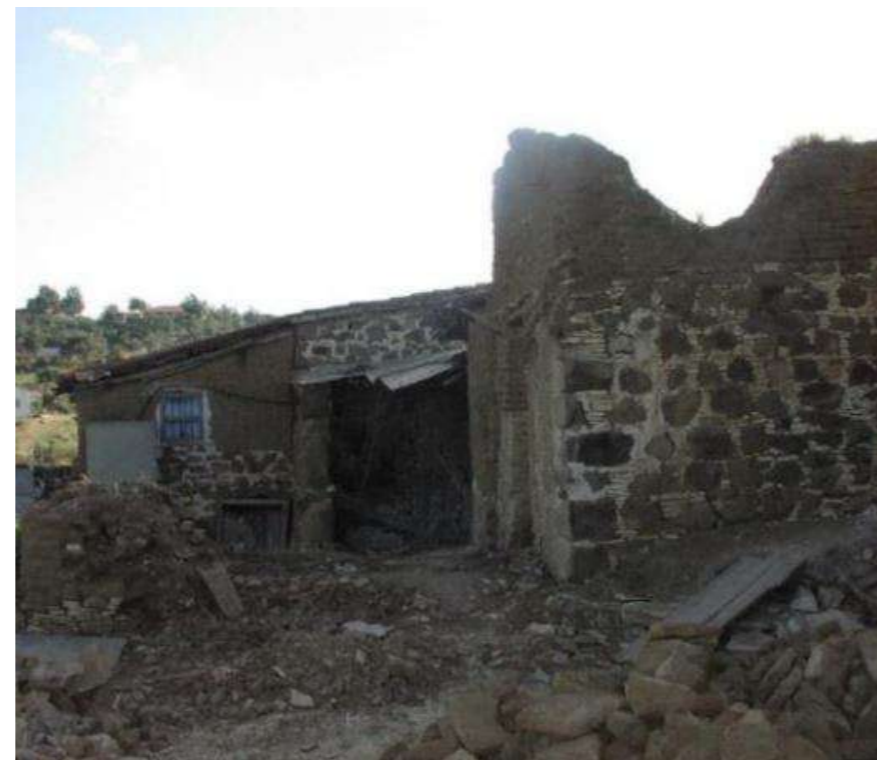
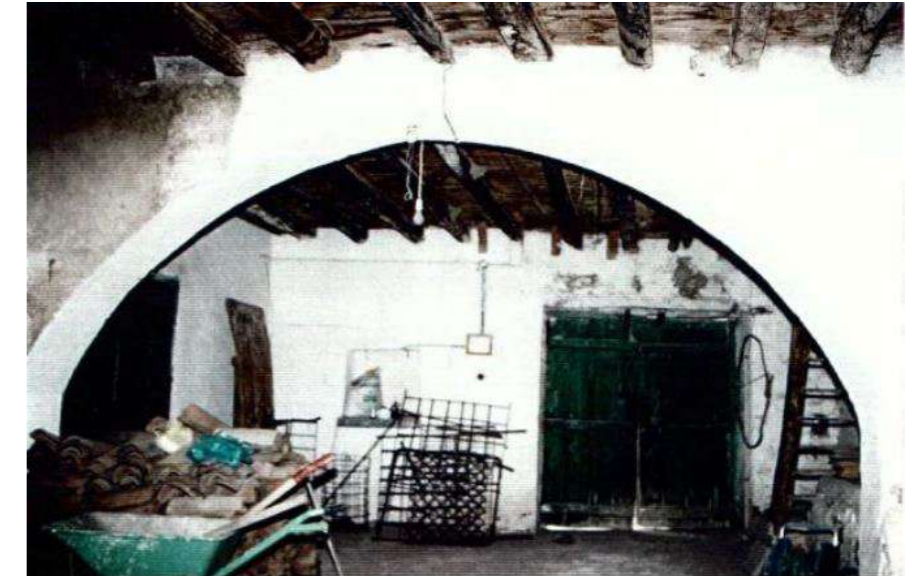
The building was in a poor structural condition before restoration. The only part of the building that was preserved in a rather good condition was the lower part of the walls made of stone. On the other hand the upper part of the walls made of adobes was in a very poor structural condition due to the cement plasters introduced later. The roof of the house was also in a bad condition mainly due to the introduction of inappropriate building materials such as reinforced concrete.

Fig.7-8: Views of the exterior and interior of the dwelling before restoration showing the condition of its structure.
© M. Philokyprou
