## Addition of attic floors.

### *Integral rehabilitation with the incorporation of an attic floor with prefabricated modules in the Barcelona Eixample.*

**Site** Carrer Muntaner 75, Barcelona, Catalunya, Spain

**Designer** IRABÉ PROJECTES S.L.  
Arch. Rosa Bassols

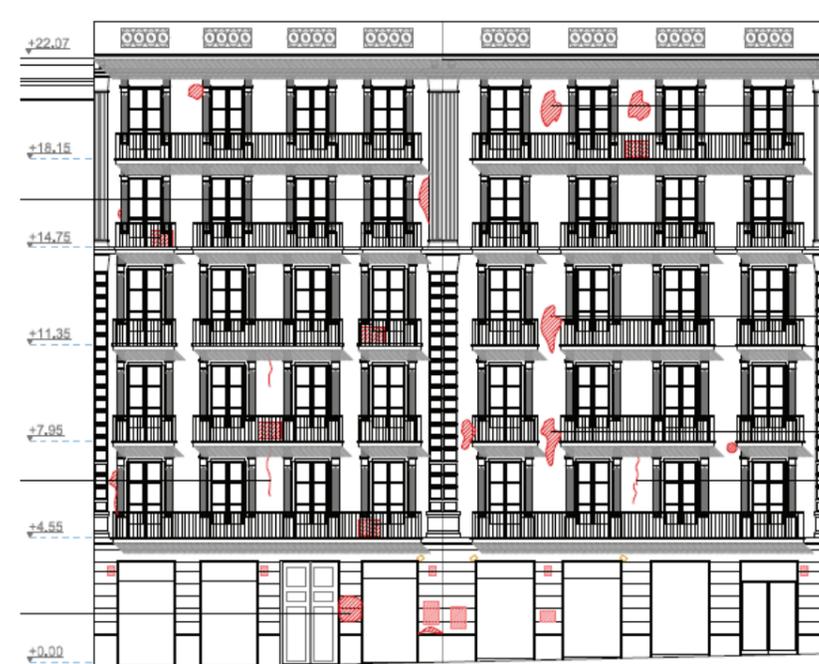
Fig.4: Detail of the damages and issues on the façades, to be repaired.

Although the main façade is in a very good state of conservation, there are some humidity stains and some cracks. There are also cracks in some balcony slabs, so it is recommended to carry out maintenance work to prevent deterioration of the property.

As for the façade, a general cleaning of the sgraffito was carried out with water mist. Where necessary, small restorations were made with lime mortar dyed in the colors identified in the color plan previously prepared for the intervention and according to the sgraffito technique. The cracks were stitched with U-shaped rods and repair mortar and some specific volumes were also repaired, as well as the cracks in the balcony slabs with reintegrating mortars. Finally, a layer of water repellent with xylophages has been applied to the entire facade. As for the façade carpentry, it has been kept all unified with a single color of satin enamel and locksmithing with a gray iron enamel paint. All distorting elements and air conditioning machines have been removed from the façade.

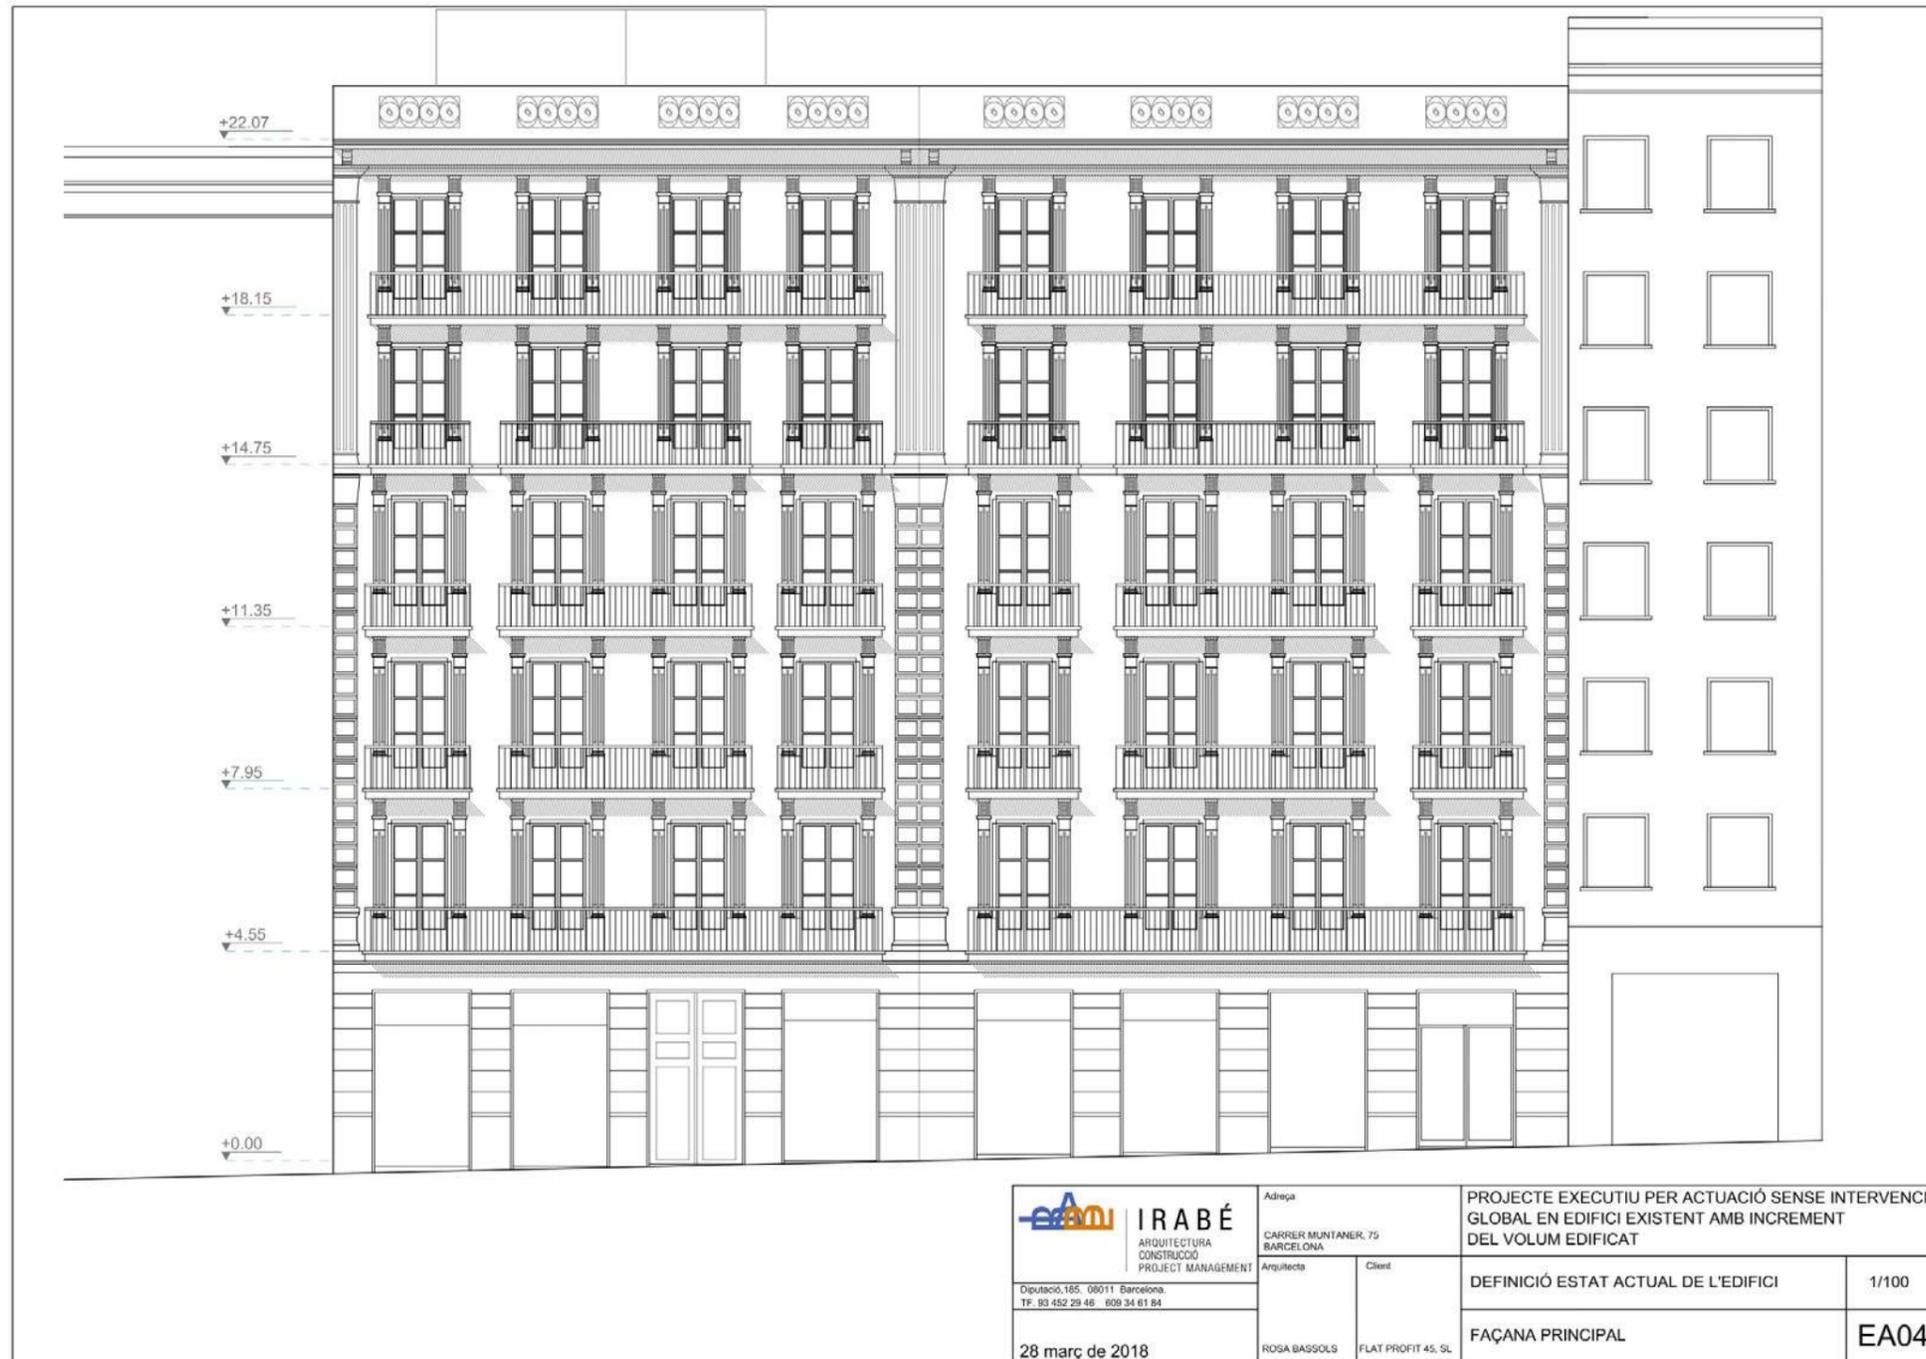
**The main façade:** the main façade was the object of an intervention within the "Raphael Program for the Restoration of Modernist Sgraffitoes" in 2002, which has been taken into account in the chromatic study carried out. The result of the intervention on the façade is very good and the current state of conservation is also satisfactory, so it will only be necessary to carry out cleaning operations.

Fig.16: Existing conditions of the façades to Muntaner and Aragó Streets.

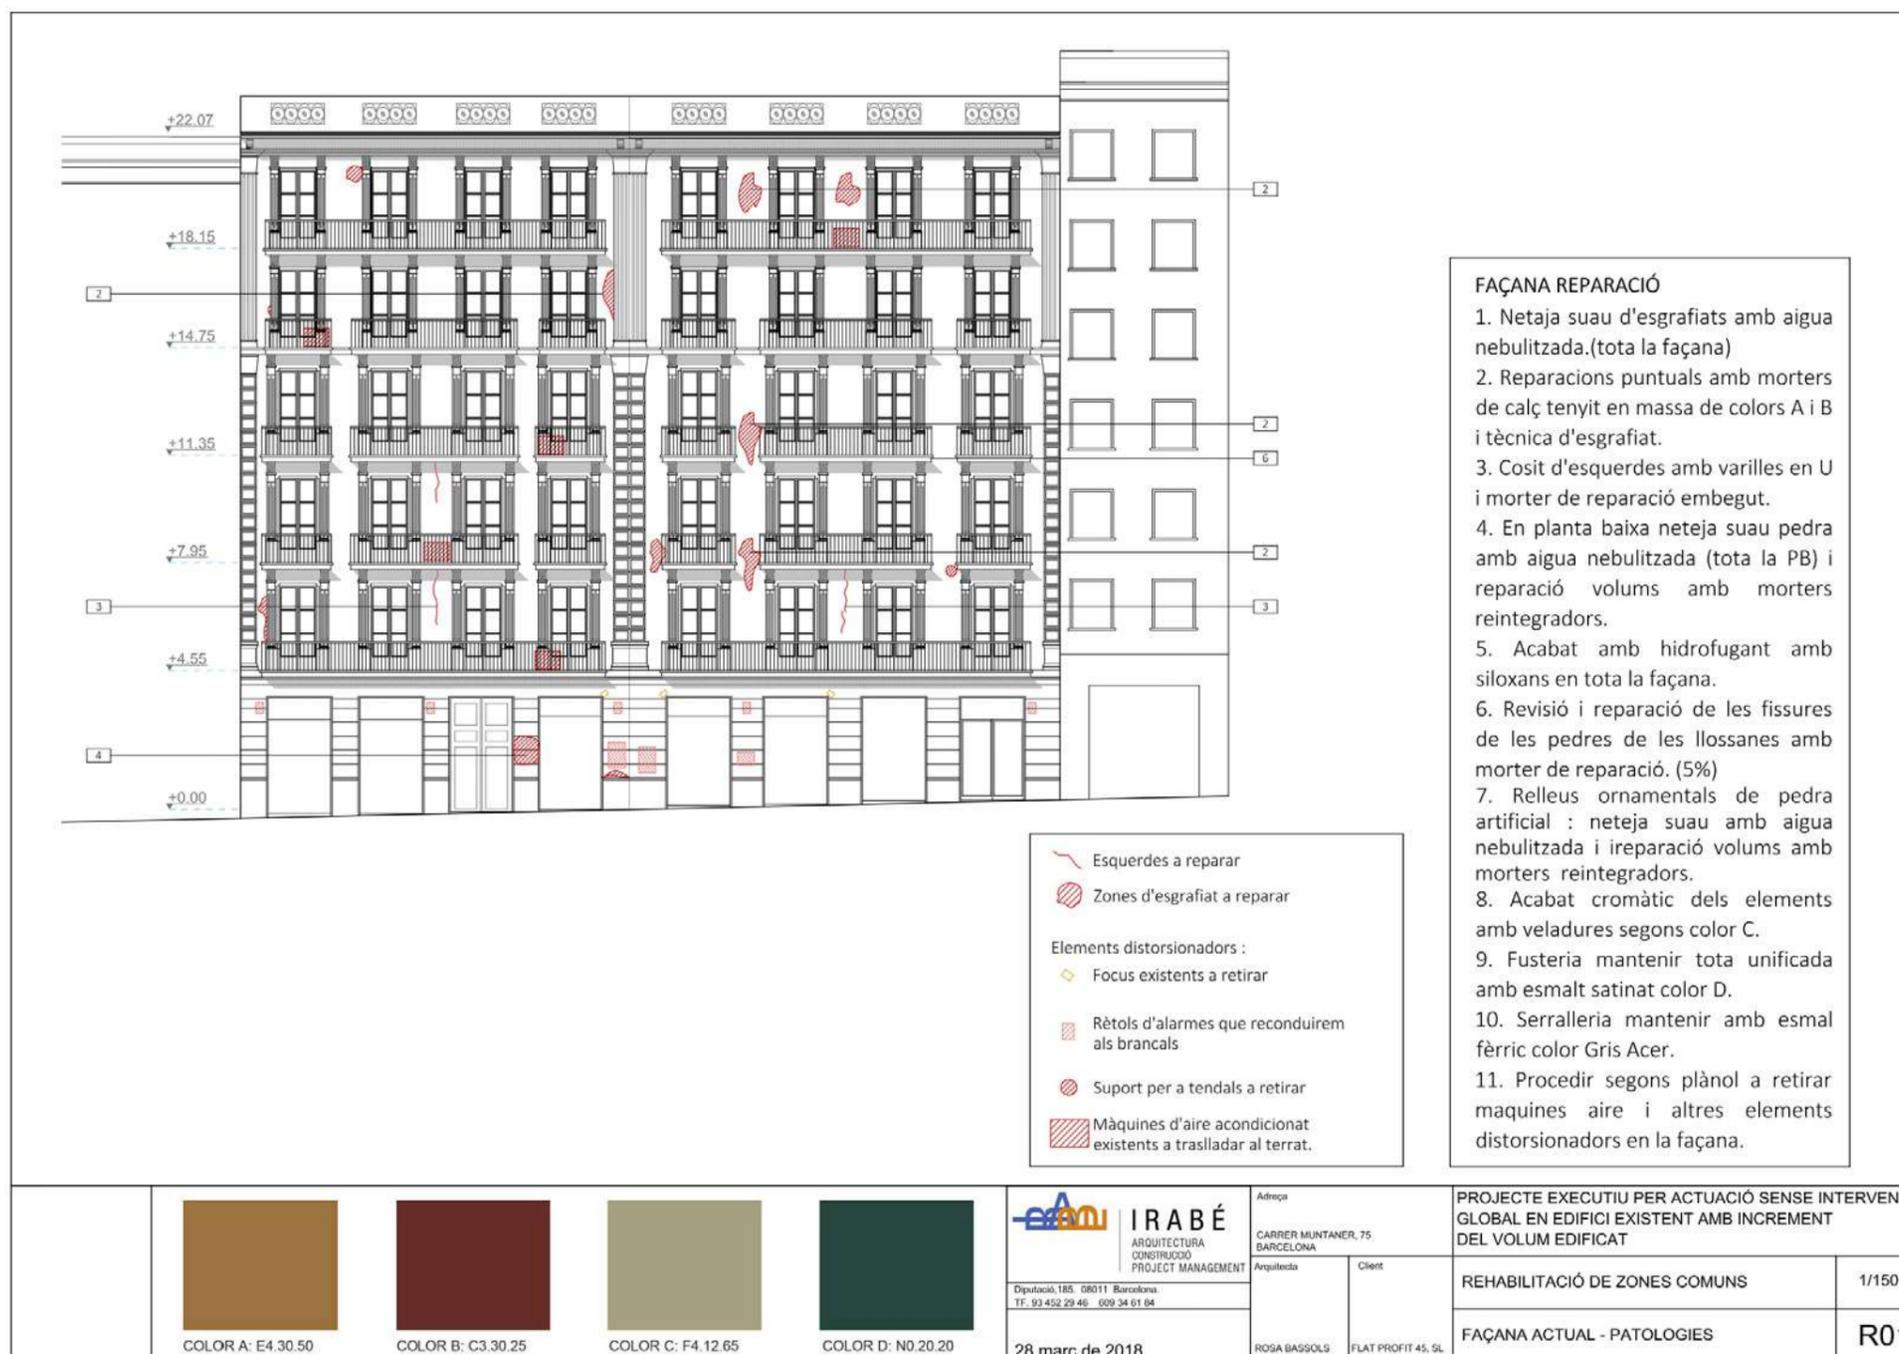
Fig.19: Pathologies on the existing façades.

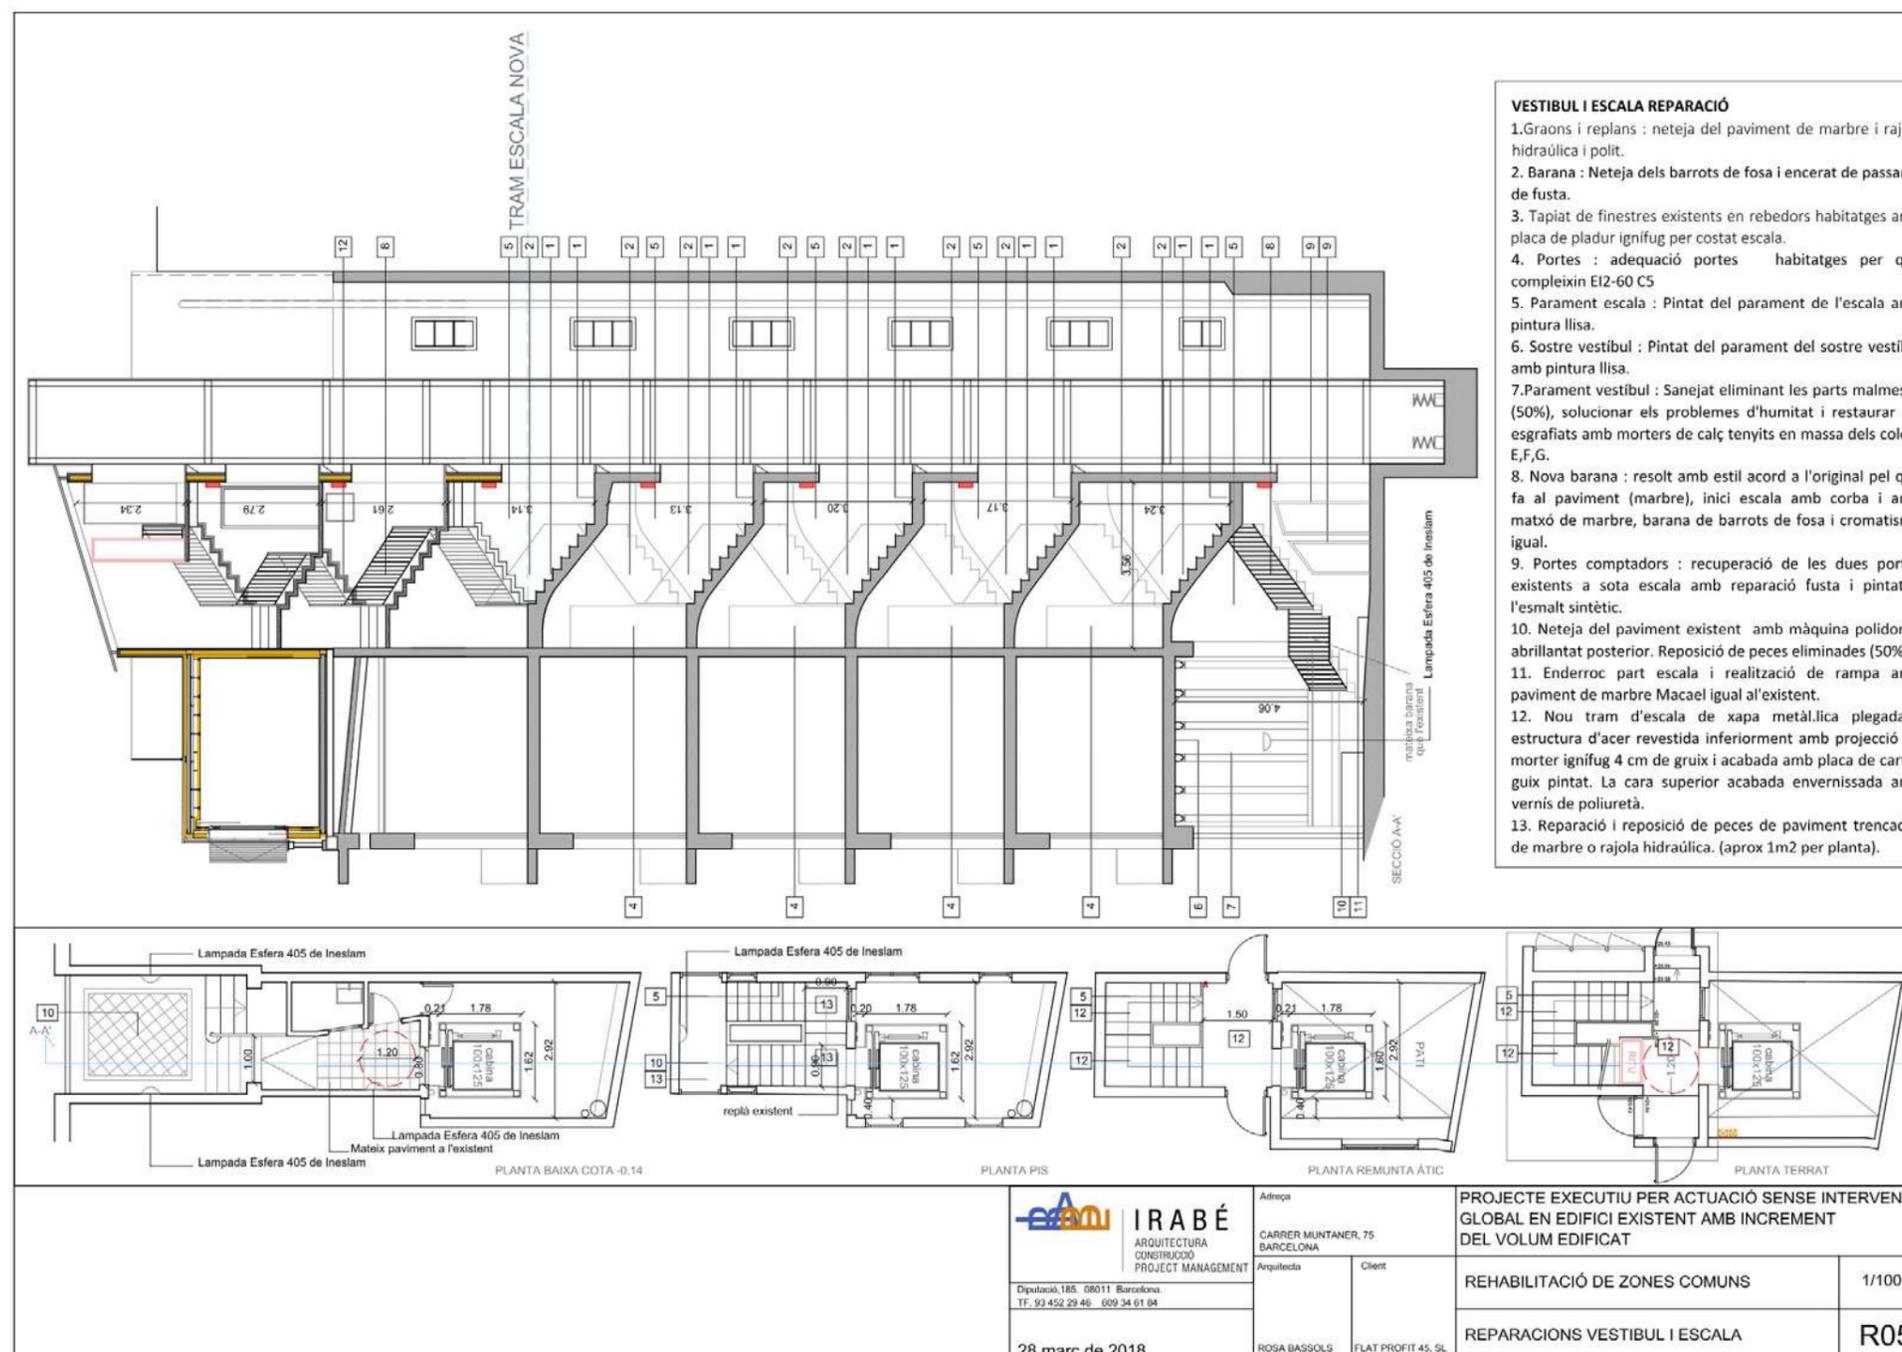
On the other hand, both the lobby and the stairwell are in a poor condition. There are many paint gaps, a generalized aging of the coatings and finishes, and many of the pavement pieces are broken or loose, so a complete rehabilitation of the whole is proposed. Since the main objective is the installation of an elevator, a complete renovation of this common space is being considered. Among the works to be carried out, the

Fig.21: Reparations of the lobby and staircase.

The works in the stairwell consisted basically of: covering the existing windows in the hallways of the apartments with fireproof plasterboard enclosures on the staircase side; replacement of doors and adaptation to comply with the corresponding fire protection standard; cleaning and removal of the damaged areas of the lobby cladding (approximately 50% of the surface); solution of the problems of rising damp; restoration of the sgraffito with lime mortar dyed in mass with colors according to the chromatic study; installation of a new handrail at the beginning of the staircase; demolition of part of the staircase leading to the landing to create a ramp to allow access to the elevator; repair and replacement of broken marble and hydraulic mosaic floor tiles, approximately 1 m<sup>2</sup> per landing; cleaning of the marble and hydraulic tile flooring and subsequent polishing; cleaning of the handrail bars and waxing of the wooden handrail; painting of the stairwell wall with smooth paint; painting of the lobby ceiling with smooth paint. A new flight of stairs was also built to allow access to the new floor and to the new roof by means of a folded sheet metal steel structure, coated on the bottom with a 4 cm thick fireproof mortar projection and finished with painted plasterboard. The upper face of the staircase has been varnished with polyurethane varnish.
