La Mina, an extreme neighborhood in Barcelona.

Improving the accessibility, installations, equipment, and the building envelope.

Site Barrio La Mina, Sant Adrià del Besós, Catalunya, Spain

Date 2003-2005

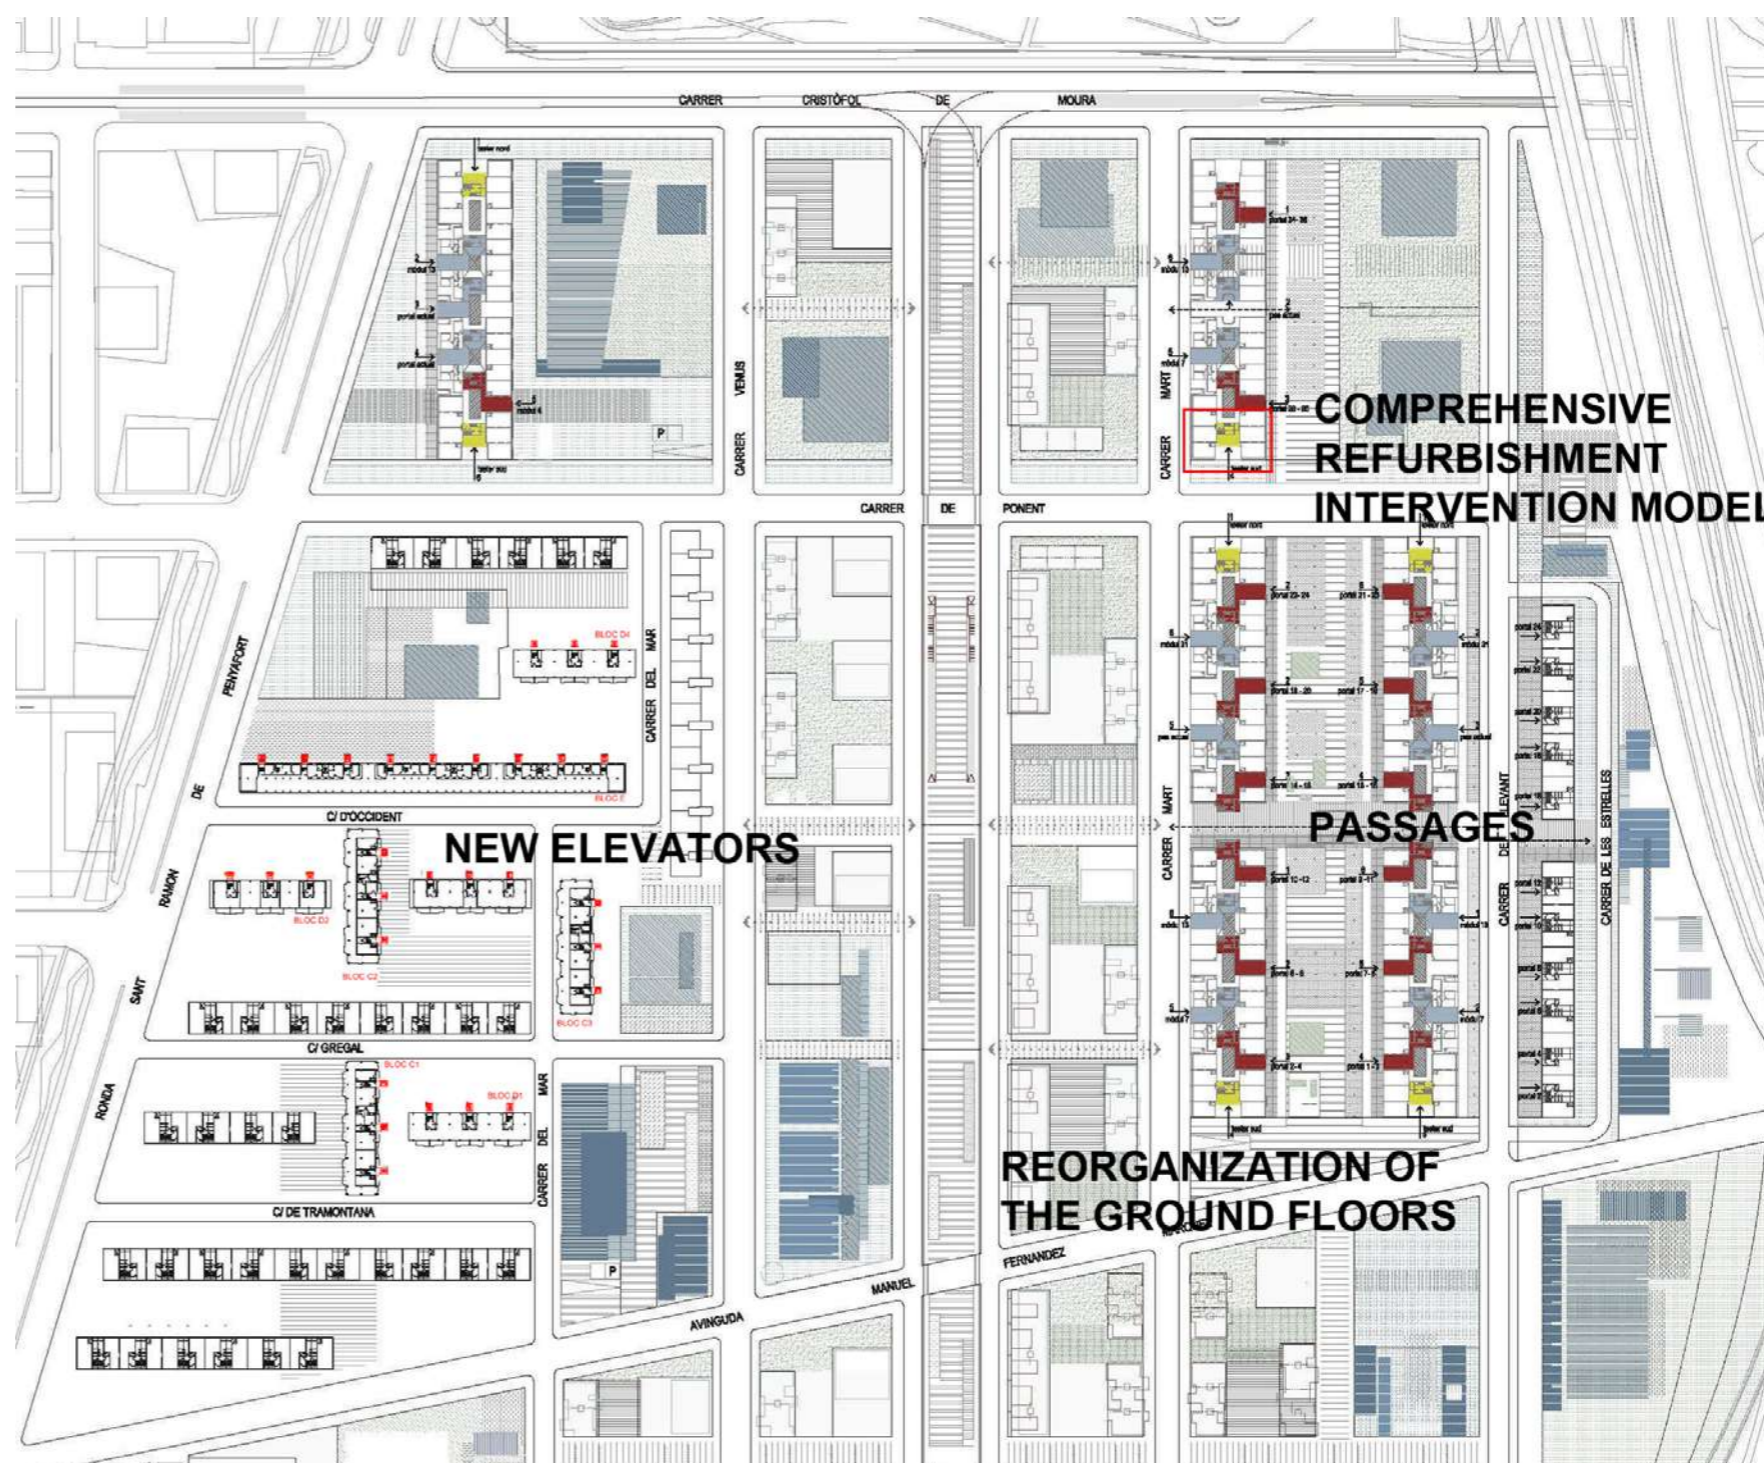
Fig.5: Rehabilitation actions carried out.

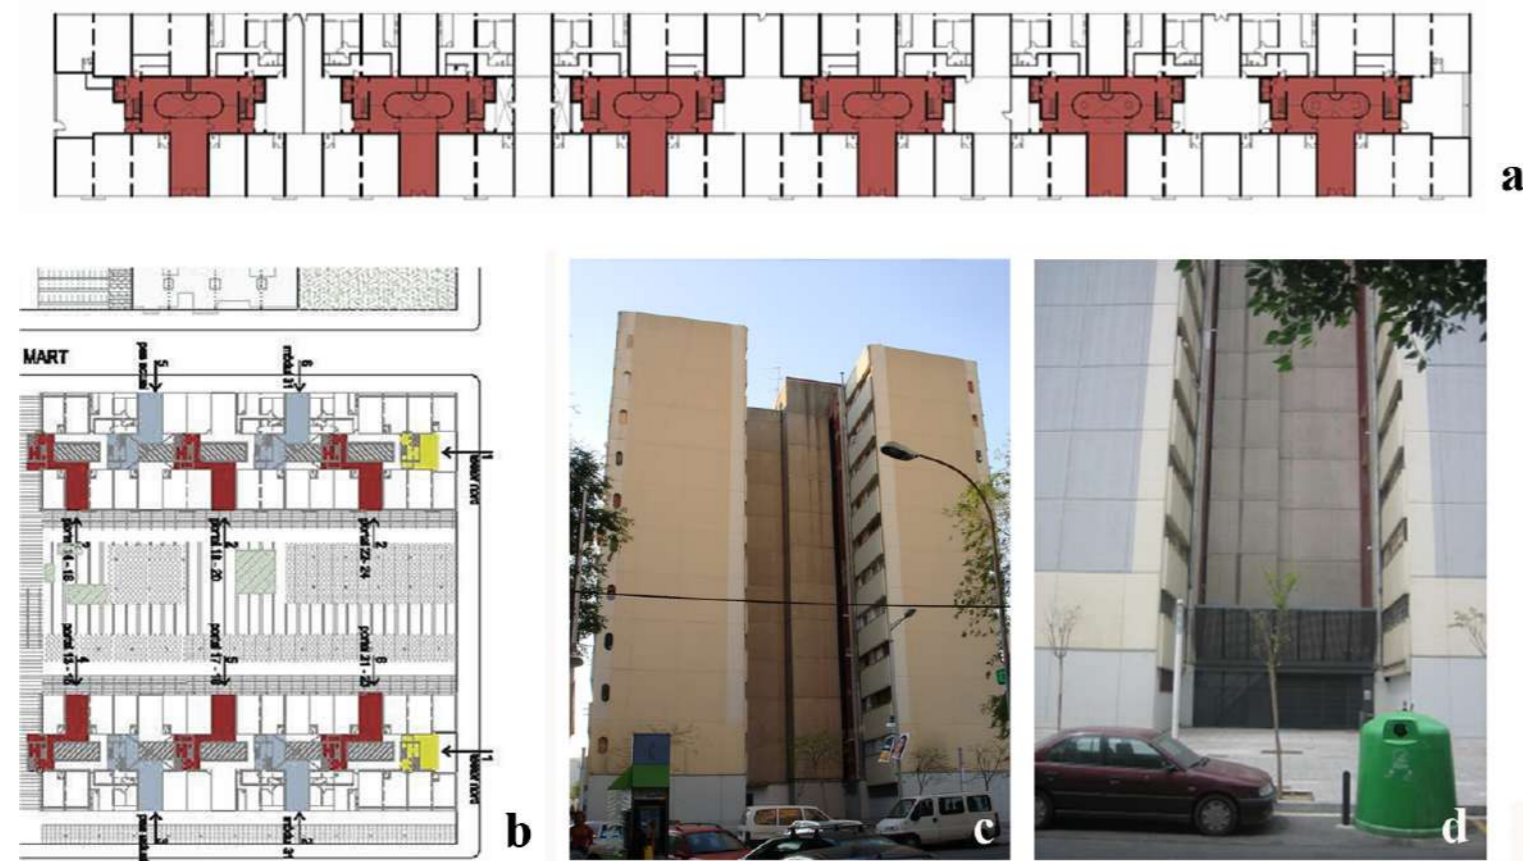
In the taller blocks of La Mina Nueva, the first floors of the buildings and the accesses to the vertical communication cores were remodeled. Originally, there was a corridor on the first floor that connected with the stairwells, which had been subdivided for safety reasons, creating an access for each of the two stairwells. This first old intervention had not been sufficient and there was still disaffection on the part of the neighbors as there was no collective appropriation by the neighbors of the accesses, which is why a rearrangement of the first floor was needed.

Fig.6: Incorporation of new accesses, rearrangement of first floor. a) and c) original. b) and d) with work completed.

First of all, it is important to talk about the rearrangement of the first floors. In order to solve the problem of the large number of dwellings that each access has to serve (one for every 80), accesses from the street are added. As a result, the building has one for every 40 dwellings, thus seeking greater neighborhood involvement in the care of these common spaces. This intervention implies the purchase by the administration of premises on the first floor in order to generate the new accesses from there.

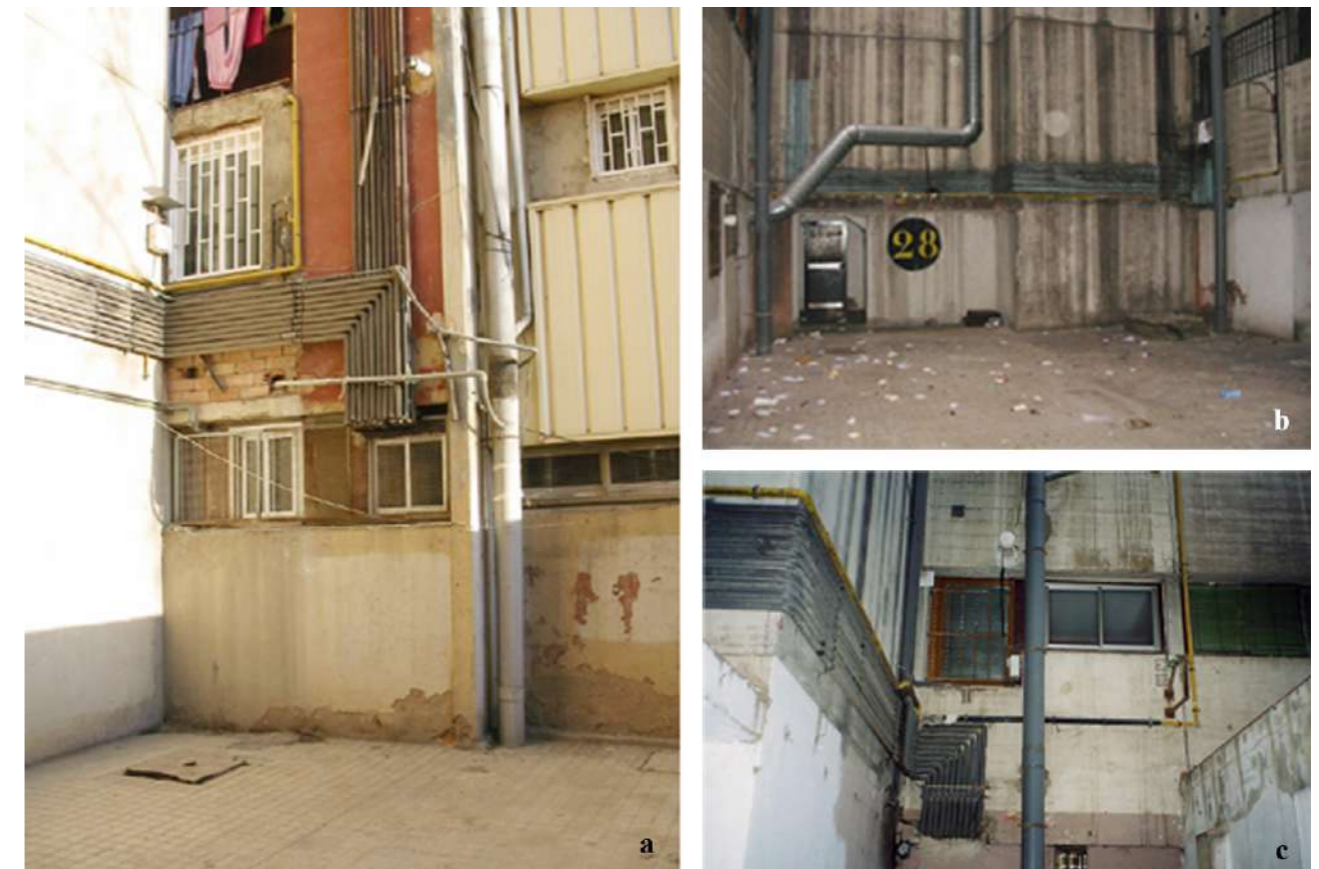
Broadly speaking, it was detected that there were deteriorated and poorly located installations, parts of the reinforced concrete were carbonated or with exposed reinforcement, surfaces and spaces with a high degree of wear and grime, and problems in terms of access and accessibility. The latter is the focus of much of the rehabilitation effort and is seen as a priority.

Fig.7: Condition of the facilities prior to the intervention.

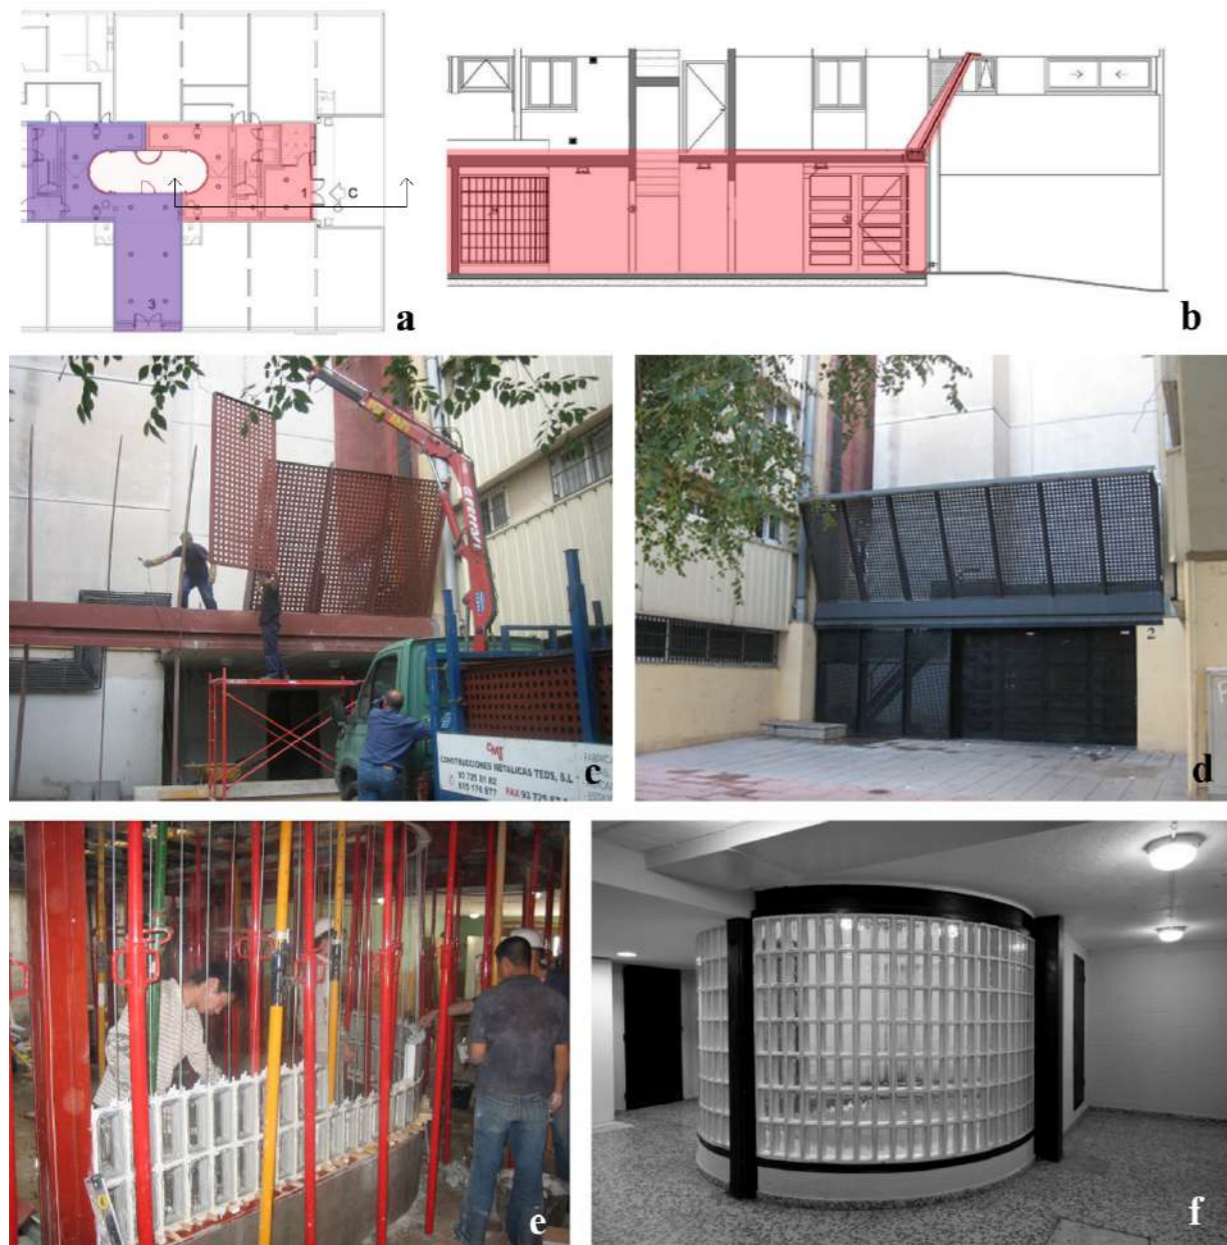
Fig.8: Design and execution of the refurbishment of the first floors at Mina Nueva.

The remodeling of the first floors, in addition to being a functional solution, is used to rationalize the existing installations and to reinforce the roof slabs of the first floor patios, which were made of ceramic slabs, and to improve their watertightness.

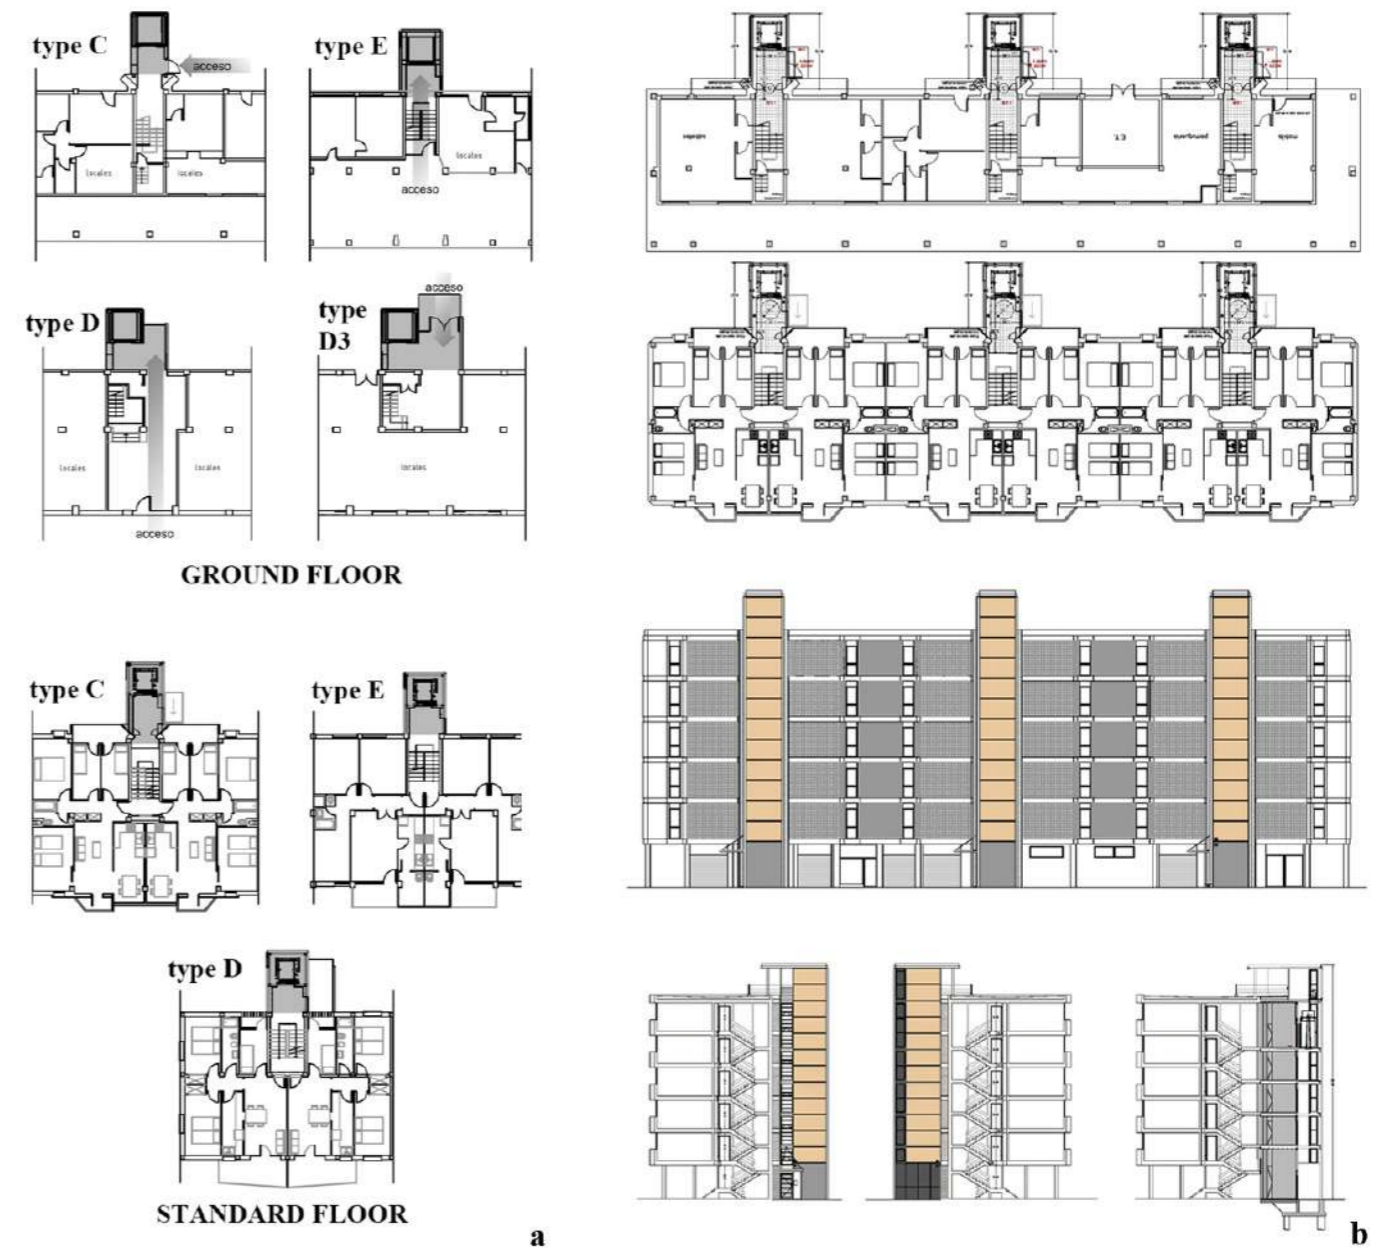
On the other hand, regarding accessibility, most of the residential blocks of the Mina Vieja did not have elevators, because at the time of construction it was not mandatory to place them. This, of course, made it difficult for all residents to reach their homes.

Fig.9: Addition of the structure to the different block types.

Meanwhile, in order to solve the problem of accessibility, most of the buildings in the Mina Vieja did not have elevators. In all of them, elevators are added from the outside, with new volumes that give access to the original stairwell of the buildings. This exterior structure was built in 3 construction

phases, the first phase with a structure of in-situ concrete frames and phases 2 and 3 with metal profiles. The enclosures are made of prefabricated concrete panels bolted together.

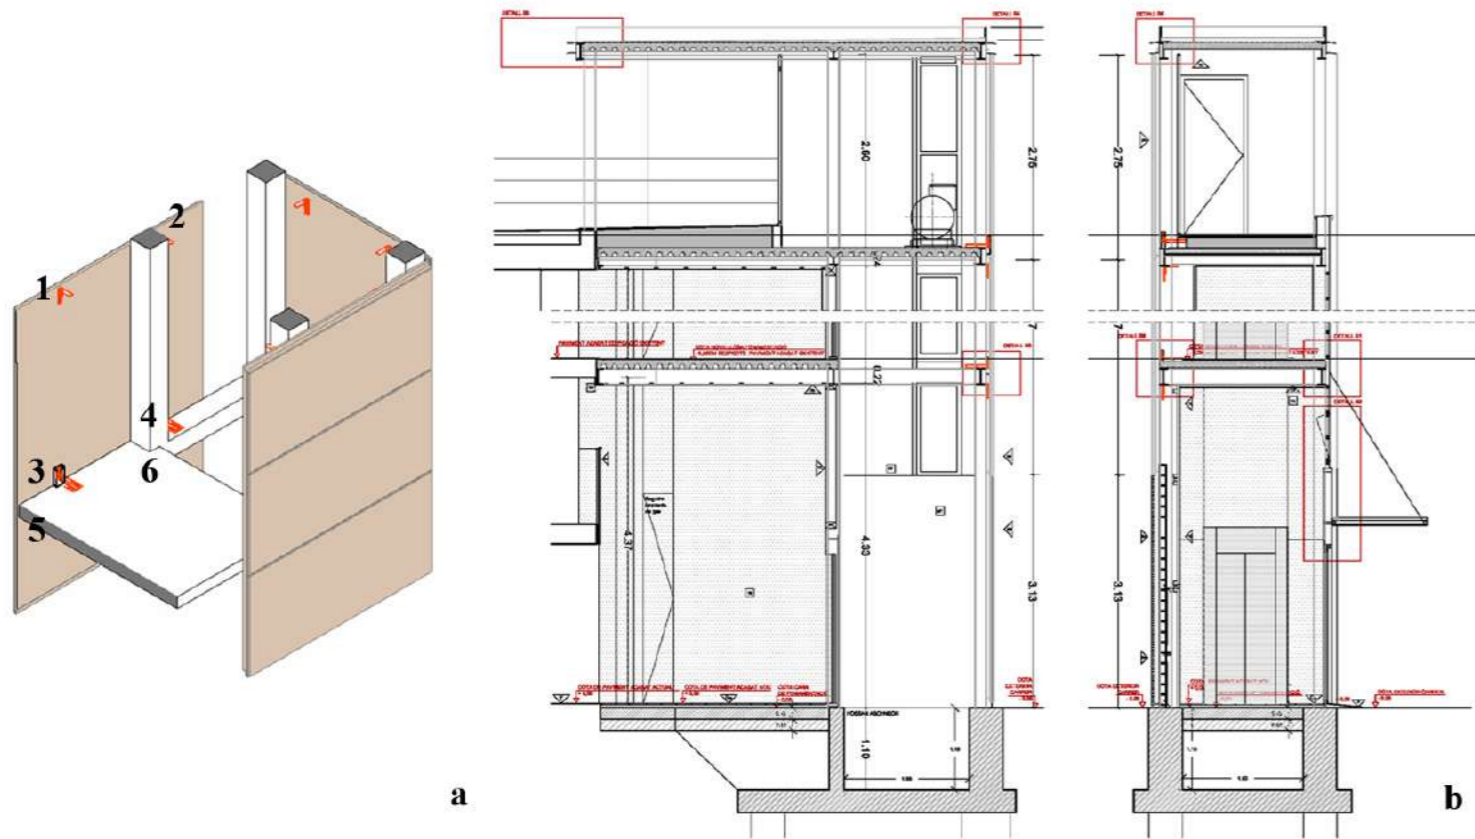
Fig.10: Detail of the joint between the new element and the existing floor slab.

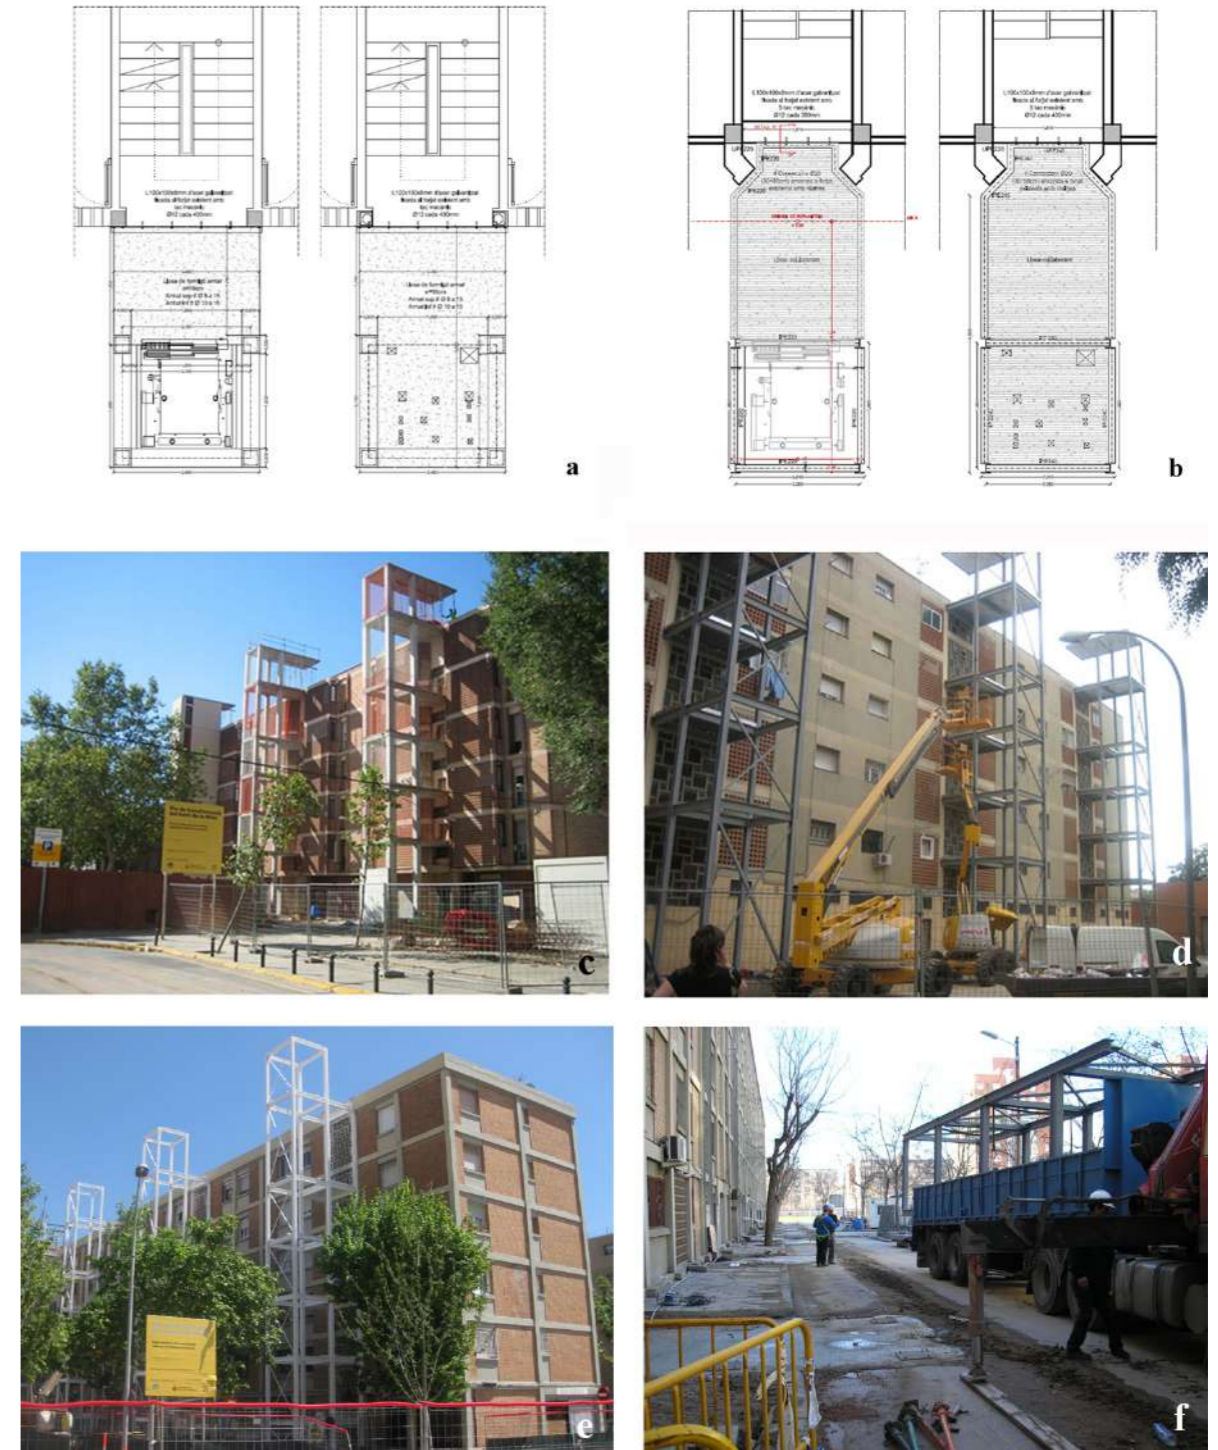
Fig.11: Addition of the exterior structure containing the elevators.

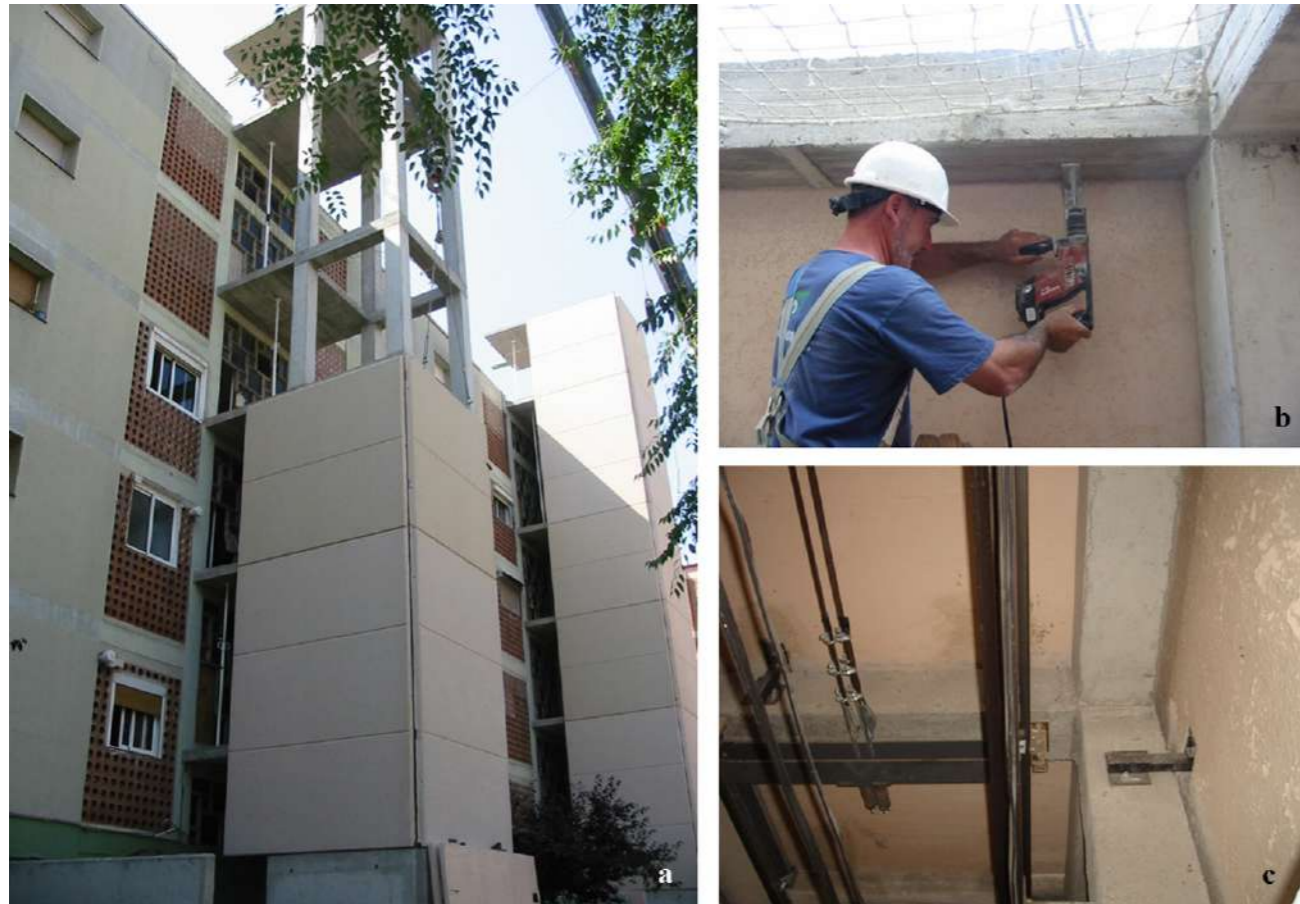
Fig.12: Installation of the external enclosure of the elevators.
