An old market as a receptacle of the city's history.

Rehabilitation of the Mercat del Born, Barcelona, Spain.

Site Mercat del Born, Plaça Comercial 12, Barcelona 08003, Spain

Date 2006-2012

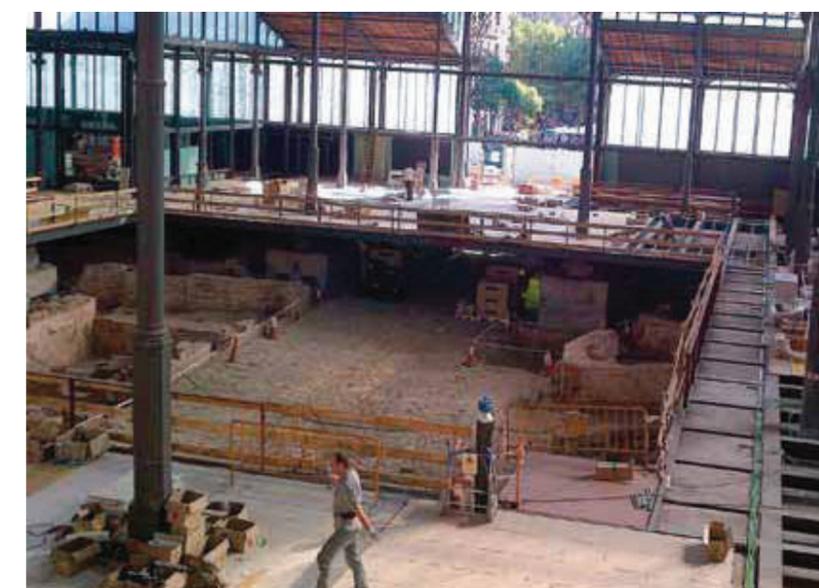
Fig.3: View of the execution of the new floor slabs, and the archeological excavations underneath.

Execution of the new floor slab and the new sewage system: The execution of the new floor slab at the level of the surrounding streets required the coordination of its

construction with the simultaneous dismantling of the working platform. In the construction of the floor slab, the main difficulty consisted of moving and placing beams weighing 6,500 kg that span fifteen meters. To this difficulty was often added the need to avoid the feet of the scaffolding used for restoration, without being able to operate from the site. This operation required the design of auxiliary equipment based on pulleys, ferrules, trolleys, etc.

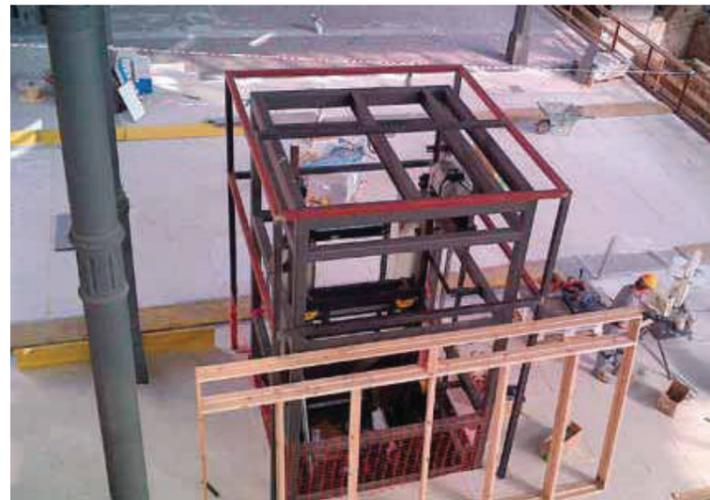
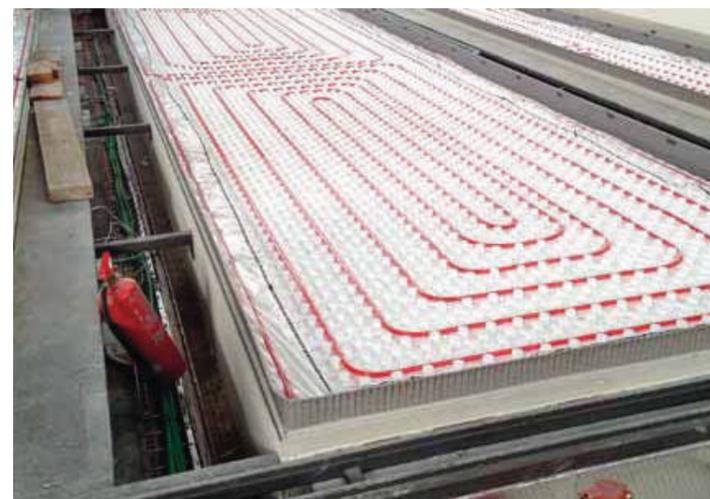
Fig.4-5: Installation of the new elevator, and radiant floor systems.

The installation of a raised floor was planned to facilitate the passage of all the installations, to make them accessible at certain points and as a base for the installation of the underfloor heating system. The installation process required a layout of the floor slabs and beams.

Since it was not possible to create a continuous raised floor, due to its interruption by the beams of the floor slab, it was necessary to brace the different panels that made up the raised floor to support the required dynamic loads.

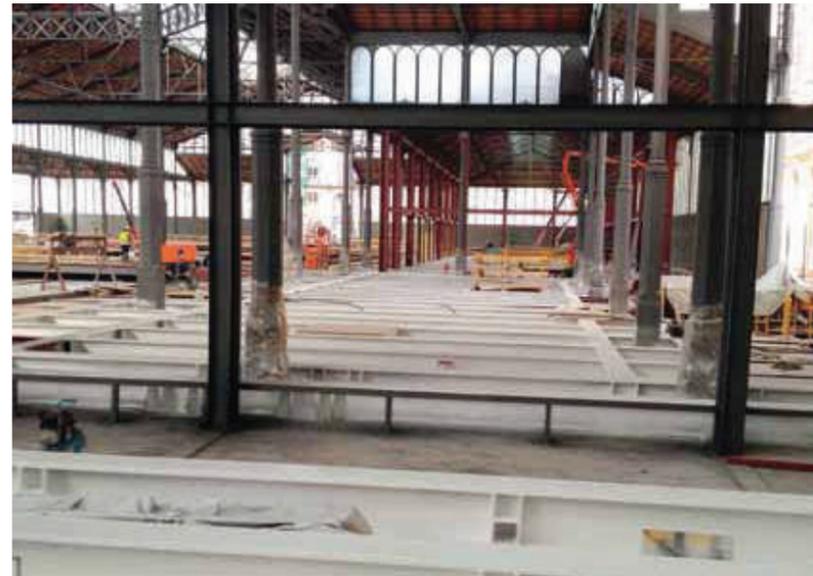
Fig.6: Construction of the new steel and glass enclosures.

The construction of the enclosures based on metal structure and glass, of considerable dimensions, required a complex strategy to allow their movement and placement inside the Born. The access and movement limitations, the archaeological site protection measures, and the loads that the new slab could withstand were all taken into account.
