Addressing structural issues on a 20th century office building.

Rehabilitation of floor slabs, stuccoes and decorative elements on a historic office building in Barcelona's Via Laietana.

Site Office building, Via Laietana 4, Barcelona, Catalunya, Spain

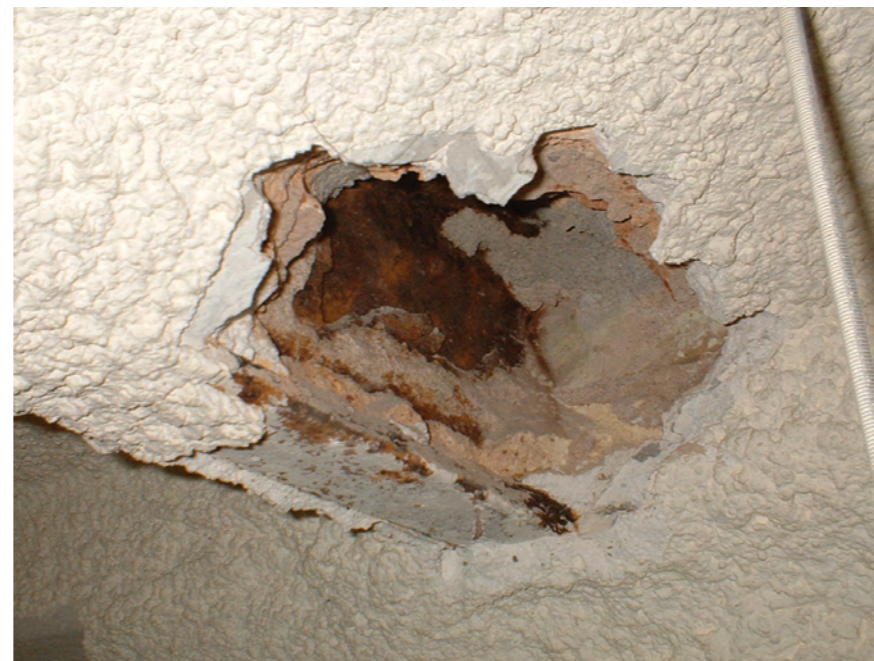
- The narrow flange profiles of all the slabs had reached the end of their useful-life years ago due to oxidation and exfoliation of the steel. The main injuries were almost hidden from sight since they occurred inside the walls in the recessed area of the beam. Also, in intermediate areas of the beam span, hidden under the ceramic coffers, even more so, since during the interior renovation they had primed the exposed surface with fireproof amalgam.

- The cause was due to the fact that lime mortar, contrary to what was considered years ago, does not protect the steel as is the case with Portland cement mortar, in which the lime hydroxide adheres to the steel and waterproofs its surface. In fact, lime carbonate does not waterproof the steel, and allows interstitial water transfer, whereby the alternation air/water leads to oxidation of the metal. The steel beams of the first-floor ceiling, made of large composite edge profiles, with a brick masonry core, were also affected and by the same issue.

Fig.2: Heads of rusty-exfoliated profiles in support area (inside the masonry wall and lime mortar).

The damaged profiles, when their heads had lost effective section for their function, were shored up and cut at a distance of approximately 50 cm from the vertical face. The attached images show the design and construction details, as well as their implementation.

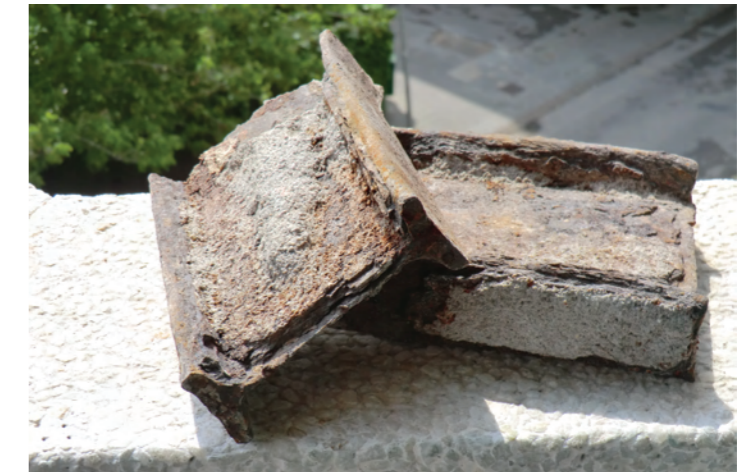
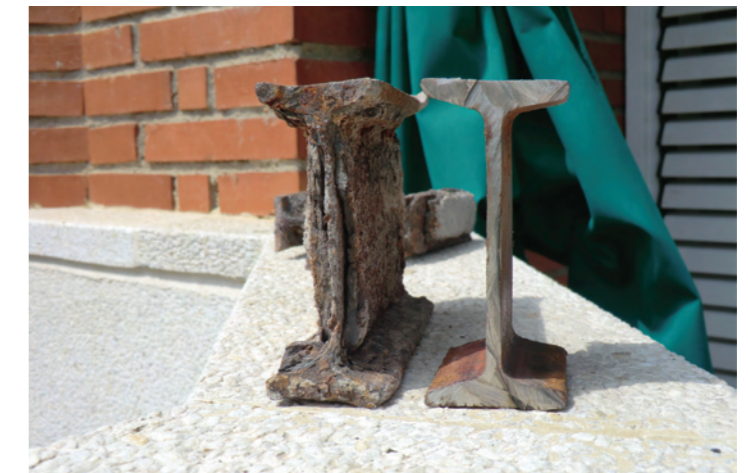
Fig.3-4: Rusted and swollen profiles; Fig.5: Narrow-wing profiles used in the building.

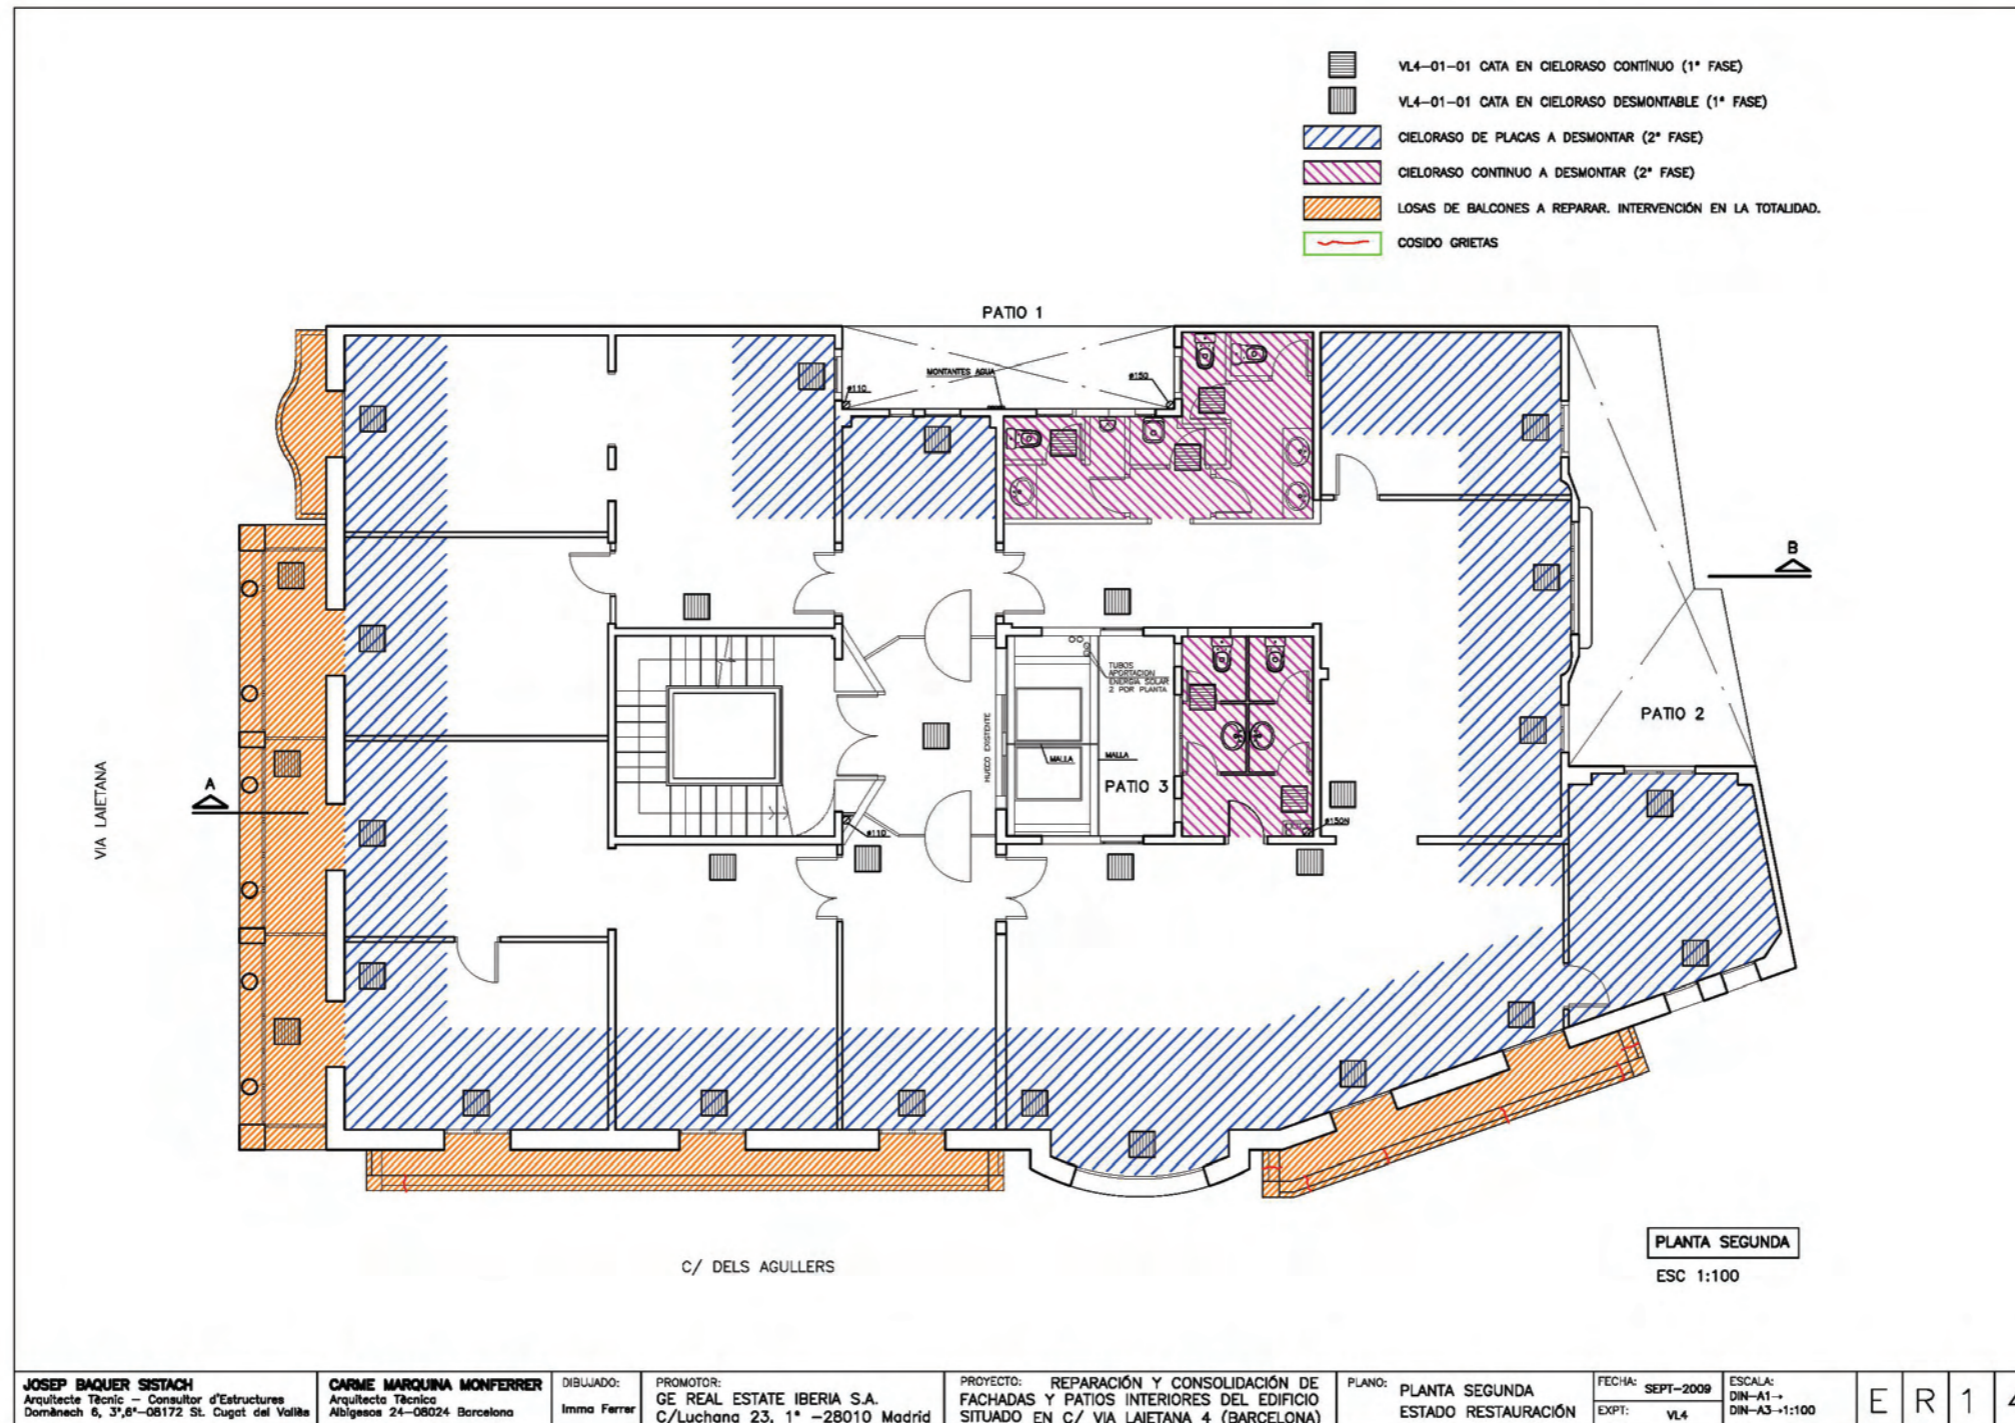
Fig.6: Typical floor plan: areas to be repaired.

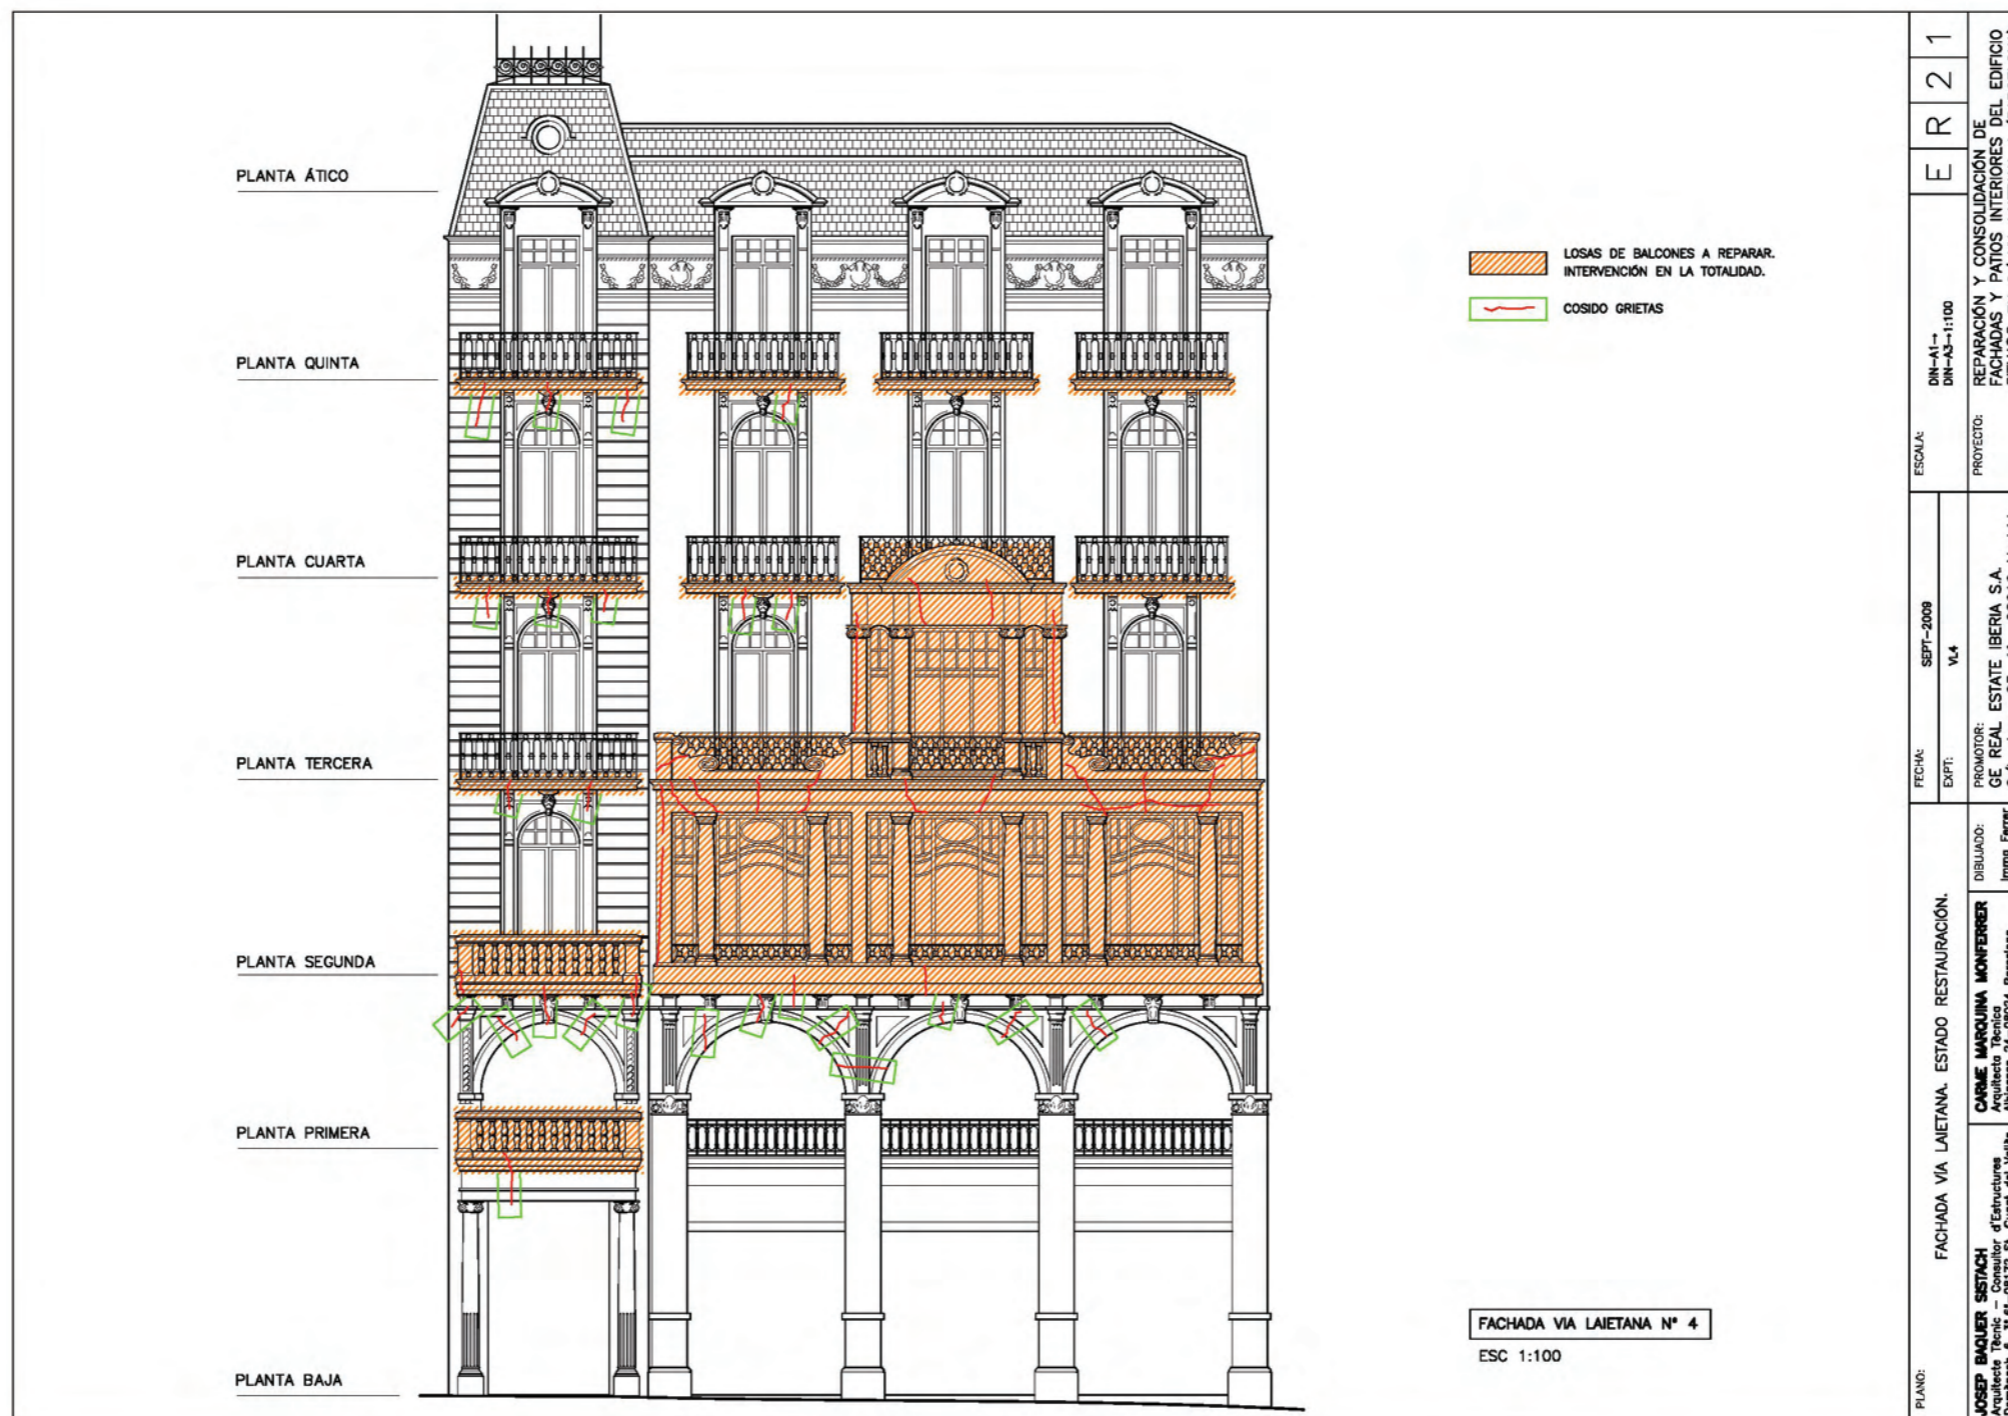
- On the facades, almost all the structural elements of the tribunes, balconies and decorative stone elements were deteriorated in unstable equilibrium.

Fig.7: Via Laietana's façade: map of lesions/damages.

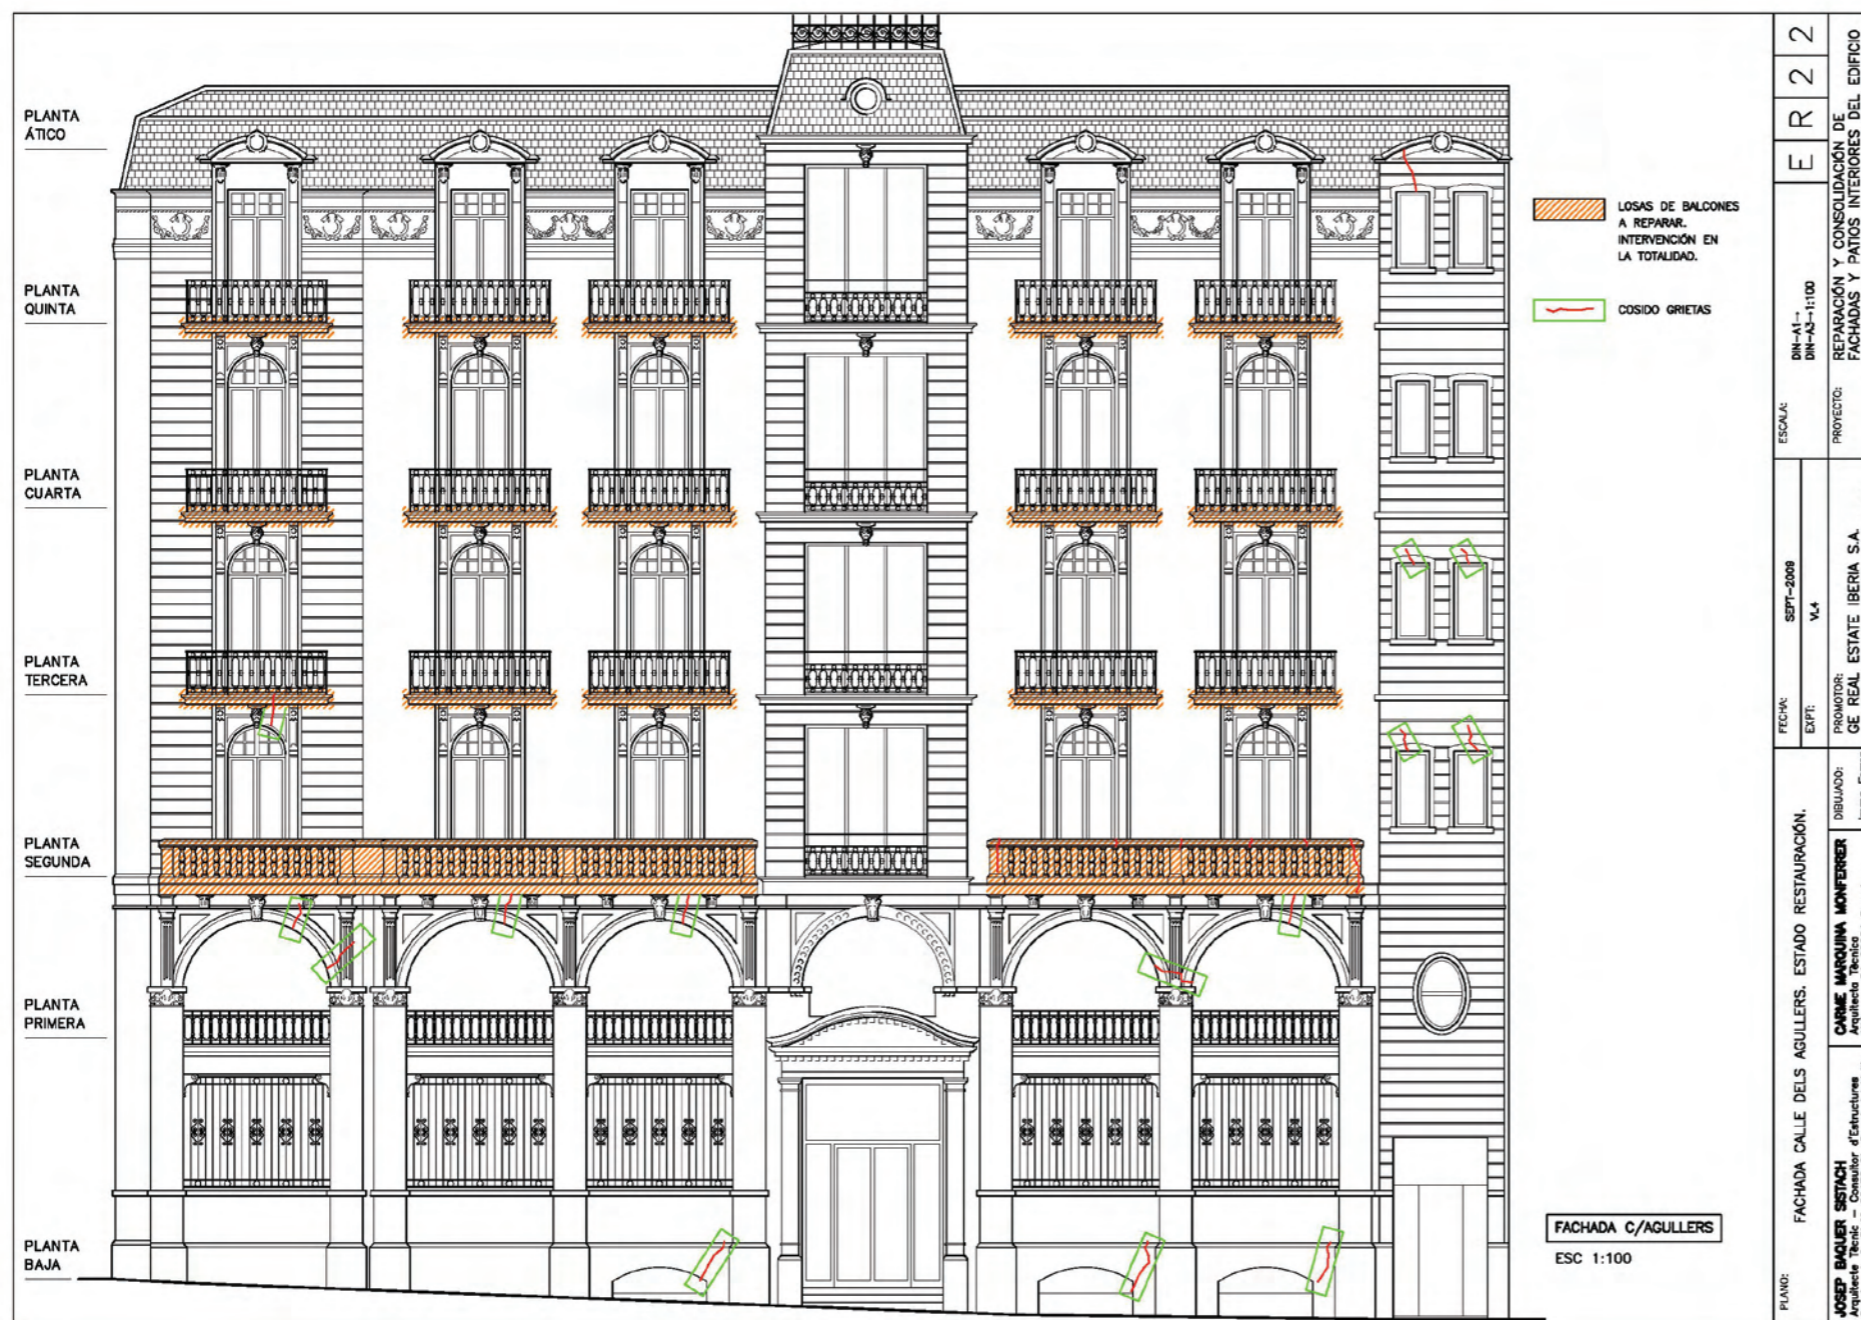
Fig.8: Agullers Street's façade: map of lesions/damages.

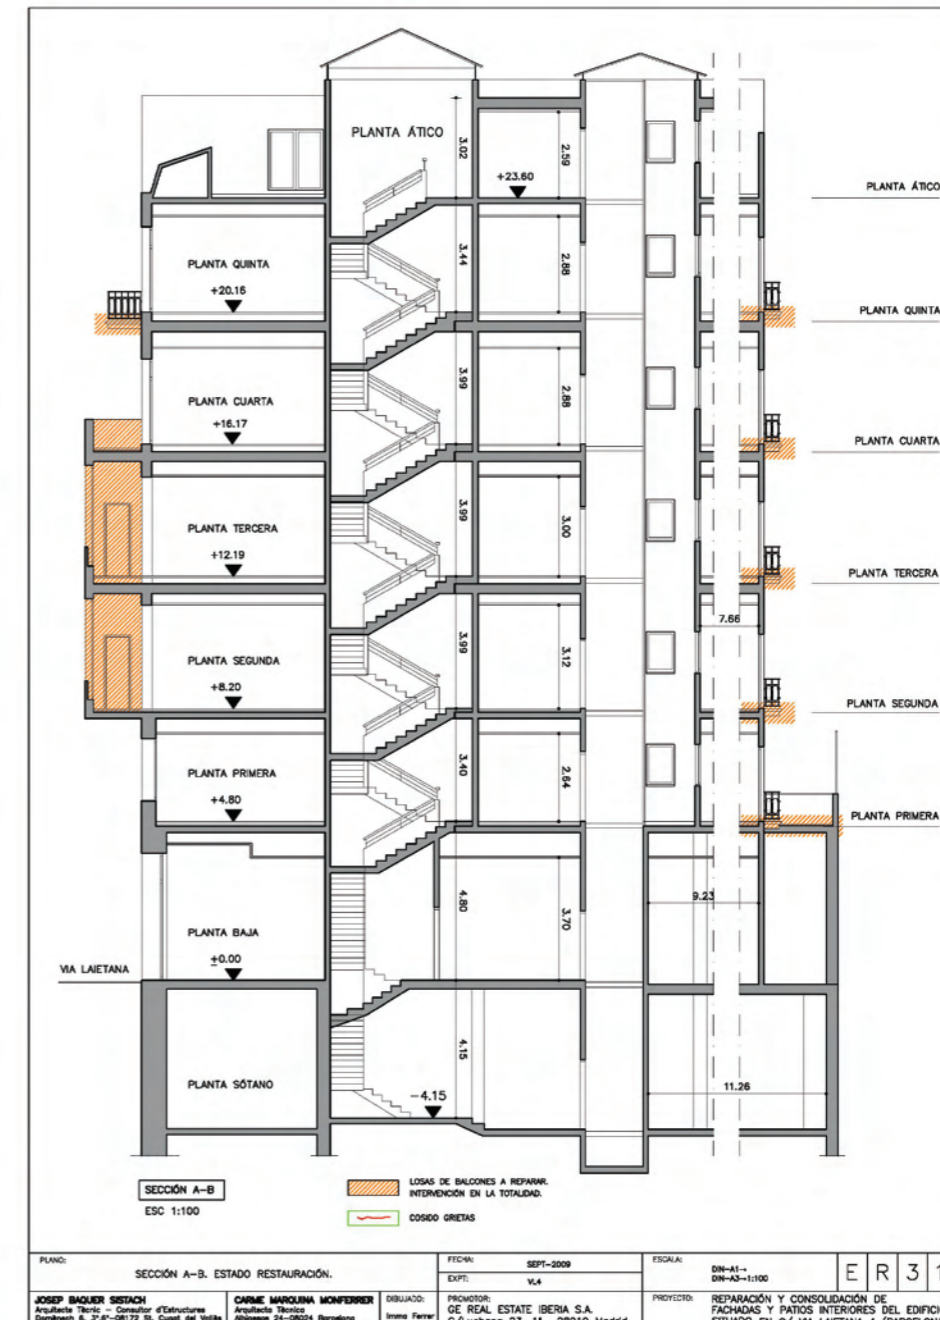
Fig.9: Section and location of areas to be repaired.

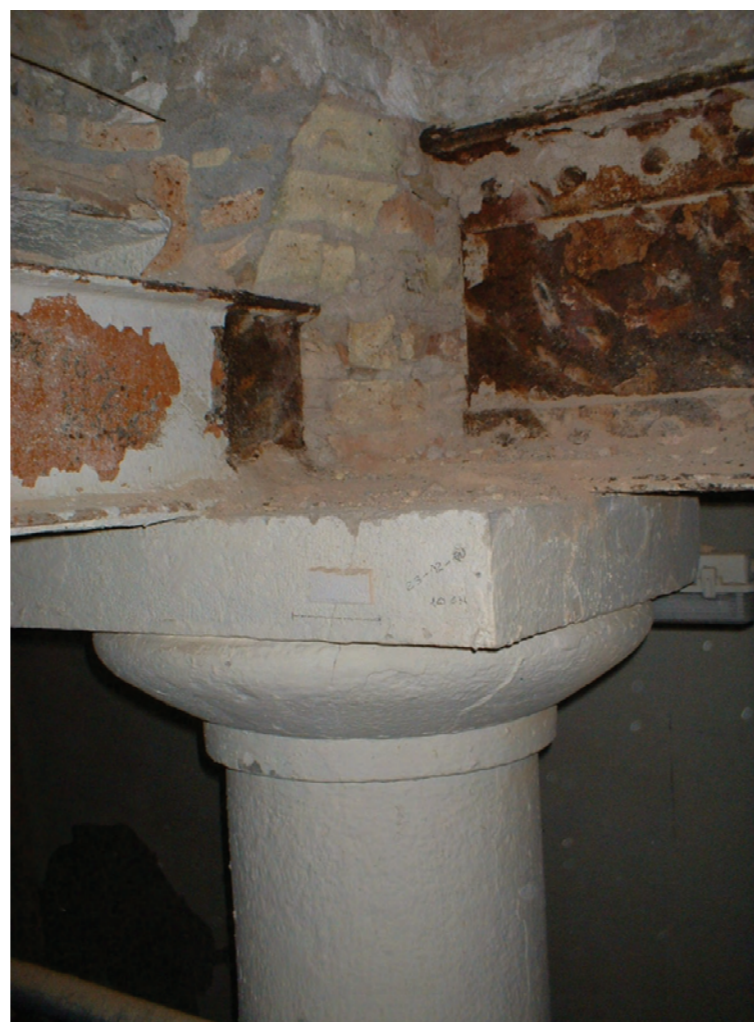
Fig.10: Existing conditions prior to the rehabilitation of the capitel and head of the composite profile beam.
