# Old mansion for modern culture.

# The ruined manor became the cultural attraction of the Lithuanian province.

| Type of intervention | |
|---|---|
| Site | Paliesius village, Ignalina municipality, Lithuania |
| Objectives | Rehabilitation and reuse of Paliesius manor. |

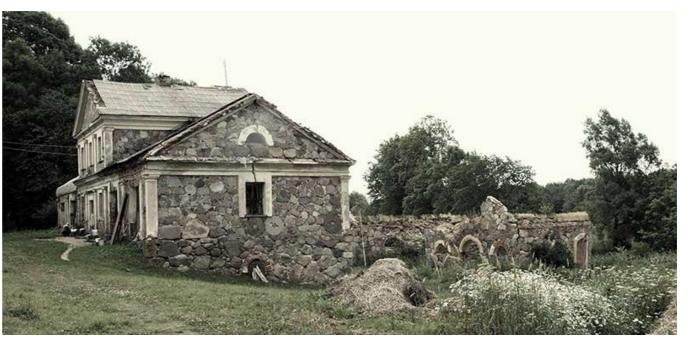
The condition of the house before the renovation work was in an emergency state: the collapsed part of the roof, the masonry walls were hovering on the upper floors, and large vertical cracks were visible.

Fig.4: Supervisor's house and cattle barn before restoration.

During the rehabilitation works, the stability of the building was ensured first of all. The stone masonry foundations (walls) were surrounded by a reinforced concrete ring along the entire outer perimeter, together with the installation of a L-shaped foundation, and a reinforced concrete slab was installed inside the building under all the basement floors. In this way, the type of foundation of the building was changed from a shallow foundation to a box foundation, the movement of the foundation on a floating clay soil was stabilized, waterproofing was installed under all foundations and at the same time all the remaining building structures were preserved.

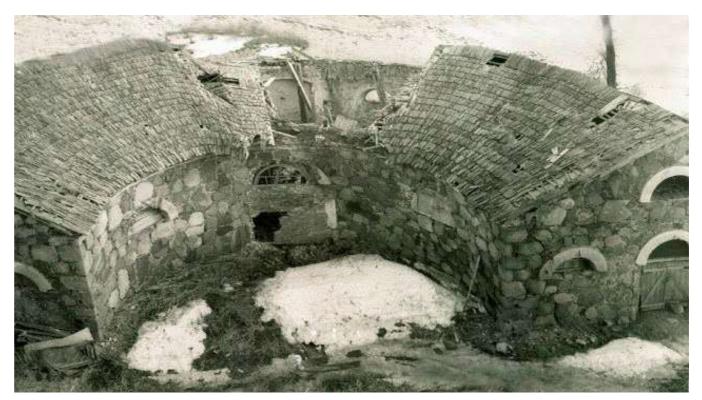
The former stable reached our times without a roof, ceilings, carpentry works, only some damaged walls were left.

Fig.5: Cattle barn before restoration.

It was decided not to restore the former volume of the "horseshoe" shape stable. Architectural solutions were determined by the very poor condition of the masonry. It would be risky to support additional loads on it, necessary to install the second both reinforcing structures to maintain them. In order to preserve the stone masonry walls maximally, the foundation was stabilized with an external contour with reinforced concrete.

After the brick masonry cornice was restored, the walls were tied with a concrete ring at the top.

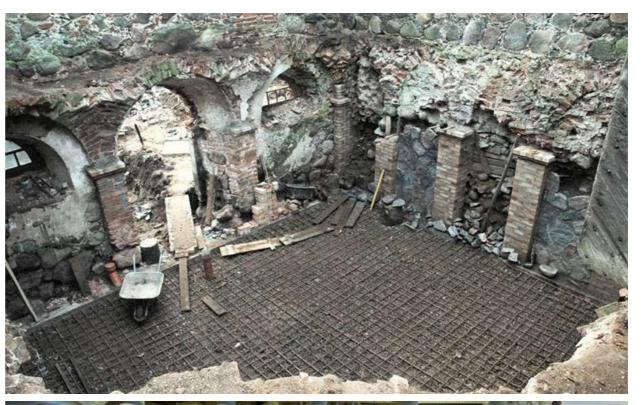
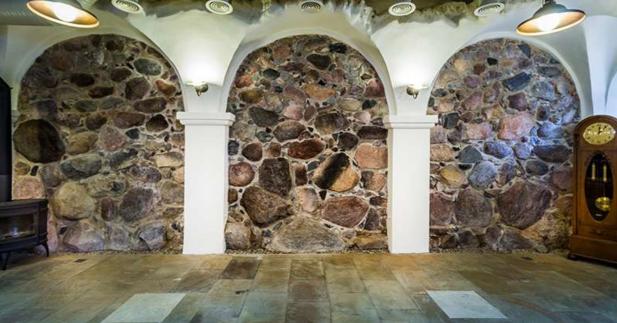
Fig.6: Interior of supervisor's house before and after renovation.

After ensuring the stability of the building, its volume was restored, new roofs and skylights were installed. The collapsed vaults and columns have been restored on the basement floor. A flat concrete floor was installed on the collapsed side; the former column locations are marked in the floor covering. The principle applied here is when changes are made in those parts of the building where authenticity is already lost.

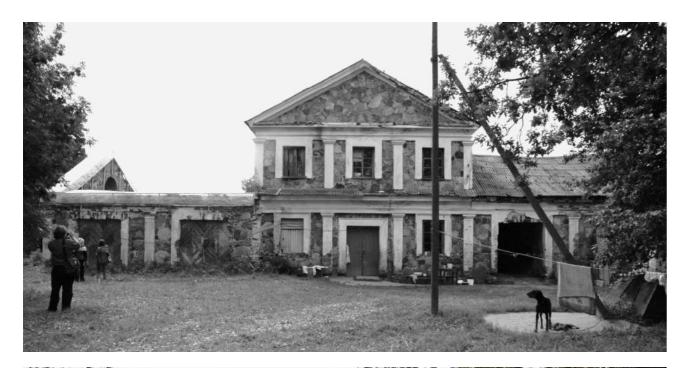
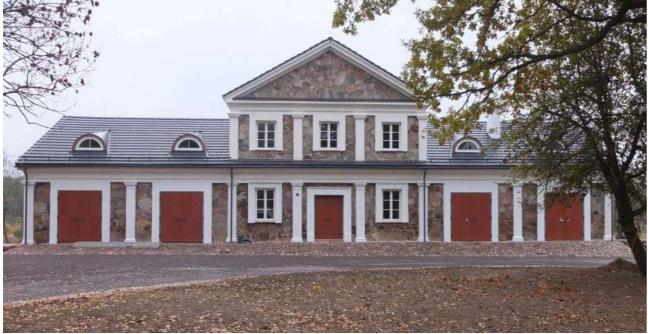
Fig.7: Facade of supervisor's house before and after restoration.

The composition of the facades of the house has not changed. The facades are made of large split field stones, the seams are clogged with dark split small stones, the masonry is neat and very decorative. The masonry was restored after injecting cracks and restoring the loss. Particularly plastered masonry of lintels, openings, pilasters, cornice bricks and plastered surfaces were restored. Preserved building structures and elements, restored planes of decorative masonry walls, wooden beams, ceilings, floors of wide boards (up to 40 cm). In the entrance hall after selecting the best-preserved fragment, the old ceiling technology is exhibited - the sticks are wrapped in a straw rope, placed next to each other and plastered. It has a good sound and heat insulation. The building has been adapted to new needs, new partitions have been built, and premises have been installed in the attic. The building has 9 guest rooms, a ground-floor café and a spa.

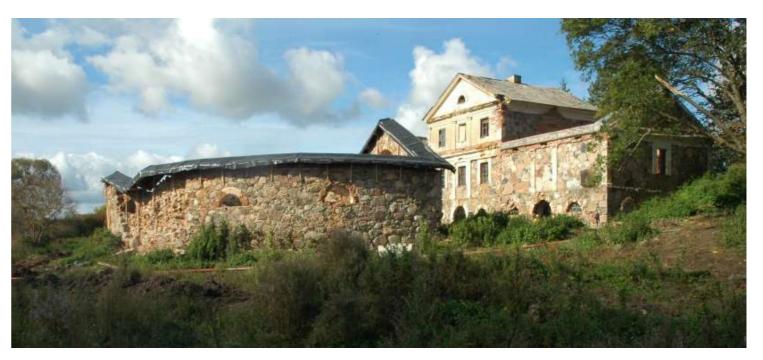
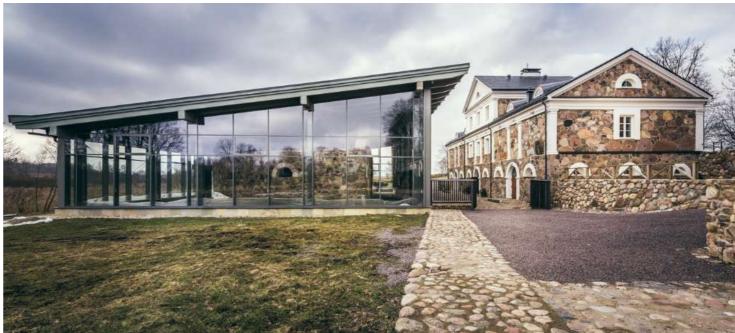
Fig.8: Exterior of supervisor's house before and after restoration.

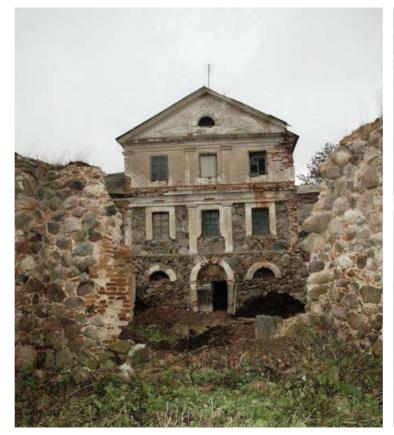
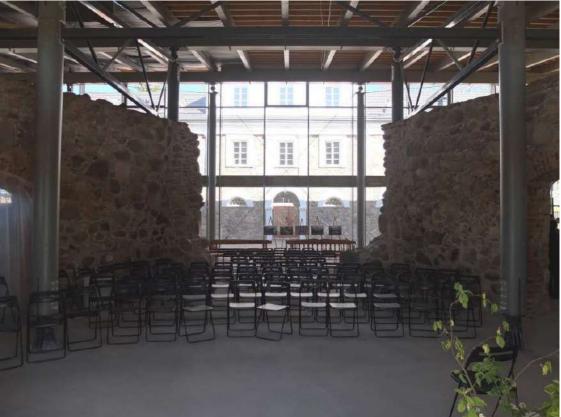
Fig.9-10: Ruins of cattle barn and supervisor's house before restoration (Left). Exposition of cattle barn's ruins after restoration (Right).

Qualitatively restored surviving outdoor stone walls, brick edging, fragments of internal plaster, in their original form, are preserved under a modern wooden glass construction hood, creating optimal conditions for the protection and exhibition of a valuable building. The wooden roof construction is based on glued wood columns with metal fasteners and ties. For the architectural expression of the building envelope, a volume with a sloping roof was chosen, determined by the configuration of the relief and the remains of the historic building.
