A largest painted wooden ceiling in Europe, rich of history and original construction techniques.

Site	Chiaromonte Palace, also known as Steri, Marina square, Palermo, Sicily, Italy
Objectives	Restoration of the wooden ceiling of the Magna Room (Sala Magna)
Property	Public: University of Palermo
Designer	Building work Director: Arch. Costanza Conti Unique Responsible for the restoration procedure: Eng. Antonio Sorce Rest. Contractor: ARES Srl, Martina Franca (TA), Italy High surveillance and protection: Superintendence of Monuments of Palermo
Date	2017-2019

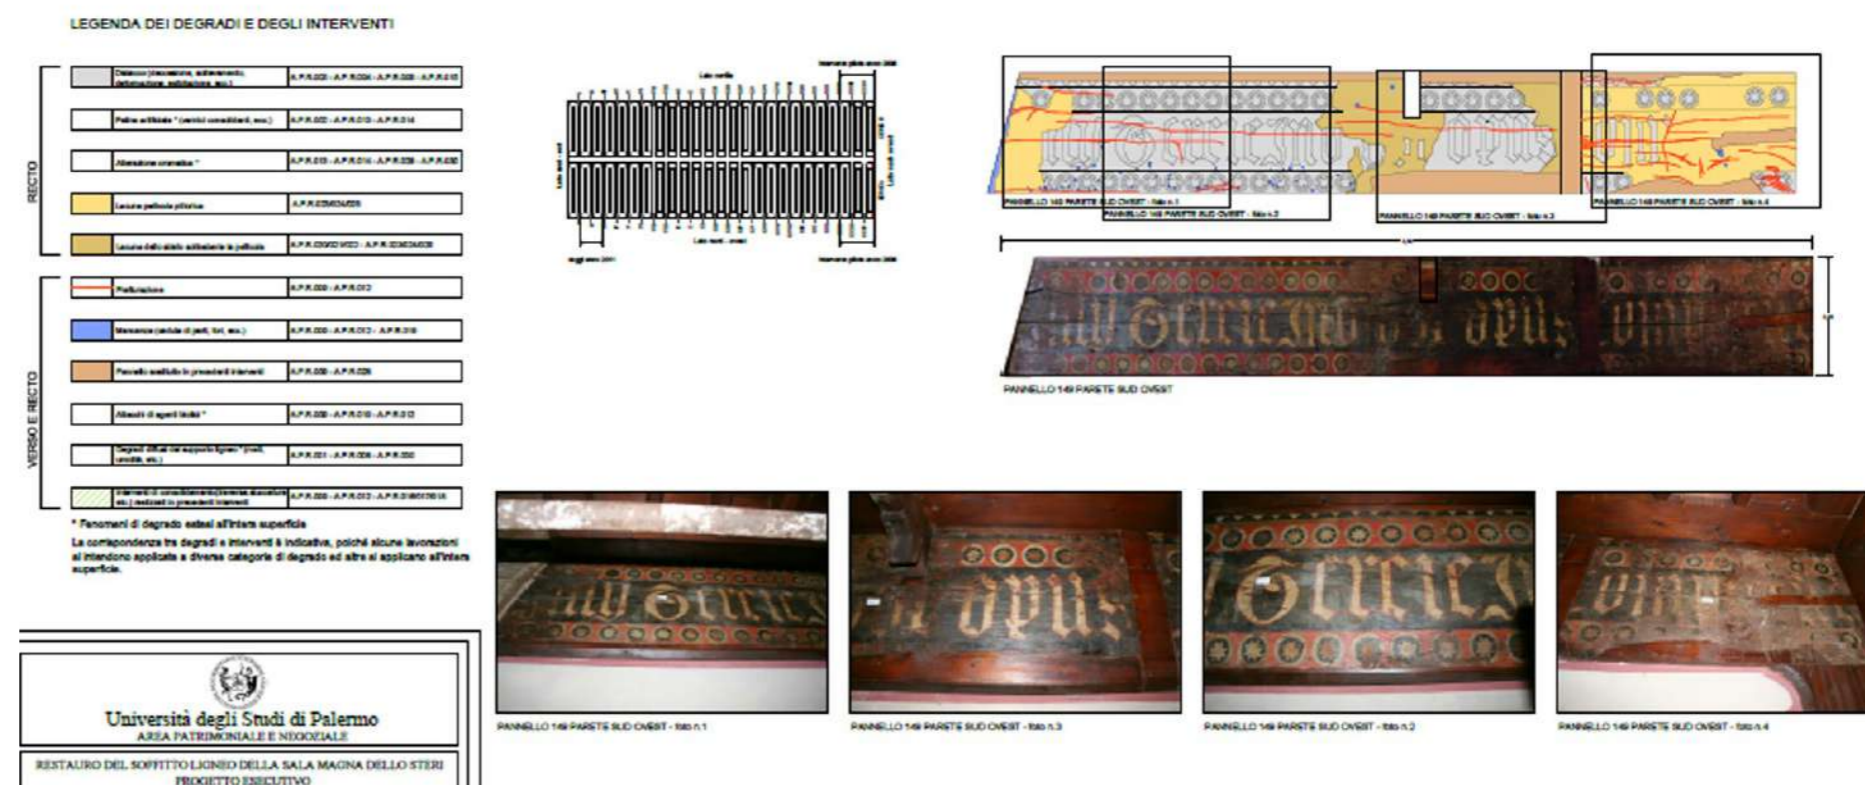
The painted panels were in an amazingly poor state of conservation, attributable both to the natural aging of the constituent materials as well as to previous restoration interventions. Consequently, they presented numerous forms of decay: superficial deposits, widespread gaps, abrasions, detachments and lifting of the pictorial film, deterioration of the binder and alteration of some pigments also complemented to lesions of the wooden support. The drafting of a ketone varnish applied in the previous restoration intervention had altered the material characteristic of the tempera technique and seriously altered the original colors. In addition, the attacks of xylophage's insects have widely affected the painted wooden panels and the support structures making up the ceiling framework, resulting in a significant reduction in the mechanical strength. The deterioration of the pictorial films and of the wooden elements was aggravated also by the construction of the floor in corrugated steel sheet which caused inevitable phenomena of condensation. These phenomena described above were triggered by interventions that had been carried out

Fig.12: Executive design of restoration works; table of degradations and related interventions of one of the wooden ceiling panels. © University of Palermo, Technical Area (Eng. A. Sorce, Arch. C. Conti)

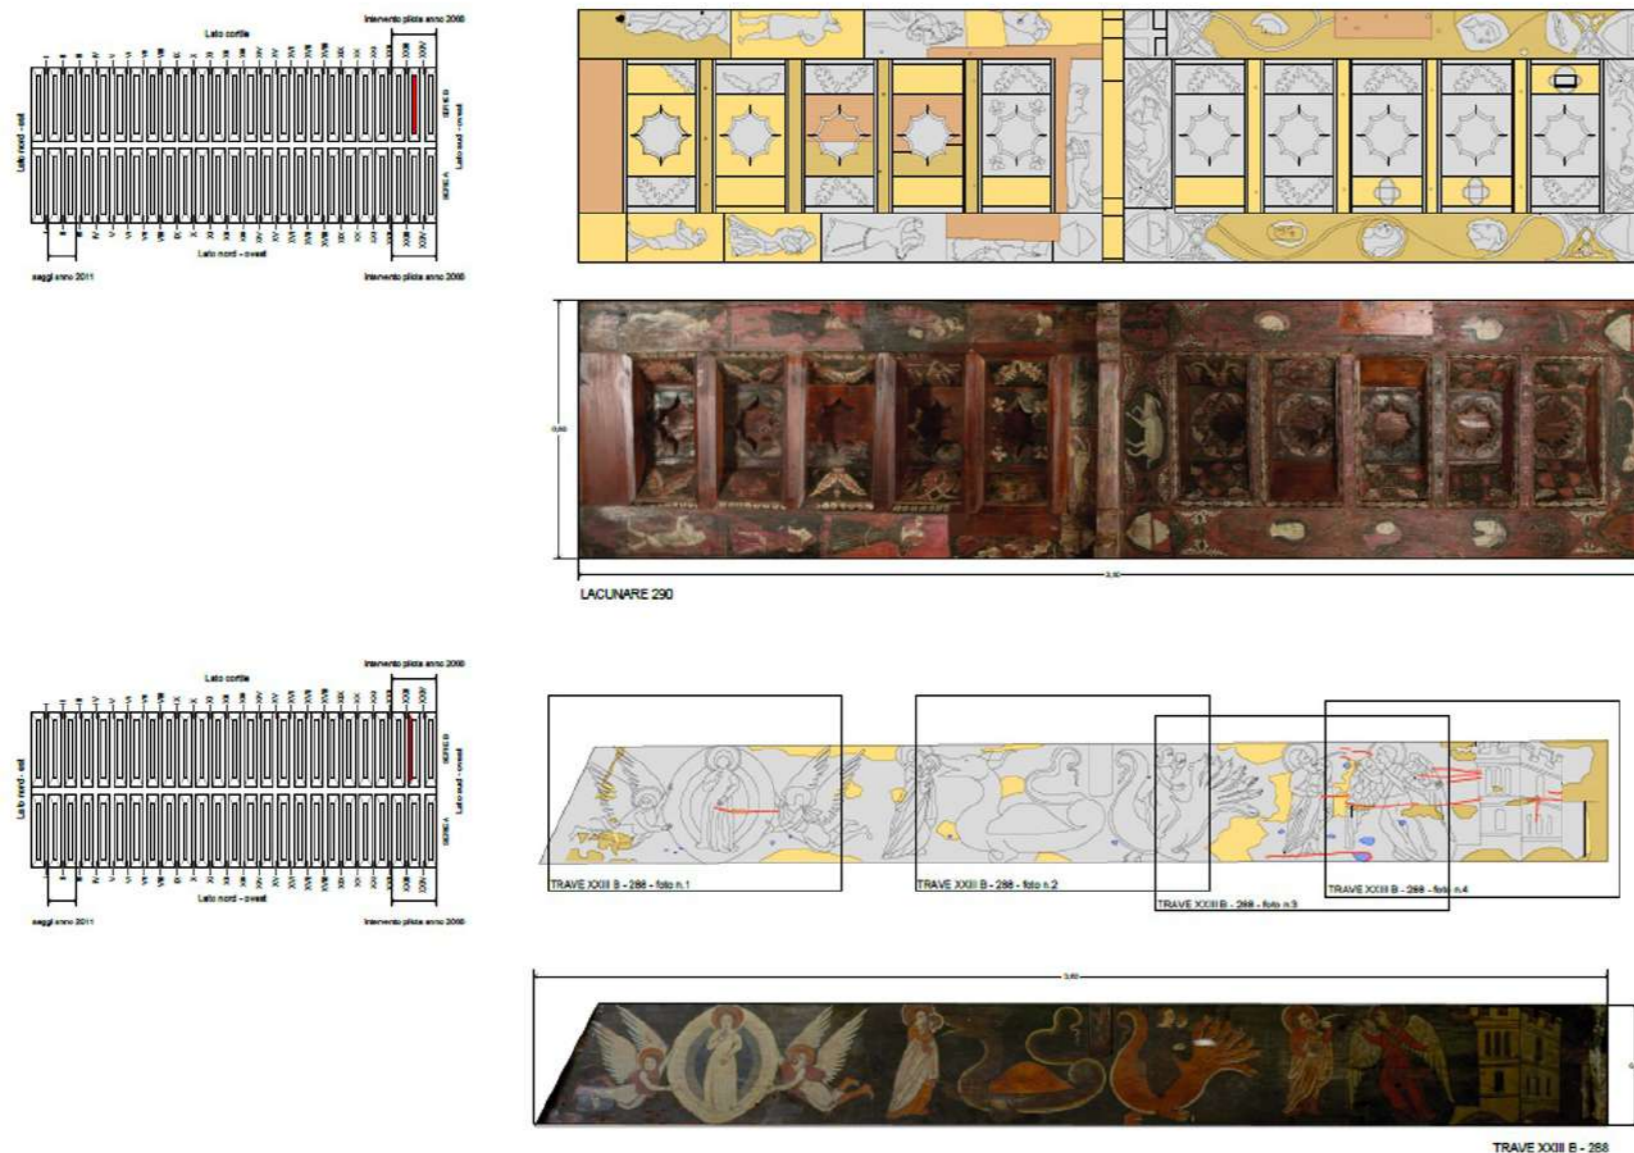
Fig.13: Executive design of restoration works; table of degradations and related interventions of one of the wooden ceiling lacunars. © University of Palermo, Technical Area (Eng. A. Sorce, Arch. C. Conti)

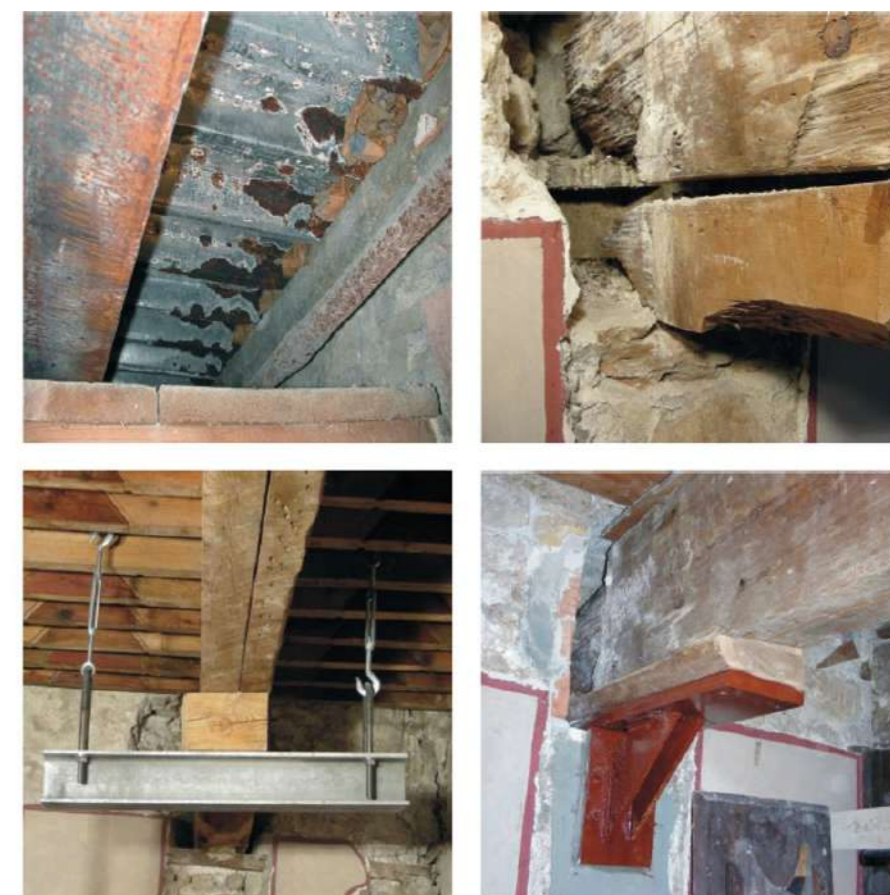
- 1 - Degradation of the ceiling in lamiera grecata realizzato nei precedenti interventi di ristrutturazione per sostituire il solaio ligneo preesistente.
- 2 - Gravi fenomeni di marcescenza delle teste delle travi principali a causa dell'assenza di un'adeguata areazione e della presenza di elevati tenori di umidità.
- 3 - 4 - Sostegno provvisorio tirantato per consentire il rifacimento delle mensole di appoggio delle travi e la realizzazione di adeguate nicchie di alloggiamento areate.

Fig.15: Detail of one of the posters clarifying the structure and the degradations of the ceiling, explaining the restoration works. © University of Palermo, Technical Area (Eng. A. Sorce, Arch. C. Conti)

The corrugated metal sheet showed widespread corrosion, with consequent disintegration of the overlying reinforced concrete screed and the metal reinforcement, which made it necessary to replace large portions of these construction systems and reconstitute the disintegrated concrete screed by casting of rheoplastic grout. With regard to the check tests carried out on the wooden beams, a strong deterioration of some of them was observed, determined by the biotic alteration of the wood due to the humidity and the temperature of the interior environment in which the wooden ceiling is located and the lack of ventilation of the holes' housings the wooden beam heads. Therefore, it was necessary to create some wooden prostheses, replacing the most severely degraded heads, also limiting the intervention to the irrecoverable portions of wooden beam and ventilated housing niches.

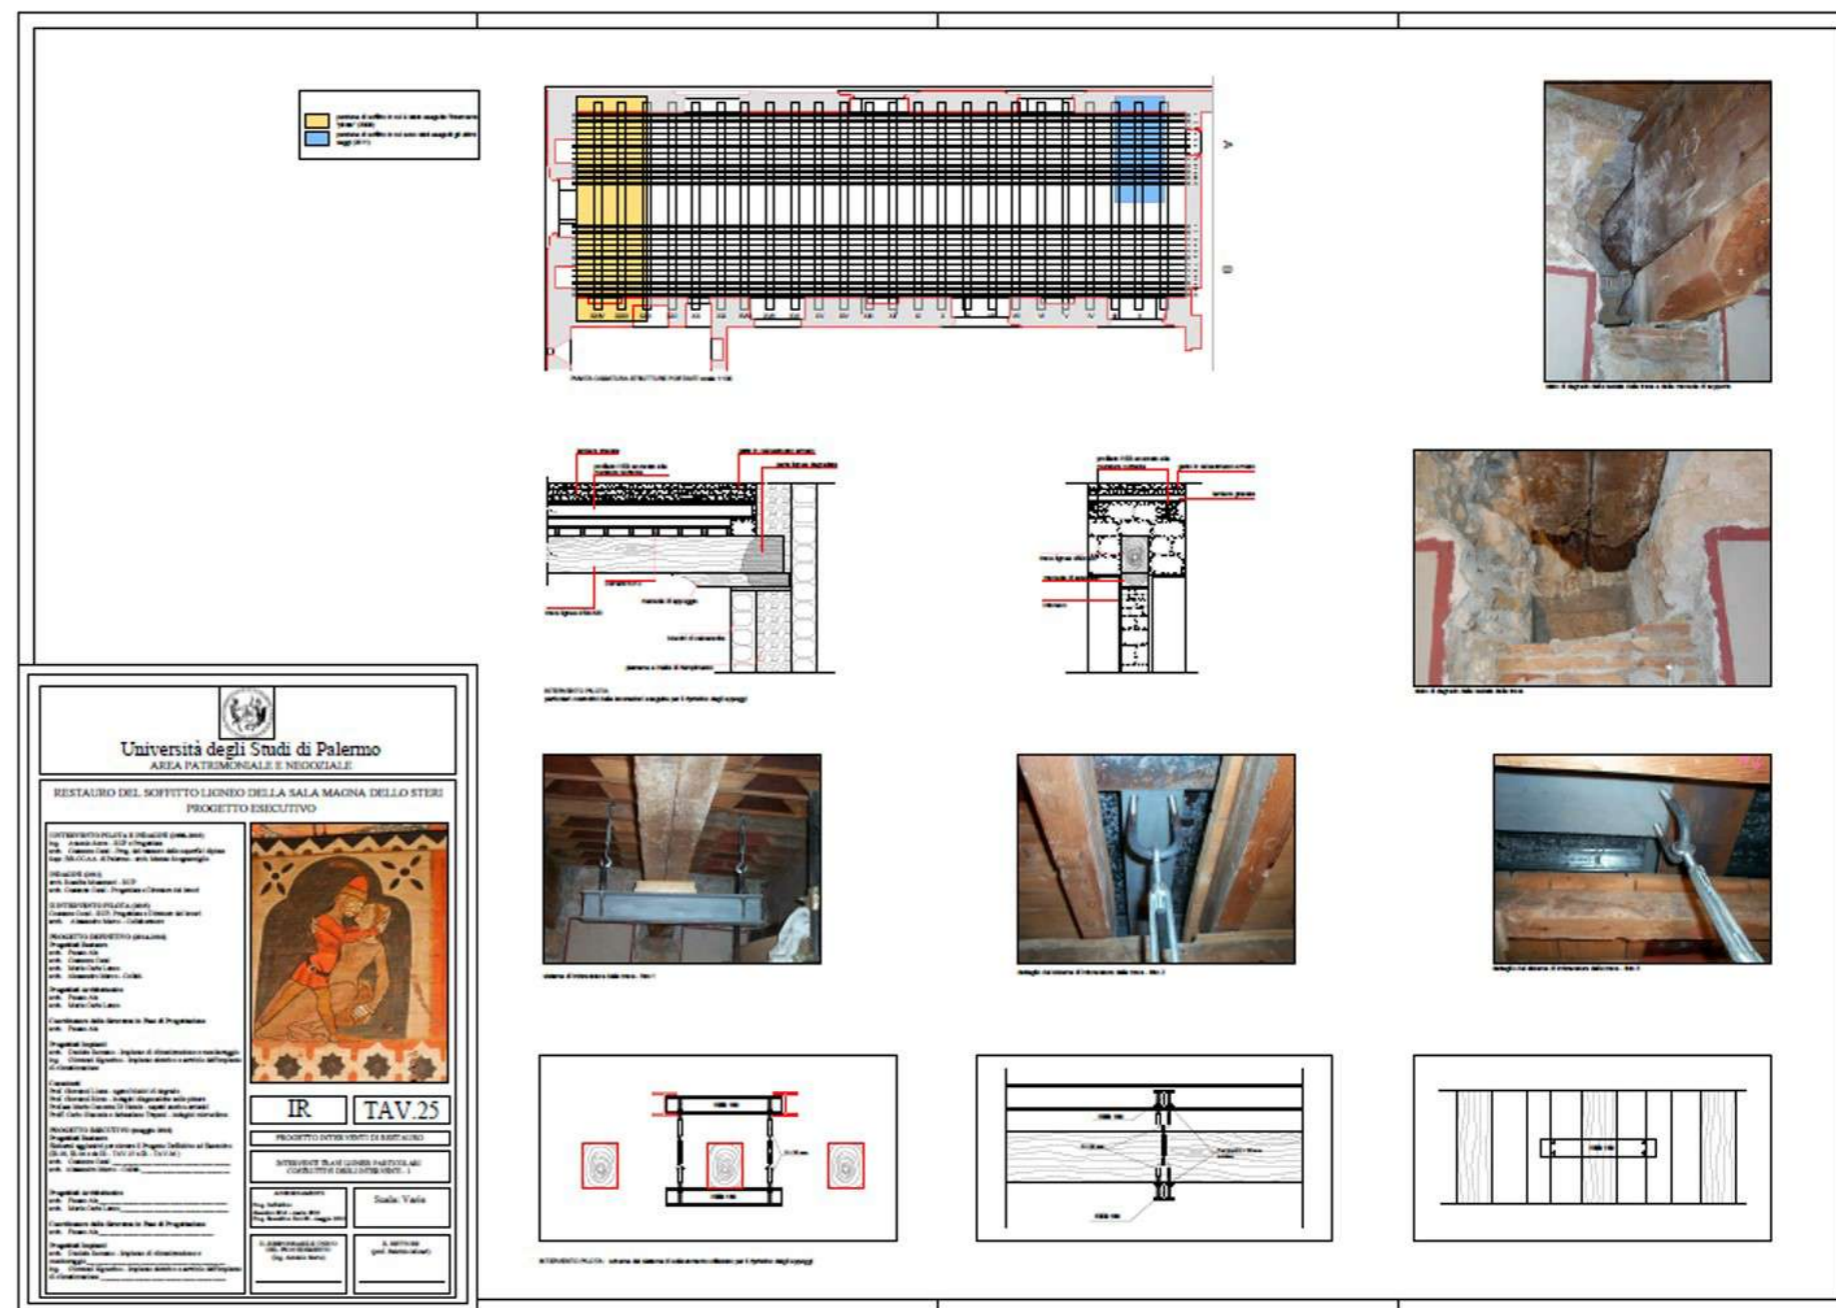
Fig.16: Executive design, table of interventions. © University of Palermo, Technical Area (Eng. A. Sorce, Arch. C. Conti)

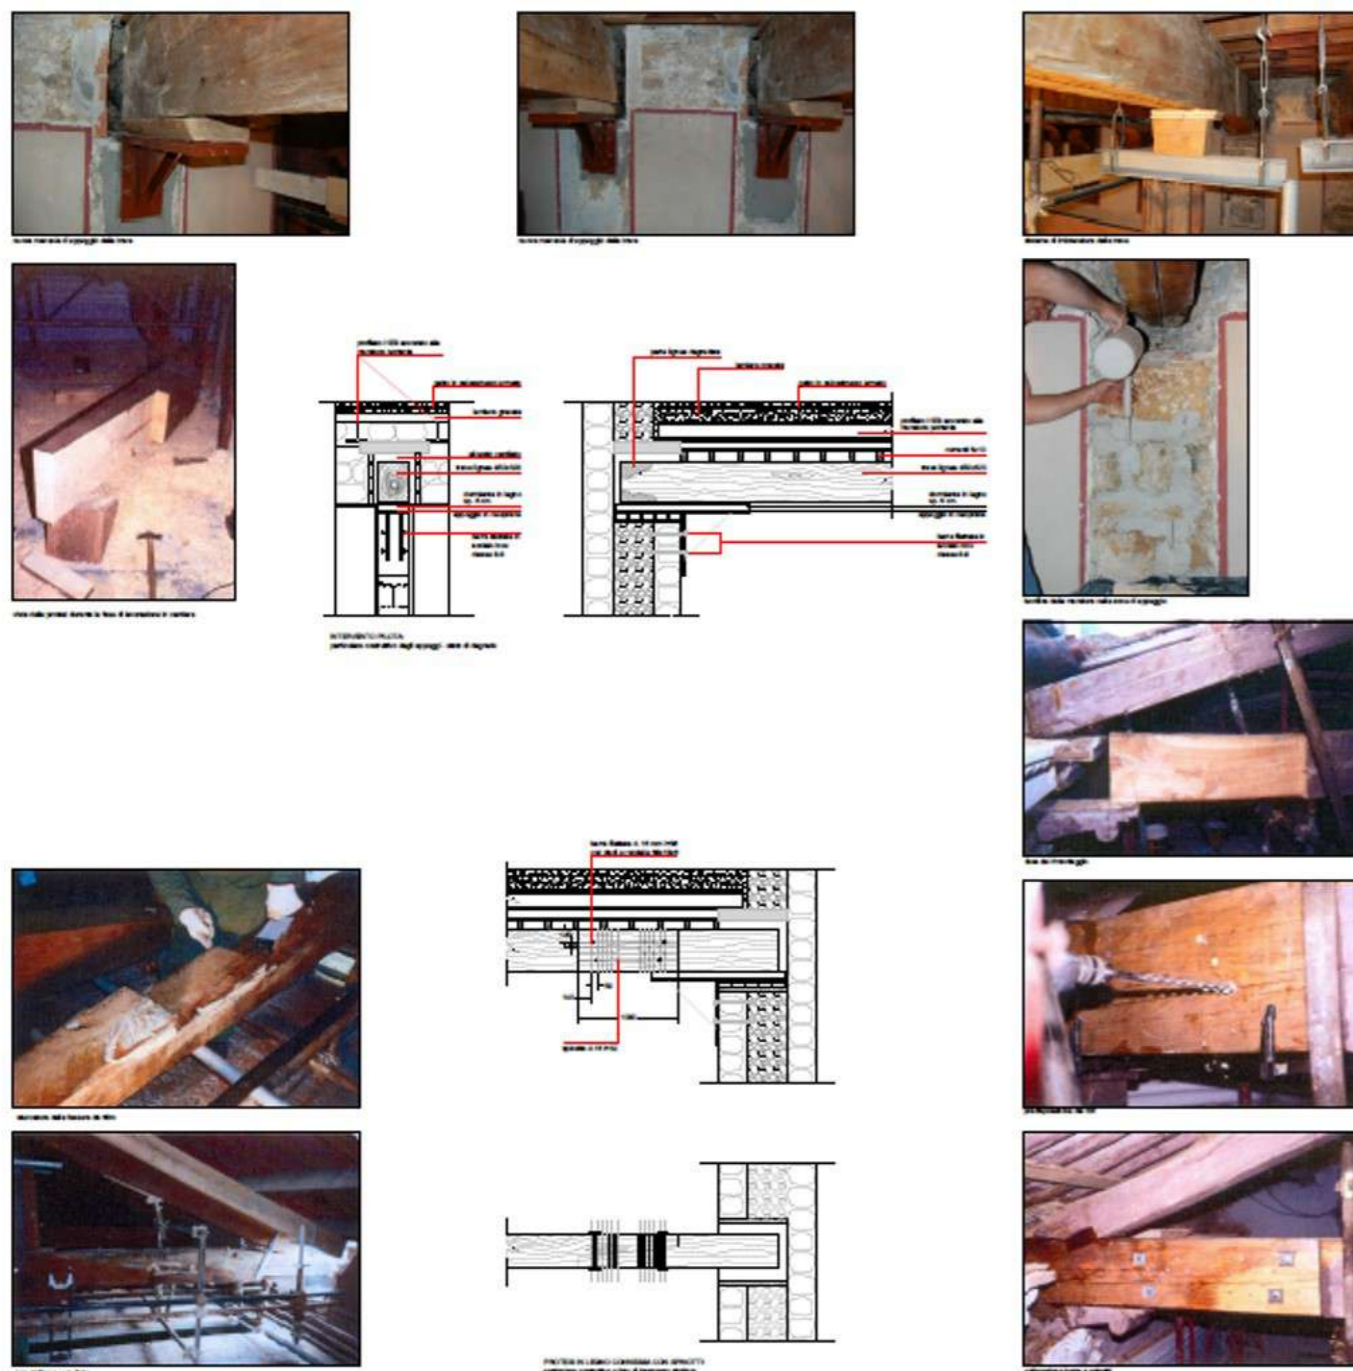
Fig.17: Executive design, table of interventions. © University of Palermo, Technical Area (Eng. A. Sorce, Arch. C. Conti)
