Urban renewal through the renovation of a façade.

Energetic rehabilitation and urban regeneration of the back façade of a multi-family housing complex.

Site Carrer Lope de Vega 111, Barcelona, Catalunya, Spain

Designer Carlos Pérez Arquitectos Asociados SLP:
Archs. Carlos Pérez Sánchez & Carlos Pérez Mir

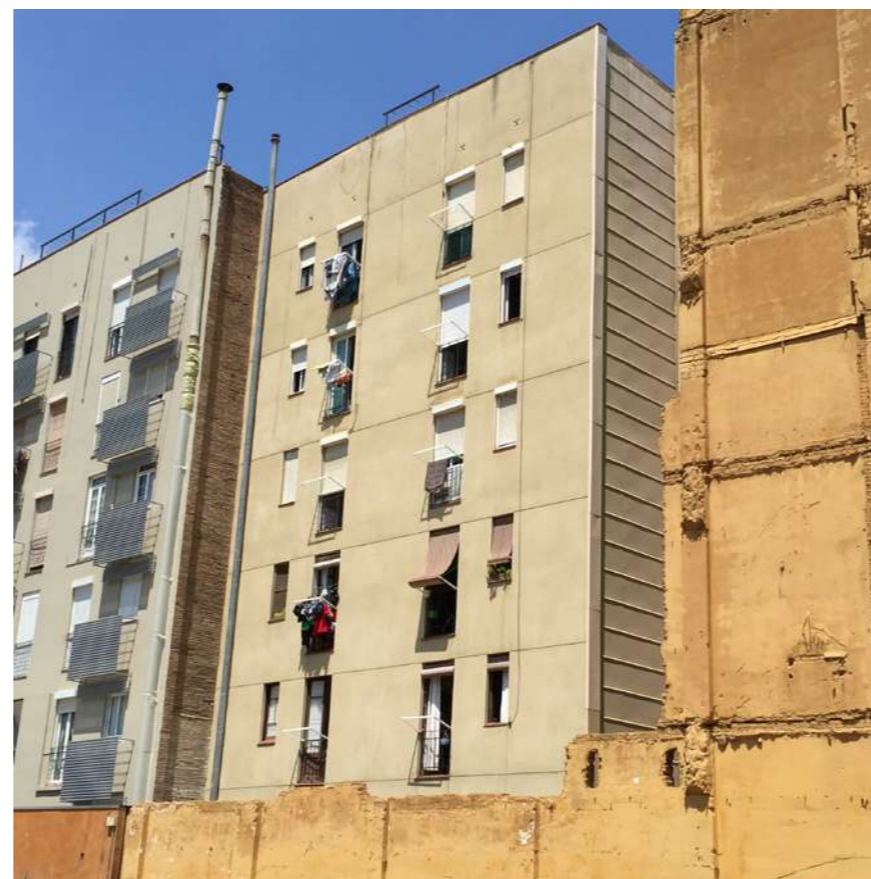
Fig.1: Existing façade.

The façade has a load-bearing character, forming part of the vertical structure of the building, which is supported by narrow-flange metal joists. The walls have a very low load-bearing capacity. The walls were of 15 cm of solid brick with lime mortar of very low resistant quality as a result of a typical construction practice of the time and as a finish it presented a single layer coating without any type of insulation. It had exposed clotheslines that distorted the urban landscape with the clothes hanging out. The walls were flat and unprotected, with no balconies or overhangs to mitigate the rigors of the weather. There were no energy efficiency criteria.

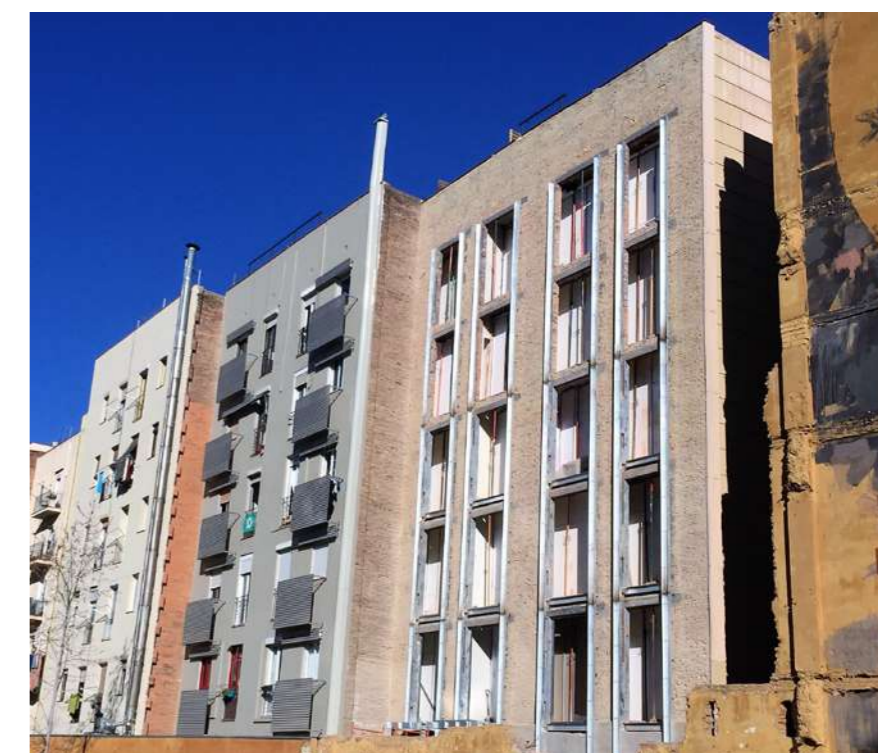
Fig.2: Enlarged window openings.

Indeed, the enlargement of the original windows, both in height and width, in order to convert them into balcony doors; the incorporation of the balcony, large enough to install a small table with chairs; the incorporation of blinds that allow sifting sunlight and create a private atmosphere inside the balcony much more pleasant, as well as the detail of designing a railing that hides the clothes hanging and at the same time graduates the passage of light and views, are elements that, together with the addition of an exterior insulation to the entire facade, taking special care in the elimination of thermal bridges, and the interior rehabilitation of some homes, made the habitability of these residences has gained in quality and comfort, while reducing energy consumption, and therefore, the cost of the energy bill.

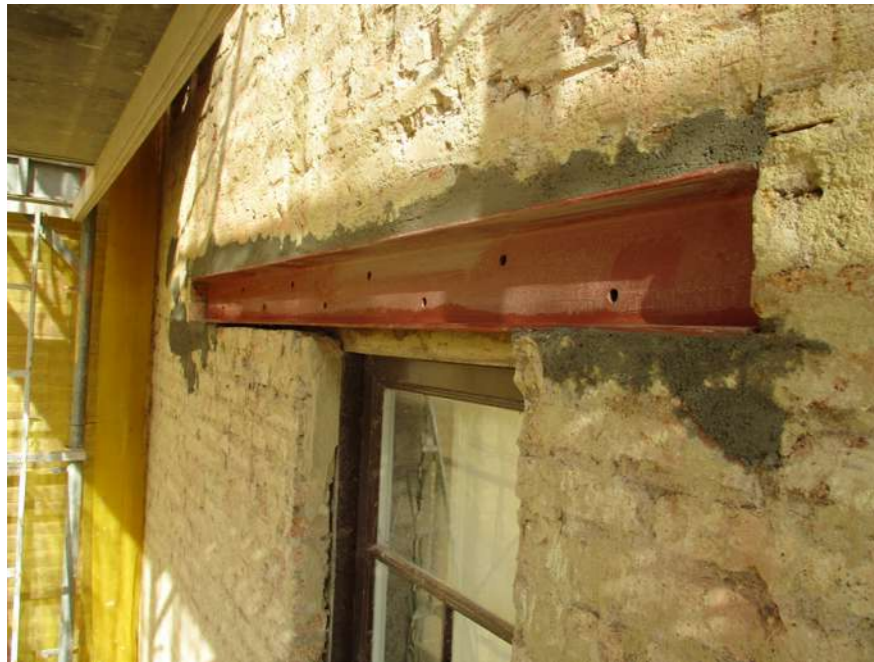
Fig.3: Reinforcement of the openings so they can be enlarged.

- Creation of balconies. Outdoor living spaces. Create hidden clotheslines integrated into the facade.
- The need to structurally guarantee the performance, given that the solid areas of the façade were reduced and that the bearing capacity of the wall was deficient, as was reflected in the laboratory tests carried out. Therefore, the section of the façade wall on the first floor was enlarged and a metal structure was created to relax the tensions in the façade.

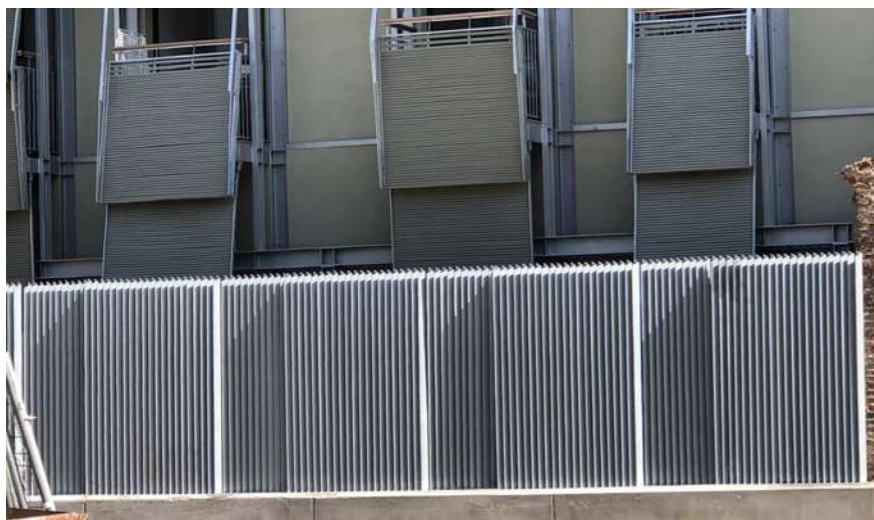
Fig.4: Detail of the fence, as seen from the square.

The project was completed with the design of a new fence on the first floor facing the new square, which provided new terraces to the dwellings on this floor and allowed some visibility of the exterior while offering security to the tenants.

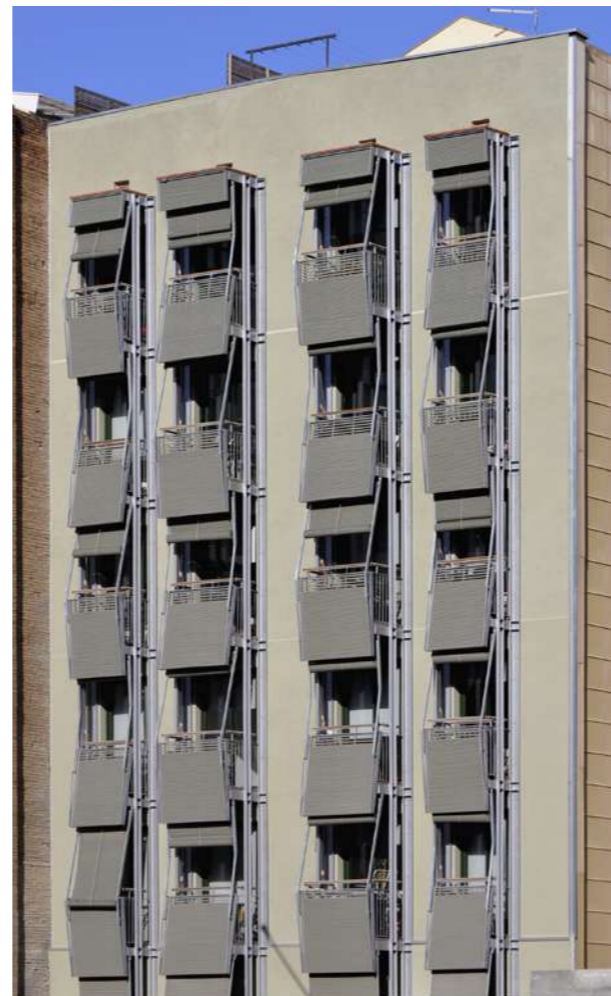
Fig.5: Finished rear façade.

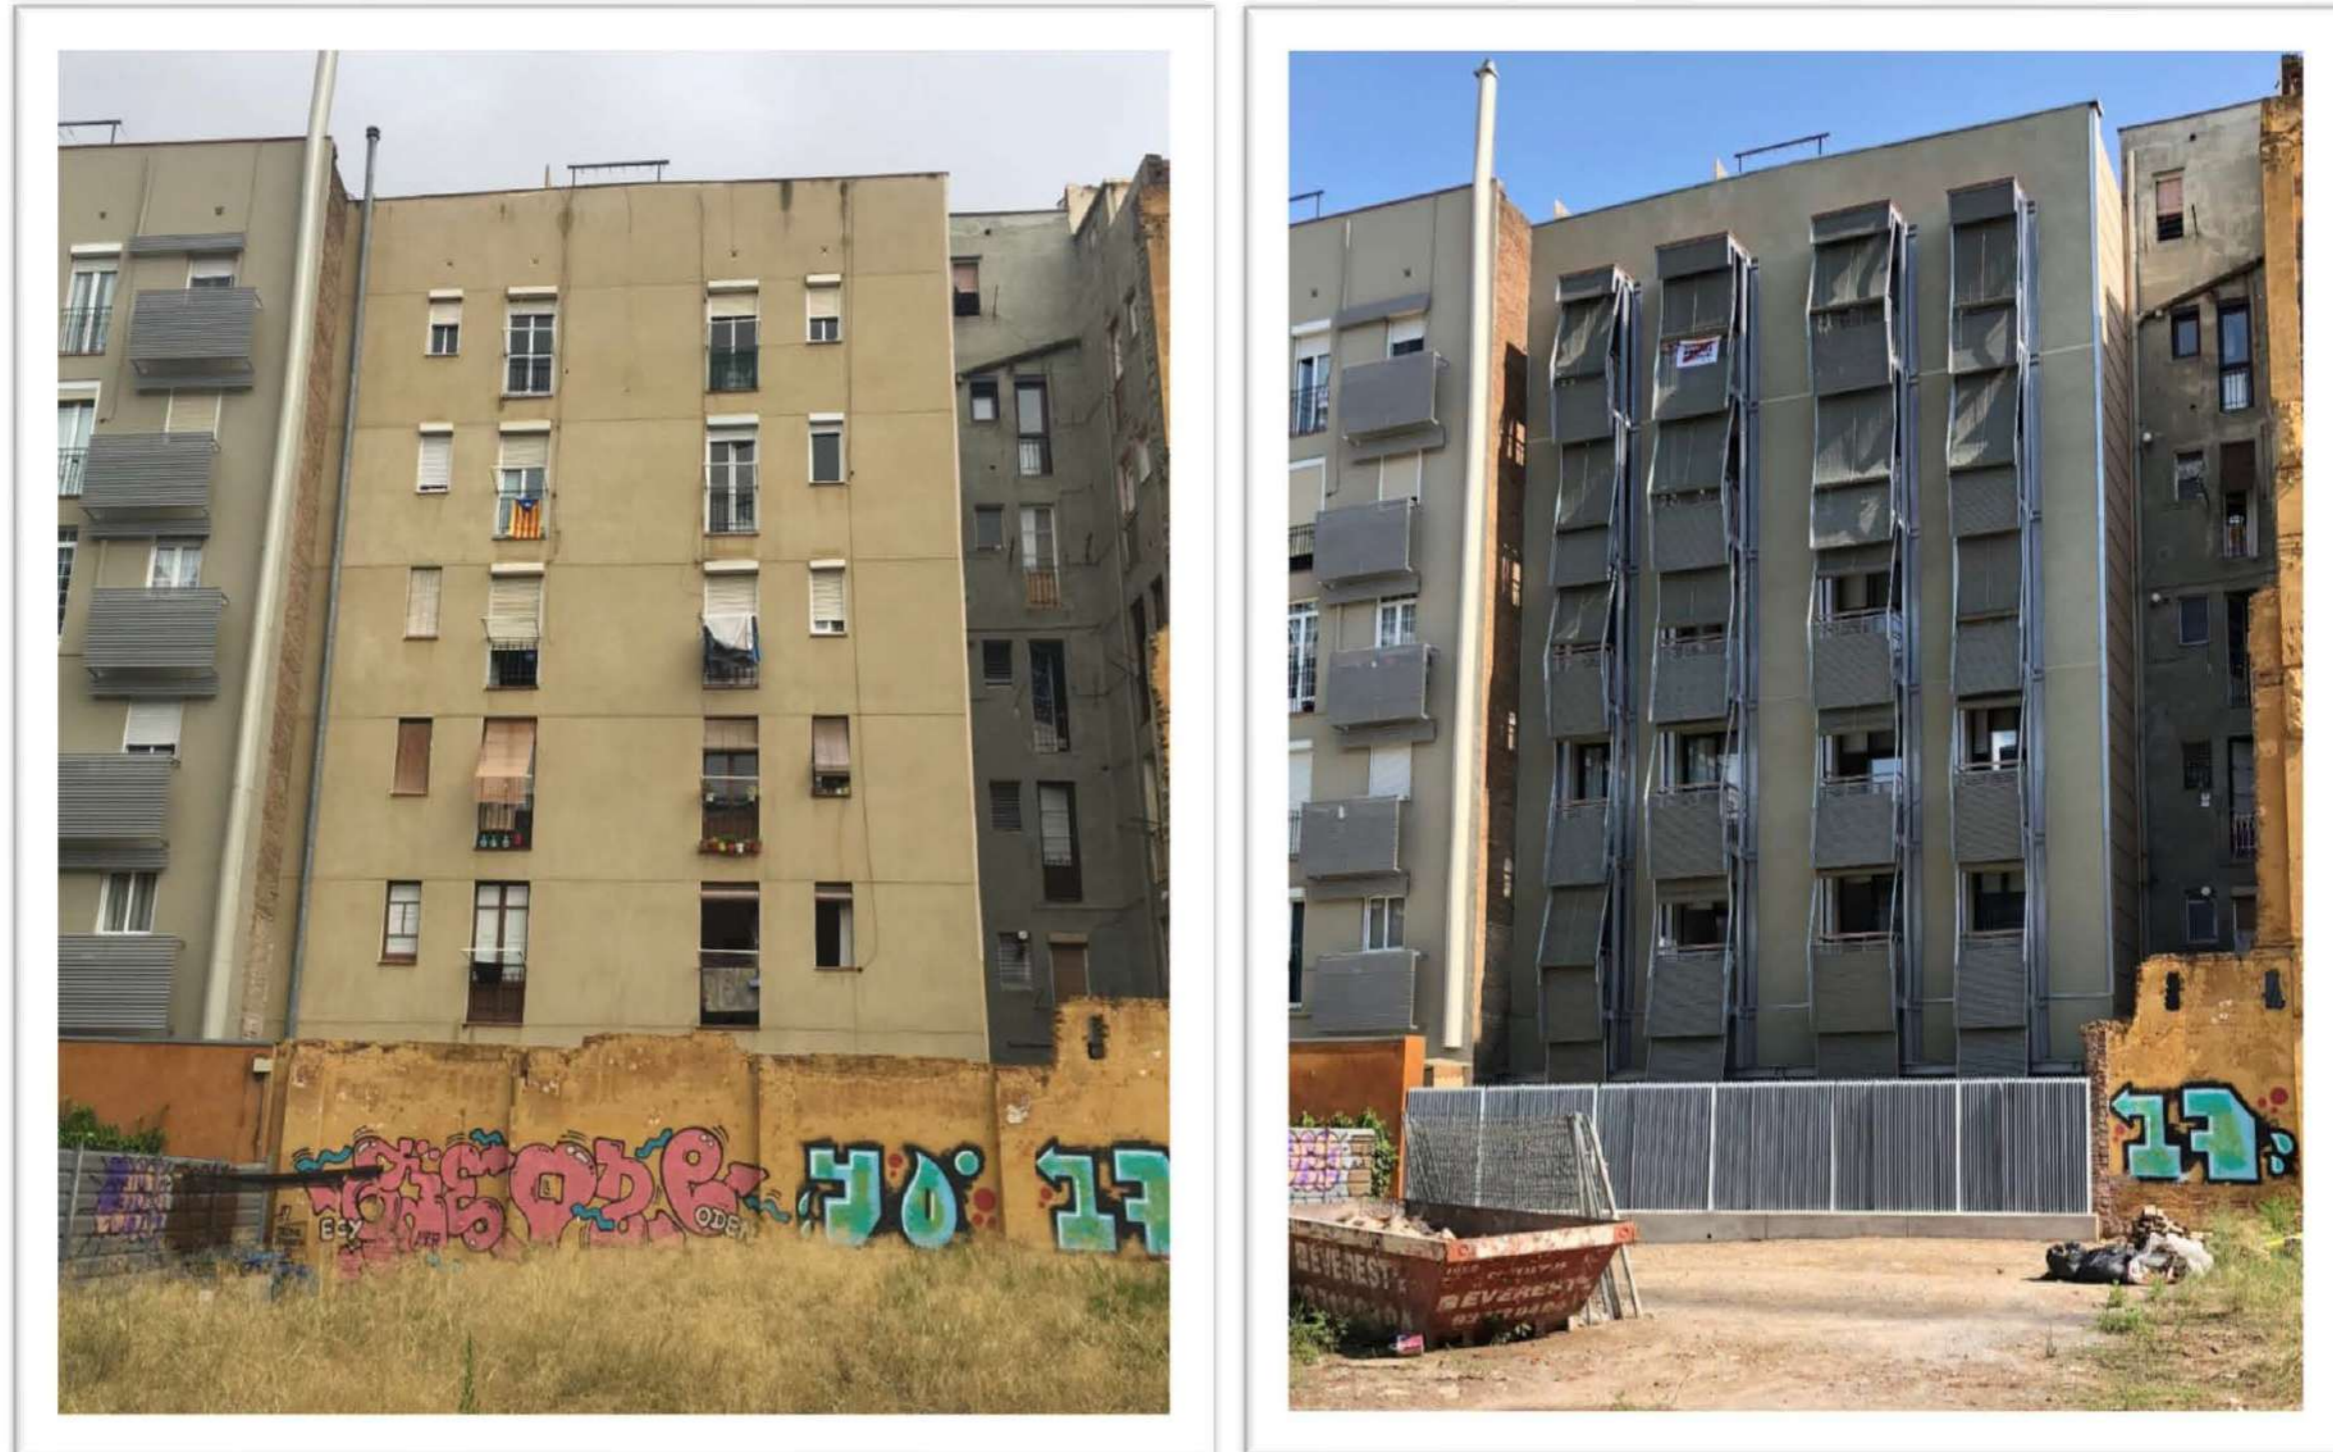
Fig.6: Before and after of the intervention.

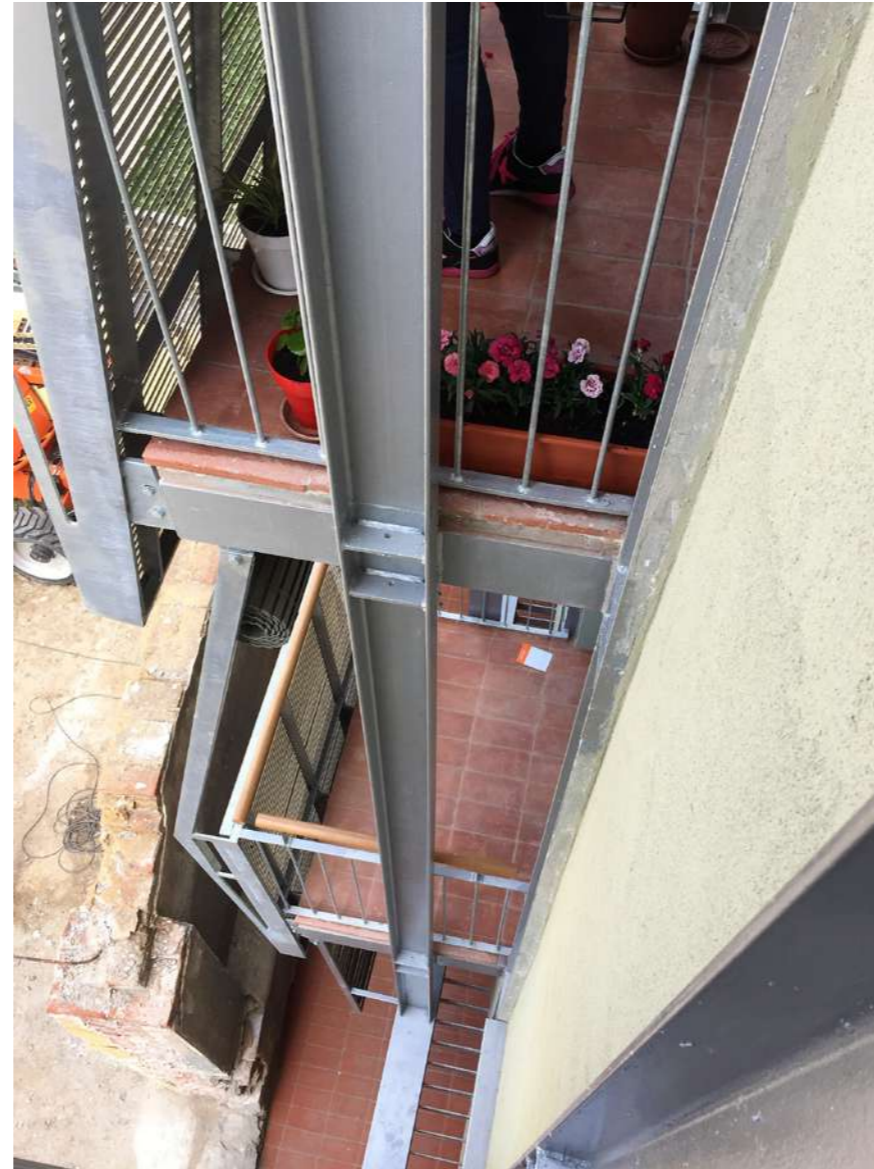
Fig.11: View of the balconies side with its new structural supports.

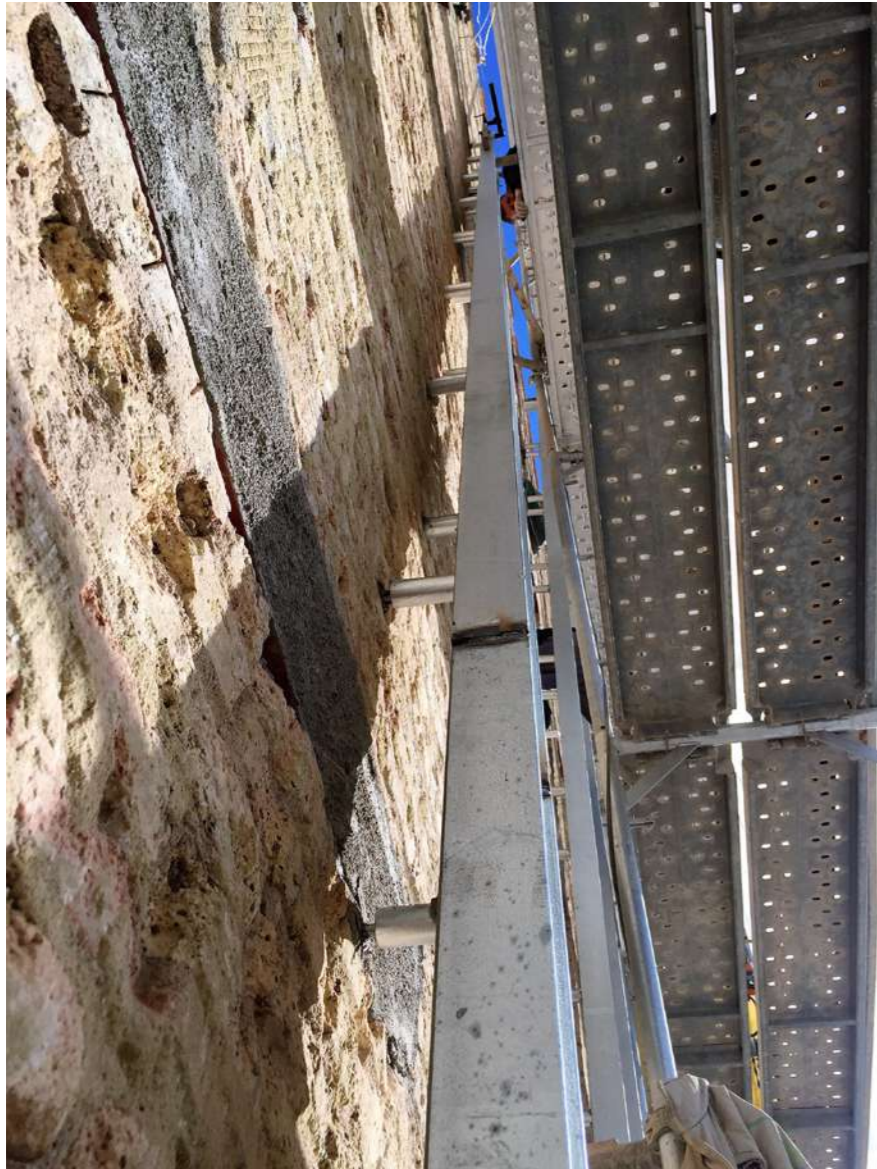
Fig.15: Anchorage of new façade's structure to the wall.

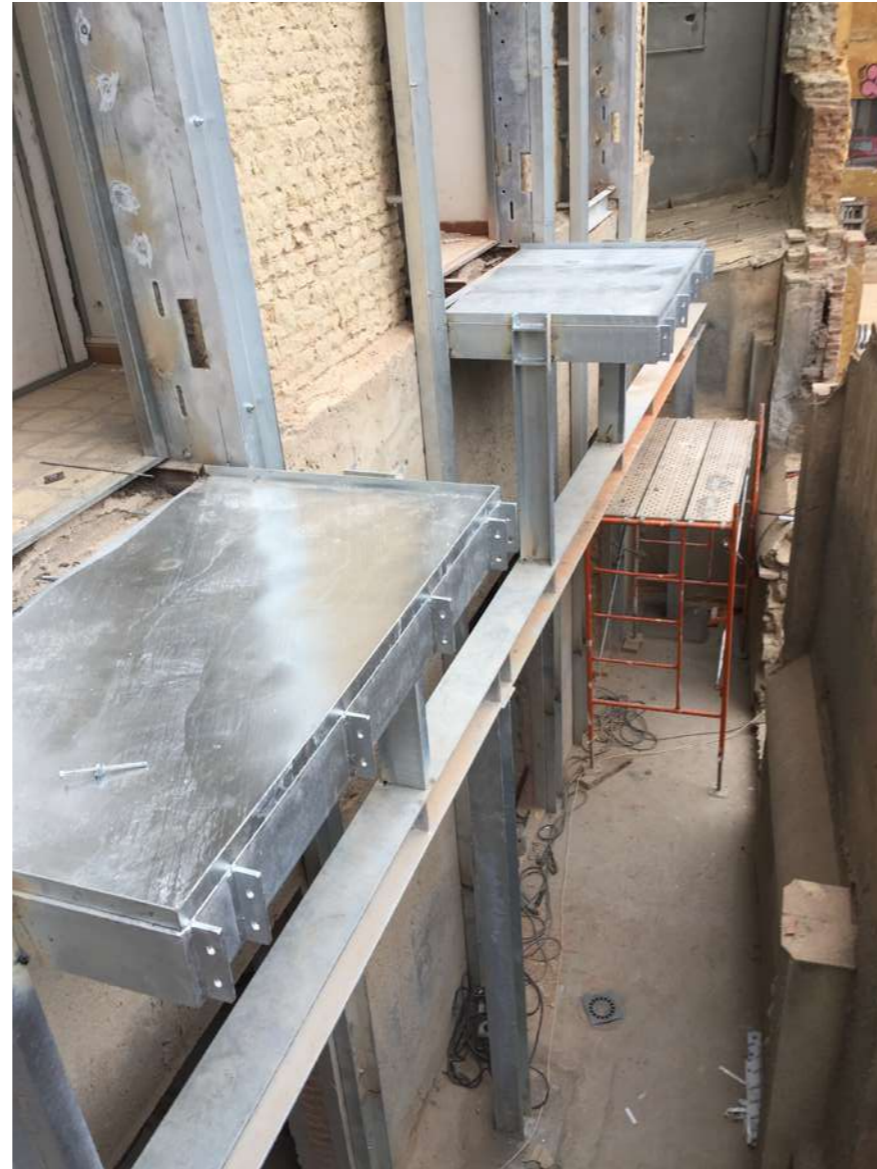
Fig.16: installation of the balconies.

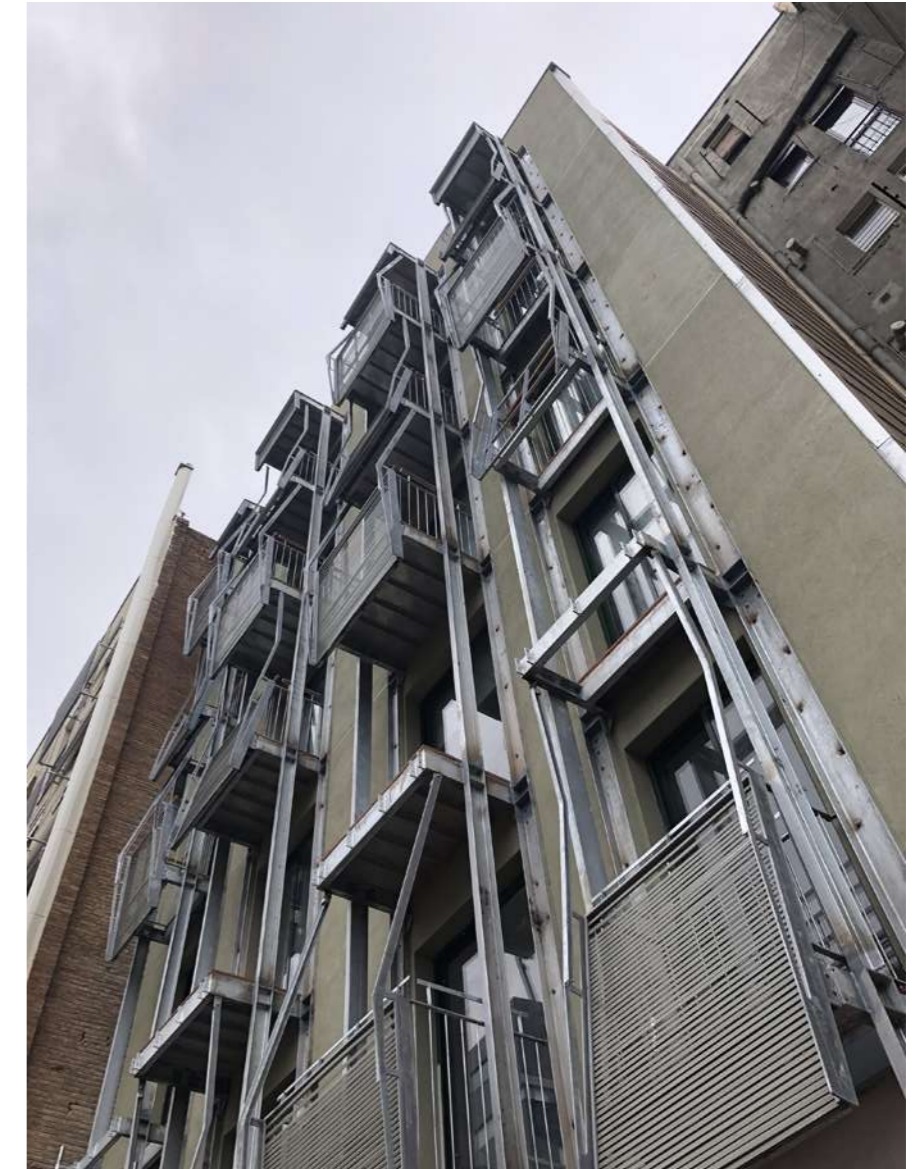
Fig.17: installation of railing and louver structure.

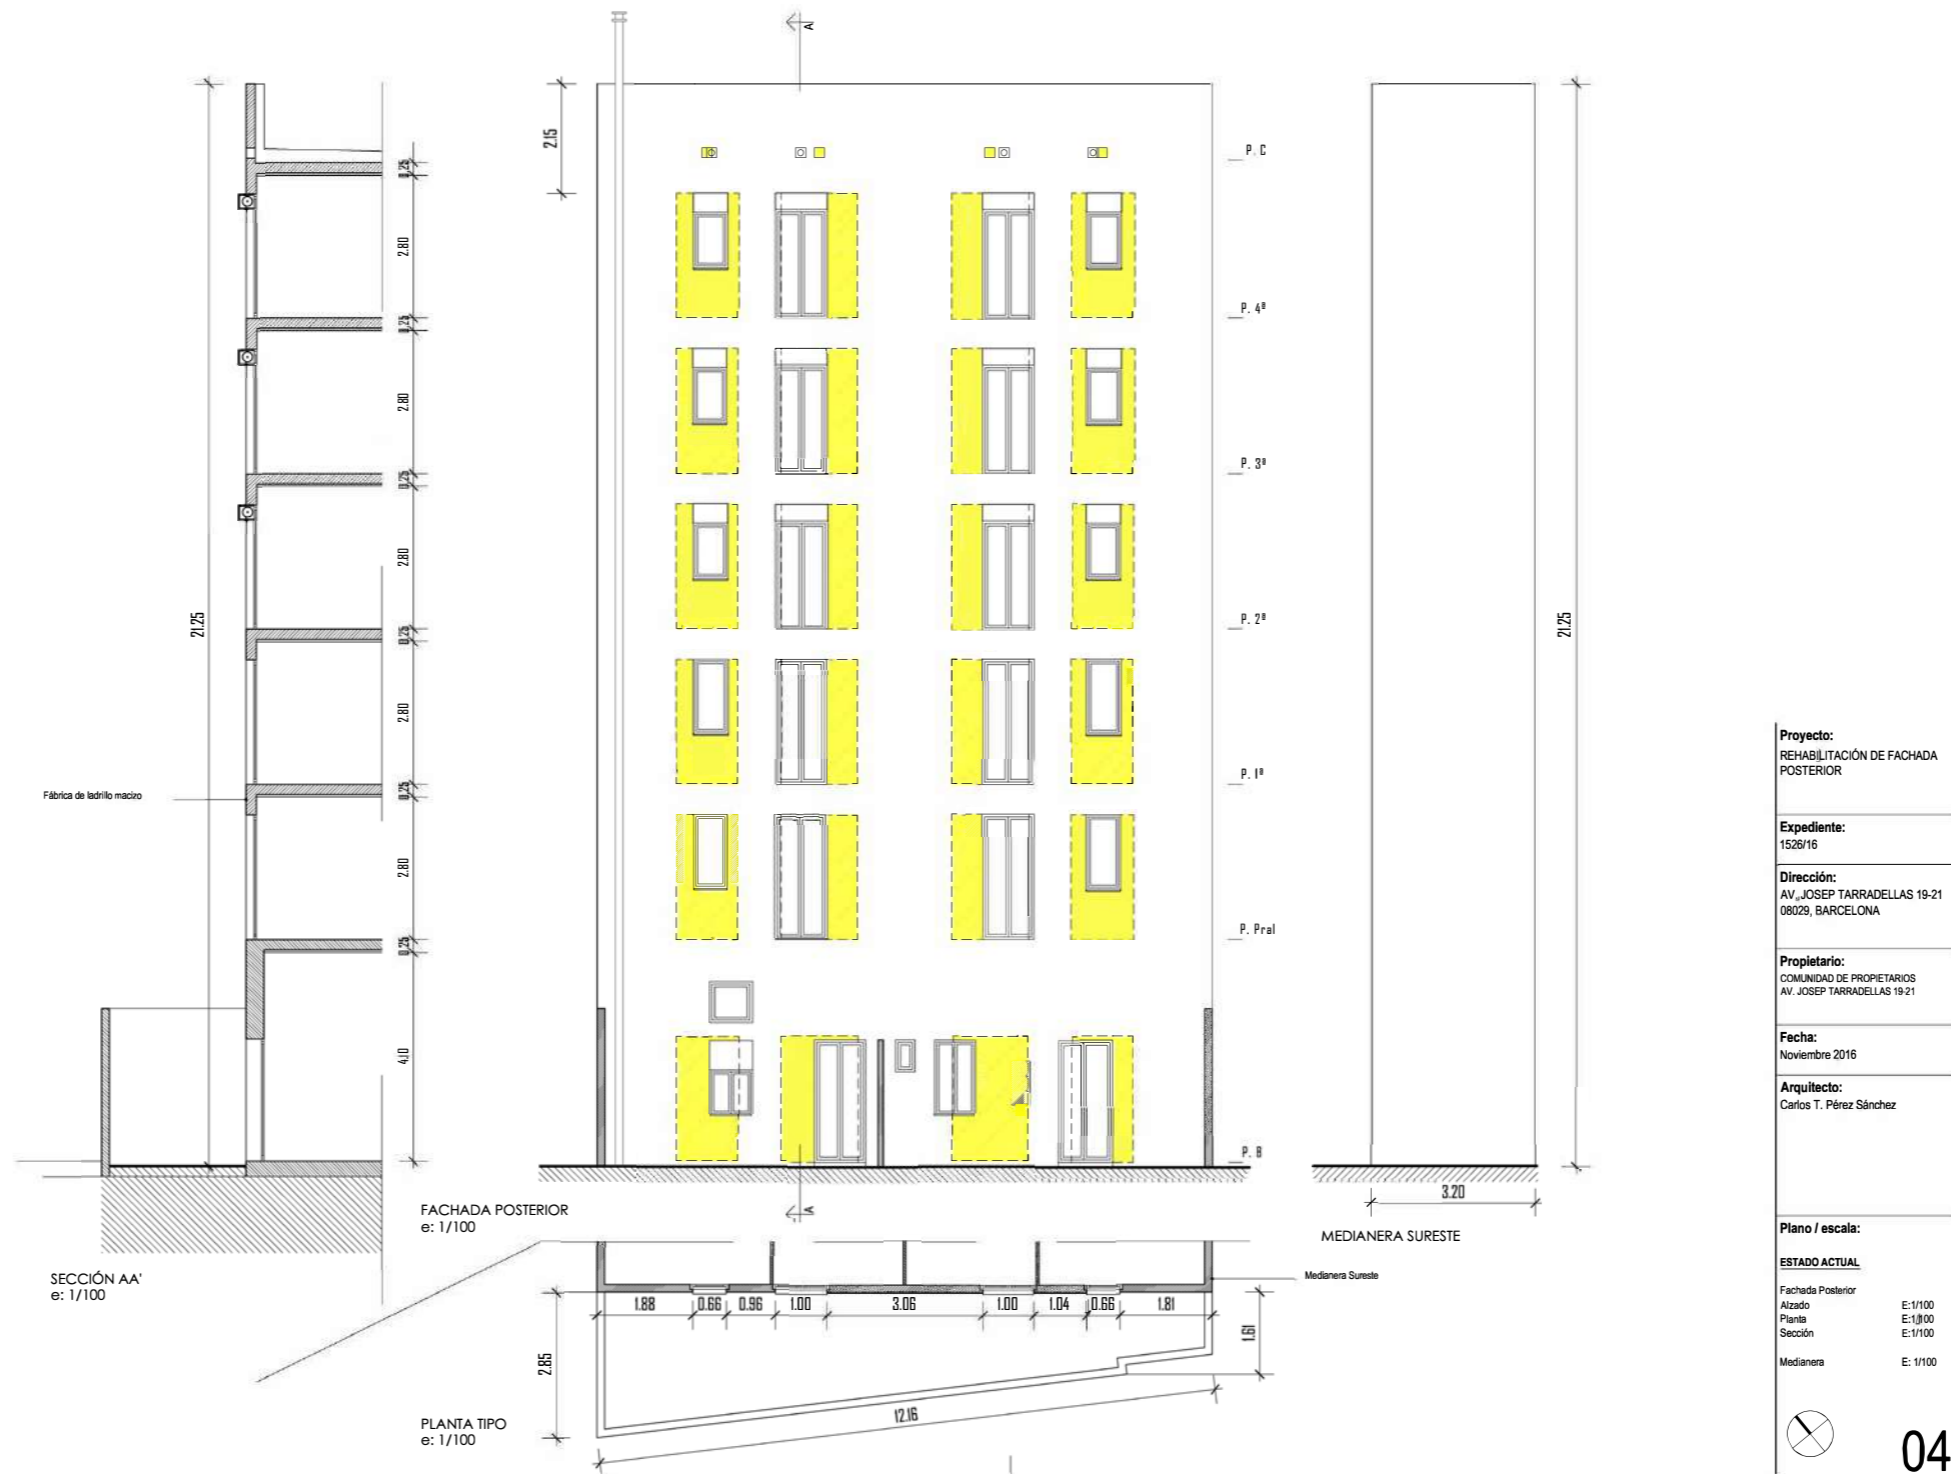
Fig.20: Window opening enlargement plan.
