CONSOLIDATION OF FOUNDATIONS FLOOR SLABS AND PAVEMENTS

Related companies: GEOSEC

DESCRIPTION

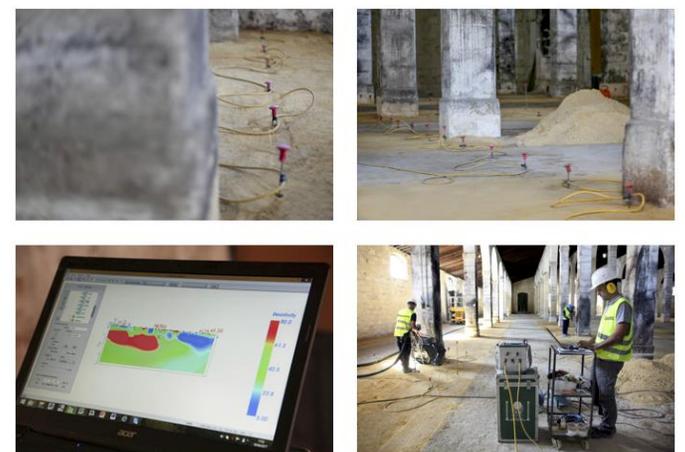
Fig.2-5: To solve the problem of differential settlement, the soil is consolidated using the SEE&SHOOT method by injecting at a maximum depth of -3.50 m. ©GEOSEC.ES

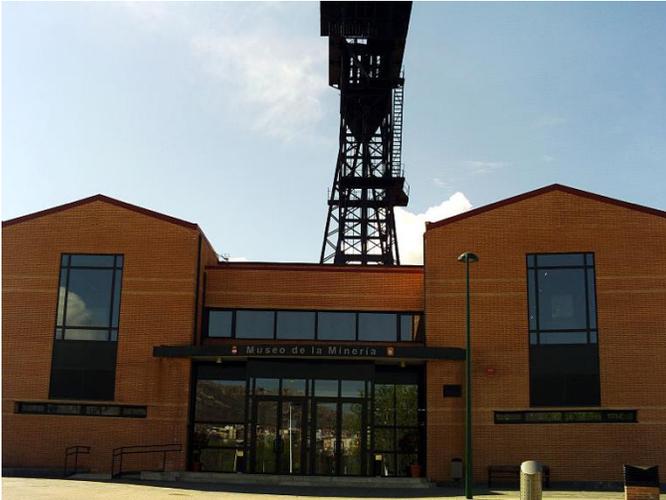
Fig.6: The Puertollano Mining Museum has an isolated foundation, distributed in 9 footings supported on a ground with a first layer of anthropic fill up to -4.00m, a second level of clay and silt of low compactness up to a depth of -15.00m, and a second layer of clay and silt of low compactness up to -15.00m.. ©Javier Martin. Public Domain.

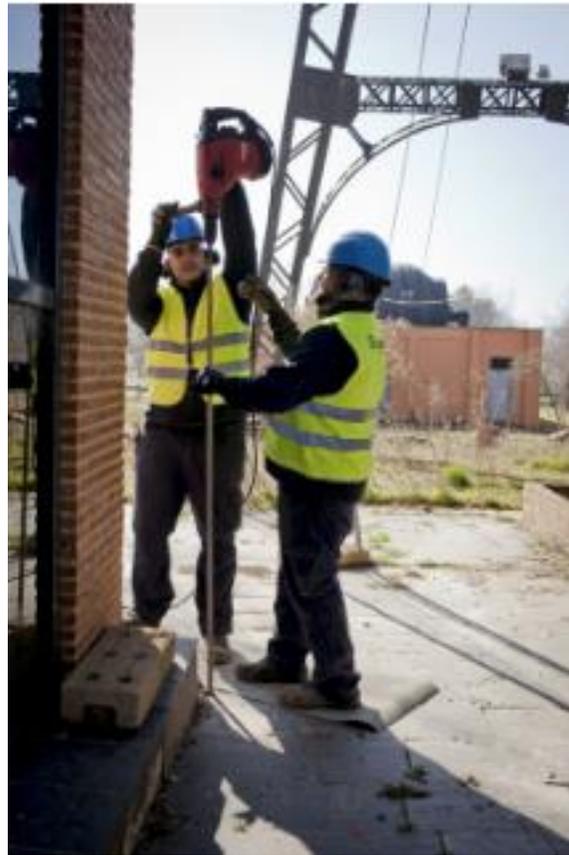
Fig.10: Intervention using the SEE&SHOOT method for soil consolidation under the foundations using 4 levels of intervention at a depth of approximately -4.50m. ©GEOSEC.ES

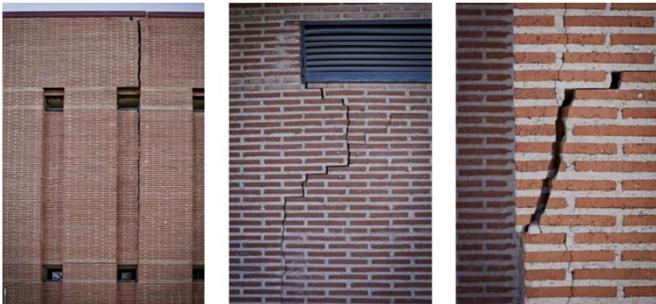
Fig.7-9: Cracks caused by differential settlements, mainly due to the presence of moisture under the foundation that generates a washout of fine soil fillings. ©GEOSEC.ES

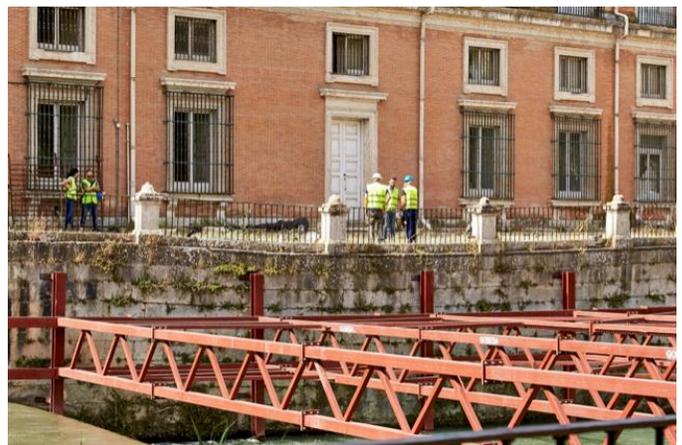
Fig.11: Royal Palace of Aranjuez. The geotechnical and geophysical characterization (on water sheet) shows that the backfill of the wall was carried out with remobilized soil and the phreatic level was found at a depth of -4.30m. ©GEOSEC.ES

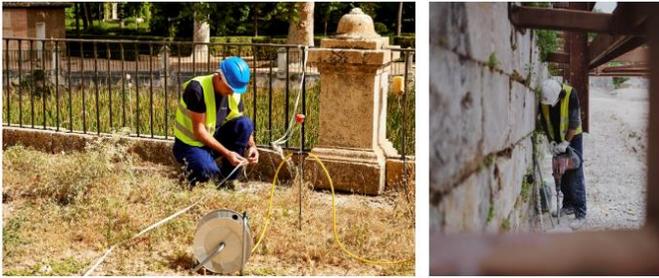
Fig.12-13: Intervention through the use of expansive resins aimed at filling the porosity of the soil, preventing the washout of fines. The bearing capacity of the soil is increased. ©GEOSEC.ES

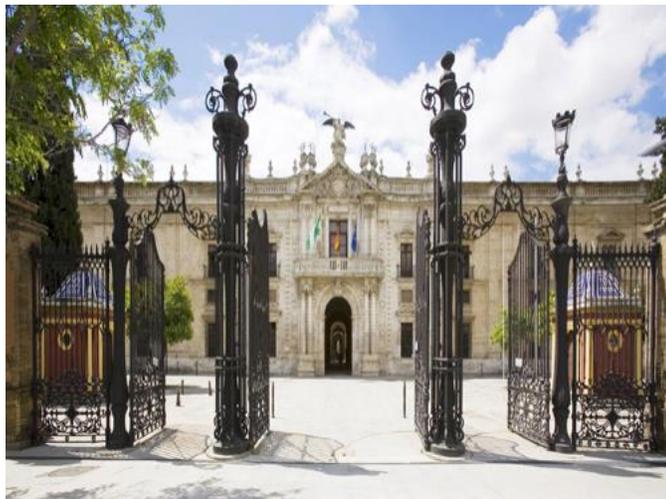
Fig.14: The Royal Tobacco Factory (18th century), currently the University of Seville. The structure of the building has multiple cracks and fissures with a collapse of the facade wall of 1 to 3 cm. The foundation rests on a clayey soil of weak consistency. ©GEOSEC.ES

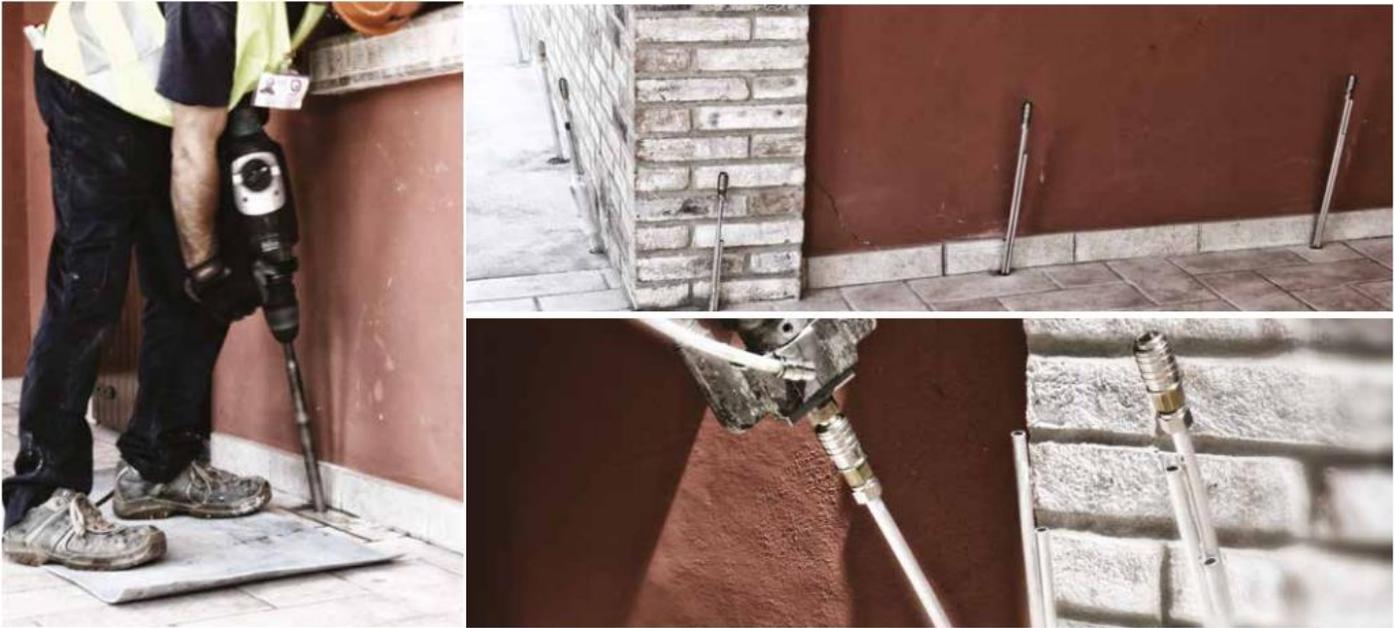
Fig.17-18: Drilling process, placement of the spears and subsequent injection of the resin. ©GEOSEC.ES

- 1) Secure the area and clear it of furniture and any interfering objects.
- 2) Drill small holes in the floor slab using hand drills.
- 3) Once the desired depth has been reached, the injection nozzles will be placed for subsequent consolidation. Several injection levels may be foreseen in the interventions, even superimposed, and it will be possible to use the same borehole to reach different depths.

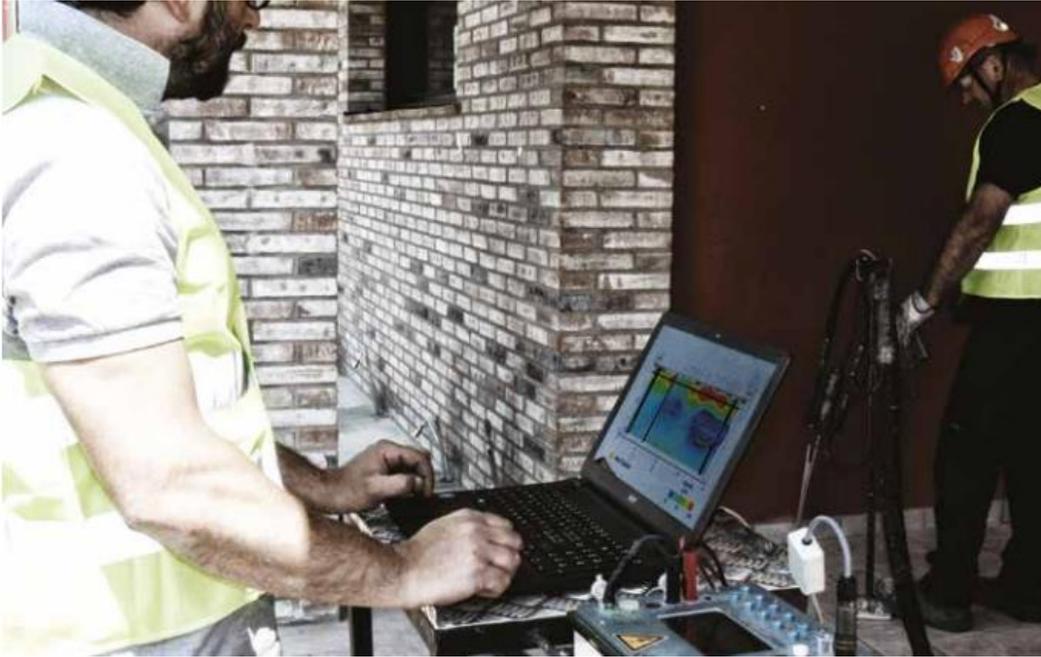
Fig.21: Constant monitoring of the behavior of the soil and the injected resins. ©GEOSEC.ES

- 5) Specialized technicians can verify precisely and in real time what is happening and make the necessary modifications to achieve the best consolidation result.
