Consolidation and repurposing of cornices.

RESTORATION AND REHABILITATION OF THE FAÇADES AND ROOF OF THE PALAZZO BARBIERIOVENE-CICOGNA, VICENZA, LATE 17TH CENTURY.

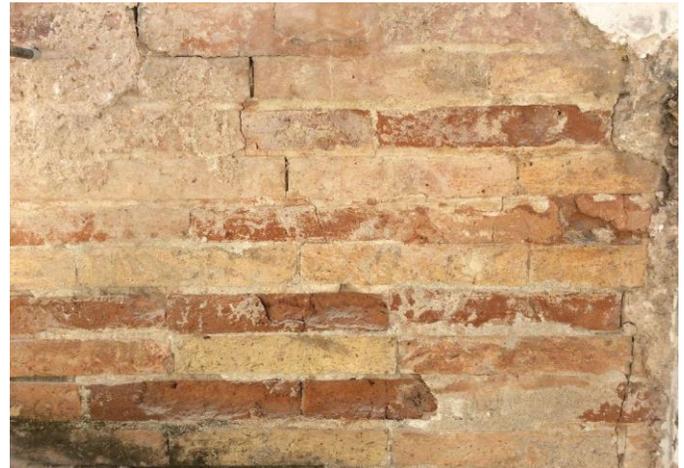
Fig.1: Wall underneath the seventeenth-century finish and dating back to the late medieval period.

All the external *marmorino* coatings (consisting of a rough-coat in *cocciopesto* and a very thin curl, very smooth and ivory-white *marmorino*) were in a very bad state of conservation. In particular, in the main façade facing the street many damages were added over time due to the action of erosion and degradation caused by the atmospheric pollution.

There were also numerous detachments, lacks and cementitious patches from various periods.

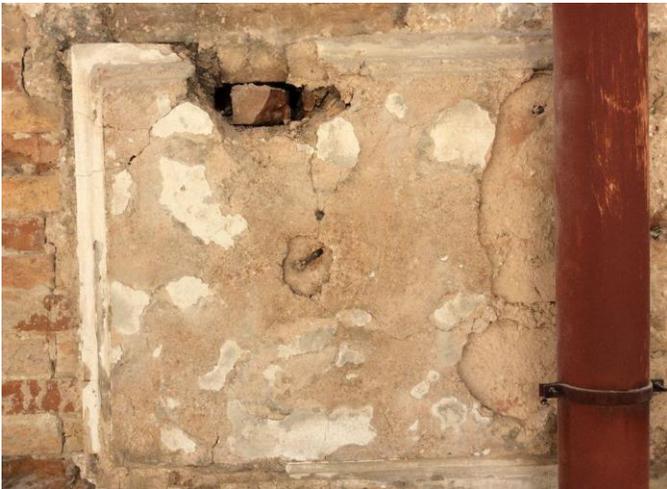
The façade showed panels made by bricks arranged in a flat position and anchored to the masonry with lime mortar and wrought iron nails.

The nails oxidated during time with the consequent volume increase and, therefore, the formation of cracking in the bricks where they were fixed, contributing to aggravate the detachment and fall of the plaster.

Fig.2: Parts of panels in relief made with nailed bricks and marmorino plaster.

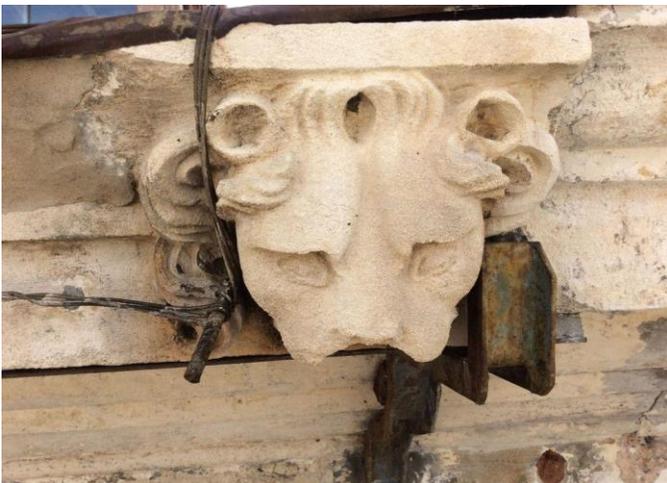
The lack of adequate maintenance also led to the fall of a statue, placed on the eaves line, which ruined the underlying cornice, which at the time was simply secured by means of some "L" brackets fixed in the wall and cables. steel.

Fig.3: Securing interventions of decorative elements.

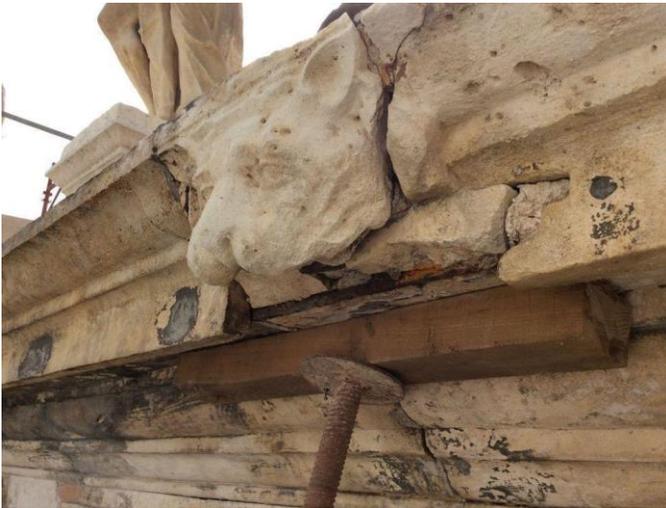
The cornice damaged by the fall of the statue has been restored giving continuity to the frame, eliminating the old and unsightly metal devices, and realigning the elements, which have been fixed to each other and to the masonry with reinforced bars.

Fig.4: Realignment of the elements of the cornice.

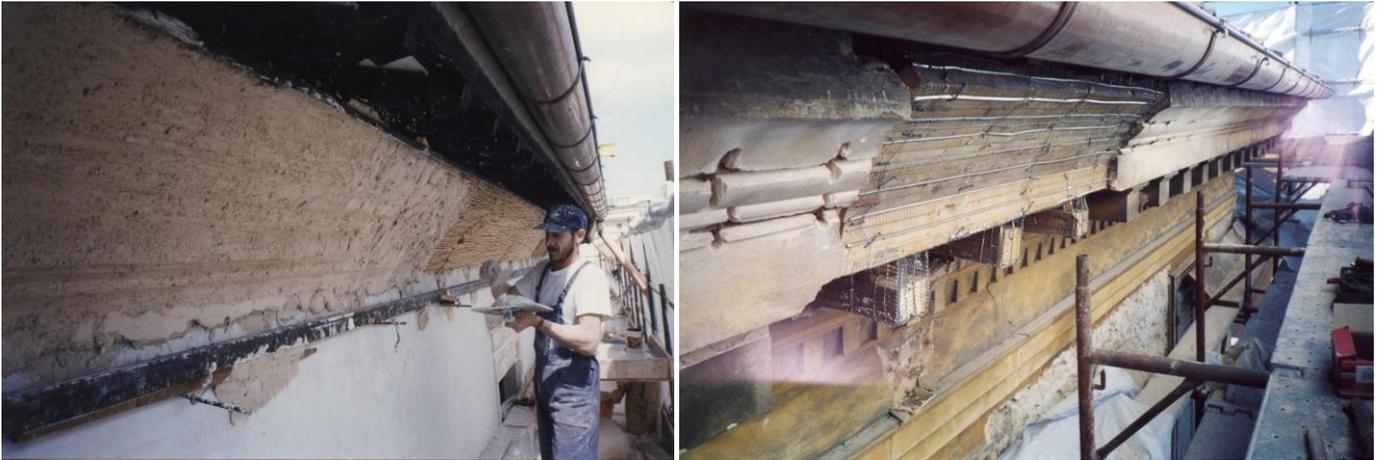
Fig.5-6: Example of reconstruction of the overhanging structure in reed mat and subsequent re-plastering (fig.5). Reconstruction of the cornice with wood and wire mesh (fig.6). © <http://www.giancarlomariani.it/wp-2/project/palazzo-saladini-pilastr/> ; <http://www.giancarlomariani.it/wp-2/project/palazzo-saladini-pilastr/>

In some cases, for the reconstitution of a cornice missing parts, a wooden and metal support is installed (Fig. 2)

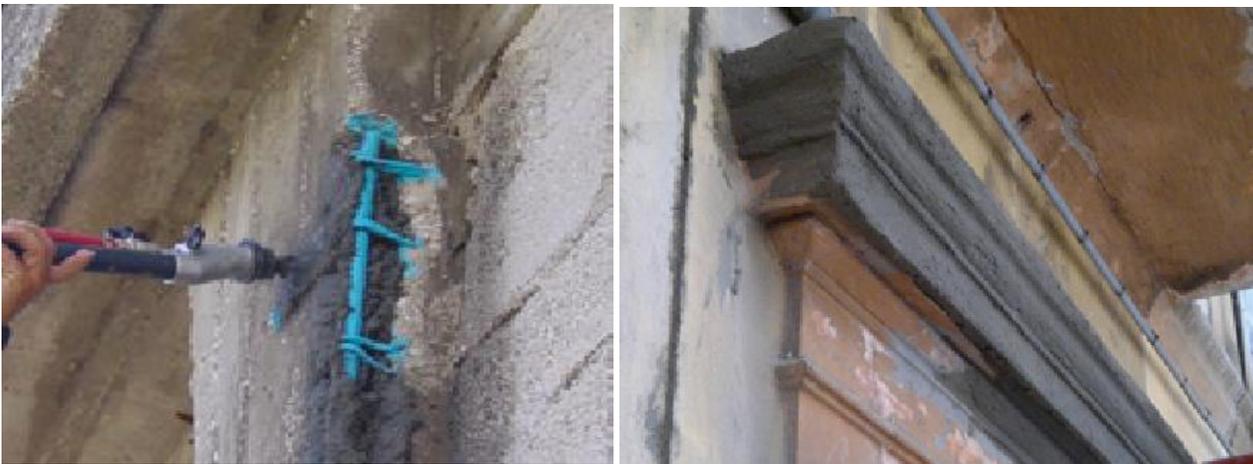
Fig.7-8: Cleaning of the steel reinforcing bars (fig.7). Restoration of the cornices with suitable mortar (fig.8). © <http://www.giancarlomariani.it/wp-2/project/palazzo-saladini-pilastr/> ; <http://www.giancarlomariani.it/wp-2/project/palazzo-saladini-pilastr/>

In the case of reinforced concrete, the degraded and detaching parts are removed until a solid and resistant substrate is reached, proceeding with an energetic brushing of the reinforcing metal or steel bars, also using abrasive discs, until eliminating any trace of rust on the surface.

The metal or steel bars are then treated with a rust converter which can be removed by brushing or covered with a corrosion inhibitor. That is done to avoid a direct contact with the cementitious mortar. Where necessary, the reinforcement is integrated through welding with other bars or steel elements, then intervening with the application of a corrosion inhibitor (Fig. 3).

The concrete shapes are then restored using a single-component, thixotropic, rheoplastic and anti-shrinkage cementitious mortar specific for concrete recovery interventions (Fig. 4).

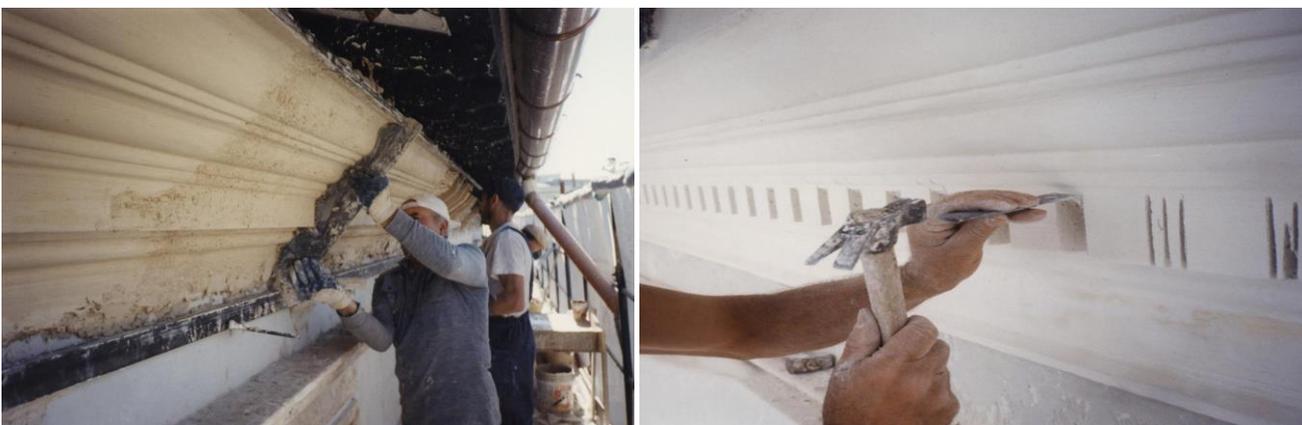
Fig.9-10: Modeling of the original molding by means of a template (fig.9). Sculpture of the cornice (fig.10). © <http://www.giancarlomariani.it/wp-2/project/palazzo-saladini-pilastr/> ; <http://www.giancarlomariani.it/wp-2/project/palazzo-saladini-pilastr/>

If the original shape shows moldings with complex designs, firstly they must be detected by casting from the intact parts (Fig. 5) and possibly defined in their complex parts with manual tools (Fig. 6).
