CONSOLIDATION OF OVERHANGING DECORATIVE ELEMENTS.

DESCRIPTION

A detail corresponding to the rehabilitation project of the facade of the "noucentista" building, catalogued as a heritage building, of the San Ignacio de Sarrià school in Barcelona, is provided at the end of this data sheet.

“Proyecto rehabilitación fachada Colegio de San Ignacio- Barcelona. 2020”

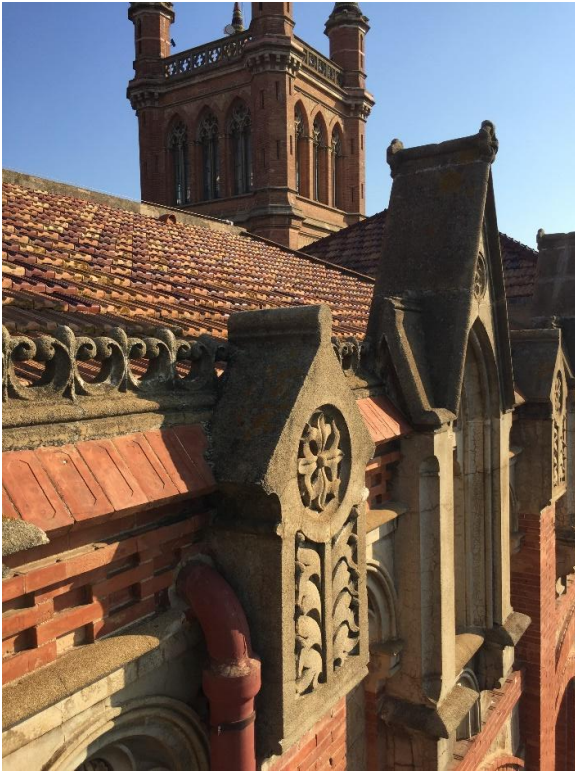
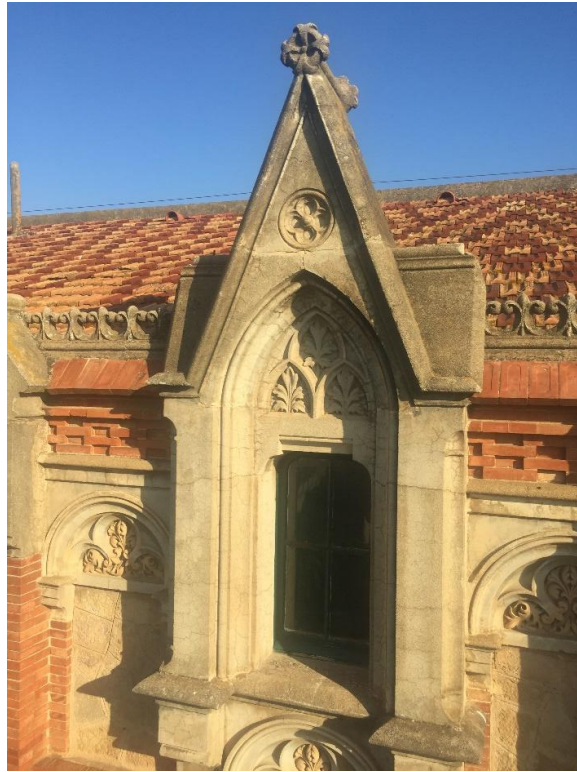
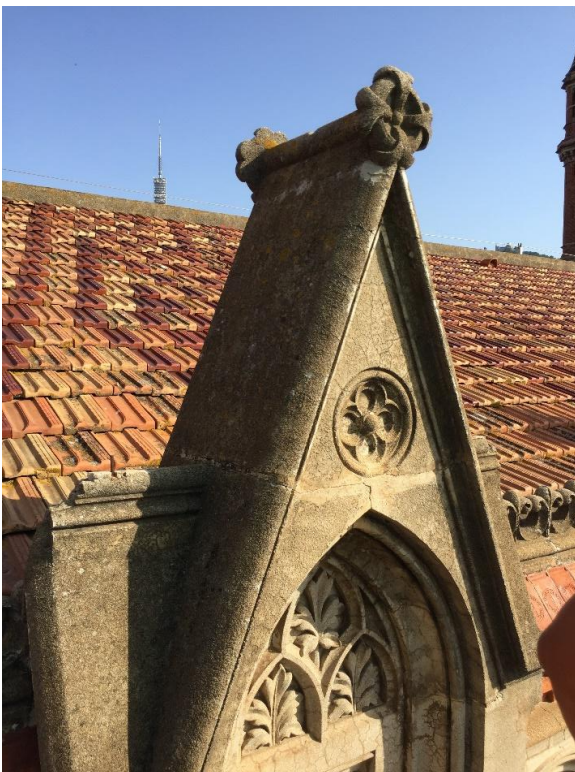
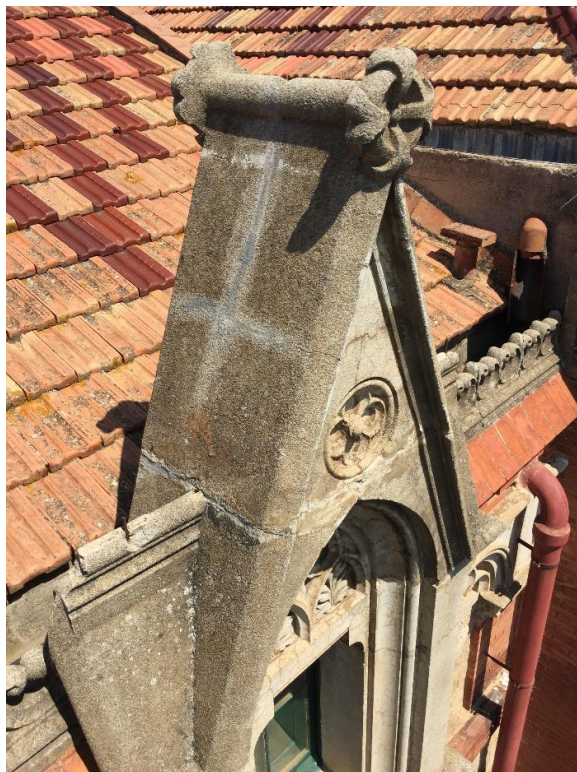
Fig.1-4: The images show the characteristic stone decorative elements of the buildings of the early 20th century, which show movements and cracks, since they are supported only by their own weight. ©Josep Baquer

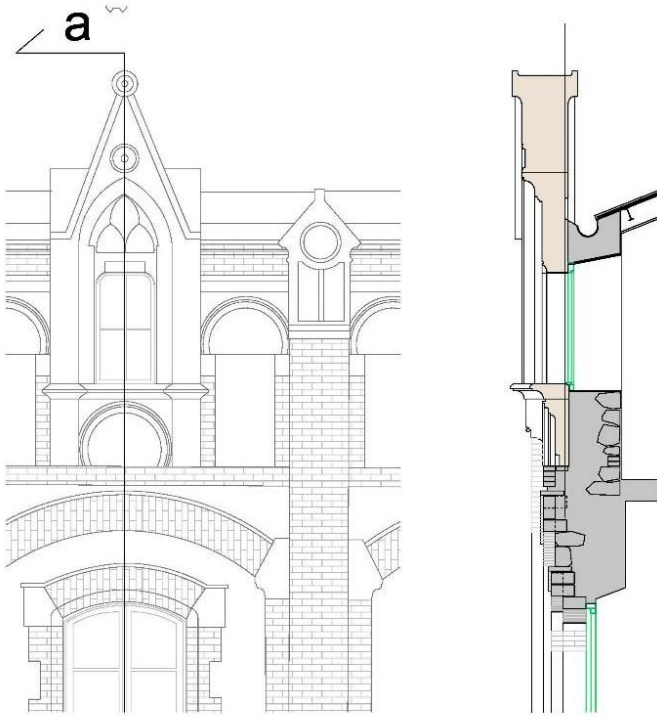
Fig.5: Elevation and section of the decorative element to be consolidated, where its weaker points can be easily appreciated. ©Josep Baquer
