# REHABILITATION OF INDUSTRIAL CERAMIC CHIMNEYS.

In historic chimneys to be preserved that need structural intervention.

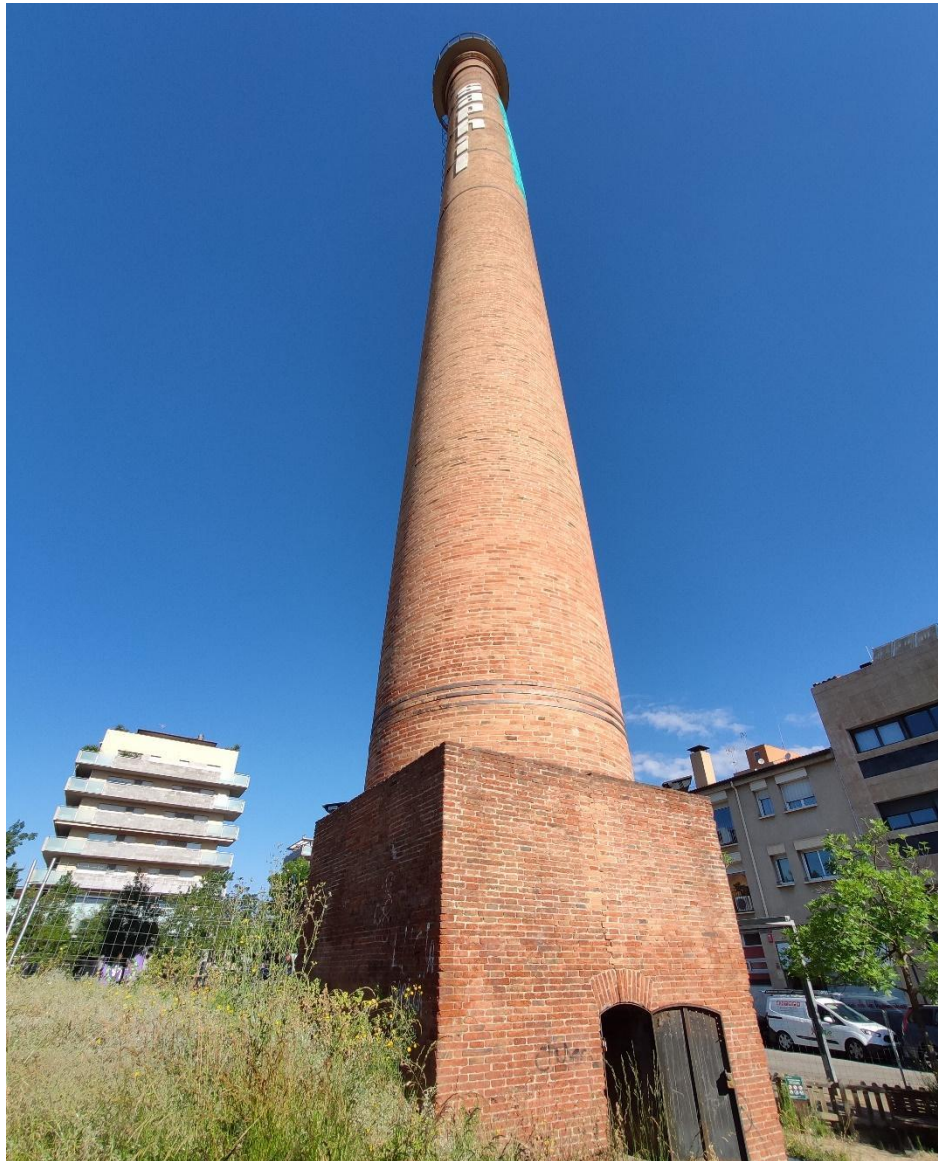
Fig.1: View of a chimney, now out of industrial use, in an urban park. Note that it was once reinforced with external metal rings, which have now caused new pathologies: cracks in the brickwork due to expansion caused by the corrosion of the steel when outdoors and with great difficulty of maintenance (no maintenance, in practice). © bisstructures

Usually, the conservation of these elements as a monument has required structural intervention. In most cases, the reinforcement elements added have been of a metallic nature. Subsequent to their rehabilitation, it is common for these reinforcements to have very low or even no maintenance, due to their difficulty (great height) leaving these steel reinforcements at the mercy of the elements, which in the long run end up causing new pathologies or aggravating the original ones.

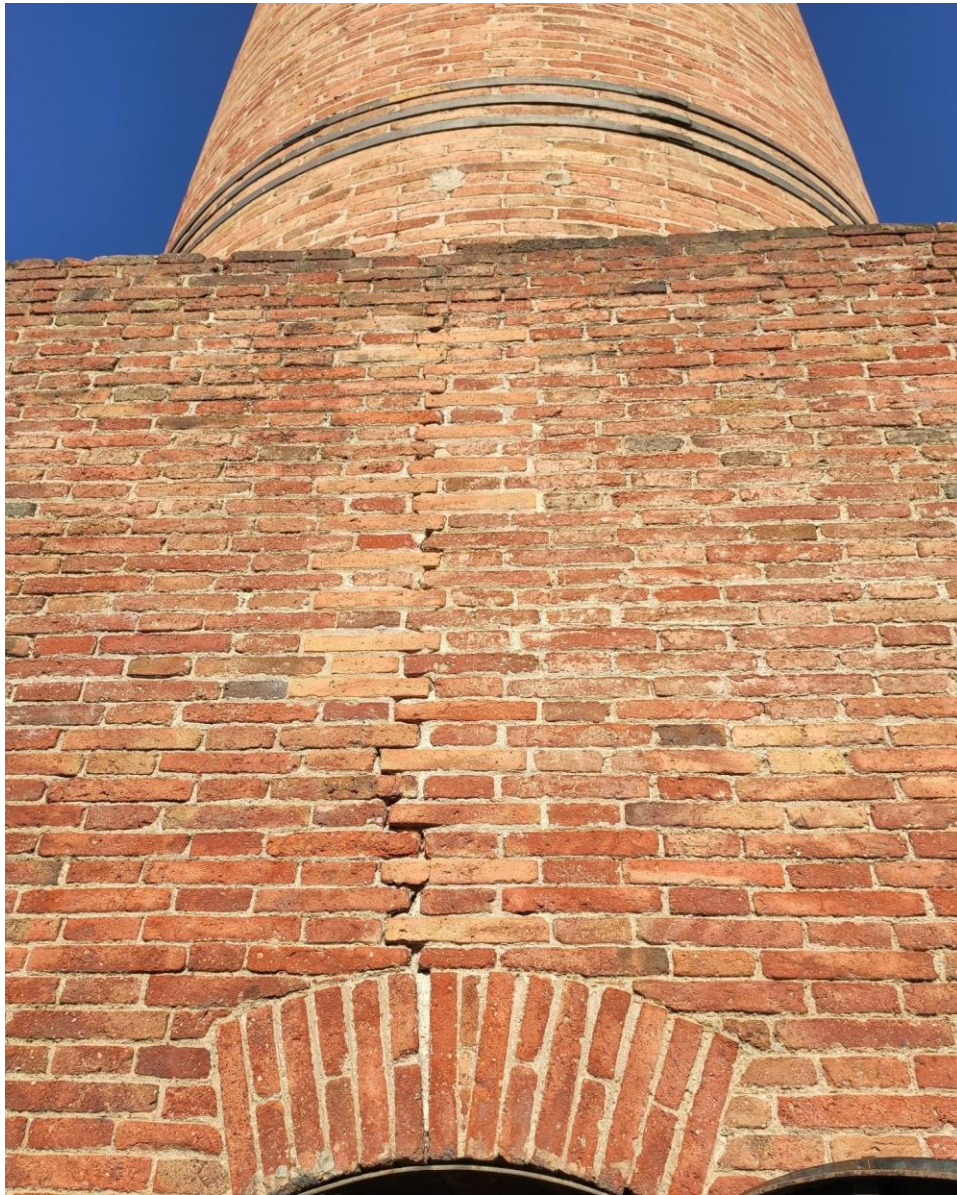
Fig.2: View of an exterior side. Note the existing metal reinforcement rings to be replaced. And the central vertical crack to be repaired. © *bisstructures*

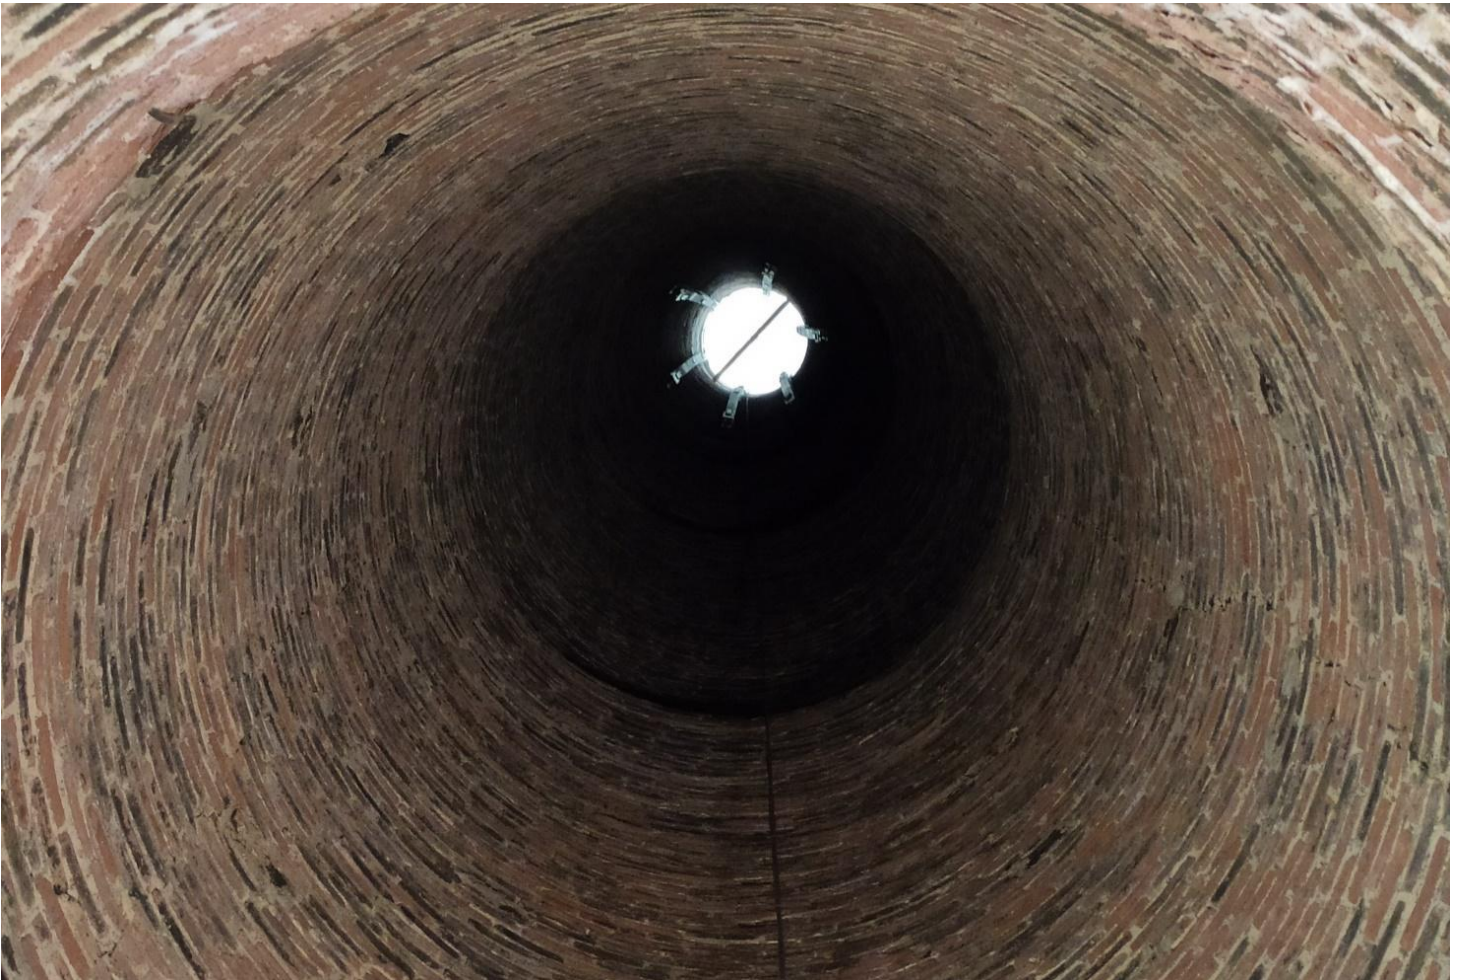
Fig.3: Interior view. Note the existing vertical metal reinforcement profiles in the upper section, to be replaced. ©bisstructures
