Drainage trench around the walls to prevent rising damp Removal of plaster from the lower part of a masonry wall facing the moisture effects.

Museum of Pancyprian Gymnasium, Nicosia, Cyprus.
[See attached images on the end of the sheet].

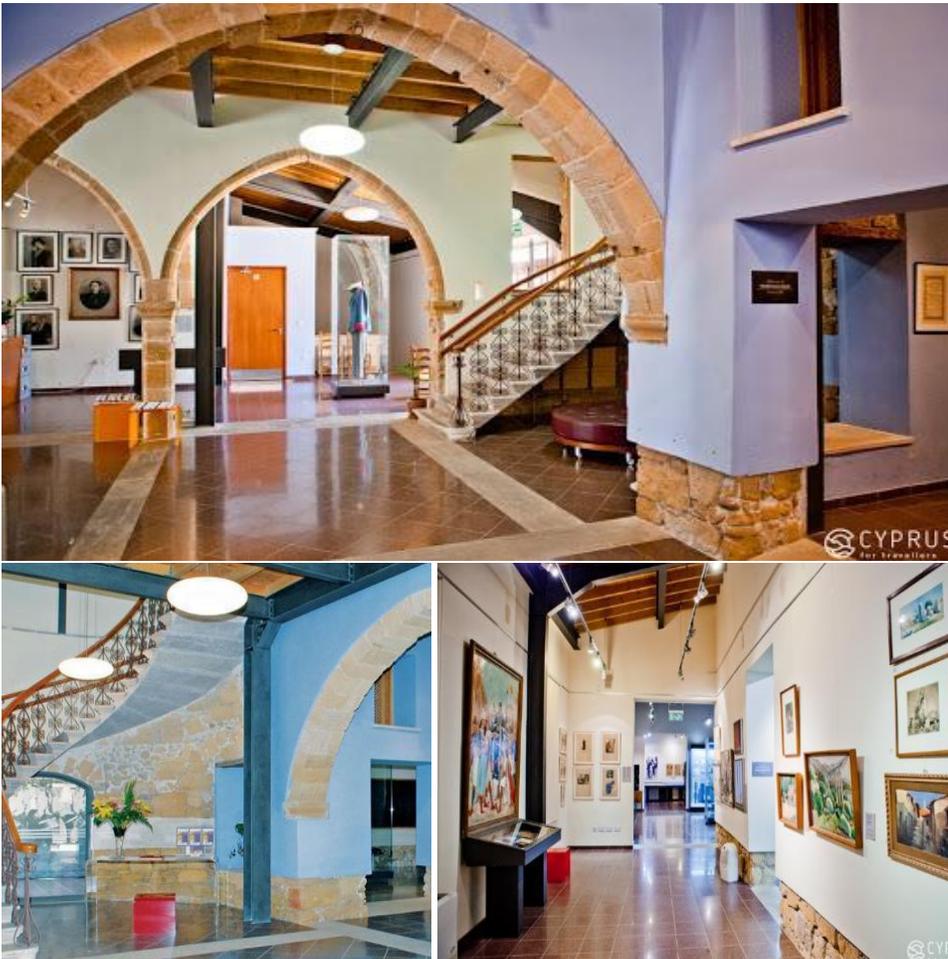
Fig.1-3: The case of Museum of Pancyprian Gymnasium. Removal of the lower part of the plaster from the exterior walls and uncovering the stone masonry for approximately 1m. Architect: Antonia Theodosiou.
