Wooden beams reinforcement and prothesis.

Related companies: No companies; university research; structural study.

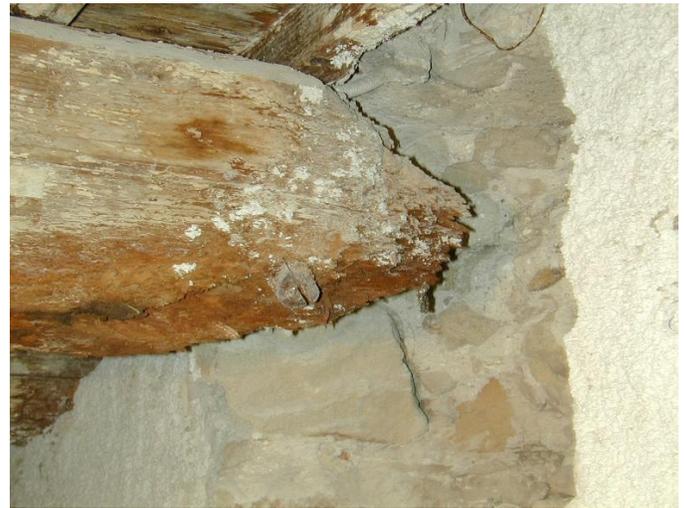
Fig.1: Head part of a damaged wooden beam.

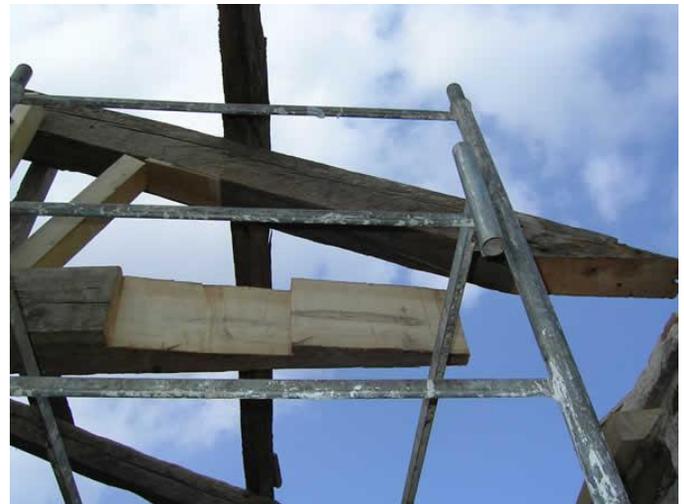
Fig.2: Cutting of the residual portion of the wooden truss tie-rod beam, useless to insert the wooden prosthesis to be connected by matching.

plane of 60 ° with respect to the horizontal one), using two nailed boards as a guide. If necessary, the cutting surface can be leveled with an electric plane;

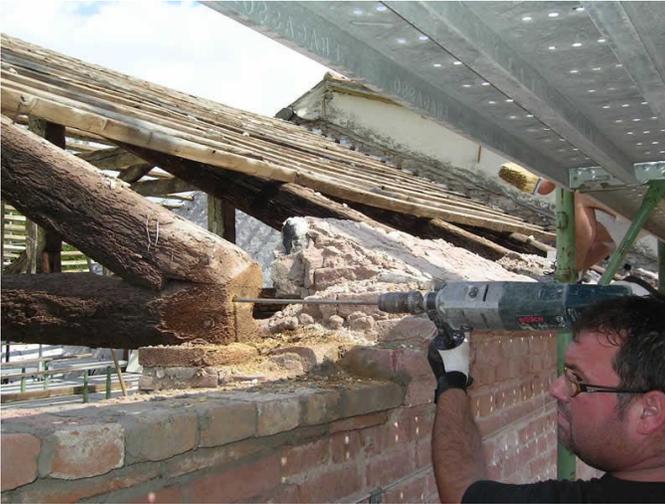
Fig.3: Making a hole with a drill to insert the adhesion bar of the existing part of the wooden truss to the newly built wooden prosthesis.

- creation in the remaining part of the original wooden beam of a special shape for the insertion of the new part of wooden prosthesis;
- drilling of the original wooden beam with a core drill in order to create one-two or more housings for threaded fiberglass or stainless steel bars;

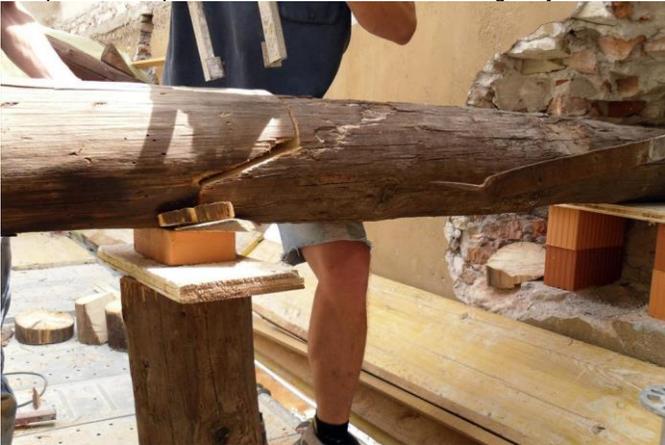
Fig.4: Cutting for making prosthesis in a wooden truss tie-rod beam.

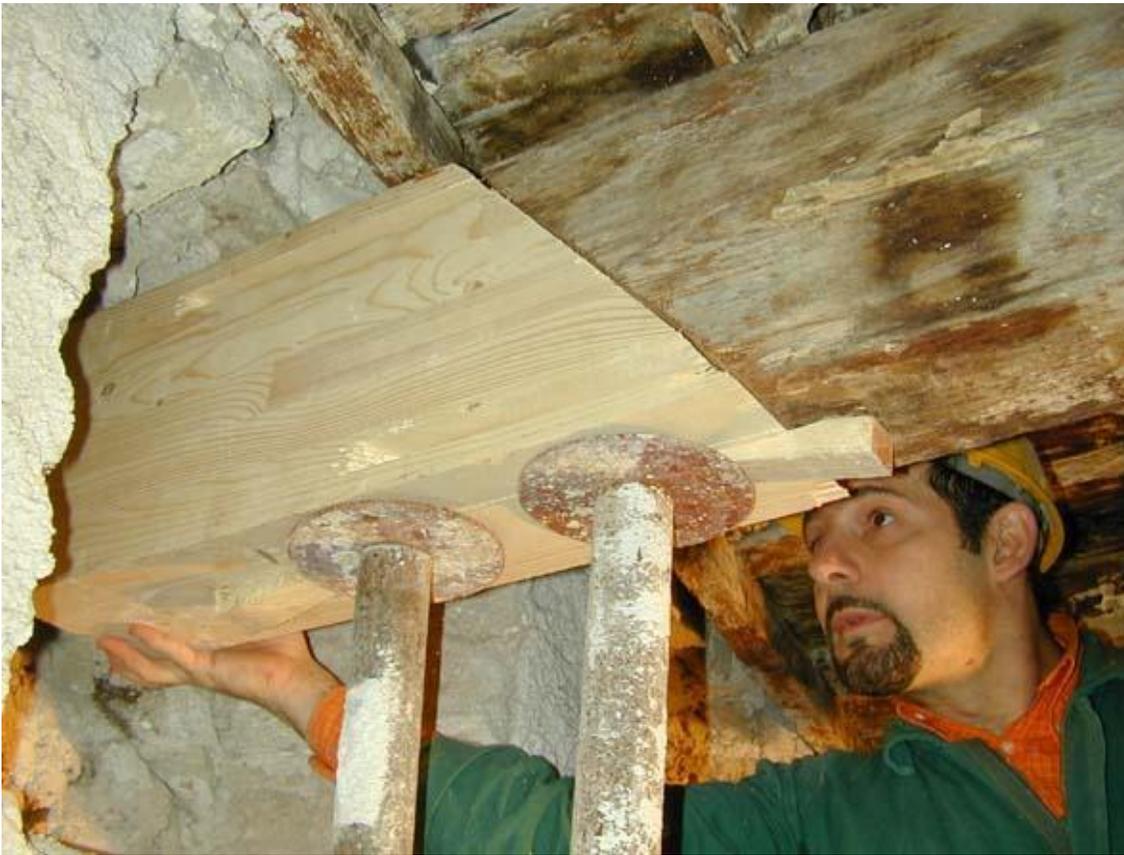
Fig.5: Introduction of supporting beams at the intrados of the floor beam or truss for safety during subsequent work. The beam must be suitably shored in order to facilitate the cutting of the damaged part. ©Mario Li Castri

- introduction of supporting beams at the intrados of the floor beam or truss for safety during subsequent work. The beam must be suitably shored in order to facilitate the cutting of the damaged part;
- removal of the degraded and terminal part of the wooden beams to be restored by cutting with a chainsaw (usually the cut is made on an inclined

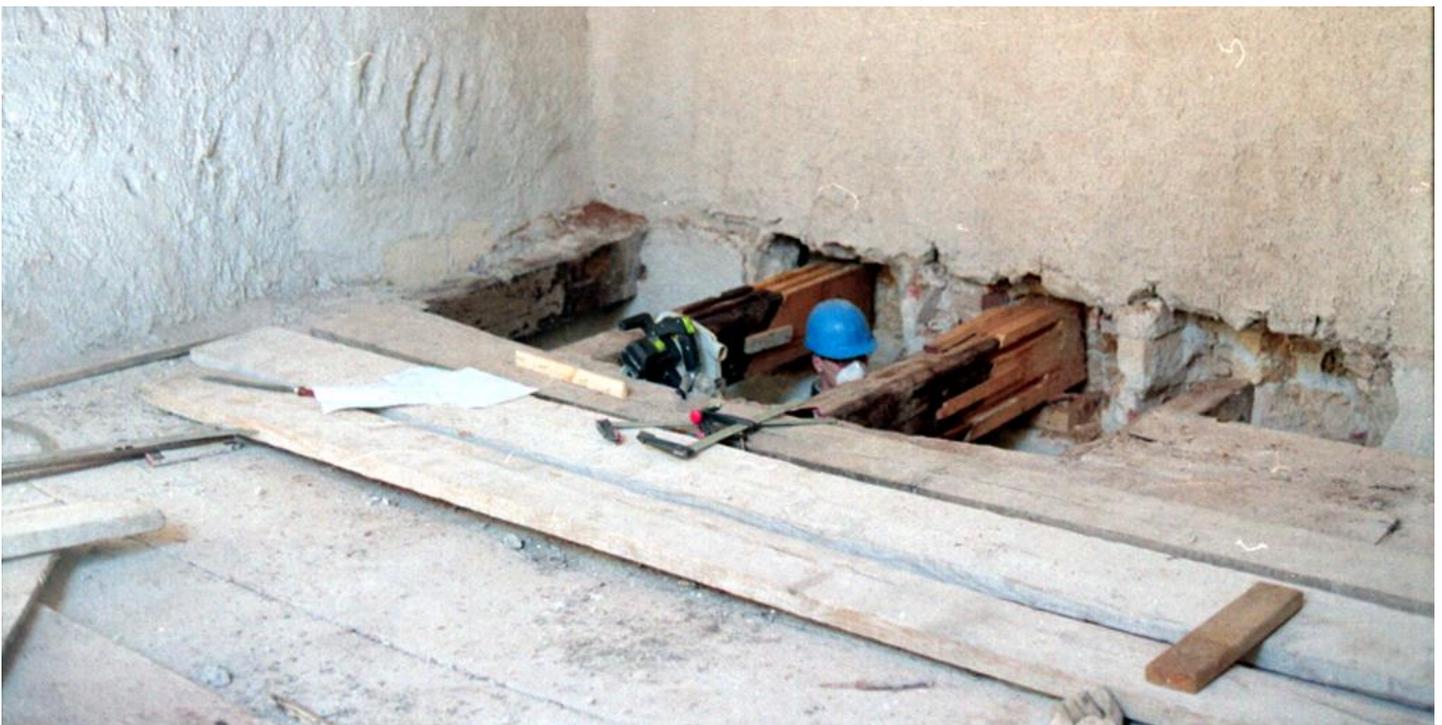
Fig.7: Construction site phase of the wooden prosthesis in some wooden floor beam. ©Mario Li Castri

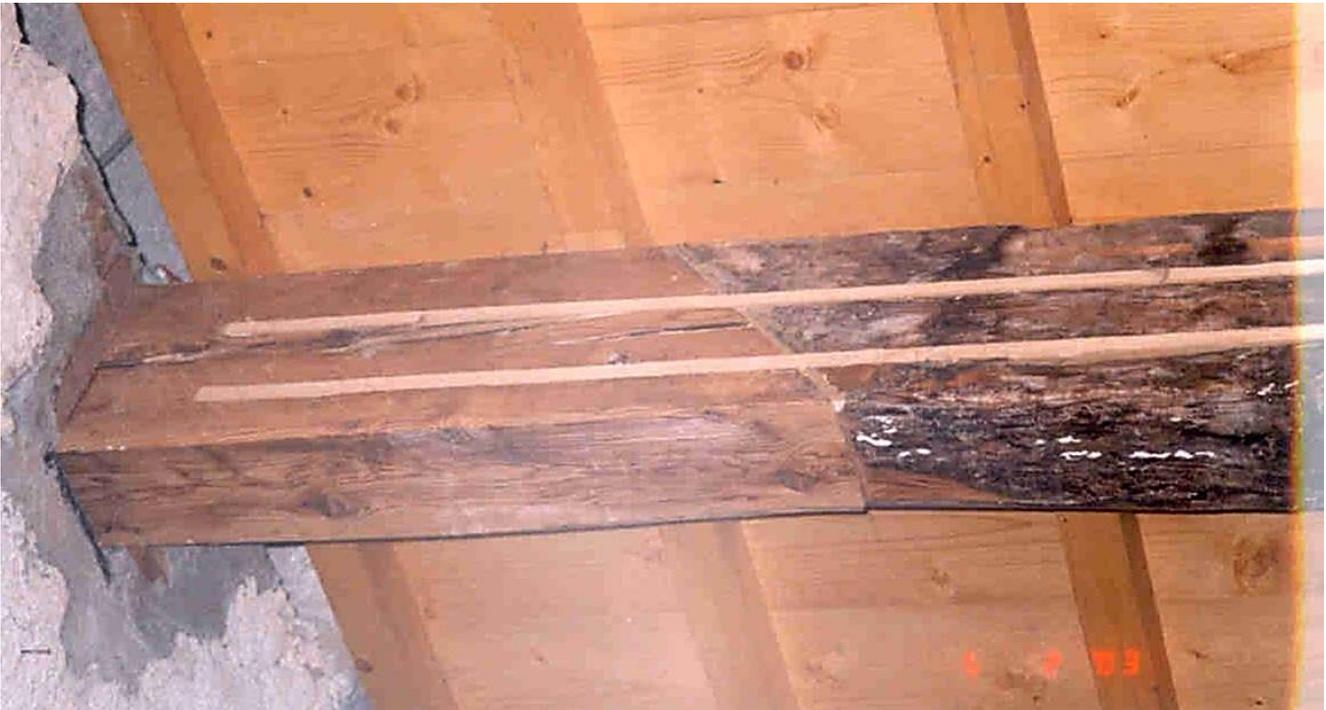
Fig.8: Reconstruction of the side face of the wooden beam by means of wooden strips useful for camouflaging the intervention and treated with paint like the pre-existing parts of the beam. ©Mario Li Castri

- positioning of the metal counter-steel plate and tensioning of the two bars in order to tension the elements thus reconstructed;
- reconstruction of the side face of the wooden beam by means of wooden strips useful for camouflaging the intervention and treated with paint like the pre-existing parts of the beam.

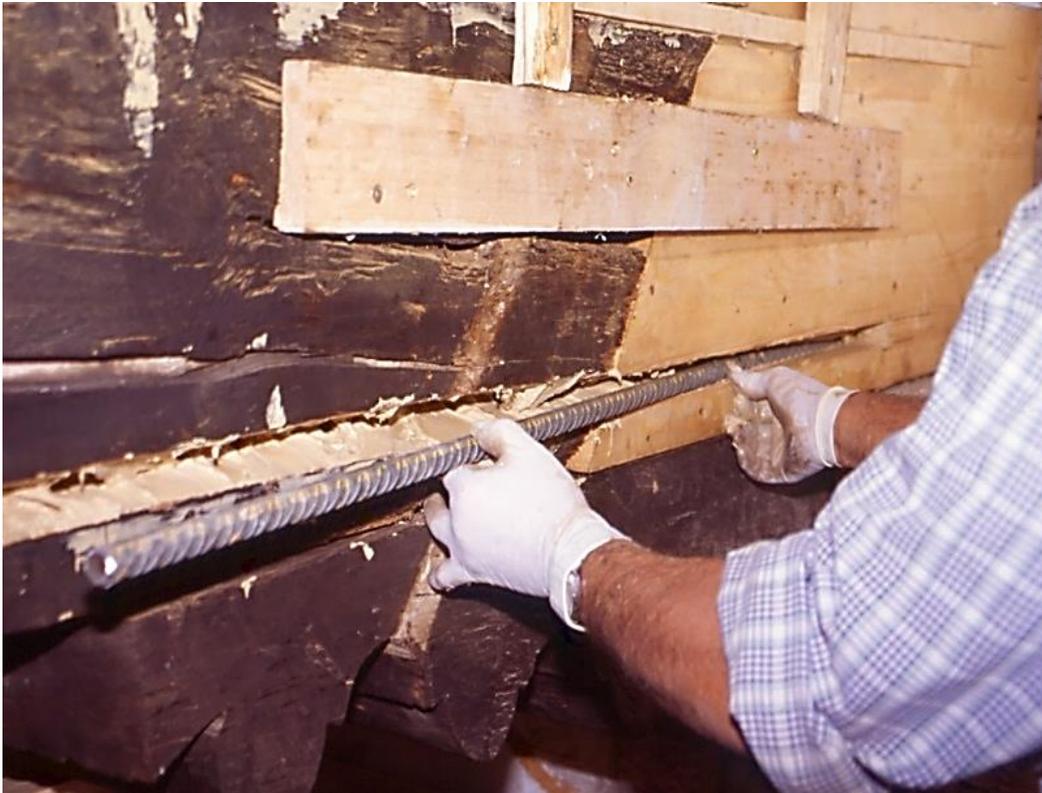
Fig.9: Injection of suitable resin inside the holes, positioning of the threaded bar that will come out from the head of the wooden beam; a special care must be taken that the whole bar is perfectly wrapped in the adhesive. ©Private archive

- insertion of suitable epoxy resin possibly pigmented to reproduce the shades of the existing wood between the surfaces in contact;
- injection of suitable resin inside the holes, positioning of the threaded bar that will come out from the head of the wooden beam; a special care must be taken that the whole bar is perfectly wrapped in the adhesive;

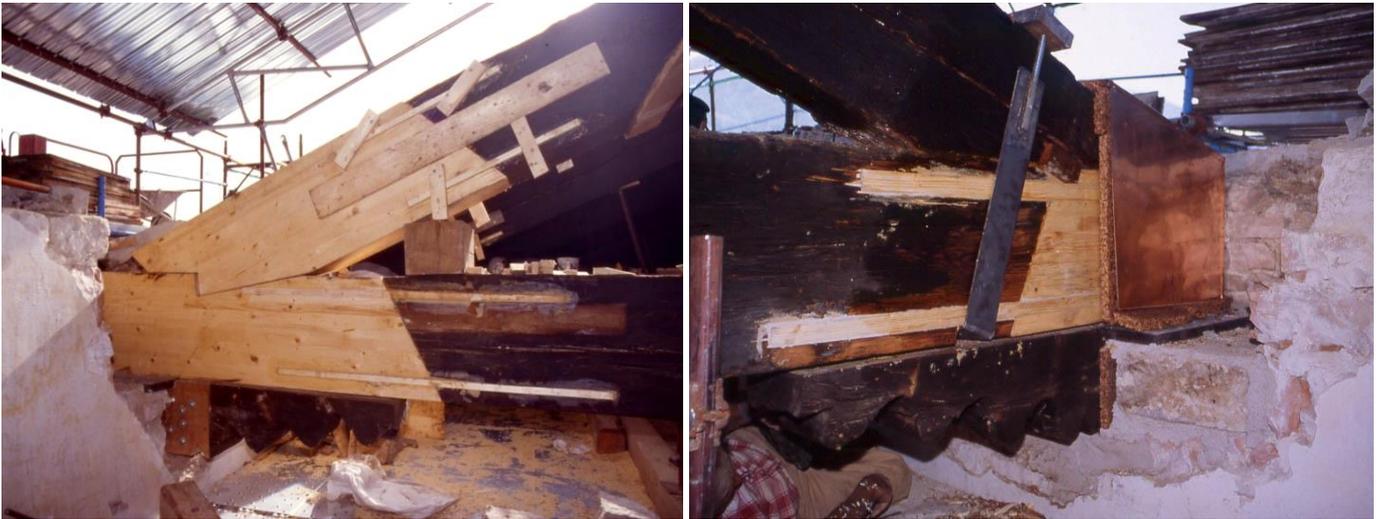
Fig.12-13: Wooden truss, the strut is often degraded only in a limited area of contact with the wooden tie-rod beam, in correspondence with the interlocking indentation; in this case it is sufficient to restore the joint by eliminating the degraded part and inserting a piece of harder wood. ©Mario Li Castri

In wooden trusses, the strut is often degraded only in a limited area of contact with the wooden tie-rod beam, in correspondence with the interlocking indentation; in this case it is sufficient to restore the joint by eliminating the degraded part and inserting a piece of harder wood (e.g.: oak).
