Rehabilitation of a modern building in Nicosia.

Preserving the modern heritage by improving its performance.

Site Alexandrou Demetriou Tower, Stasinou & Salaminos Str.
Nicosia, Cyprus

Date 2009-2012

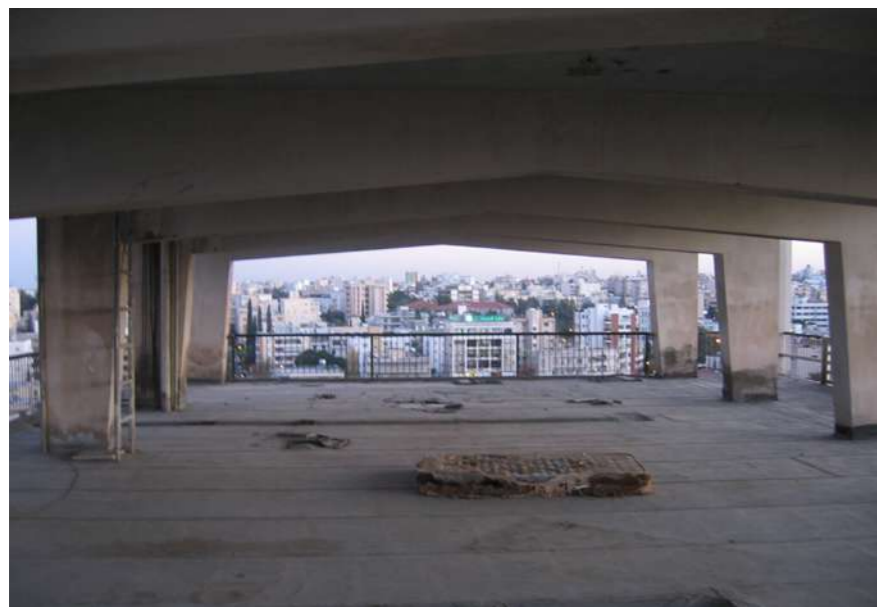
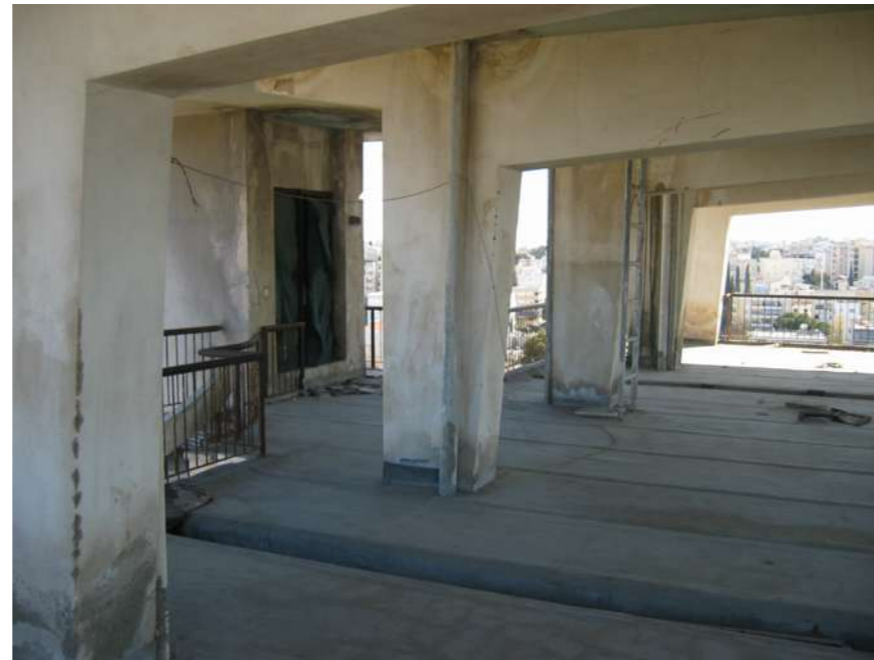
Fig.10-11: Photographs of the building before the intervention. © A. Michael's archive.

The lack of maintenance was the main factor who led the building to a state of decay. However, the building was in a good structural condition before restoration.

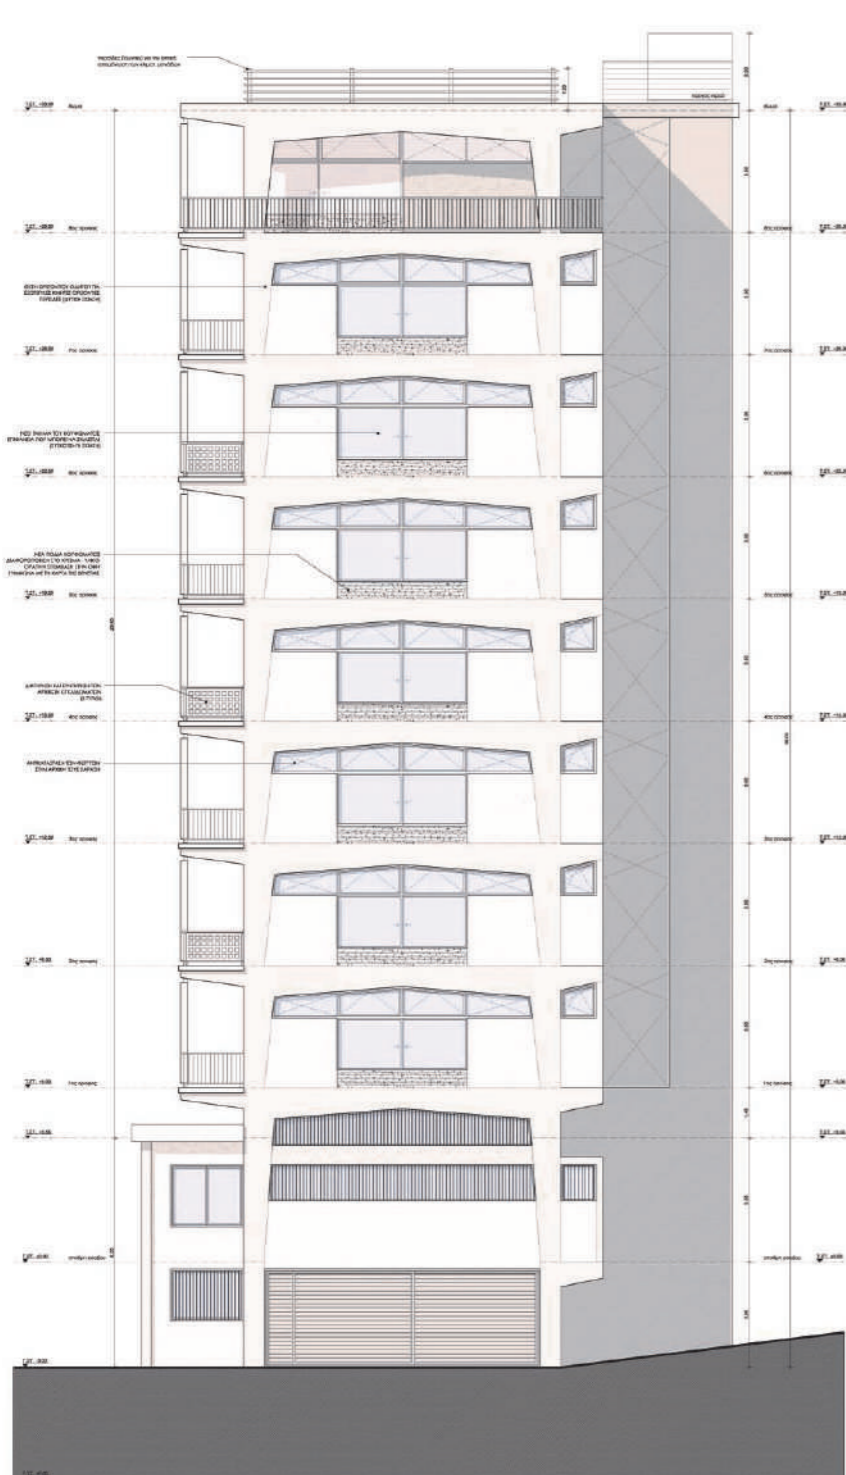
Fig.17: Elevations after interventions. © A. Michael's archive.

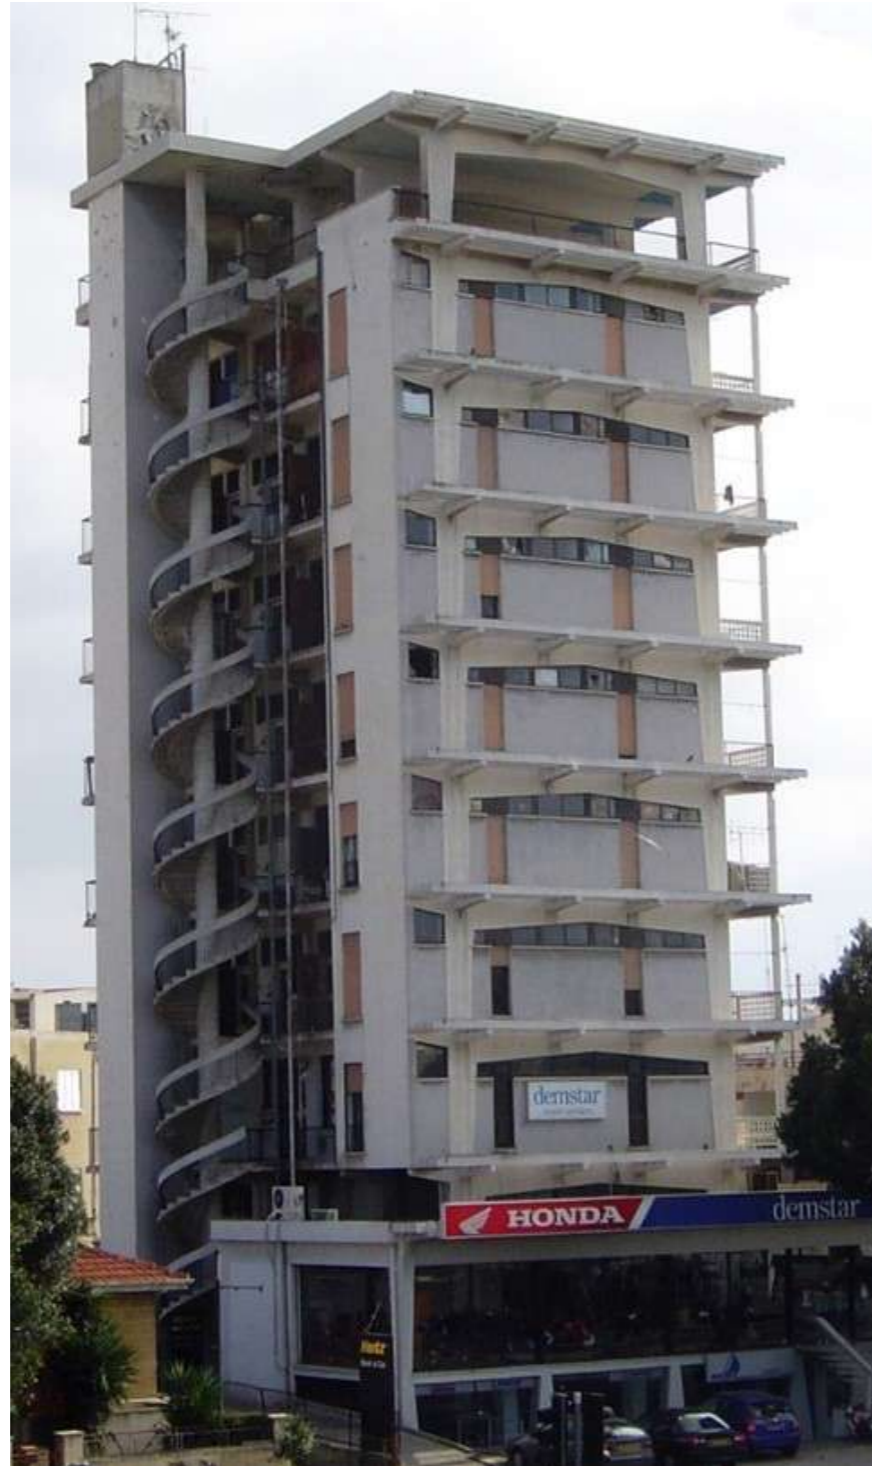
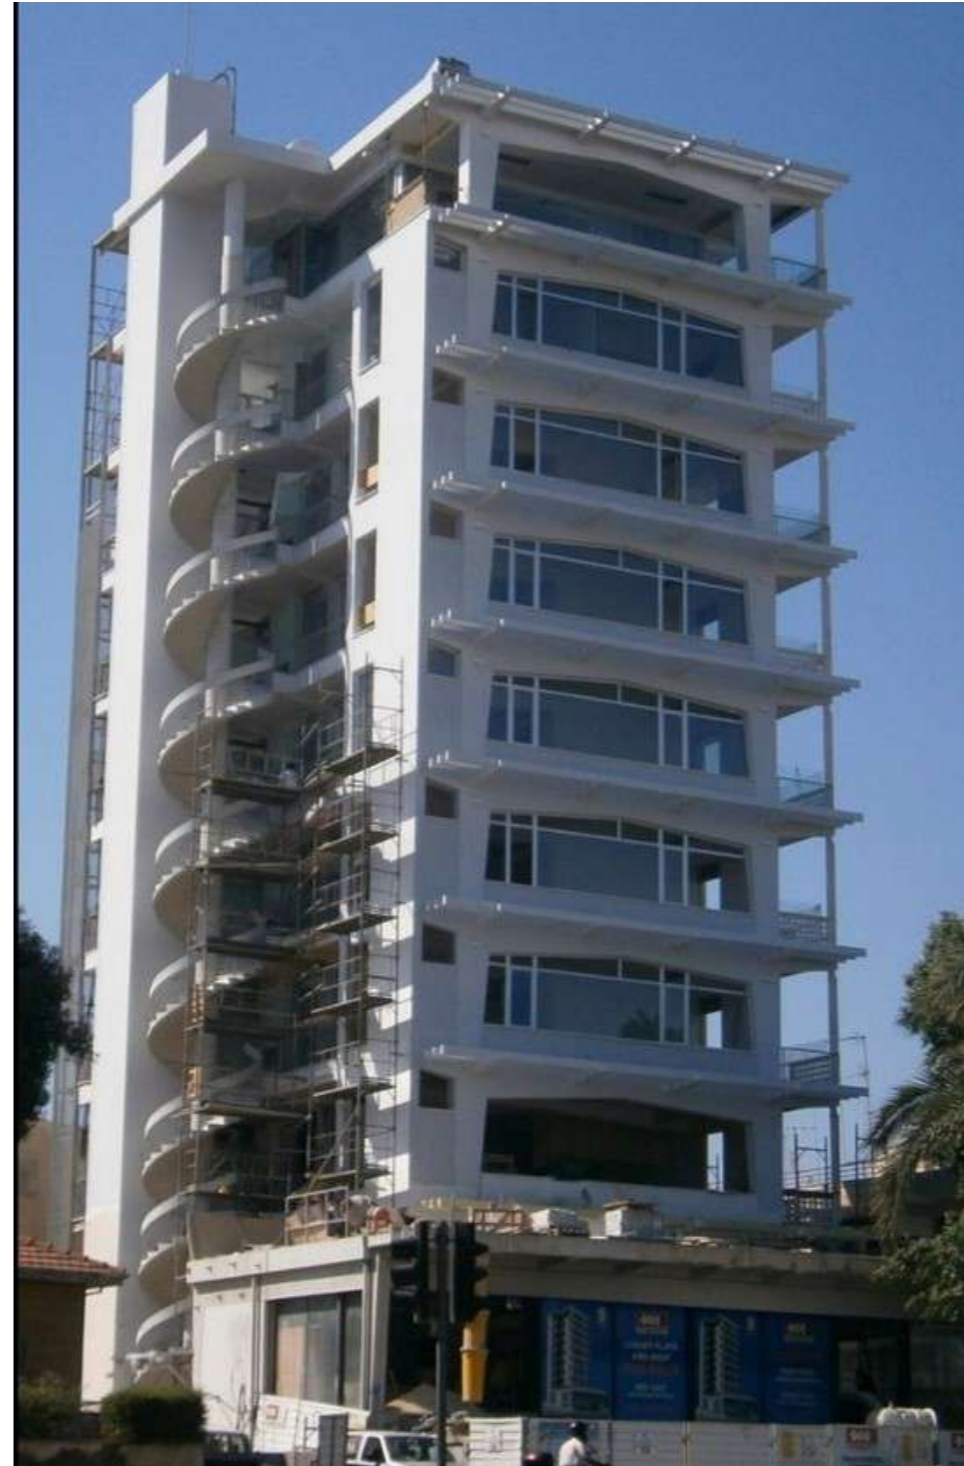
Fig.19-20: Photographs before and after interventions. © A. Michael's archive.
