Restoration of an old Carob Mill.

Old industrial building transformed into a cultural center.

Site Lanitis Carob Mill, Vasilissis Street, Limassol, 3042, Cyprus

Designer Chief Architect: Kristian Christou Architects,
Job Architect: A. J. Brooks, Architect.
Contractor: CYBARCO

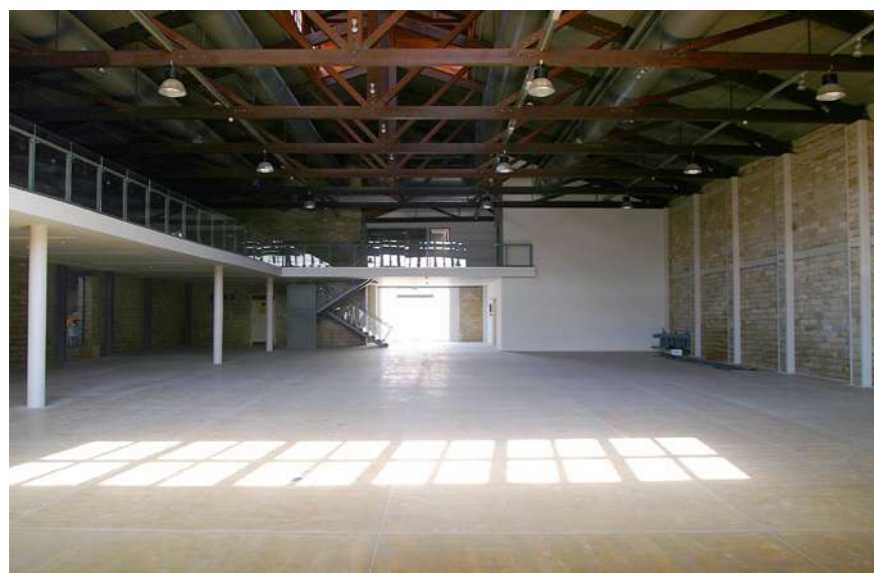
Fig.2: In the North hall, central, free-standing concrete columns and metal trusses were removed and replaced with single span timber laminated trusses with no intermediate support. © Kristian Christou Architects, A. J. Brooks, Architect.

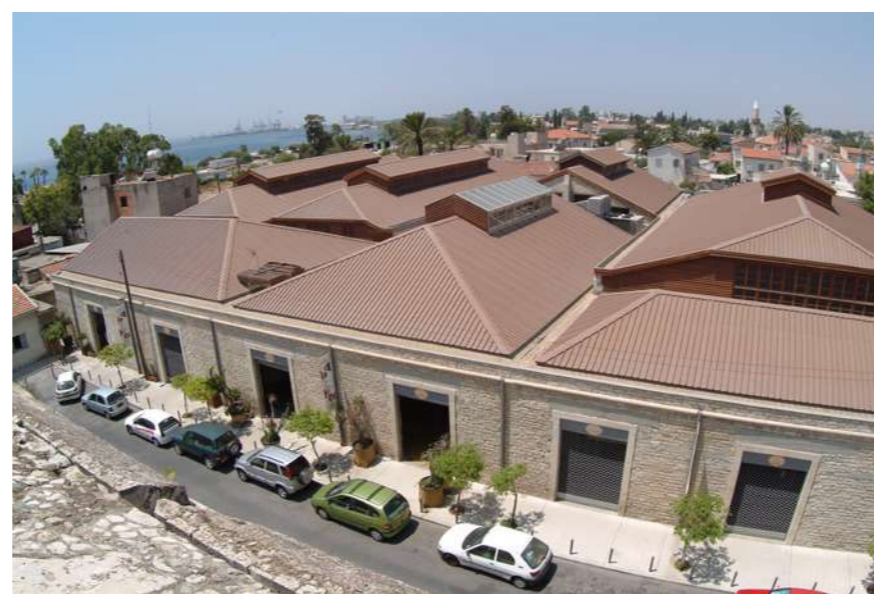
Fig.3: Removal of all asbestos roofing material, in accordance with the regulations. The new roof covering is an insulated, built up metal sheet roof with a noise absorption under-layer and a sound deadening intermediate layer. © Kristian Christou Architects, A. J. Brooks, Architect.

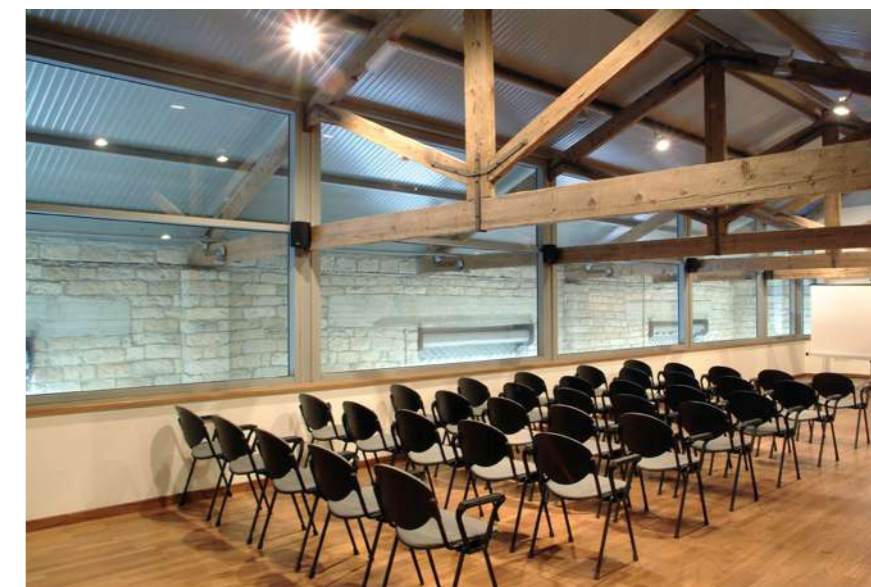
Fig.4: View of the rehabilitated interior, and new mezzanine space. © Kristian Christou Architects, A. J. Brooks, Architect.

The tall internal height of the halls allowed for the construction of mezzanines, approx 500sqm in total, to accommodate various ancillary functions. These are all removable without affecting the original fabric.

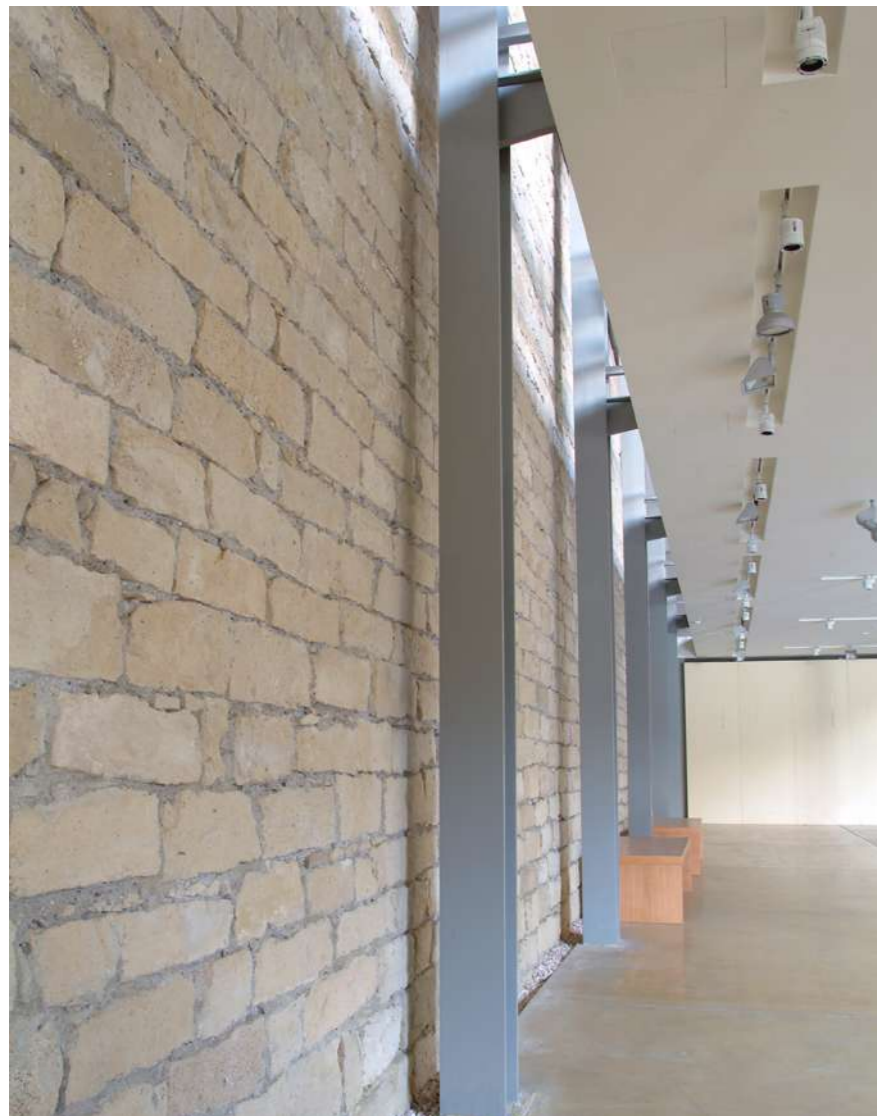
Fig.5: View of the rehabilitated interior with new interventions.
© Kristian Christou Architects, A. J. Brooks, Architect.

The new interventions have been constructed of lightweight materials, dry-wall for the solid elements and glazing to allow transparency and an appreciation of the continuation of the space.

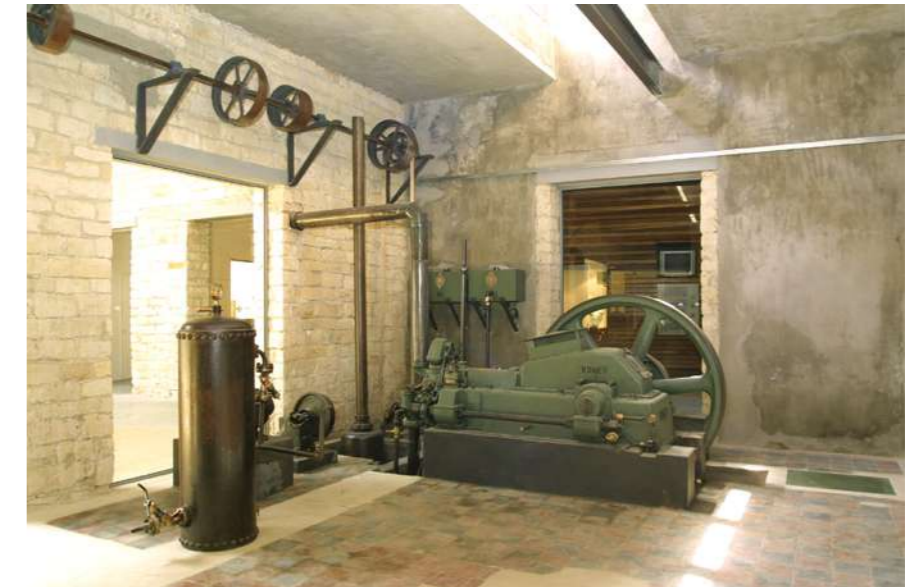
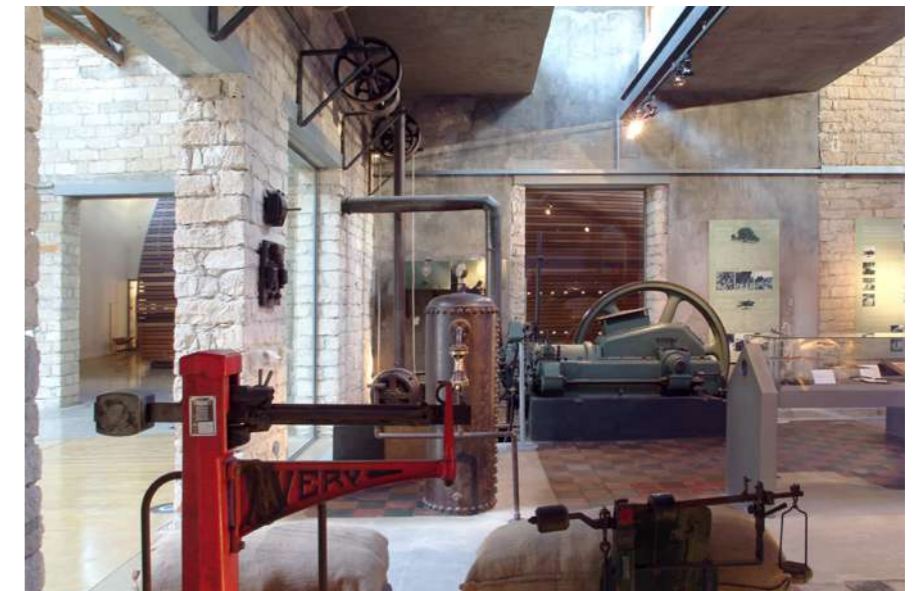
Fig.7-8: View of the restored machines.
© Kristian Christou Architects, A. J. Brooks, Architect.

to increase their visibility from other surrounding spaces, thus acquiring a dominant presence through their size and appearance. All the milling machinery is clad with timber.

All the timber elements were treated and protected against damp and insects. The metal elements were either painted to match their original colours or treated with rust converter.

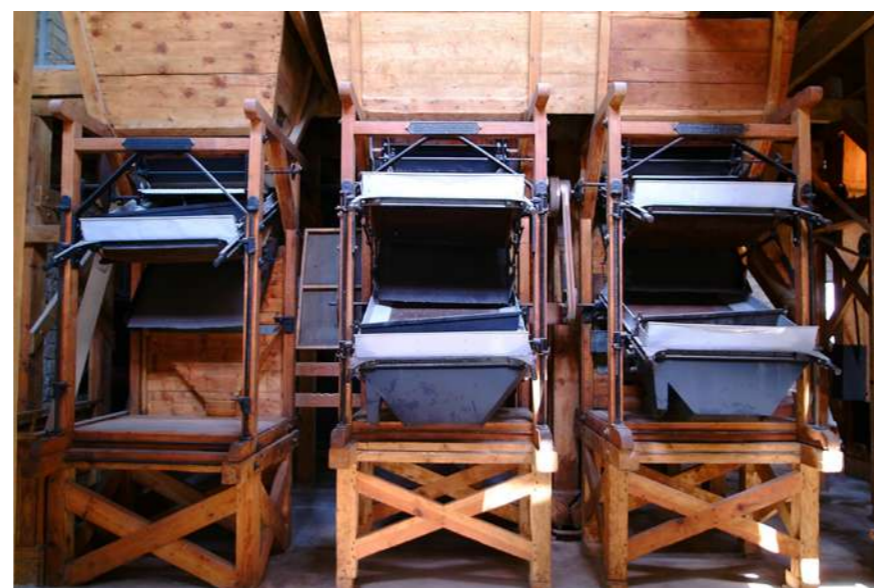
Fig.10: View of the restored machines.
© Kristian Christou Architects, A. J. Brooks, Architect.

The diesel engines and other elements of the line-shaft system were treated in the same way.

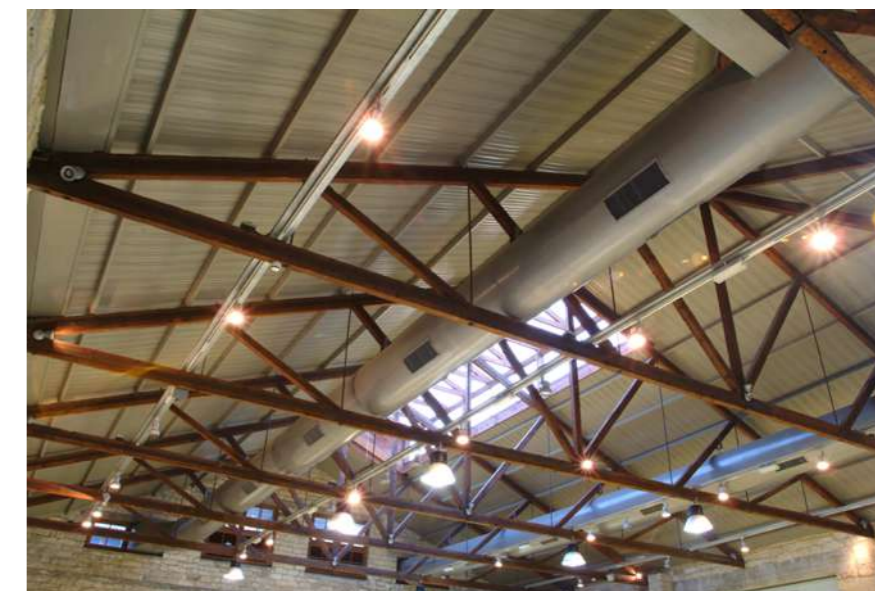
Fig.11: All air-conditioning ducts and light tracks are exposed in the roof truss zone. © Kristian Christou Architects, A. J. Brooks, Architect.

Heating and cooling is provided by tubular air ducts suspended within the trusses and visible. The main compressors are all housed in an enclosure in the parking area on the west side. Others that serve smaller areas in the mezzanines on the east side are housed on anti-vibration mountings in recesses in the

roof space, so as not to protrude over the roof. All spaces and halls are independently controlled so that they can be used separately and independently. The general lighting, local lighting and effects light fittings, speakers, safety systems etc are all located on or within the truss space in the roof. These provide for a wide variety of functions ex: cinema events, art exhibitions, conferences etc.

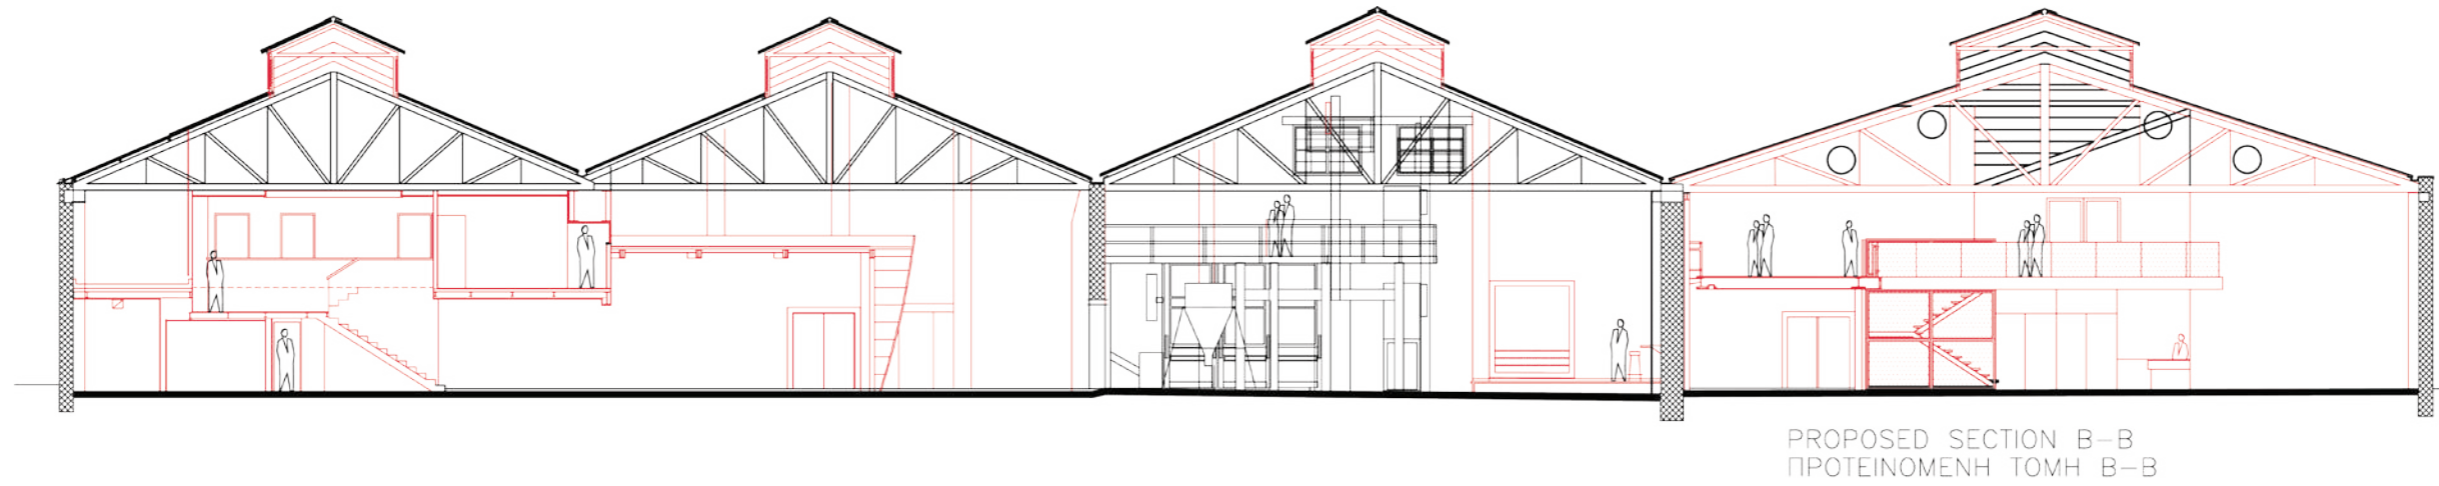
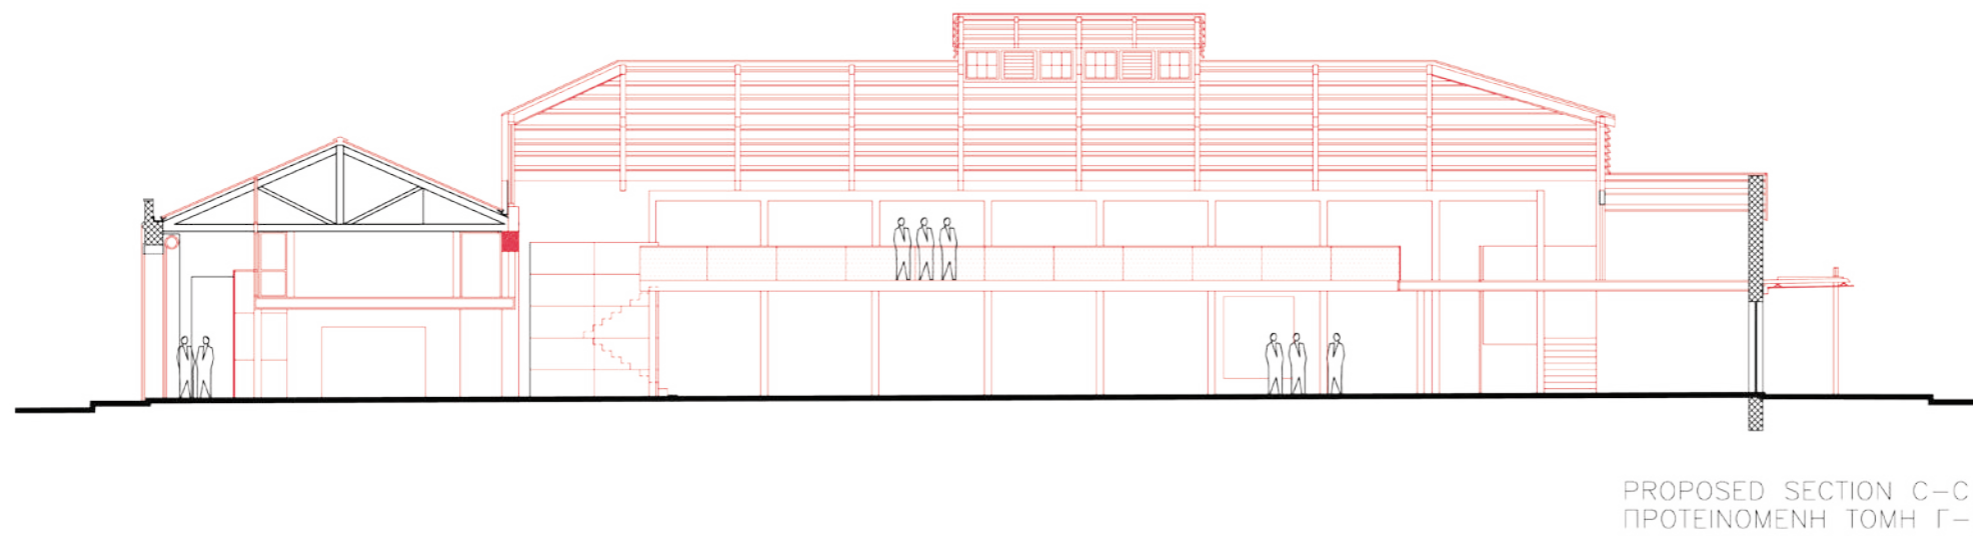
Fig.12: Section drawings of the proposed intervention. © Kristian Christou Architects, A. J. Brooks, Architect.

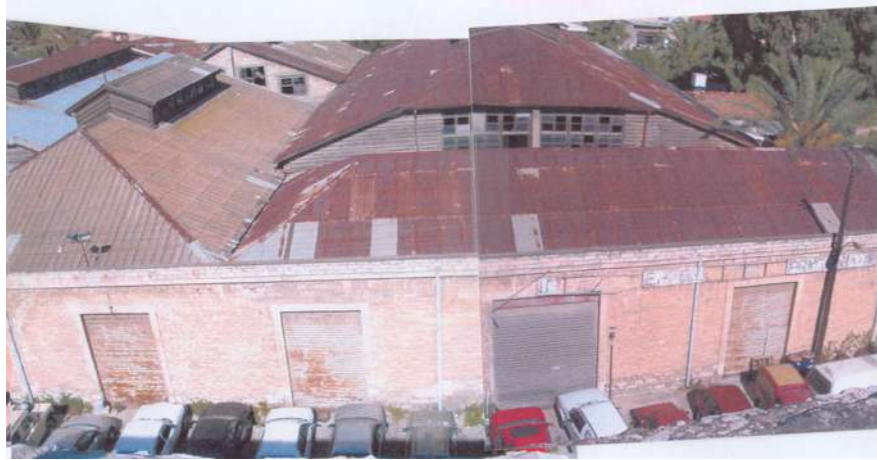
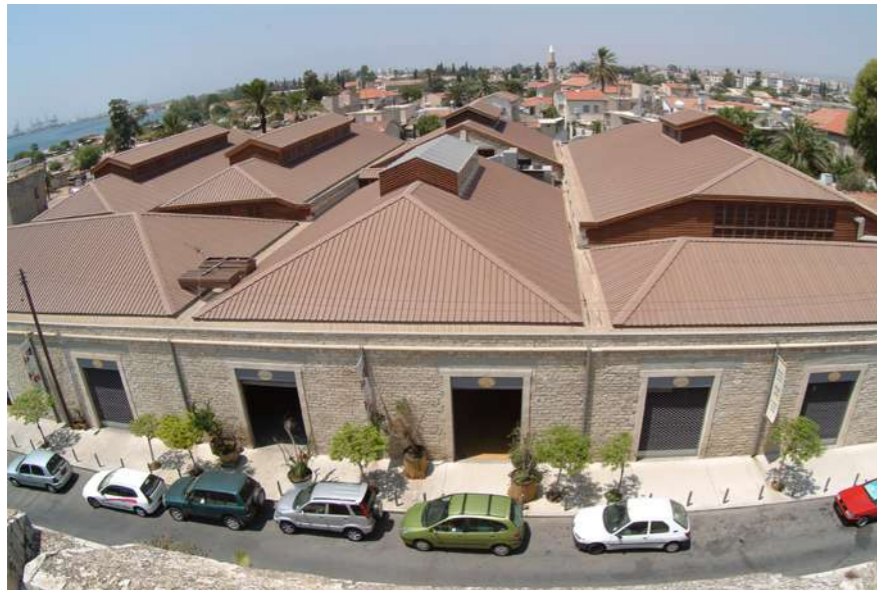
Fig.15-16: Front (East) elevation - before and after. © Kristian Christou Architects, A. J. Brooks, Architect.

New internal glazing elements were constructed of a curtain wall system with exposed fixing bolts. In the large openings in the east wall, traditional industrial roller shutters were installed, without the decorative roller covers.

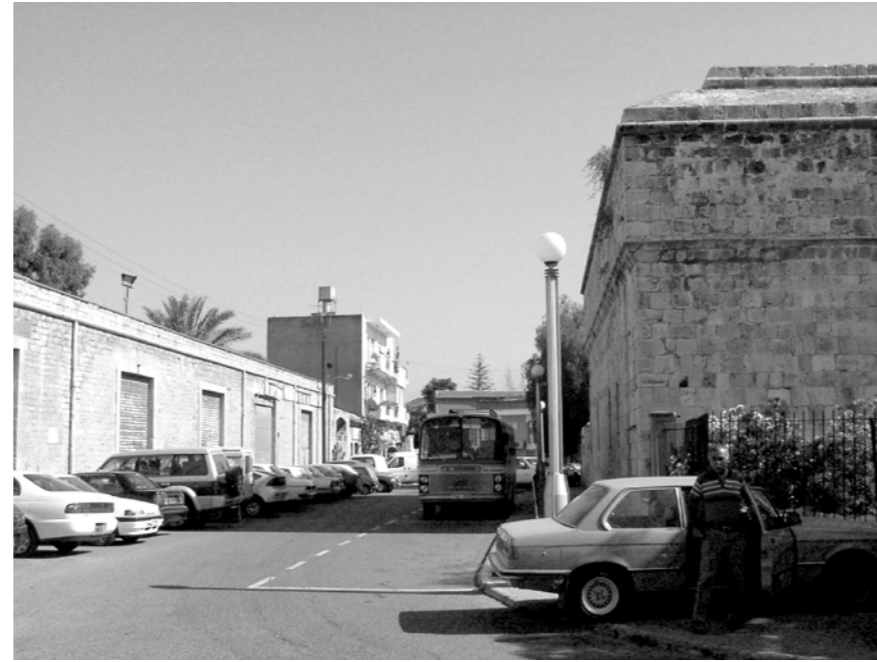
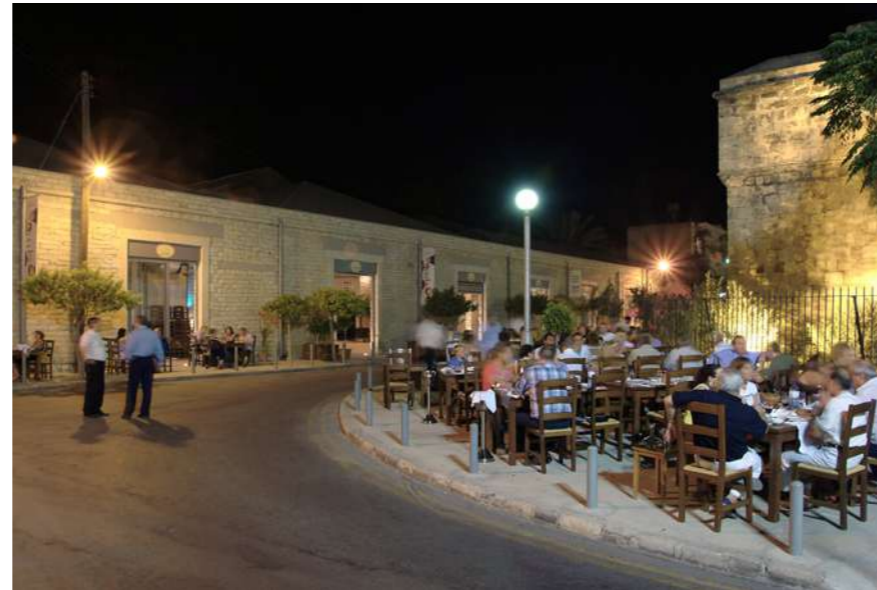
Fig.17-18: Public street - before and after. © Kristian Christou Architects, A. J. Brooks, Architect.

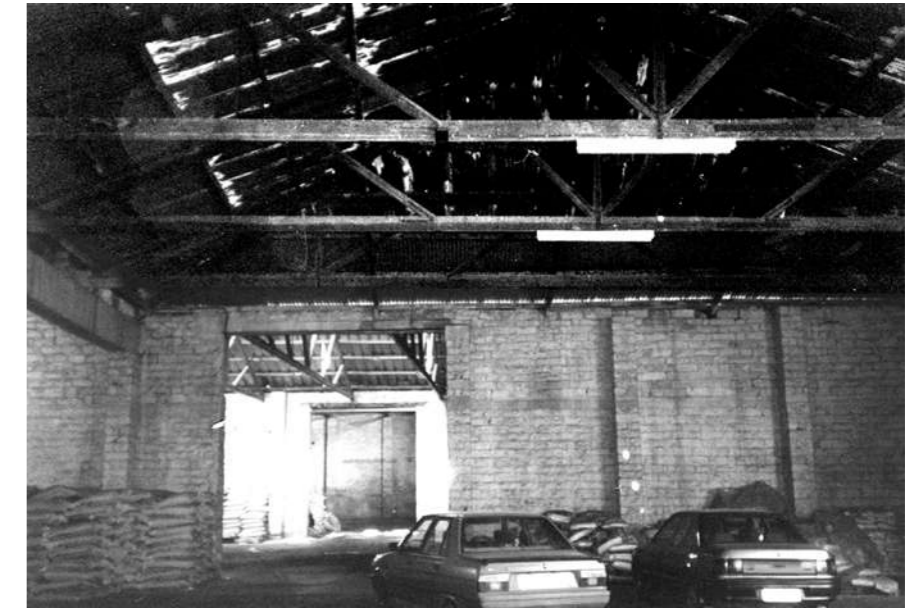
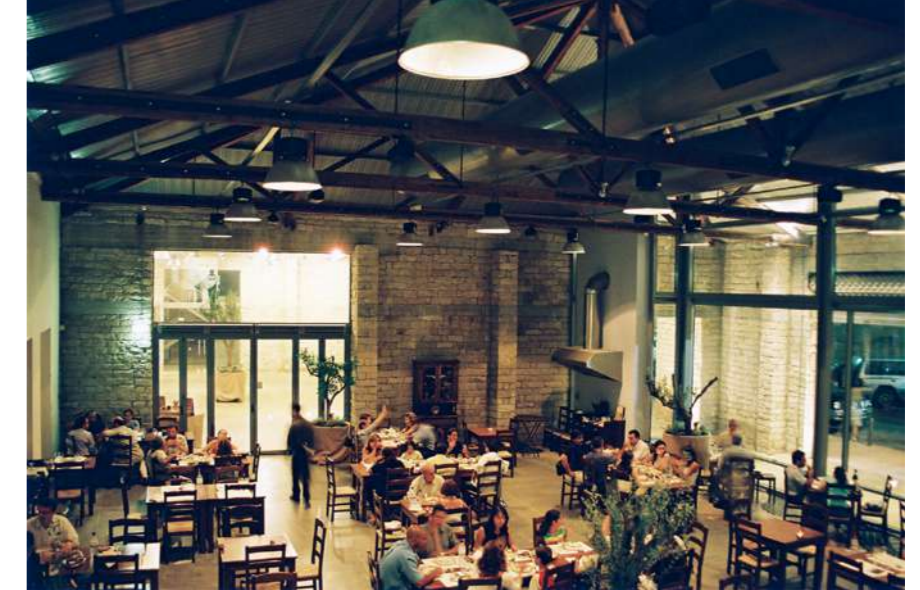
Fig.19-20: South hall, East side - before and after. © Kristian Christou Architects, A. J. Brooks, Architect.

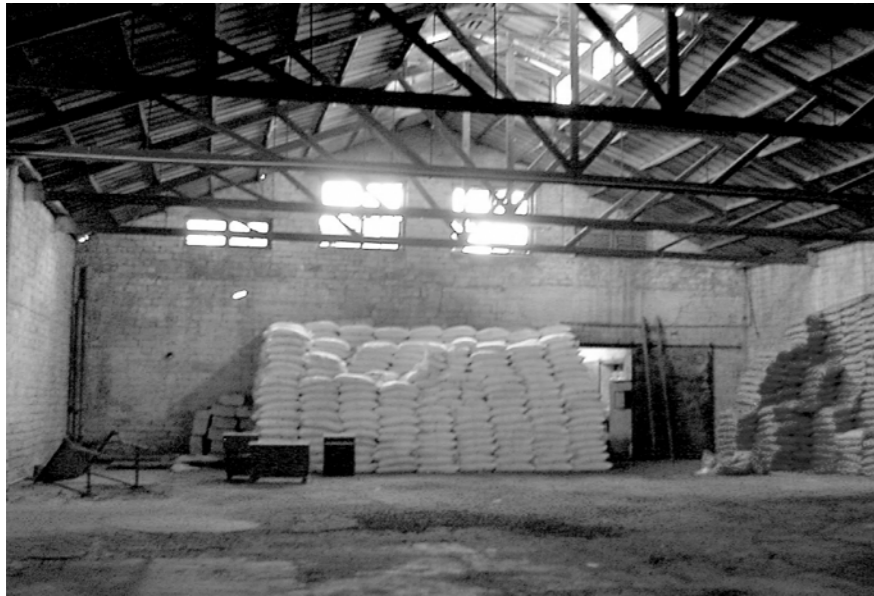
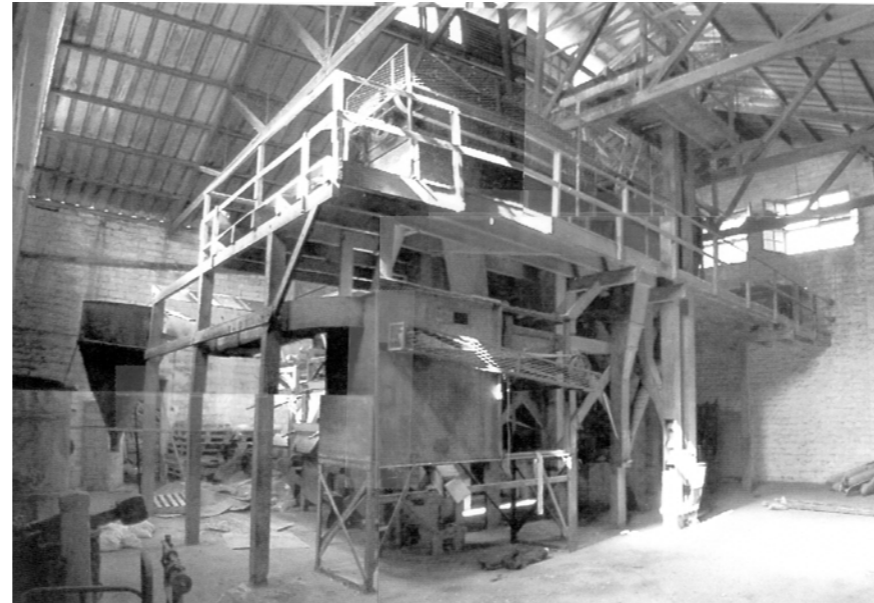
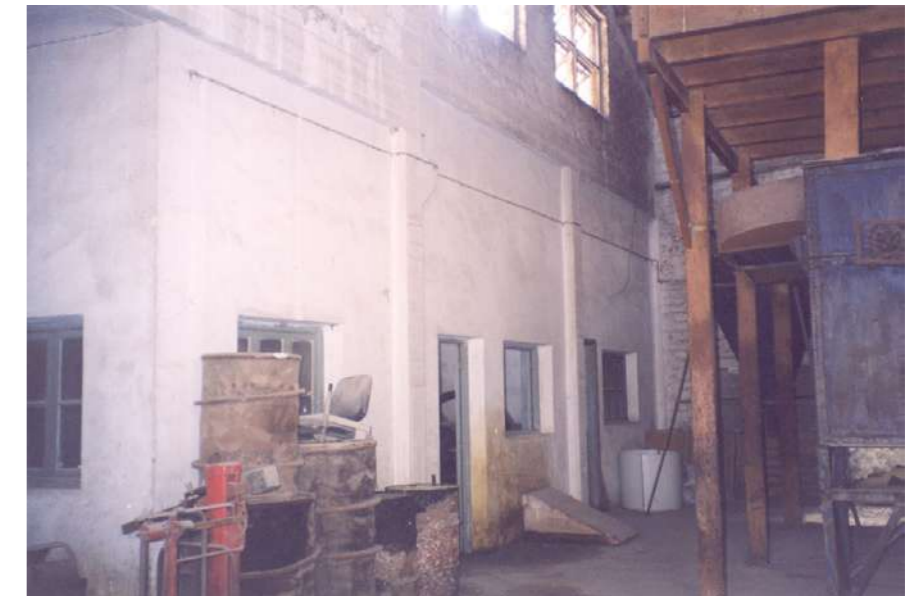
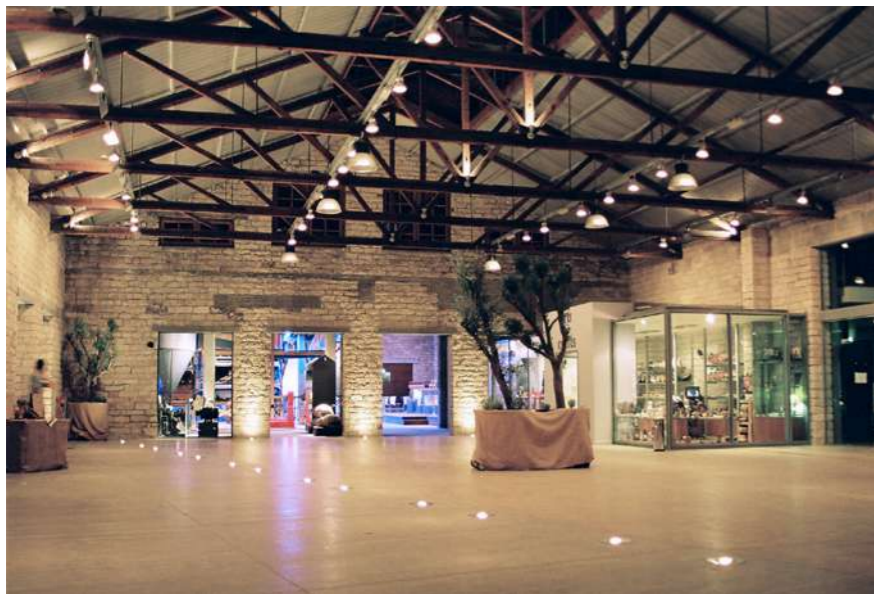
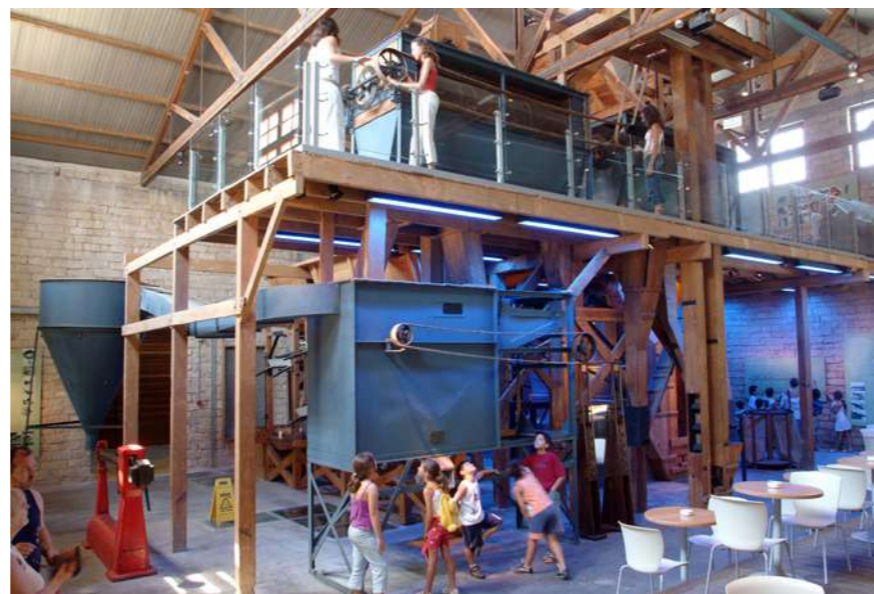
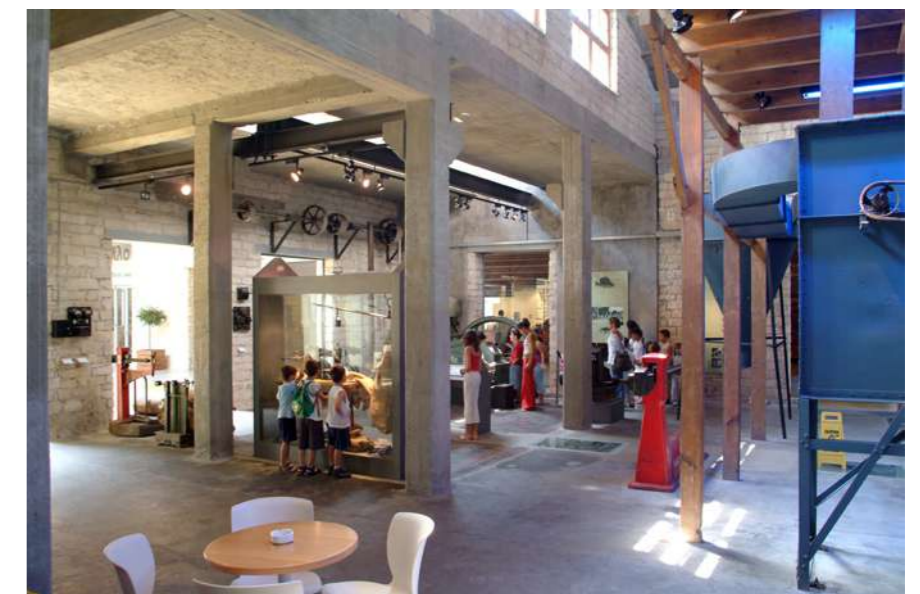
Fig.21-22: Central hall, East side - before and after. © Kristian Christou Architects, A. J. Brooks, Architect.

Fig.23-24: Carob Mill - before and after. © Kristian Christou Architects, A. J. Brooks, Architect.

Fig.25-26: Engine room - before and after. © Kristian Christou Architects, A. J. Brooks, Architect.

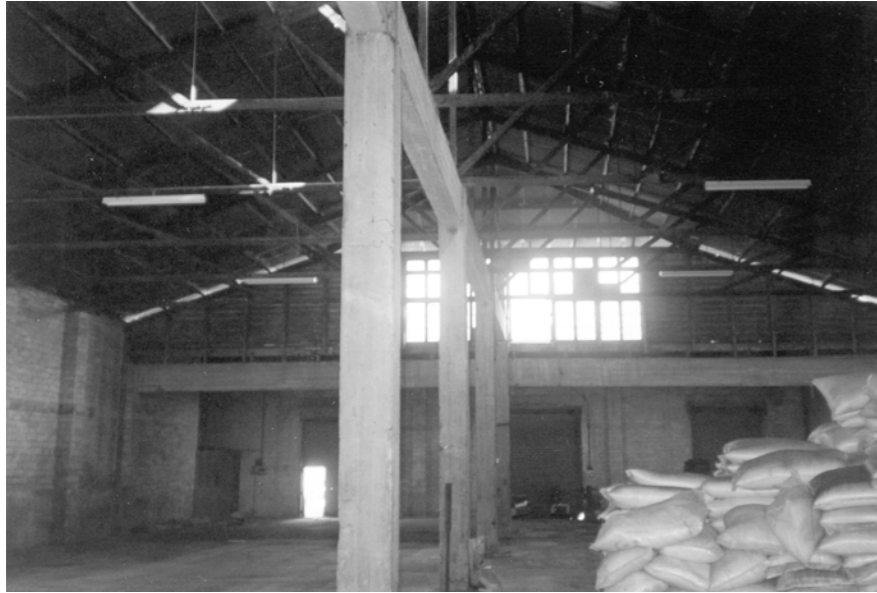
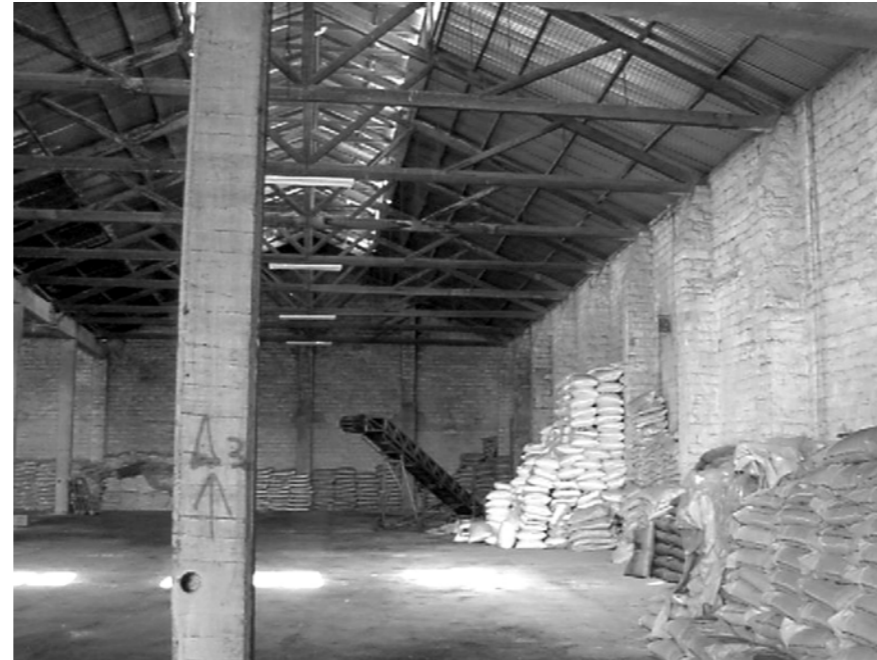
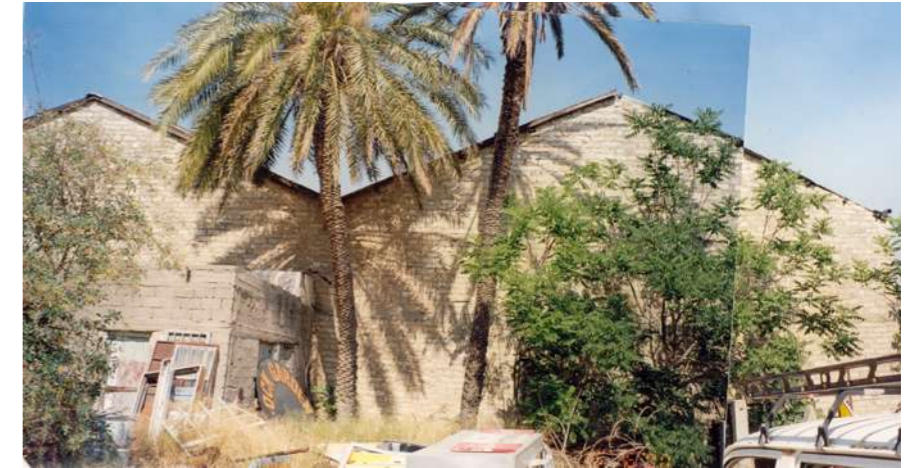
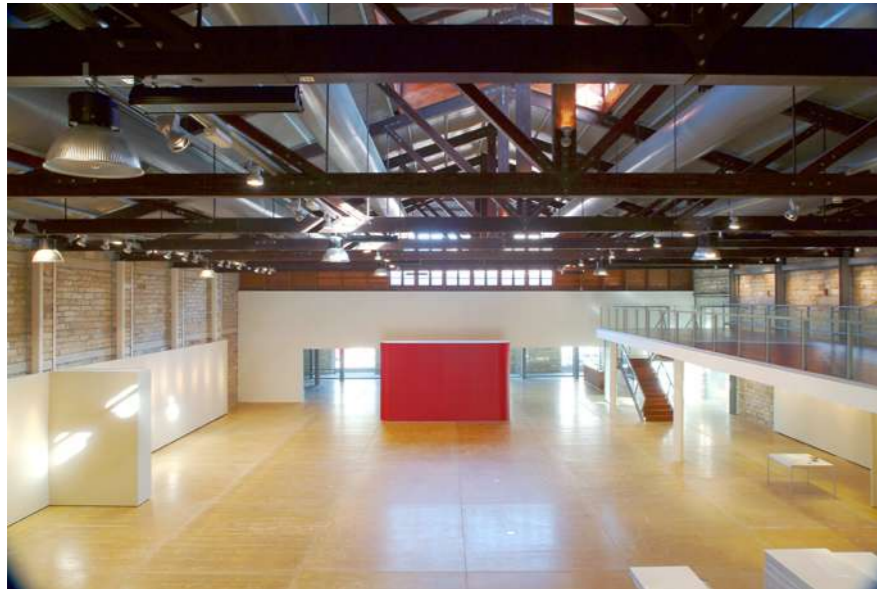
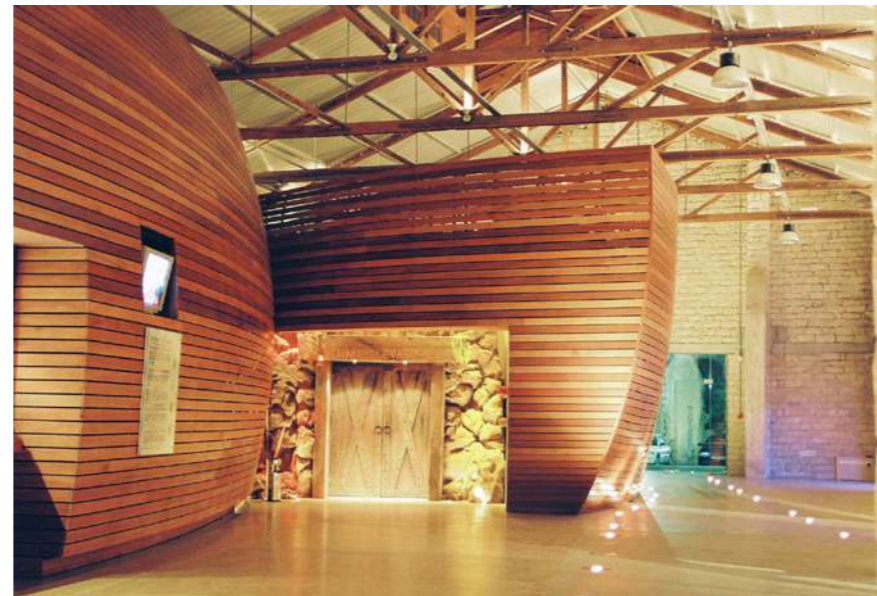
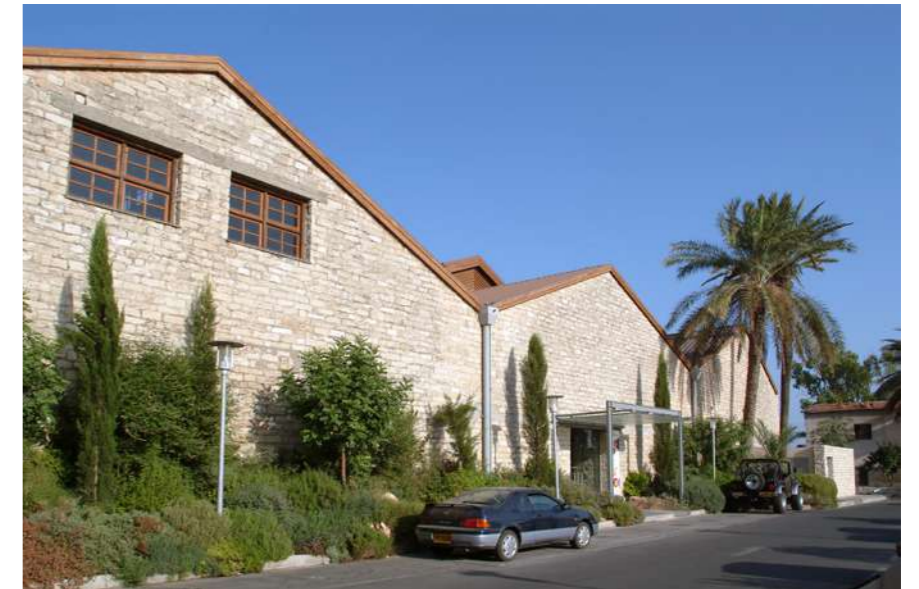
Fig.27-28: North hall - before and after. © Kristian Christou Architects, A. J. Brooks, Architect.

Fig.29-30: South hall- before and after. © Kristian Christou Architects, A. J. Brooks, Architect.

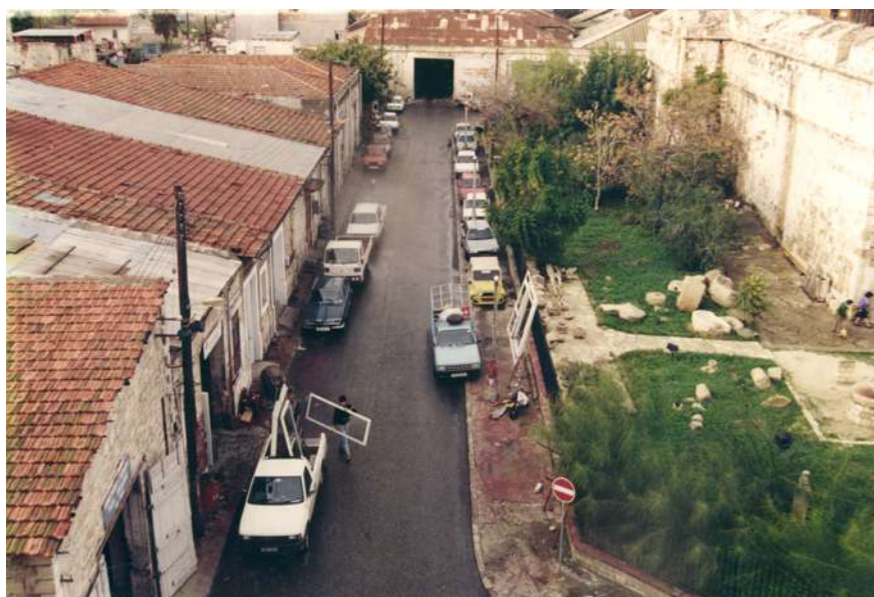
Fig.33: Approach road to Carob Mill before. © Kristian Christou Architects, A. J. Brooks, Architect.

In 2010 the Limassol Municipality, with funding from the European Regional Development Fund, embarked on a programme of upgrading the infrastructure in the area which included all aerial service lines being housed underground, repairing and renovating building facades, pedestrianization of roads, etc.

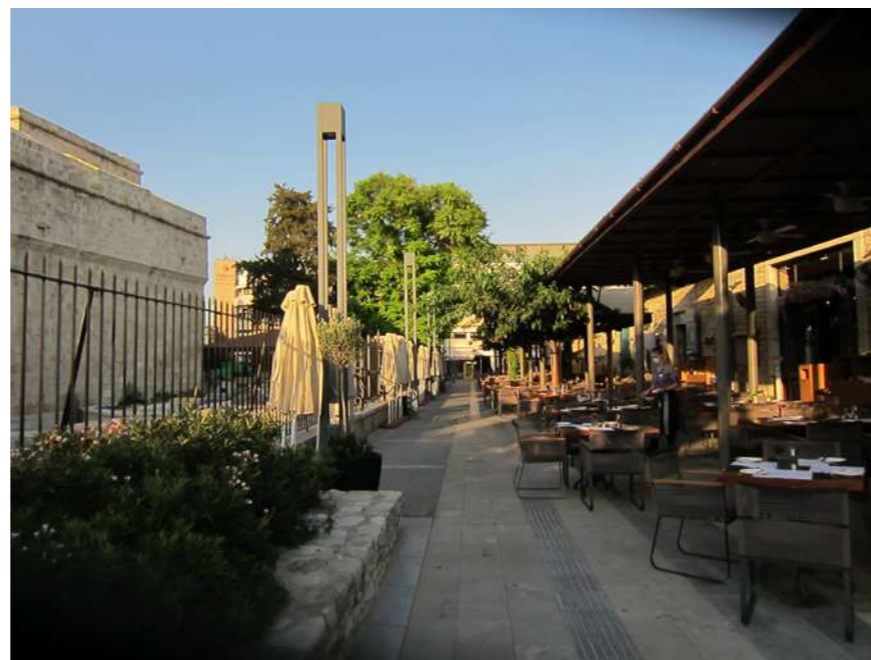
Fig.34: Approach road to Carob Mill after. © Kristian Christou Architects, A. J. Brooks, Architect.

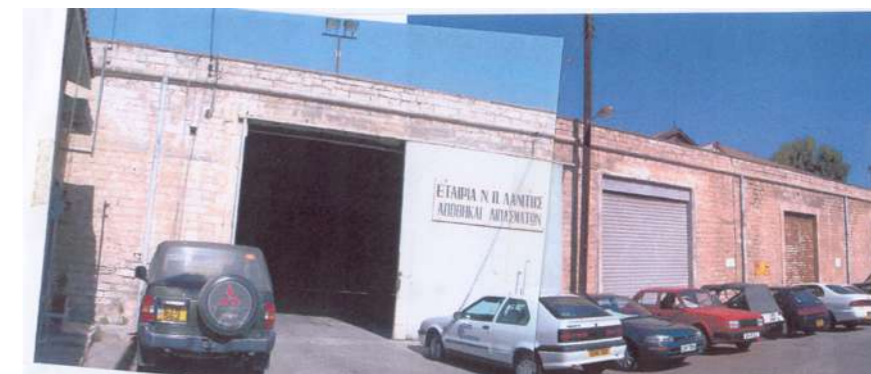
Fig.36: Original condition with traffic access. © Kristian Christou Architects, A. J. Brooks, Architect.

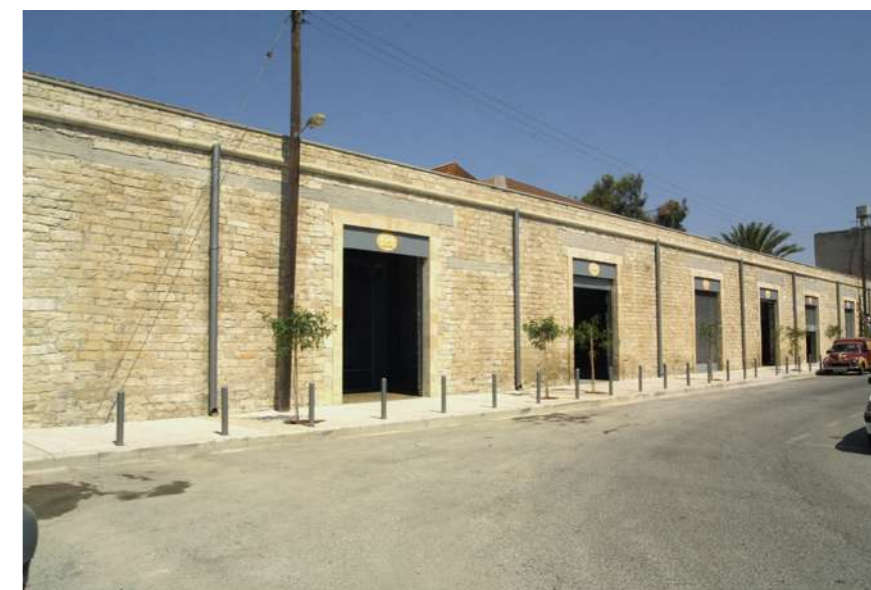
Fig.37: After restoration with traffic access. © Kristian Christou Architects, A. J. Brooks, Architect.

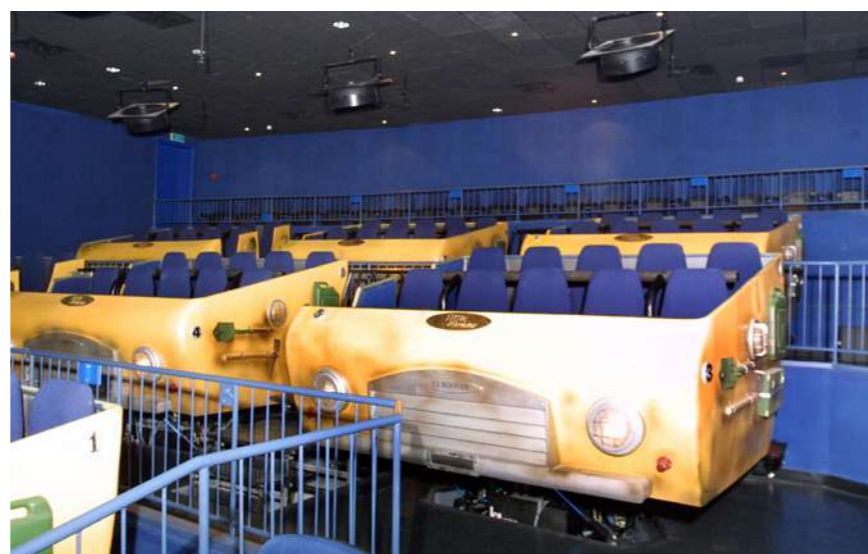
Fig.39: Time elevator interior. © Kristian Christou Architects, A. J. Brooks, Architect.

As a result of the decision to separate the new interventions from the original fabric of the building, it was possible to totally remove the Time Elevator installation and refurbish the space as an events hall.
