Open for works. A way to disseminate the restoration.

Restoration of Antoni Gaudí's Casa Batlló, a UNESCO World Heritage Site.

Site Casa Batlló, Passeig de Gracia 43, Barcelona, Catalunya, Spain

Date Project development: 2019
Works: 2019-2020

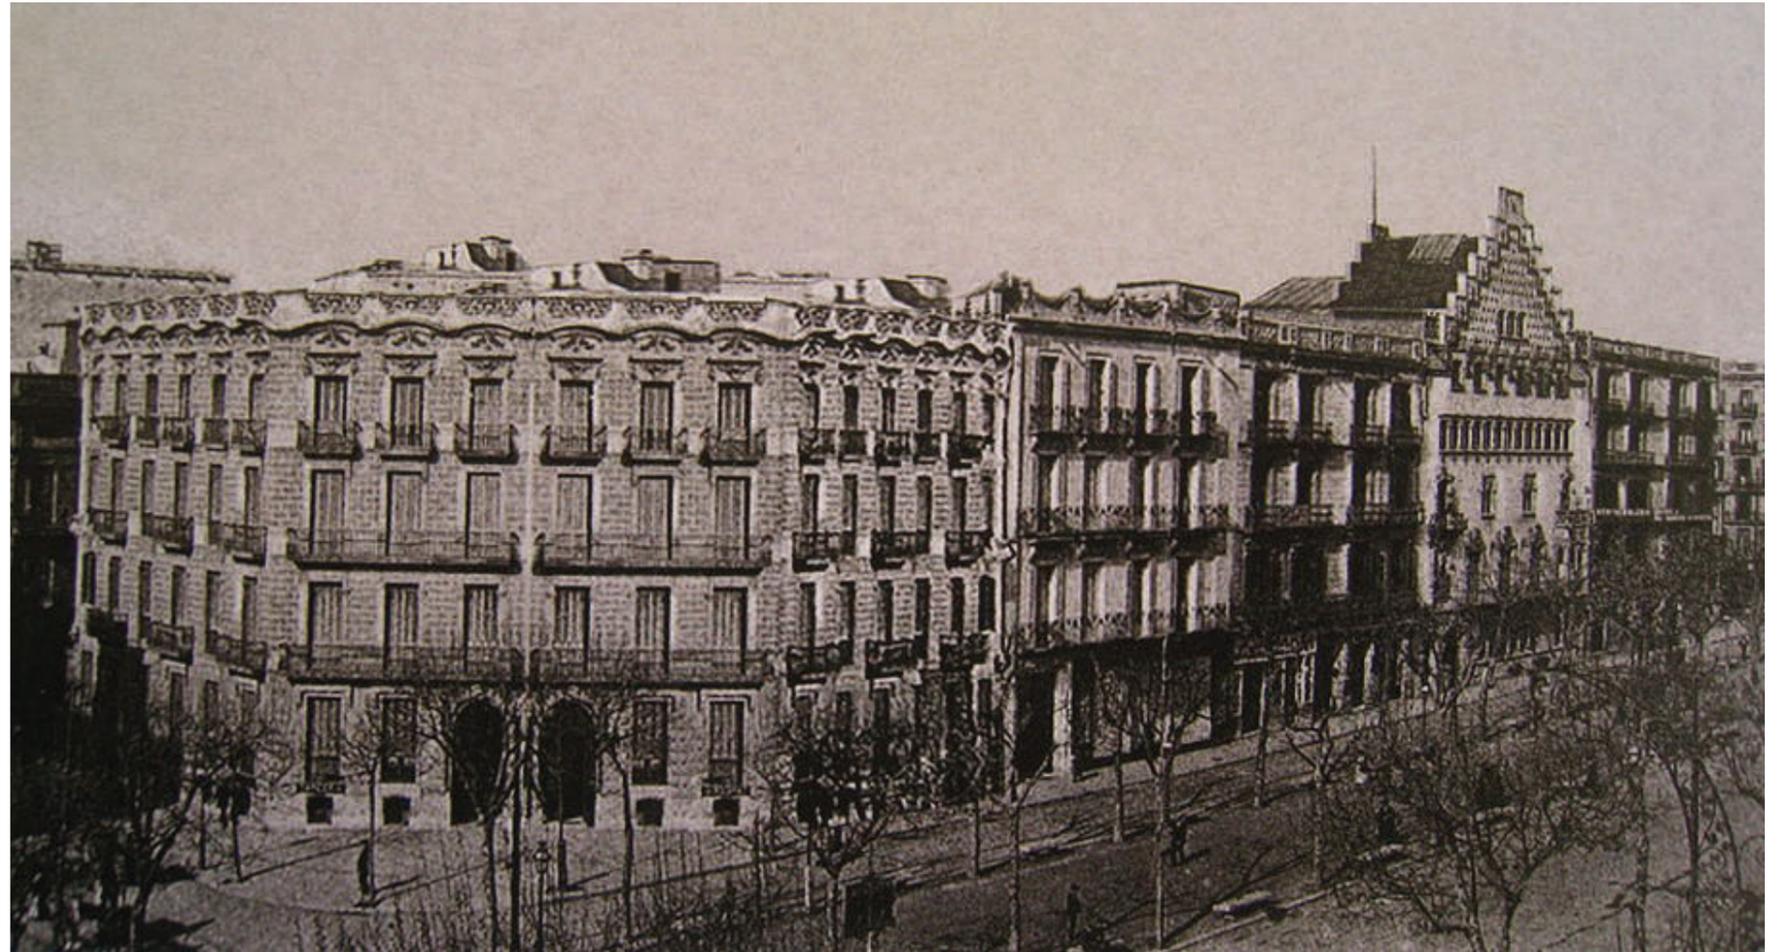
Fig.1 Next to the Amatller house you can see the facade of the house before the intervention of Antoni Gaudí 1904-1906
Historical engraving (web of Casa Batlló <https://www.casabatllo.es/en/antoni-gaudi/casa-batllo/history/> 10.25.2021)

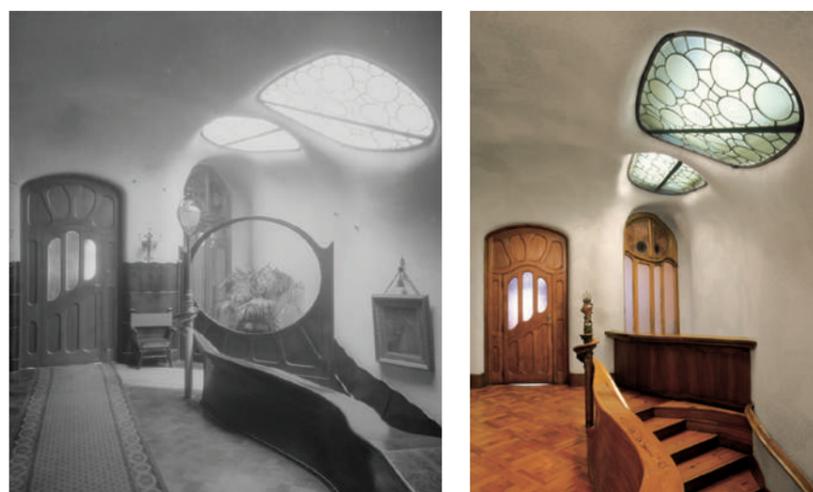
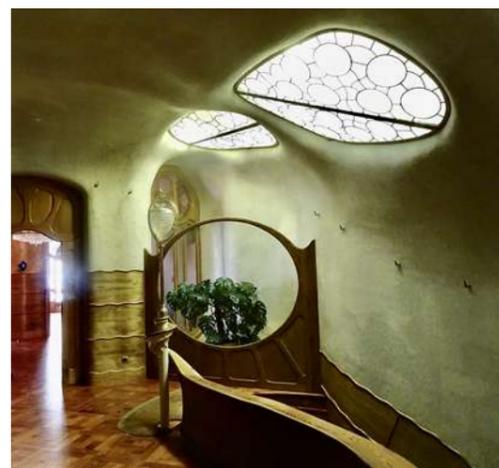
Fig.2 Evolution of the entrance hall to the main floor:
2.1 Original condition, year 1906; 2.2 Previous state, year 2014;
2.3 Restoration, year 2019. Arxiu Mas (2.1), Joan Olona (2.2, 2.3)

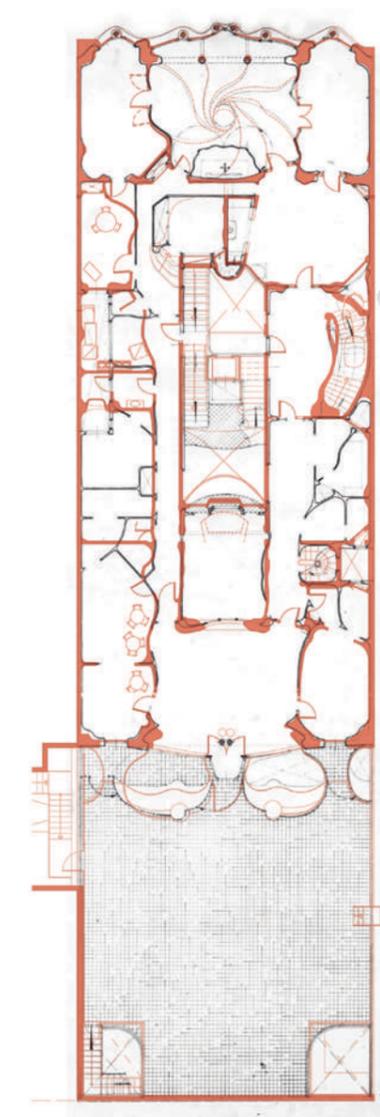
The superposition of the layout plans of the piano nobile from 2014 with the survey carried out in the early 1950s by the Friends of Gaudí, clearly indicates the alterations that have occurred in the floor belonging to the Batlló-Godó family.

Fig.3 Main floor layout plan: superposition in red from the 2014 survey, in black, drafted by the Friends of Gaudí.
Joan Olona, Mireia Bosch

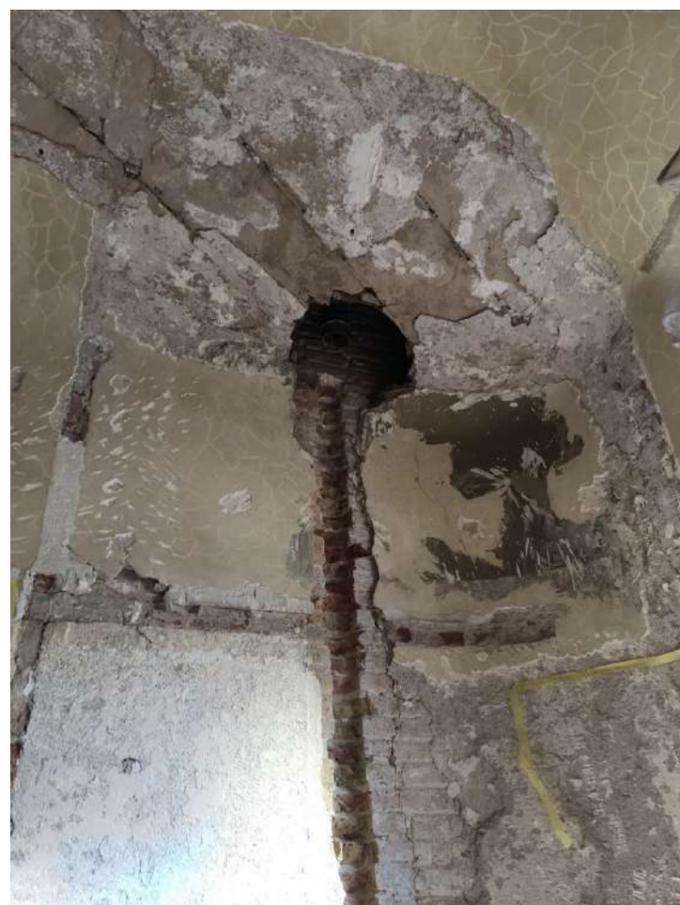
Fig 4. Previous condition of the North corner of the North room main facade. A vertical cut, missing stucco and underlying remains that appeared under layers of paint can be see.

The elimination of the wainscoting in almost the entire piano nobile (all but the elevator lobby) caused half of the vertical walls to be significantly altered. On the ceilings and the upper part of the walls, the stucco pre-sented an uneven degree of conservation: grooves cut in some areas, sporadic or large gaps, making it impossible to read as a composition, while the ceilings, in areas where they were still preserved, showed a good state of conservation of the original finishes. (The wooden flooring is a reproduction of the original, laid in the 1990s).

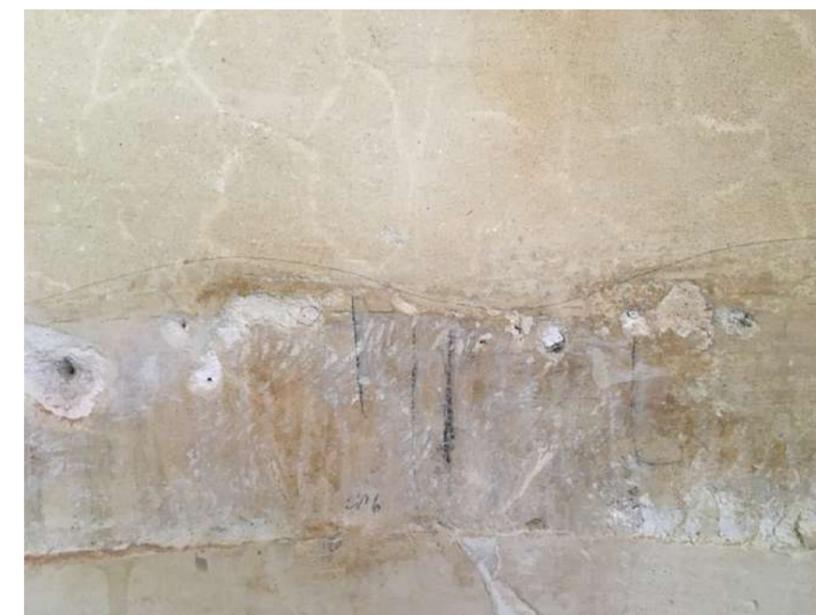
A third round of inspections was launched, in which a team of restorers began to strip small areas of wall, and thus verify the whole surface. The restoration of these first areas showed where the wooden wainscoting had been, and the discovery was also made of the original wainscot numbering, in graphite pencil, on the wall of the different rooms, and even the drawing of the upper undulation of the skirting, made during the construction phase of Gaudí 's work.

Fig 4. Wainscot stratigraphy: original graphite pencil markings with original slab geometry and numbering. Joan Olona

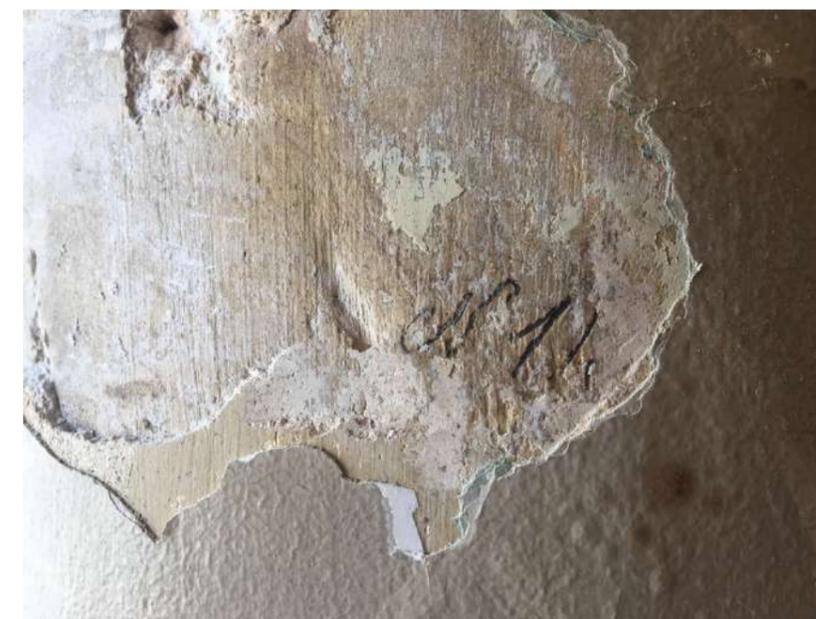
A second round of samples were taken from strategic places of the main floor, this time expanding the types of tests to try to obtain the maximum information, from below numerous layers of paint from the 1960s to the present day. The results showed that the technique used consisted of a multitoneal lime stucco, where in addition to the three traditional coating layers, incisions were made to etch the “trencadís” which were then filled again with mortar of lime, and the result finished with a layer of waxes.

Fig 6. Statigraphy layers of paint on original finish and wainscot numbering.

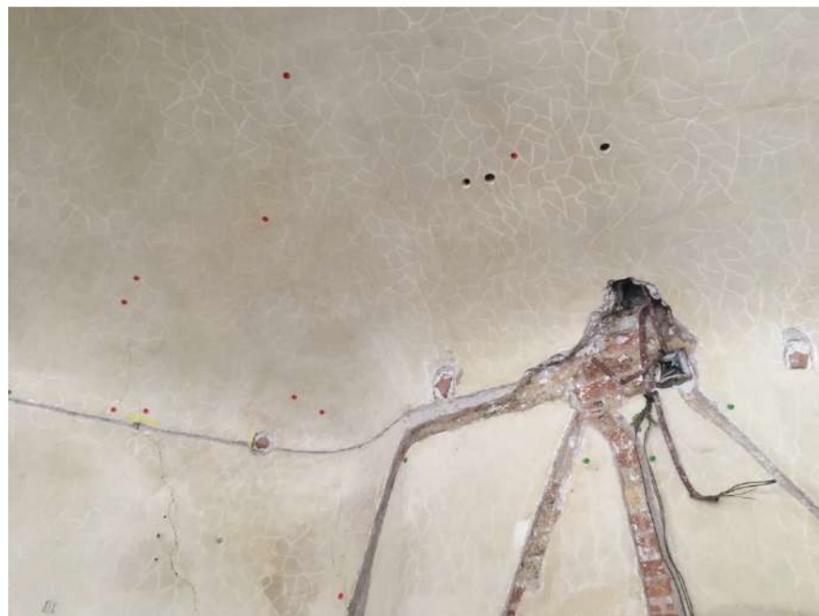
Fig 7. Documentation criteria. Coloured dots identify the different reintegration interventions.

The replacement of the coatings was carried out differentiating the restoration of the large gaps, with the reproduction of the original stucco technique, while specific repairs were filled with a neutral finish. In both cases, the chromatic intervention allows the integration of the parts with respect to the whole, while also allowing a visual distinction from close range. Throughout the processes, the alterations were documented one by one prior to restoration in order to facilitate the understanding of this intervention.

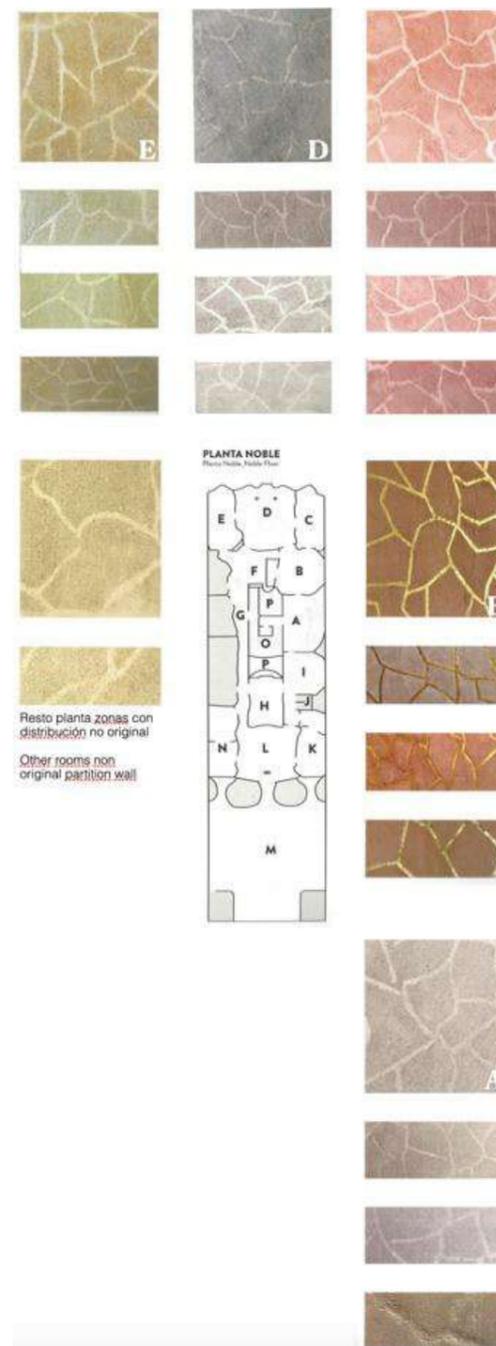
Fig 8. Plan of the original restored stucco. *Joan Olona, Mireia Bosch* according the *Restoration Guide of Casa Batlló*.

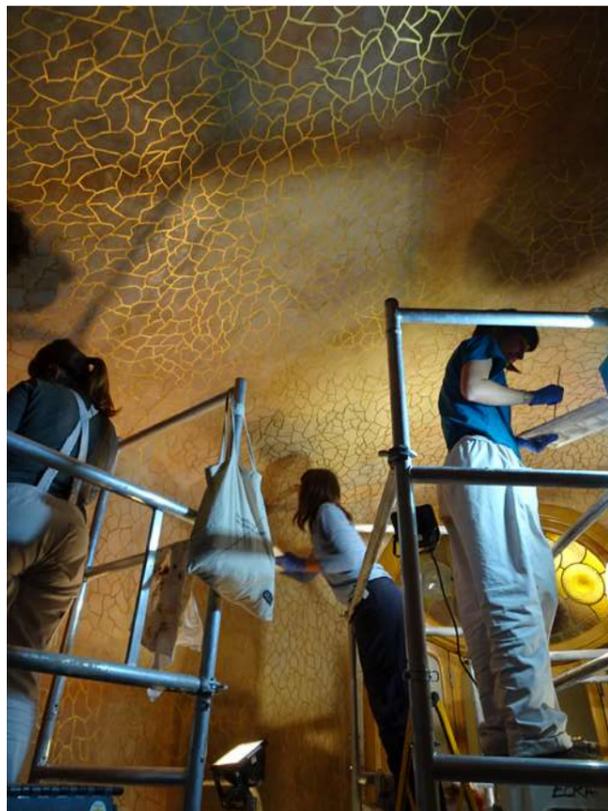
Fig 9.1. Reintegration works of gaps in.

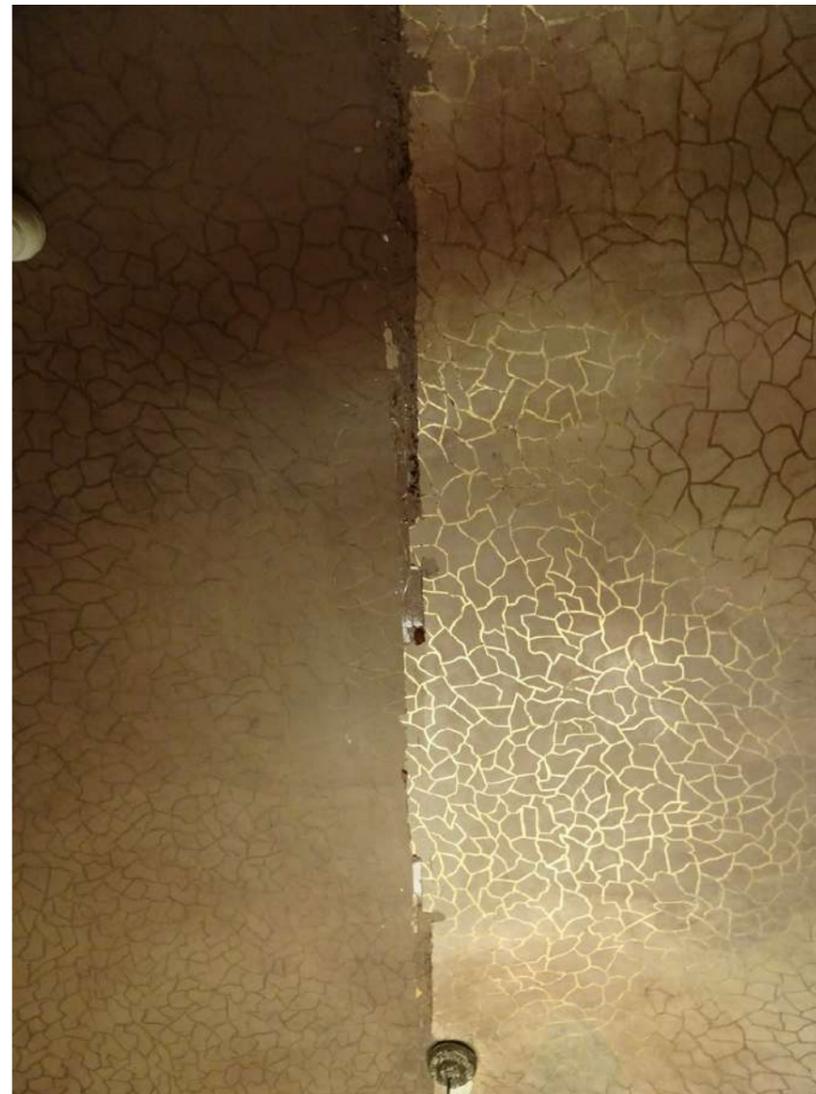
Fig 9.2. Left, painting state prior to restoration; right, surface restored

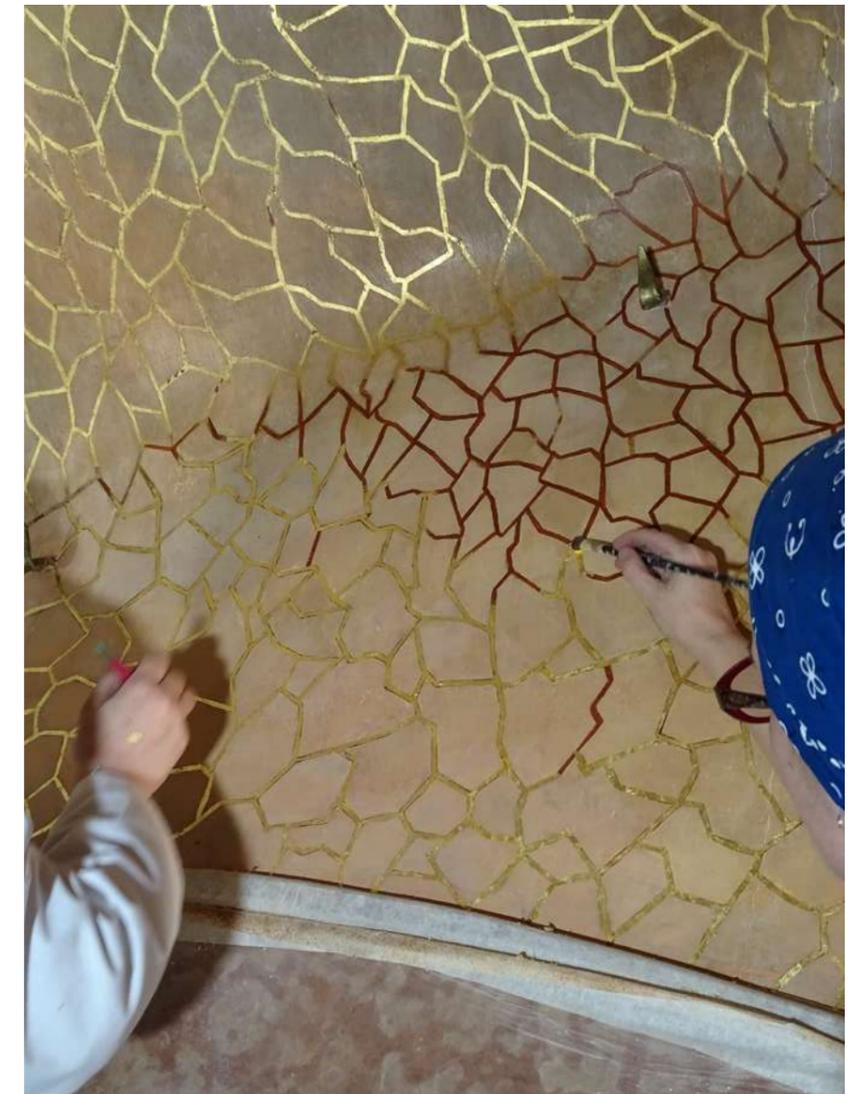
Fig 9.3. Gold leaf reintegration detail.

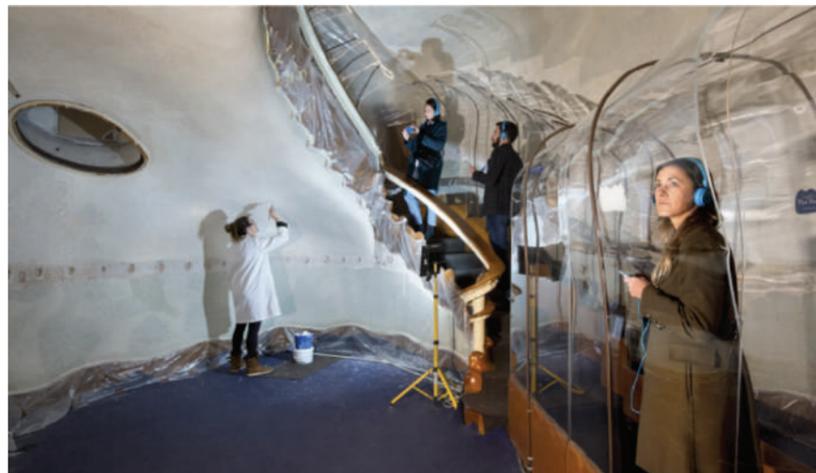
Fig 10.1. Screen adapted for spaces to protect but also allow the visitor to see during the restoration process.
Oscar Criado - Archivo Casa Batlló

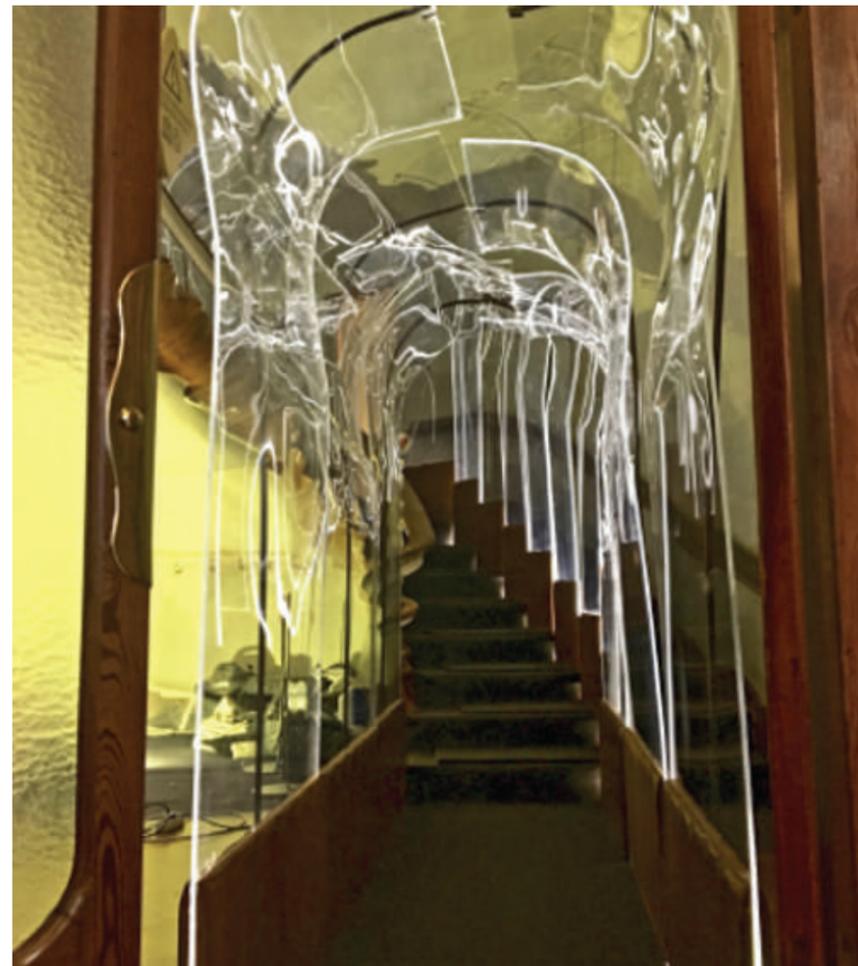
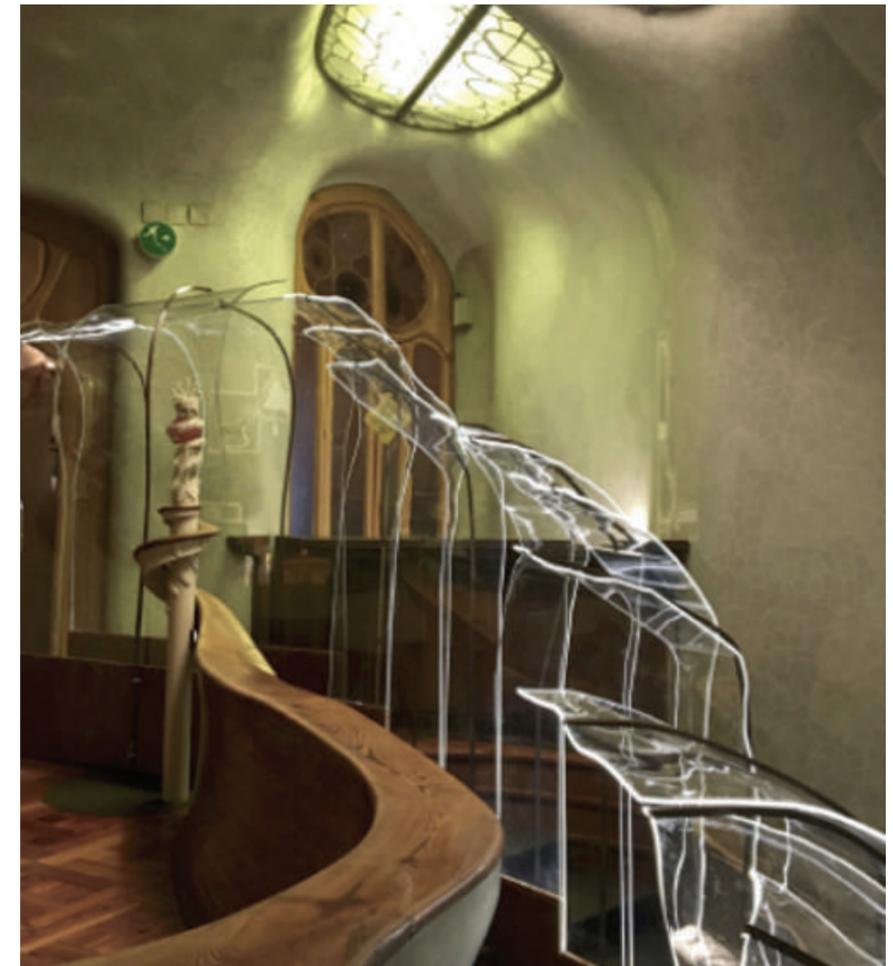
Fig 10.2 & 10.3. A series of perspex partitions allowed the viewing of, and almost physical contact with the restoration, in order to meet the demand for visualization and transparency of the work that was being carried out.
