Rehabilitation of the traditional urban architecture of Nicosia.

Adaptation of a traditional building as a social center.

Site 66 Perikleous Street, Nicosia, Cyprus.

Objectives Maintenance and Restoration of a Listed Building on Perikleous Street and Creation of a Social Solidarity and Networking Centre "The Shack".

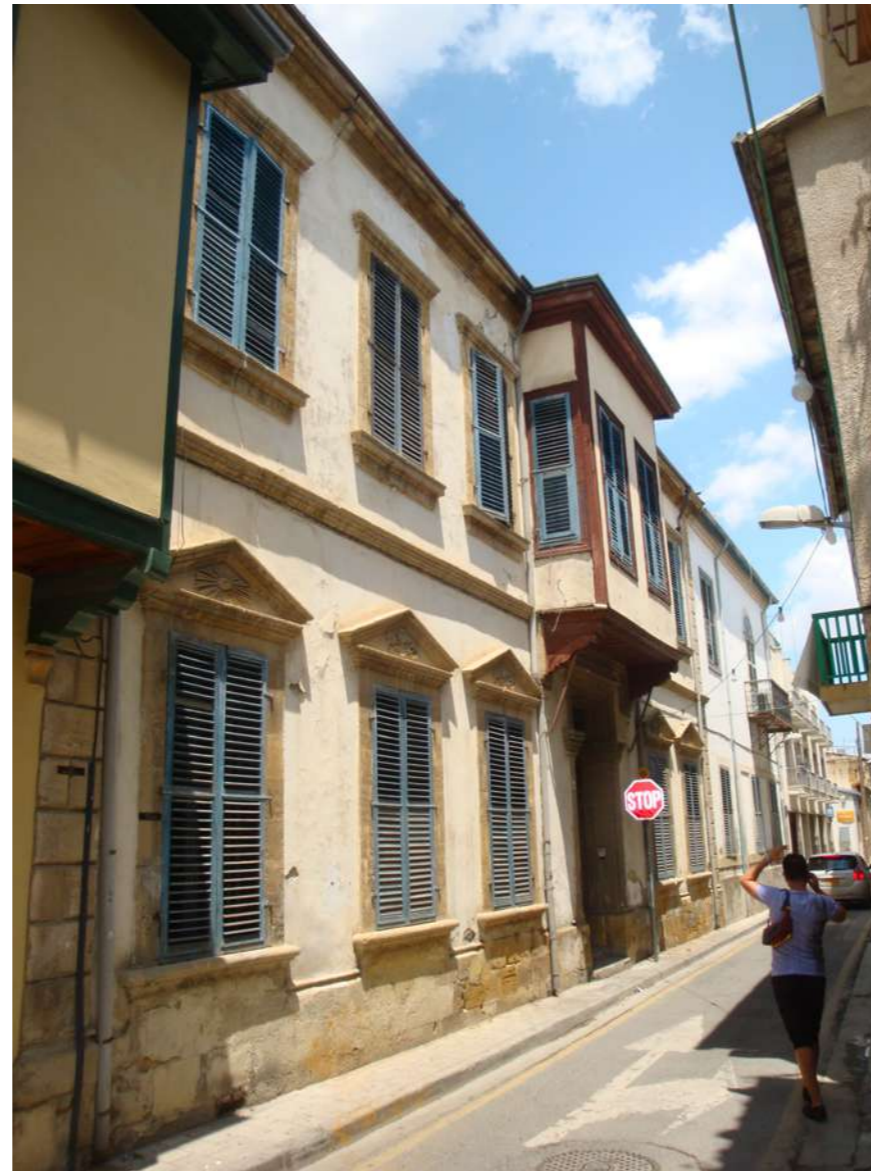
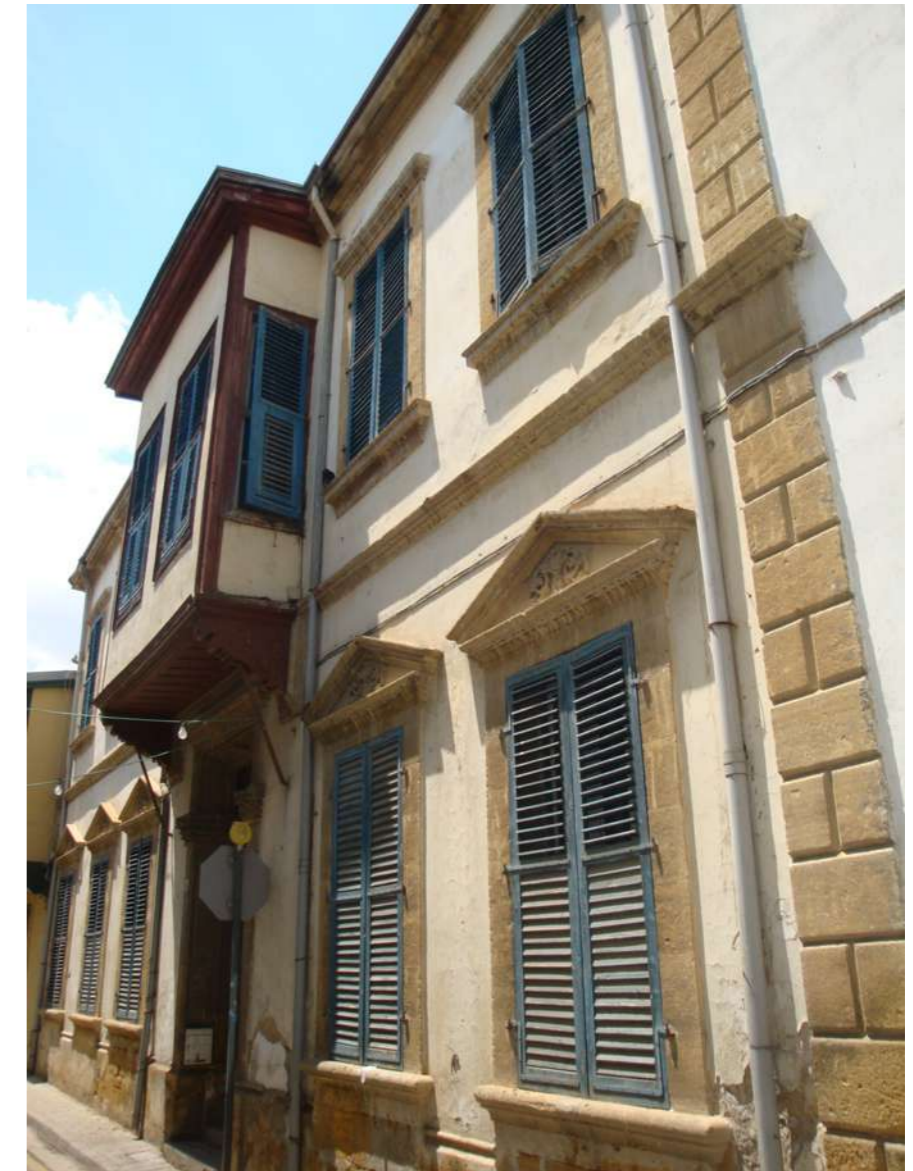
Fig.1-2: Exterior view of the building from Perikleous Street. © Simos Drousiotis/A. M. Andronicou Ltd

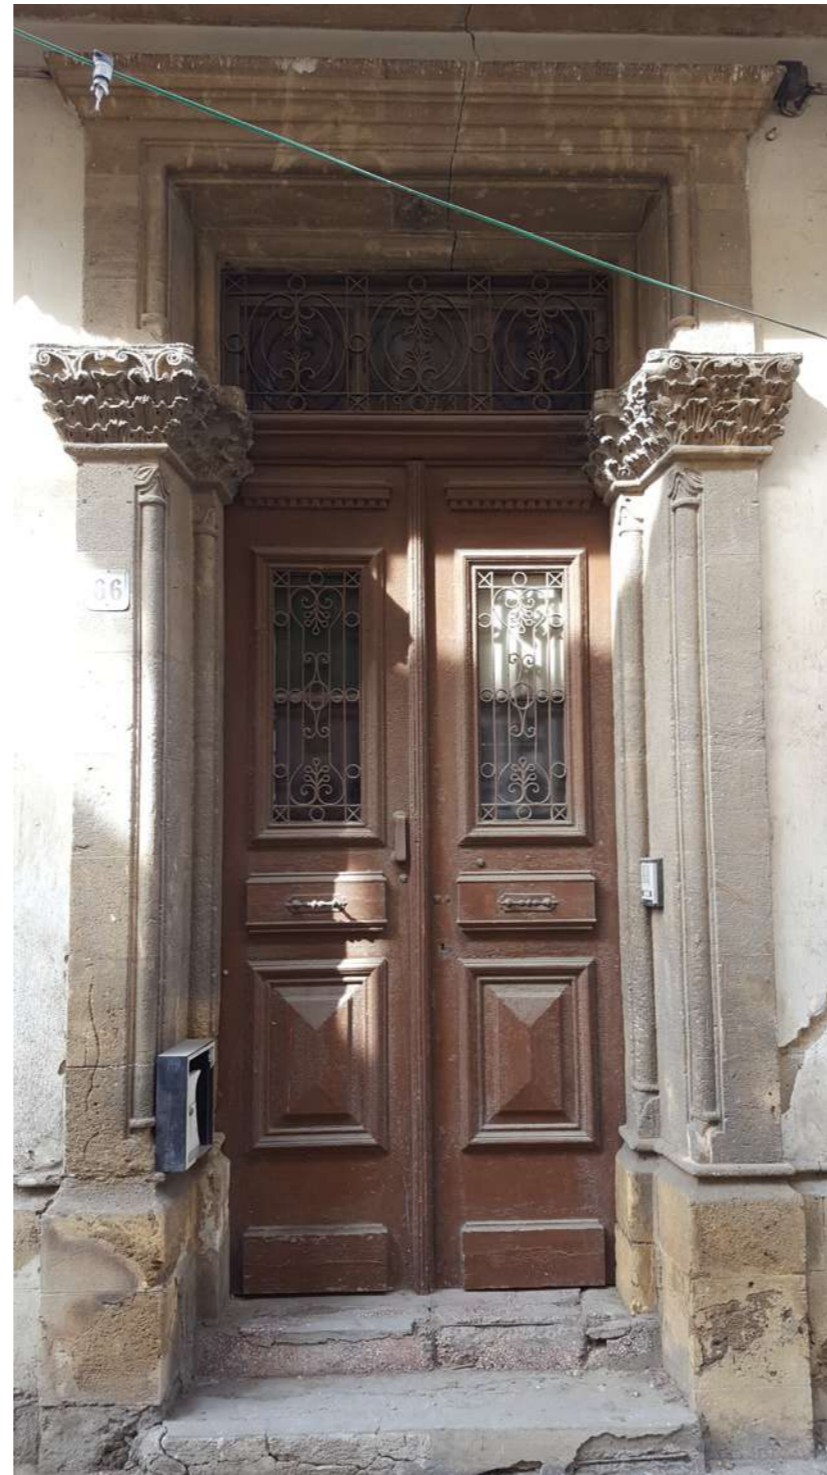
The house consists of load-bearing masonry walls made of stone (rubble and ashlar limestone) and partition walls made of solid red bricks and timber frame structures (dolma). The roof is made of timber elements covered with ceramic traditional tiles. The masonry is plastered with gypsum.

Fig.3-4: Left to right: The main door before restoration, view of an interior partition wall. © Simos Drousiotis/A. M. Andronicou Ltd

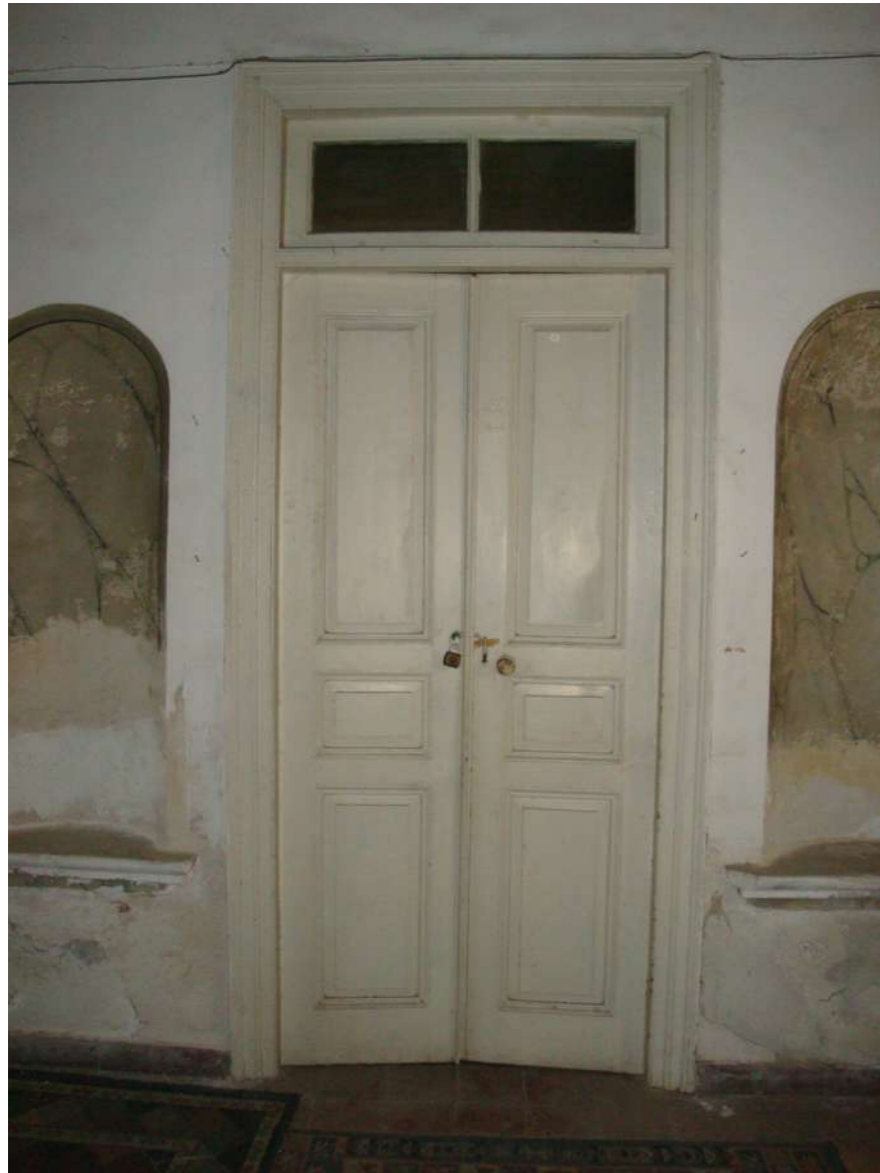
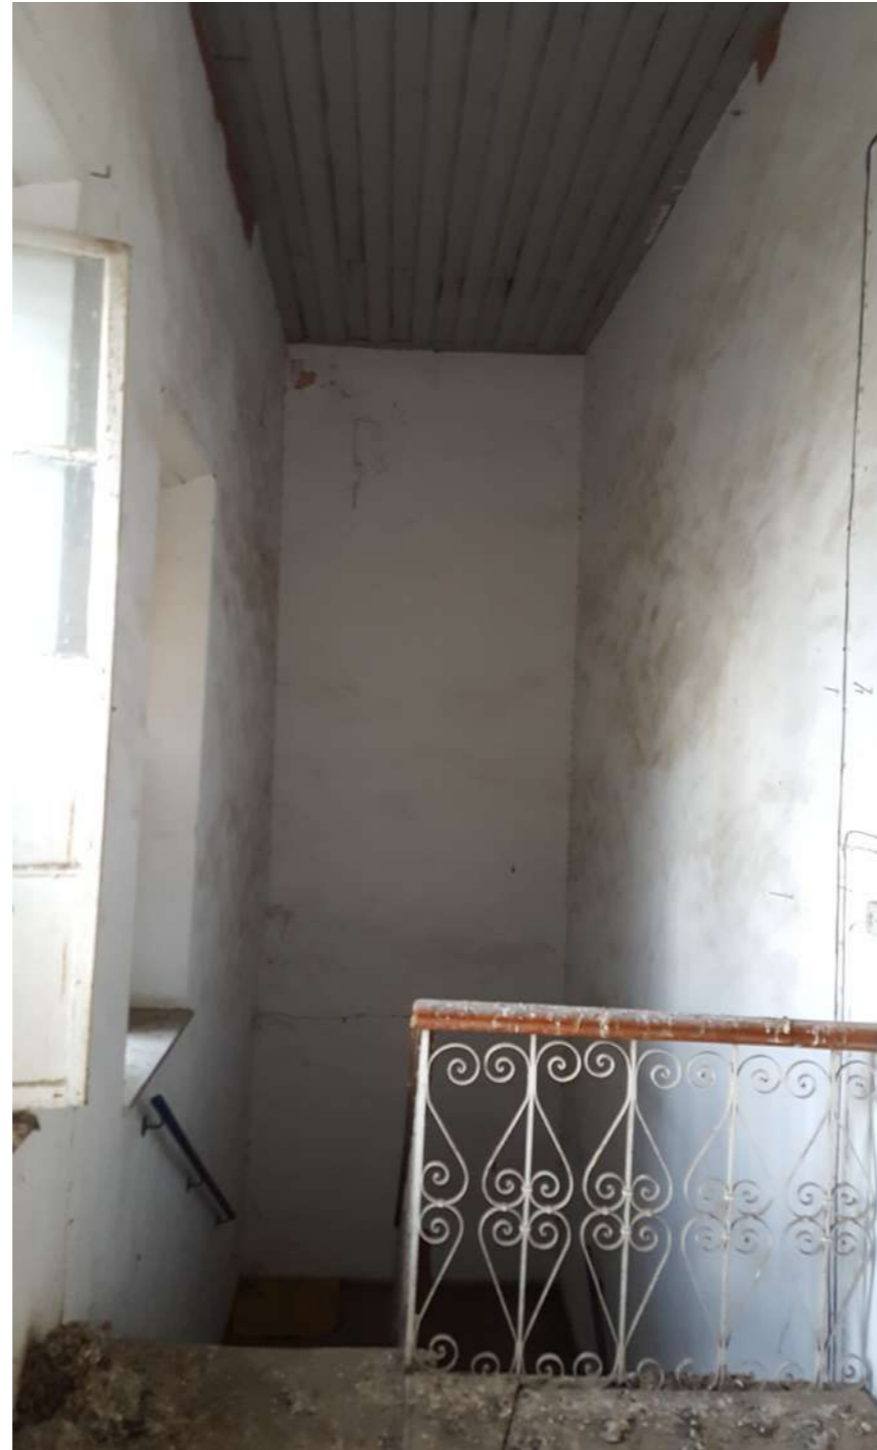
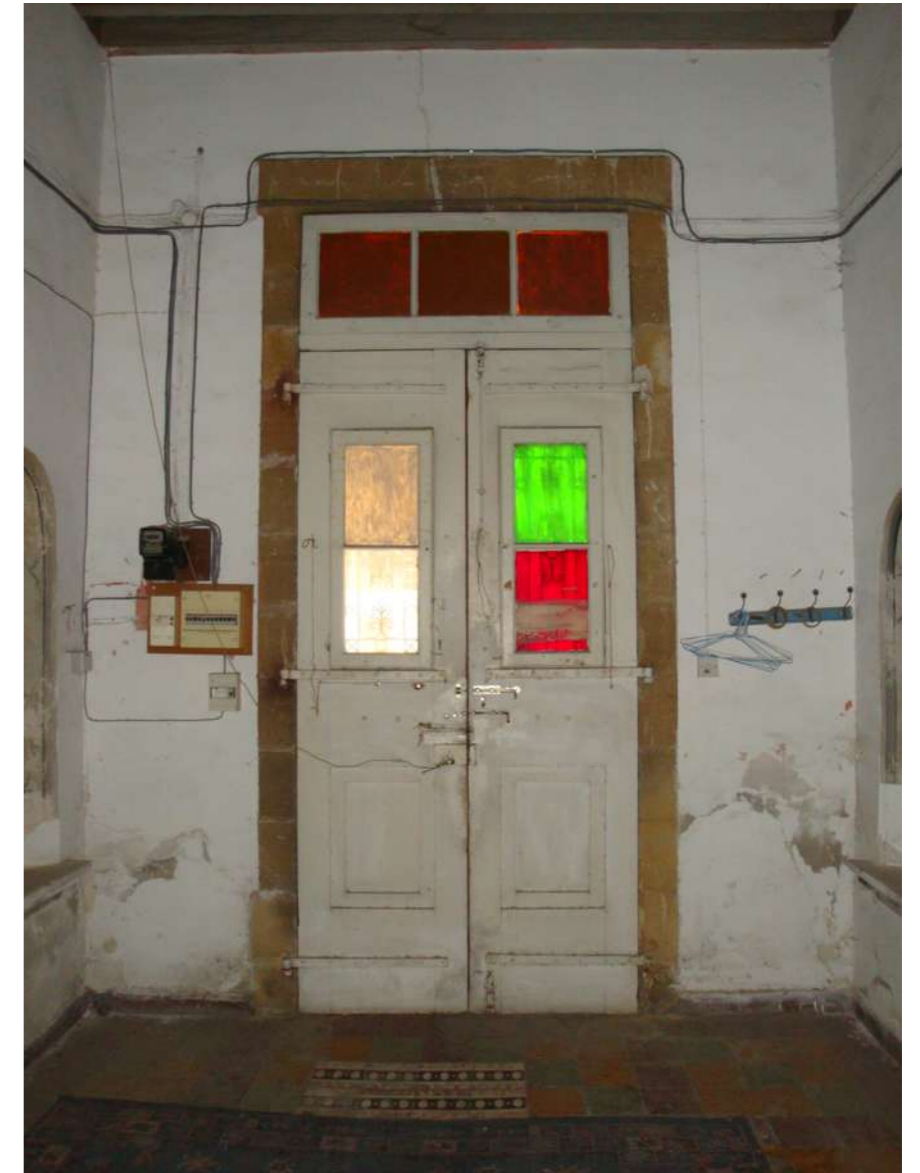
Fig.5-7: Interior views of the house before restoration showing openings and staircase. © Simos Drousiotis/A. M. Andronicou Ltd

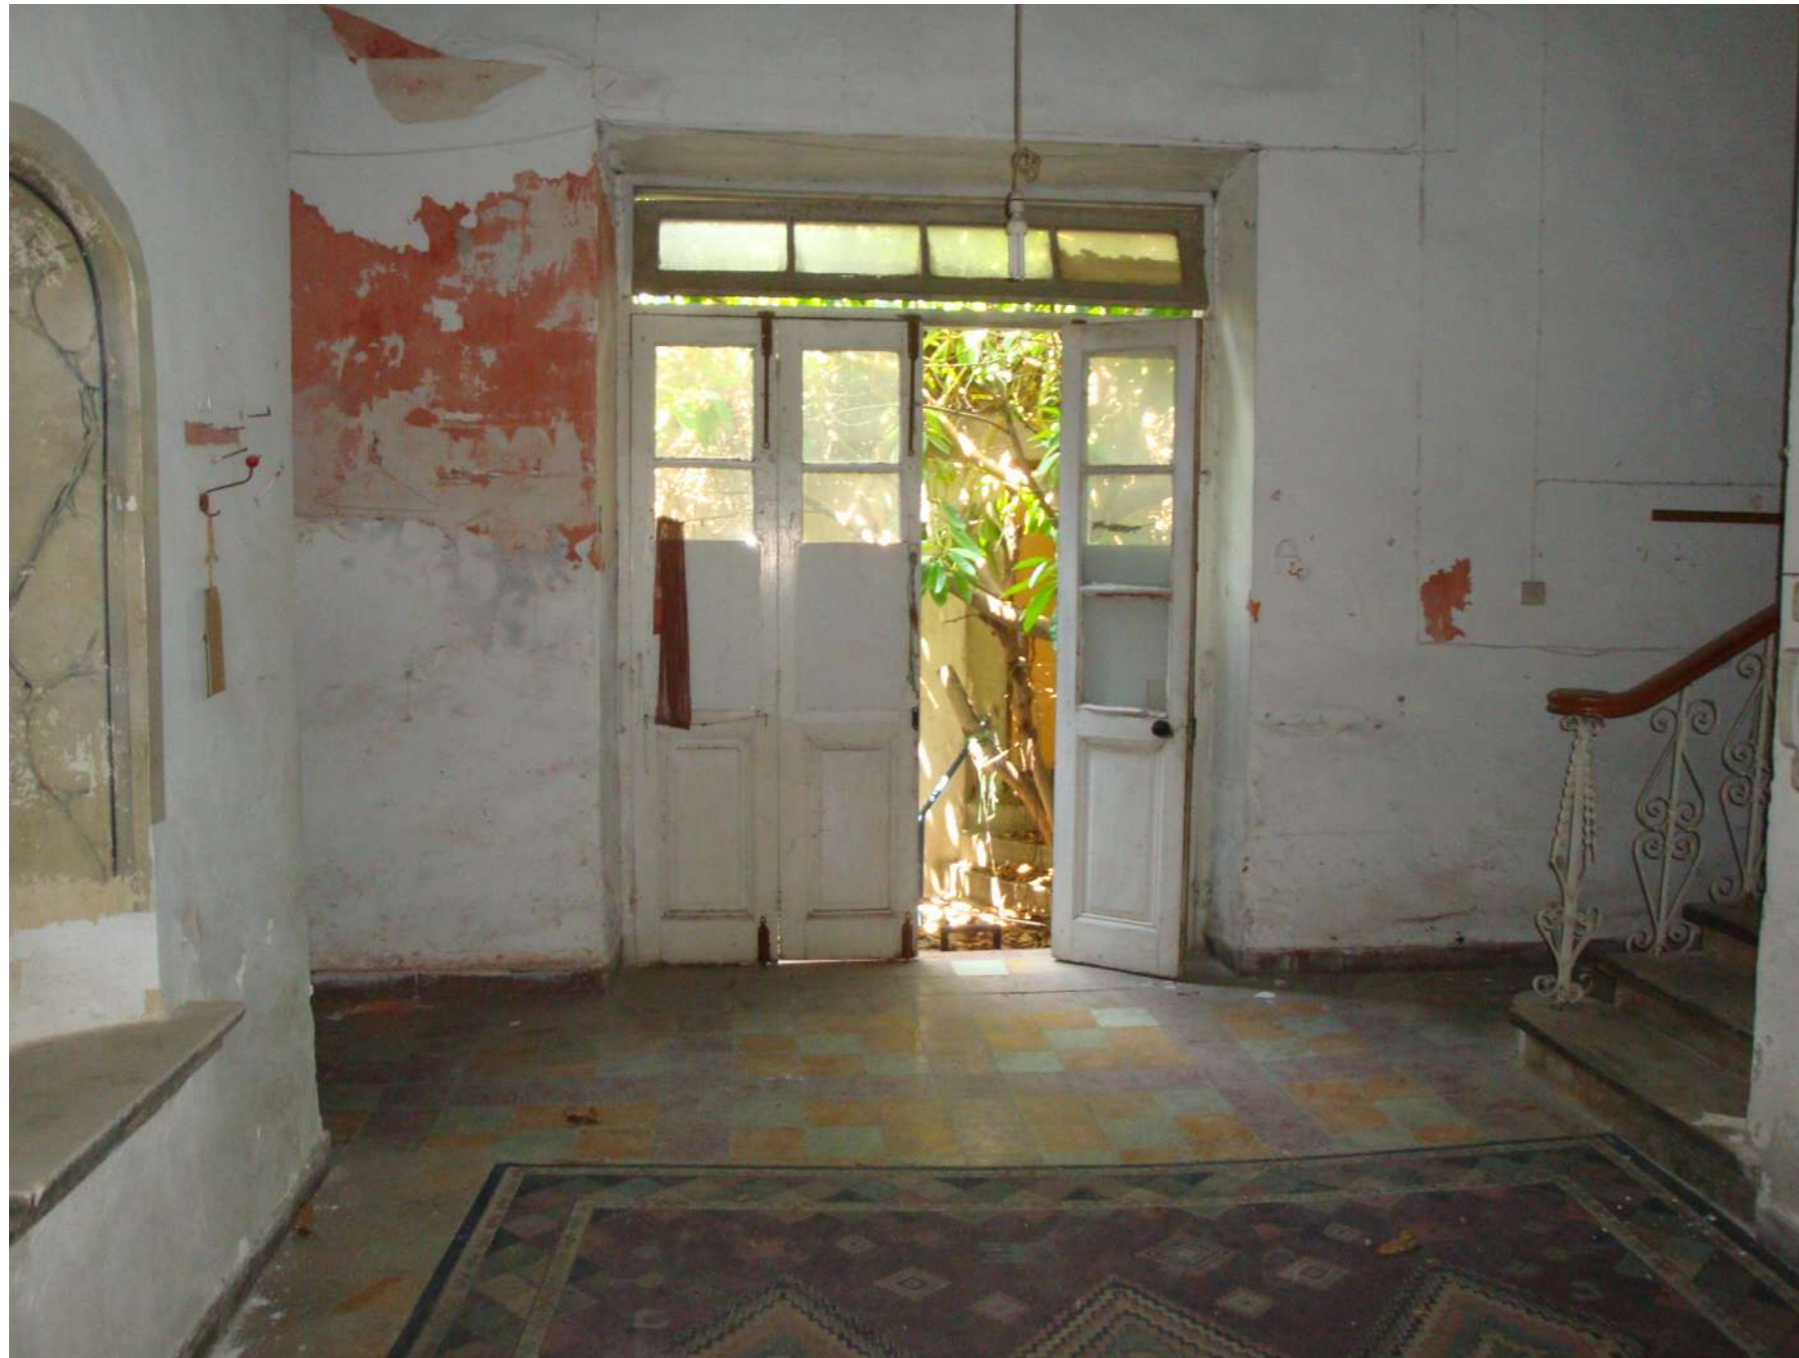
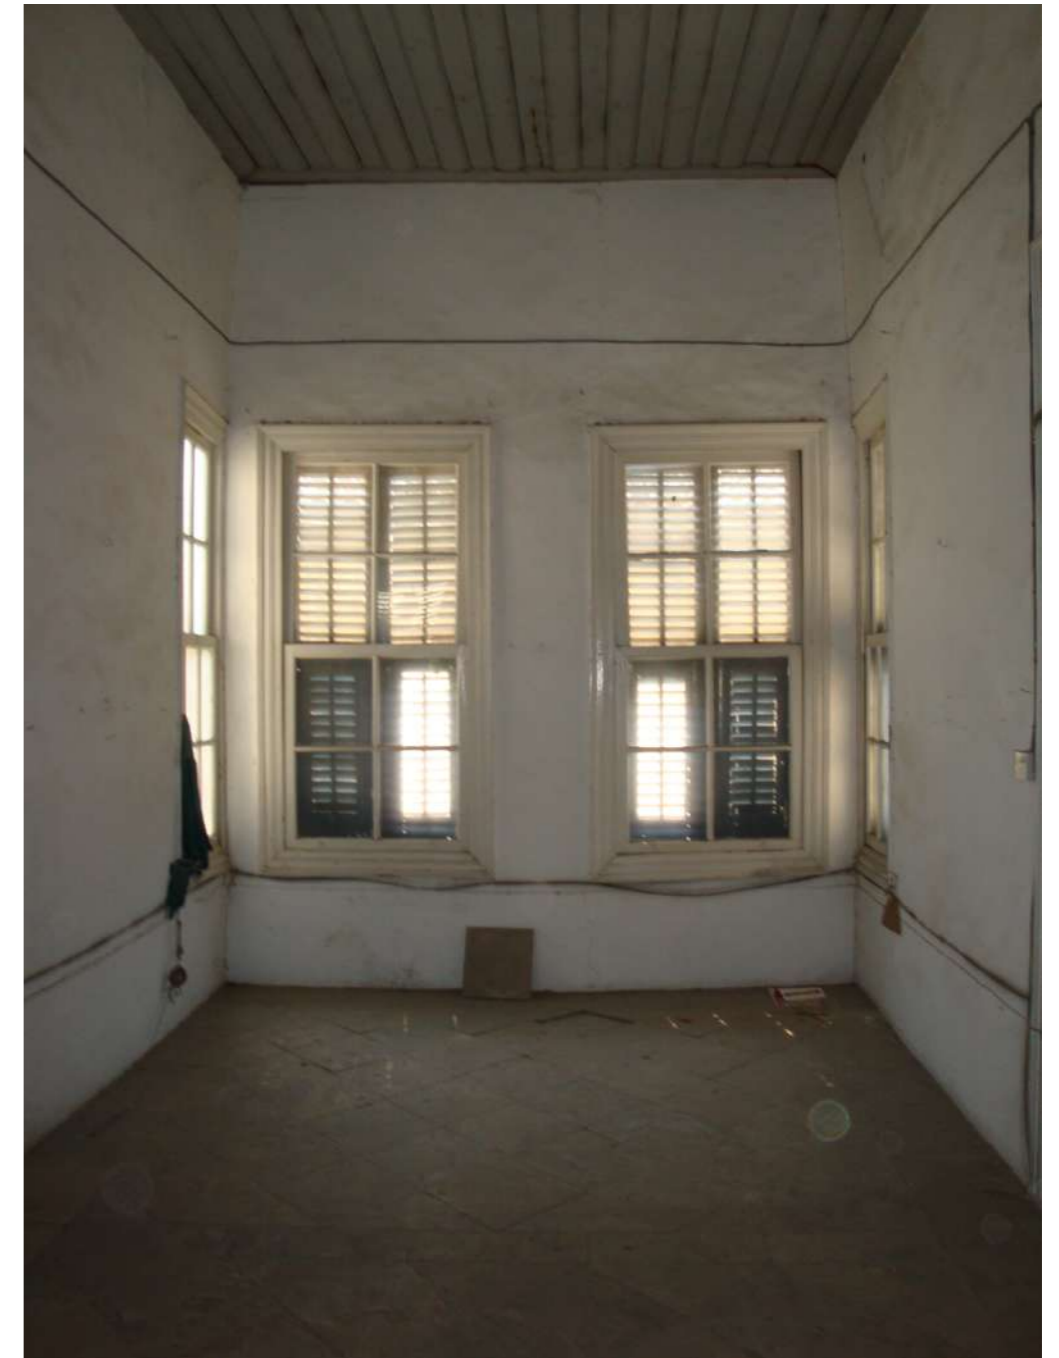
Fig.8-9: Interior views of the central area of the house before restoration. © Simos Drousiotis/A. M. Andronicou Ltd

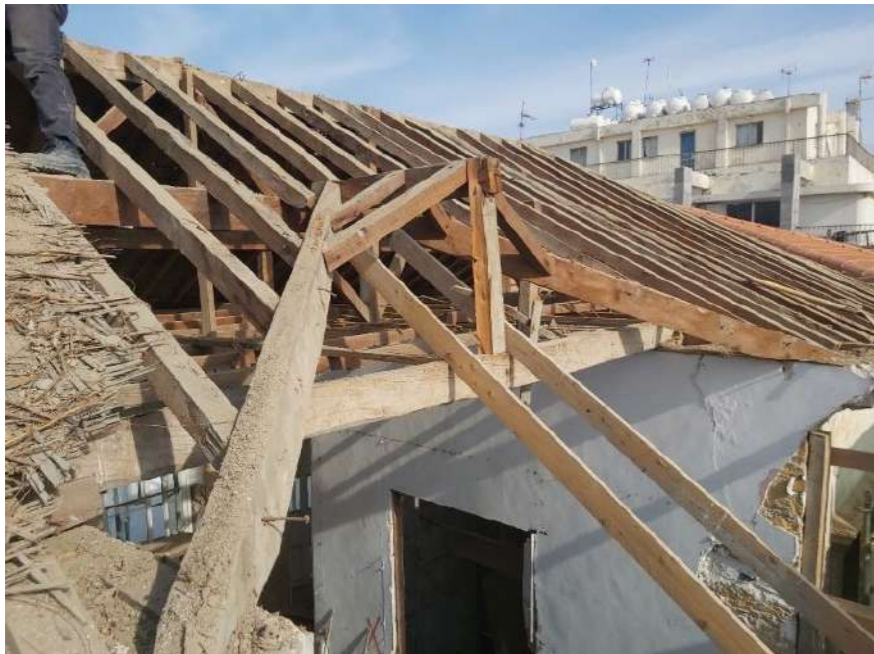
The building was in a rather good condition before restoration. The bearing stone and adobe walls were in good condition but all timber elements of the roof and the openings were in a state of disrepair and should be replaced. The building is a typical traditional urban dwelling within the walled city of Nicosia and incorporates many characteristics of the vernacular architecture of the city, such as a tripartite arrangement with a central iliakos, the sachnisi at the centre of the upper floor, the ashlar frames of the openings, etc. Thus, the house encapsulates different architectural and cultural values, such as references to the local aesthetic, history, society, environment, etc.

Fig.10: Exterior view of the roof during restoration works.
© Simos Drousiotis/A. M. Andronicou Ltd

The proposal for the conservation and reuse of the building included the maintenance and restoration of the masonry. The interior face of all the masonry rubble walls have been maintained / restored and plastered with the use of gypsum, while lime plaster was used for the outside of the building. New timber framed partition walls and plasterboards were constructed, as well as a new timber roof with new ceramic tiles.

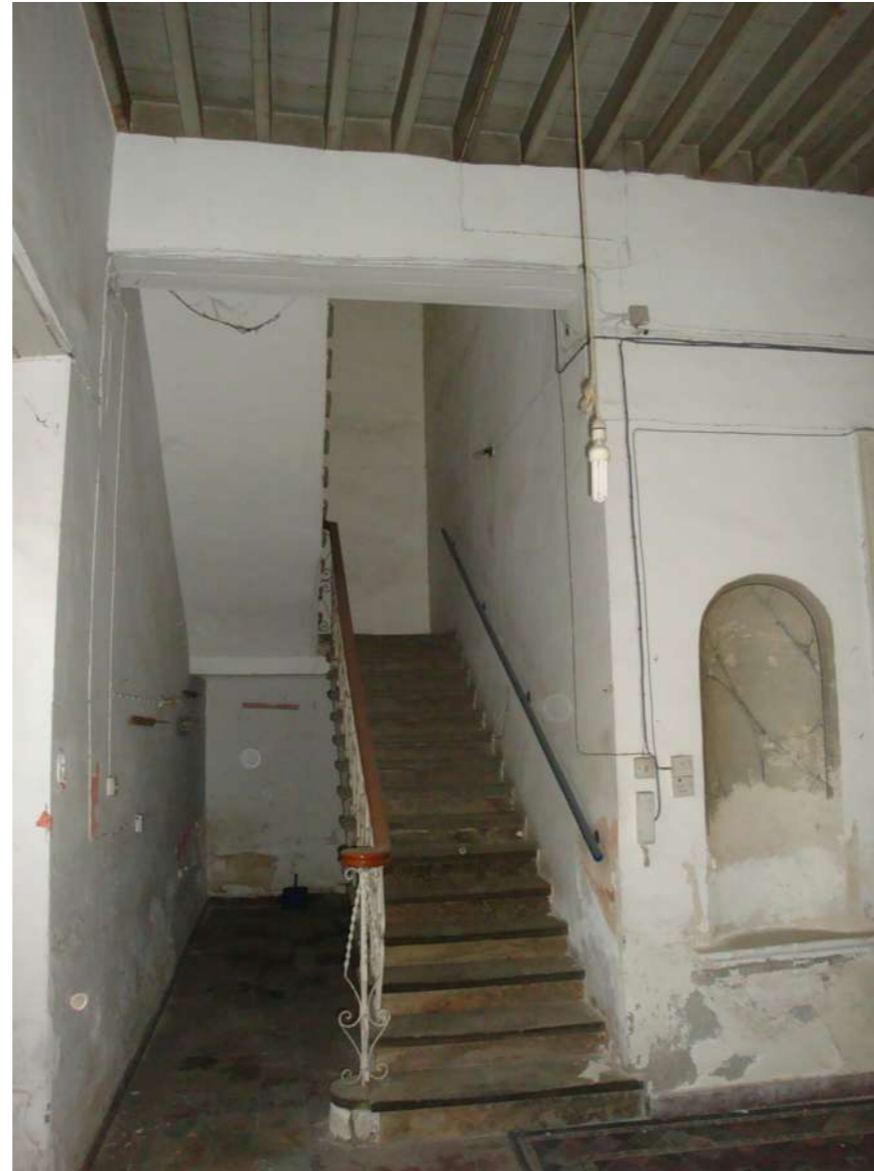
Fig.11-12: Interior views of the building during restoration works. © Simos Drousiotis/A. M. Andronicou Ltd

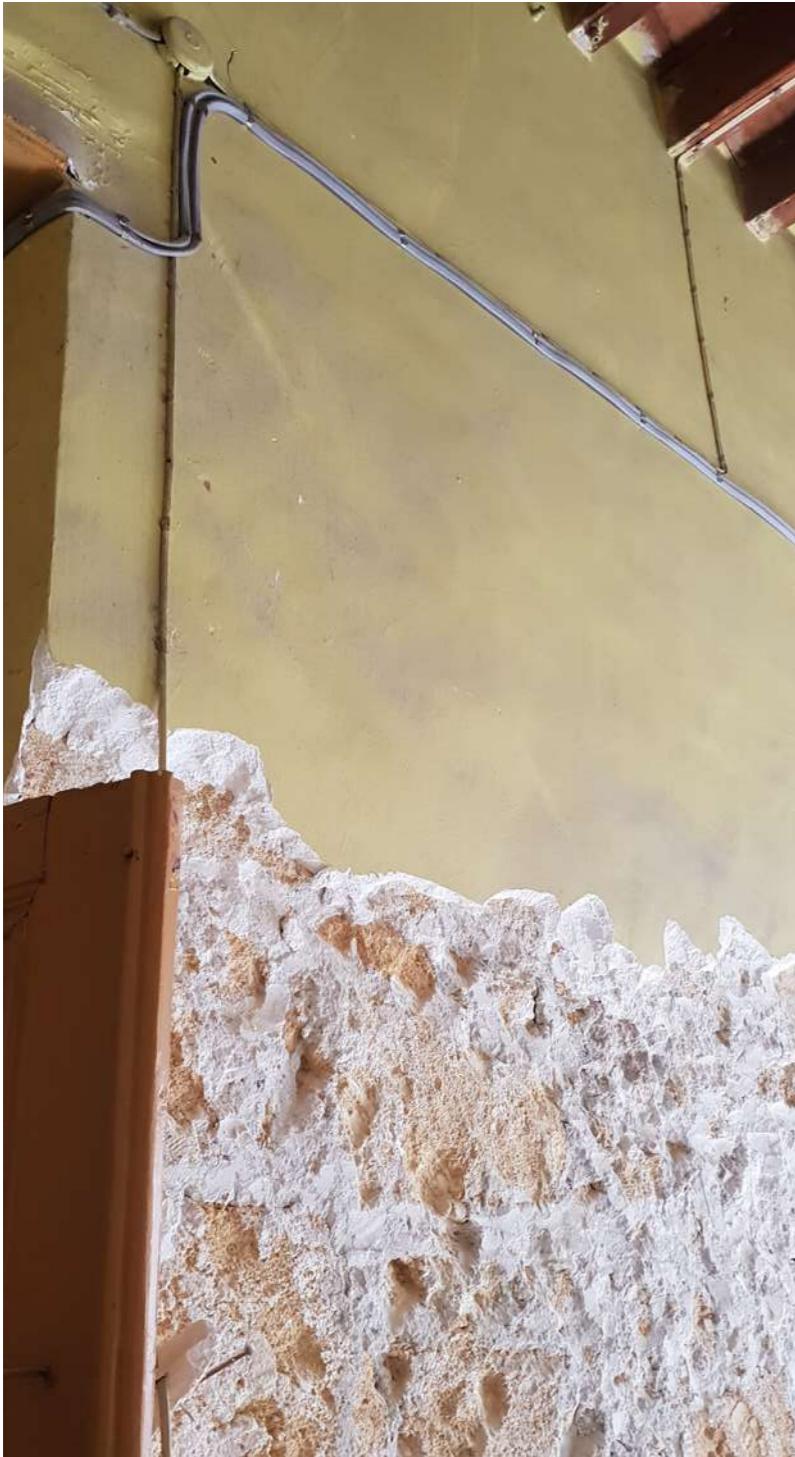
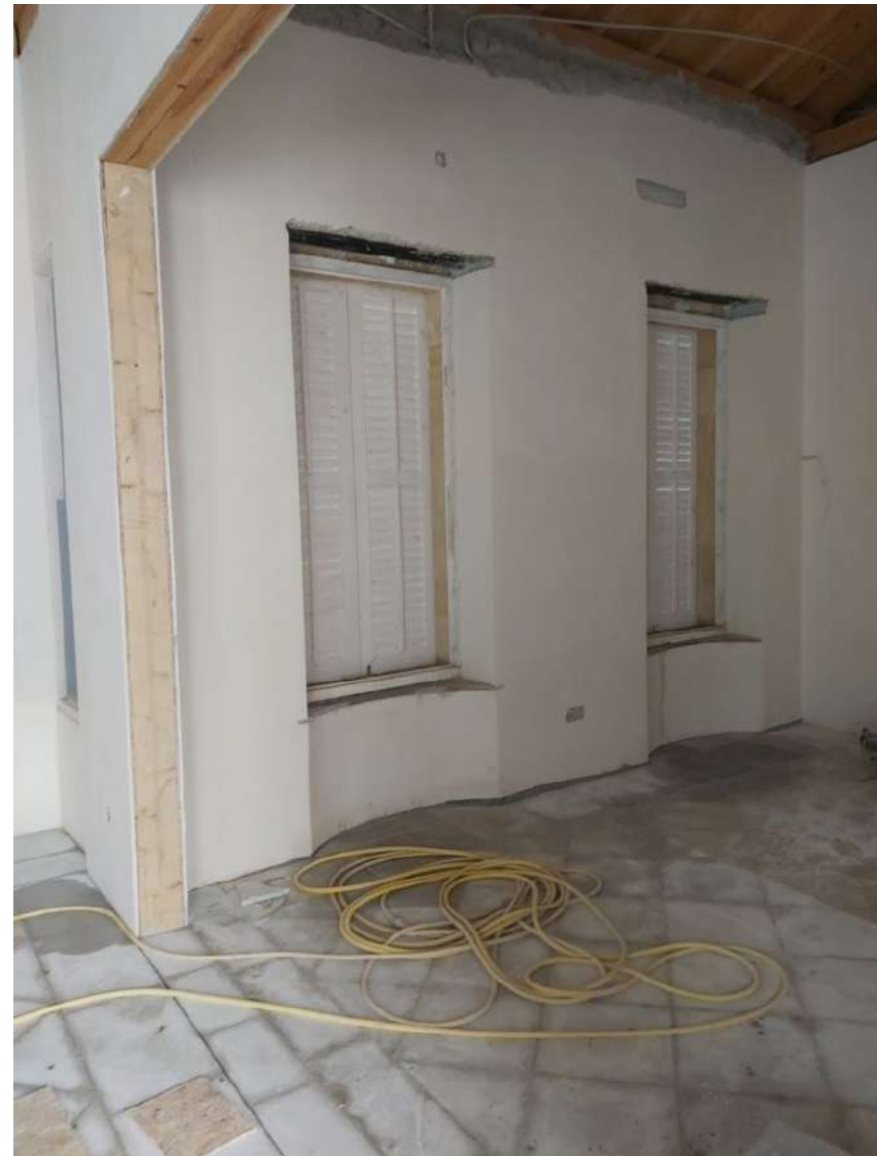
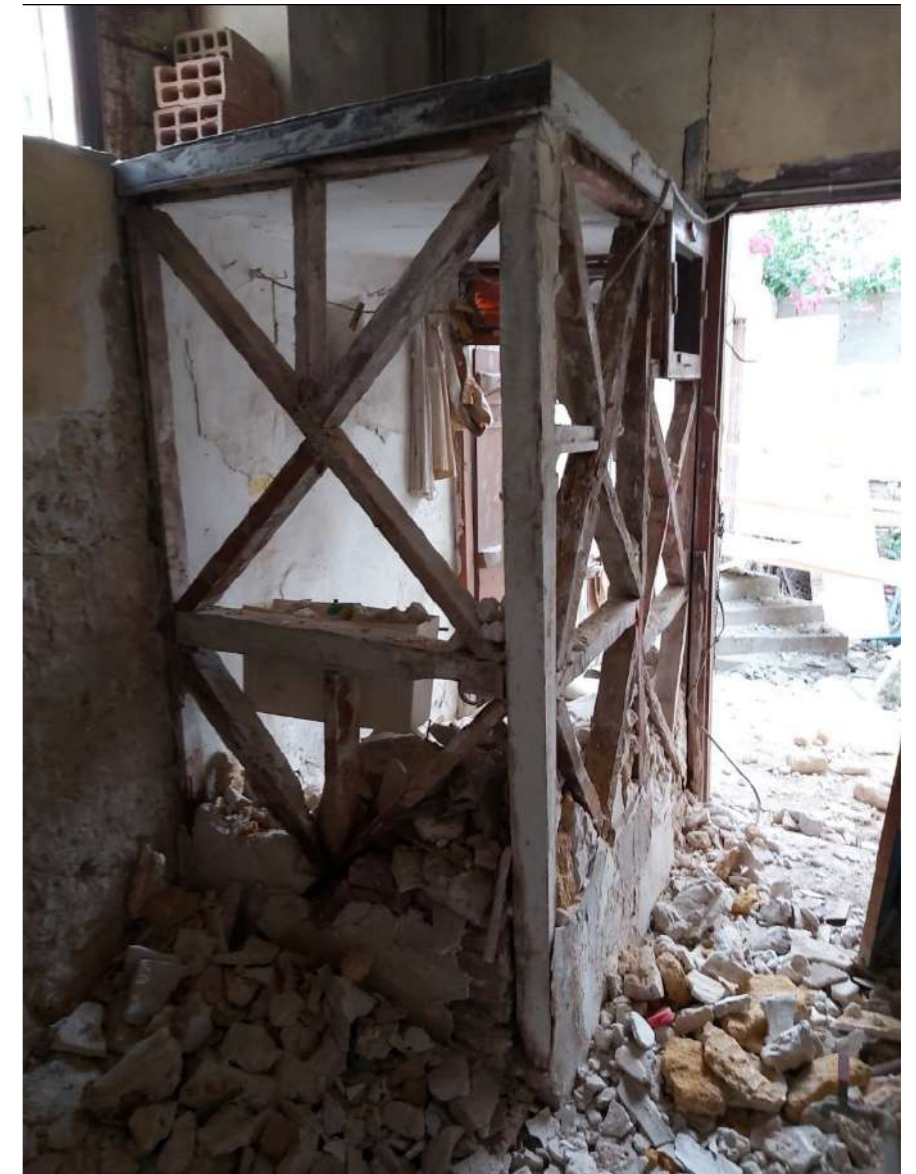
Fig.13-15: Views of the building during conservation. © Simos Drousiotis/A. M. Andronicou Ltd

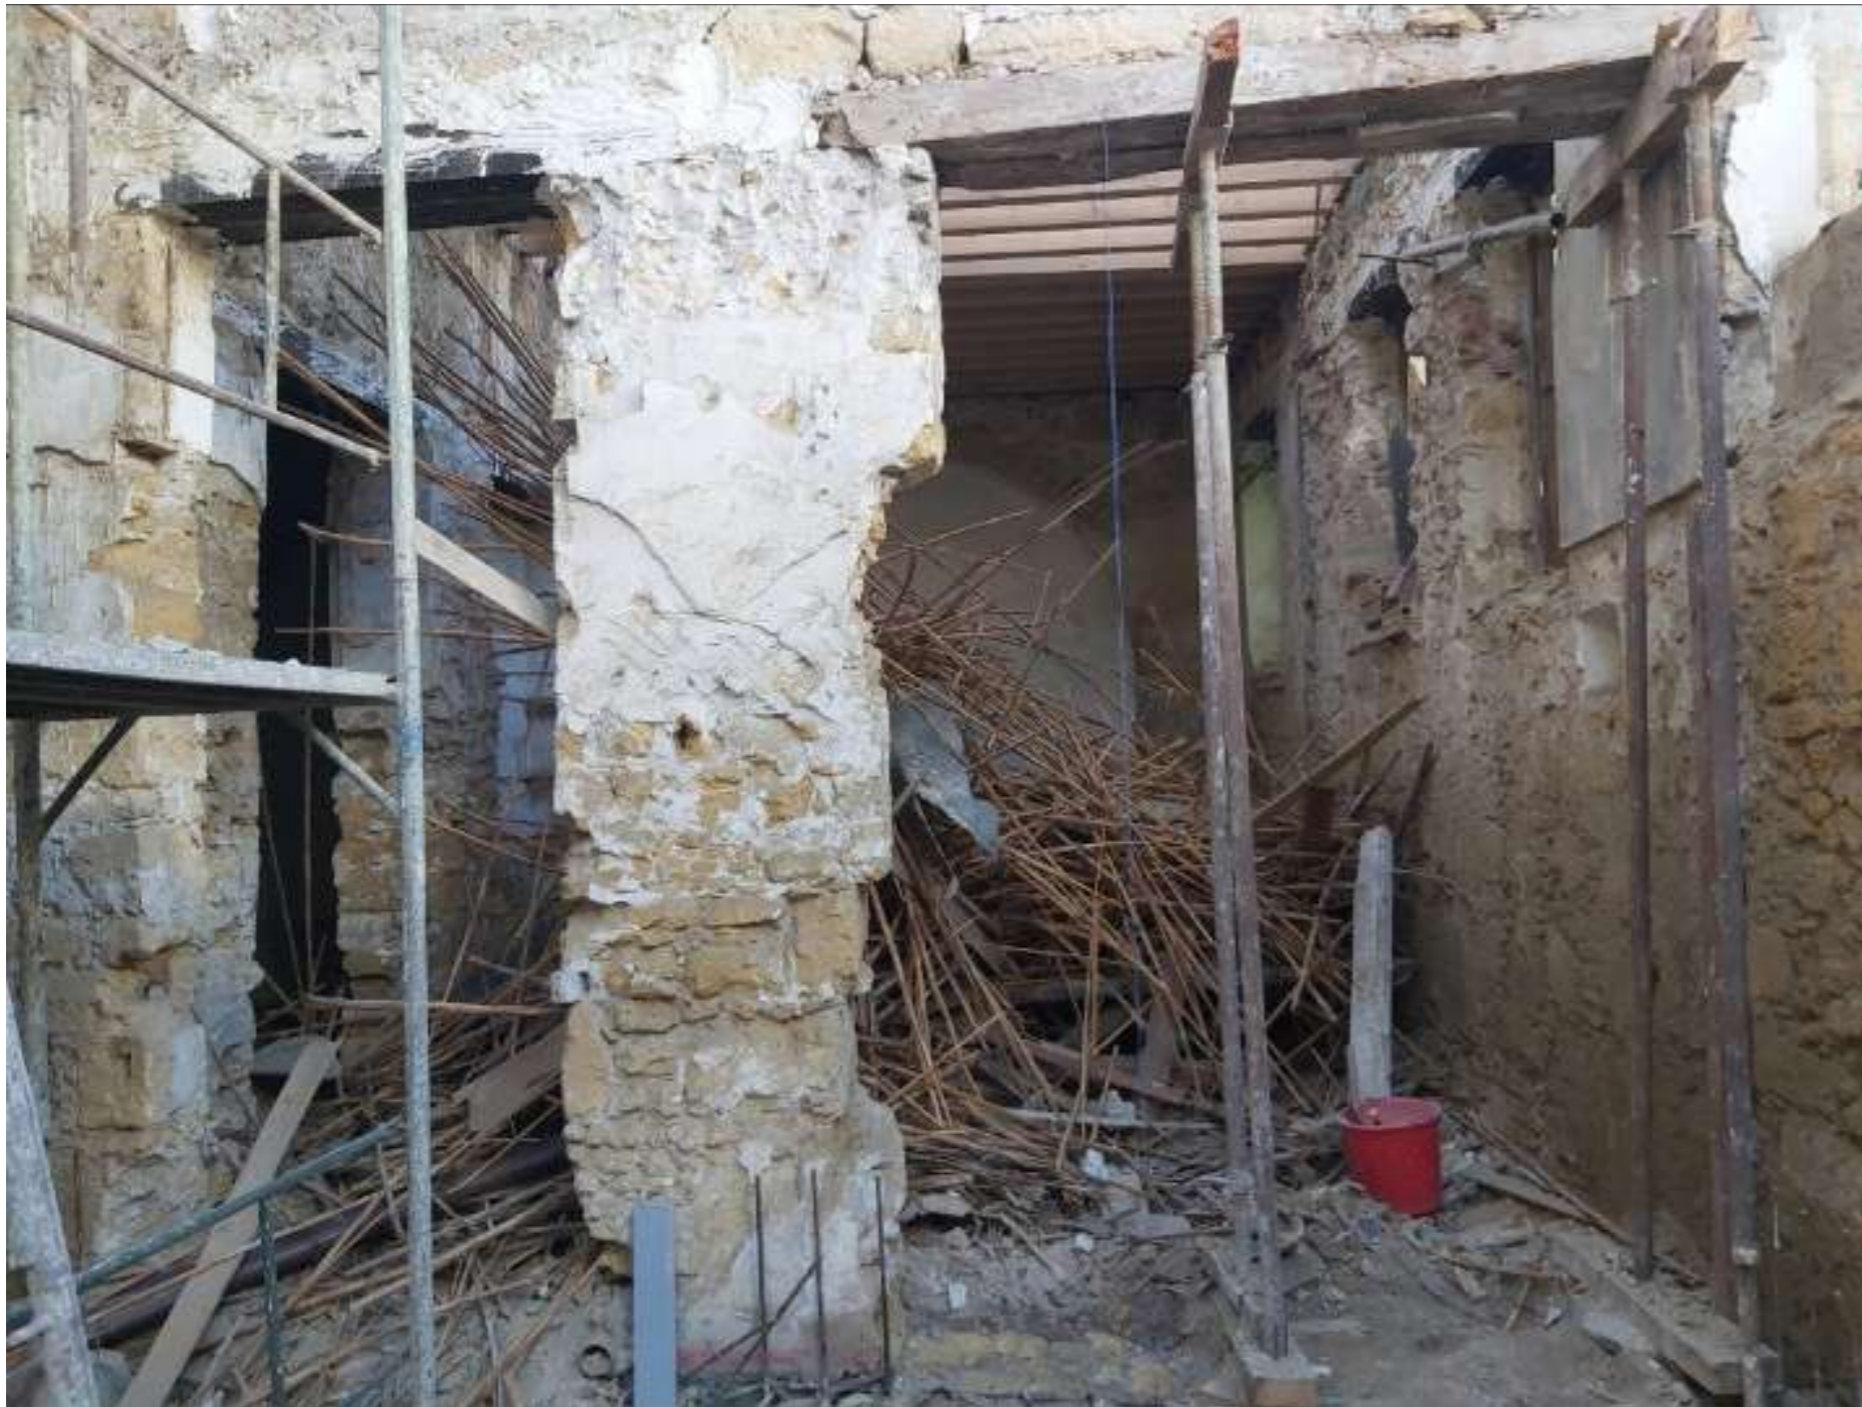
Fig.16: Views of the building during conservation. © Simos Drousiotis/A. M. Andronicou Ltd

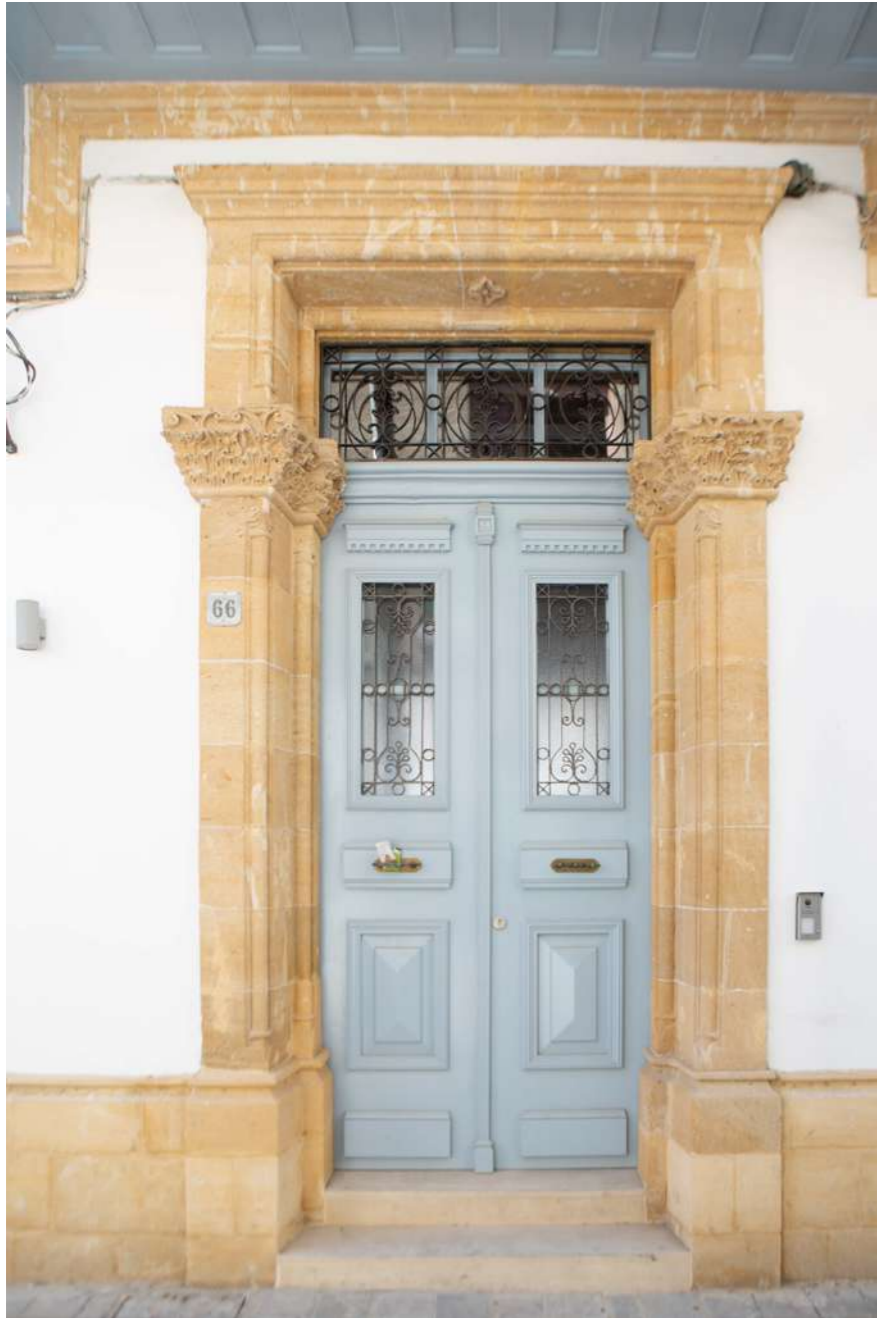
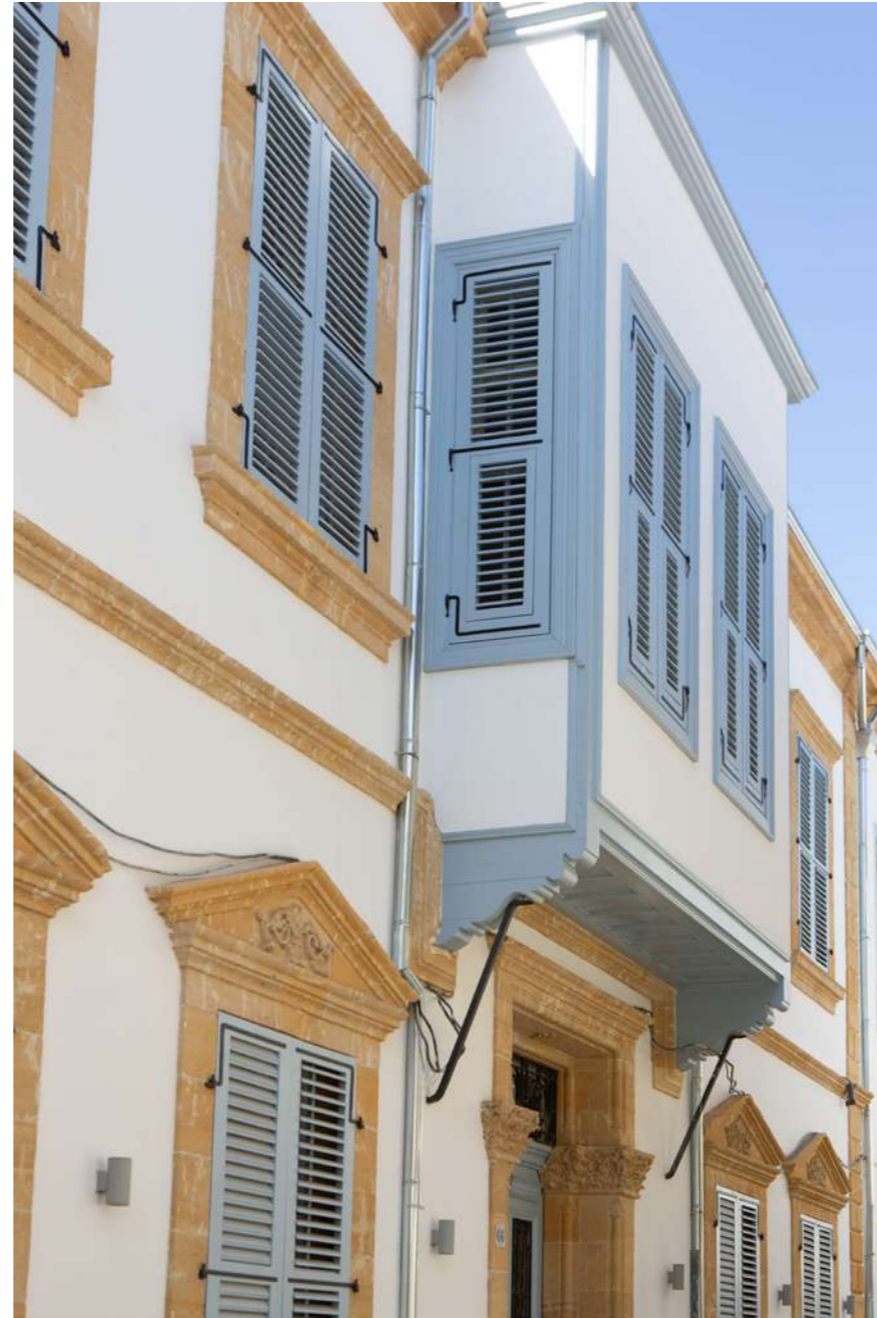
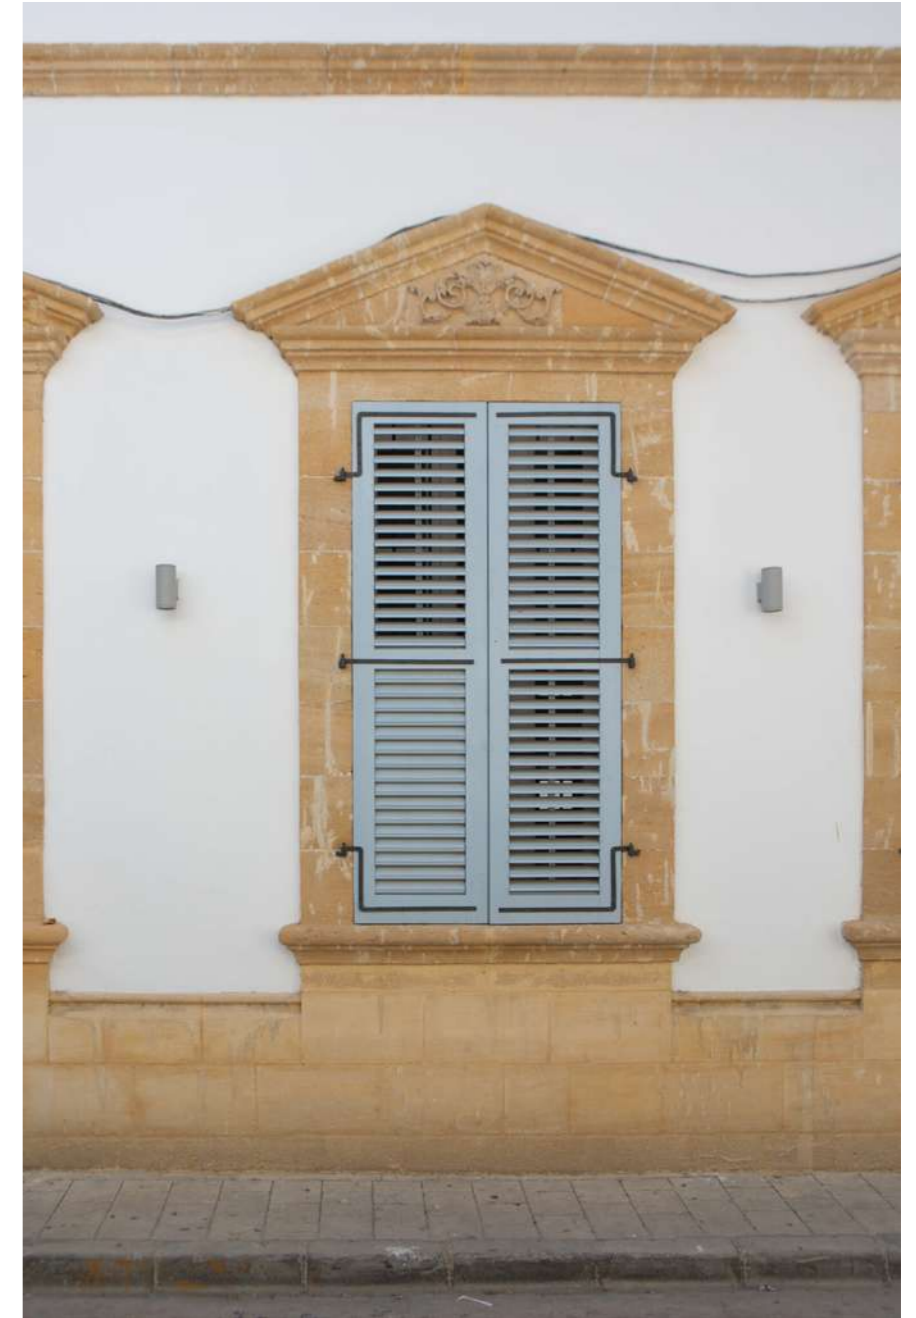
Fig.17-19: Exterior views of the building after restoration. © Simos Drousiotis/A. M. Andronicou Ltd
