Rehabilitation of the traditional urban architecture of Nicosia.

Adaptation of a traditional building as a social center.

Site 66 Perikleous Street, Nicosia, Cyprus.

Objectives Maintenance and Restoration of a Listed Building on Perikleous Street and Creation of a Social Solidarity and Networking Centre "The Shack".

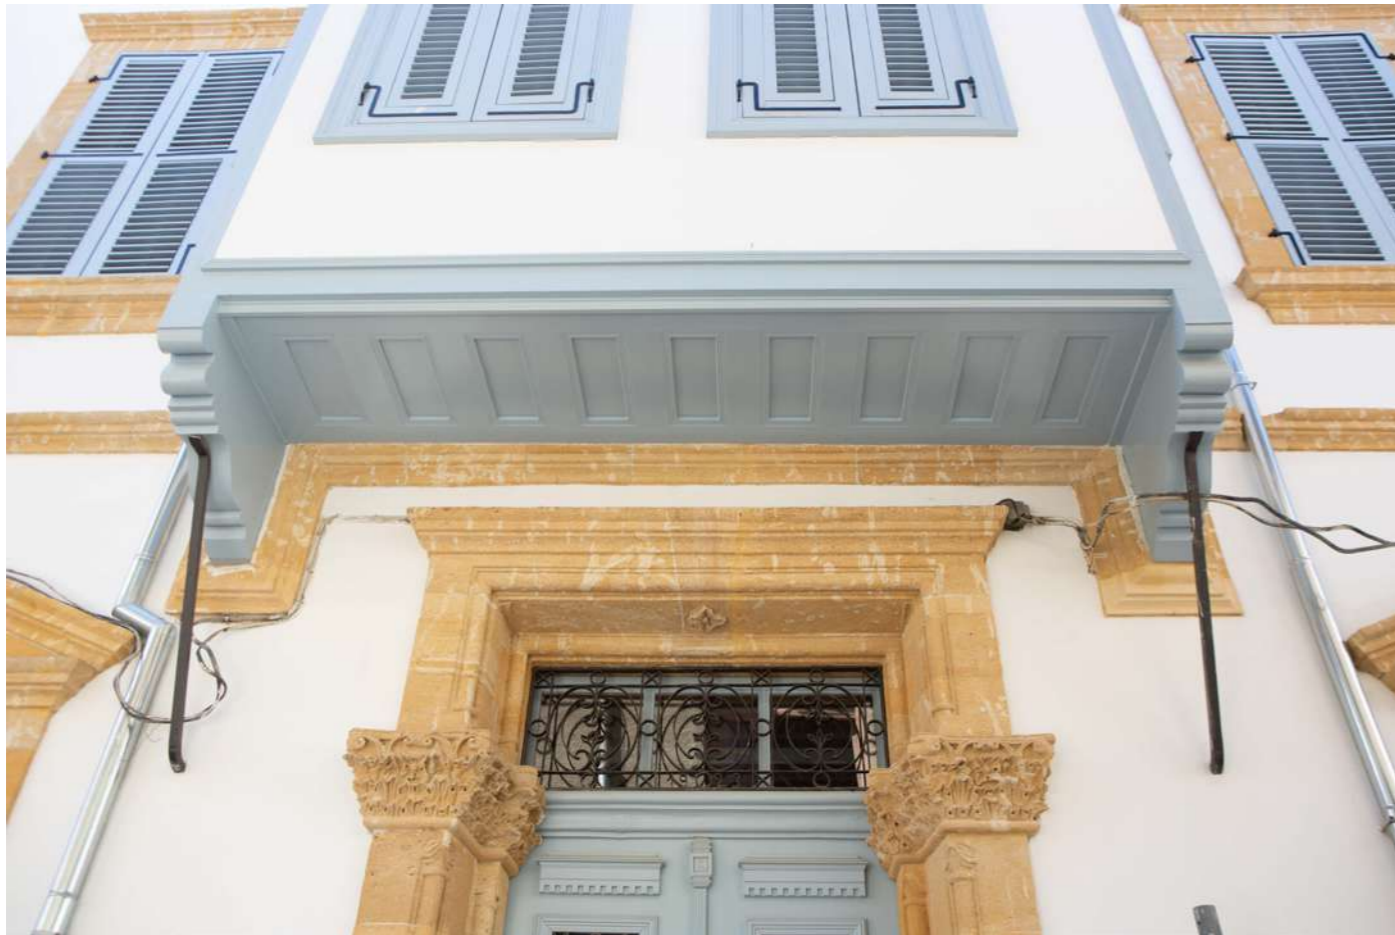
Fig.20: Exterior view of the building after restoration. © Simos Drousiotis/A. M. Andronicou Ltd

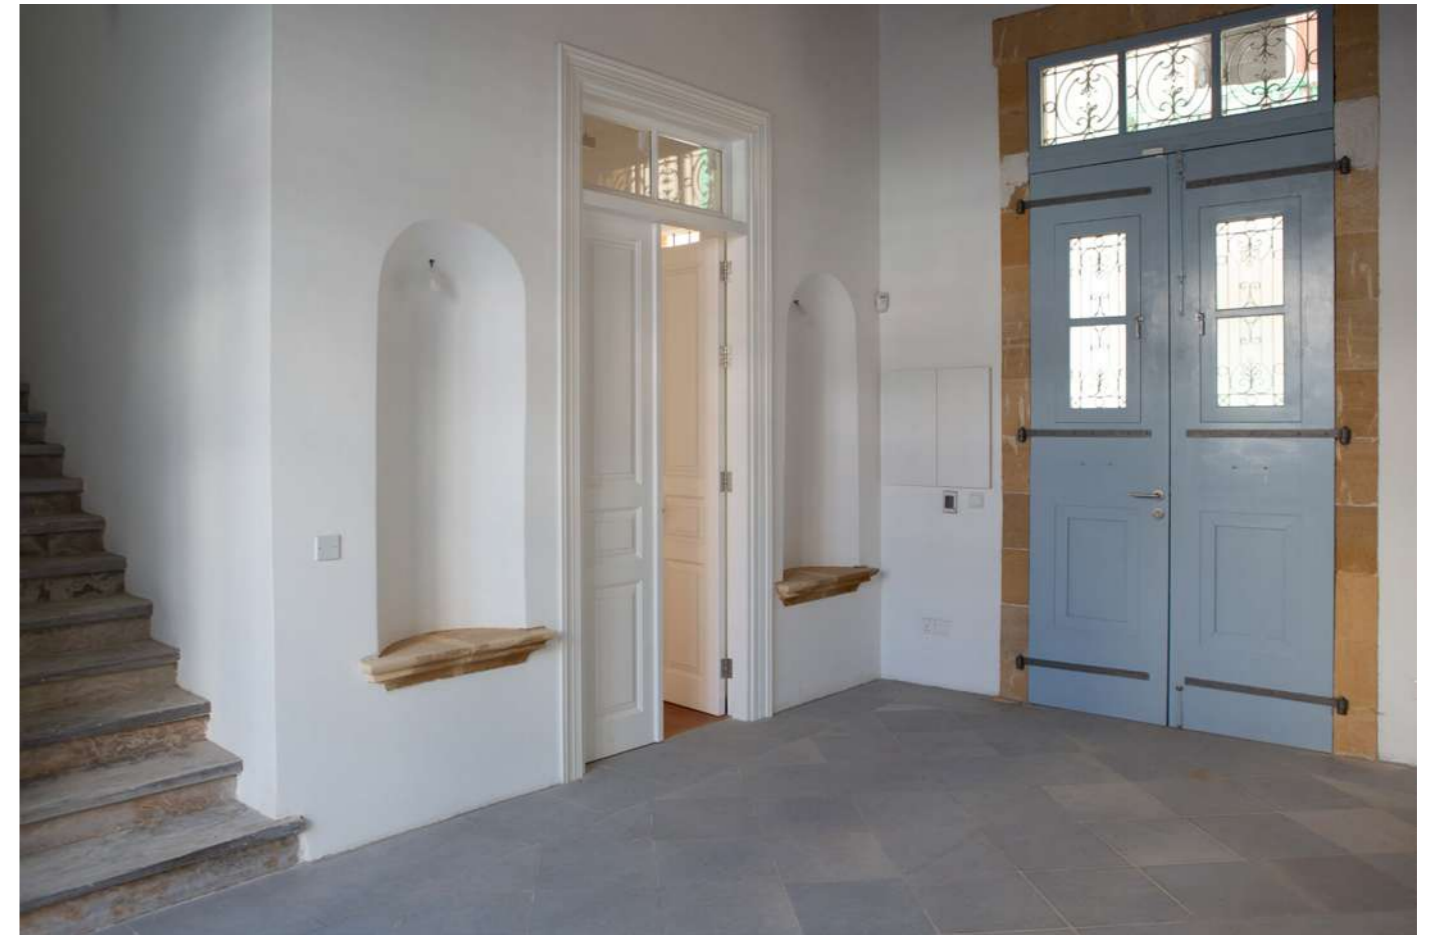
Fig.21: The interior of the central space – portico after restoration. © Simos Drousiotis/A. M. Andronicou Ltd

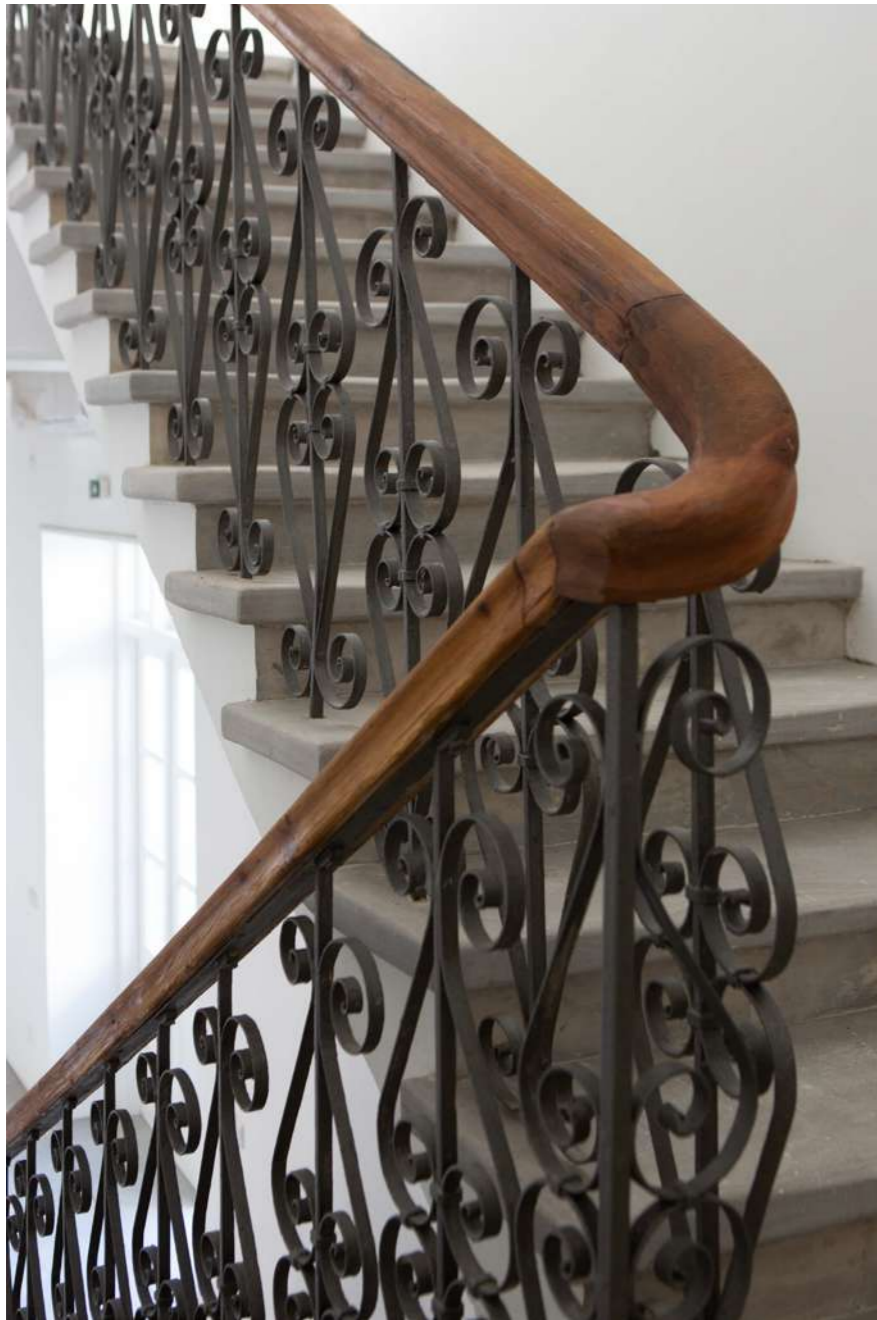
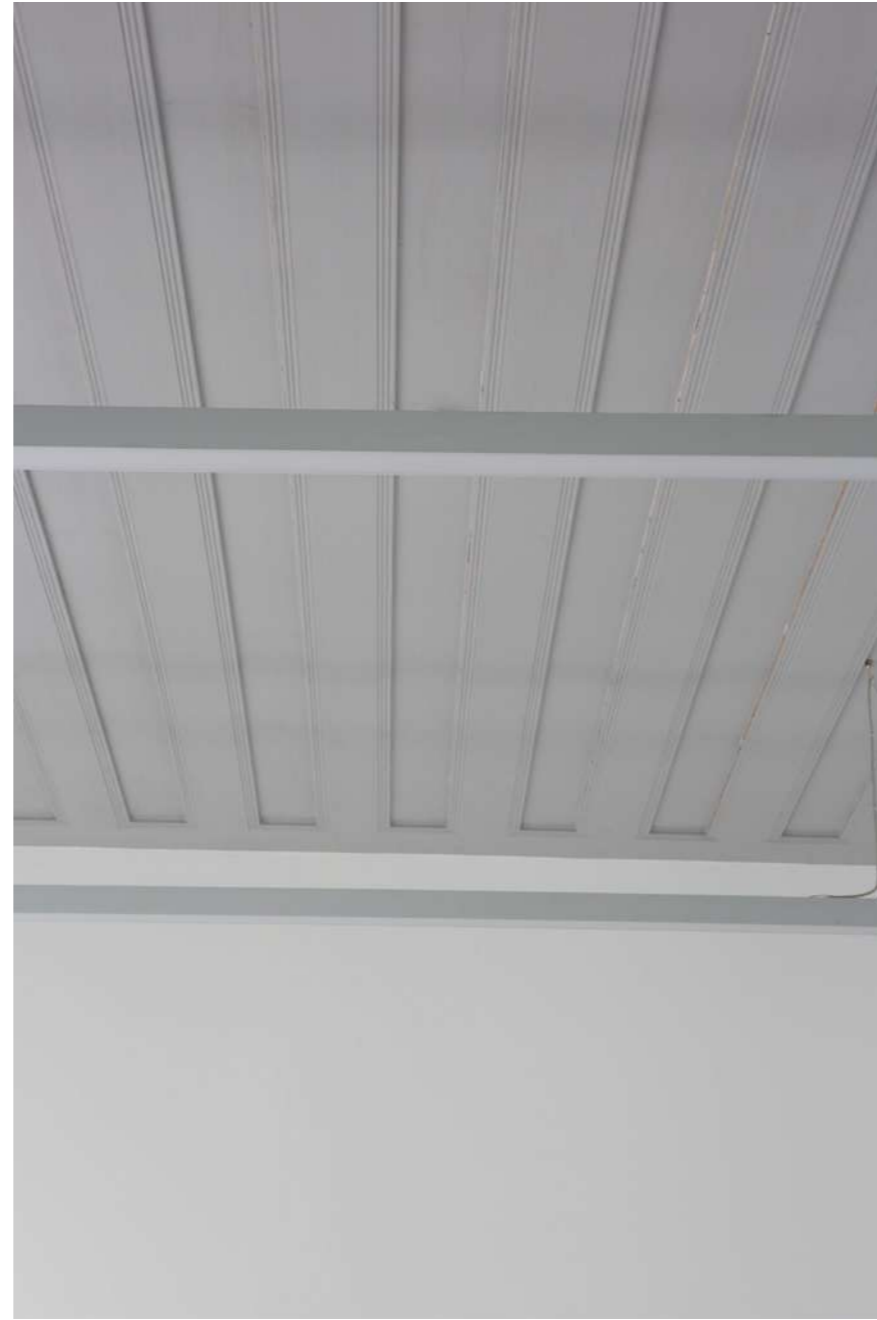
Fig.22-23: The staircase and timber ceiling after restoration. © Simos Drousiotis/A. M. Andronicou Ltd

The proposal for the conservation and reuse of the building included the maintenance and restoration of the masonry. The interior face of all the masonry rubble walls have been maintained / restored and plastered with the use of gypsum, while lime plaster was used for the outside of the building. New timber framed partition walls and plasterboards were constructed, as well as a new timber roof with new ceramic tiles.

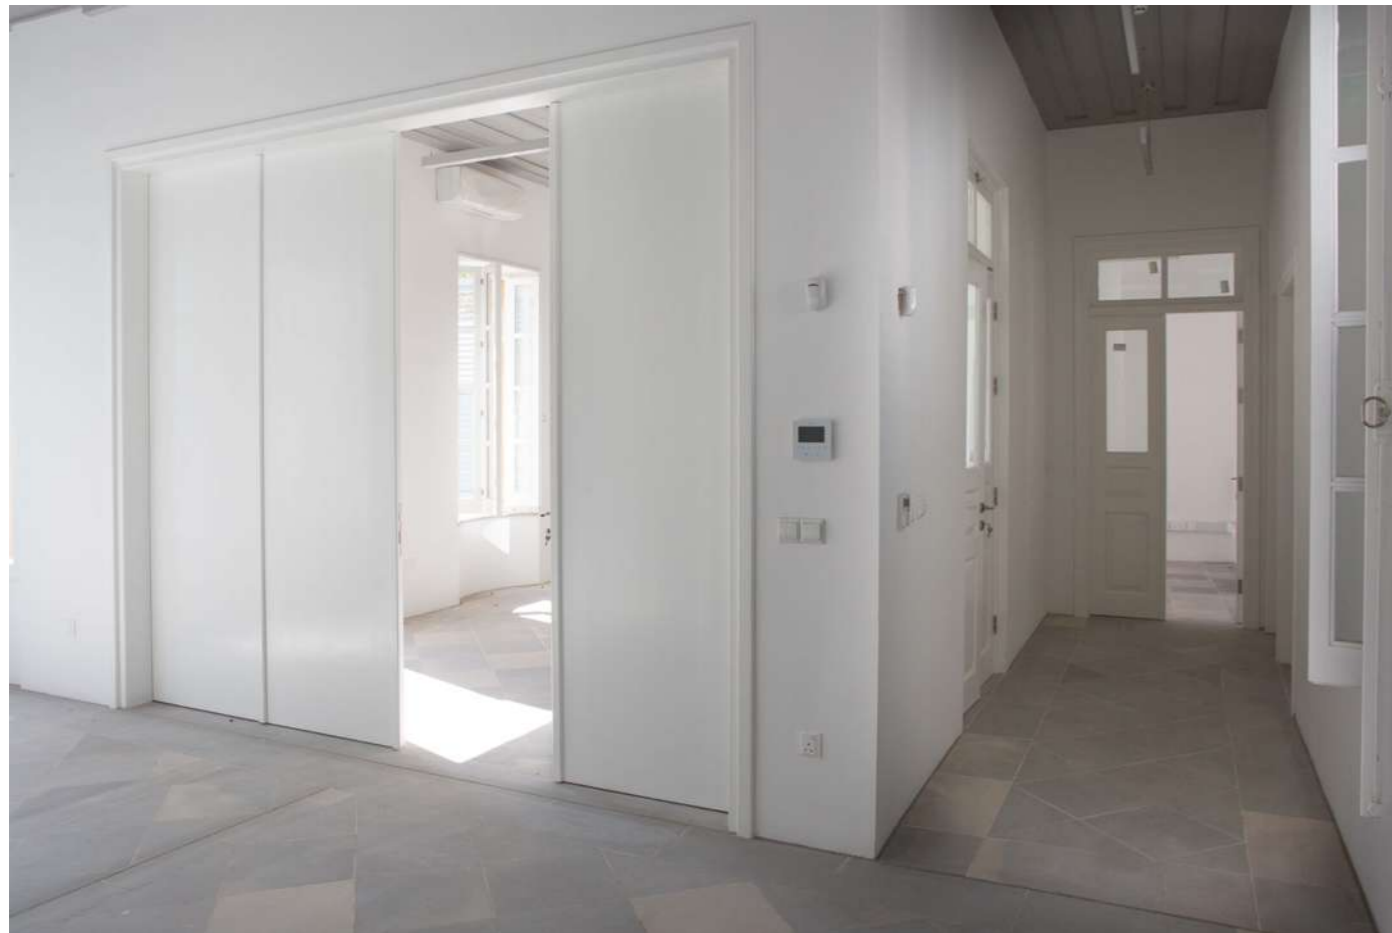
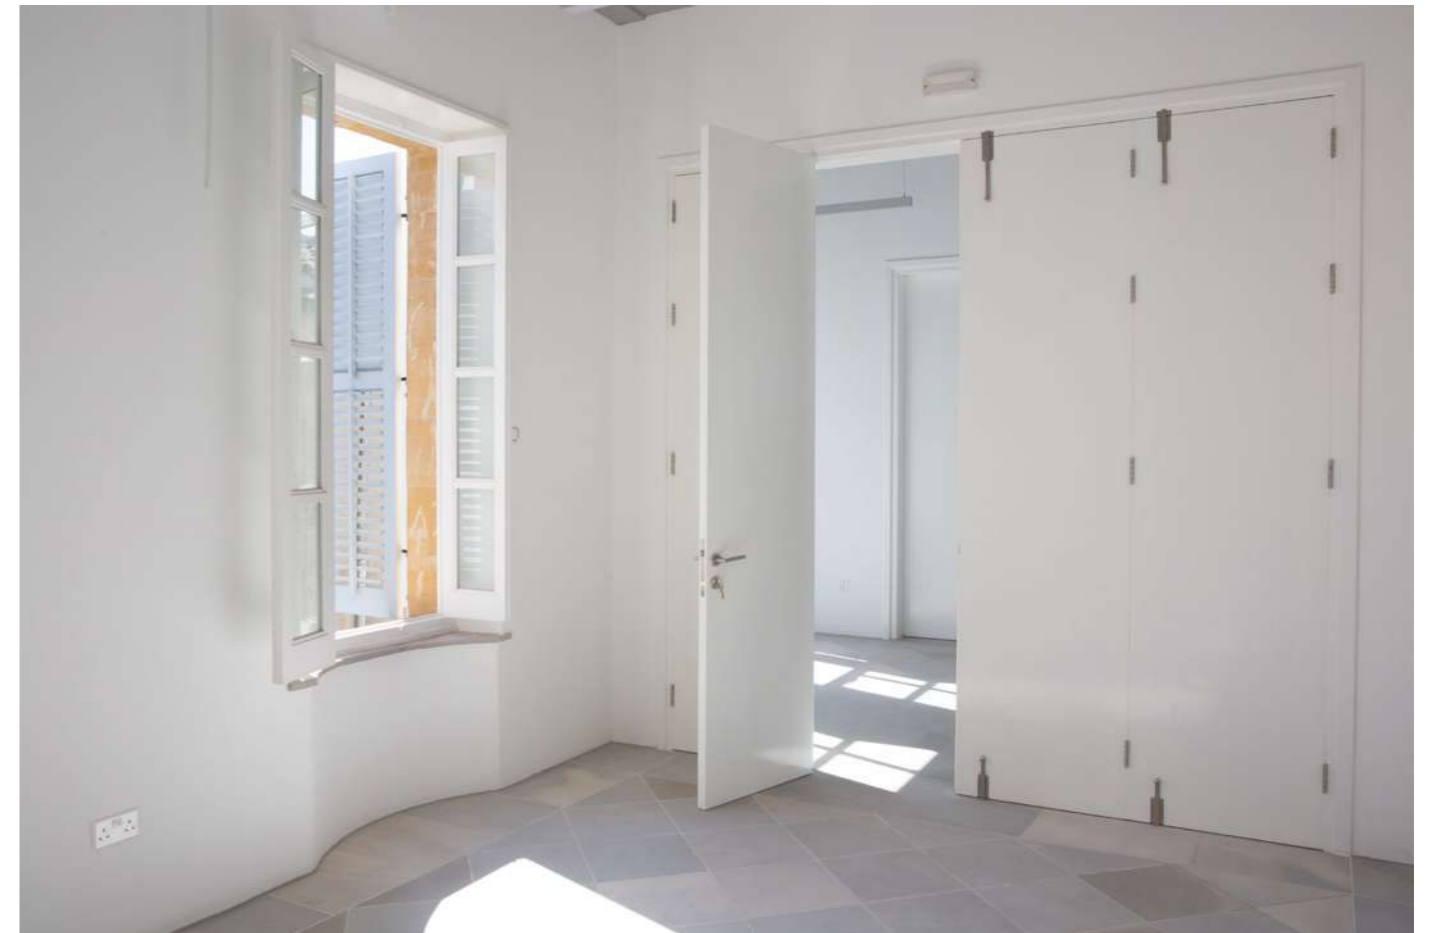
Fig.25-26: View from the interior of the building after restoration. © Simos Drousiotis/A. M. Andronicou Ltd

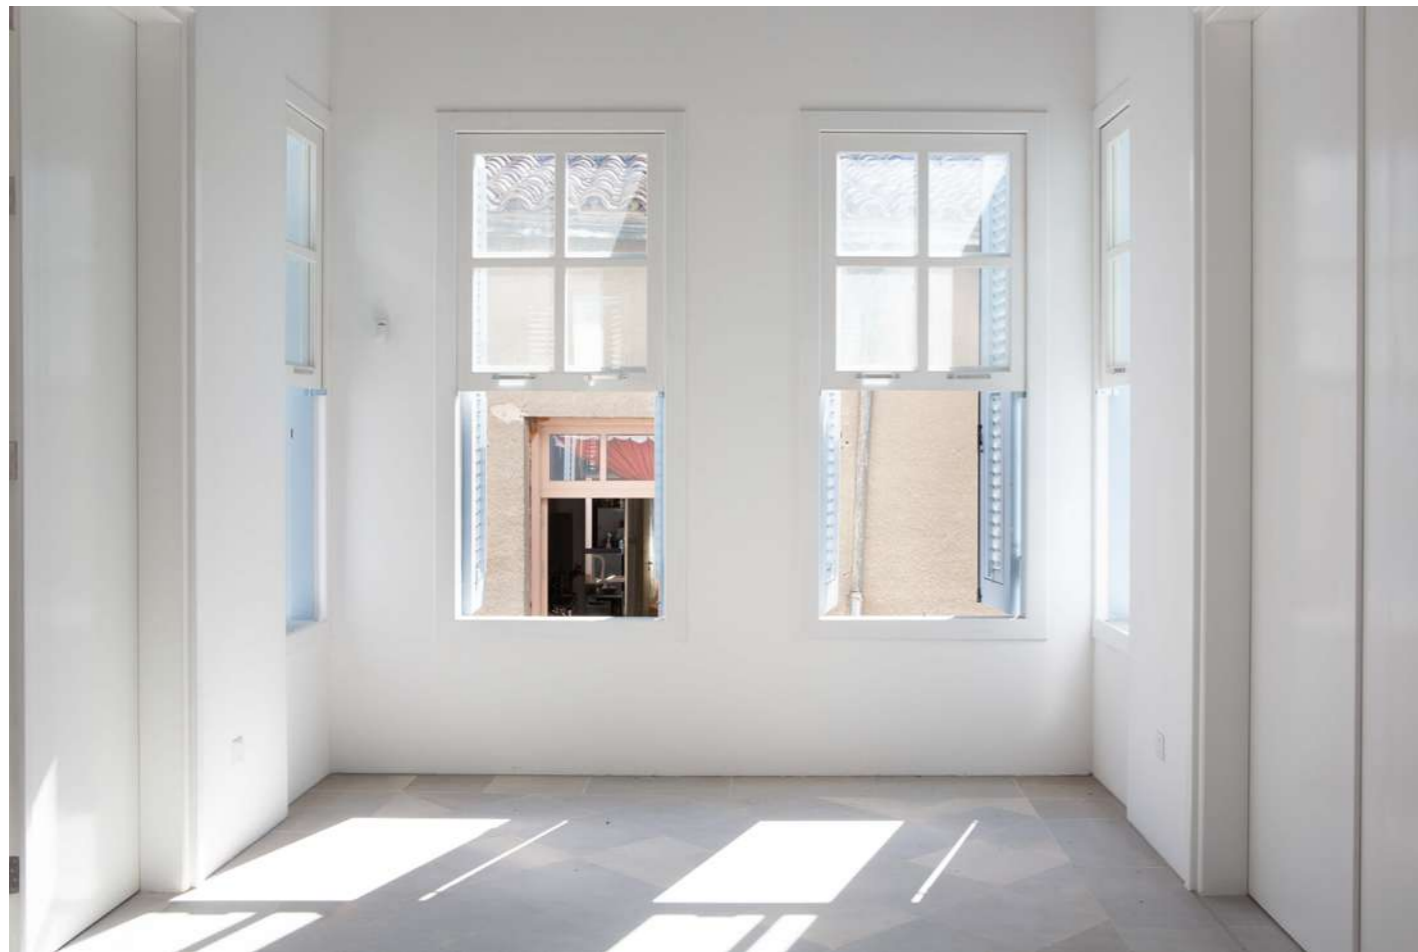
Fig.27: First floor after restoration. © Simos Drousiotis/A. M. Andronicou Ltd

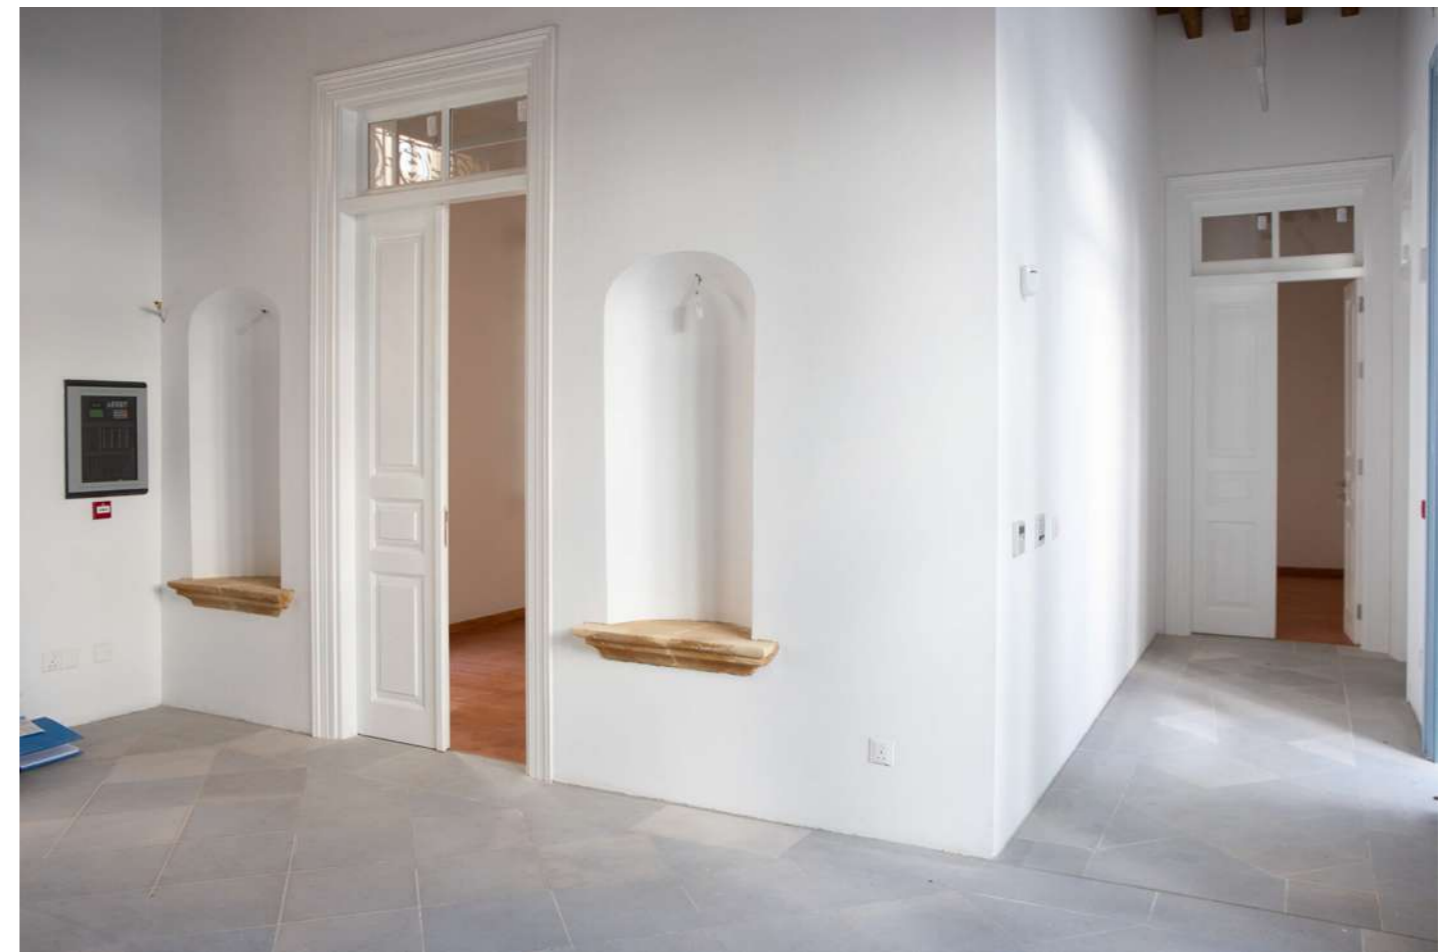
Fig.28: Ground floor after restoration. © Simos Drousiotis/A. M. Andronicou Ltd

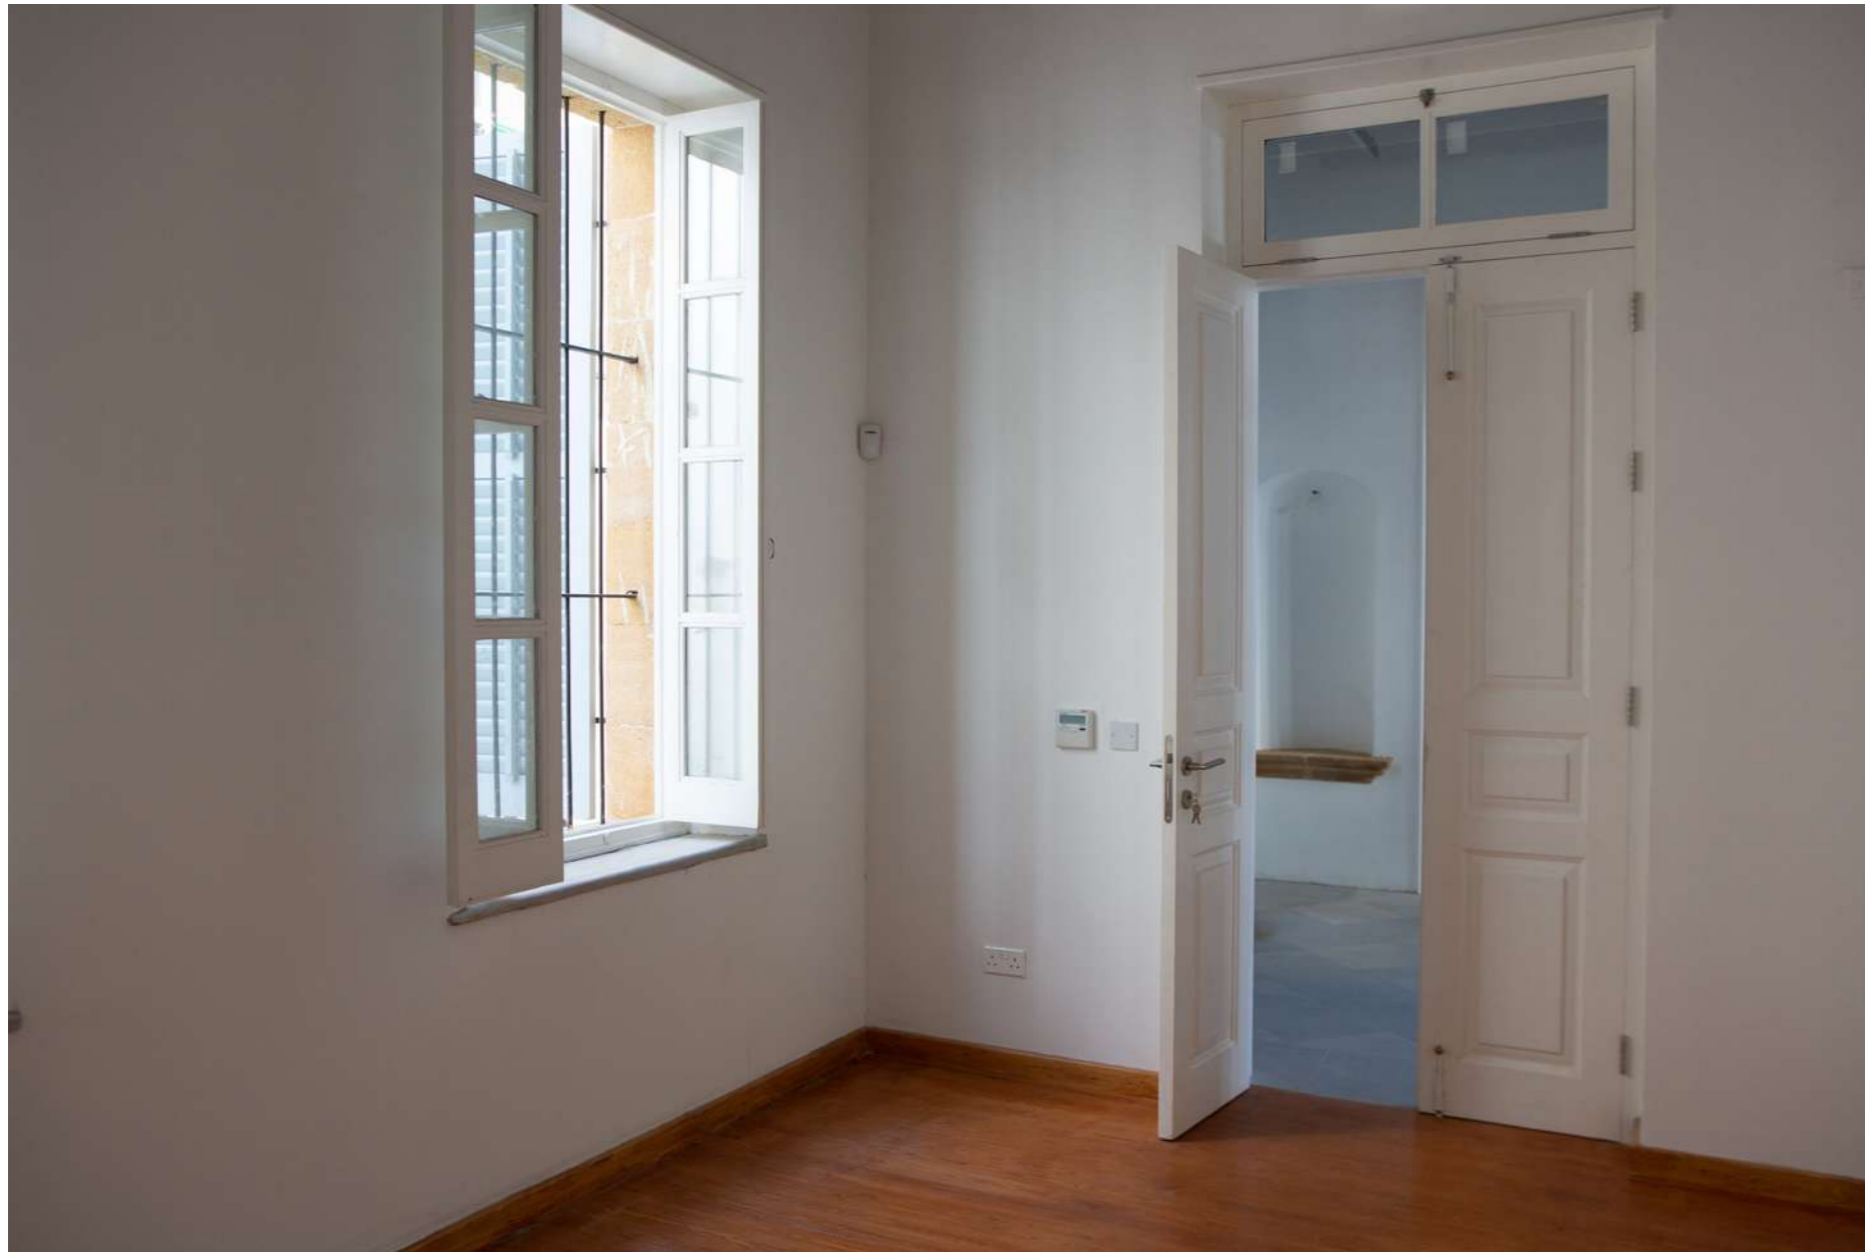
Fig.29: Ground floor after restoration. © Simos Drousiotis/A. M. Andronicou Ltd
