## Ambulance for valuable buildings.

**Mobile workshop teams help owners and managers maintain buildings.**

**Objectives** FIXUS Mobilis project – a system for preventive monitoring and surveillance of cultural heritage sites.

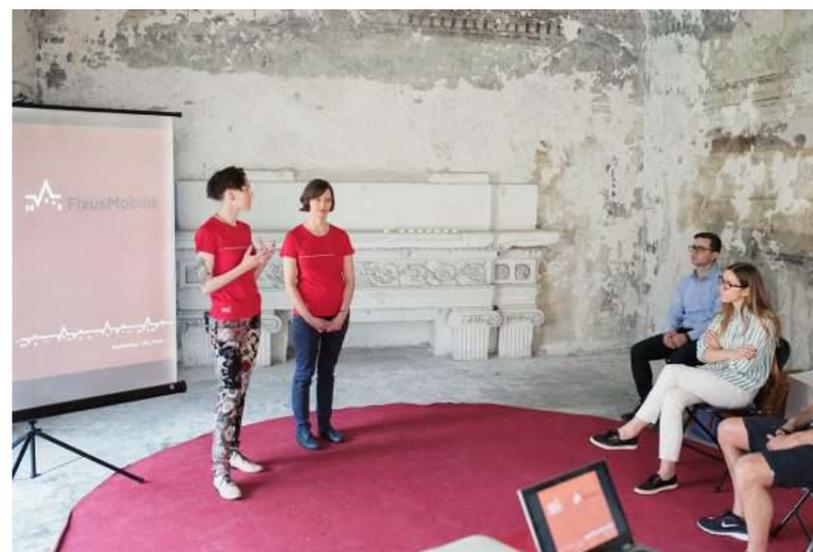
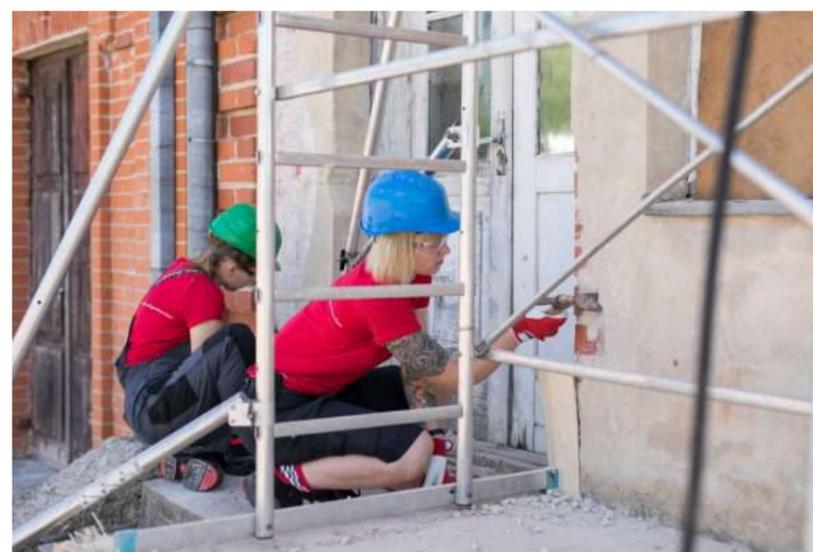
Fig.5-7: Fixus team in action.

The team-mobile workshops research and provide reports on the condition of the selected objects, consult the owners and managers of the objects, perform minor maintenance work, and prepare an individual maintenance calendar for the object.

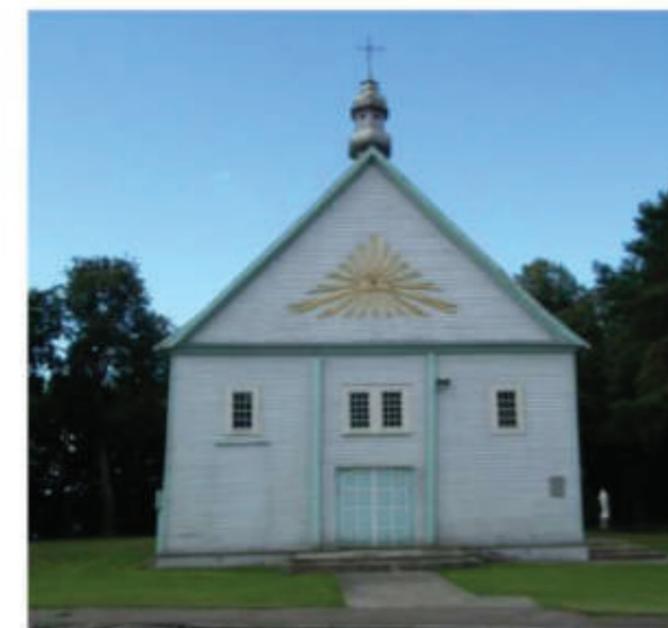
Fig.8: Example of the report.

Rumšiškių Šv. arkangelo Mykolo bažnyčios (u.k. KVR 970, Pajūrio g. 2, Rumšiškės, 56337 Kaišiadorių raj.) būklės vertinimo ataskaita ir priežiūros planas

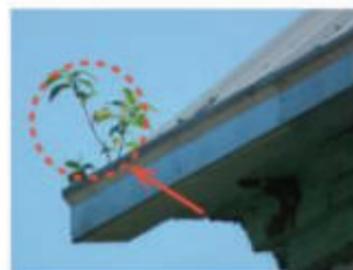
FF-2.1 Užnešti stogo lietoviai, juose auga augalai. Per užsinešusius lietovius vanduo negali tinkamai nutekėti, todėl vanduo bėga pro kraštus, tyška ant fasado, cokolio. Sudreikusios perteklinės sąnašos atšildyta ligiu todėl lietoviai dažniau būna pavirkti drėgmės, kuri paspartina koroziją. Galimos stogo konstrukcijų, fasado apdailos bei lietovių padalio (puvinys, surūdijimas).

Dažnyčius lietoviai blogai išvalyti, šiaurinėje statinio dalyje lietoviuose auga jauni medeliai (FF-2.1). Susikaupusios sąnašos, stabdo vandens nutekėjimą, jis kaupiasi lietoviuose, todėl laikui bėgant atsirado lietovių korozinių pažeidimų (rūdys) ir deformacijų (FF-2.2; FF-2.3). Nėra įrengta lietaus surinkimo ir nuvedimo sistema (lietoviai ir lietvamzdžiai) ant zakristijų stogelių (FF-2.4). Lietaus vanduo laisvai nubėga ir tyška ant grindinio, tokiu būdu aptaškudamas cokolį. Kad šios cokolinės dalys kenčia nuo drėgmės, identifikuoją apsaugę dumbliai (FF-2.5). Cokolio apskardinimas pietinėje statinio dalyje prie zakristijų įėjimų yra įrengtas netinkamu nuolydžio kampu - lietaus vanduo subėga į kampą tarp sienų (FF-2.6). Vietomis aplink objektą grunto lygis pakilęs ir yra aukščiau nei esama įrengta nuogrinda - vanduo neturi galimybės nutekėti tolyn nuo pastato (FF-2.7).

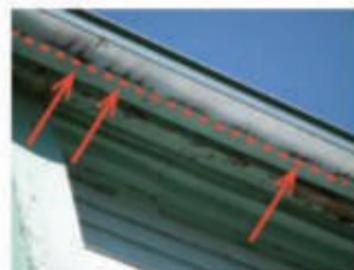
FF-2.2 Korozijos (rūdžių) pažeistas lietovis. Neišvalytose lietoviuose kaupiasi perteklinis vanduo. Lietovis neatlieka savo pagrindinės funkcijos - vanduo pradeda bėgti pro kraštus ir lašėti pro korozijos paveiktas vietas. Abiejuose galimose lietovių, stogo konstrukcijos, fasado apdailos padalio (surūdijimas, puvinys).

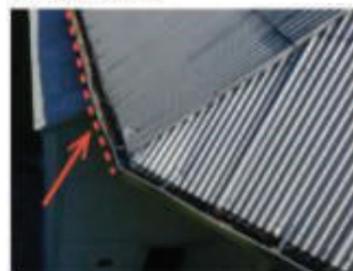
FF-2.3 Neišvalyti ir deformuoti lietoviai. Dėl per

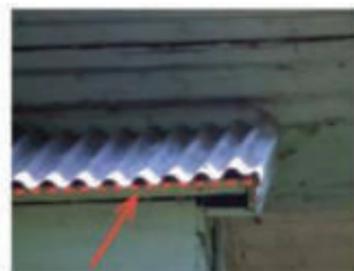
FF-2.4 Neįrengta zakristijų stogelių vandens

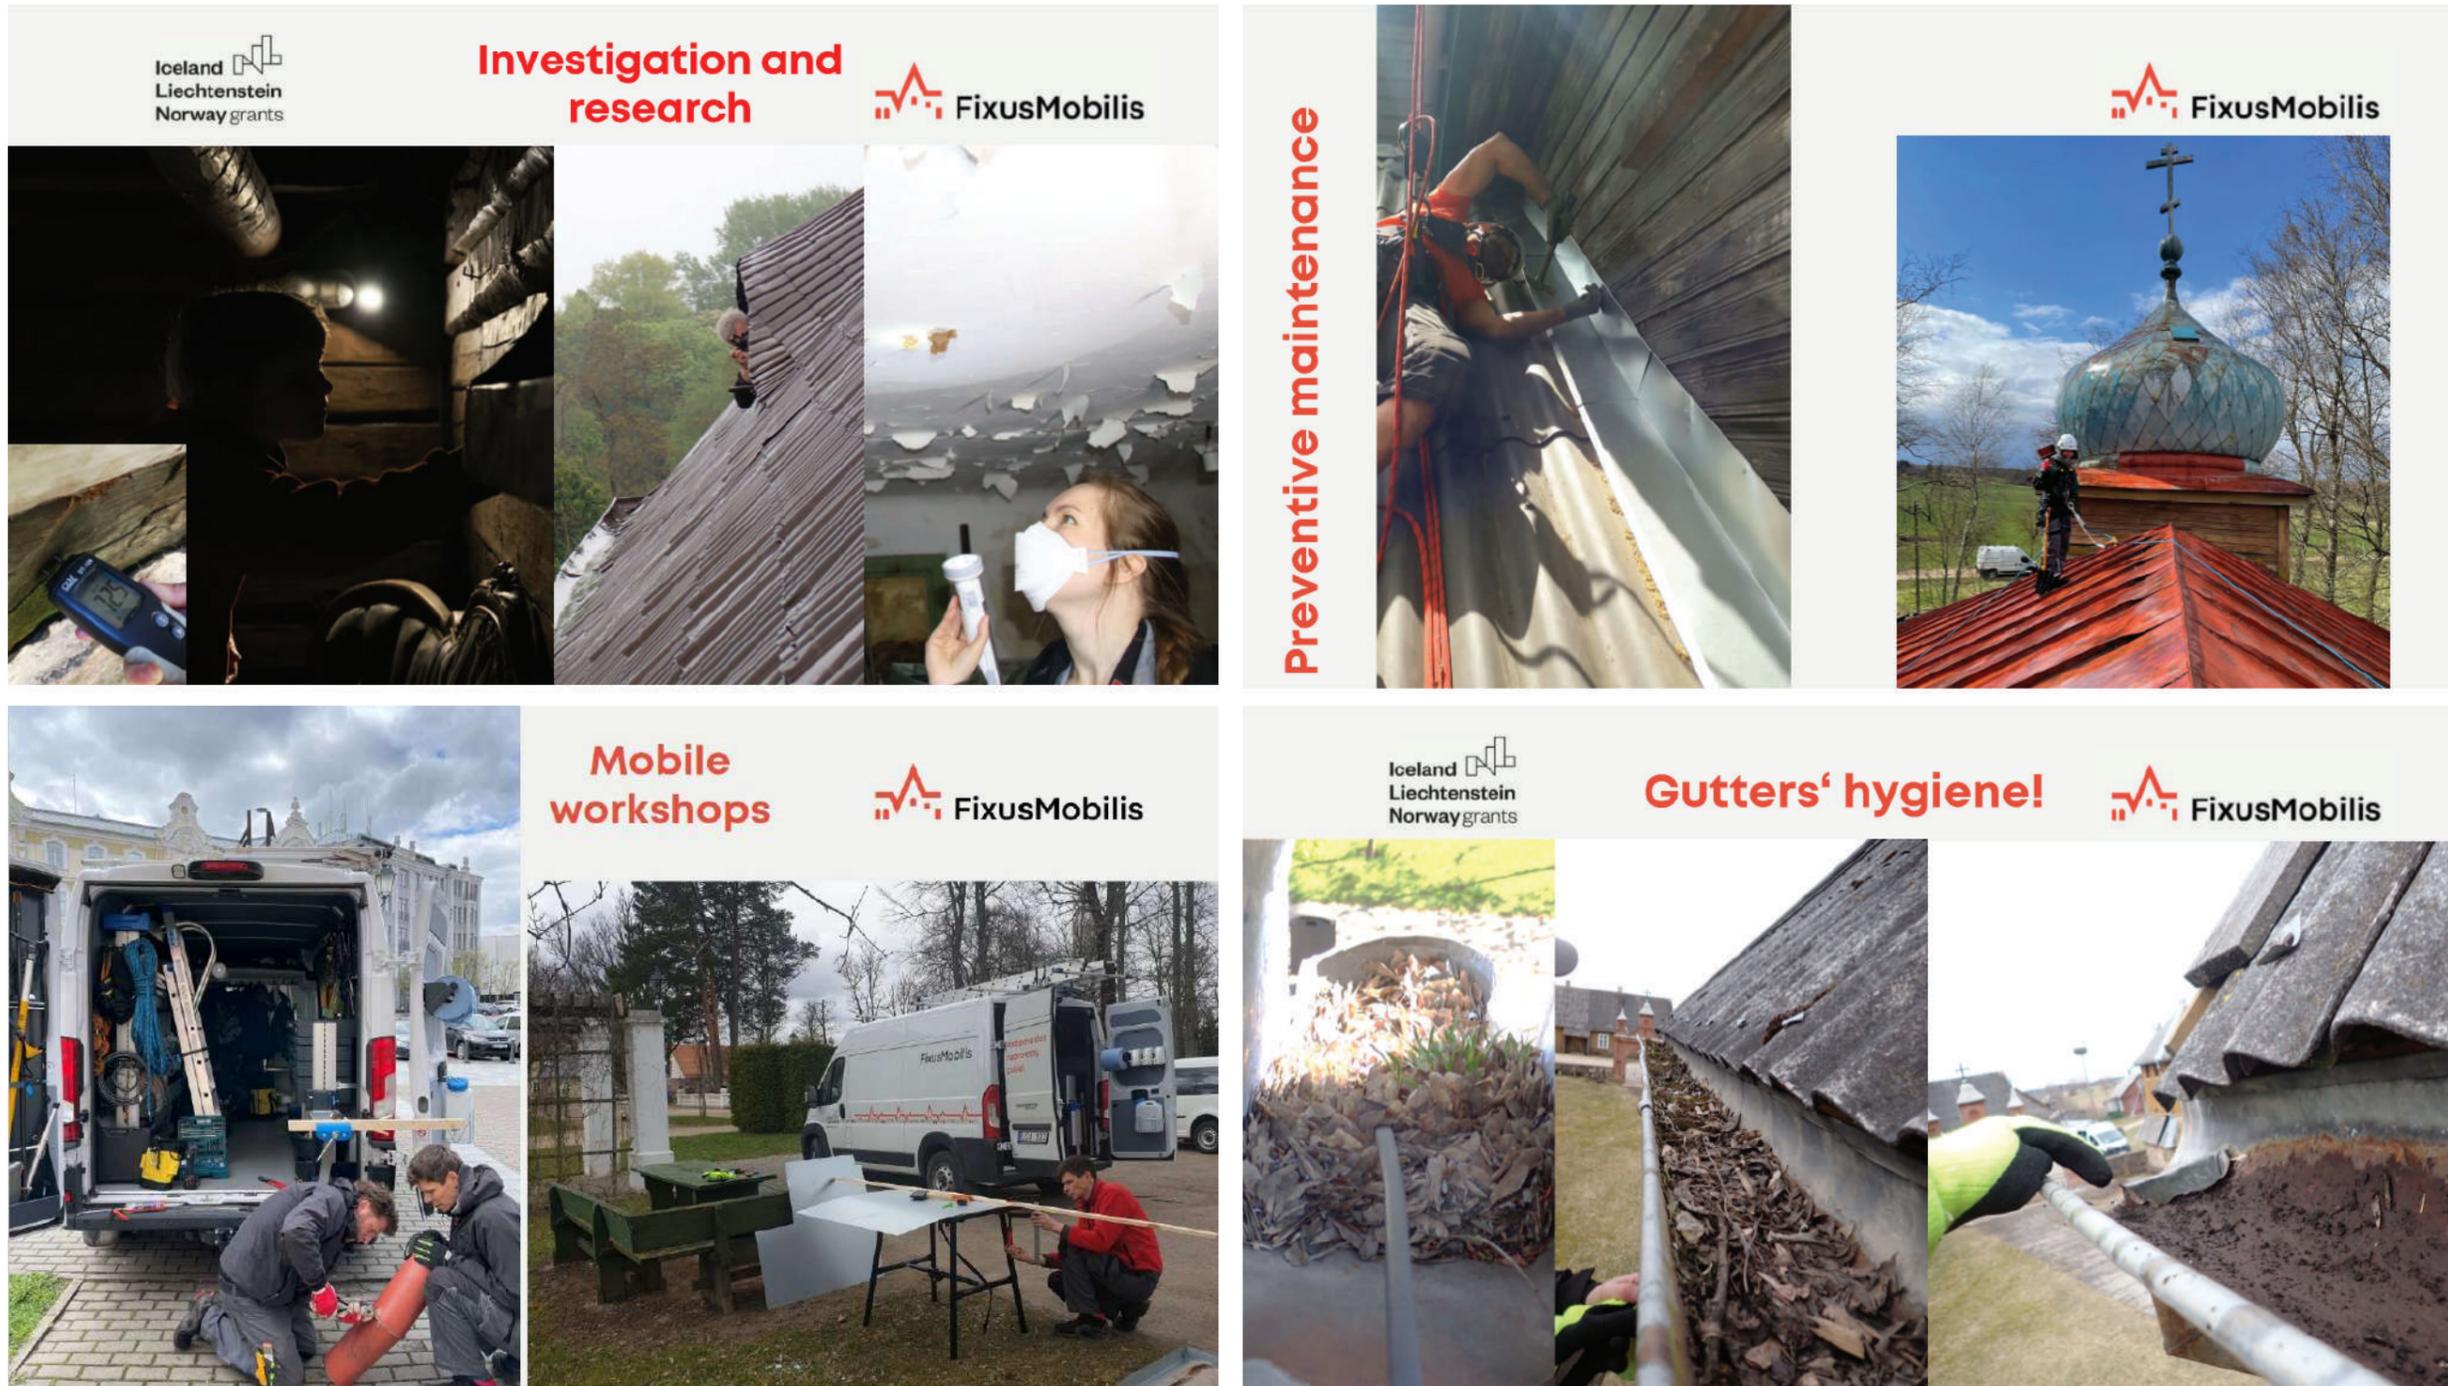
Fig.12-15: Example of the tasks performed by Fixus Mobilis.

The FIXUS Mobilis team of specialists inspects all parts of the building, even those that are difficult to access, in detail, cleans the downpipes if necessary, performs small-scale maintenance work, and takes samples for the necessary laboratory tests. The owner is provided with a building inspection report - an assessment of the technical condition of the building and a plan for further maintenance. Independent FIXUS Mobilis specialists advise and answer questions about building maintenance and management.
