Rehabilitation of a traditional building in Aglantzia.

Pilot experience to improve the thermal performance of a traditional building.

Objectives Rehabilitation intervention and energy retrofit.

Designer FOSS Research Centre for Sustainable Energy, University of Cyprus: Aimilios Michael, Chryso Heracleous, Maria Xenophontos

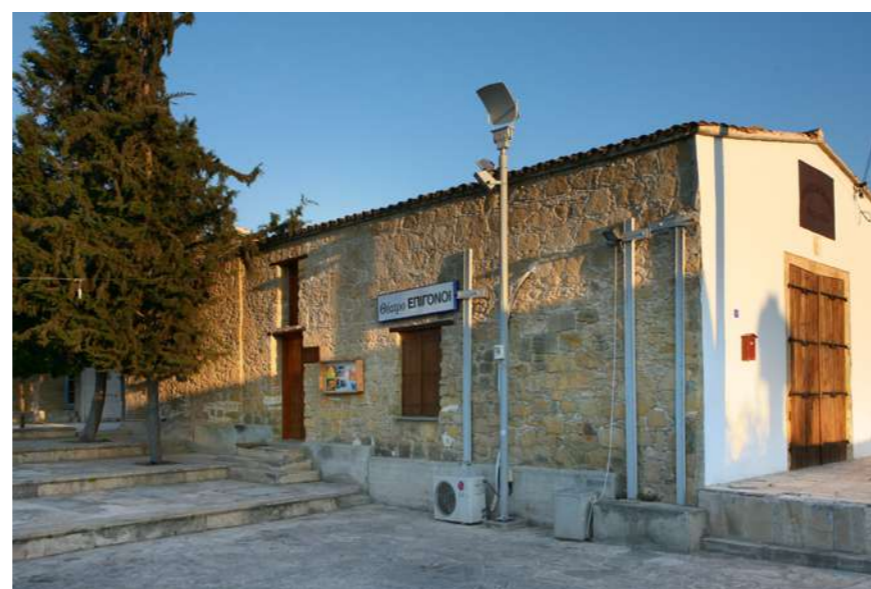
Fig.1: Exterior views of the building before conservation.
© FOSS Research Centre for Sustainable Energy / University of Cyprus

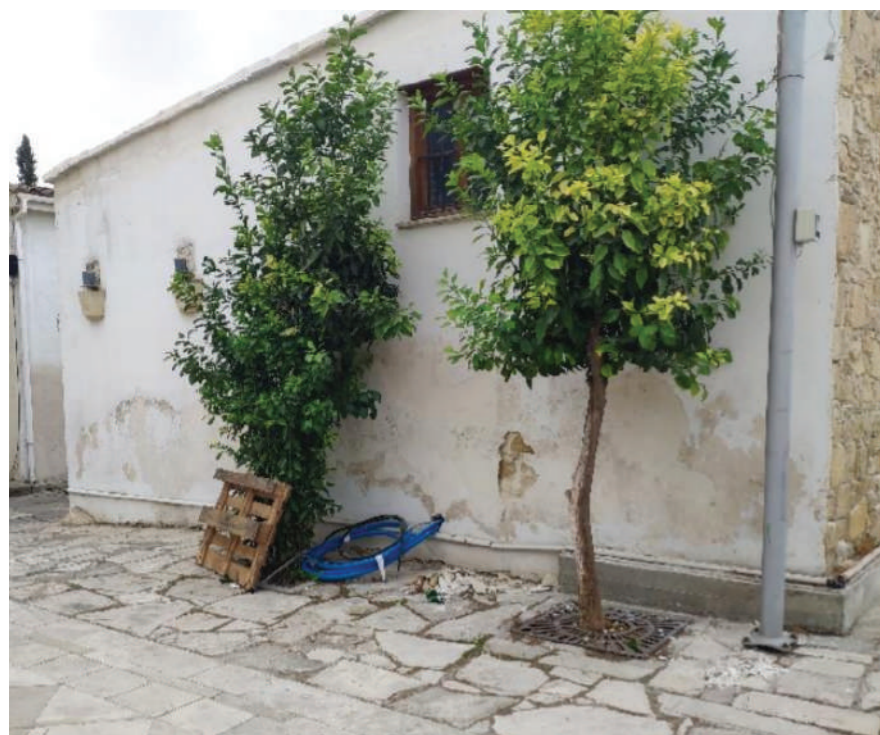
Before the rehabilitation of the building, the building was not in use and empty. The building had no heating and cooling systems, leading to high levels of moisture in the walls. Moreover, suffering from obsolete electrical and lighting systems and with no furniture equipment relevant to the proposed use.

Fig.4: View of the building before restoration. © FOSS Research Centre for Sustainable Energy / University of Cyprus

The internal configuration of auxiliary spaces (toilets and mechanical room) has been changed in order to assist in the smooth operation of the building. Moreover, the problems of moisture on the walls inside and outside have been repaired.

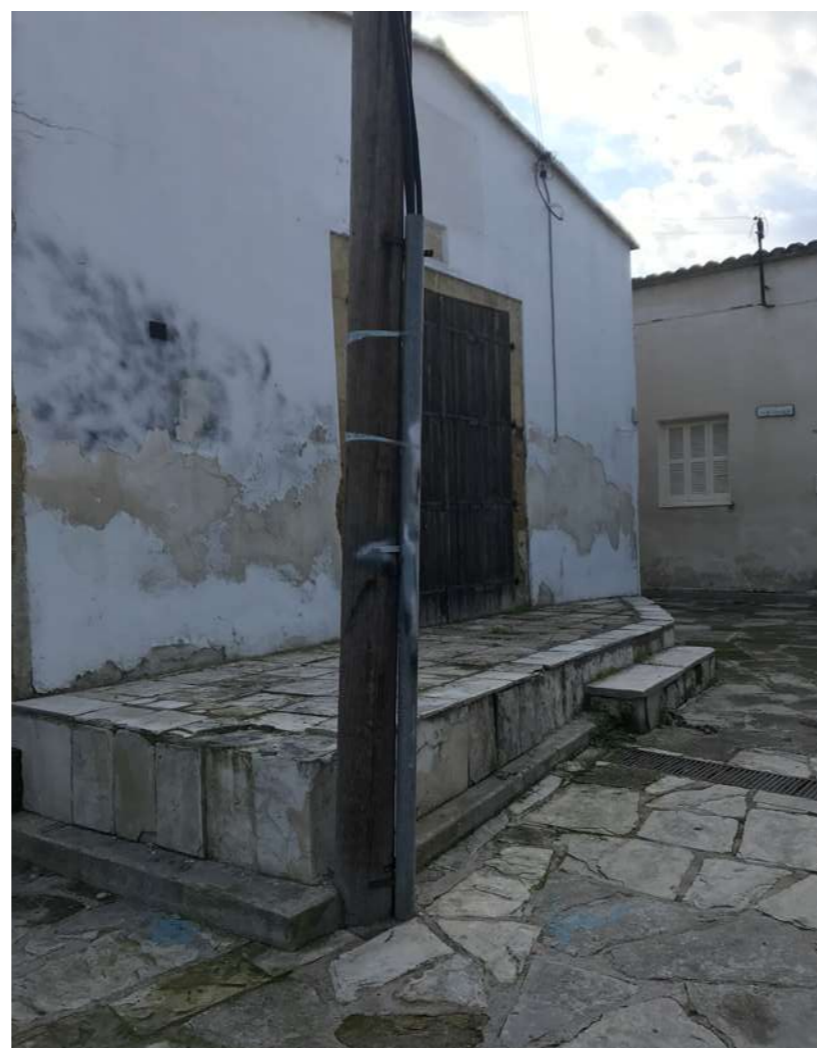
Fig.5: View of the building before restoration. © FOSS Research Centre for Sustainable Energy / University of Cyprus

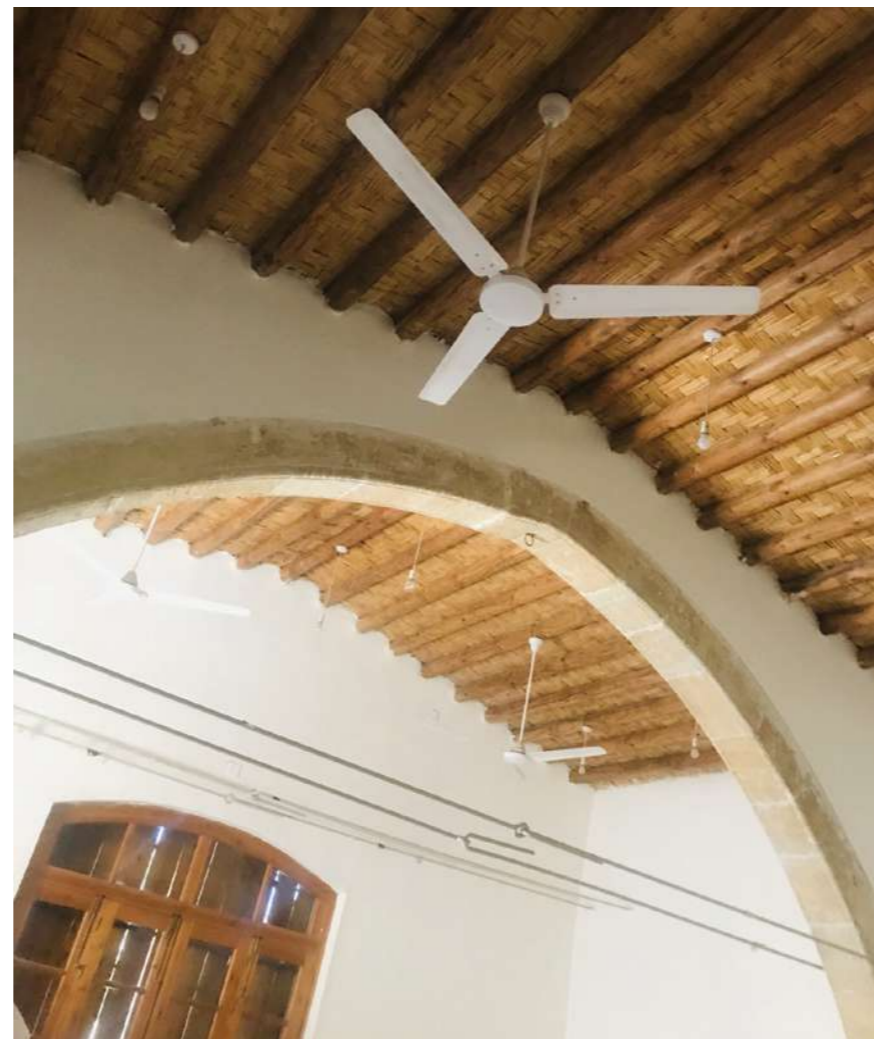
Fig.7: Interior view of the central space – double space room (dichoro). © FOSS Research Centre for Sustainable Energy / University of Cyprus

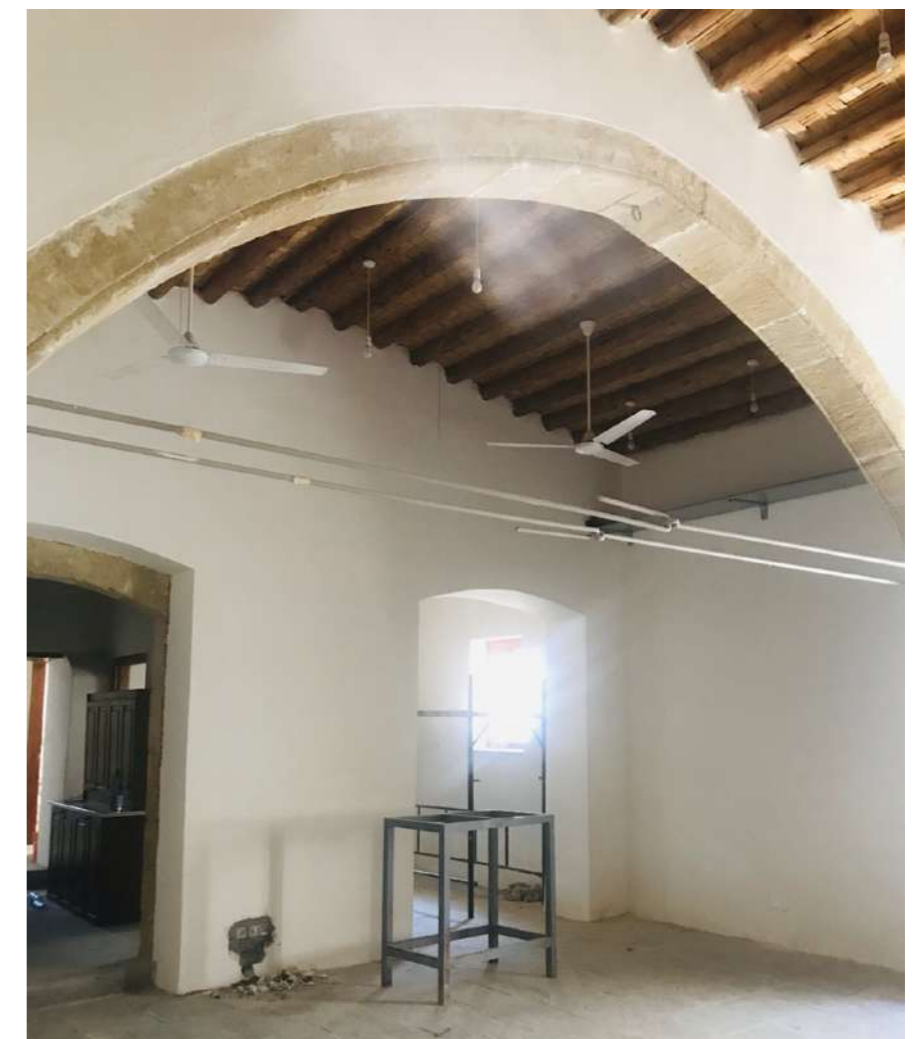
Fig.8: Interior view of the central space – double space room (dichoro). © FOSS Research Centre for Sustainable Energy / University of Cyprus

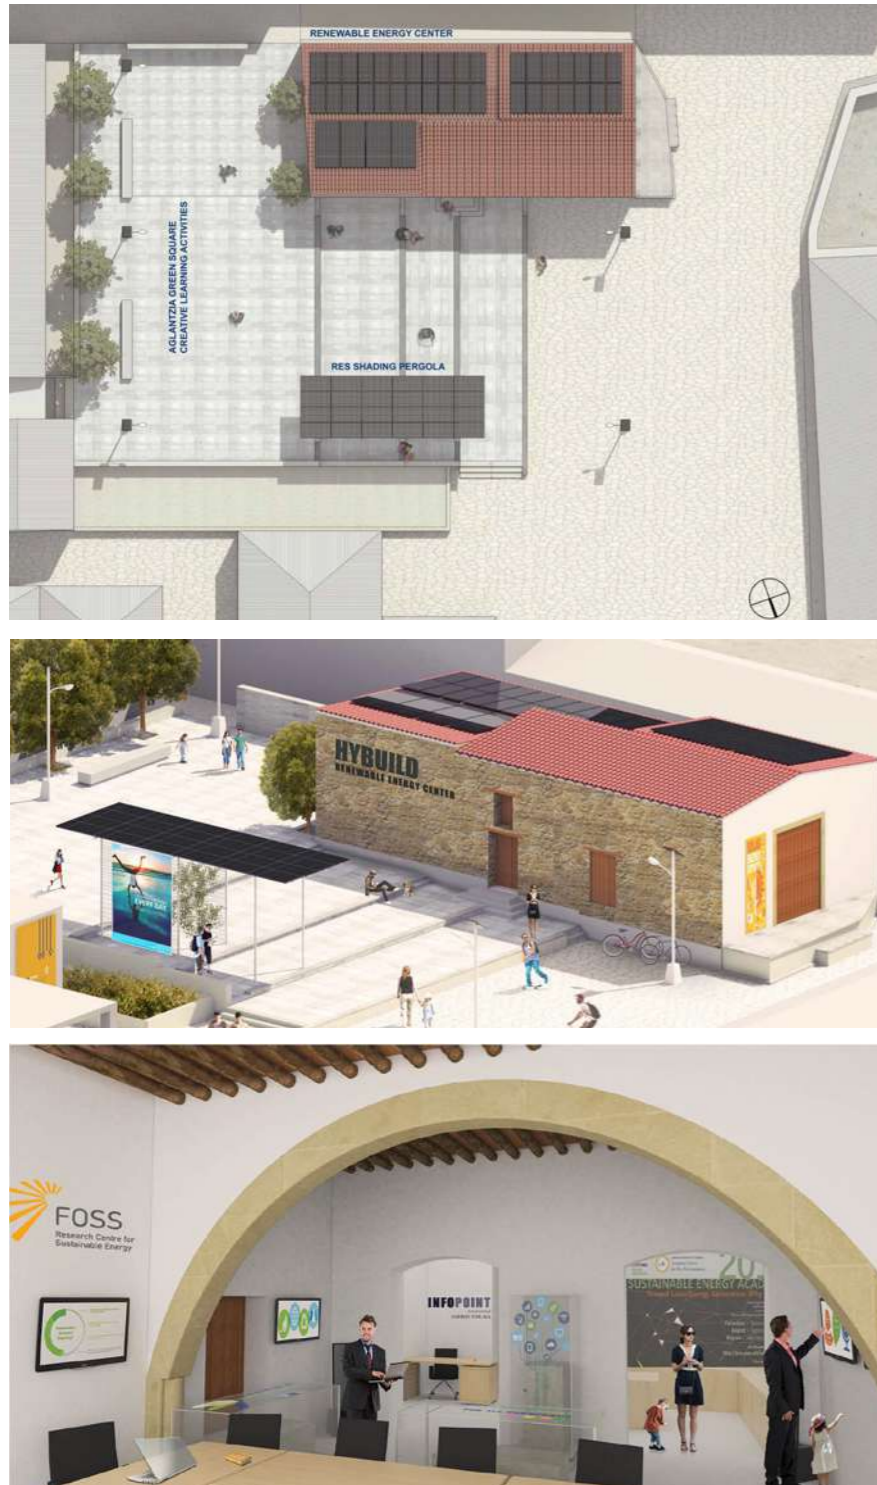
Fig.9-11: Renderings of the proposal.

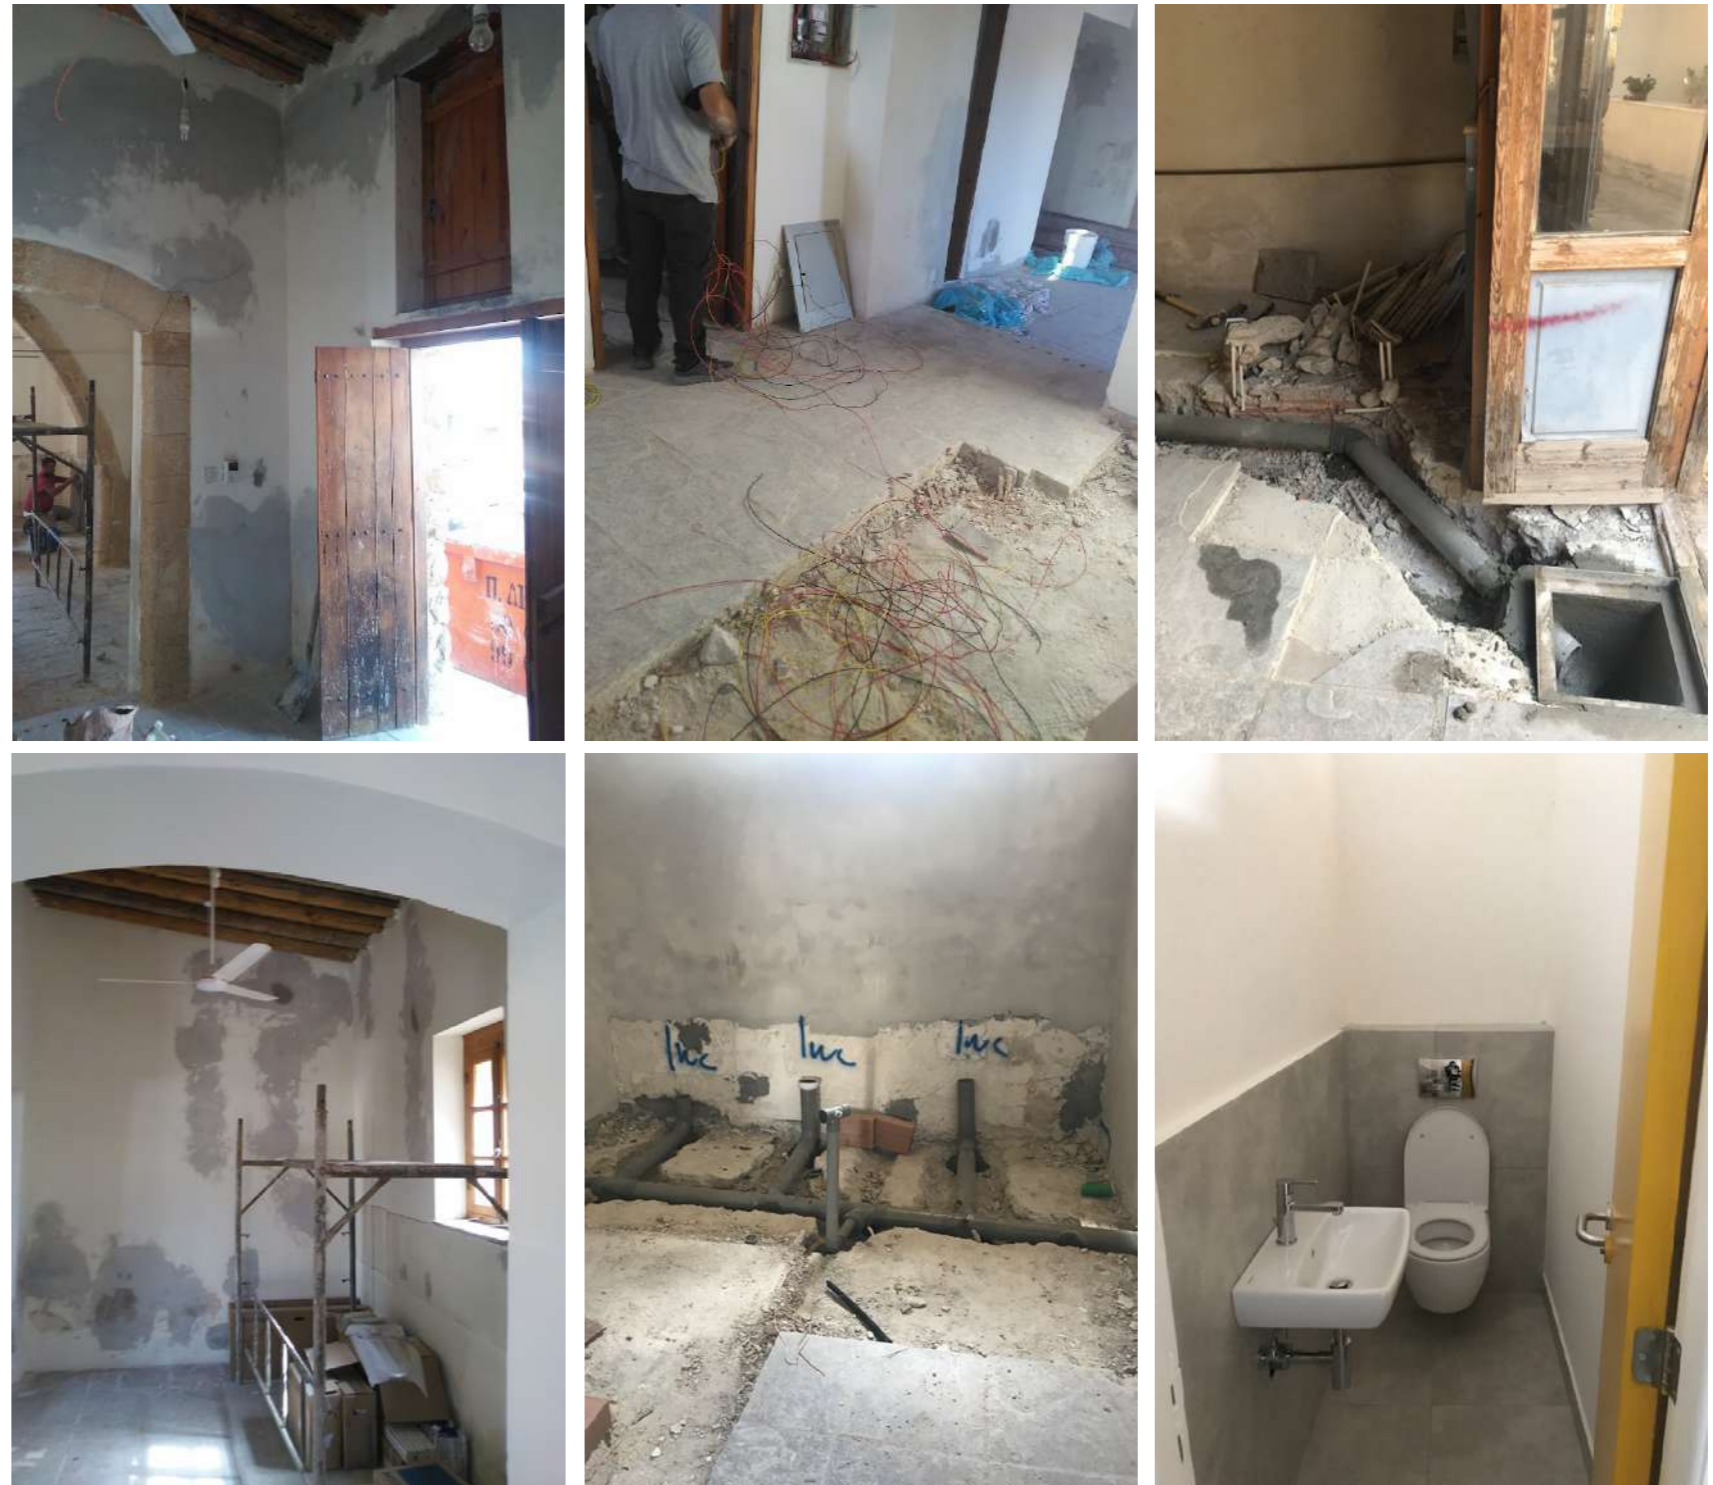
Fig.12-17: Views of the building during conservation. © FOSS Research Centre for Sustainable Energy / University of Cyprus

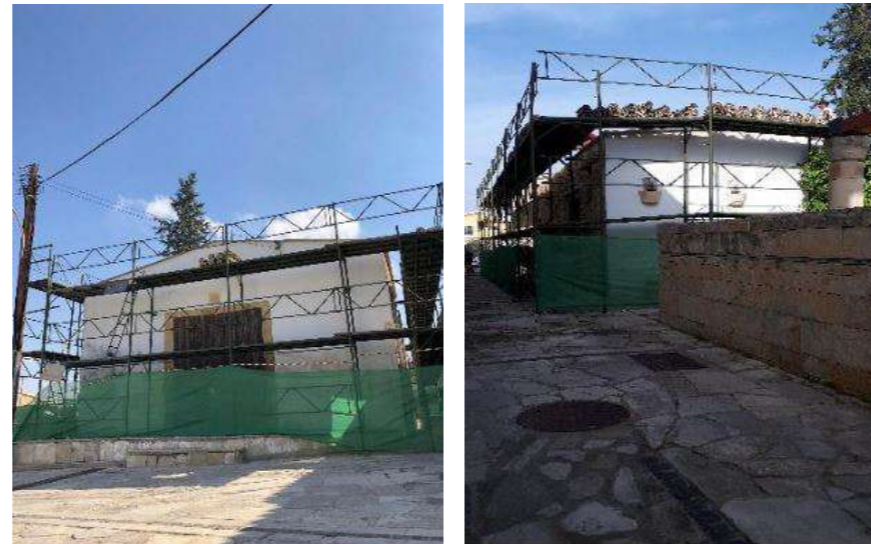
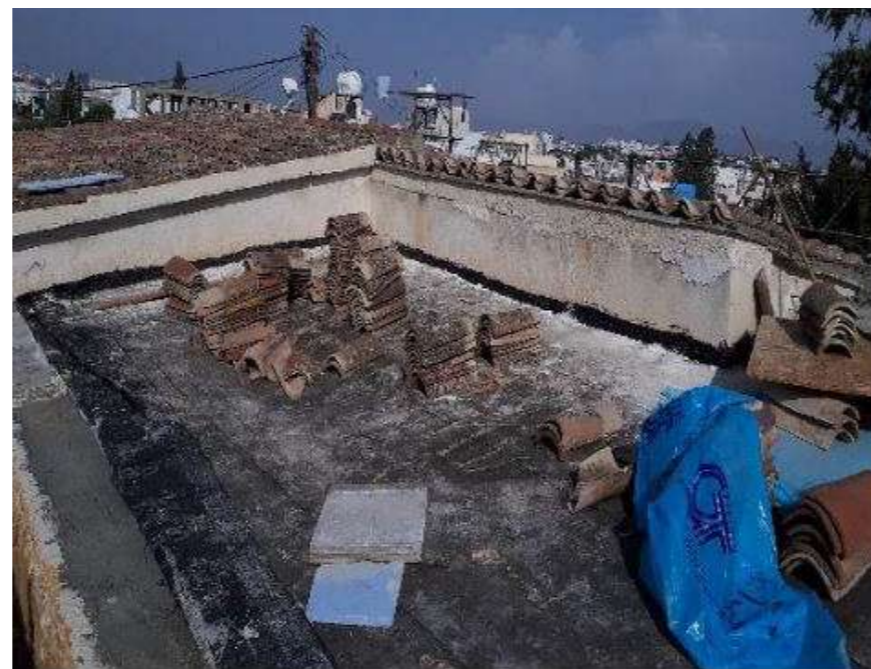
The roof is slightly inclined and originally consisted of a thick layer of beaten earth which was laid on matting. The roof layers were supported by timber beams. At the retrofitting stage the beaten earth was replaced with OSB and thermal insulation of 12cm extruded polystyrene giving a thermal conductivity of U value = 0.28 W/m²K. The windows consist of single glazing with 30% of surface to be wooden frame of total U value 4.7 W/m²K.

Fig.20-22: Improvement of the roof's thermal performance. © FOSS Research Centre for Sustainable Energy / University of Cyprus

At the retrofitting stage the beaten earth was replaced with OSB and thermal insulation of 12cm extruded polystyrene giving a thermal conductivity of U value = 0.28 W/m2K.

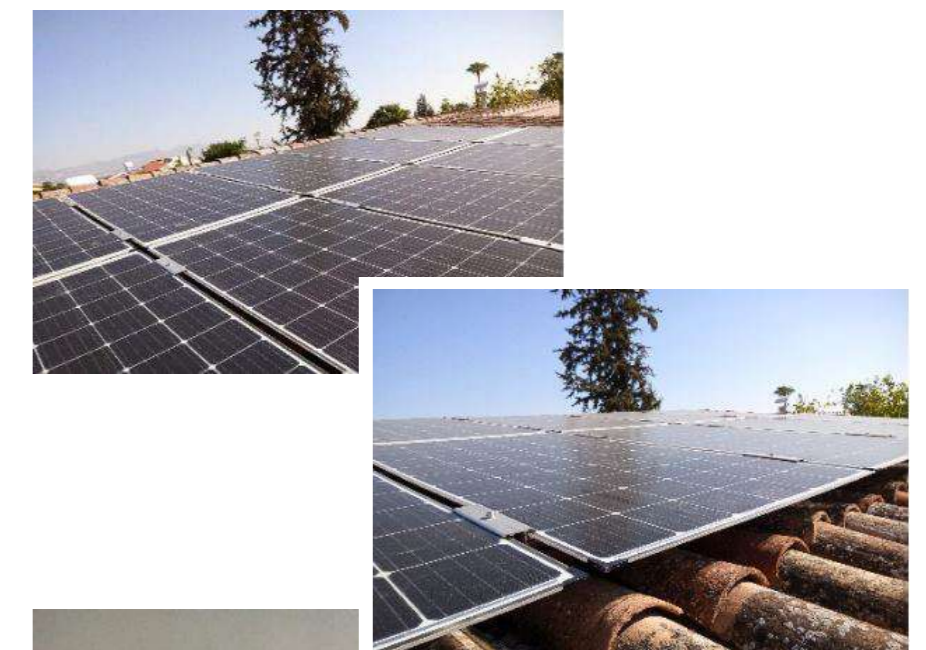
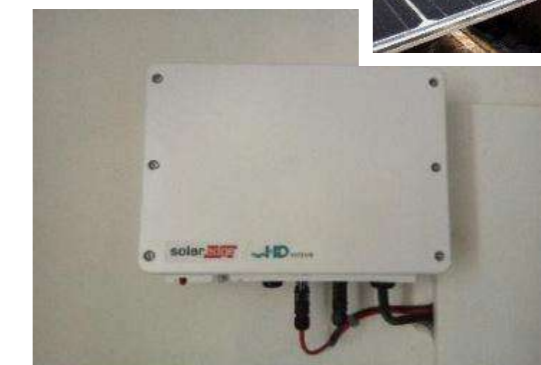
Fig.23-25: Installation of PV System.

For the needs of the project, 5kWp installed peak power were installed.

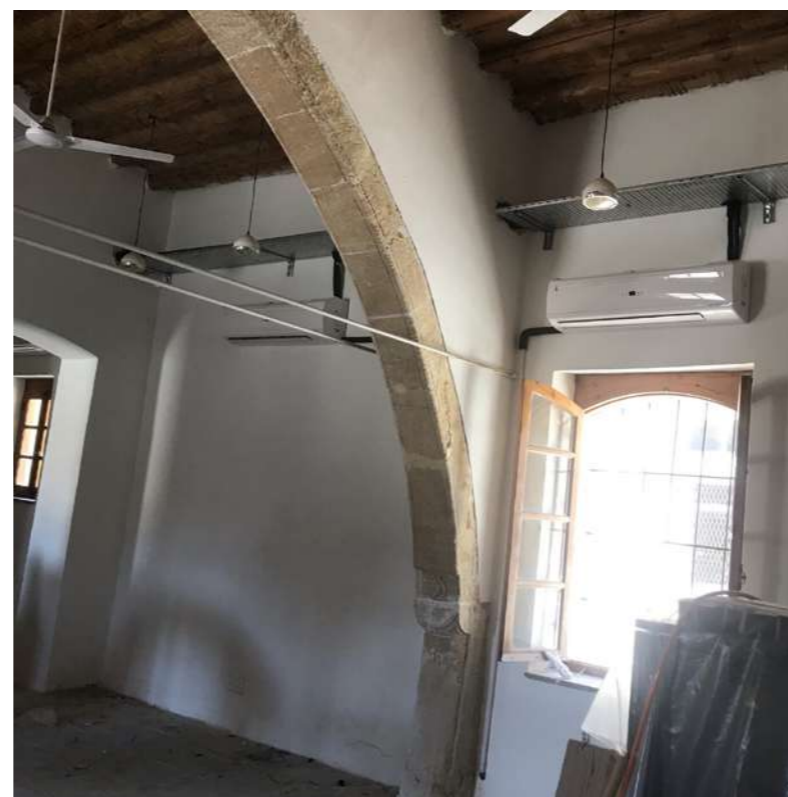
Fig.26: HYBUILD System installation. © FOSS Research Centre for Sustainable Energy / University of Cyprus

The system is divided into two main subsystems, the electrical system and the thermal system.

The electrical system consists of a 5kwp installed photovoltaic system which is connected via a DC-DC string optimizer to the electric rack which includes the battery with its charging controller, power meters, optimizers and the DC-AC inverter for connection to the main AC distribution grid.

On the other hand, the thermal system consists of the Heat Pump (HP), which is powered by DC power from the DC side

of the DC-AC inverter, the Dry cooler which is the outdoor unit of the HP, and the RPW- HEX with the latent storage module. Motorized 3 way valves allow the reversibility of the chiller between cooling and heating modes, by swapping the hydraulic circuits.

This selection is made through a central controller (PLC) which receives data from the various sensors of the system and is designed to decide the optimal operation of the system.

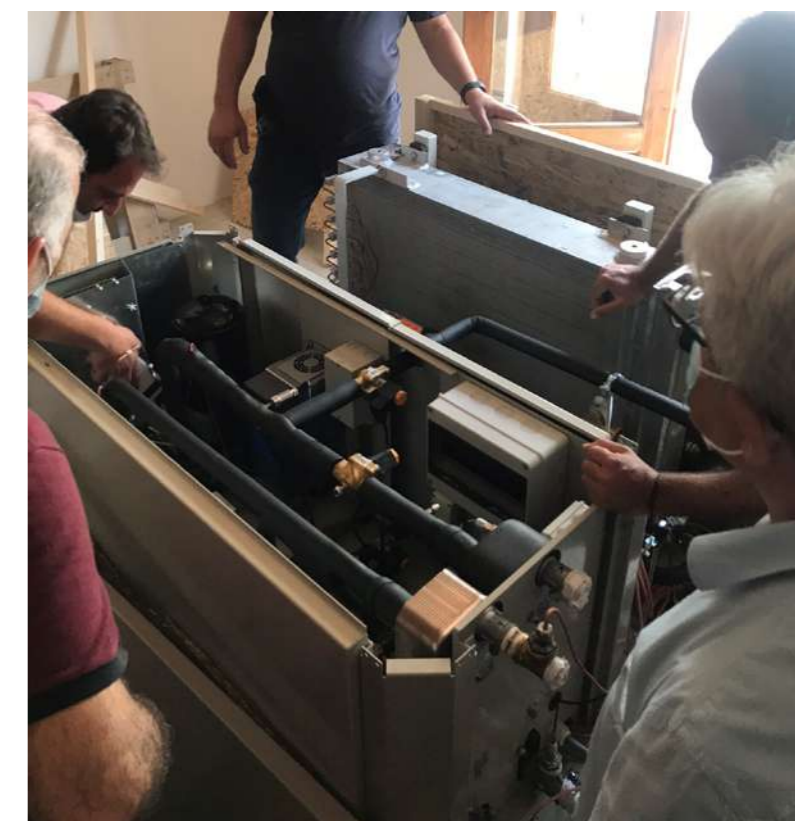
Fig.27: HYBUILD System unpacking. © FOSS Research Centre for Sustainable Energy / University of Cyprus

Depending on the internal temperature of the building, the ambient temperature, the condition of the various components of the system as well as the needs of the user, the system can automatically decide the optimal scenario to follow and which function it will perform.

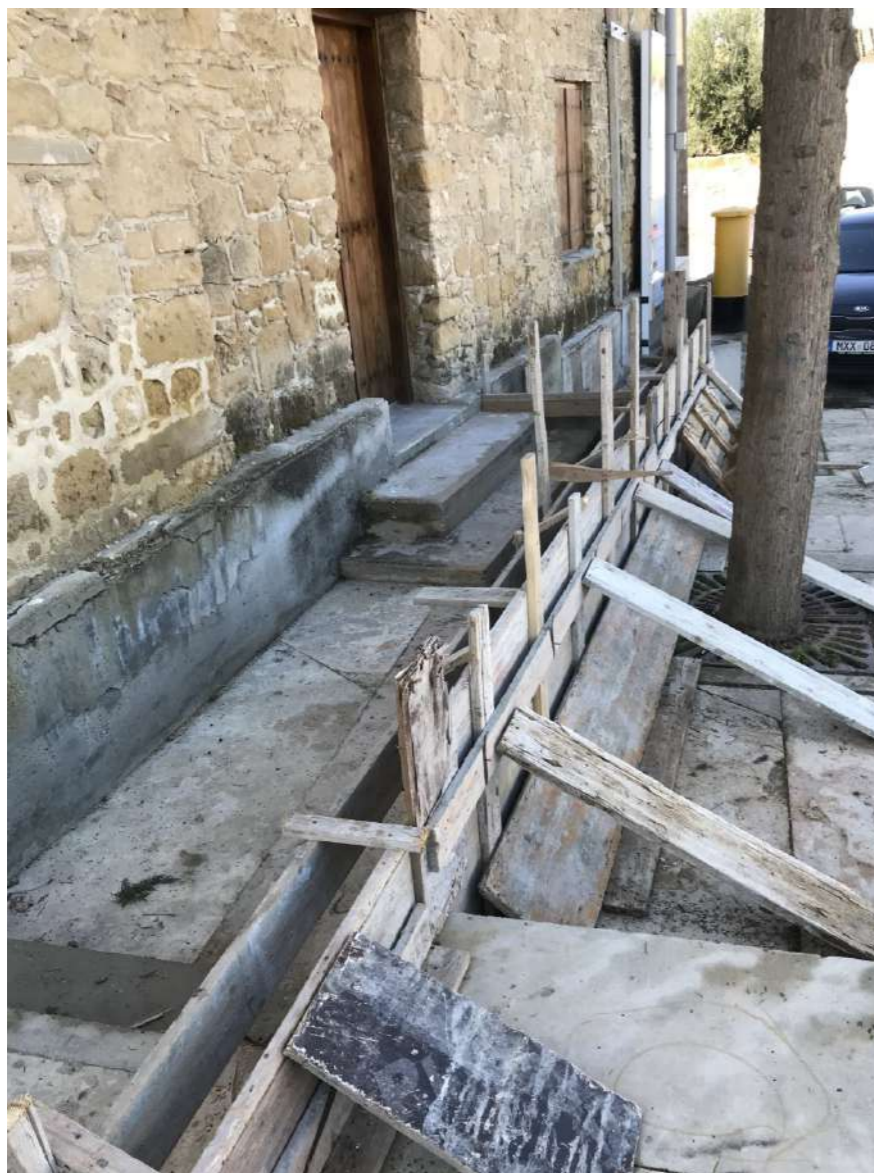
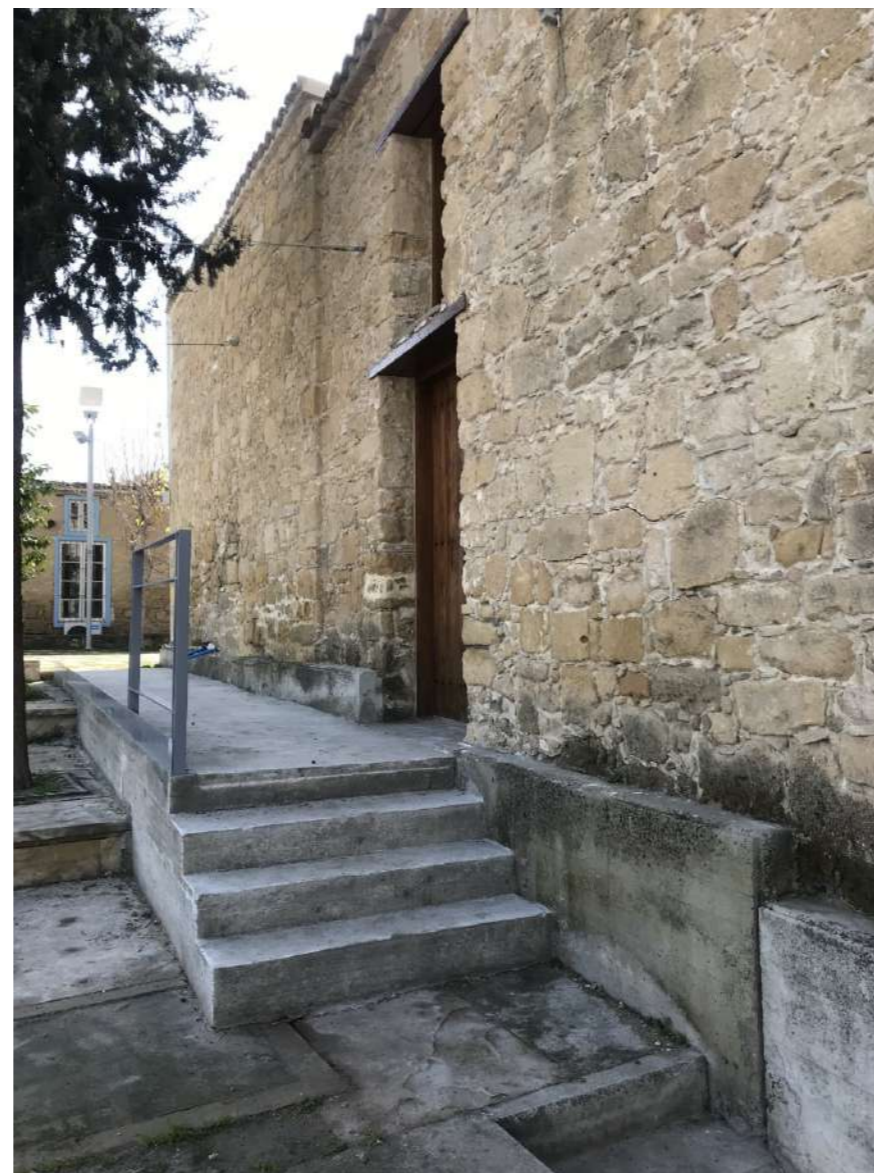
Fig.28-29: Construction of accessible routes for the building. © FOSS Research Centre for Sustainable Energy / University of Cyprus

The intervention project also implemented accessibility to all, through the introduction of a ramp connecting the level of the square with the main entrance of the building.
