Rehabilitation of a traditional house in Kapedes.

Improving the house while maintaining its life.

Site Historic House, Kapedes Village, Cyprus

Date Project 1986-1989

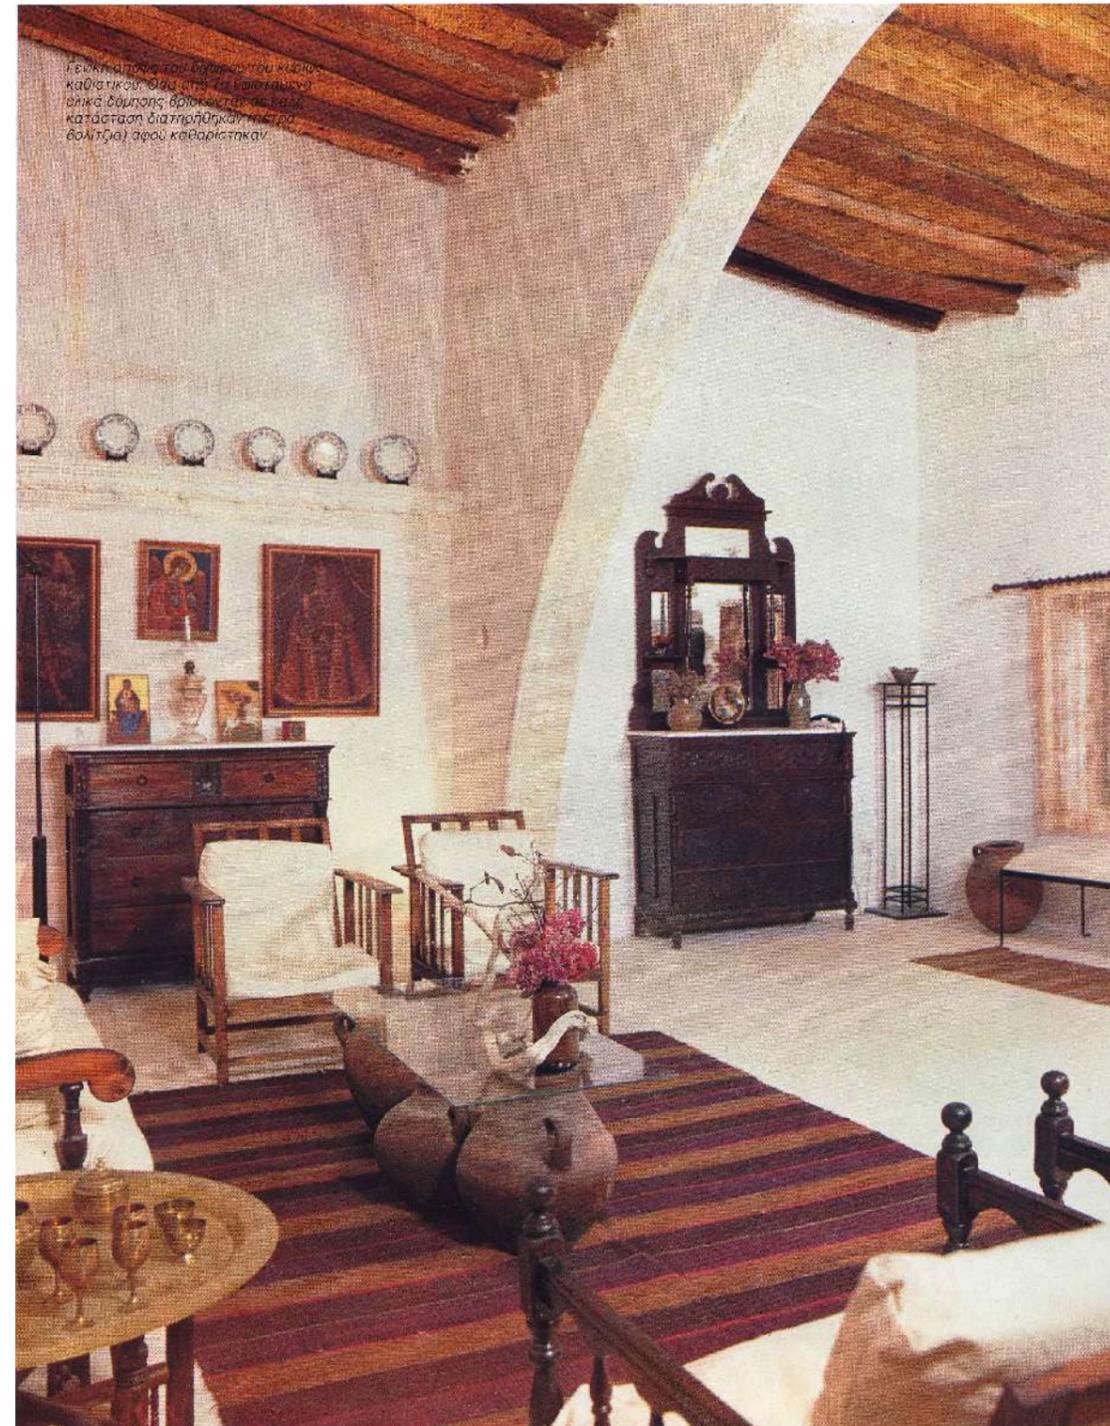
Γενική άποψη του εσωτερικού του κτιρίου
καθώς είναι διατηρημένο. Τα στοιχεία
ολική δόμησης βρίσκονται σε καλή
κατάσταση διατήρησης (μετά
βαλτιδα) αφού καθαρίστηκαν.

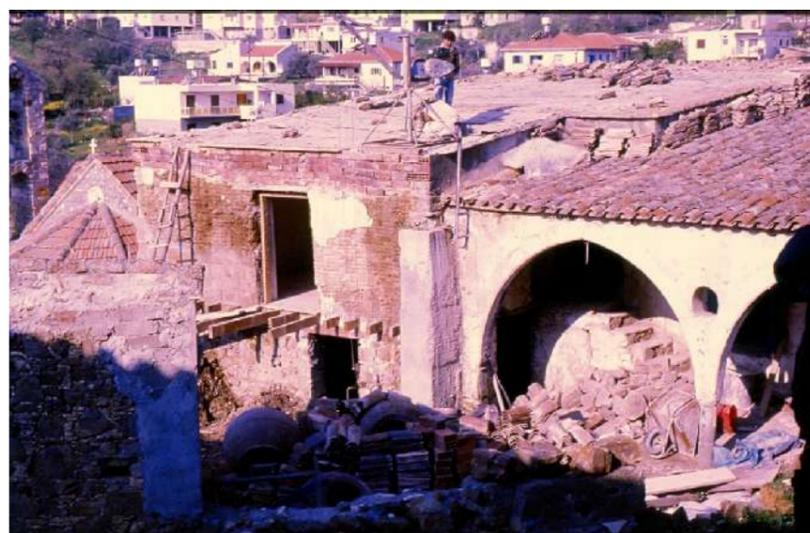
Fig.1: Façade of house during the renovation works.
© N. Chrysochou

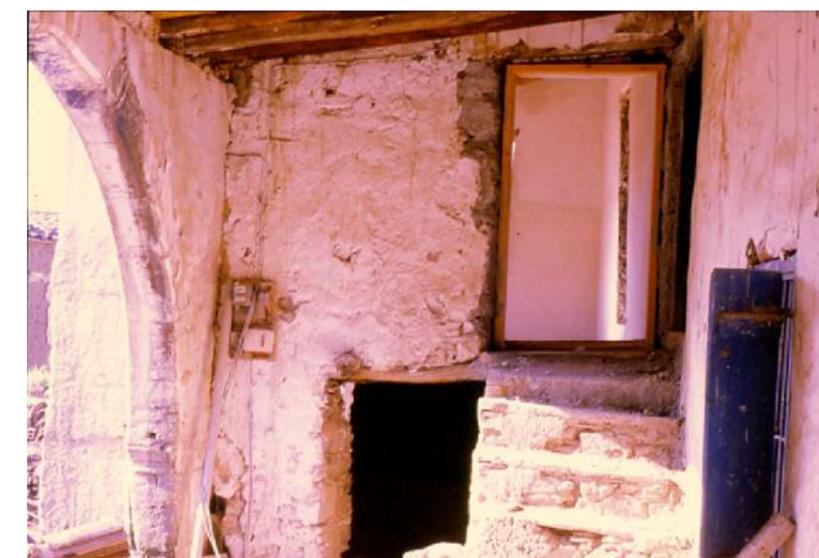
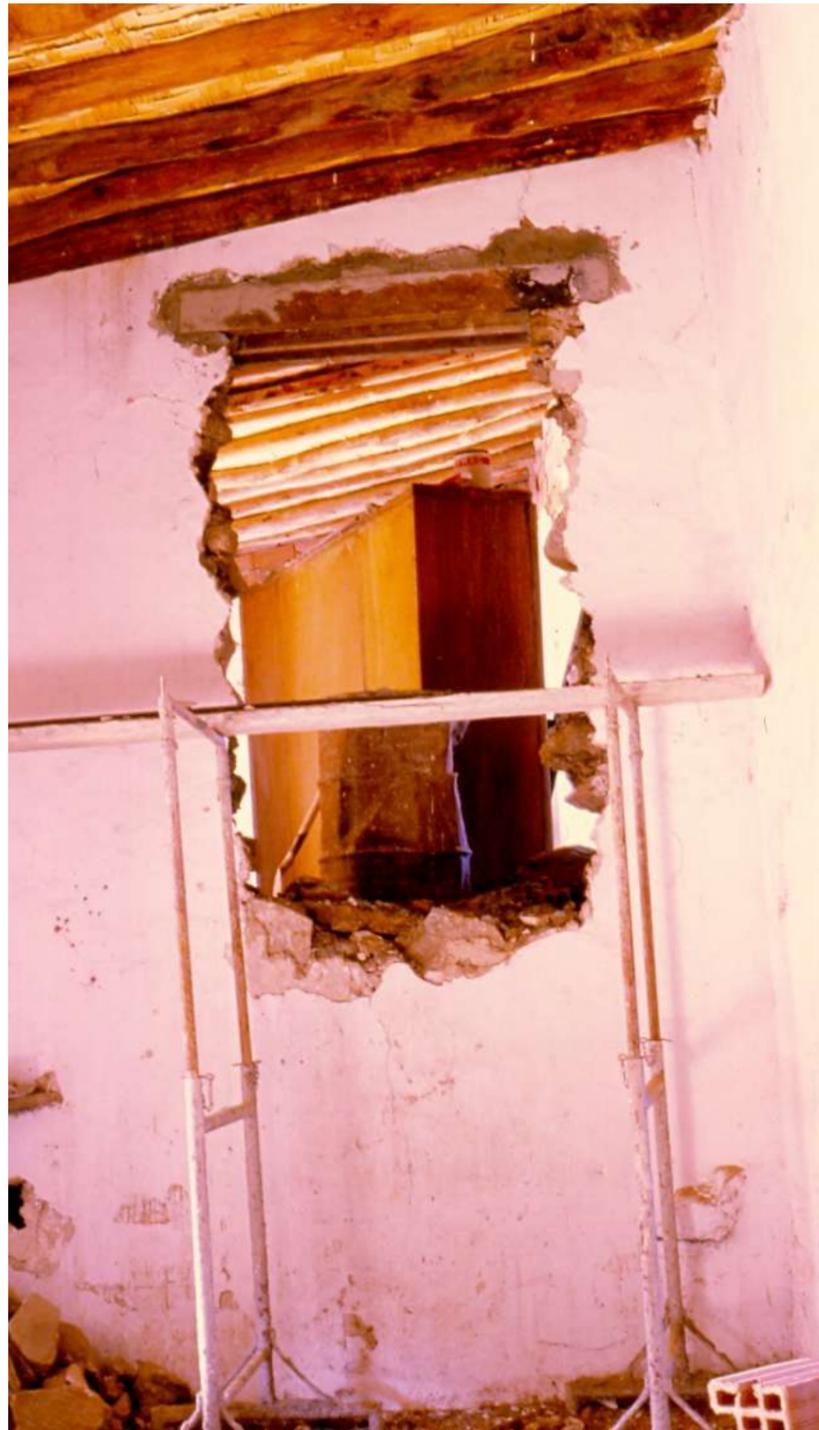
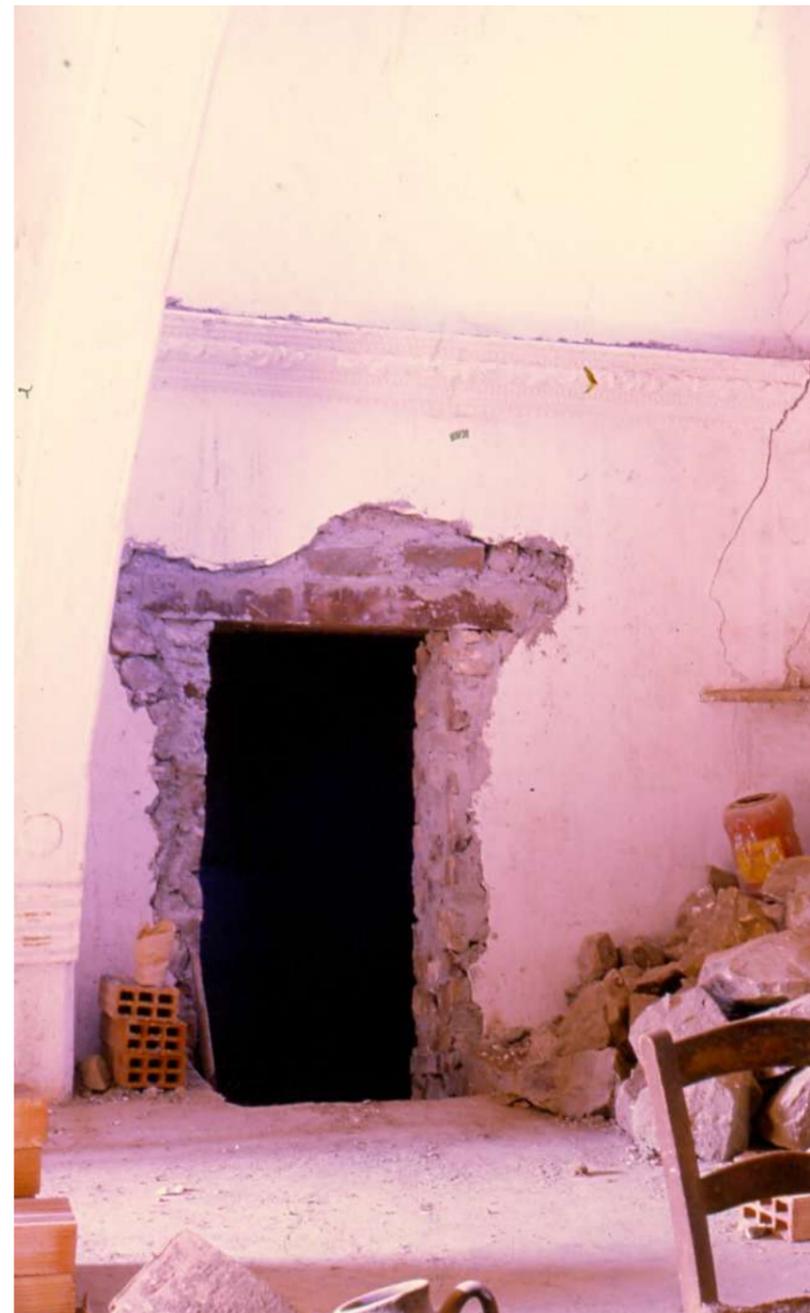
Fig.2-4: Openings between portico and upstairs rooms and large arched room and upper and lower side section of house.
© N. Chrysochou

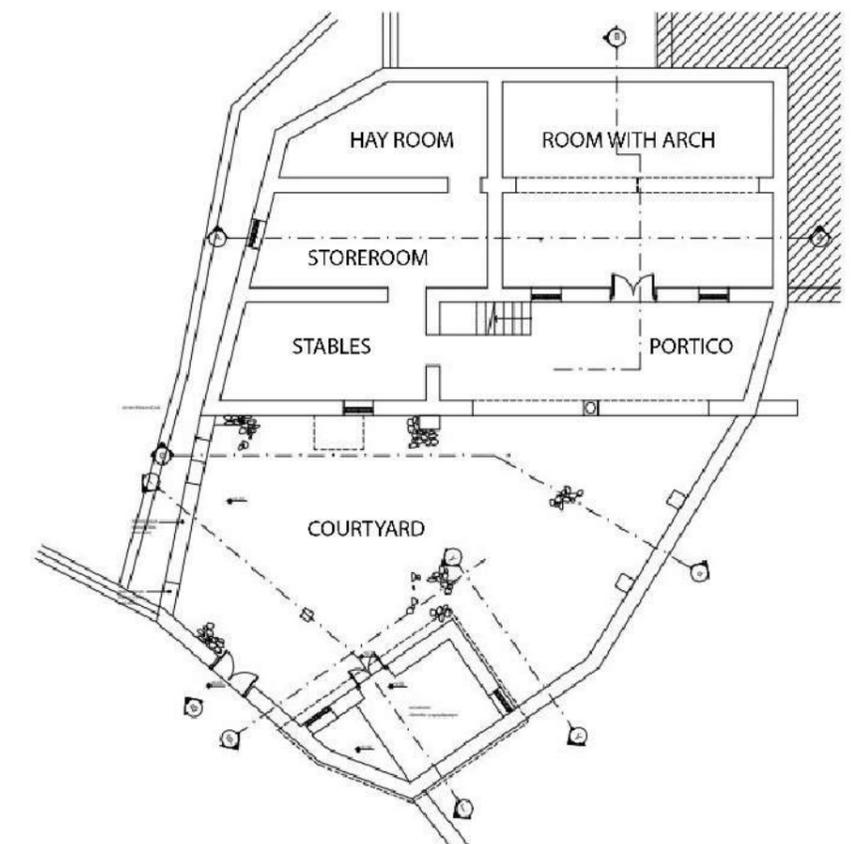
Fig.5: Existing Floor plan of house before conservation works.
© N. Chrysochou

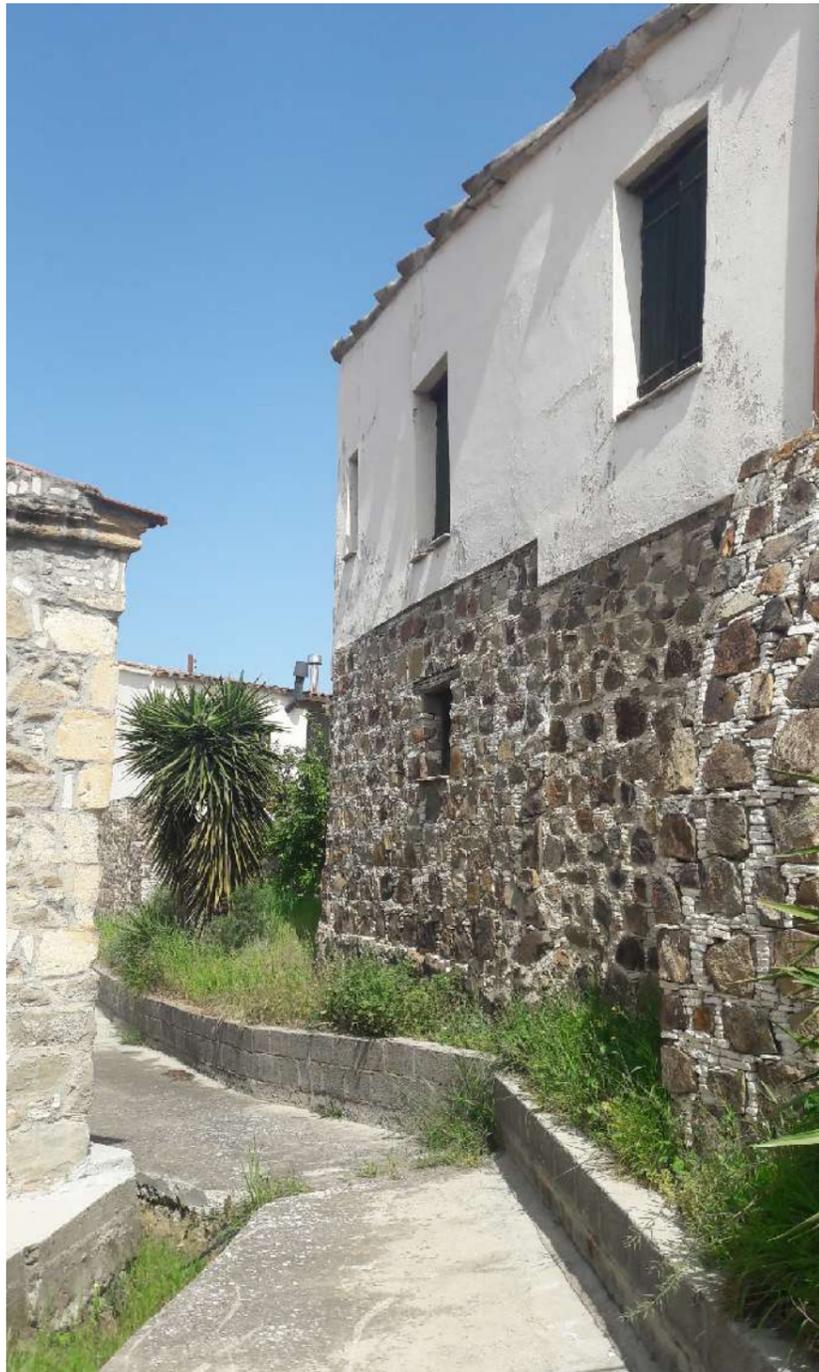
Fig.6: Side elevation of house. © N. Chrysochou

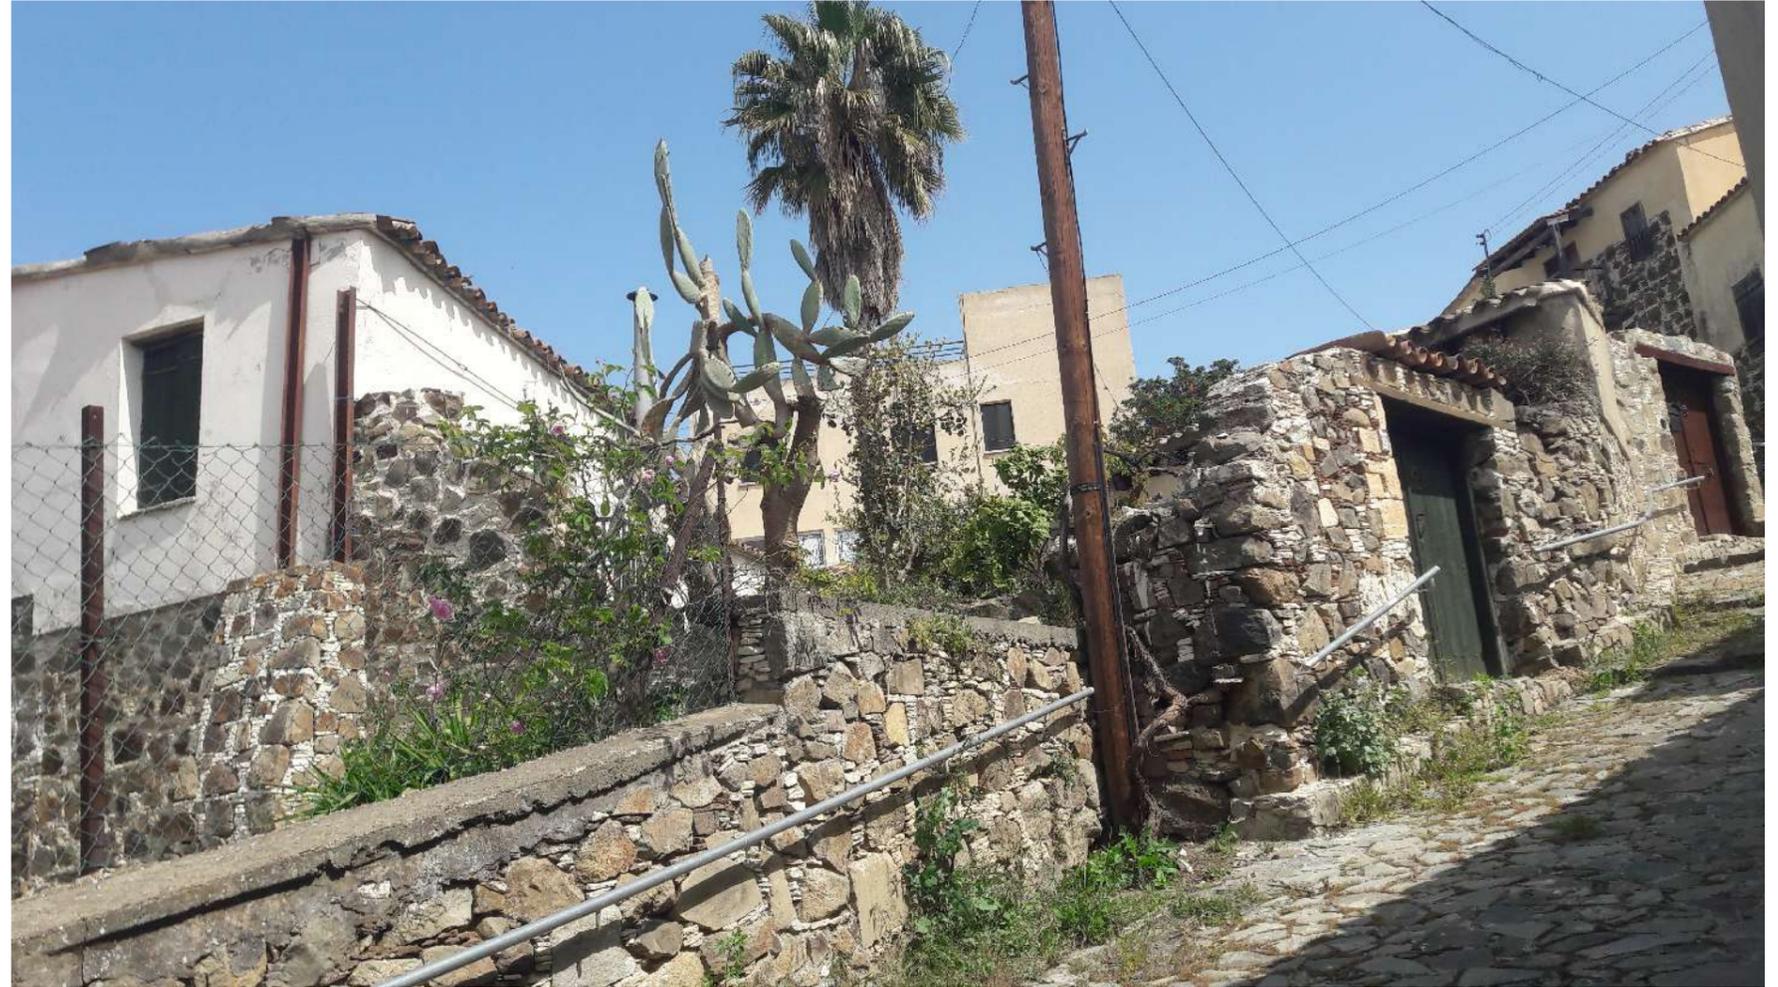
Fig.7: Pedestrian street elevation. © N. Chrysochou

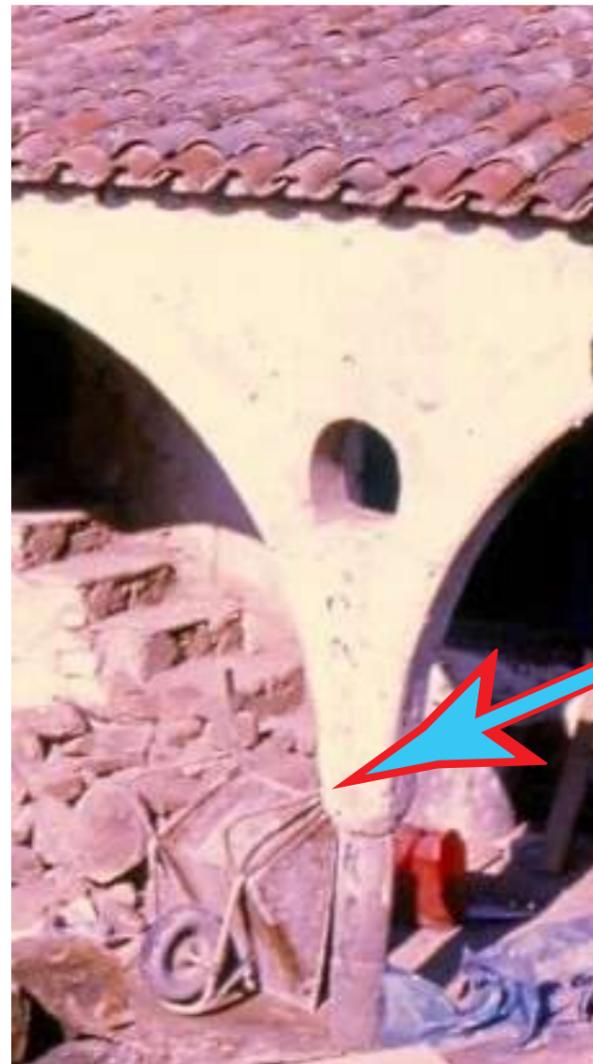
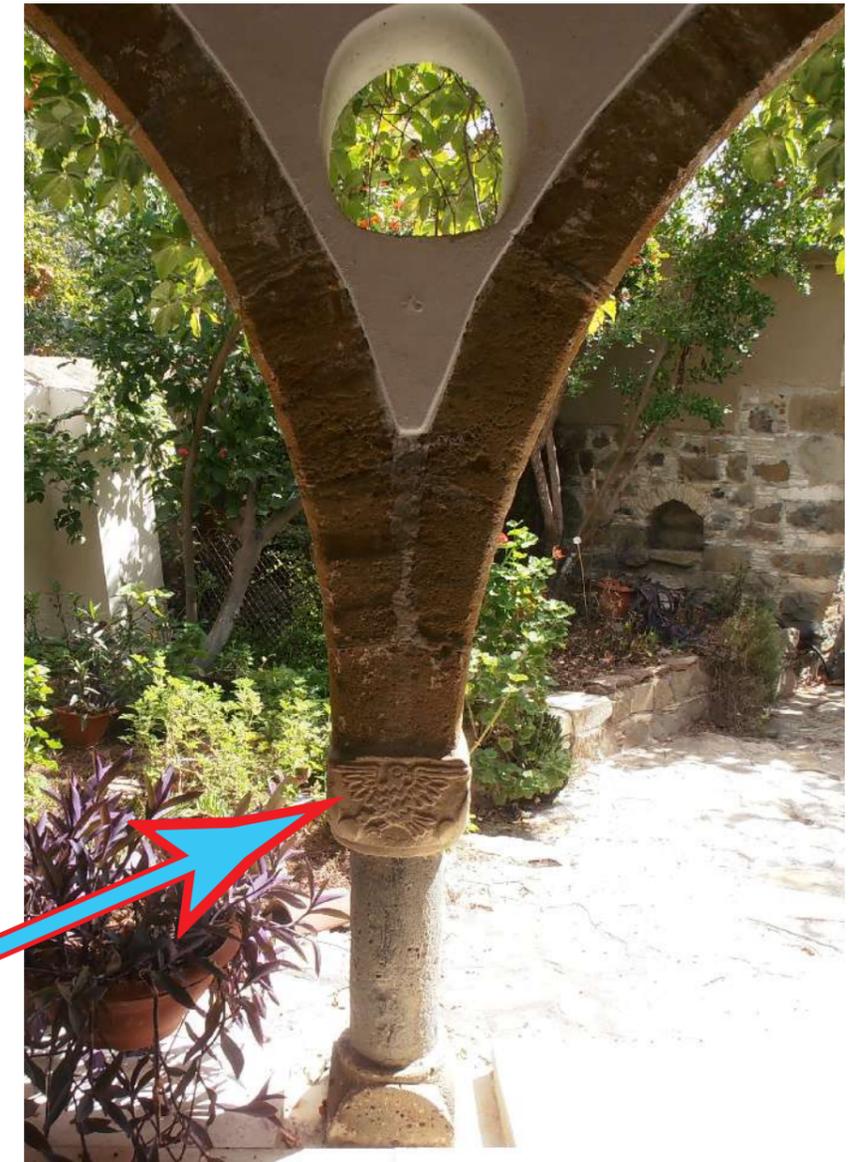
- absence of a heating/plumbing system
- absence of windows and doors
- absence of existing electrical and lighting systems;
- absence of a plumbing system.
- Absence of connections between the spaces meant the use of the external portico as a means of moving through the various parts
- The column supporting the portico arches was out of vertical plumb and the sandstone capital was dangerously eroded. It was obvious the foundation had shifted.

Fig.9-10: The main column supporting the arches of the portico had its deteriorating capital replaced while a second capital discovered during excavations for its foundation was used as a base. © N. Chrysochou

The most difficult and dangerous main structural work was the restoration of the column supporting the two arches of the portico. The arches were supported with scaffolding and the stone column was removed in order to construct a foundation. Upon digging for the foundation, a stone capital in reuse was discovered to have been used as a foundation stone. This was unearthed and once a proper foundation was built it was used as the base of the column while a new capital was sculpted by a famous local artist.

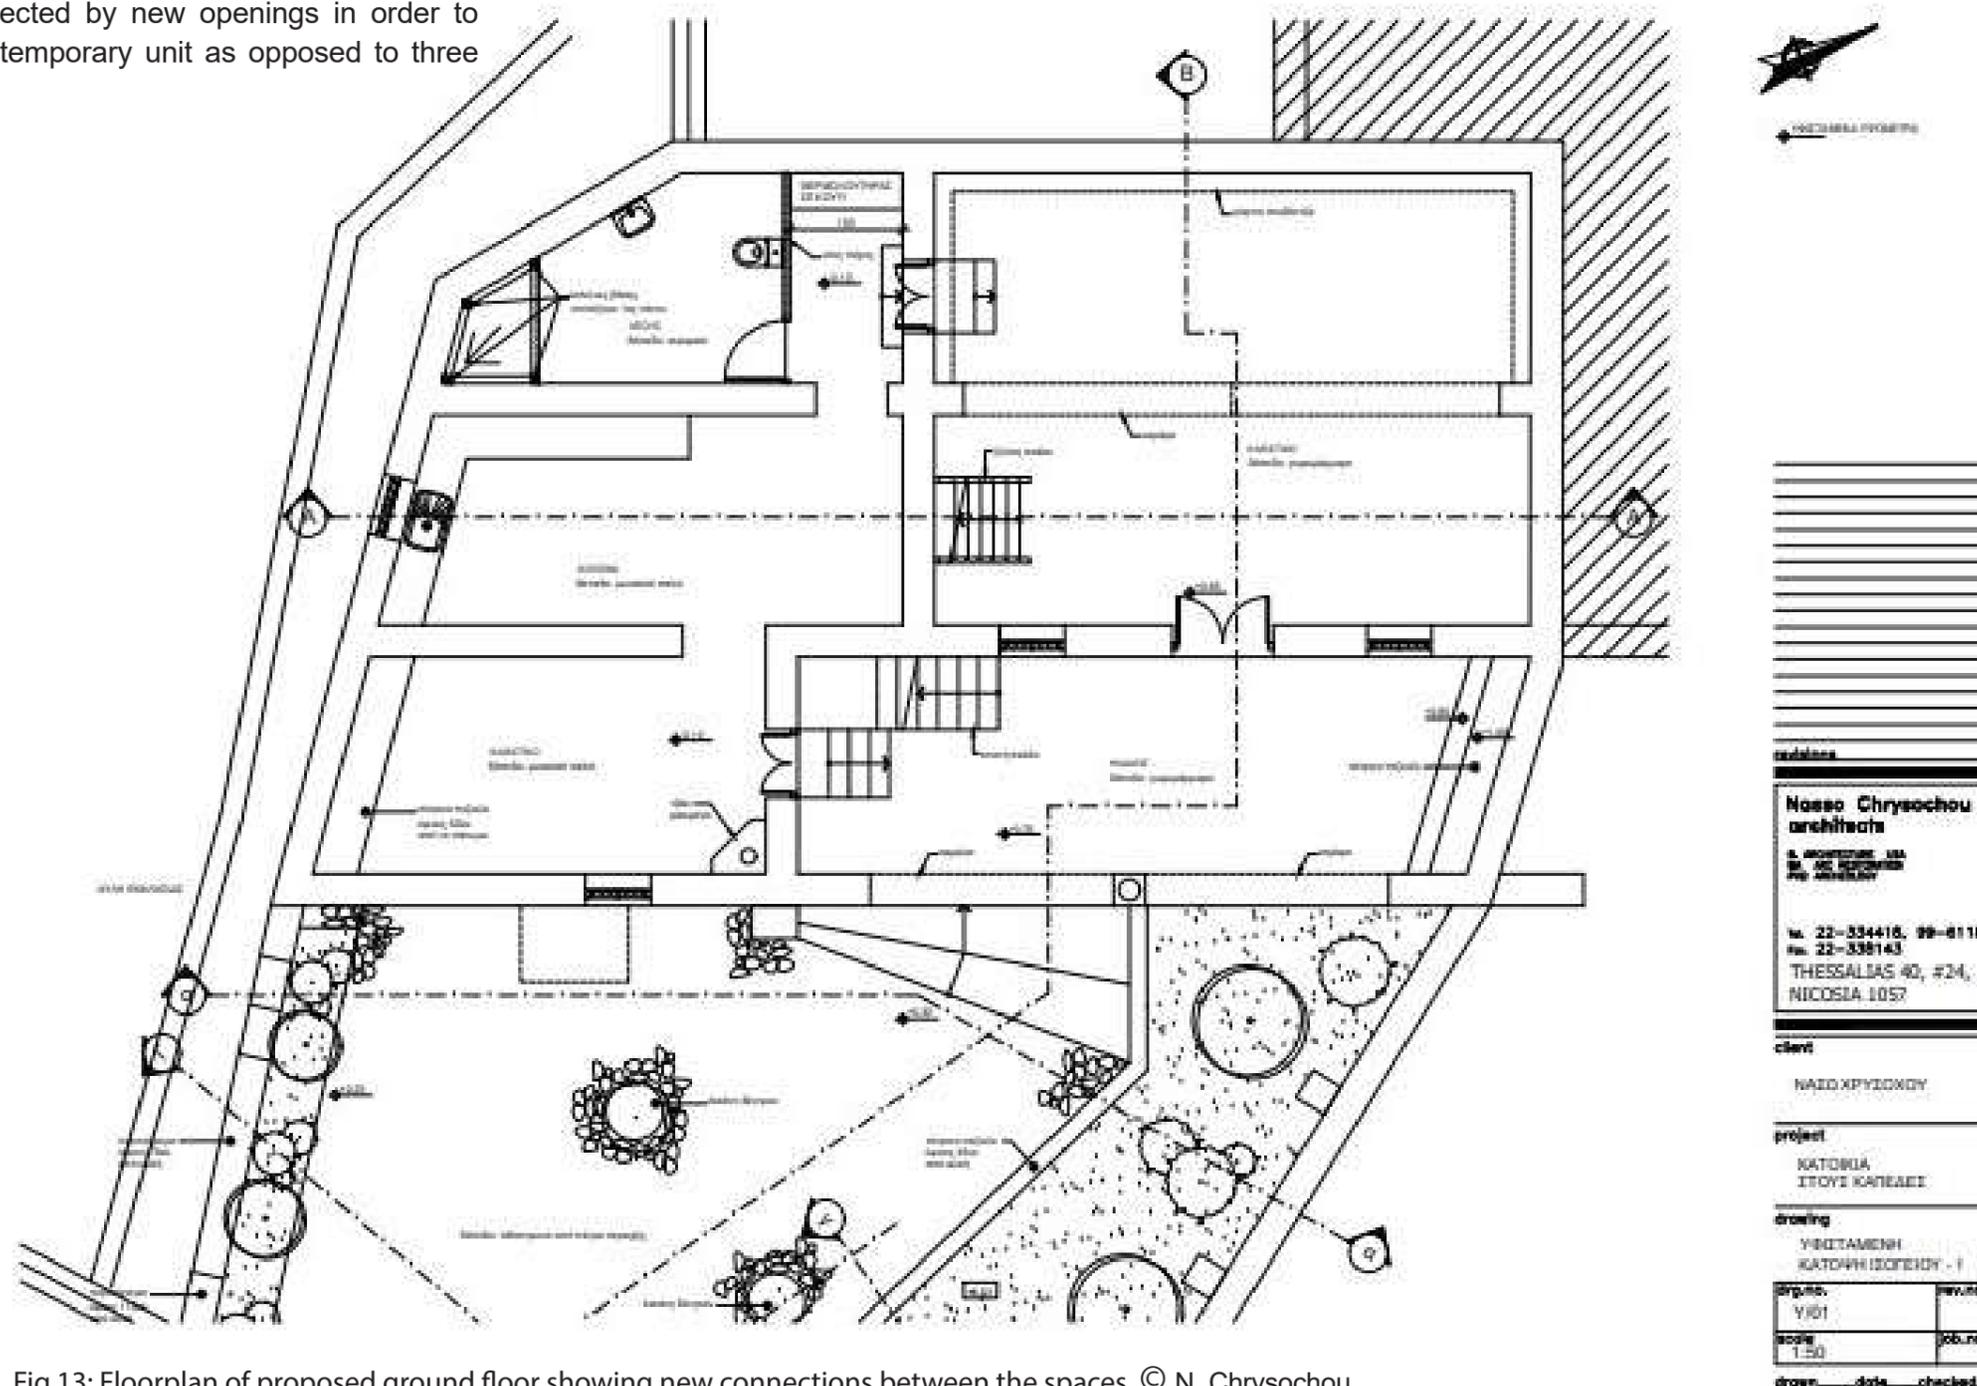
Fig.13: Floorplan of proposed ground floor showing new connections between the spaces. © N. Chrysochou

The various spaces of the stable, the storerooms and the main arched space were connected by new openings in order to make the house one contemporary unit as opposed to three separate parts.

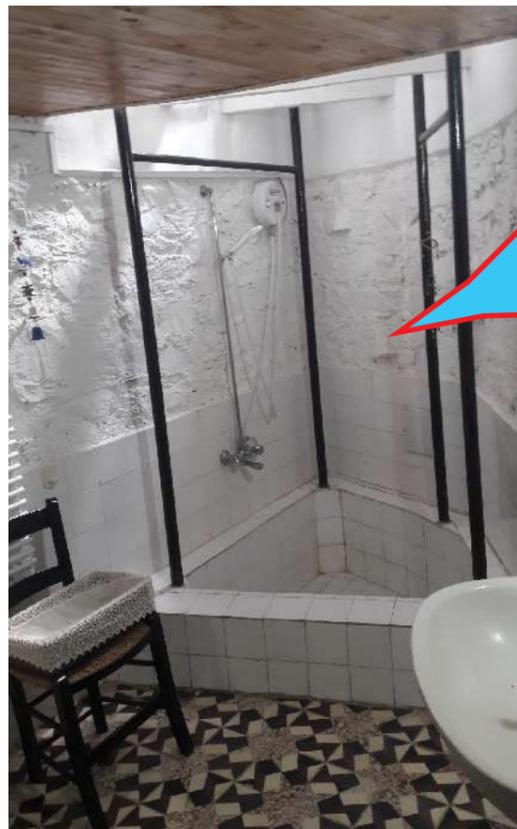
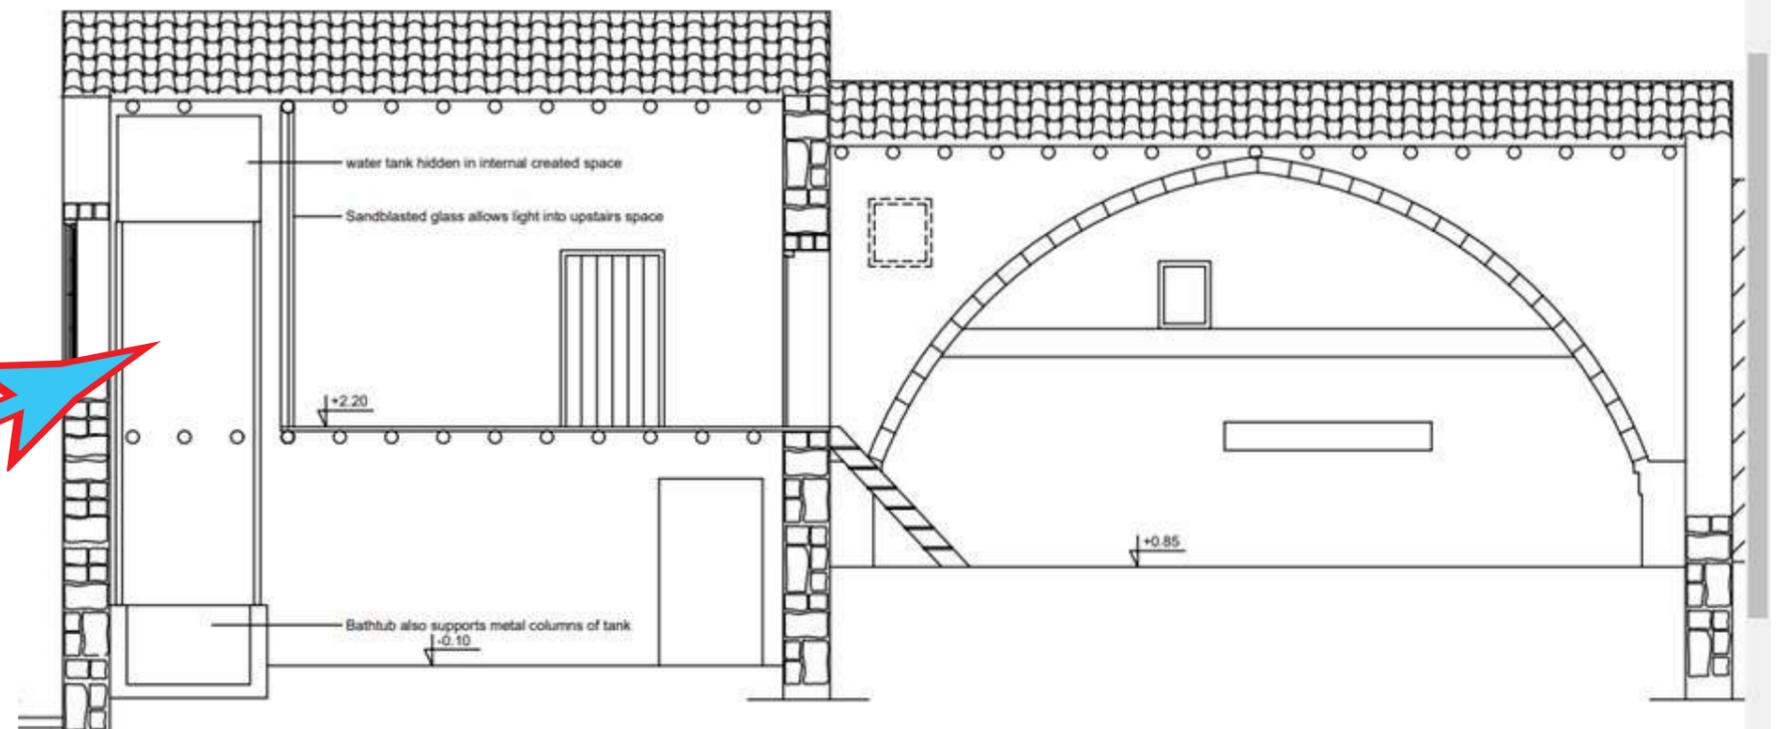
Fig.14-15: The space cut out of the upper room allowed the positioning of the water tank in a hidden space as well as the opening of a window in this space to allow lighting in a windowless room. (prior hay storeroom). © N. Chrysochou

The village does not have continuously running water therefore it was important to place a large water storage unit somewhere in the building at a high area so that gravity would create pressure. Also, the far southwestern corner room used as a hay storeroom had no windows. As its walls were of stone and two stories high, a window was punctured on the second floor and a shaft was cut out of the upstairs room in order to accommodate in it the water tank placed upon columns high into the roof space. The window in this shaft lights the bathroom space but also the upstairs room as a sandblasted glass screen allows light to enter without interrupting the privacy of the bath space below. As the water tank stands suspended in this shaft a built-in bathtub was created under it.

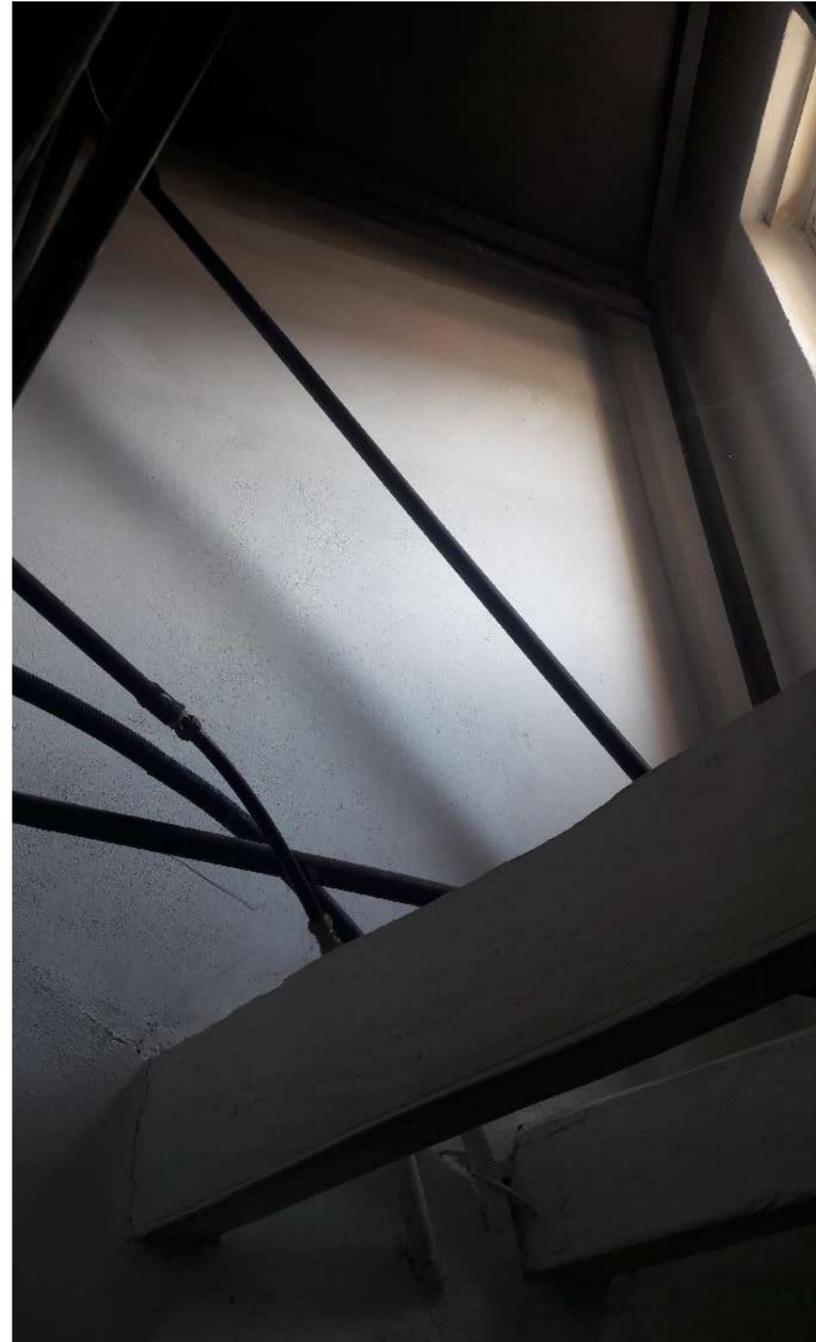
Fig.16-17: Space hiding tank (behind cupboard) is glassed in with sandblasted operable glass doors for servicing. © N. Chrysochou

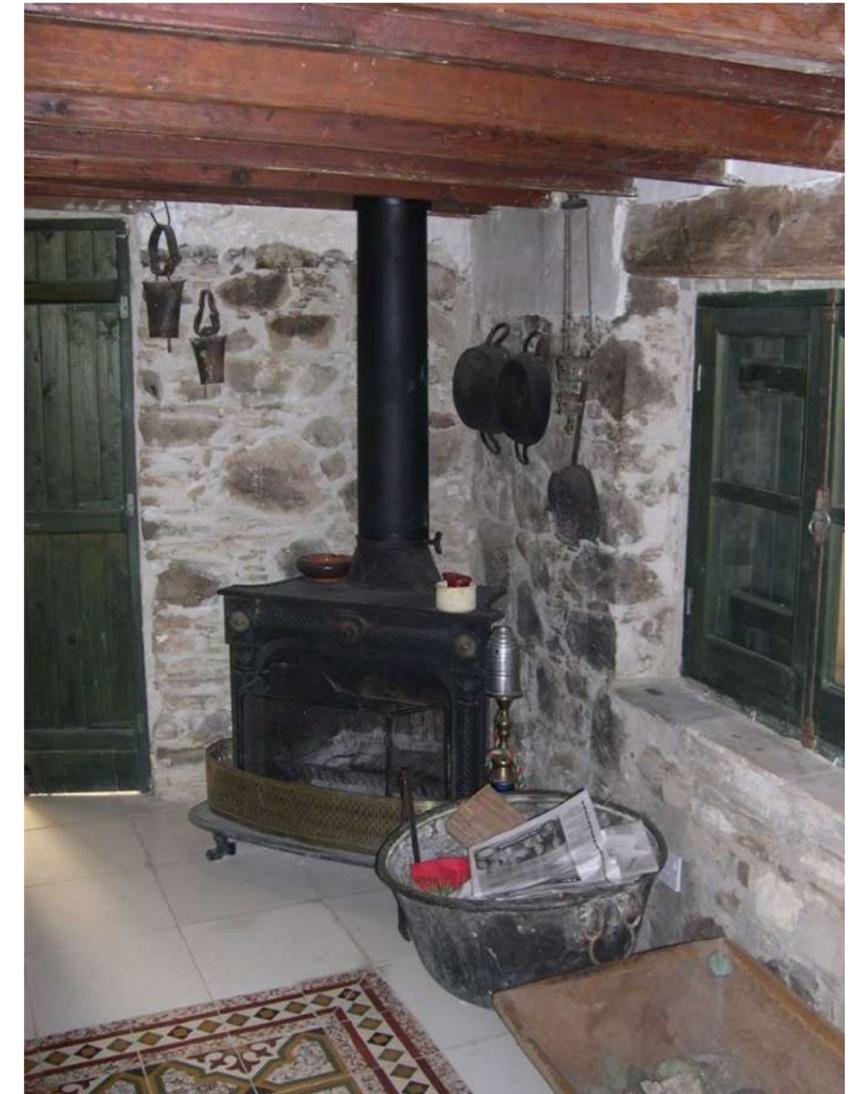
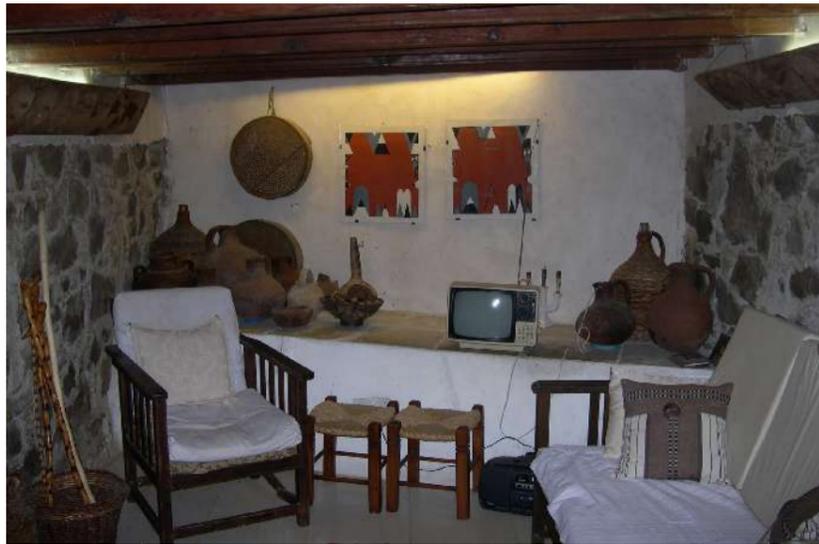
Fig.18: Reuse of features and items found in house such as trough and wooden bread boards which hide modern lighting.
© N. Chrysochou

Fig.19: Reuse of features and items found in house such as trough and wooden bread boards which hide modern lighting.
© N. Chrysochou

The stable trough was reused as a sitting bench, while lighting was hidden behind hanging wooden bread boards.

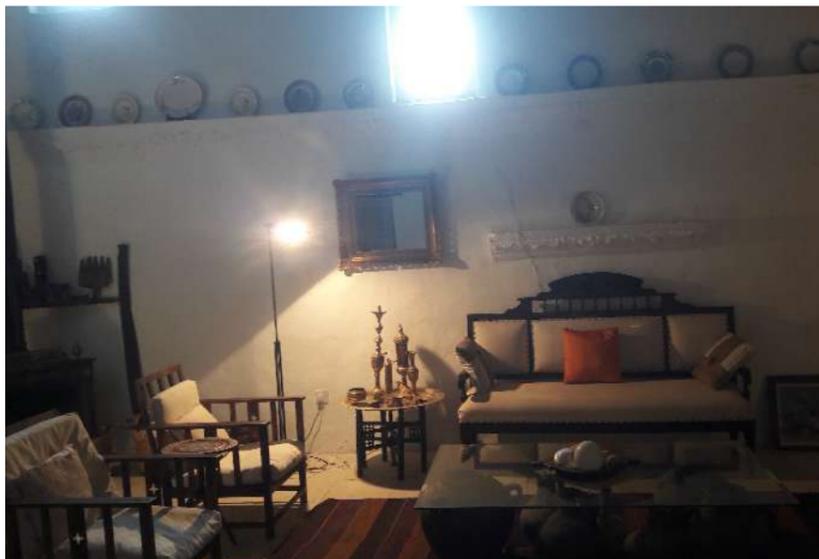
Fig.20: The large arched room had a wood burning stove inserted for heating. © N. Chrysochou

The heating is done through two wood burning stoves in the downstairs sitting room (prior stable) and the arched large space. Its chimney flute also warms the upstairs space.

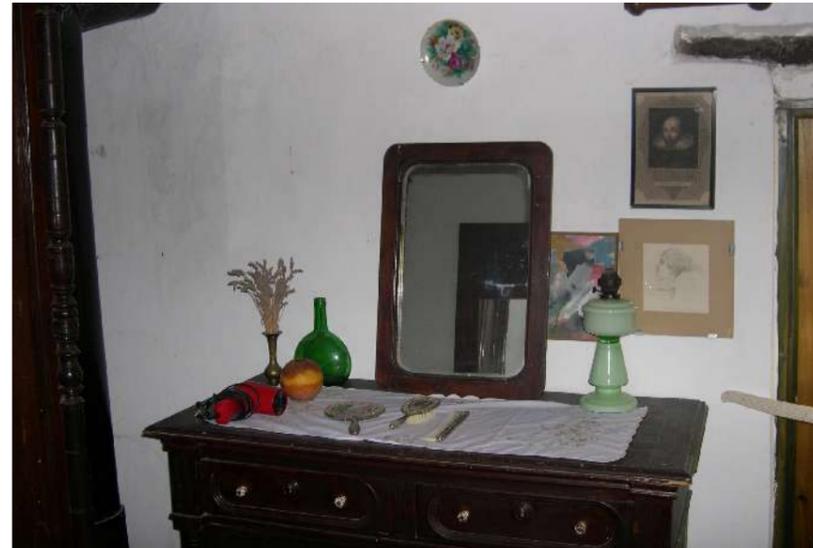
Fig.21: Flue of downstairs fire place passes through upstairs bedroom to heat it. © N. Chrysochou

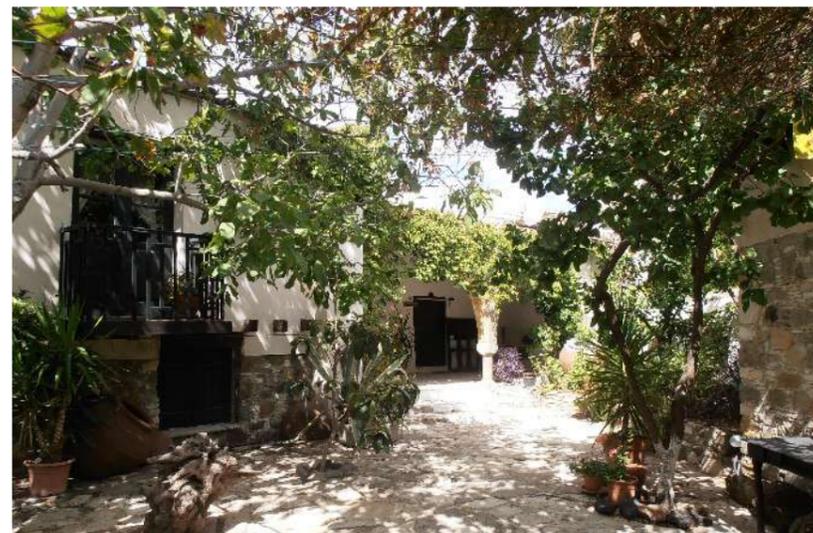
Fig.22: Courtyard after planting. © N. Chrysochou

The garden was planted in such a way as to reduce heat gain both to the courtyard as well as the portico and the house. Deciduous trees were planted to provide shade in the summer but also sunlight in the winter. Once the leaves fall in the winter, the thick stone and adobe walls act as thermal mass collectors that retain heat and release it internally at night. There is at least a 4 degree cent. difference in the summer between the shaded courtyard and neighboring unplanted ones.

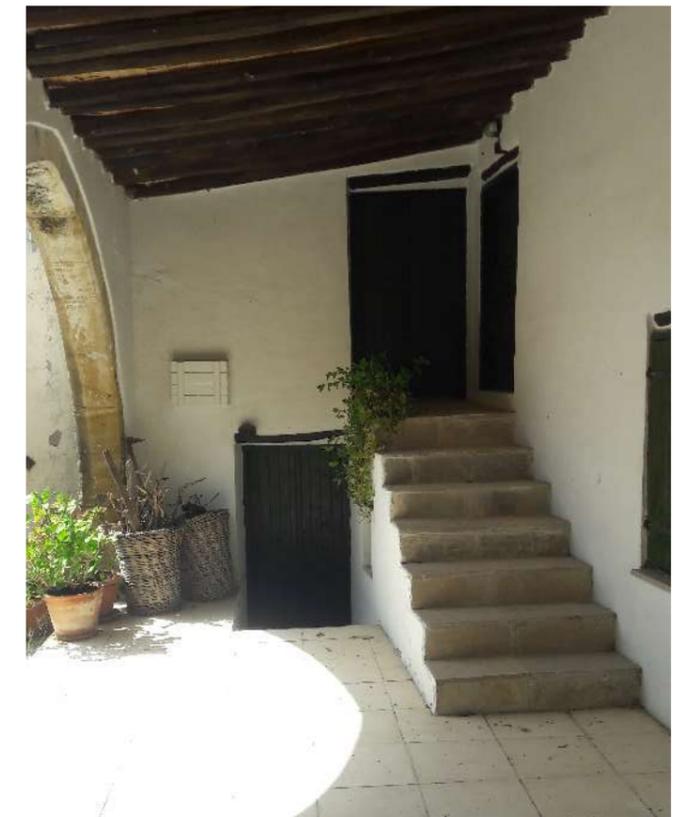
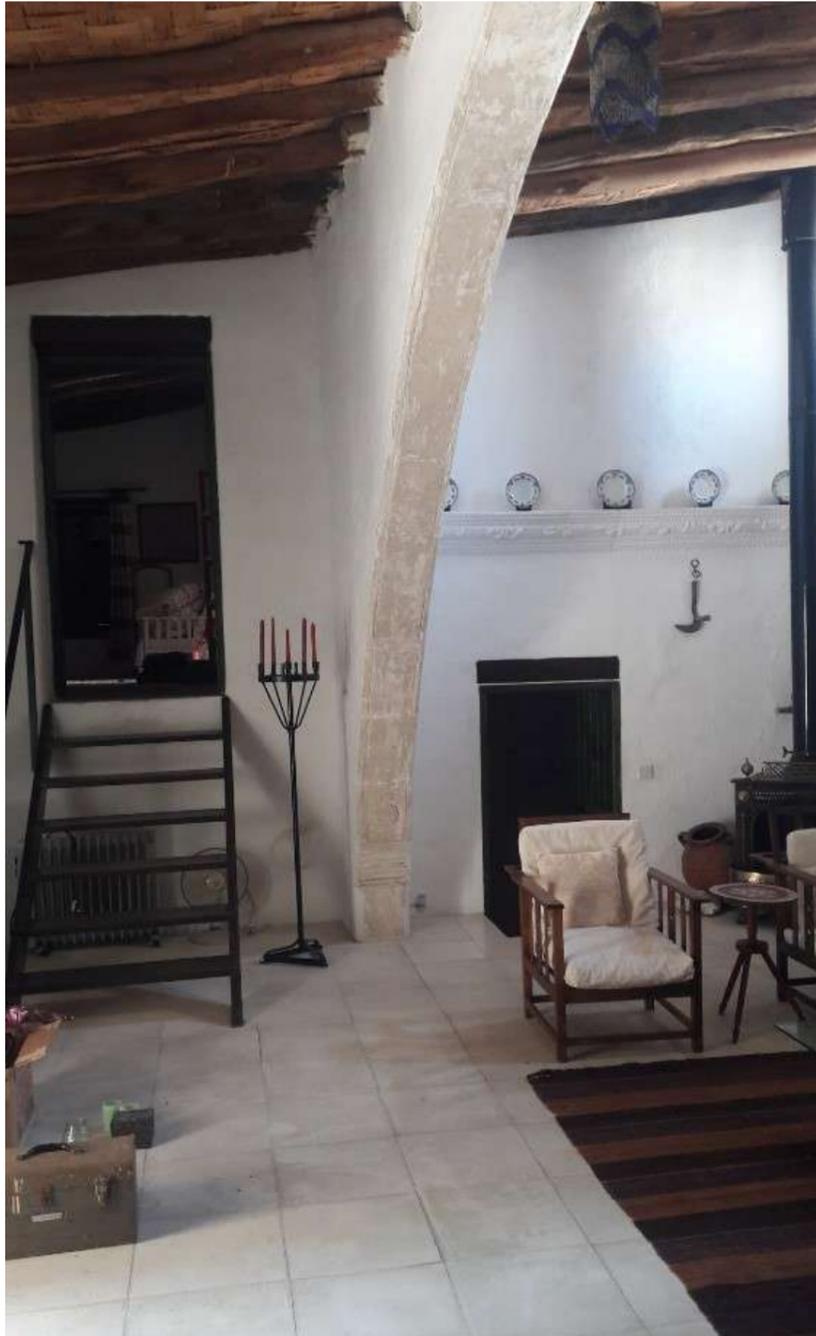
Fig.23-24: Openings connecting the portico with upstairs and large room with lower and upper spaces. © N. Chrysochou

The intervention project is also aimed at implementing accessibility, through the introduction of stairs and openings to allow internal connections for the various spaces.
