The rehabilitation of the Sant Antoni Market, as a trampoline for a neighborhood.

Rehabilitation and revitalization of an old iron market in Barcelona.

Site Mercat de Sant Antoni, carrer Comte d'Urgell 1, Barcelona, Catalunya, Spain

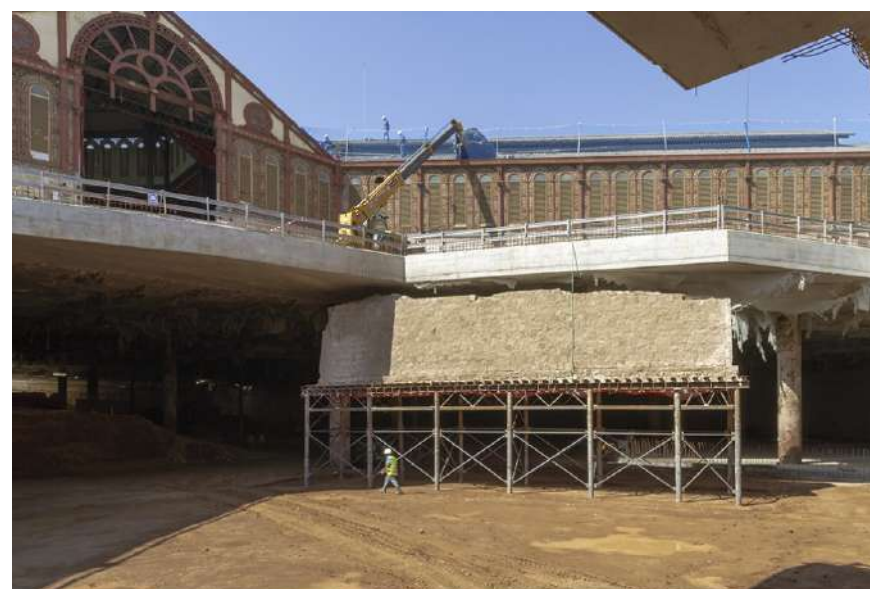
Fig.1: Remains of the original bastion and its position in relation to the market.

In addition, the underground floors had to be built again by excavating in the ground. All of them with a robust reinforced concrete structure and pile foundations. The only thing that needed to be rehabilitated in this area are the remains of the bastion of the original wall, which have been entirely preserved by re-shoring them for their support.

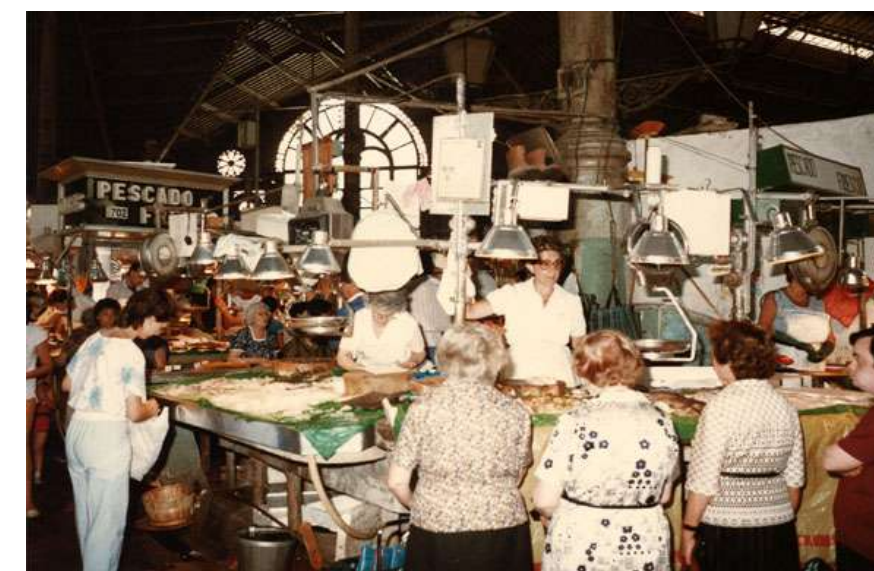
Fig.2: Stand at the Mercat de Sant Antoni, before the refurbishment.

comfortable place to shop it was open to the outside but at the same time sheltered and there was a diversity of products. Over the years, in addition to the general aging of the equipment, there were deficiencies in the dimensions of the aisles and stalls and in the spaces for loading and unloading. For this reason, in 2007 a call for tenders was issued for its rehabilitation.

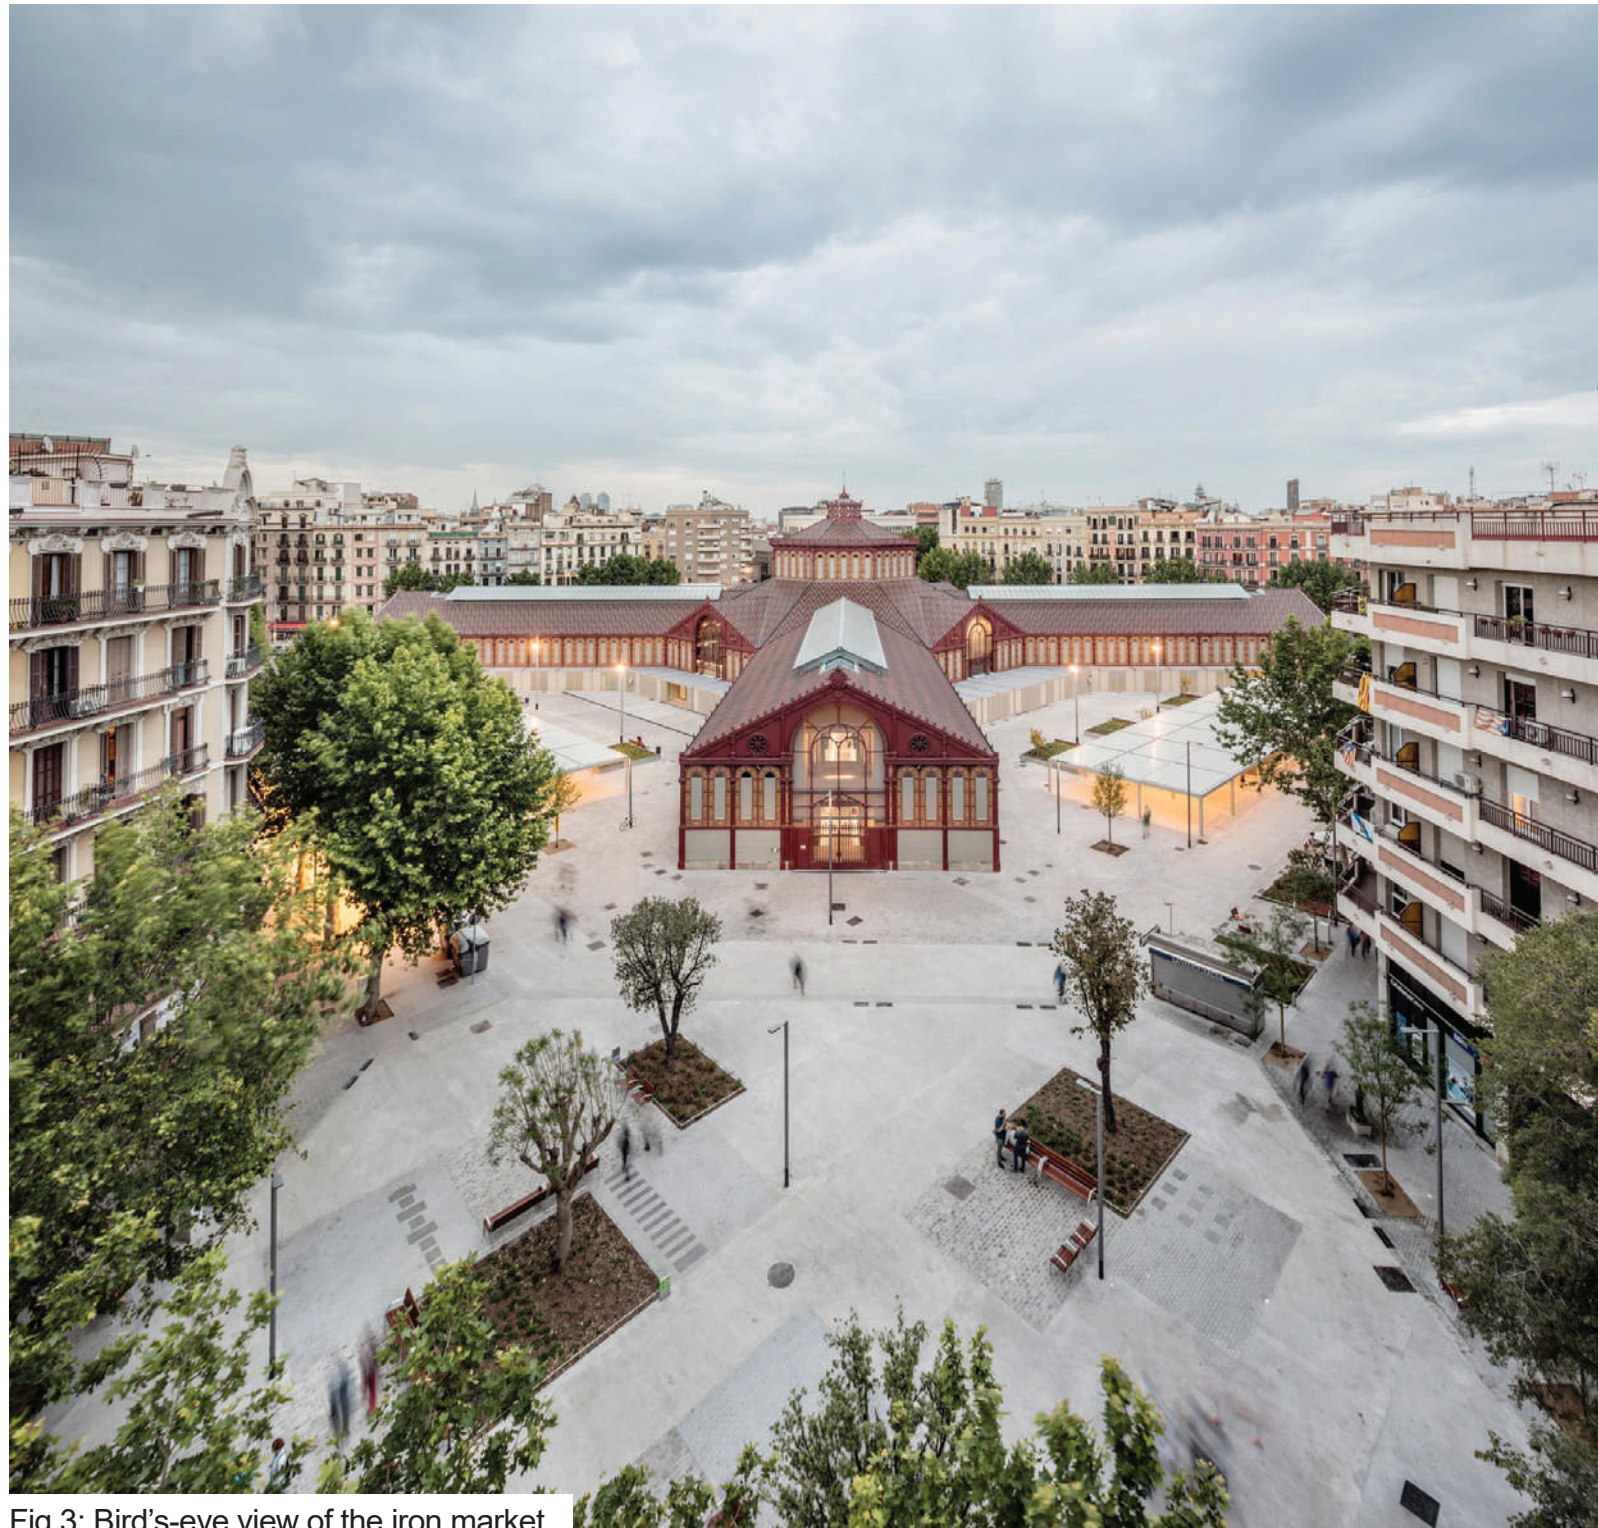
Fig.3: Bird's-eye view of the iron market.

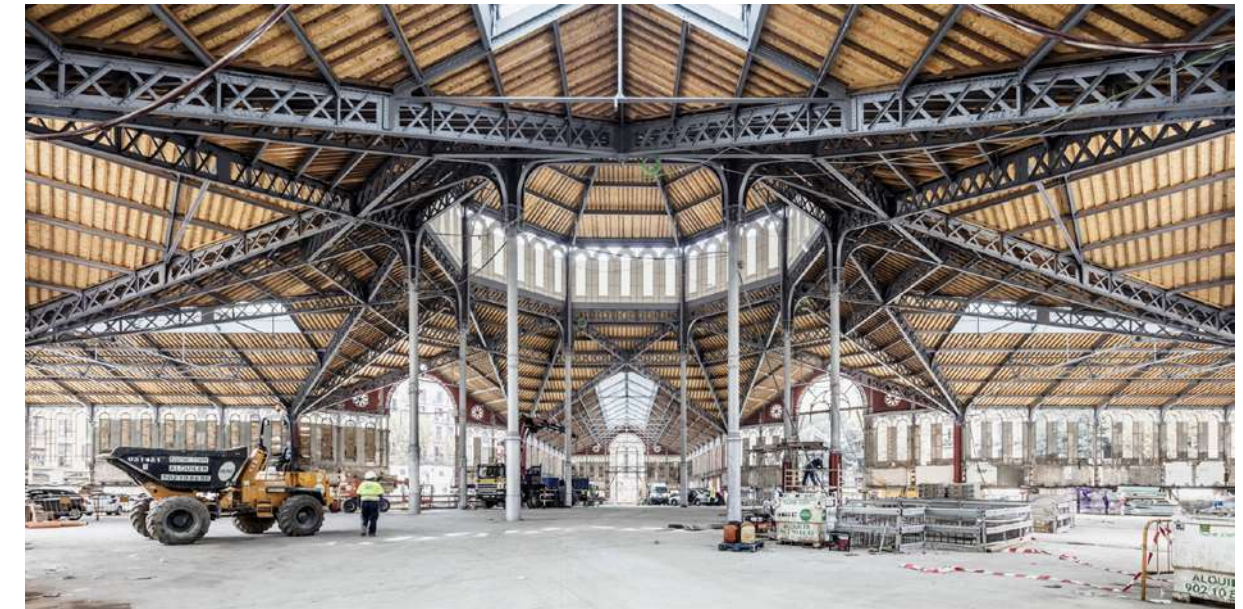
Fig.4: Interior view of the market, where the entire original cast-iron structure can be seen.

Most of the building was in good condition. For this reason, the iron structure was able to be preserved and, therefore the entire envelope. However, the roof required total renovation due to its poor state of preservation.

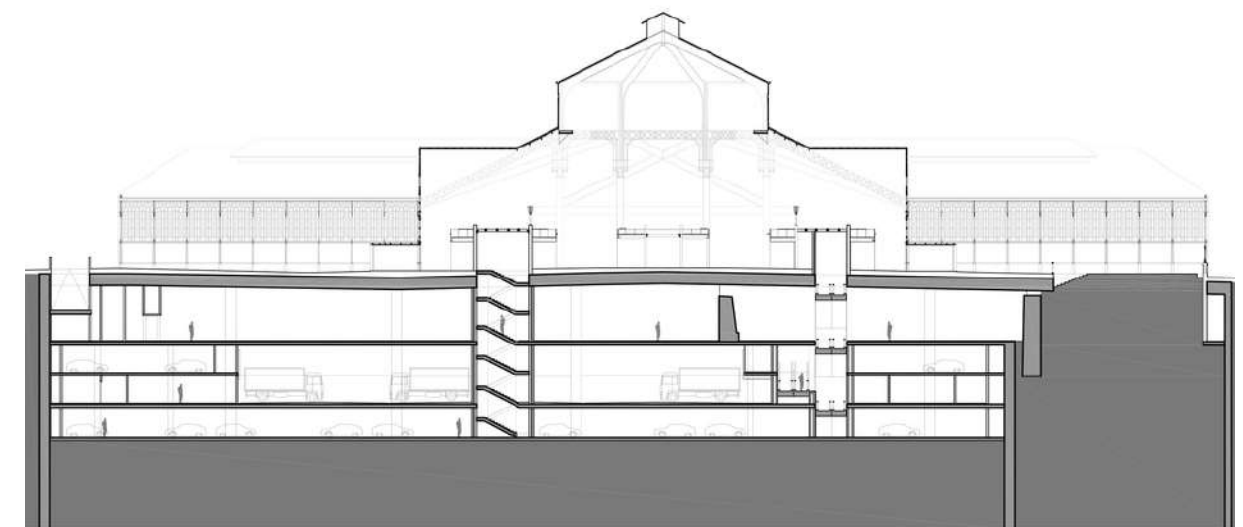
Fig.5: General Section.

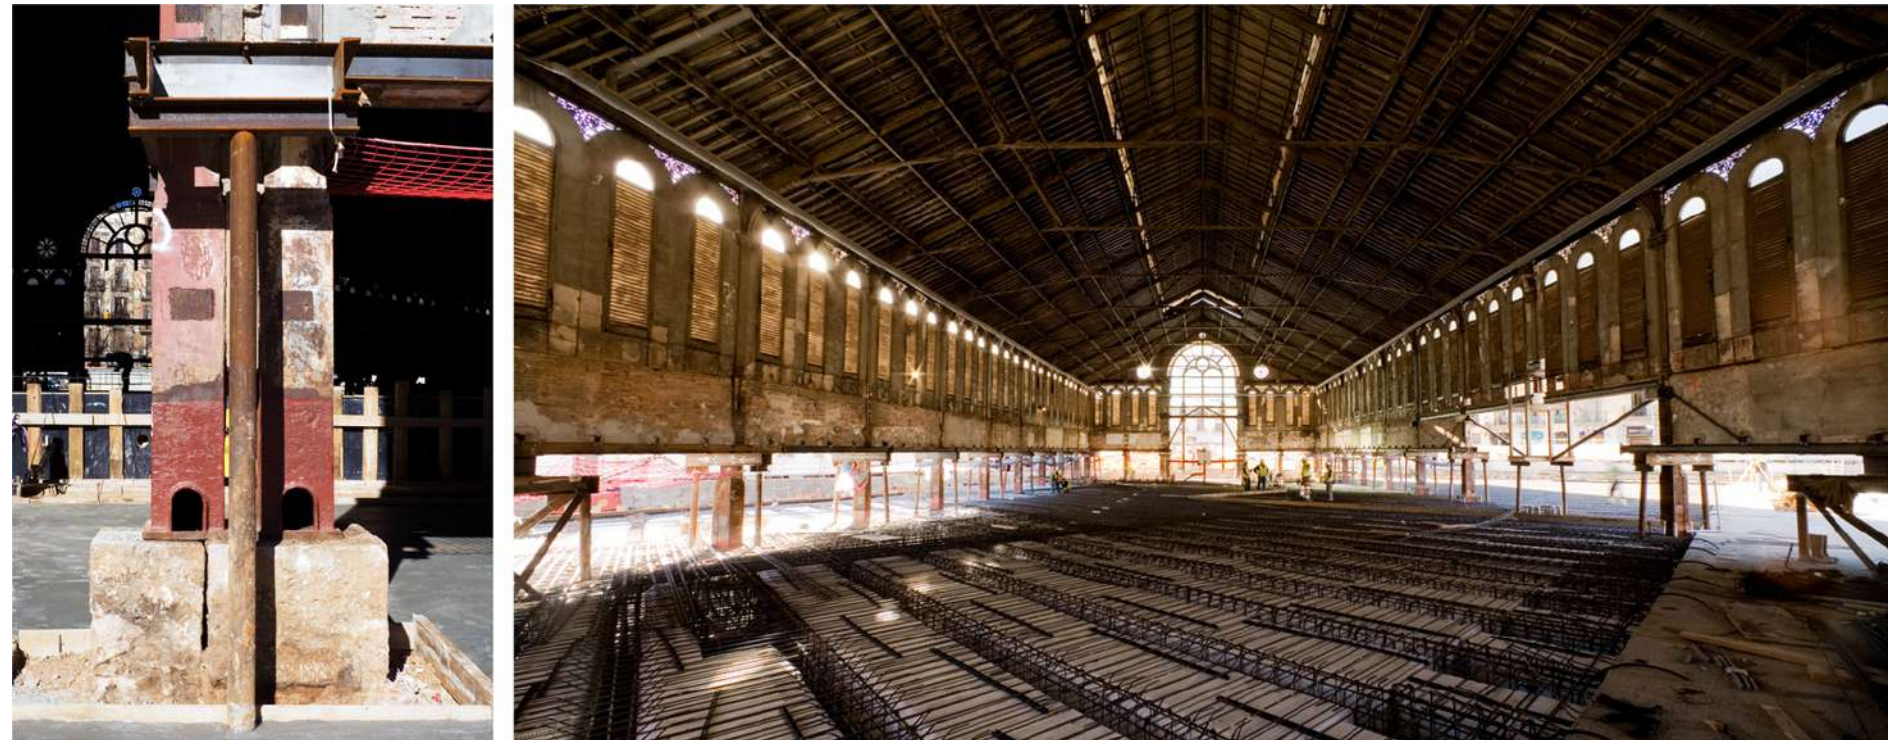
Fig.6: Old façade fastened to allow the concrete to be poured for the new floor slab.

Despite having a similar appearance to the original, there are many significant changes. First of all, on the outside (where most of the market is located) the entire facade has been preserved (including the masonry walls, windows and iron parts); to do so, the adjacent buildings and enclosures were demolished, leaving the volume as clean as possible. The main challenge in the refurbishment was the construction of four basement floors under the current floor of the market. These are destined to spaces for loading and unloading of products, parking, storage, and other businesses such as large commercial supermarkets. These operations involved the perimeter strapping of the façade, to be able to support and work under it.

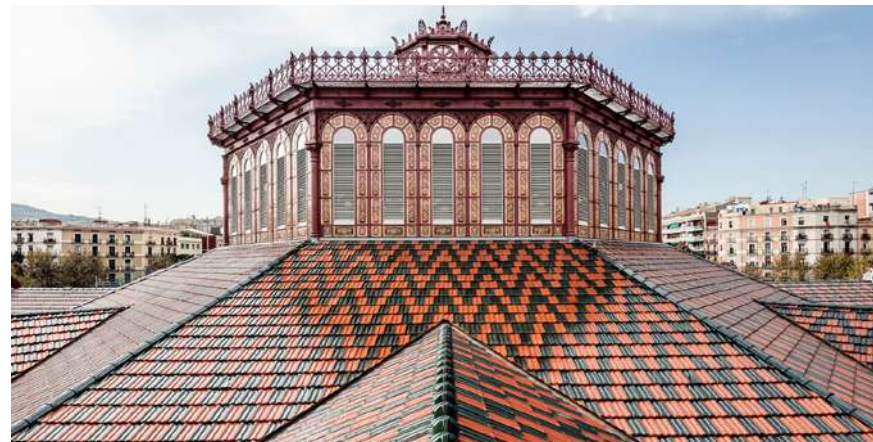
Fig.7: Roof and lantern, covered in colored ceramic tiles with patterns.

On the other hand, all the components of the roof have been changed since it was originally composed of glazed tiles, then it was changed to fiber cement and, with this rehabilitation, it was decided to return to glazed tiles (for aesthetic and health reasons). In addition, the slab, the floor of the market's ground floor, was re-concreted with a reinforcement suitable for the stresses it will be subjected to.

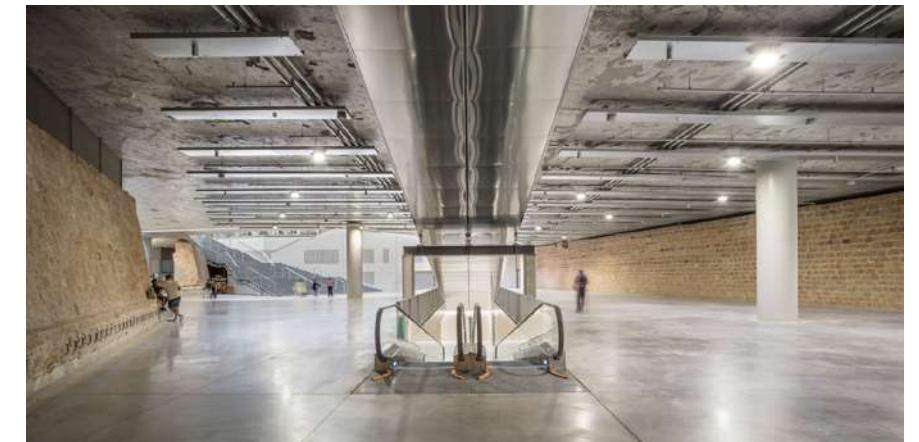
Fig.8: View of the underground floor level, with the remains of the baluard walls.
