Old Town Quarter for Youth Education.

Adaptation of a former candy factory in the Old Town of Vilnius to a school.

Site VILNIUS INTERNATIONAL SCHOOL
Vilnius, Rusų g. 5

Objectives Rehabilitation and reuse of historical houses, reconstruction from an industrial building to a school.

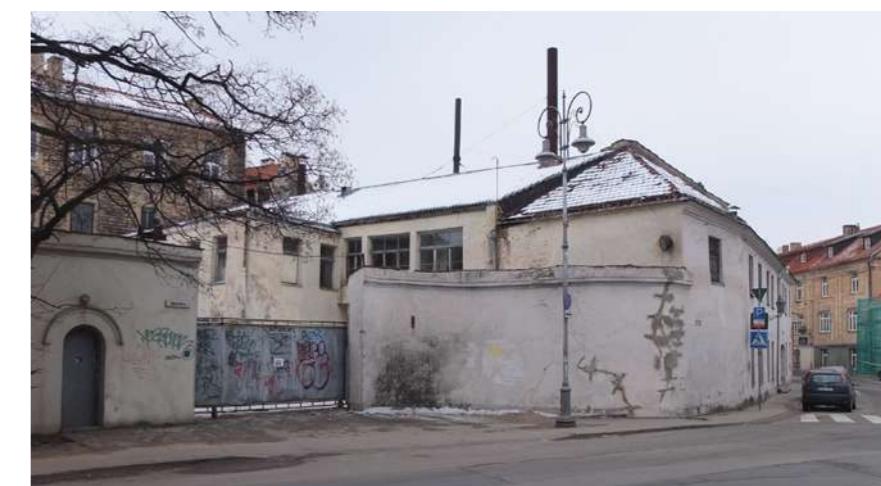
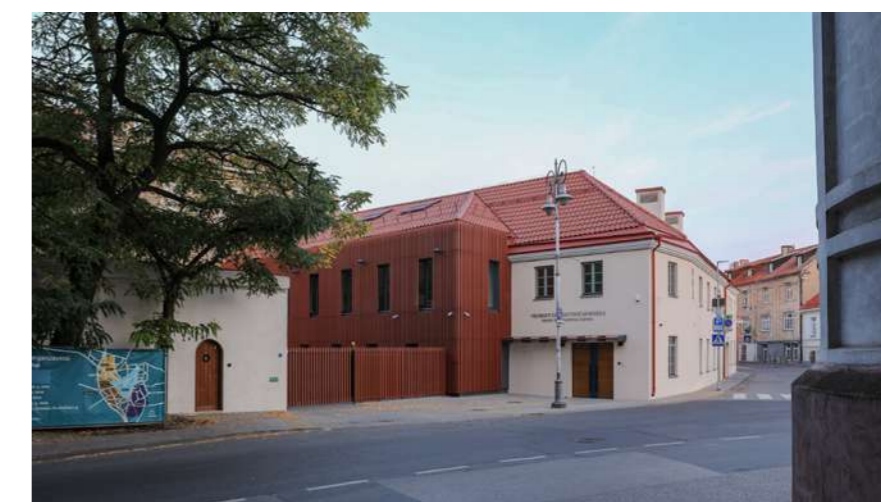
Fig.2: View of the complex from Maironio street before and after Rehabilitation.

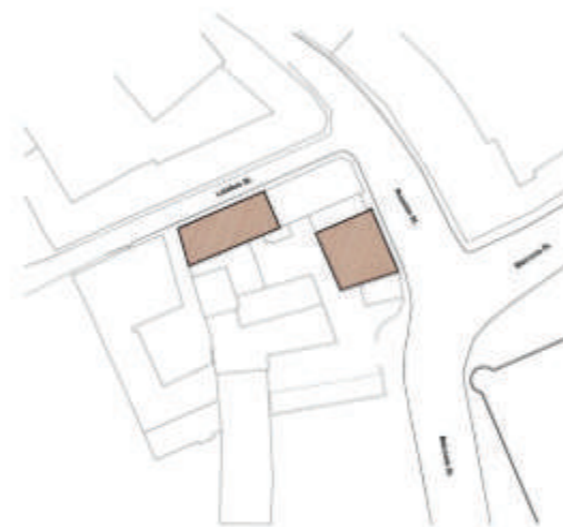
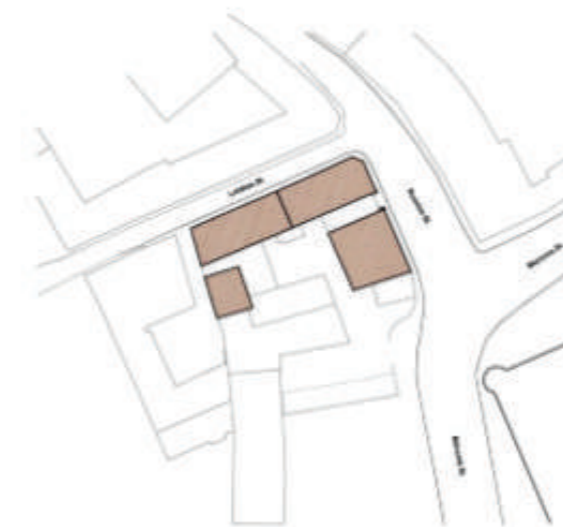
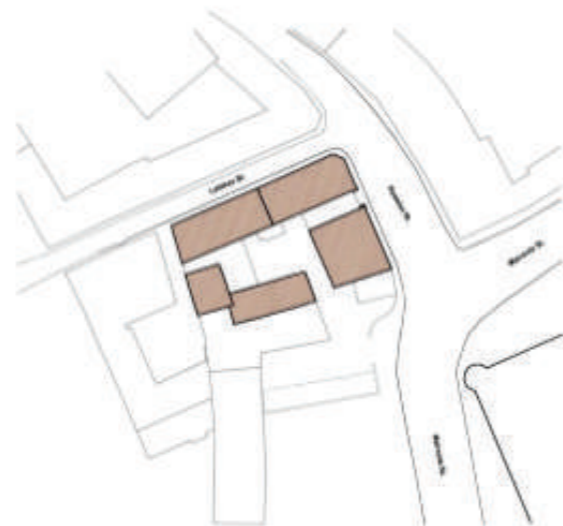
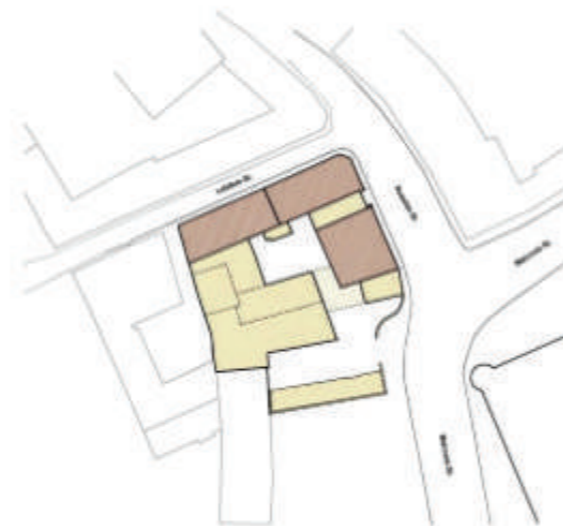
Fig.3: View of the complex from Maironio street before and after Rehabilitation.

1790 the former wooden mansion is mentioned

From 1806 to 1808, the plot had a tavern, a café and a craft workshop.

1840 the plot with buildings was handed over to the Orthodox church.

1921 There was a café "Fortuna" with an entrance in the corner of the building at the intersection of streets. A cottage for a guard was built.

From 1945 to 1957, a major reconstruction took place, during which the second floor was built for the southern building, and a fence was built.

From 2019 to 2020, reconstruction of the former confectionary into the VIS high school annex.

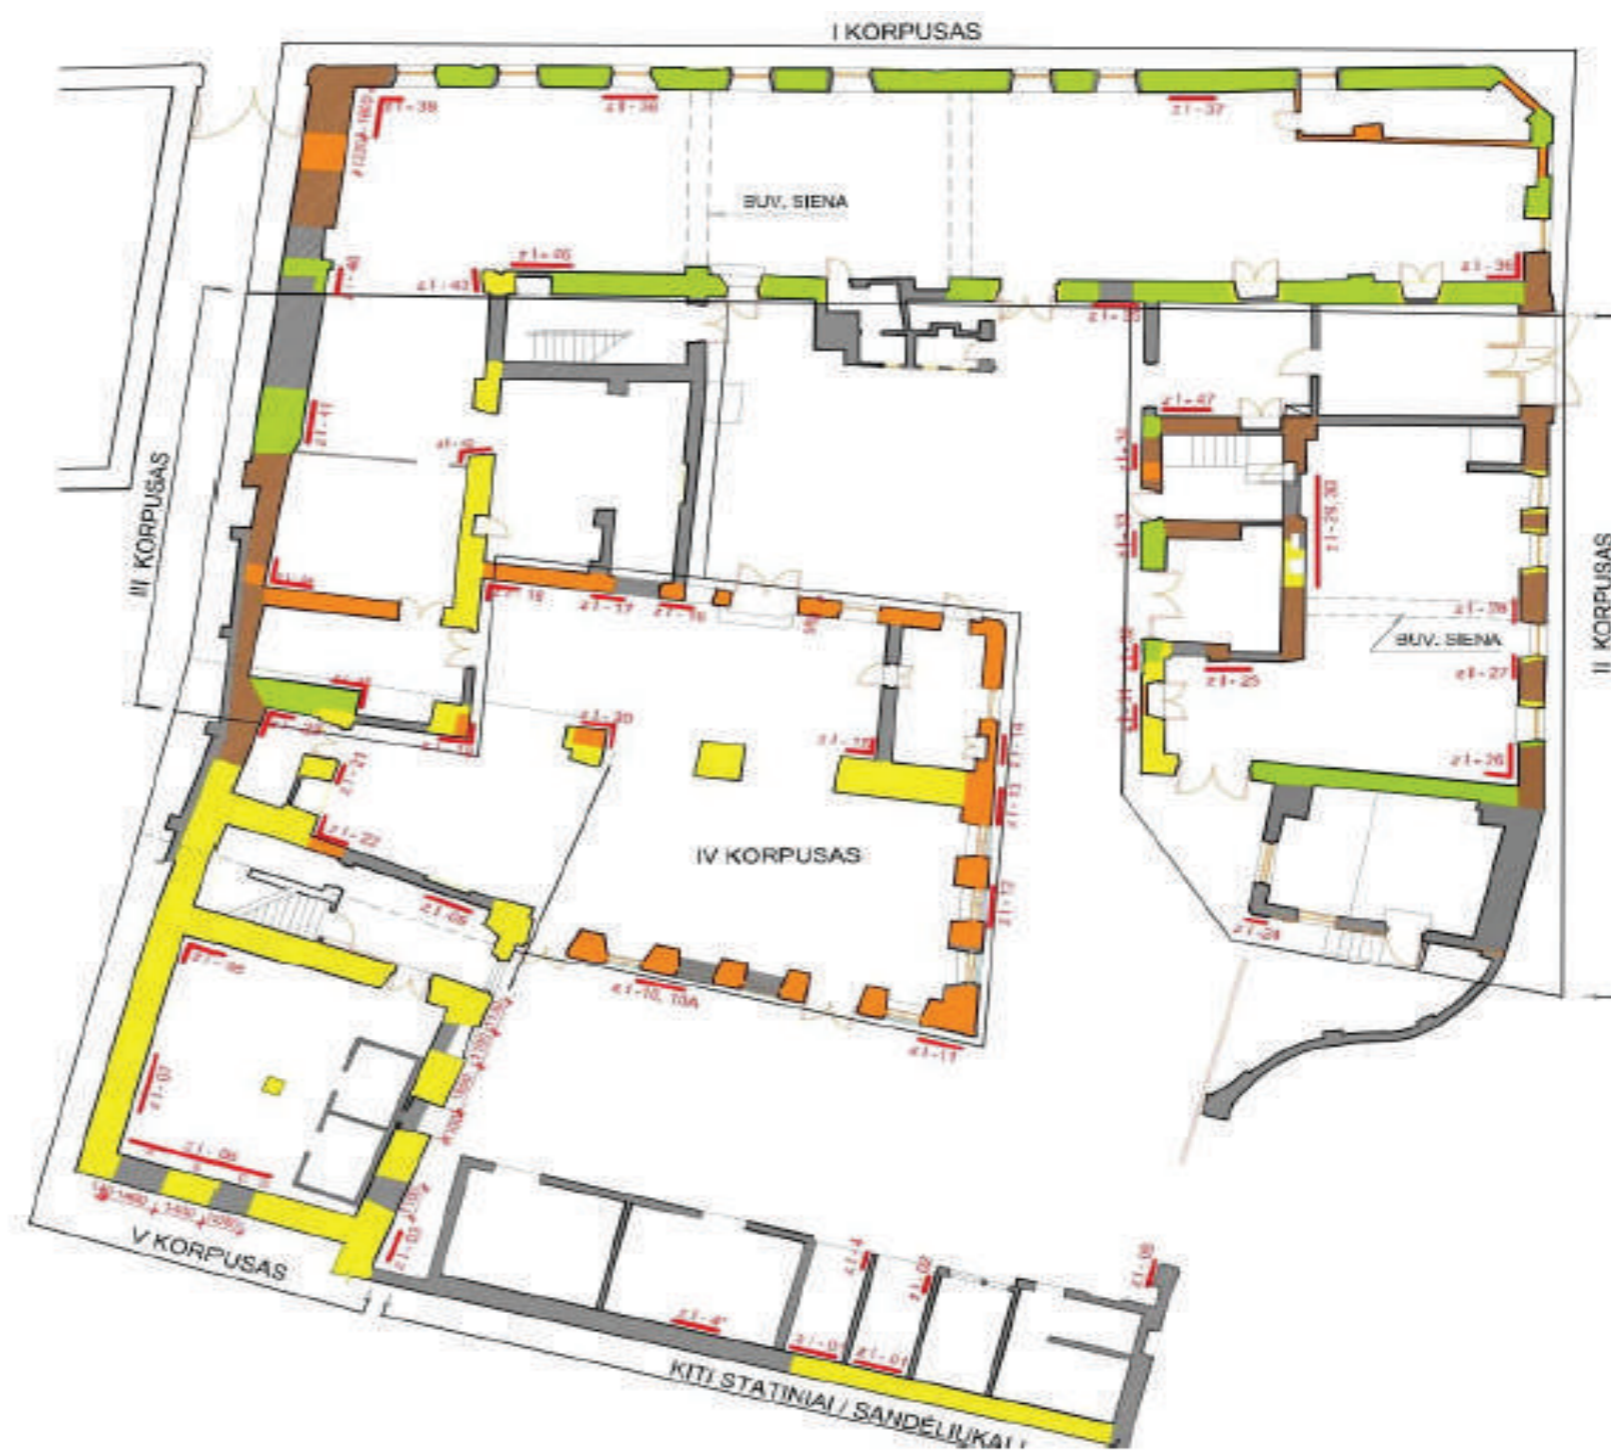
Fig.4: Plan of the building complex.

Of note is that some of the earlier structures on the site had been replaced and enlarged with Soviet additions (1945 and 1953), (shown in orange and gray) when the building was nationalized and later made into the Vilnius Pergalė Confectionary Factory. Much of the historic fabric had been compromised, particularly the original building on Russian St (shown in brown).

Further architectural, construction, historical, geological and archeological research was done in 2017 (Fig. 4). Of note is that some of the earlier structures on the site had been replaced and enlarged with Soviet additions (1945 and 1953), (shown in orange and gray) when the building was nationalized and later made into the Vilnius Pergalė Confectionary Factory. Much of the historic fabric had been compromised, particularly the original building on Russian St (shown in brown).

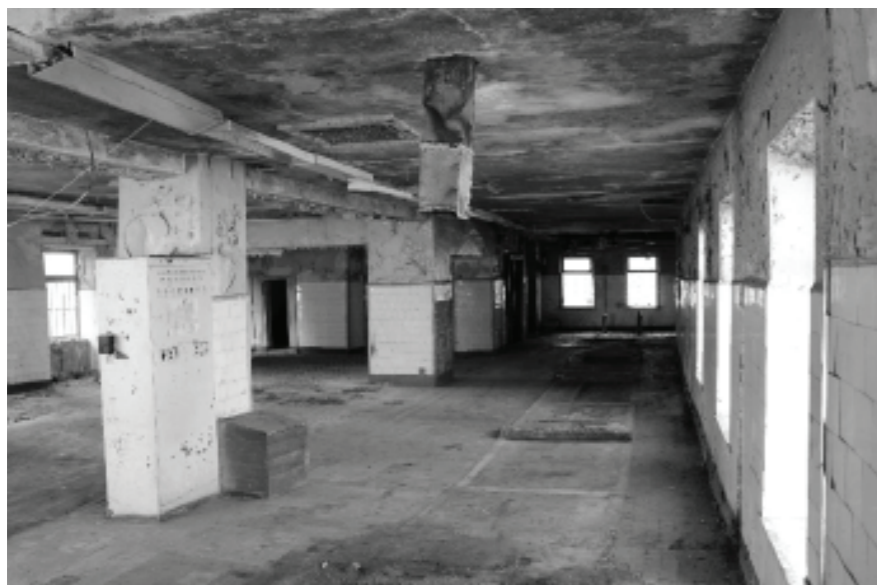
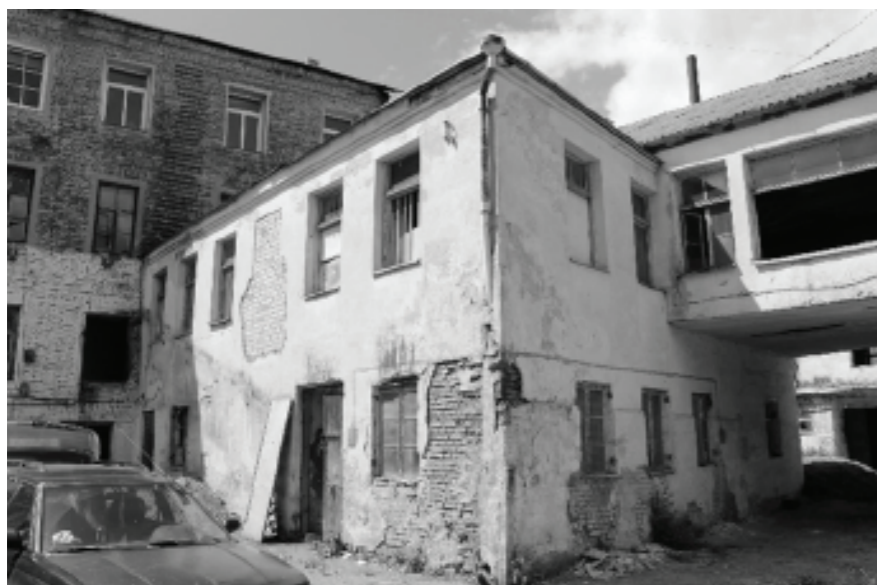
Fig.5: Views of the complex before reconstruction.

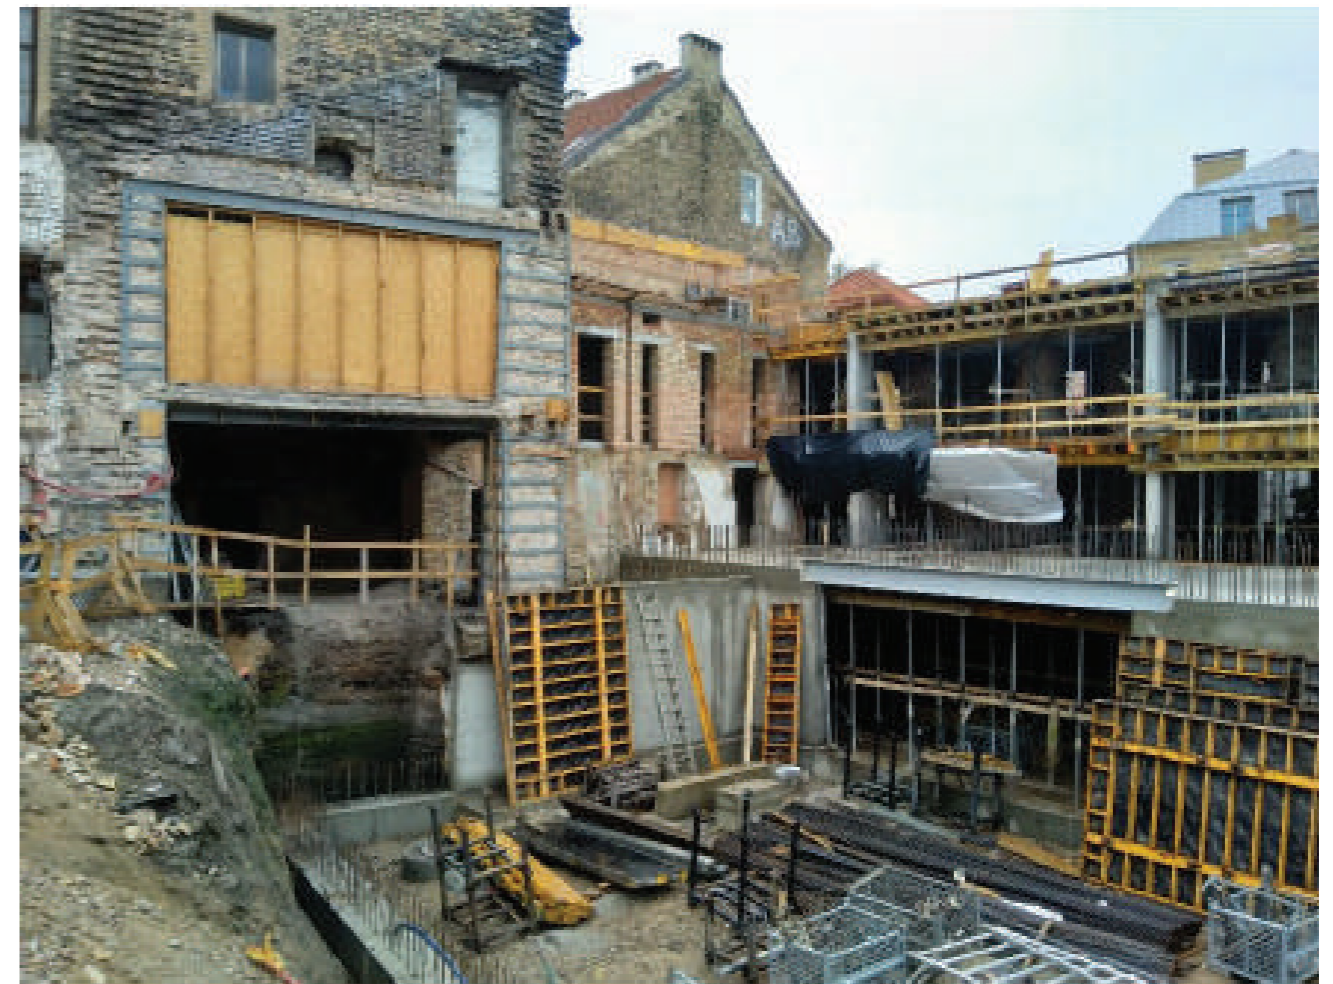
Fig.8: Restoration work.

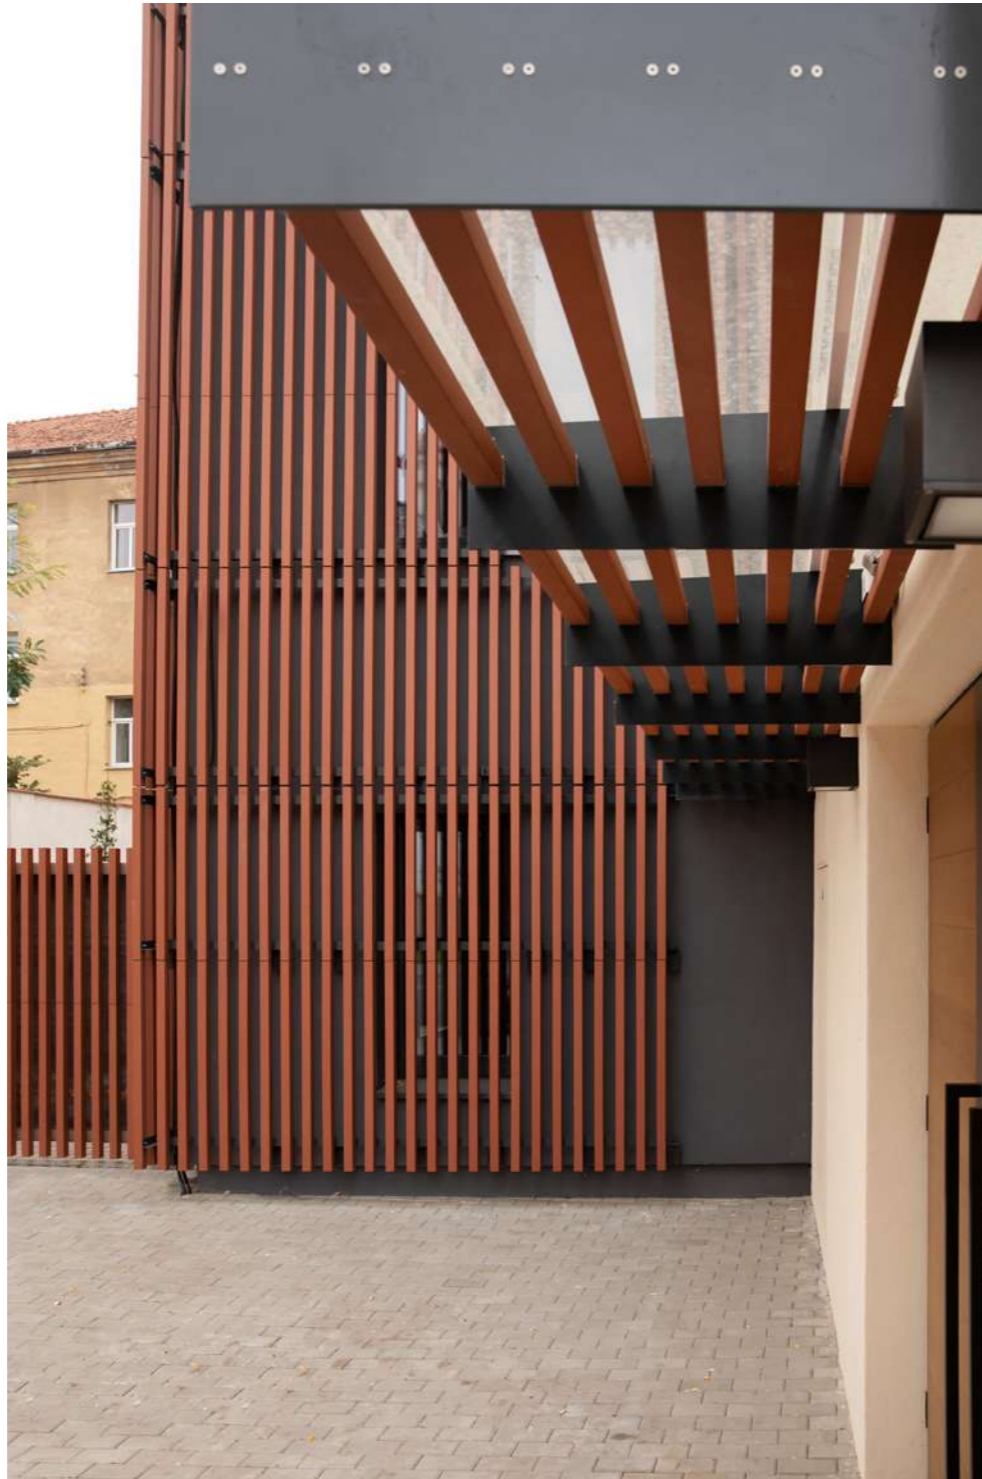
Fig.14: New elements in the exterior of the building.

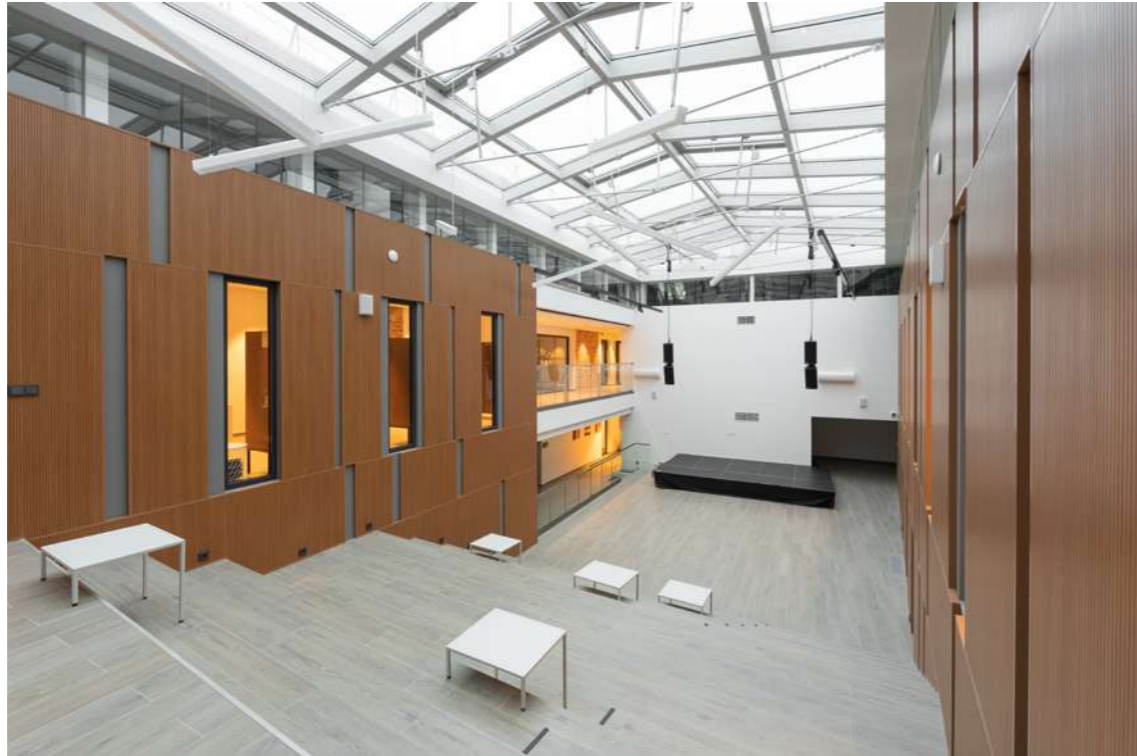
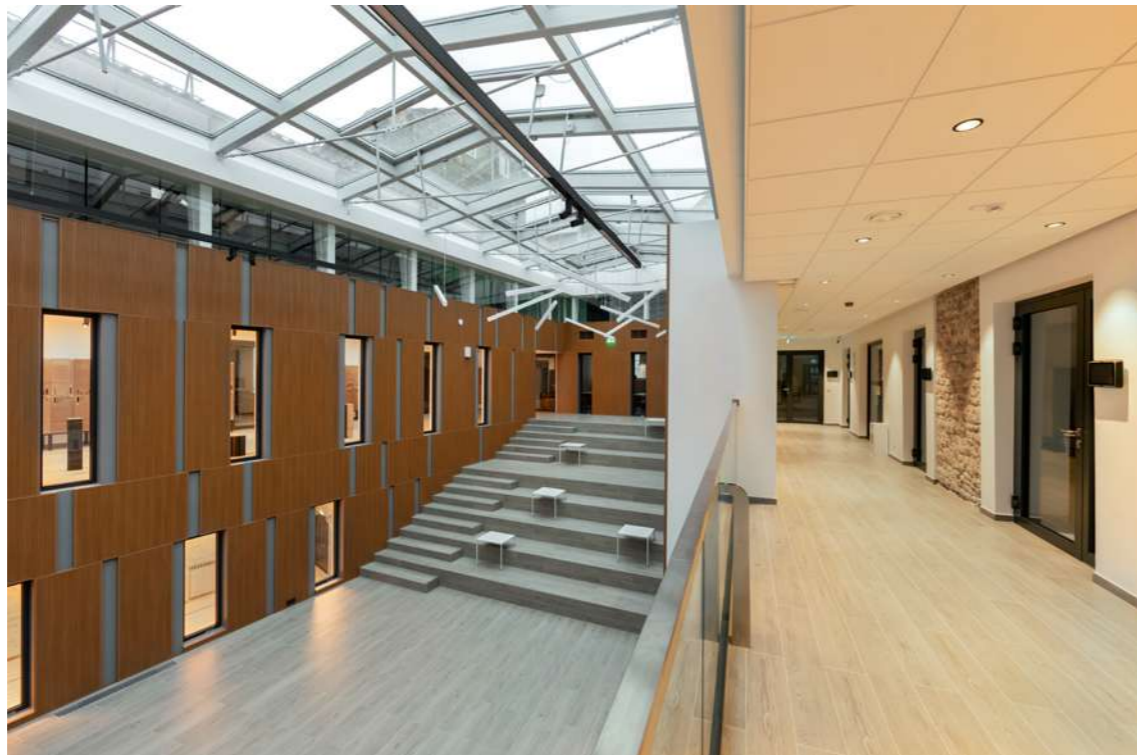
Fig.16-18: Images and drawing of the atrium.

One of the clearest solutions – to cover the inner yard with a glass - aluminum construction, to install an auditorium in the atrium, around which the existing and newly designed school premises would be located. The former courtyard space, covered with a glass-aluminum structure, has become a central auditorium for about 100 people, a venue for formal events and gatherings. Not only classrooms and classrooms are equipped, but also informal spaces. The architects sought
