## New life in the old village huts.

### *The abandoned threshing barn was turned into a ballroom.*

**Site** Pagulbis village, Molėtai municipality, Lithuania

**Objectives** Rehabilitation and reuse of Pagulbis threshing barn.

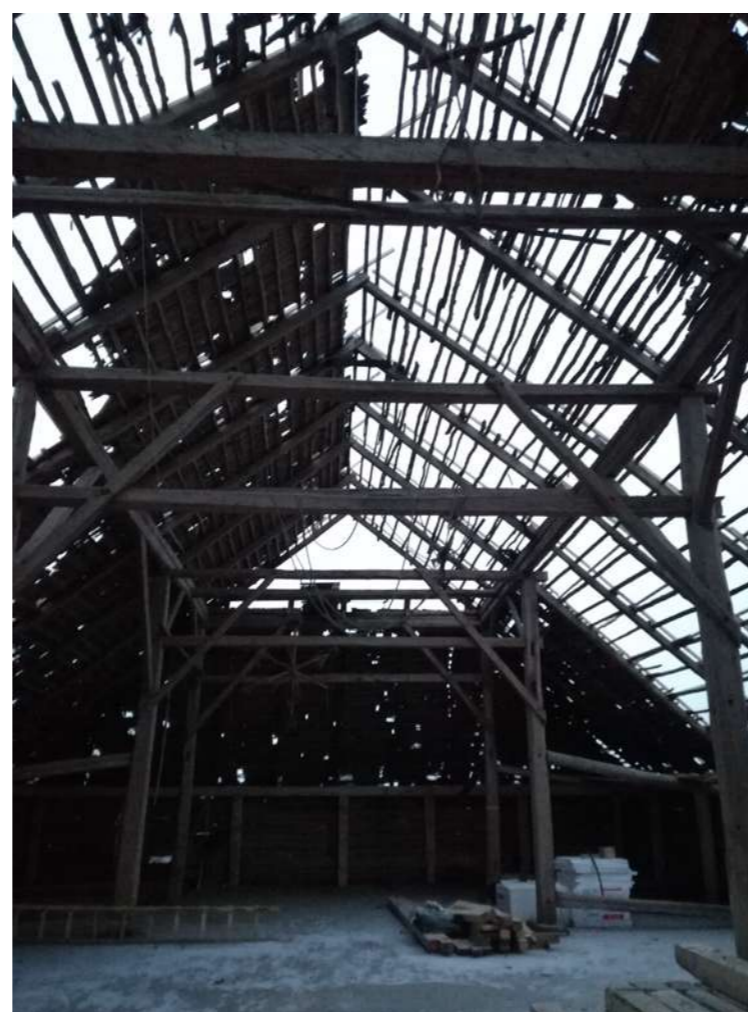
Fig.6: Threshing barn image before reconstruction.

When the current owner acquired this farmstead, the clone belonging to it was no longer left. And that was exactly the kind of building that stood in the neighbourhood, and it was decided to buy and renovate it. The condition of the building was poor: the roof on the north side had already collapsed and the wall had already collapsed, so it was worth taking work immediately. However, the main structures were still supported by a powerful roof plane. Poles and walls made of quality forest materials, wooden door details, some roof battens and rafters have survived. The most valuable parts of a building are the roof structure, the roof shape, the wall structure, the gate.

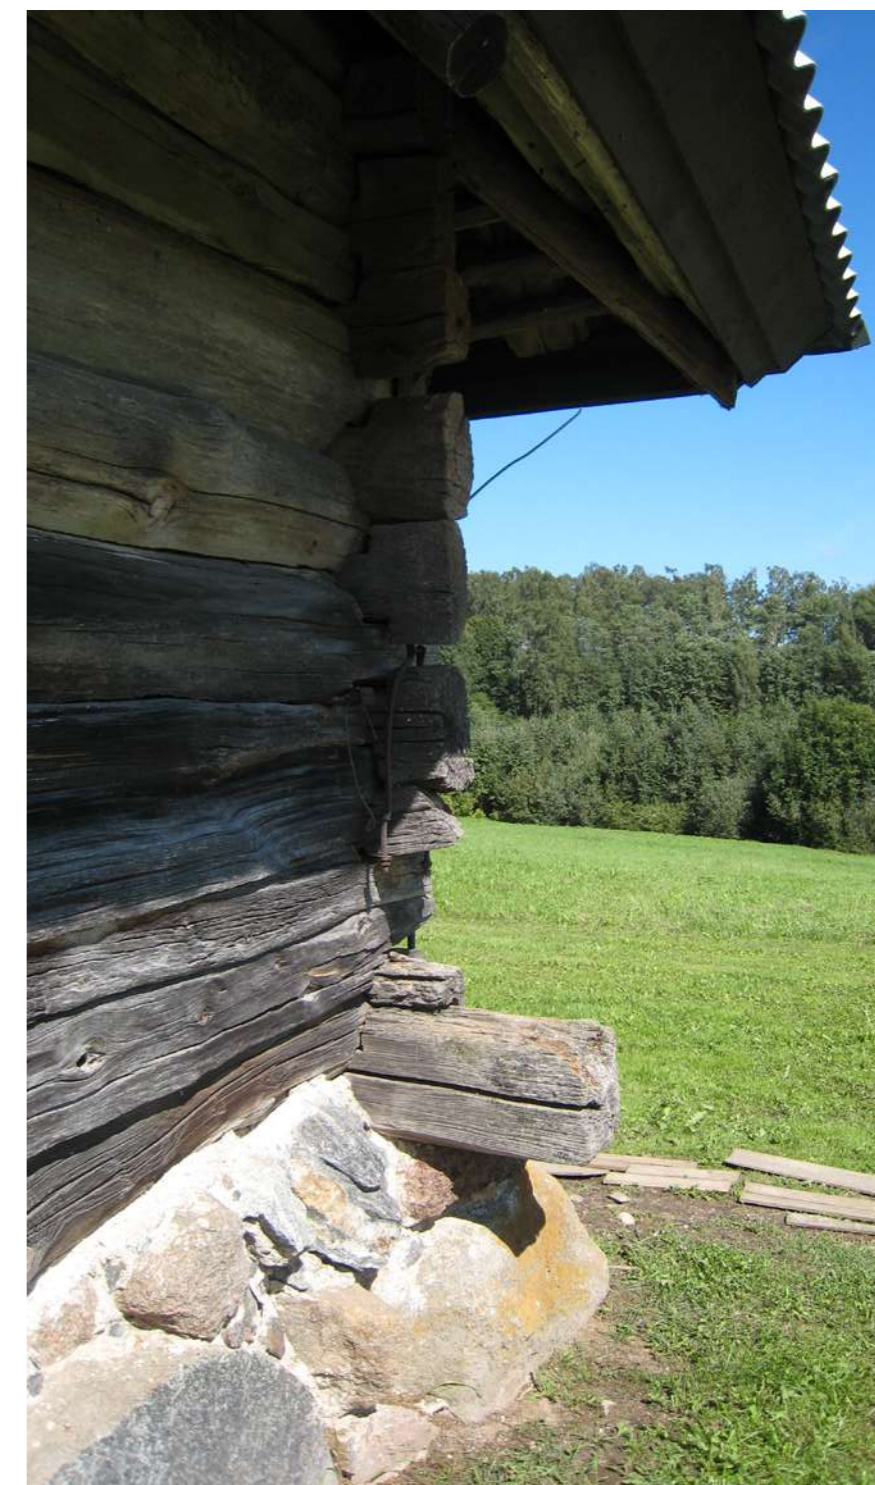
Fig.7: Foundation and rent of threshing barn.

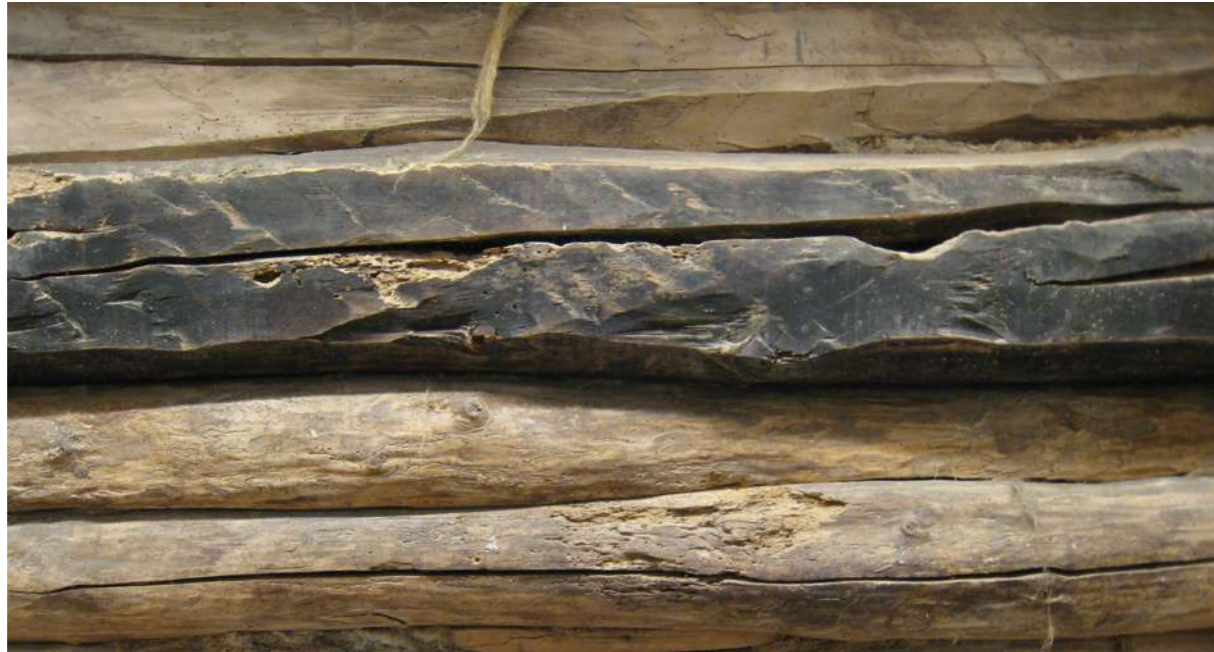
Fig.10: A fragment of the threshing barn rent.

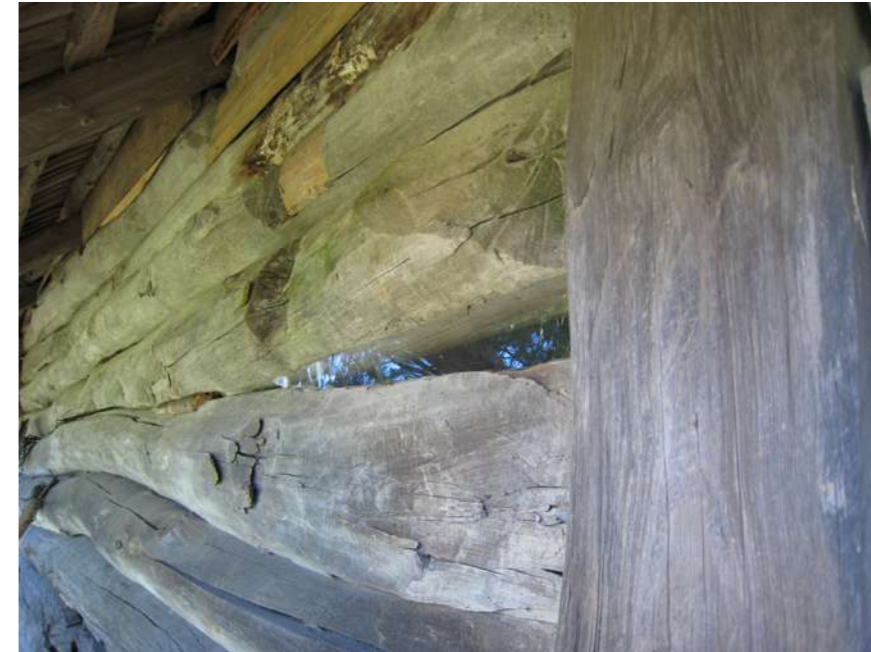
Fig.11: Rent cracks filled with glass.

The new purpose needs more light: a glazed opening in one gate, triangles at the roof, even cracks between the walls. Equipped with a cooking room, stage, bathrooms, accommodation and even a reading area. Above the entrance space there is a mezzanine with a spiral staircase leading to it. Where possible, wood is used: for the walls of new premises, for the wall of the bar. Partitions made of small wooden strips do not dissonize, but assist the composition. Such is the bar furniture, the stage.

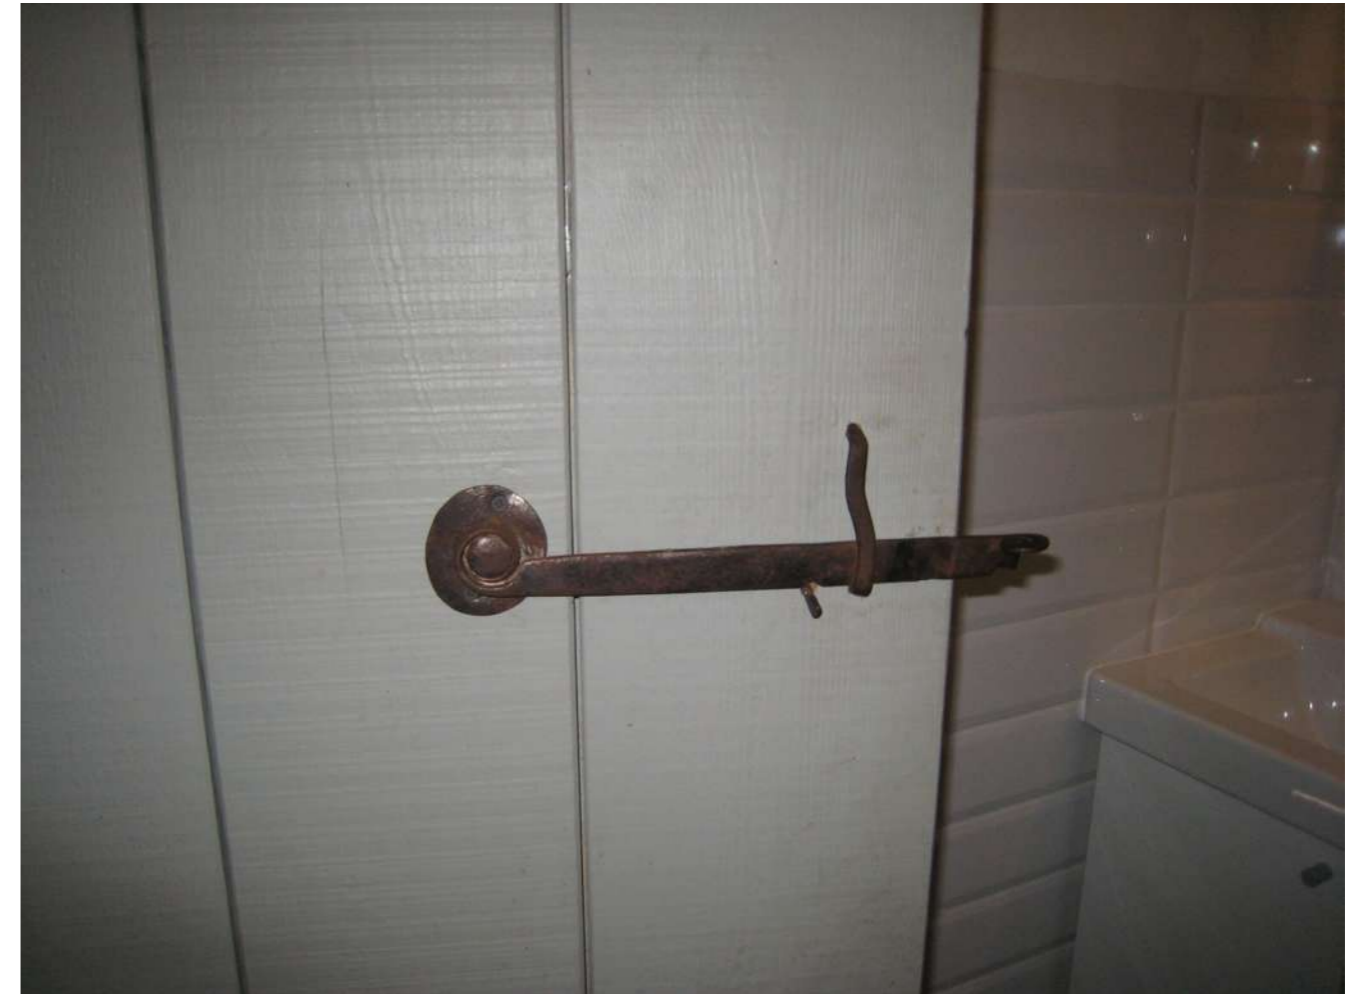
Fig.22: An old door handle is used.

Some of the new structural details have been adapted from other parts of the old wooden buildings, such as the poles supporting the mezzanine. To use the locks of the new doors for the product of the old blacksmith. The new concrete floor is similar to the traditional - compacted clay. Old chips are left under the new roof covering, they can be seen in the interior, the colour of the new beams has been applied to them. Masonry foundations are reminiscent of outdoor stones supporting the installed columns.

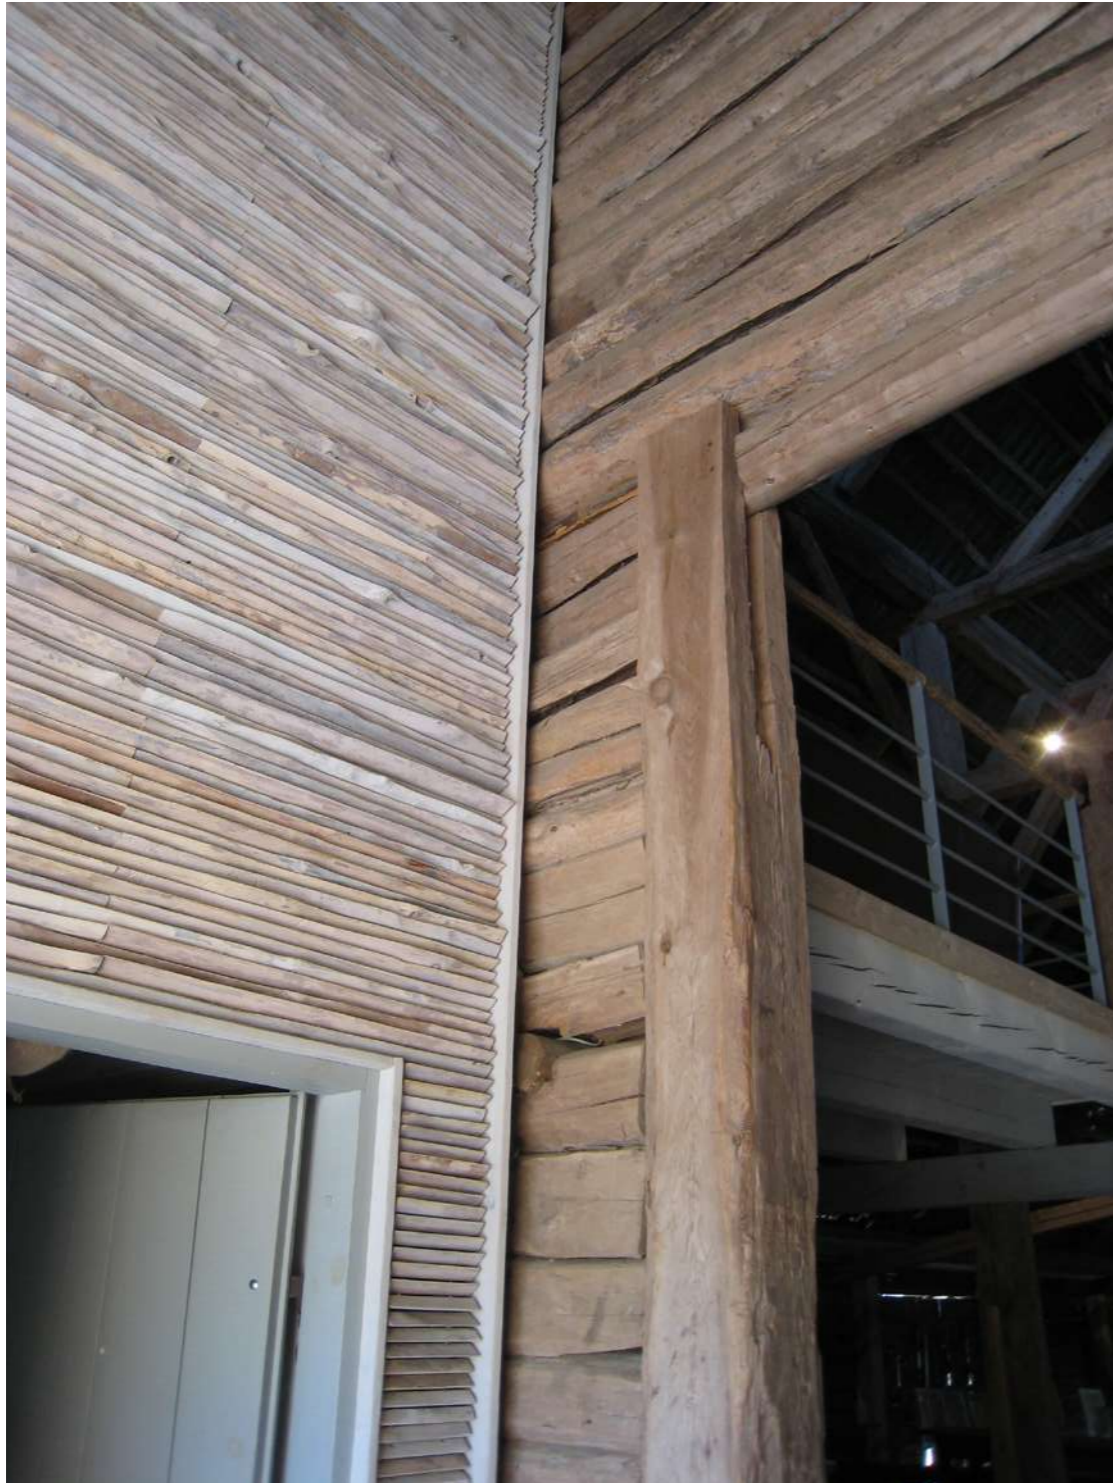
Fig.23: Connections of old and new parts.

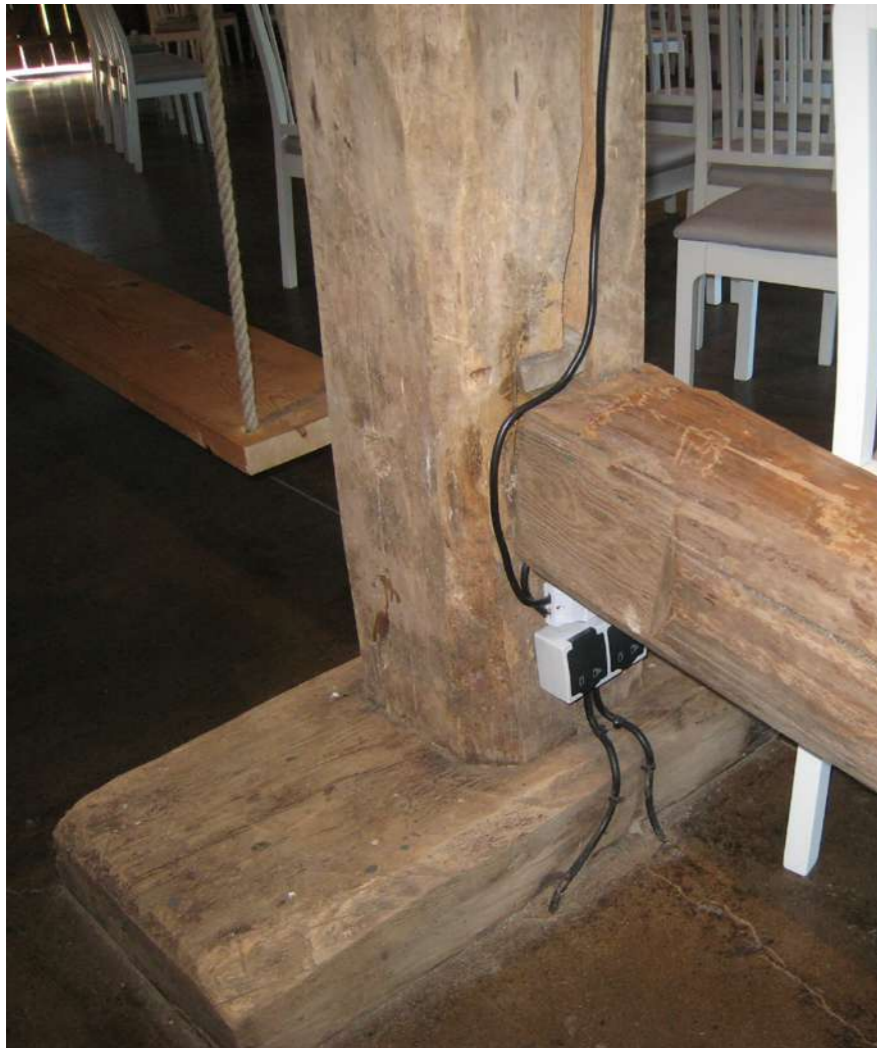
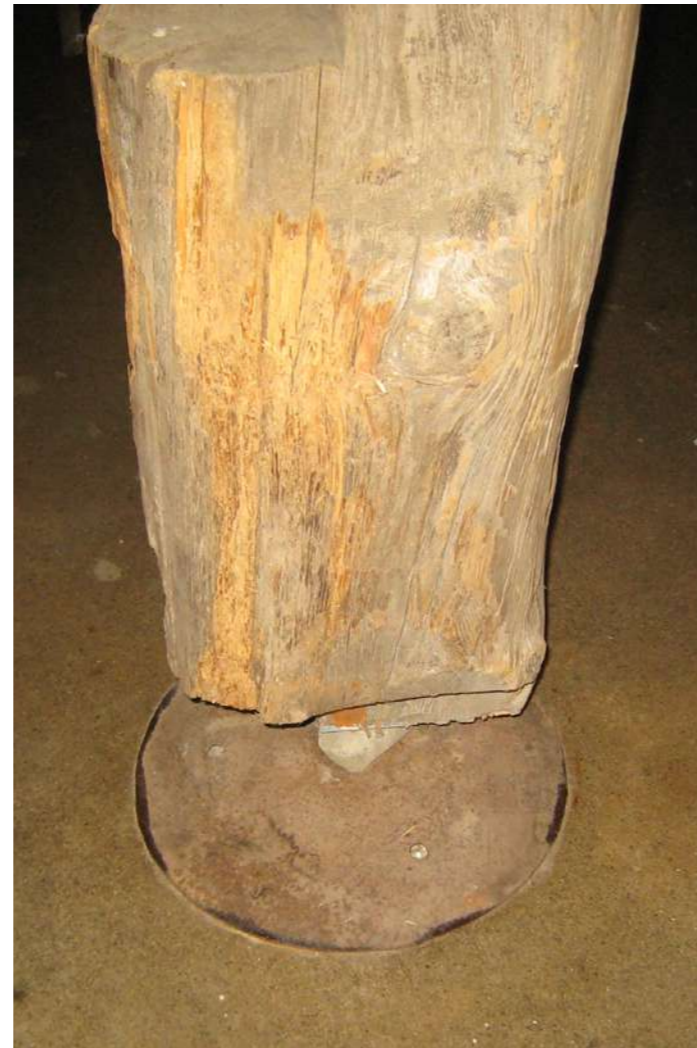
Fig.27-28: Connections of old and new parts.

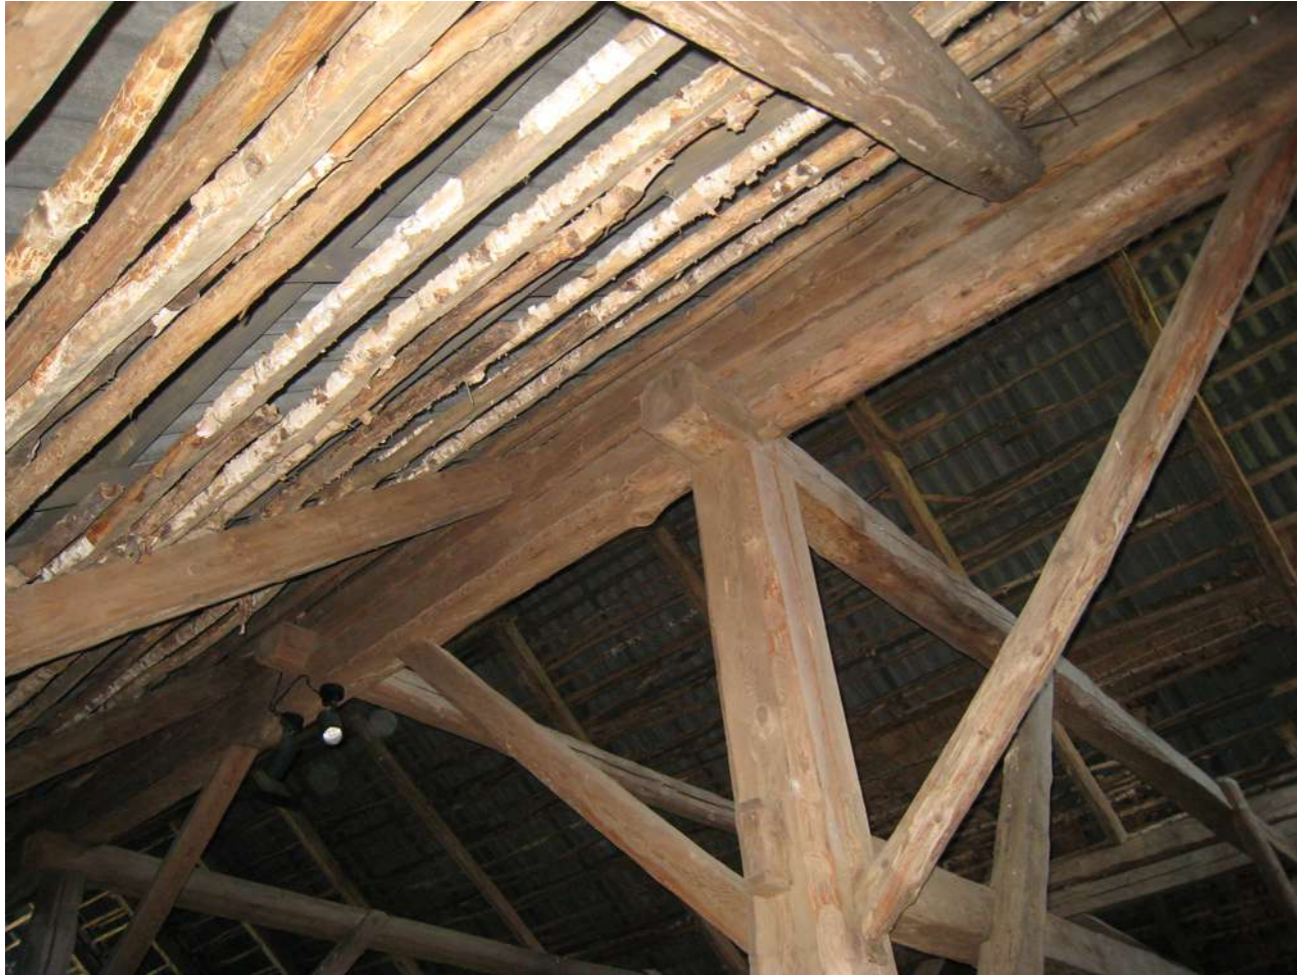
Fig.33: Old roof construction.

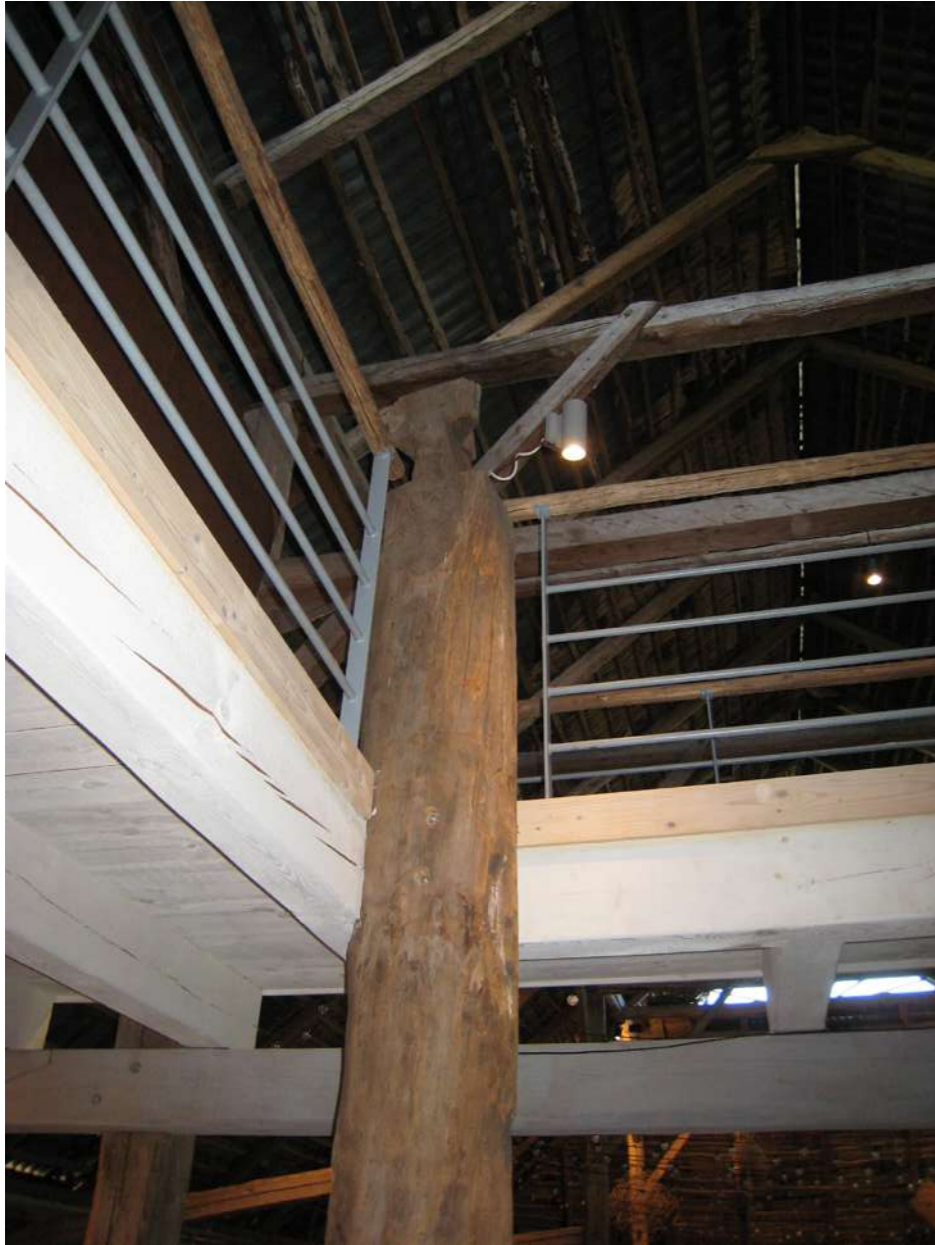
Fig.35: Connections of old and new parts.

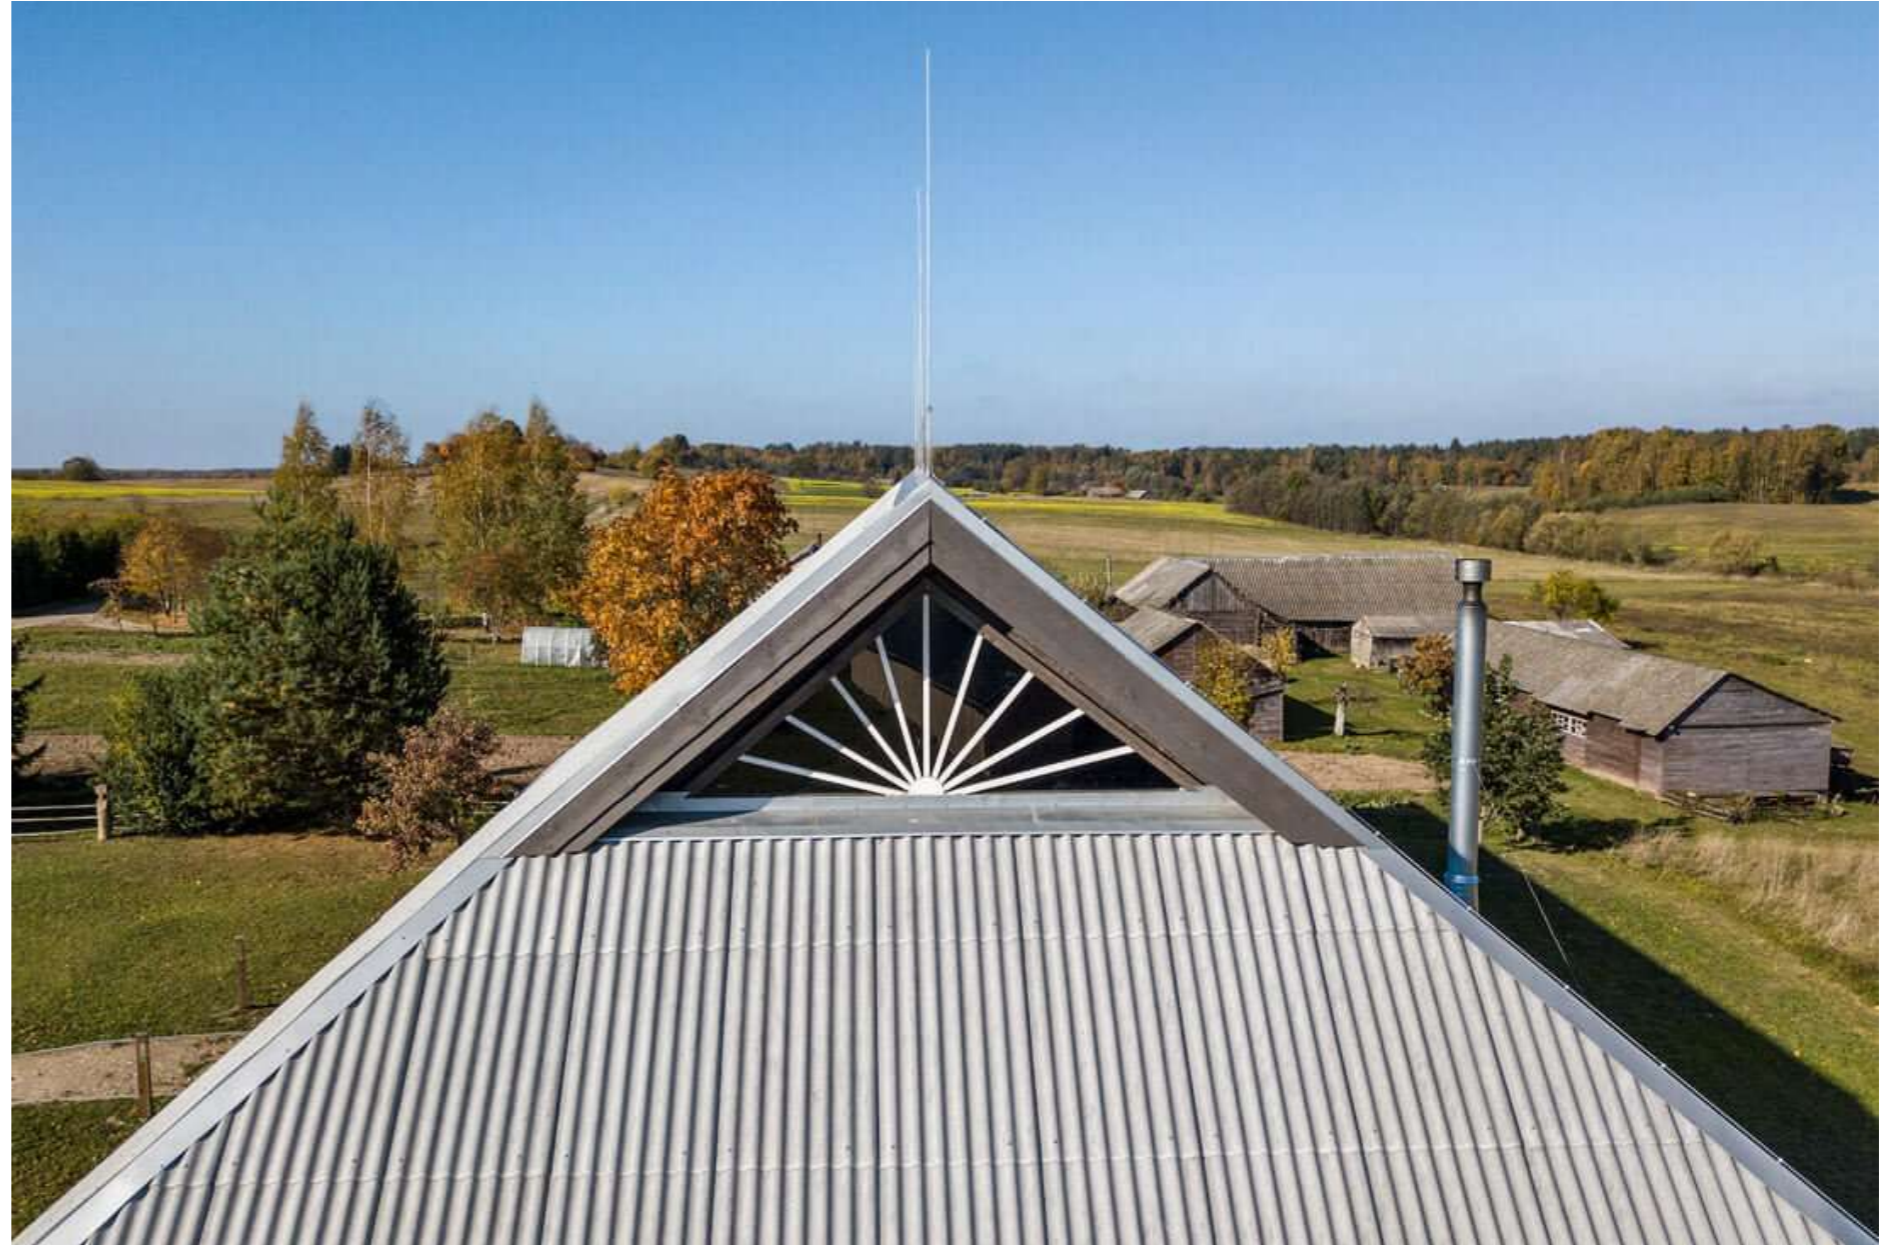
Fig.36: Opening at the ridge of the roof.

Some parts are made of new materials: glass, metal stairs and handrails. The glow of the white roof is the least typical expression of traditional architecture. He and the motif of rays in the roof openings are not so much an ethnographic, but an interpretation of the archaic, spiritual layer, the "glow of the ages", as the architect says.
