Continuity of the city's wooden architecture.

Adaptation of a wooden building with a unique decoration in Vilnius to modern family life.

Site Poškos 61, Vilnius, Lithuania

Objectives Reconstruction / extension of a family house.

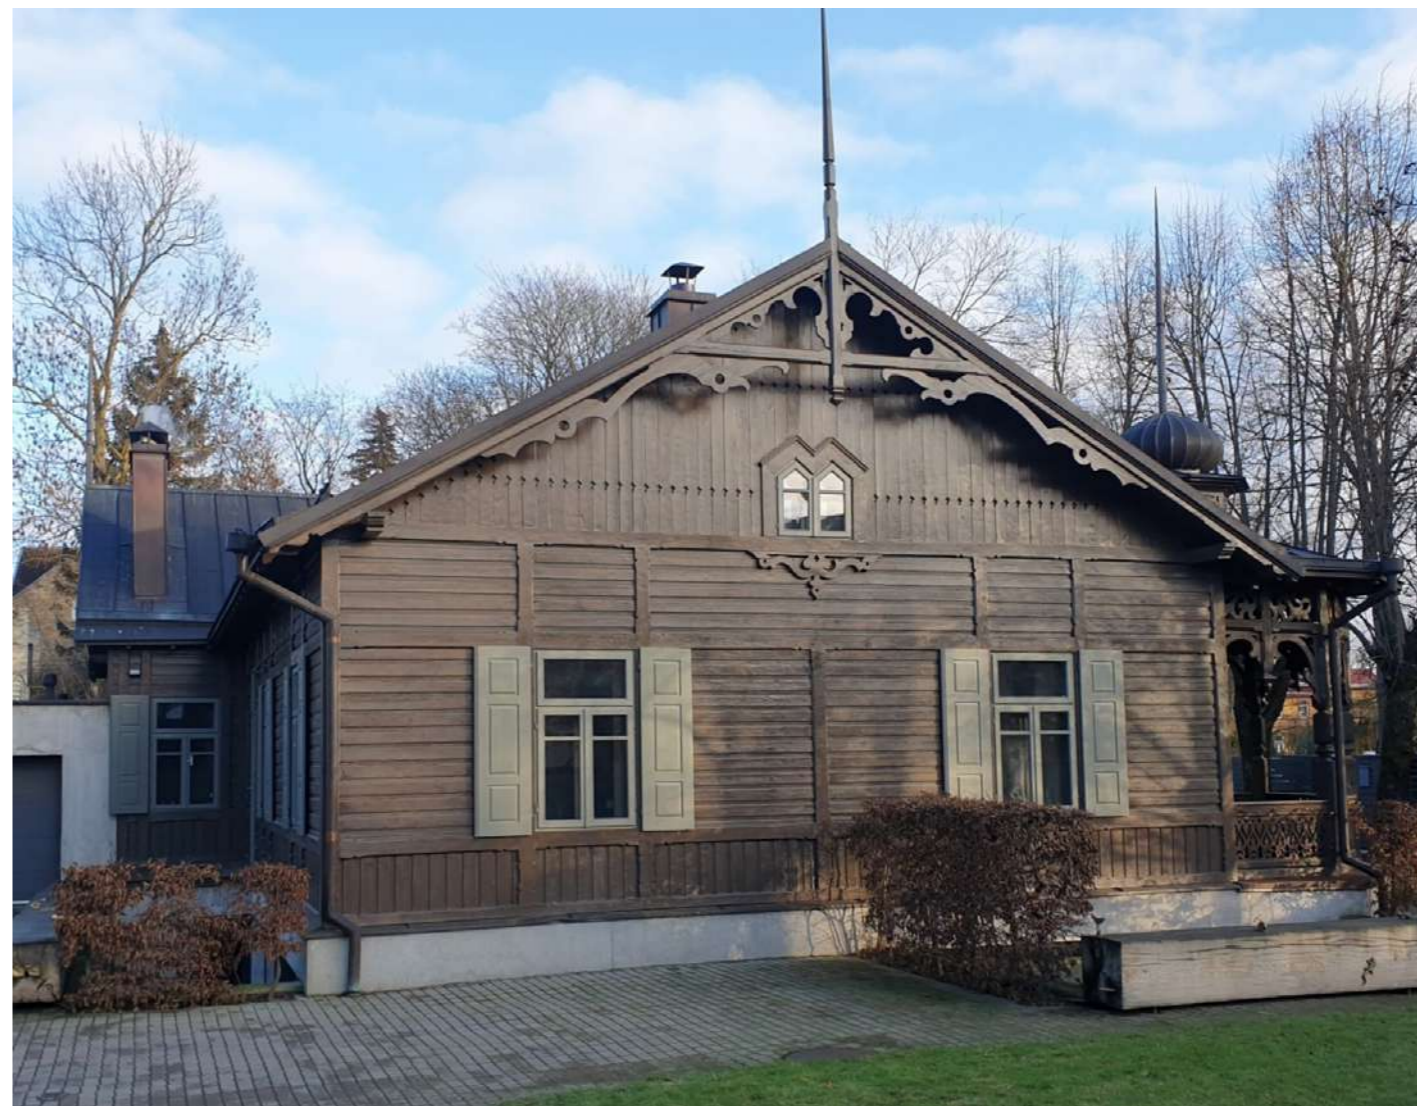
Fig.5: West Façade.

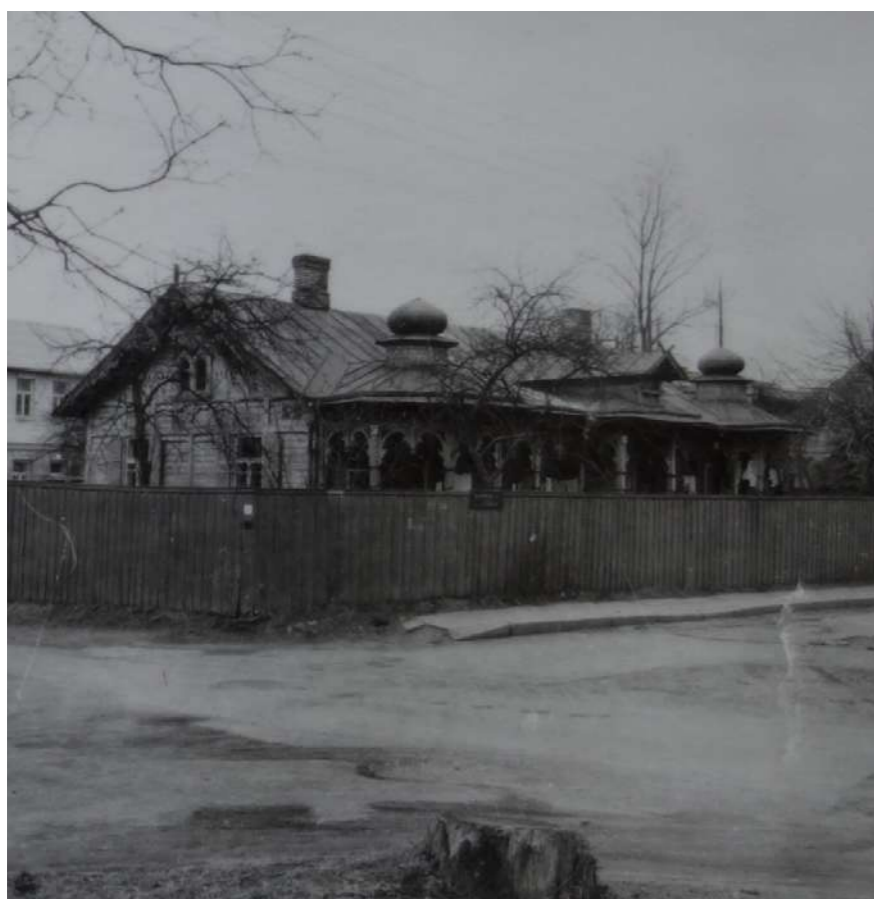
Fig.8: Photo of the end of the 20th century.

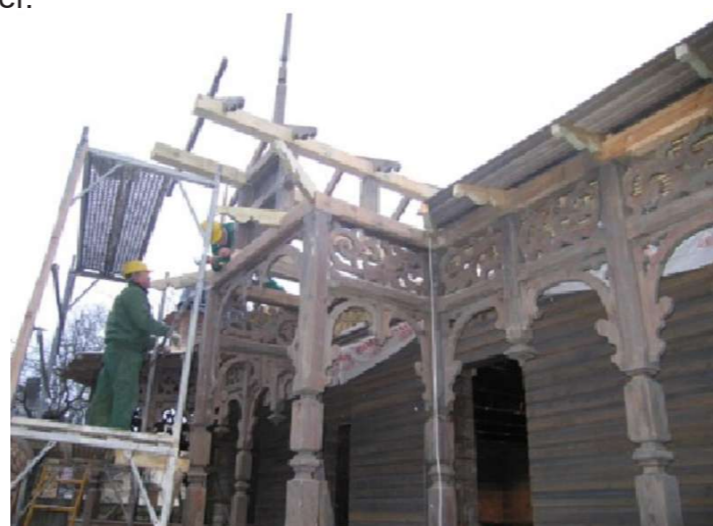
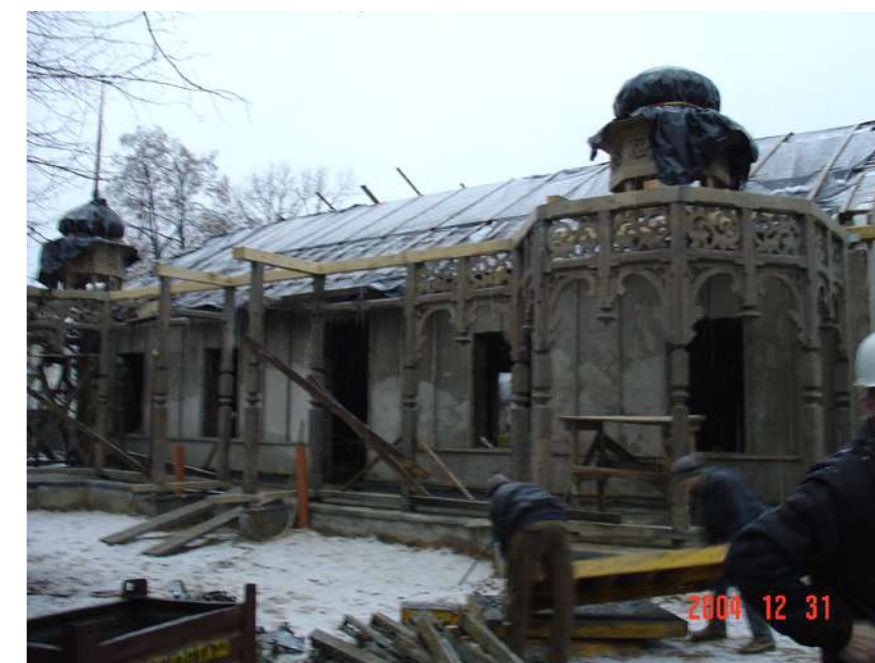
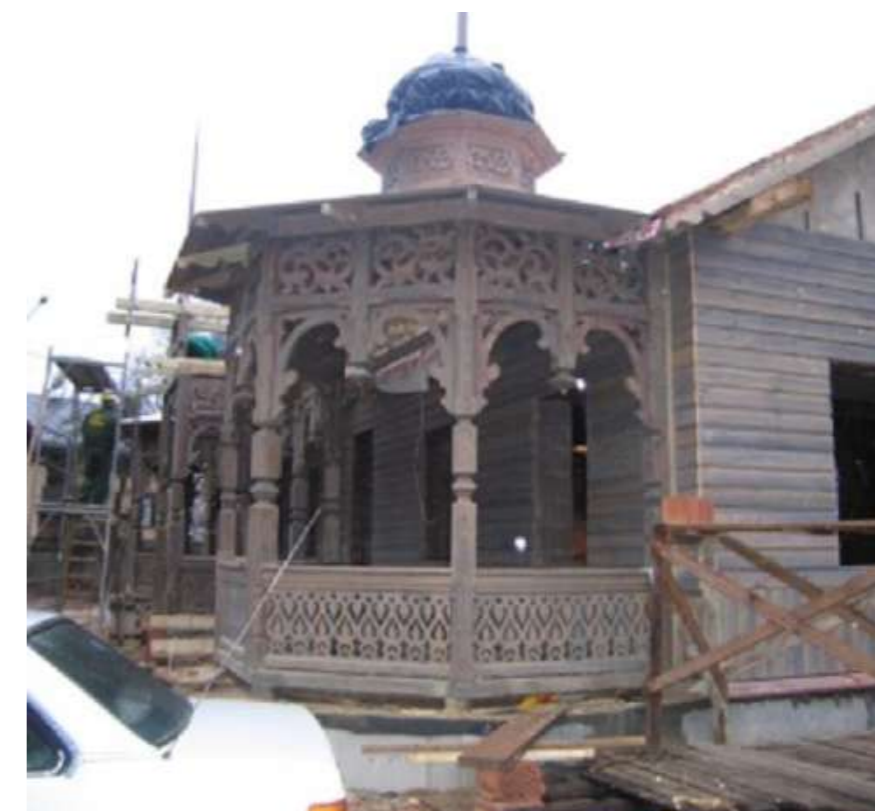
Fig.9-11: Reconstruction works.

During the reconstruction of the building, the wooden above-ground part was restored, essentially without changing the former view, except for the ground plane. Forms of the wooden villa were carefully restored. Original exterior shape was successfully preserved, adapting the interior to new needs. For this purpose, a basement was installed, which is illuminated through the windows in the base part of the building and the light pits formed next to them. The novelty does not detract from the authentic image as it does not change either the volume or the proportions of the building. The upper house is richly carved with intricate shapes and details carefully restored to the original example. This reconstruction is welcomed not only because of its professionalism, but also because of the socially and culturally significant position of the client and the architects, which elevated the 19th and 20th centuries.

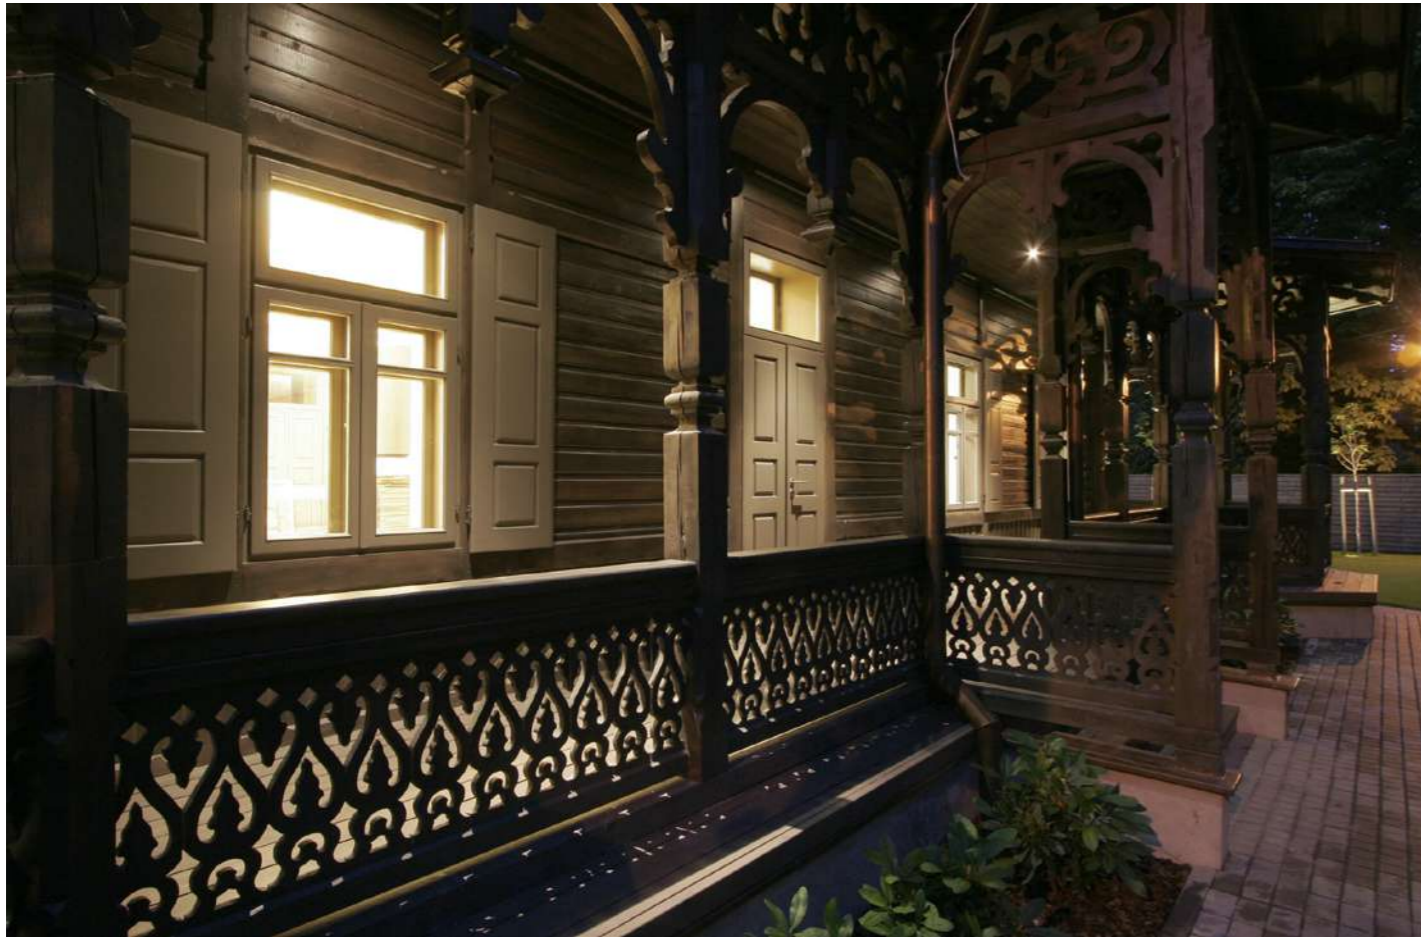
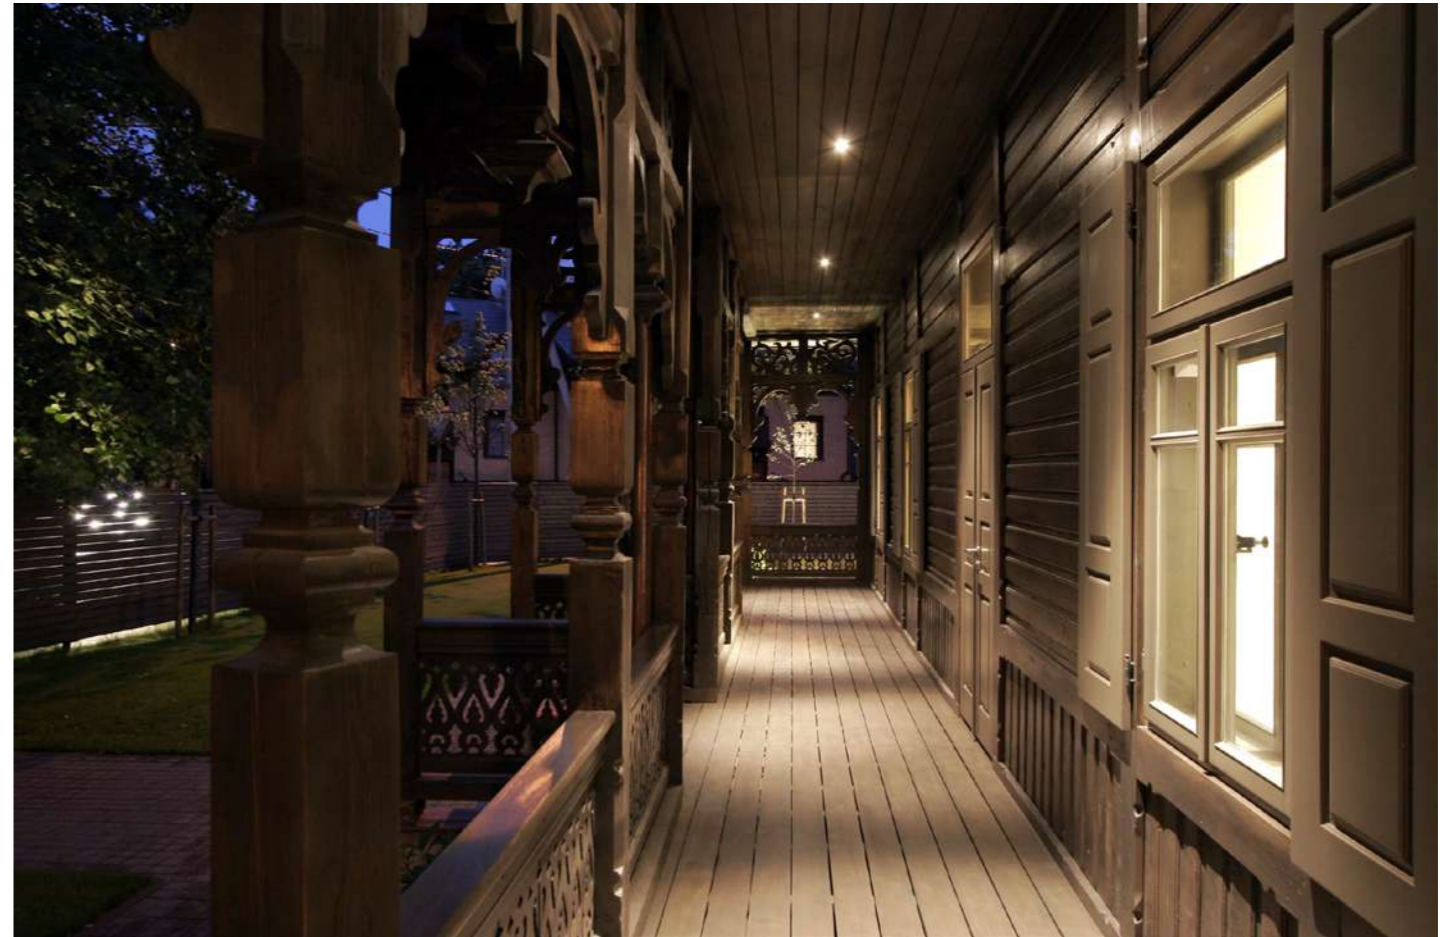
Fig.12-13: Views of the gallery after reconstruction.
