Rehabilitation as a strategy for urban acupuncture.

Rehabilitation and consolidation of two residential buildings to obtain new housing in the old city of Barcelona.

Site Carrer Robadors 25, Barcelona, Catalunya, Spain

Designer Chief architects:
Pere-Joan Ravetllat
Carme Ribas

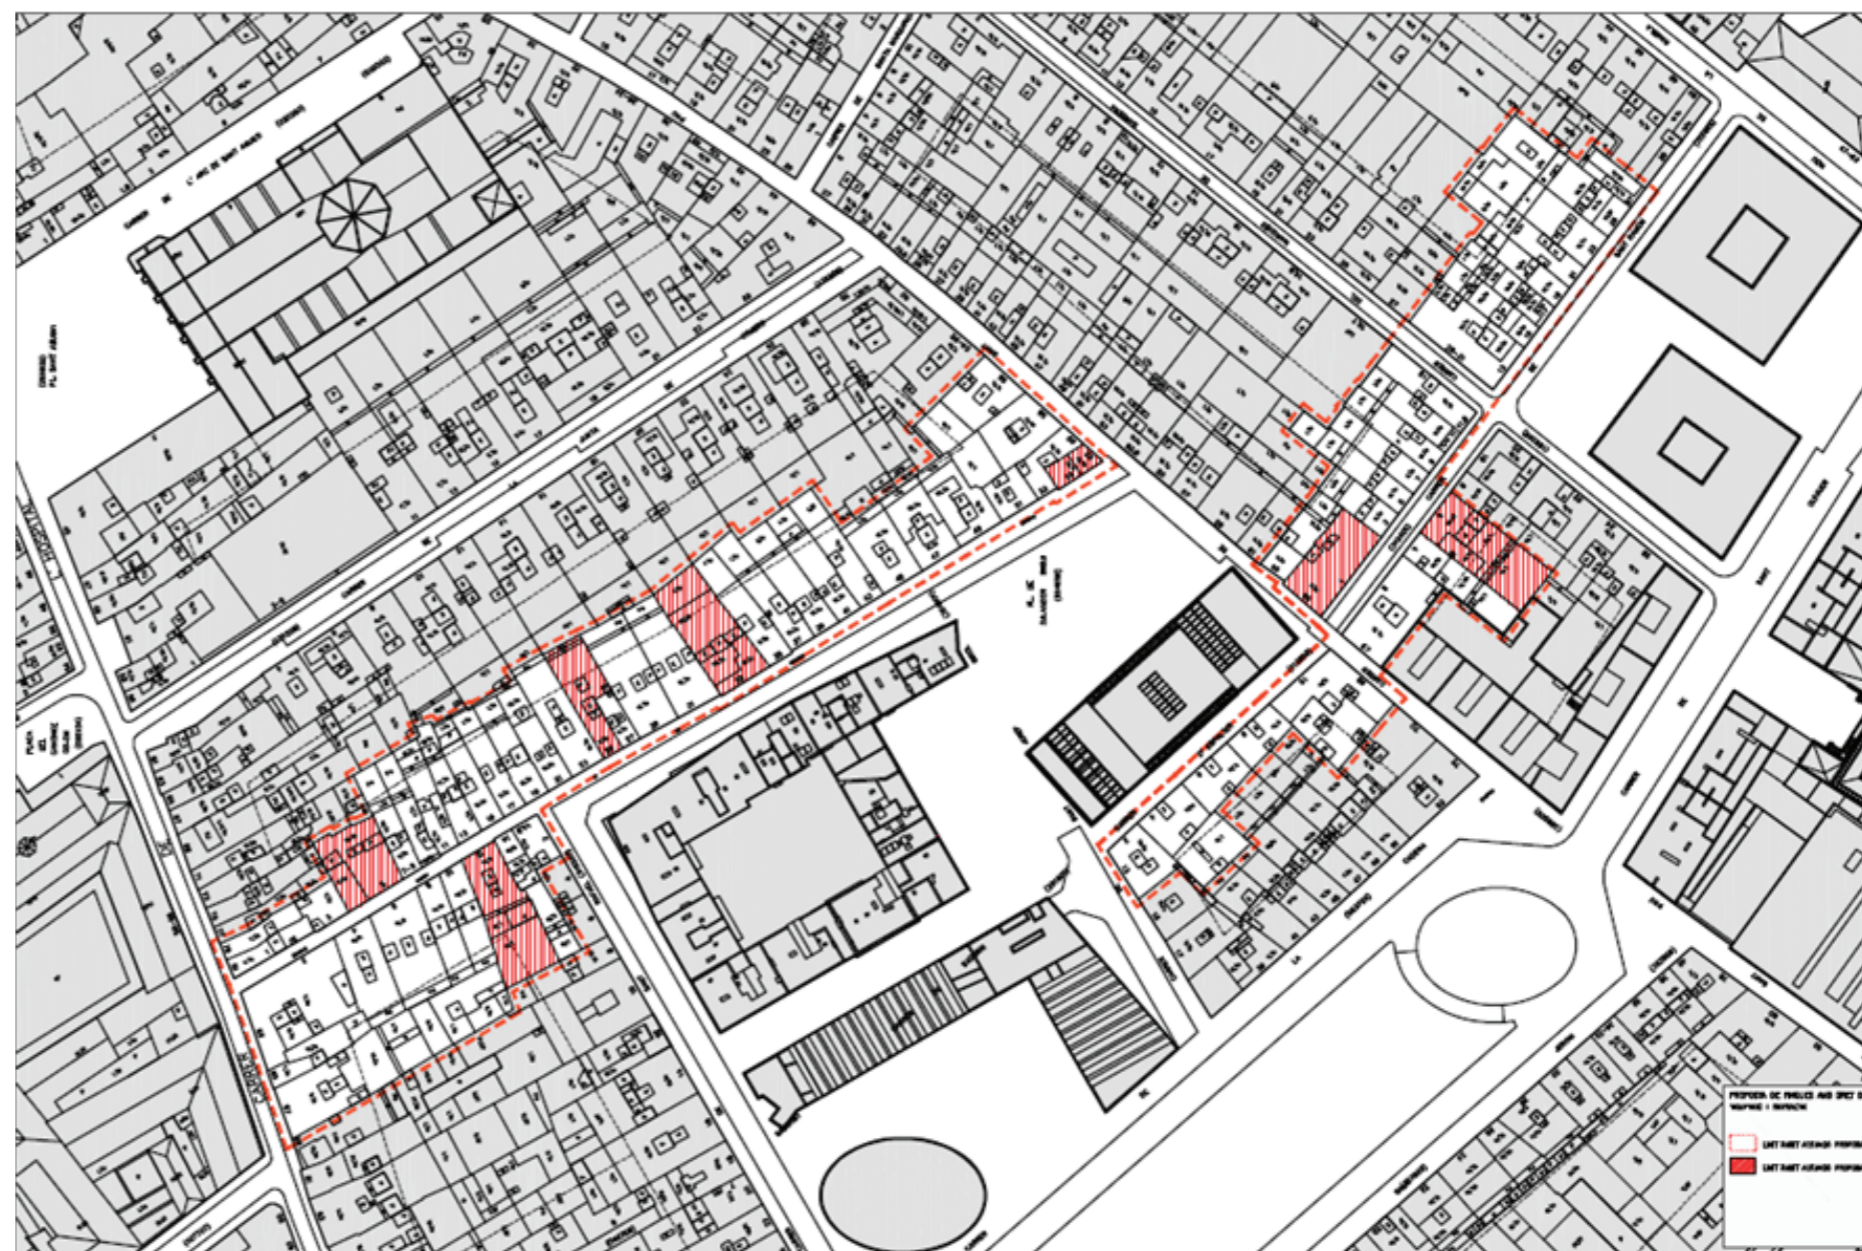
Fig.1: Proposal of properties to be rehabilitated in the ACR Robador Sant Ramon.

The intervention is part of the Robador and San Ramón Conservation and Rehabilitation Area, which includes 62 buildings on these two streets. The stated objectives of this project are:

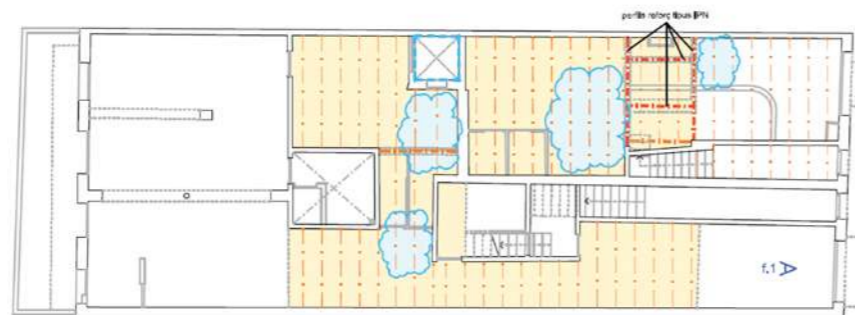
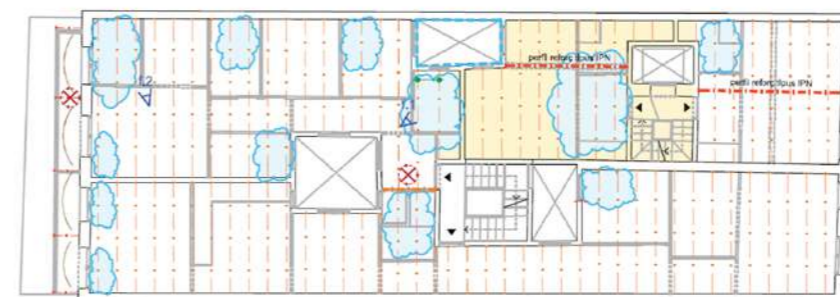
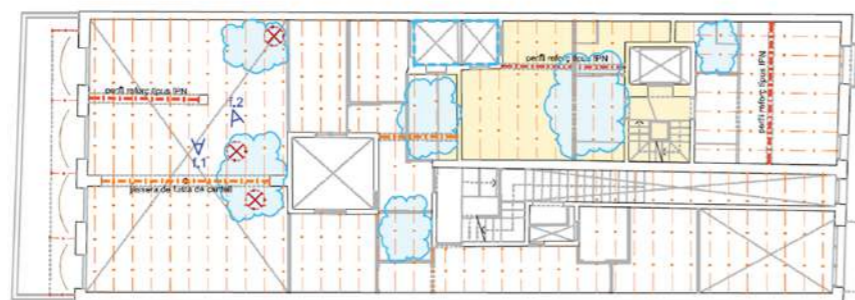
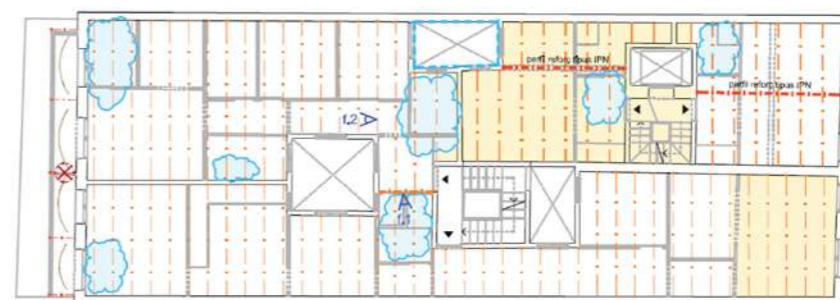
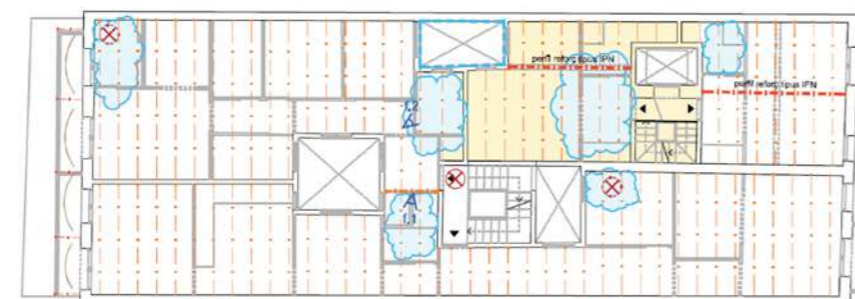
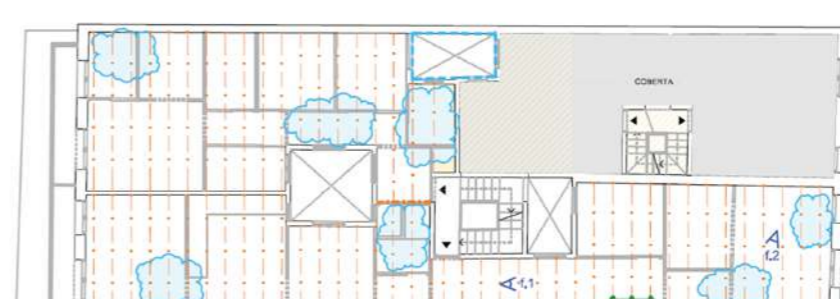
Fig.5: Original floor plans of the two buildings

Initially, the vertical structure of this set of two buildings is solved by main bearing walls of masonry, of thickness between 15 and 30 cm, which support the set of ceilings all of them resolved by wooden joists (of varied sections although there are predominant joists of 16*22 cm with an interaxis of 60 cm) and vaults of flat brick vault, and balconies resolved with metal profiles embedded in the load-bearing wall of the façade and double-layered flat brick vaults. The staircases are all resolved by double-layered Catalan vaults that are embedded in the side walls of the stair core.

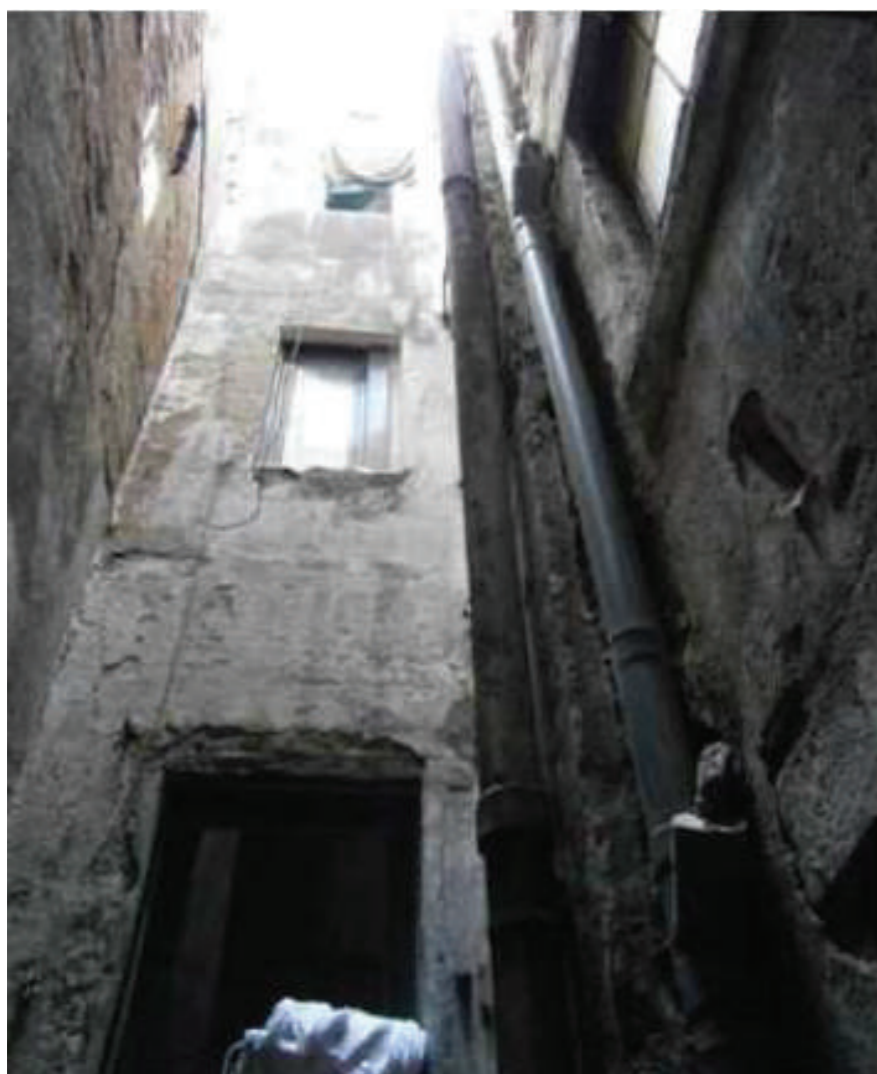
Fig.6: Condition of the inner patio prior to the intervention.

The property at number 25 is in a regular state of conservation, but with the possibility of being rehabilitated. The property at number 27 is in a very poor state of conservation.

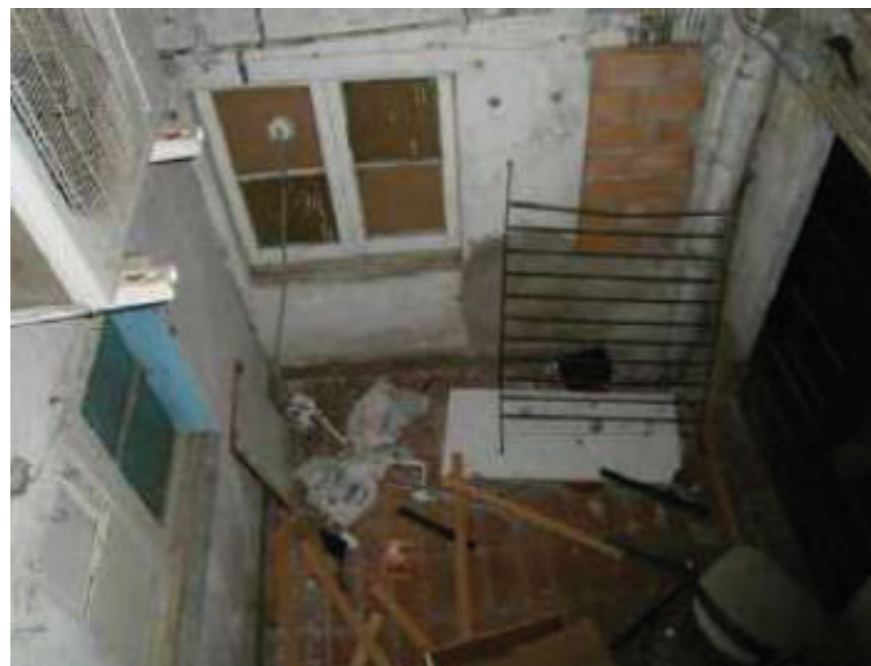
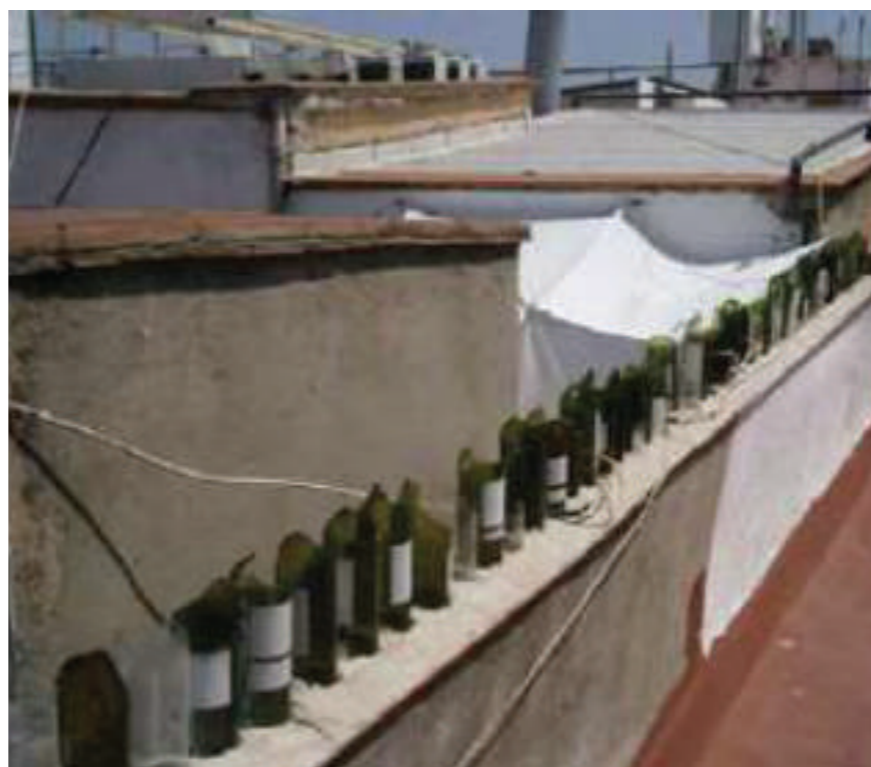
Fig.7-8: Conditions of the patio and rooftop prior to the intervention.

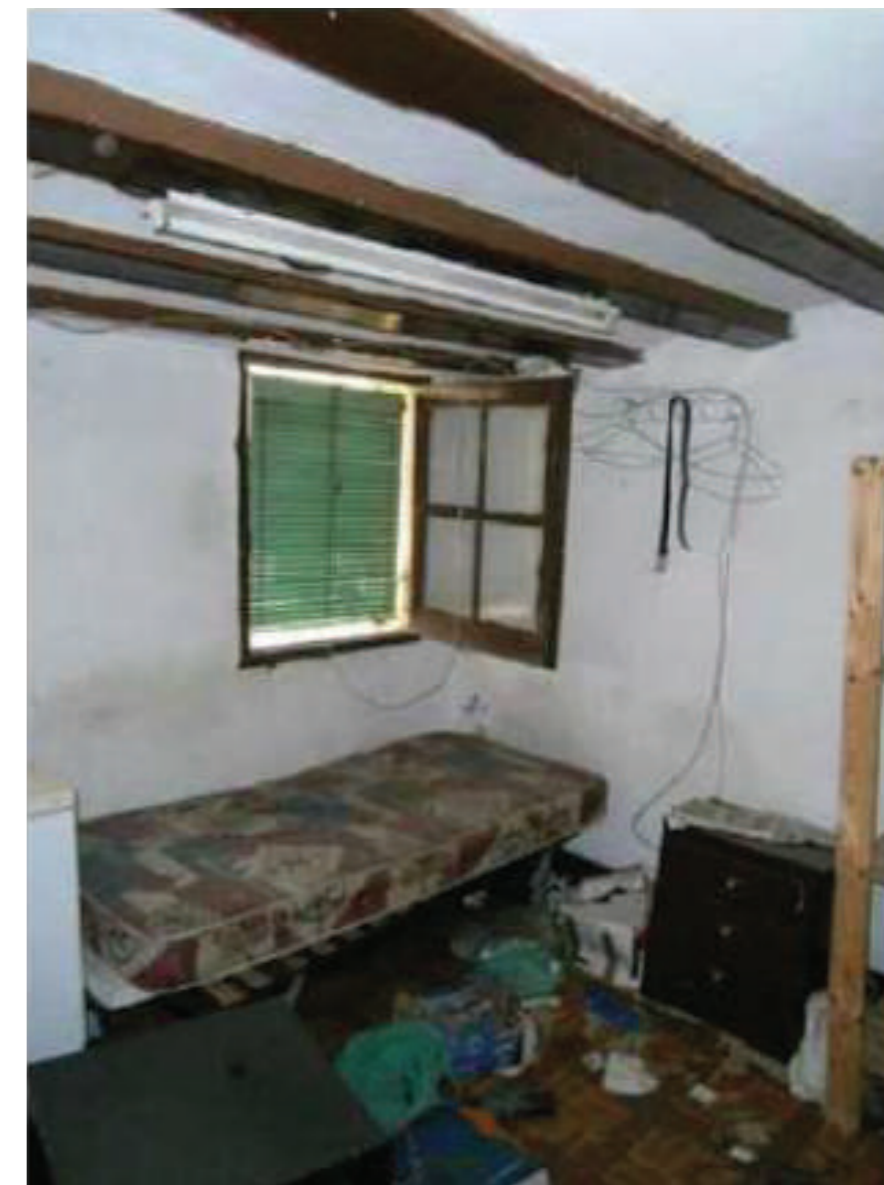
Fig.9: Conditions of the interior of dwellings prior to the intervention.

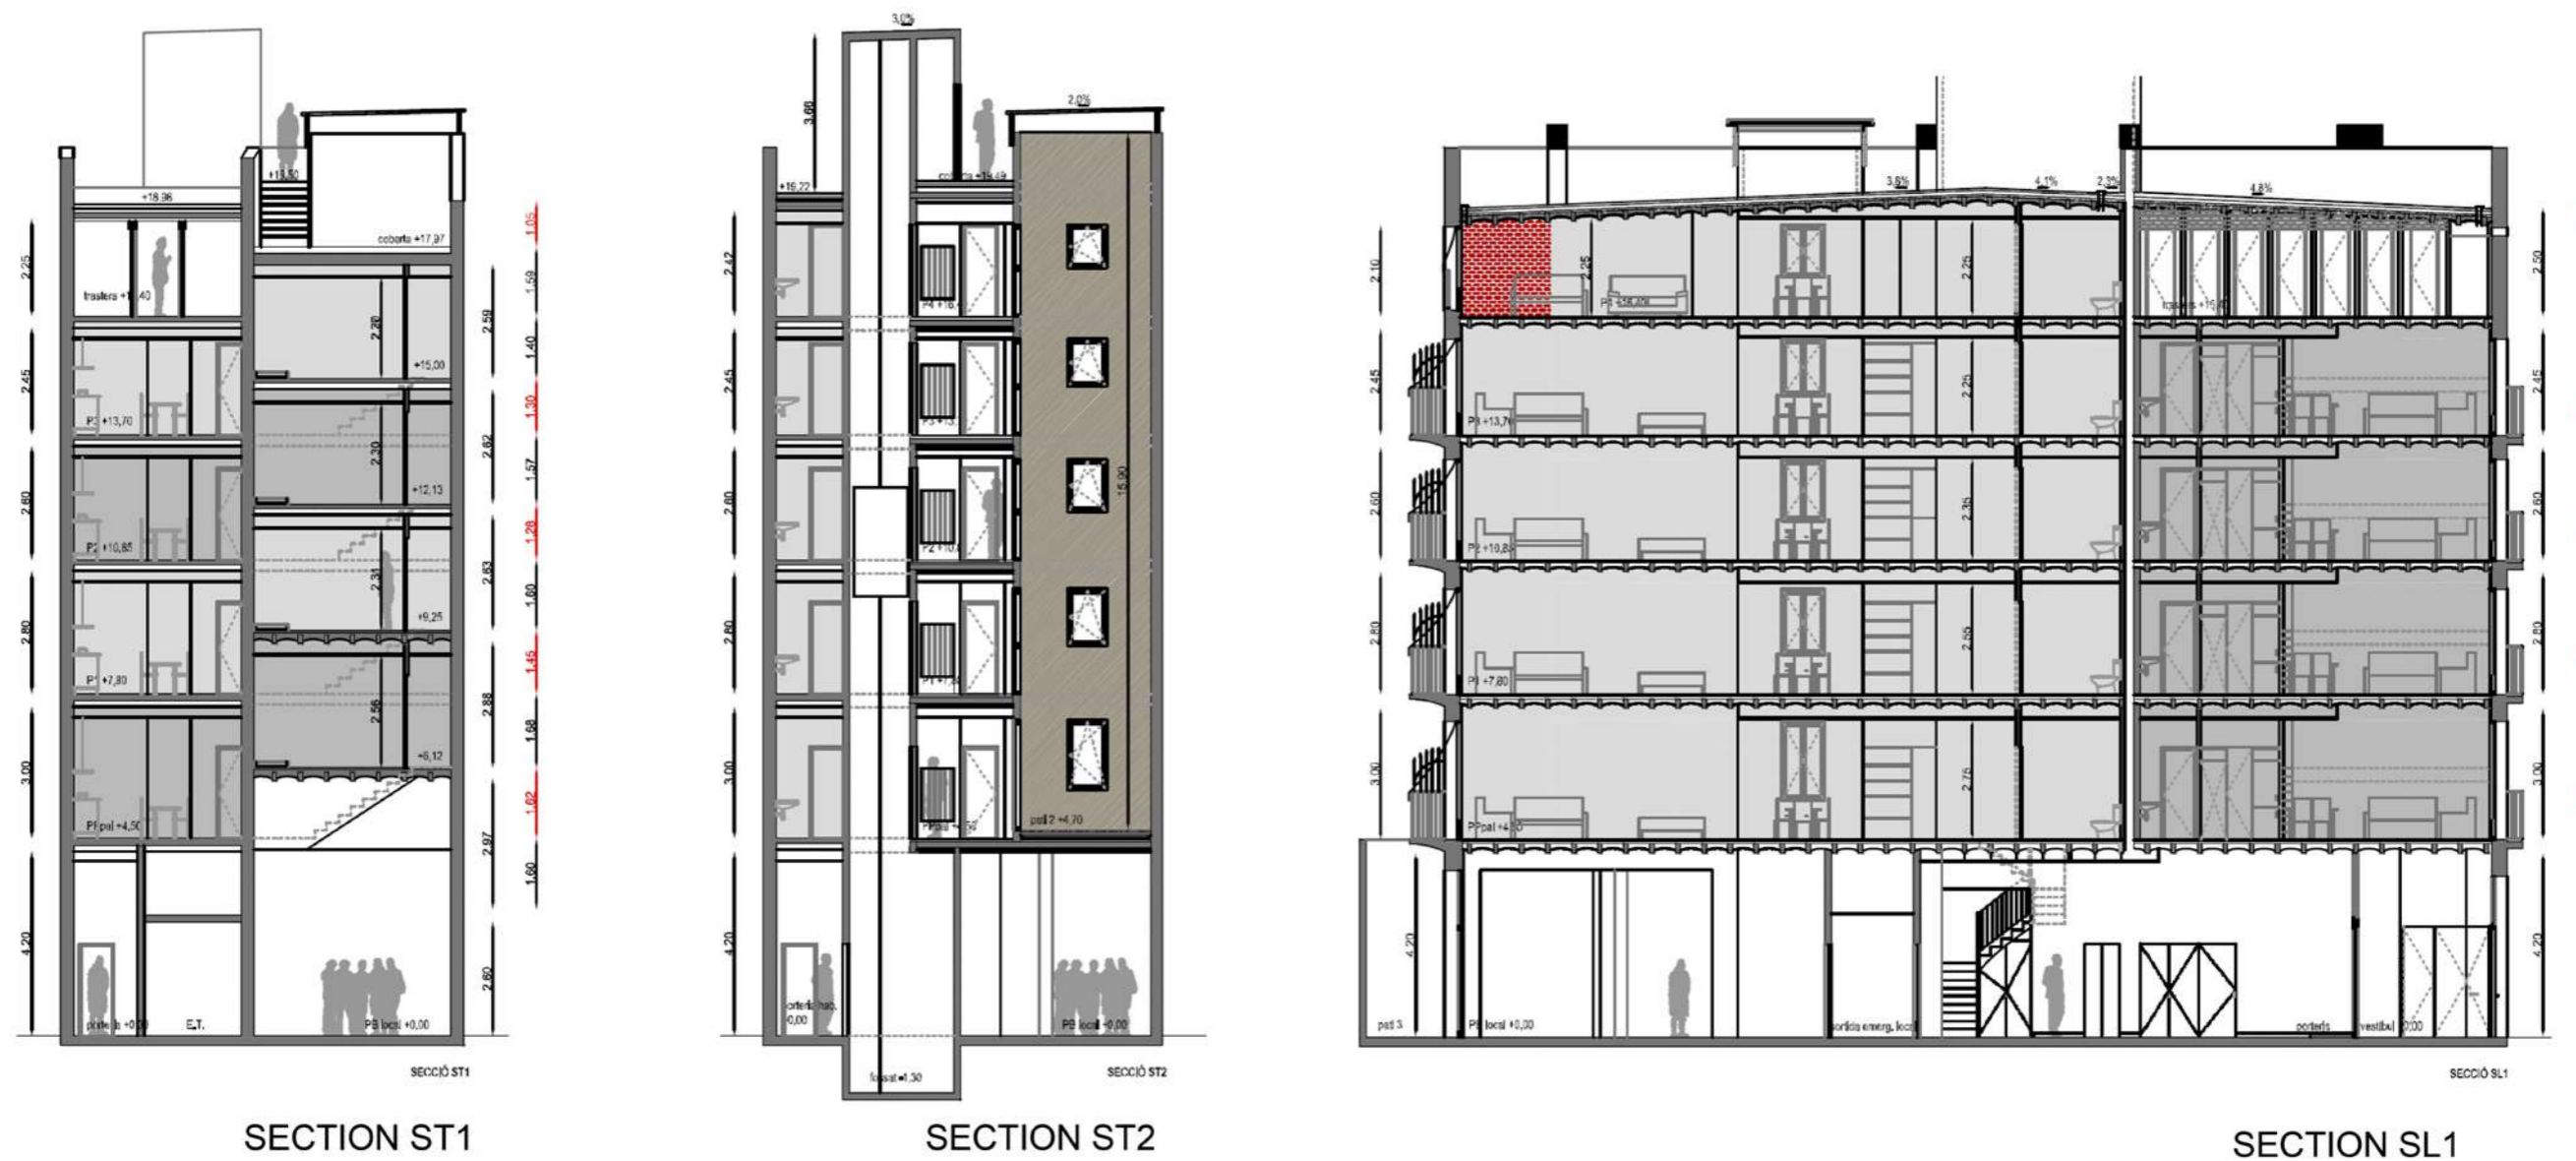
Fig.11: Sections.

The sum of properties with different levels is overcome with the difficulty of providing the compressed fabric of the old town with a substantial improvement in accessibility and in the environmental conditions and comfort of the housing complex. The new accessibility is concentrated in the most generous nucleus, which, located in the center of the complex, facilitates the clearing of the new elevator access to the dwellings. The original materiality of the staircase space takes center stage in its vertical development. The cleansing and improvement of these spaces, accompanies one of the main contributions of the project: the opening of a new ventilation courtyard that illuminates and generates cross ventilation throughout the dwellings. The dimension achieved by this new courtyard is relevant if we compare it with the usual dimensions of similar spaces in neighborhoods with such old and dense buildings, such as the Raval.

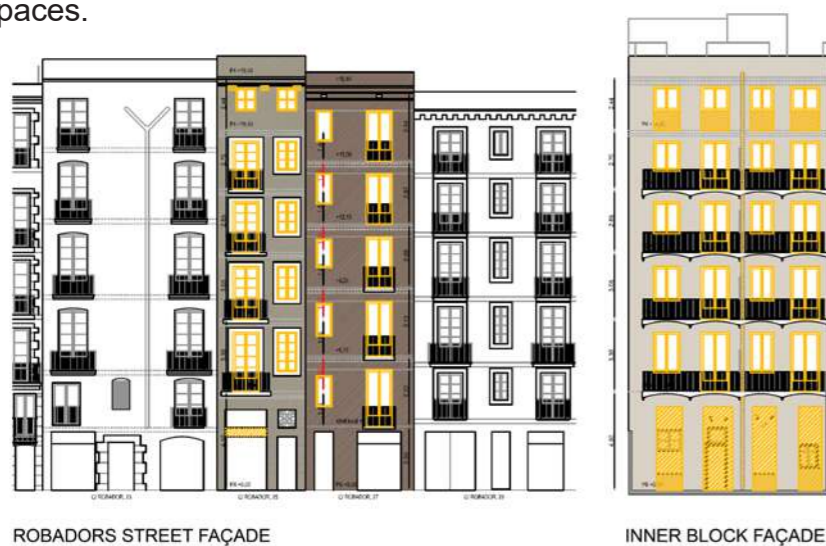
Fig.12: Drawings of the front & back façades.

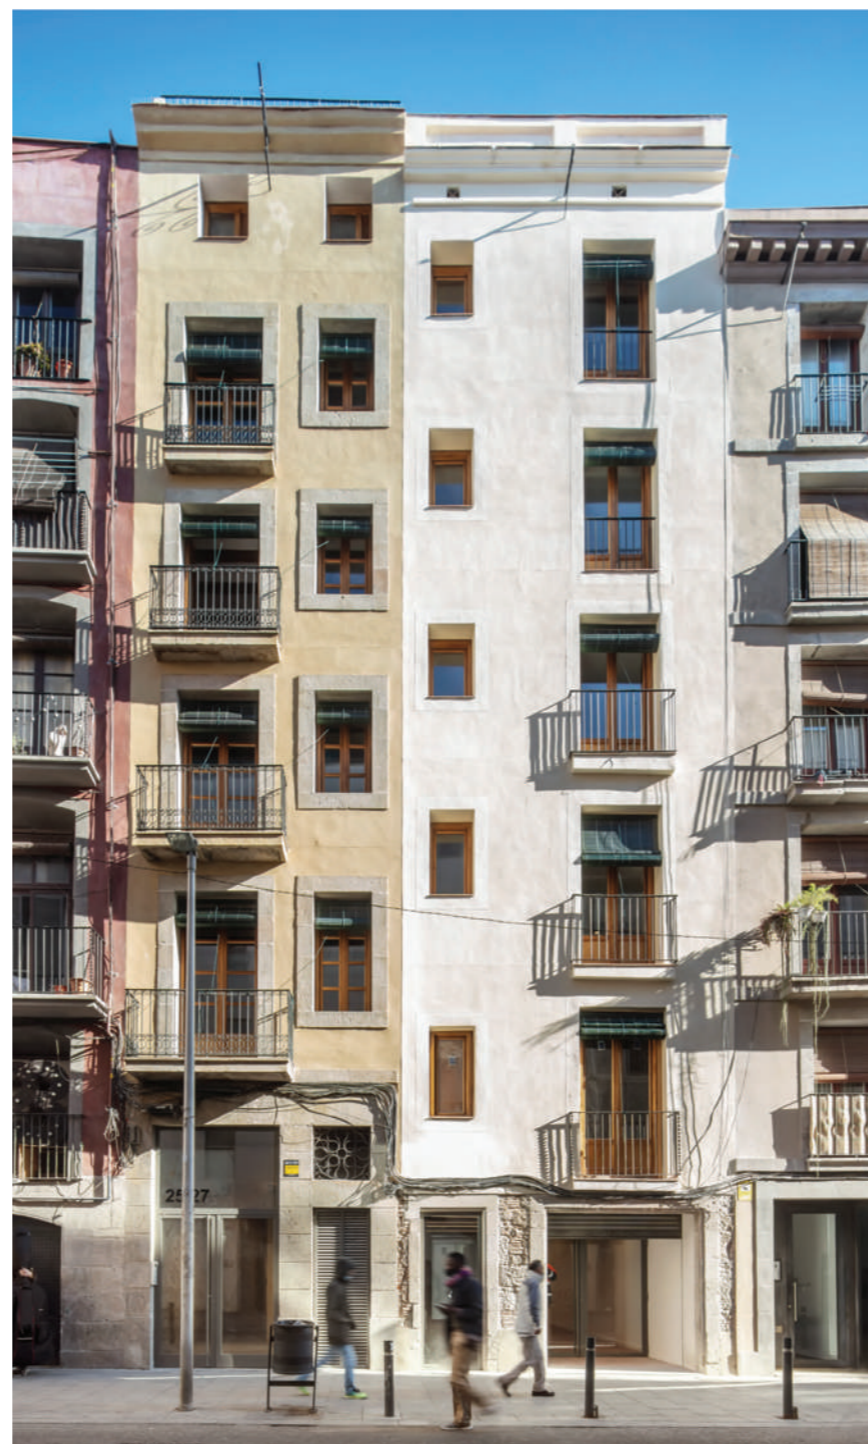
Fig.13: Front façades.

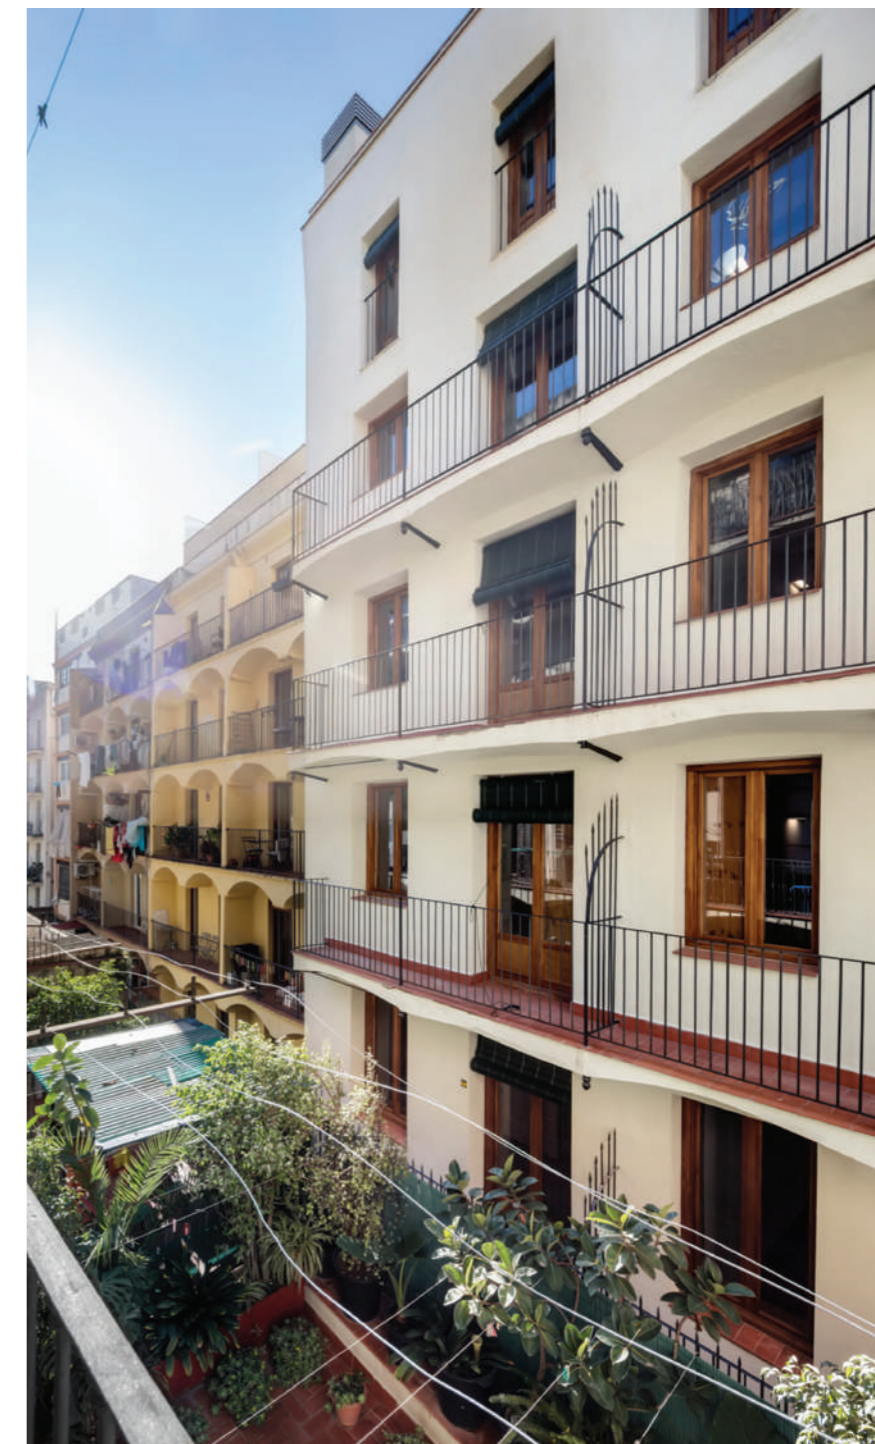
Fig.14: Back façade.

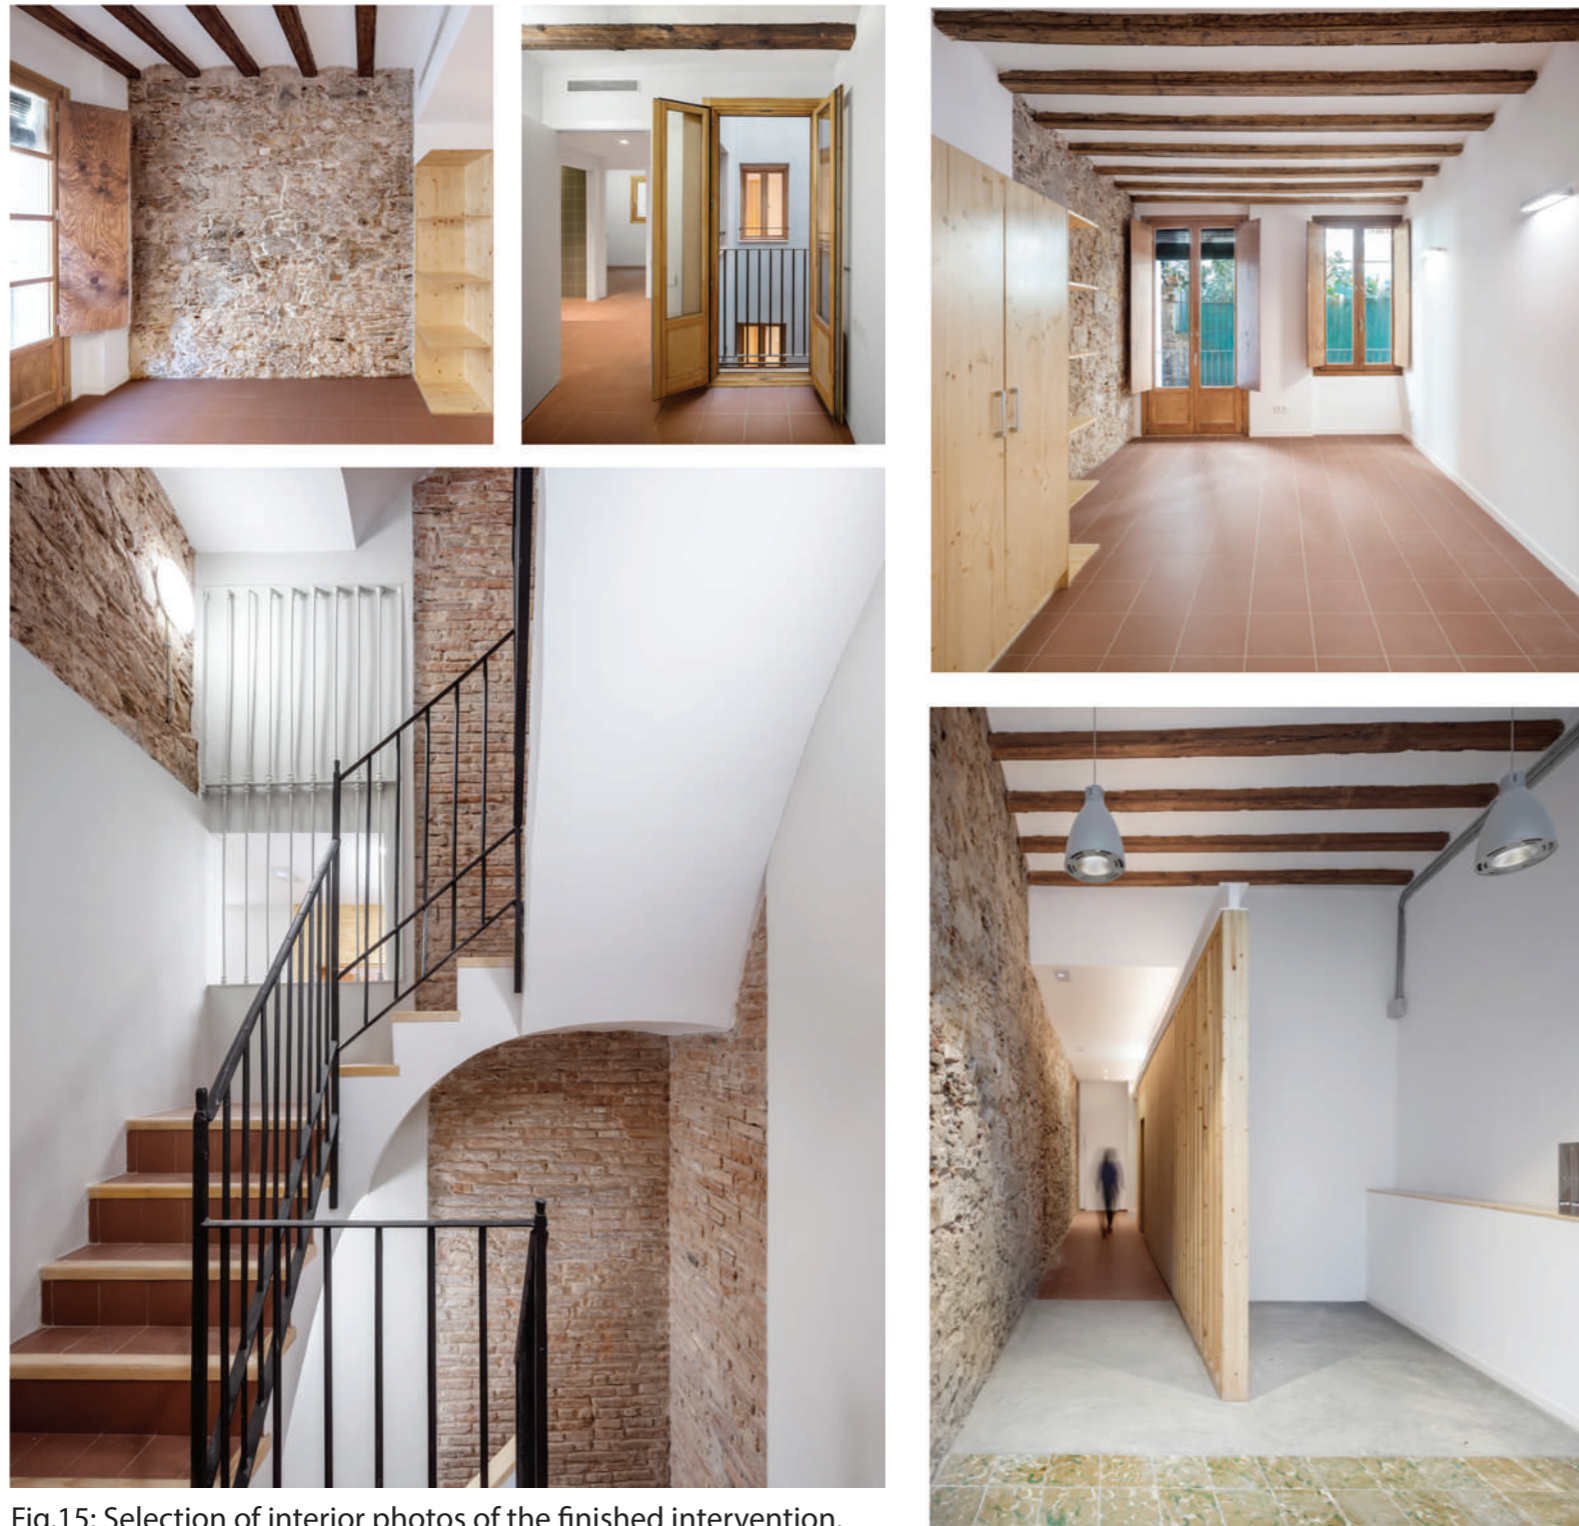
Fig.15: Selection of interior photos of the finished intervention.
