## Restoring a wine architecture in Sicily.

***A pilot site for the rediscovery and revival of historical construction techniques for the creation of a museum center of the agricultural tradition and cultural events.***

Restoration  Rehabilitation / Renovation

**Site** Royal Bourbon cellar, Partinico (PA), Italy

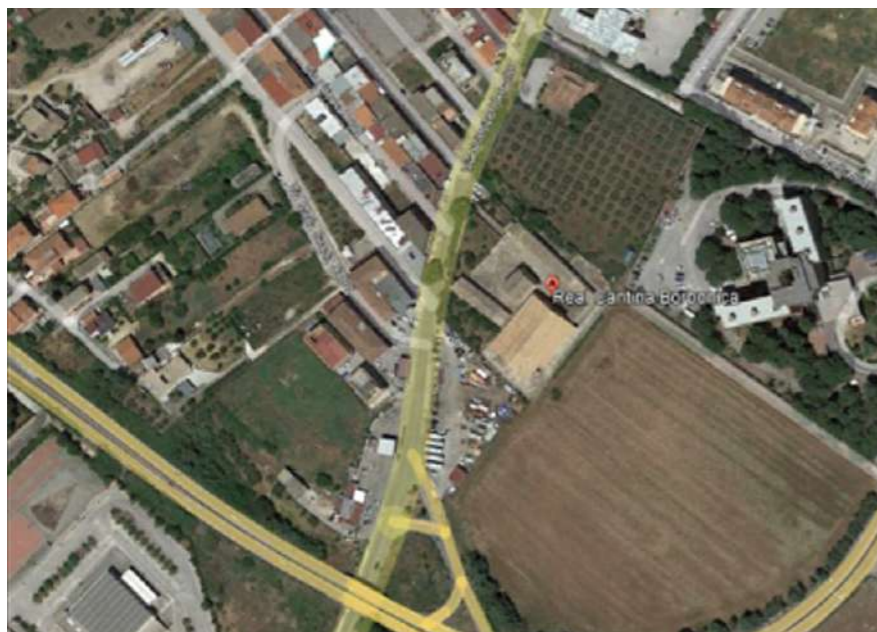
Fig.2: Planimetry of the area. @ Eng. Marinella Fiore

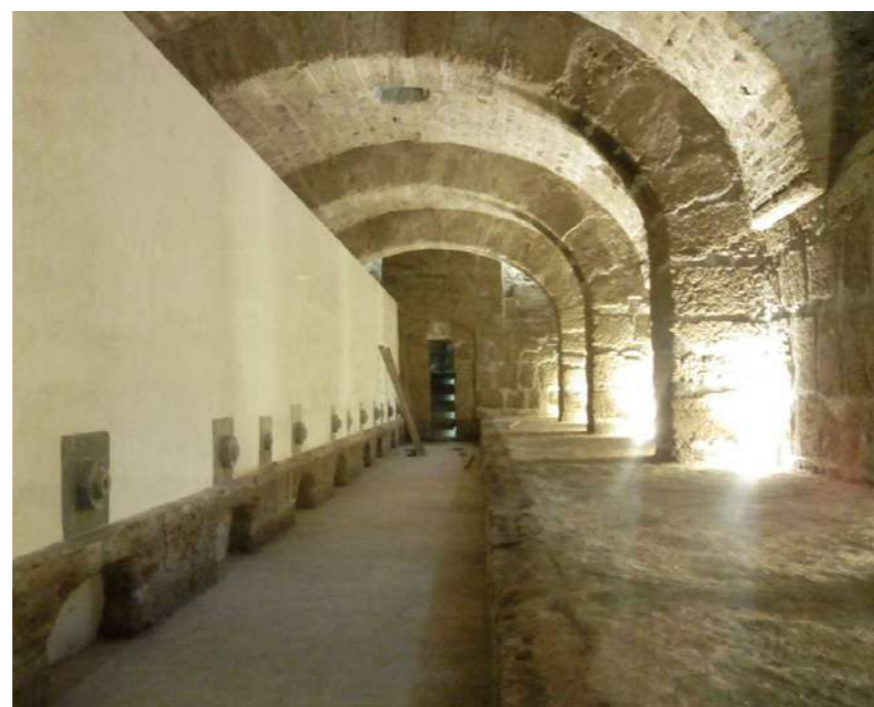
Fig.4: View of the underground level under the right nave, with masonry wine containers, after the restoration works - @ Eng. Marinella Fiore

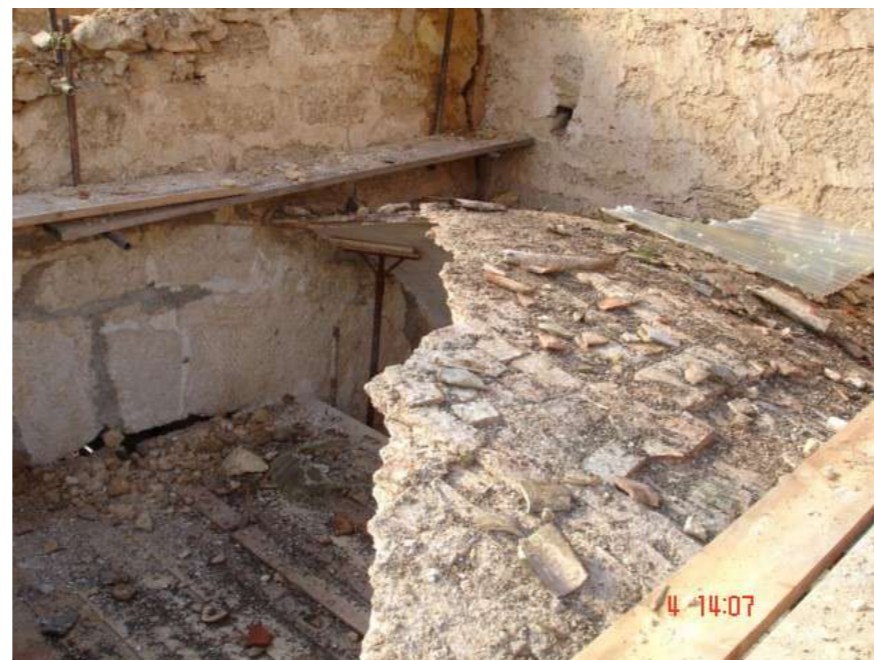
The building, as received by the Municipality of Partinico, was in an extreme state of abandonment. After the end of the wine activity, the complex was completely left in a state of degradation and improper uses. For instance, it was at a different time occupied by the homeless, used as a stable, as a warehouse. The masonry was in a critical state of maintenance, with many parts collapsed; some vaults were completely or partially collapsed and all the wooden frames were in a terrible state for the presence of water, and the biological attack. Finally, all the finishing was completely degraded.

Fig.8: State of maintenance of the vaults, with diffuse collapses. @ Eng. Marinella Fiore

The vaults, where present, have been completely consolidated by stripping the structures (extrados, counter-vaults, etc.), tacking of eventual cracks and detachments using hydraulic lime mortar both on the extrados and the intrados, the reconstitution of the abutments, the verification of the solidity, the reconstruction of the missing parts, the whole consolidation by means of carbon fiber tapes, stringing of the chains, and all the accessory and finishing works.

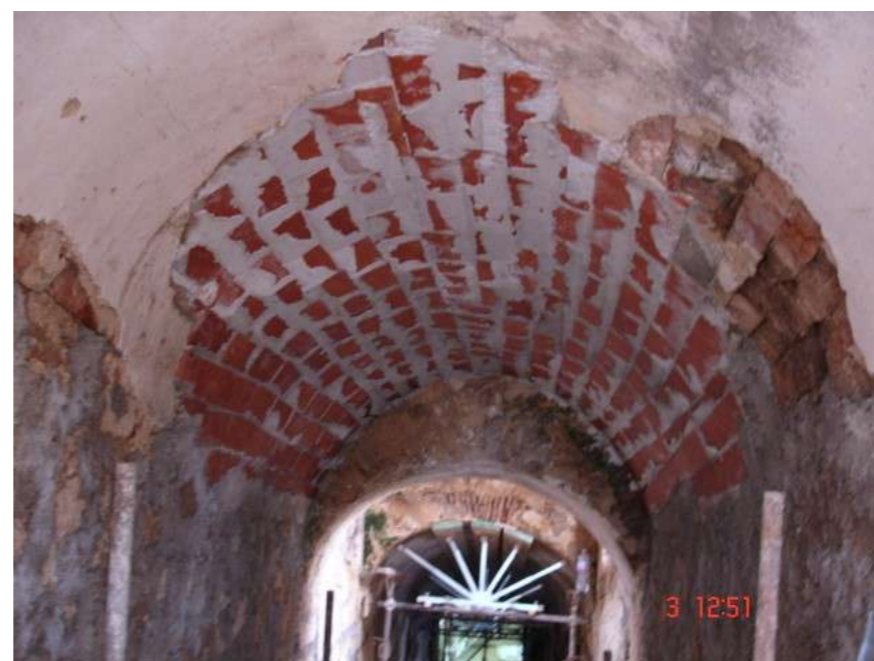
Fig.9: State of maintenance of a brick-made vault, with partial structural failure and diffuse degradation. @ Eng. Marinella Fiore

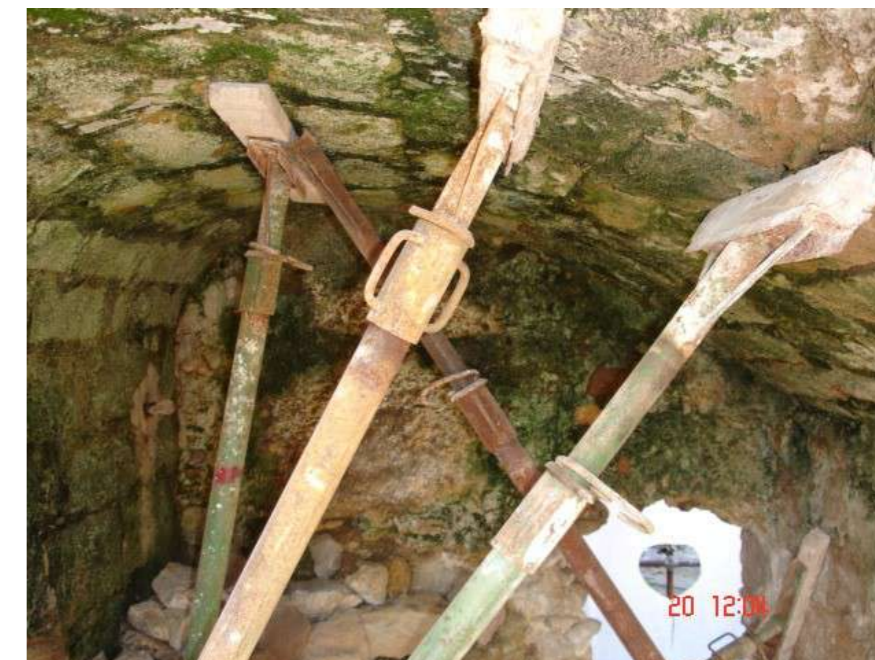
Fig.10: A propped-up vault to avoid further collapses waiting for the restoration work. @ Eng. Marinella Fiore

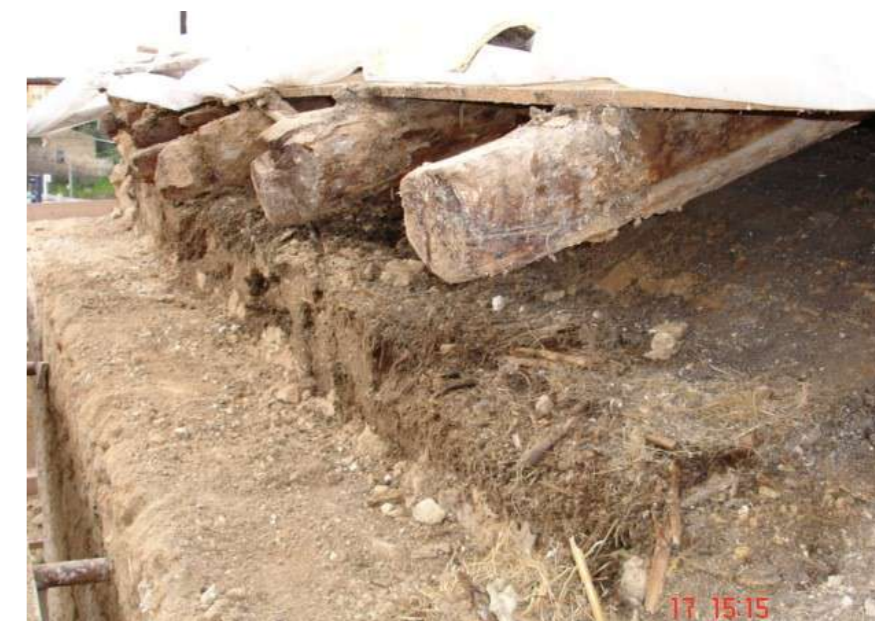
Fig.11: State of maintenance of the wooden roofs, with diffuse collapses, lack of material, degradation of the heads of the beams, bird nests and vegetation. @ Eng. Marinella Fiore

Reconstruction, even total due to the advanced state of decay, of the wooden roof floors was made by wooden beams as the main framework, above which smaller half beams (half “ginelli”) were placed. Finishing was made of the traditional Sicilian brick tiles (Sicilian “coppo”) according to the traditional constructive technique. The rainwater disposal system was completely rebuilt as it was originally, using “gargoyles” and the free-fall system directly from tiles.

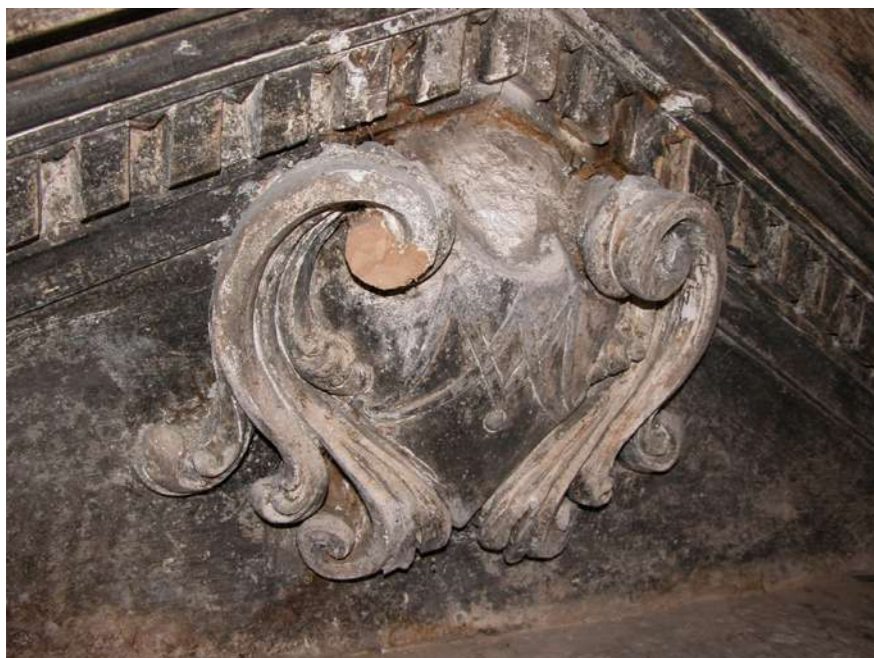
Fig.12: State of maintenance of the inner plaster and the stucco decoration of the spaces, in the picture the friezes of the chapel before the restoration works. @ Eng. Marinella Fiore

Where present, the original plasters have been consolidated or completely reconstructed using the original techniques. The finishes were all made with traditional lime mortar.

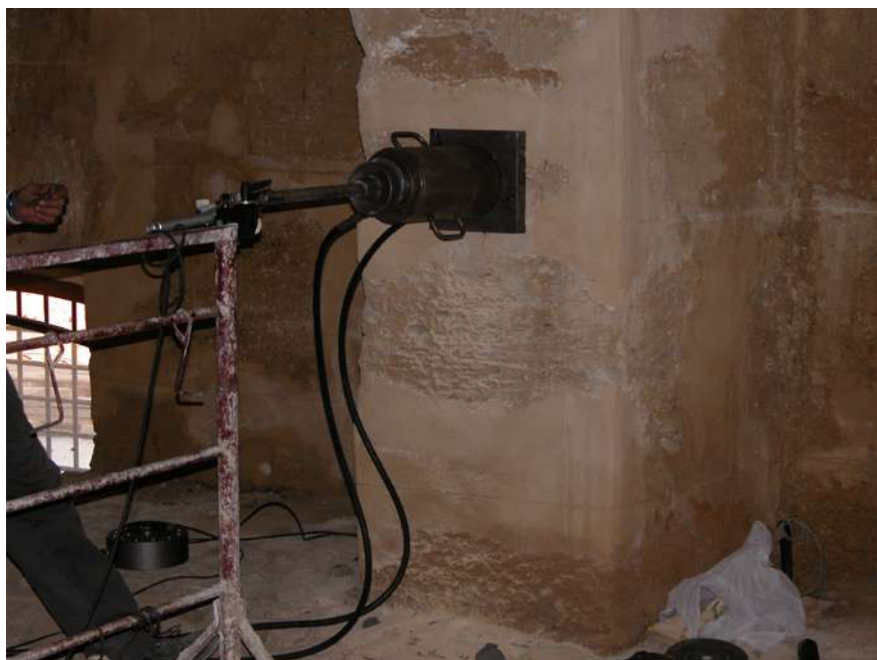
Fig.14: Restoration of the load-bearing masonry and verification of its structural integrity, during the restoration works. @ Eng. Marinella Fiore

In particular, the works have seen the complete recovery of the masonry structures, through cracks repair, injections of low-pressure hydraulic lime mortar, relocation of stone ashlar where missing, partial reconstructions of the collapsed areas, improvement of the connections between the central supporting walls, construction of curbs at the top of the walls to ensure the

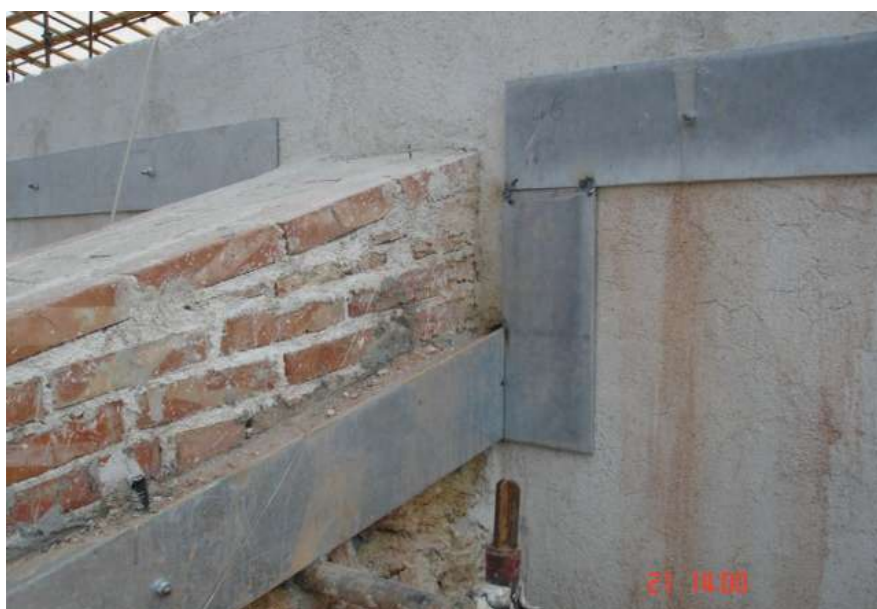
Fig.15: Construction of curbs, made of reinforced concrete, located at the walls' top to ensure a box-like behavior and avoid future collapse, during the restoration works. @ Eng. Marinella Fiore

box-like behavior of the wall sections and avoid detachments, or even collapses, in the event of seismic events.

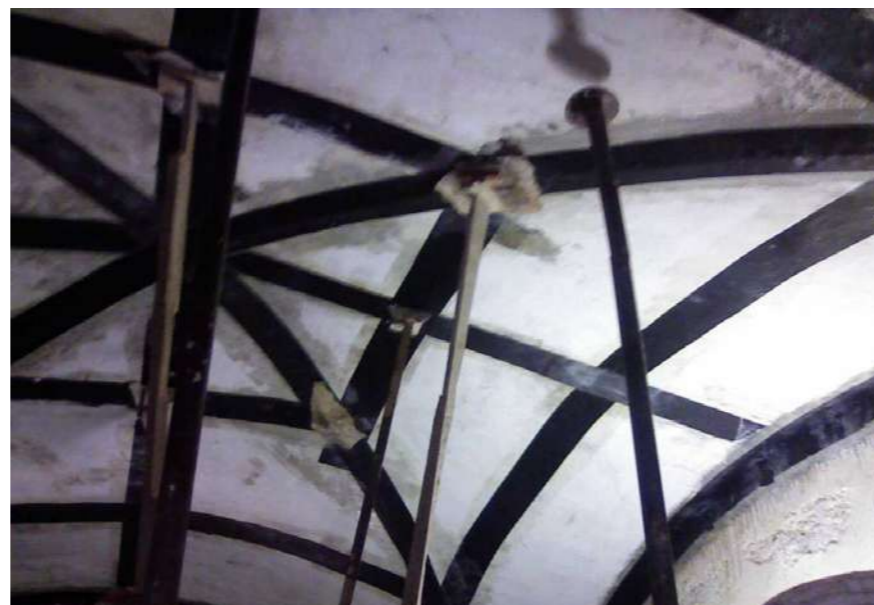
Fig.16: Reconstruction of stone vaults with carbon fibres reinforcement (FRP), view of the intrados. @ Eng. Marinella Fiore

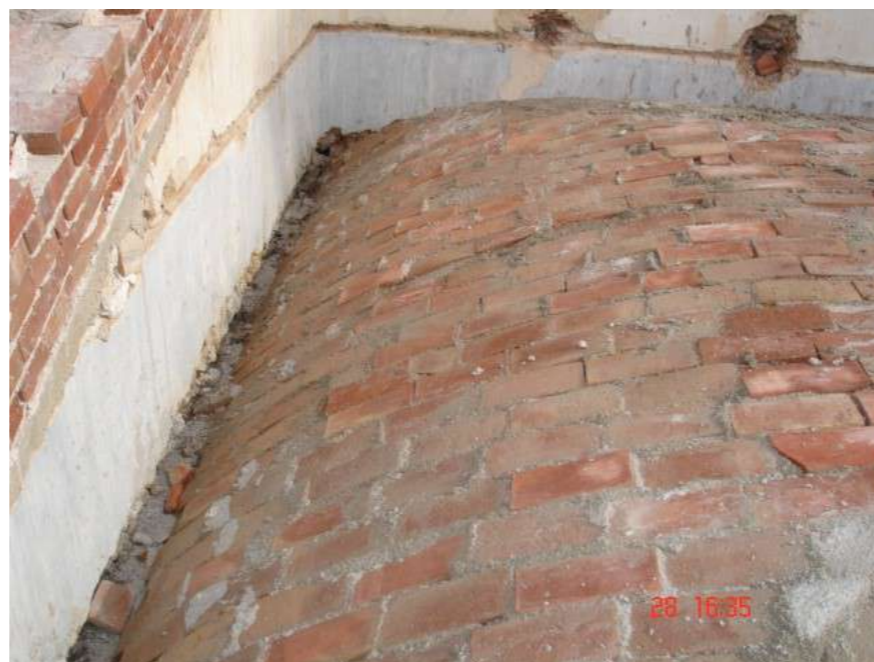
Fig.17: Reconstruction of stone vaults, view of the just finished extrados, during the restoration works. @ Eng. Marinella Fiore

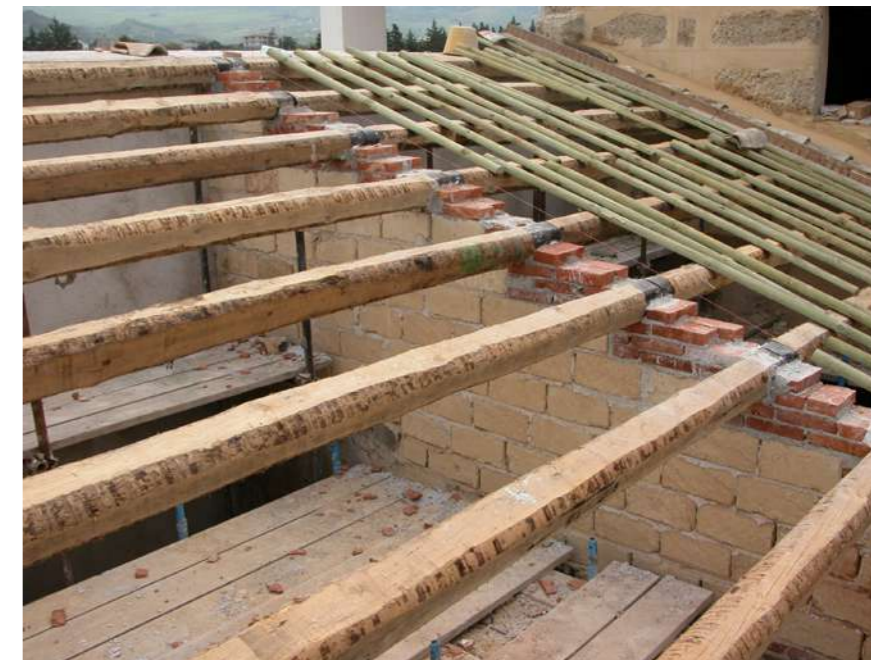
Fig.18: Reconstruction of the roofs through the installation of main wooden beams, surmounted by half smaller wooden beams, during the restoration works. @ Eng. Marinella Fiore

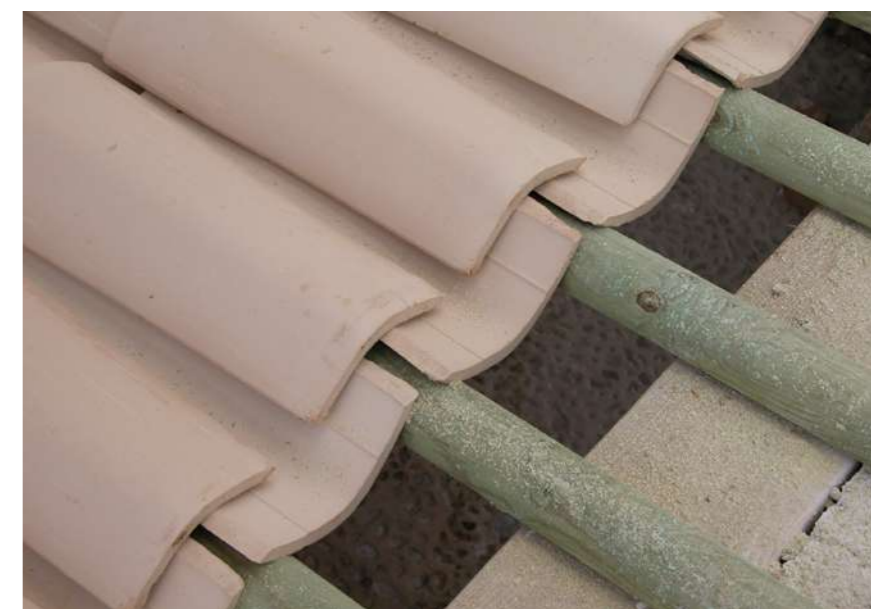
Fig.19: Reconstruction of the roofs, installation of half smaller wooden beams on the main wooden ones, surmounted by corrugated plank, during the restoration works. @ Eng. Marinella Fiore

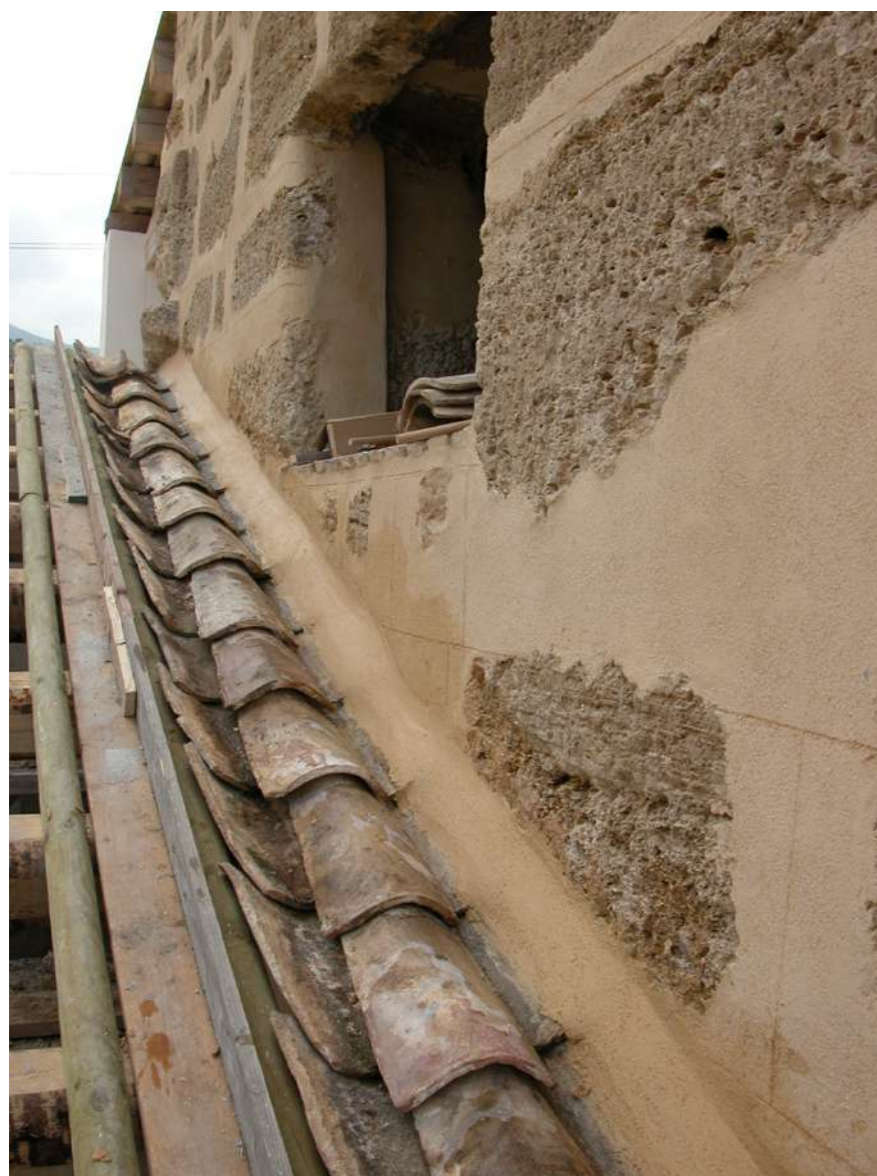
Fig.20: Reconstruction of the roofs, installation of traditional terracotta tiles (Sicilian coppo), during the restoration works. @ Eng. Marinella Fiore

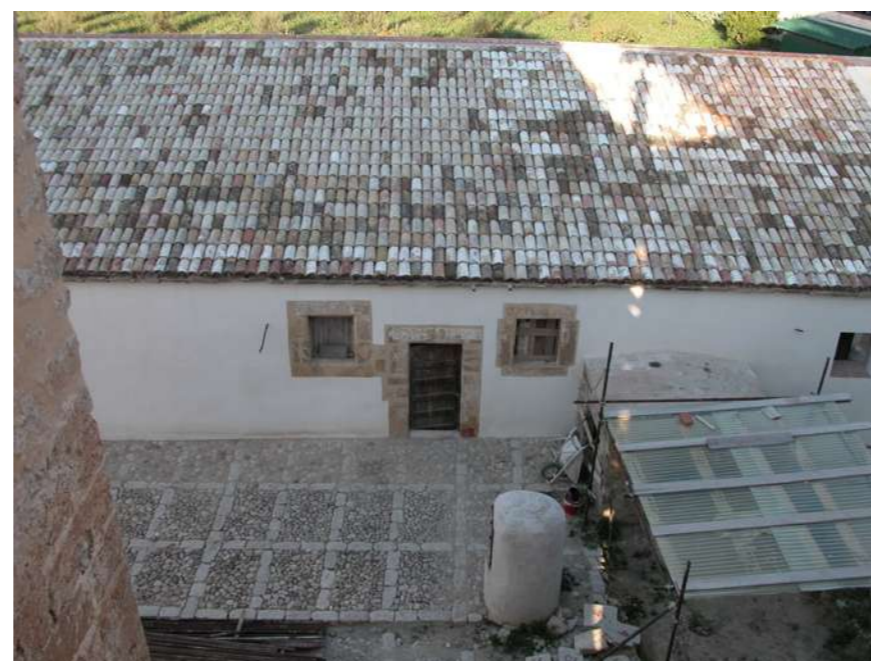
Fig.21: Reconstruction of the roofs, top view after the end of the reconstruction. @ Eng. Marinella Fiore

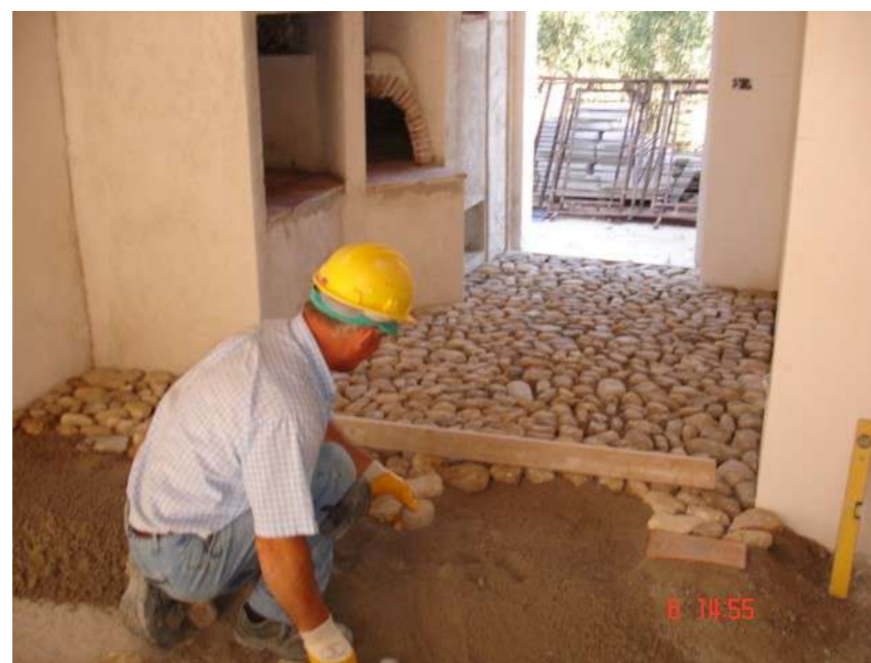
Fig.22: Reconstruction of the traditional cobblestone paving, during the restoration works. @ Eng. Marinella Fiore

The floors have been restored using the ancient limestone blocks, along the entrance paths, and using pebbles in the internal areas, as it was in ancient times.
