From silence to lively life: a convent restored to become a University center for Italian and foreign students.

A complex restoration intervention, intersecting structural aspects and finishing ones.

Site Convent of St. Antonino and Military Wooden Mill, St. Antonino Square, near the Central Station, Palermo, Sicily, Italy

Designer University of Palermo Technical Area, Arch. Costanza Conti; Eng. Antonio Sorce

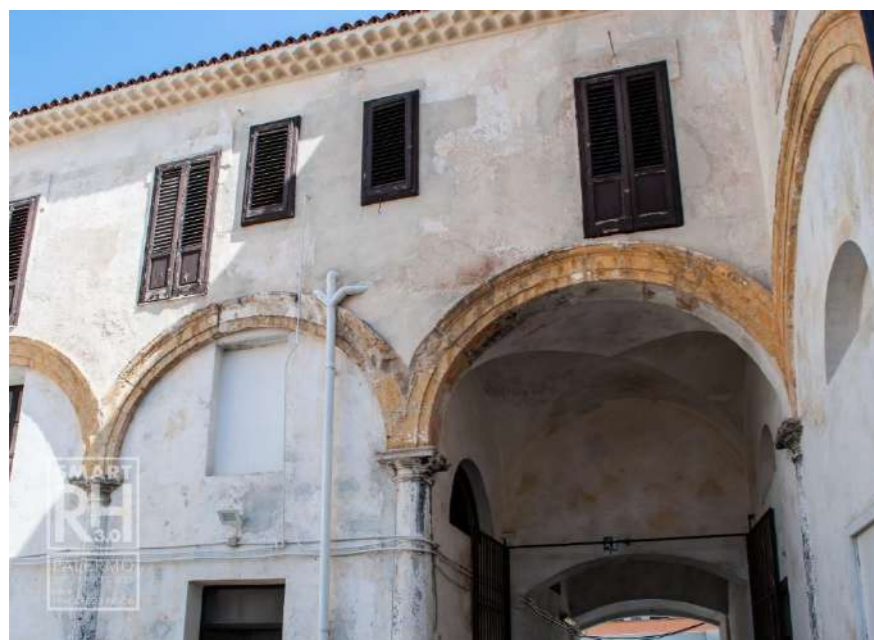
Fig.4: Detailed view of the inner portico. ©Francesco Renda

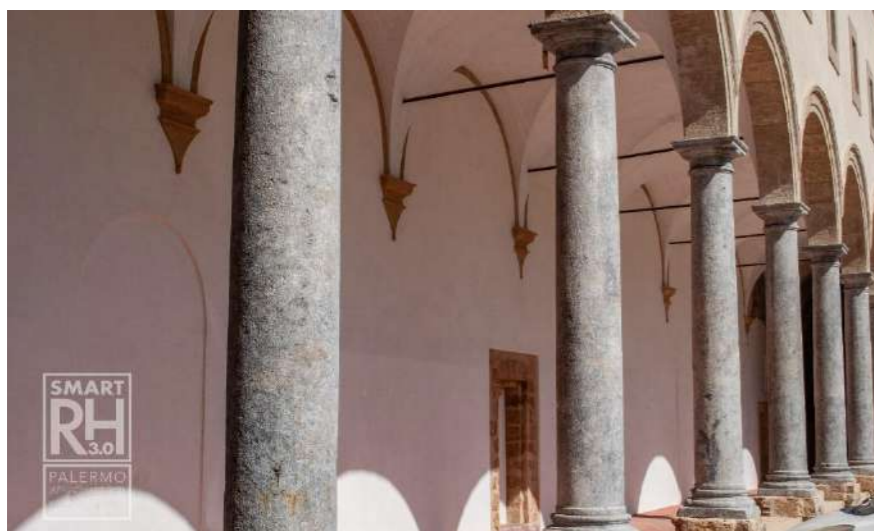
Fig.5: Detail view of one of the arms of the inner portico with columns of compact grey limestone and shell limestone arches. ©Francesco Renda

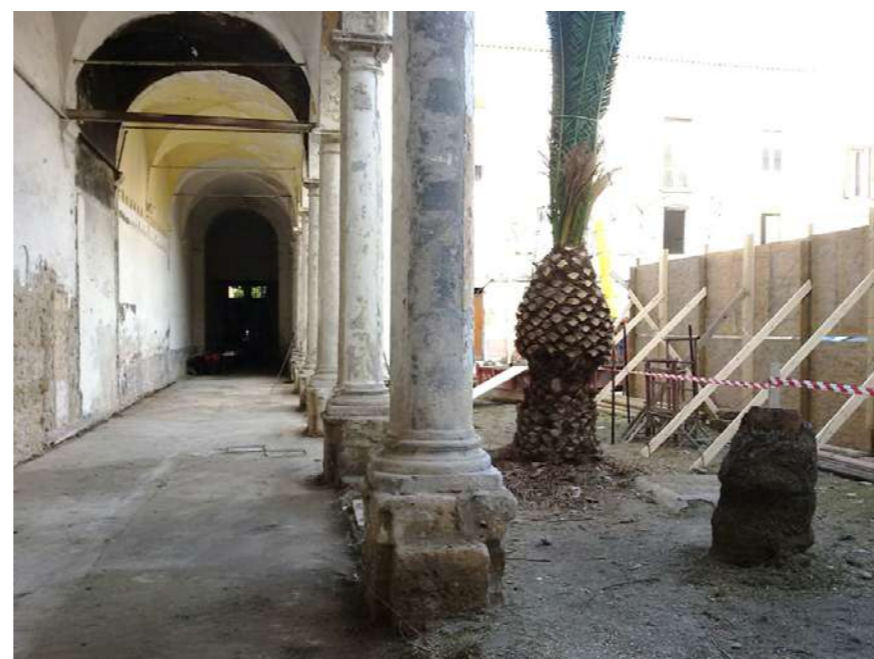
Fig.6a: Detail view of one of the arms of the inner portico with stone cross vaults, set on corbels and metal chains to eliminate horizontal actions, before the interventions. © University of Palermo, Technical Area

- consolidation and restoration of the stone vaults;
- disassembly and replacement of the reinforced concrete horizontals and reconstruction of floors with typological characteristics similar to the original ones (wooden floors, roofs with wooden trusses, etc.);
- construction of traditional anti-seismic protection works (metal connections at the heads of the wooden beams, metal tie rods with adjustment sleeves, solid brick curbs reinforced at the top of the walls of the last elevation);
- restoration of existing metal chains, or if necessary, replacement of the same.

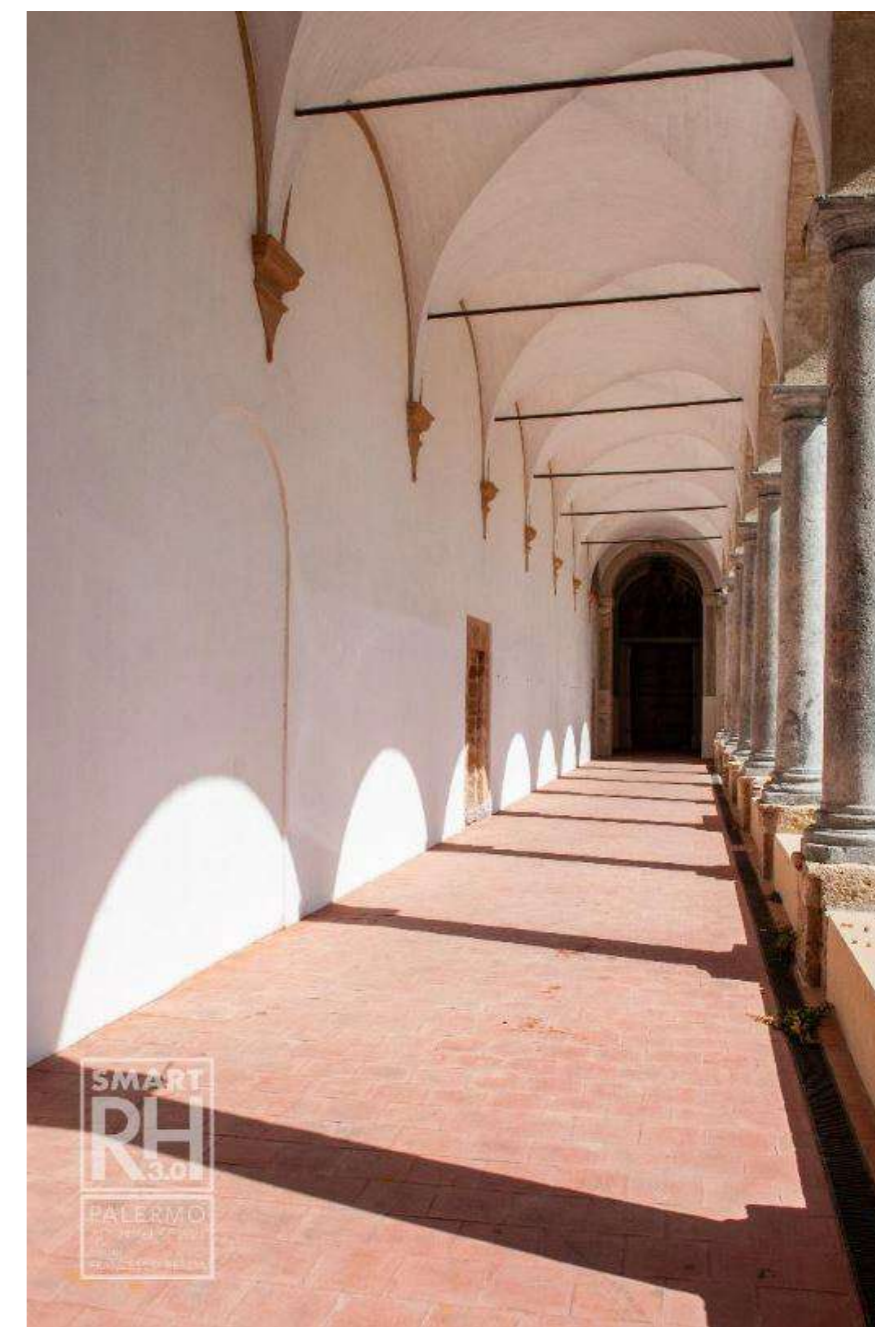
Fig.6b: Detail view of one of the arms of the inner portico with stone cross vaults, set on corbels and metal chains to eliminate horizontal actions. ©Francesco Renda

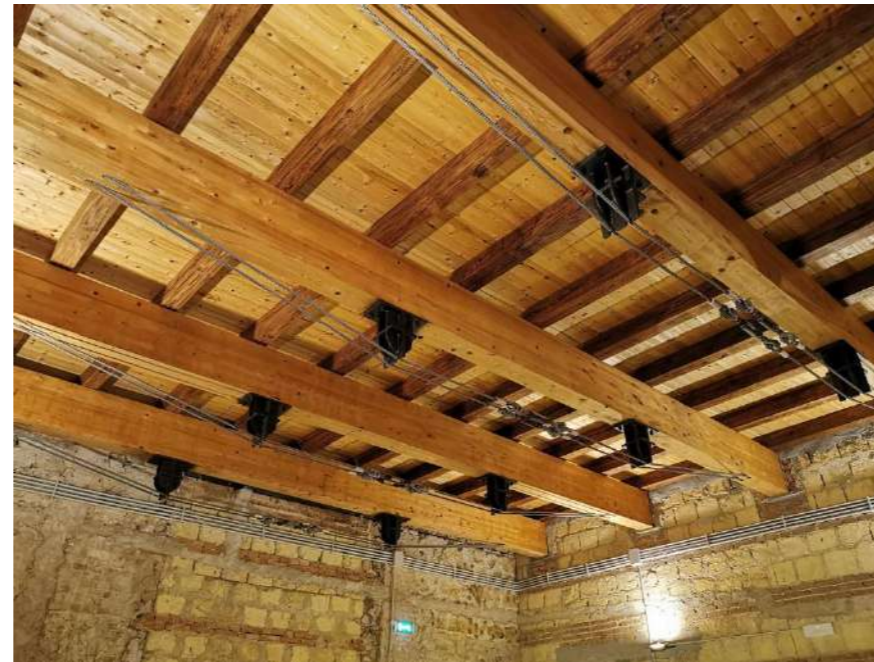
Fig.9a: New wooden floors. © Manfredi Saeli

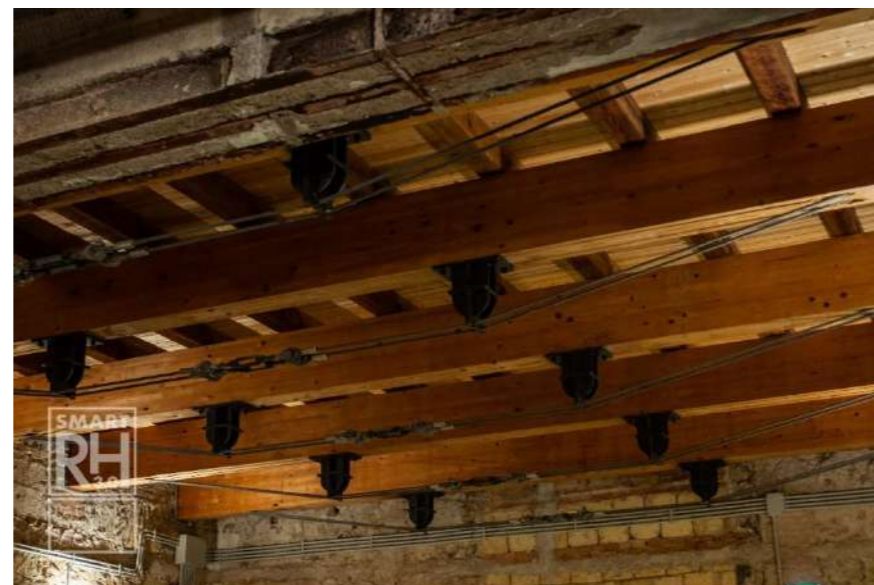
Fig.9b: New wooden floors; detail of the reinforced wooden beams. © Francesco Renda

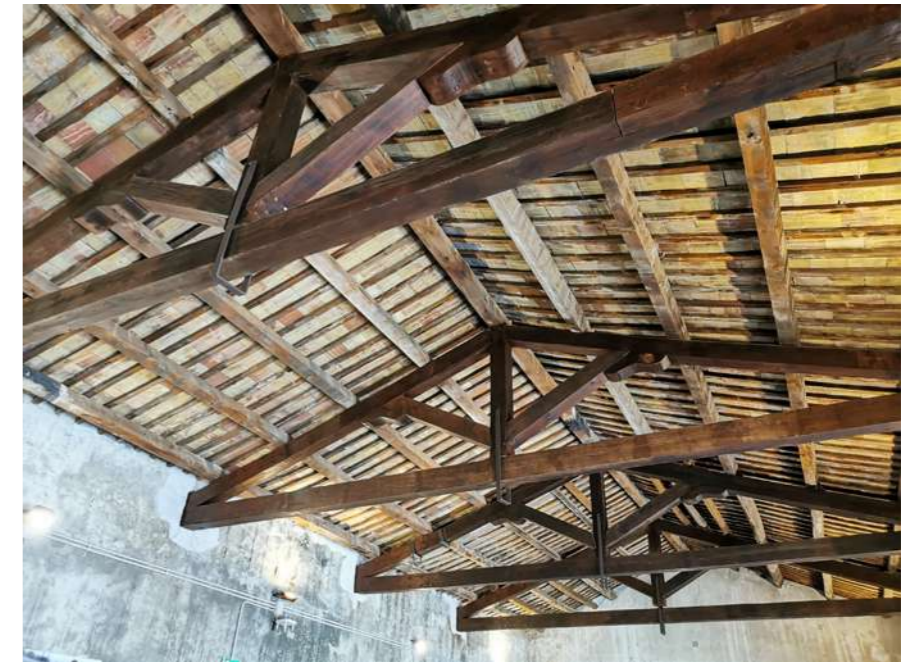
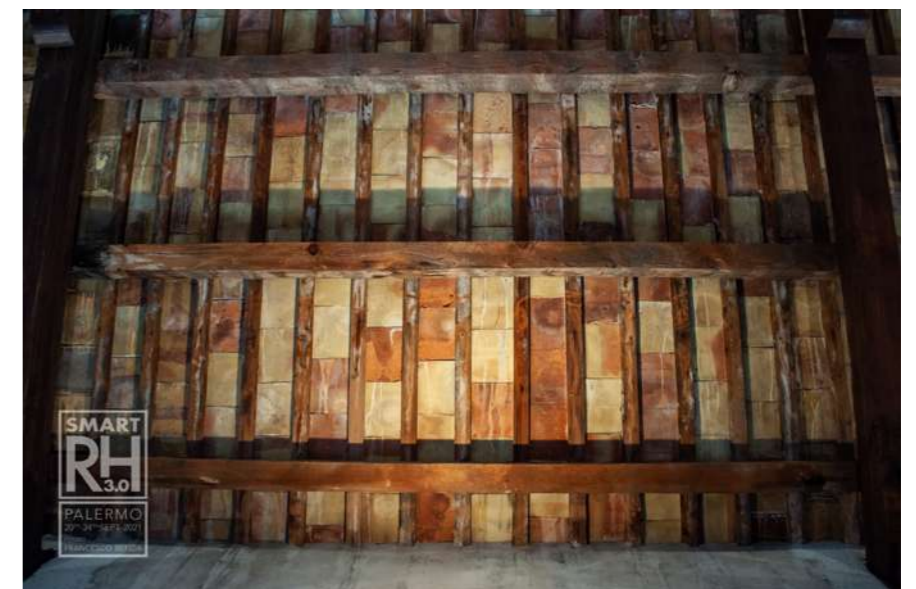
Fig.10a-b: Timber structure of roof with trusses. © Manfredi Saeli & Francesco Renda

- revision of existing trusses and replacement of those seriously damaged;
- reconstruction of the rainwater disposal system, using copper gutters and downspouts;
- replacement of external doors and windows, using wooden frames having traditional construction characteristics and designs.

Where truss replacement is necessary, the new structures have a type and static functioning similar to the pre-existing ones. Particular attention was paid to the connection to the masonry and to any overlying stiffening planking, as well as to the housings of the heads of the wooden beams.

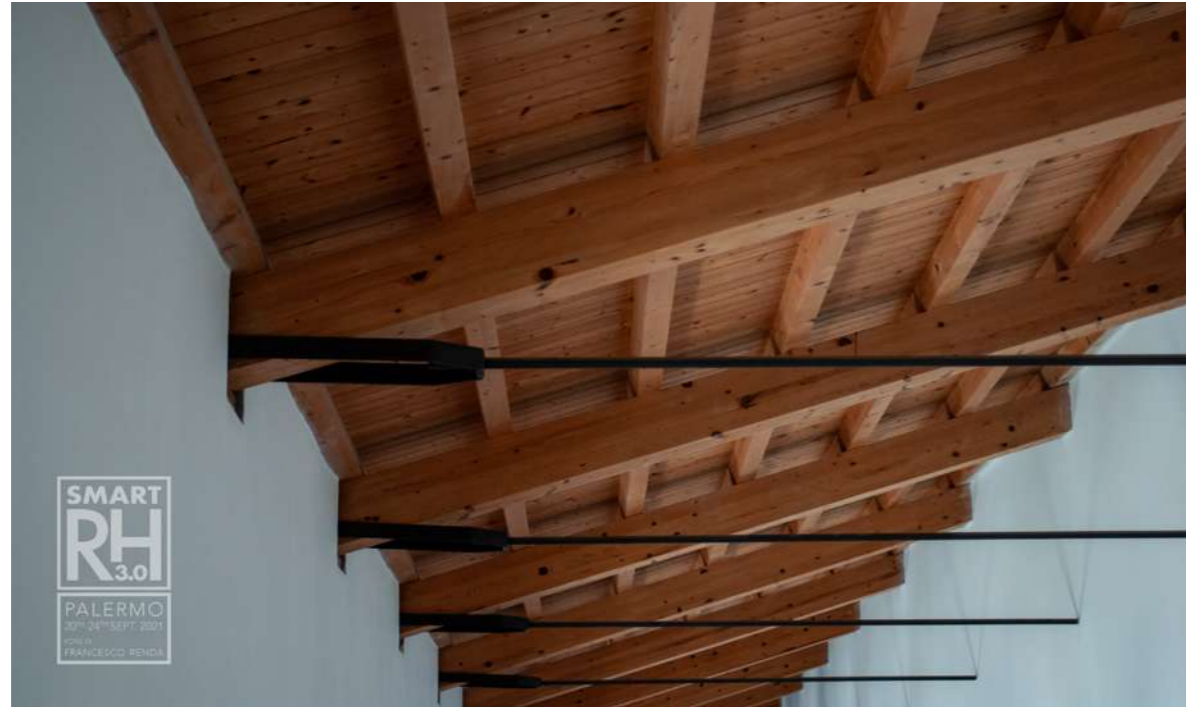
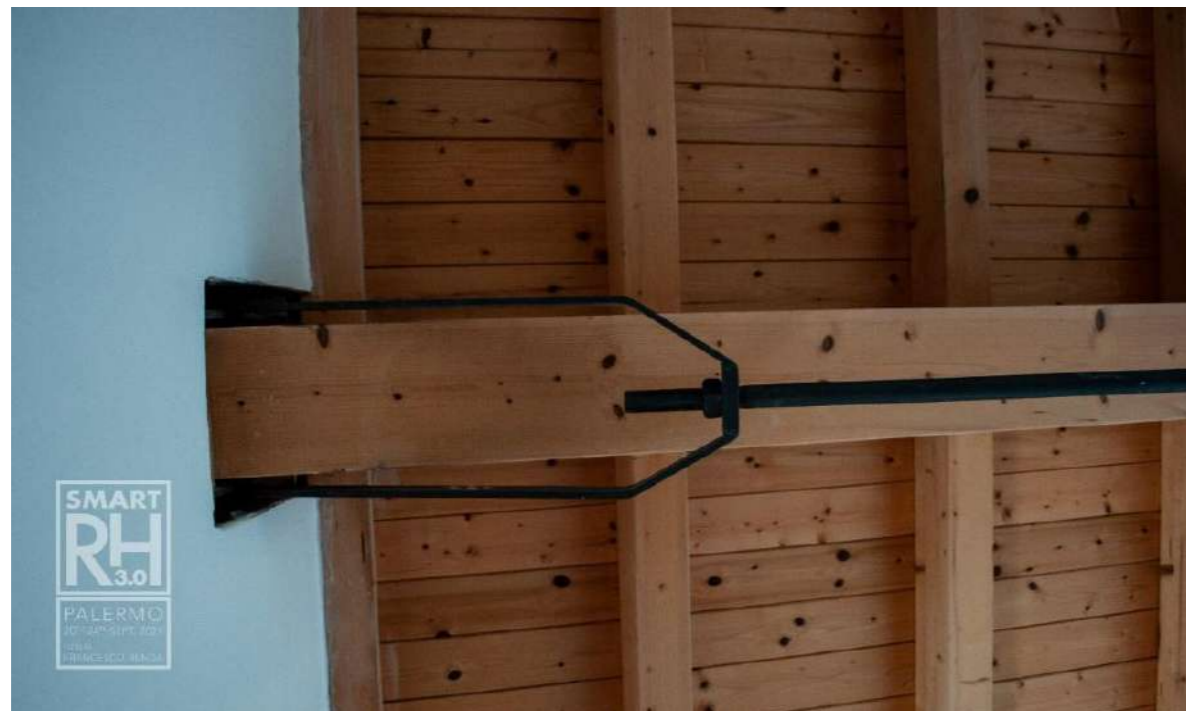
Fig.11a-b: View of new timber structure of a roof with steel tie rods to eliminate pushing actions. ©Francesco Renda

structures falling within the seismic area, the used techniques have preferred the execution of seismic protection works similar to the original existing ones (metal tie rods, etc.) in order to eliminate any thrusts transmitted to the walls.

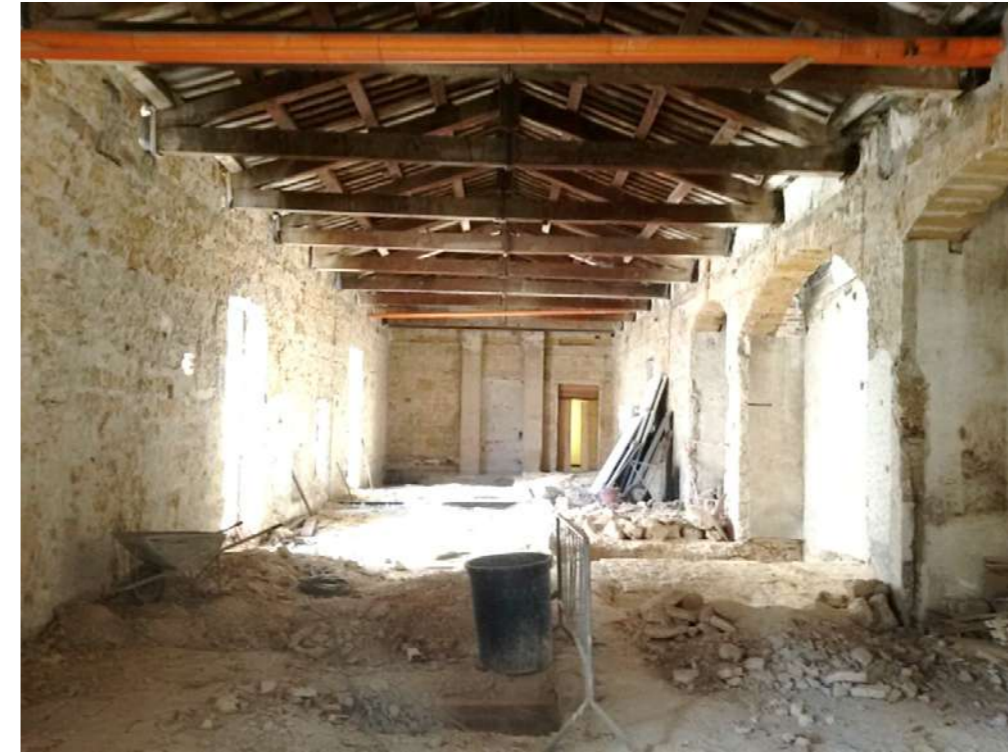
Fig.12: View of restoration phases. ©University of Palermo, Technical Area

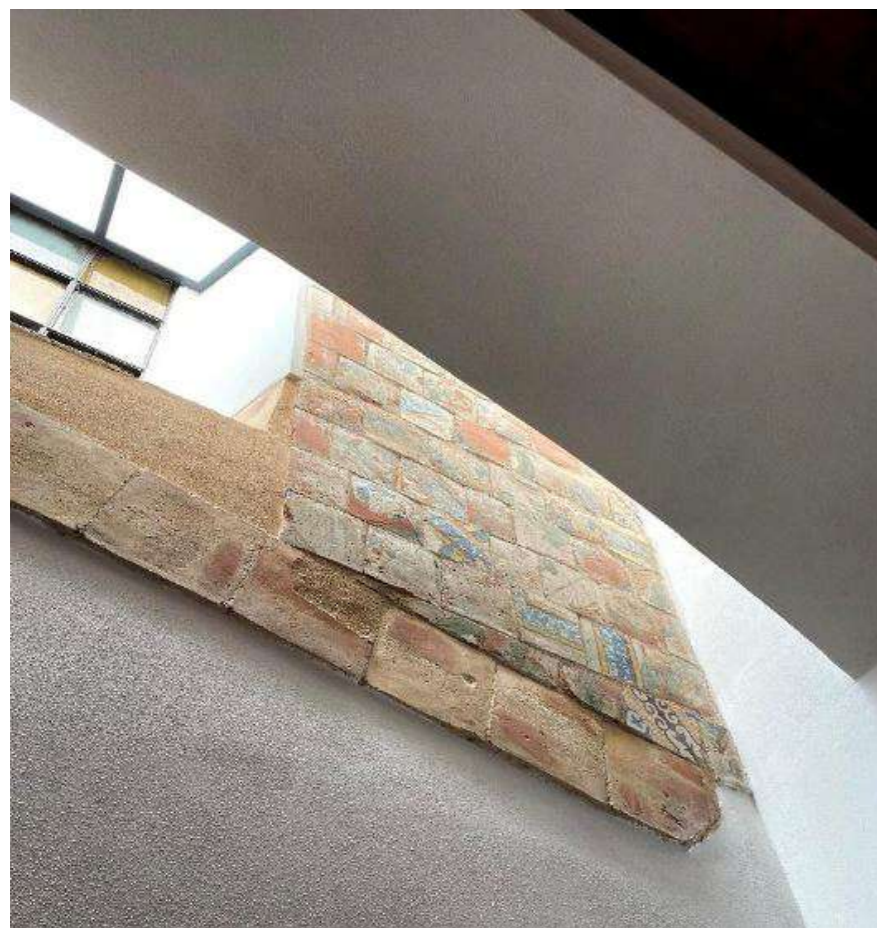
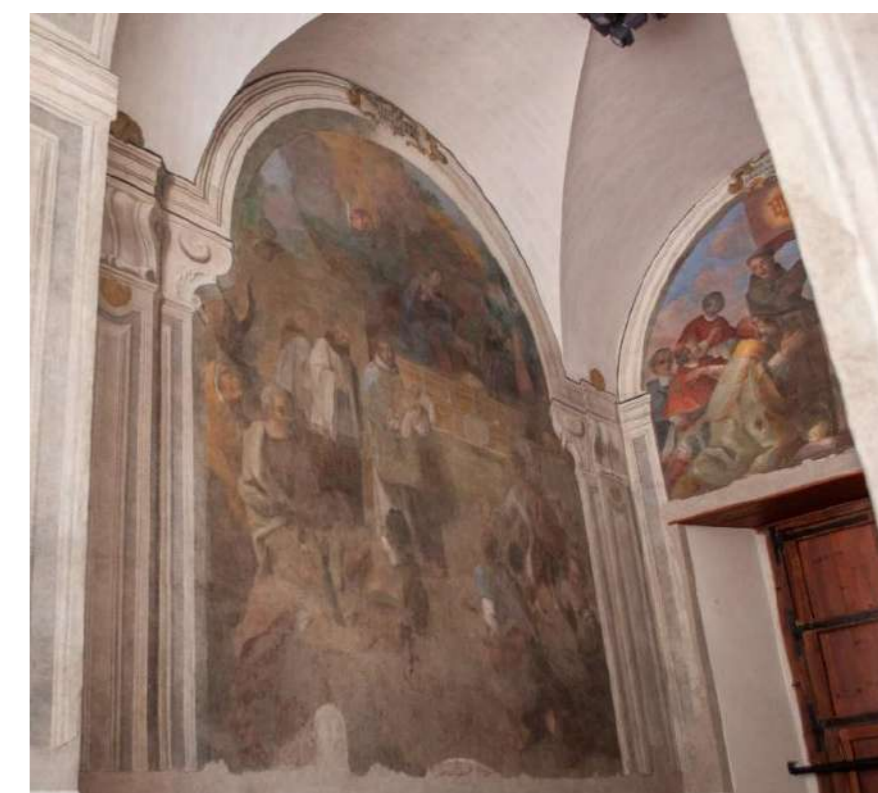
Fig.14: View of the restored paintings. ©Francesco Renda

The pictorial reintegration, performed in watercolor, observed the criterion of chromatic selection and the mending with neutral tones of the abraded portions, in order to reduce the visual interference caused by the multiple and extensive falls of the pictorial film and more or less deep abrasions. This technique made it possible to bring out the original pictorial material by minimizing the restoration work, whose primary purpose is the conservation of the asset.

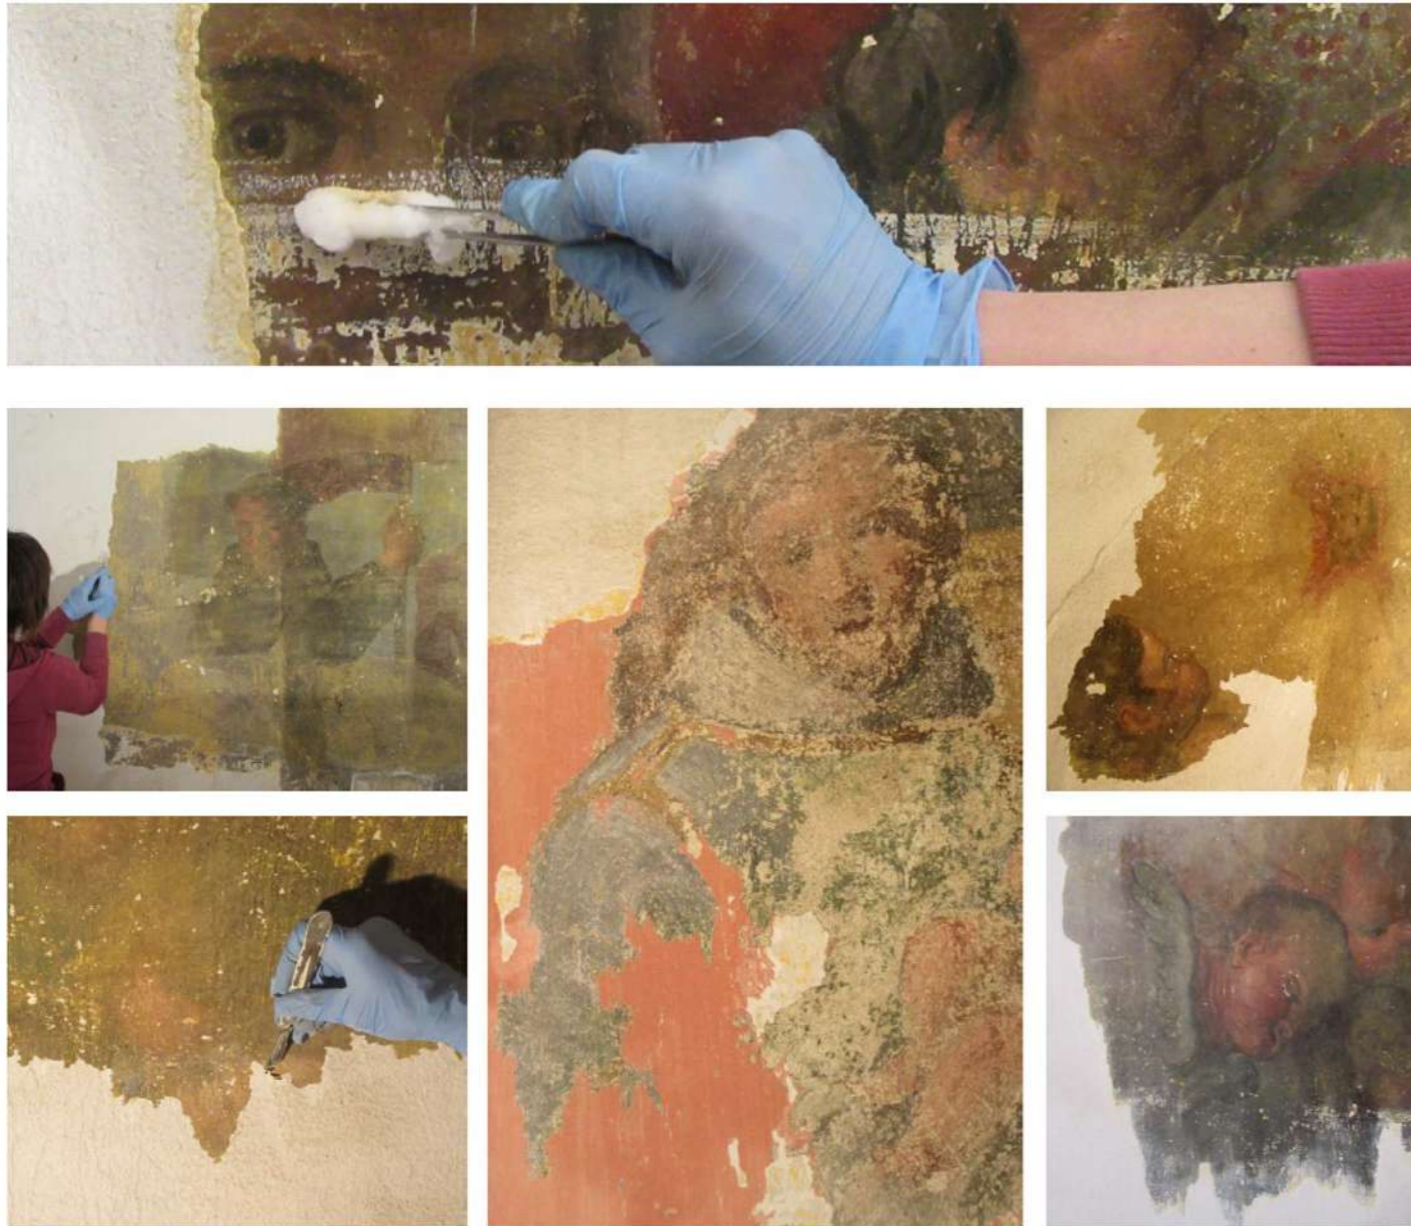
Fig.15: Restoration phases of discovered fresco paintings. ©University of Palermo, Technical Area

The restoration intervention was characterized, in the first phase, by the removal of the thick layers of whitewash that hid the entire pictorial cycle. The pictorial surface was covered by a more or less dusty residual layer of the yellowish lime/gypsum paints, not removable with water. The descalco operations were carried out dry with the aid of scalpels and metal blades where part of the more superficial layers were swollen and not adhered. Preliminarily to the cleaning phase, a preconsolidation of the plasters was performed, noting a certain disintegration of the same which, post-cleaning, was followed by consolidation. Samples useful to apply the most suitable cleaning technique have led to a fair result in the use of ion exchange resin. During processing, to optimize the result, detecting the presence of an organic substance as a binder of the residual bleaching, the application of cellulose pulp tablets supporting solutions of suitable solvents was made, obtaining the removal of the residual chalky part and the part of organic glue. During the cleaning operations, unsuitable mortars were mechanically removed which were then reconstituted with mortar more

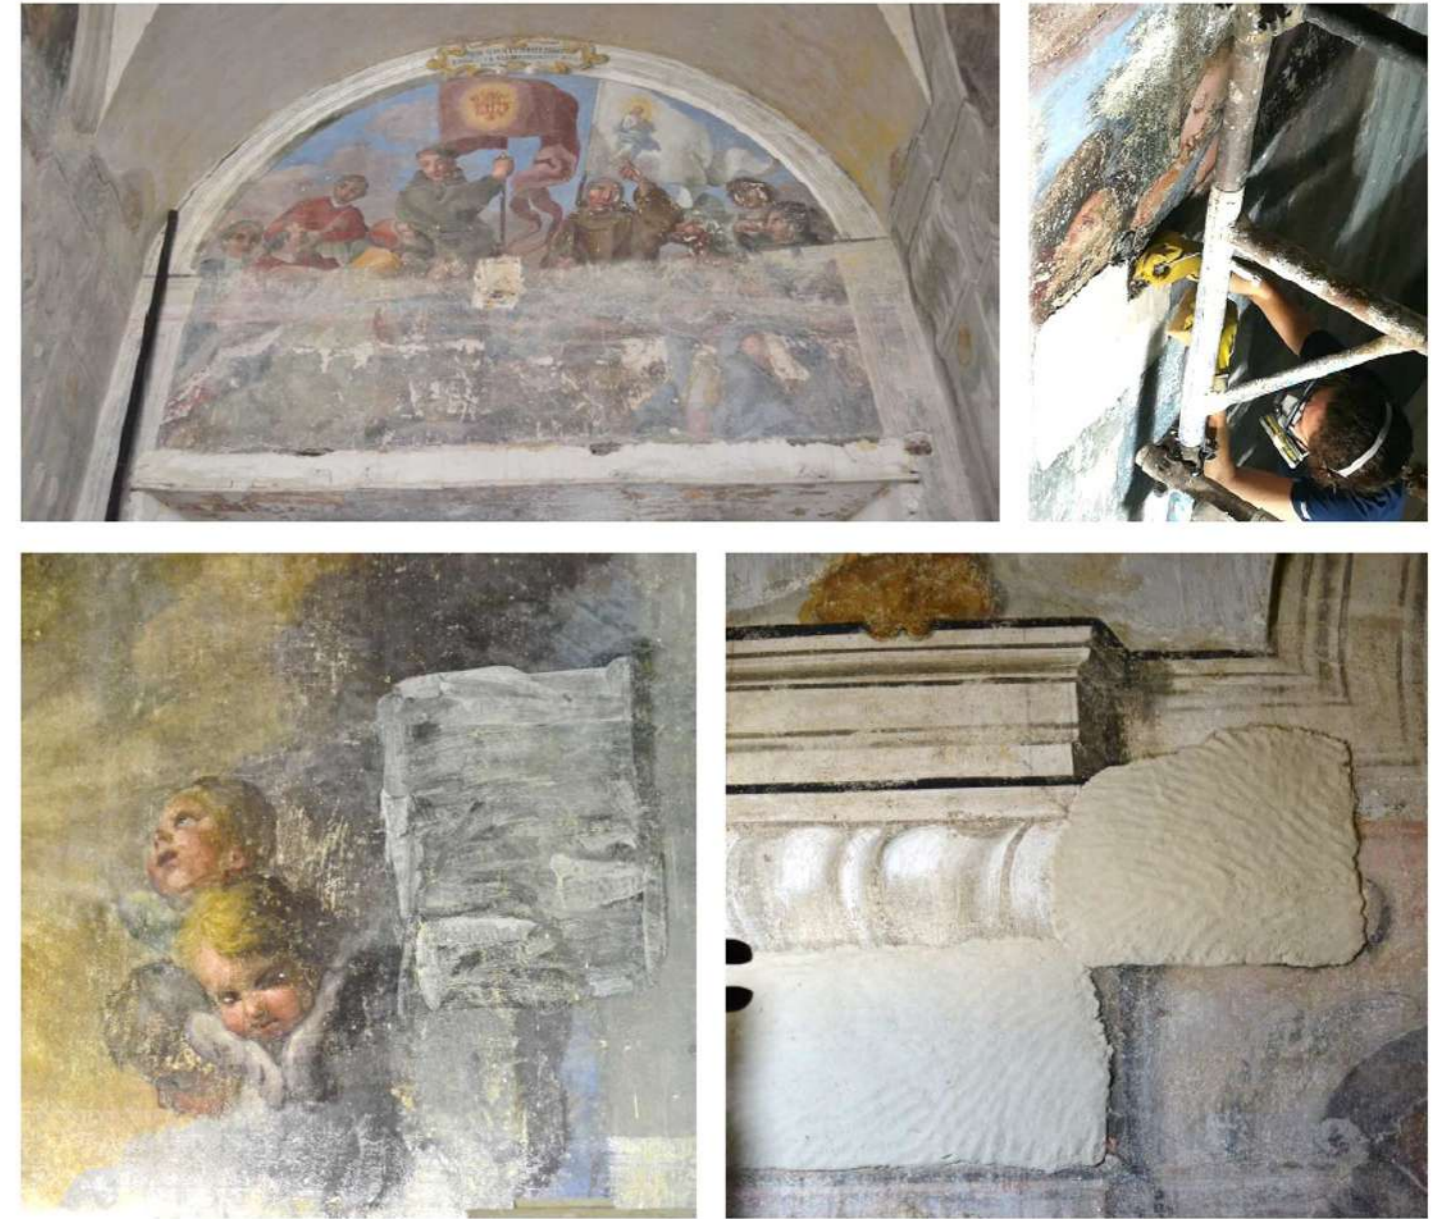
Fig.16: Restoration phases of discovered fresco paintings. ©University of Palermo, Technical Area

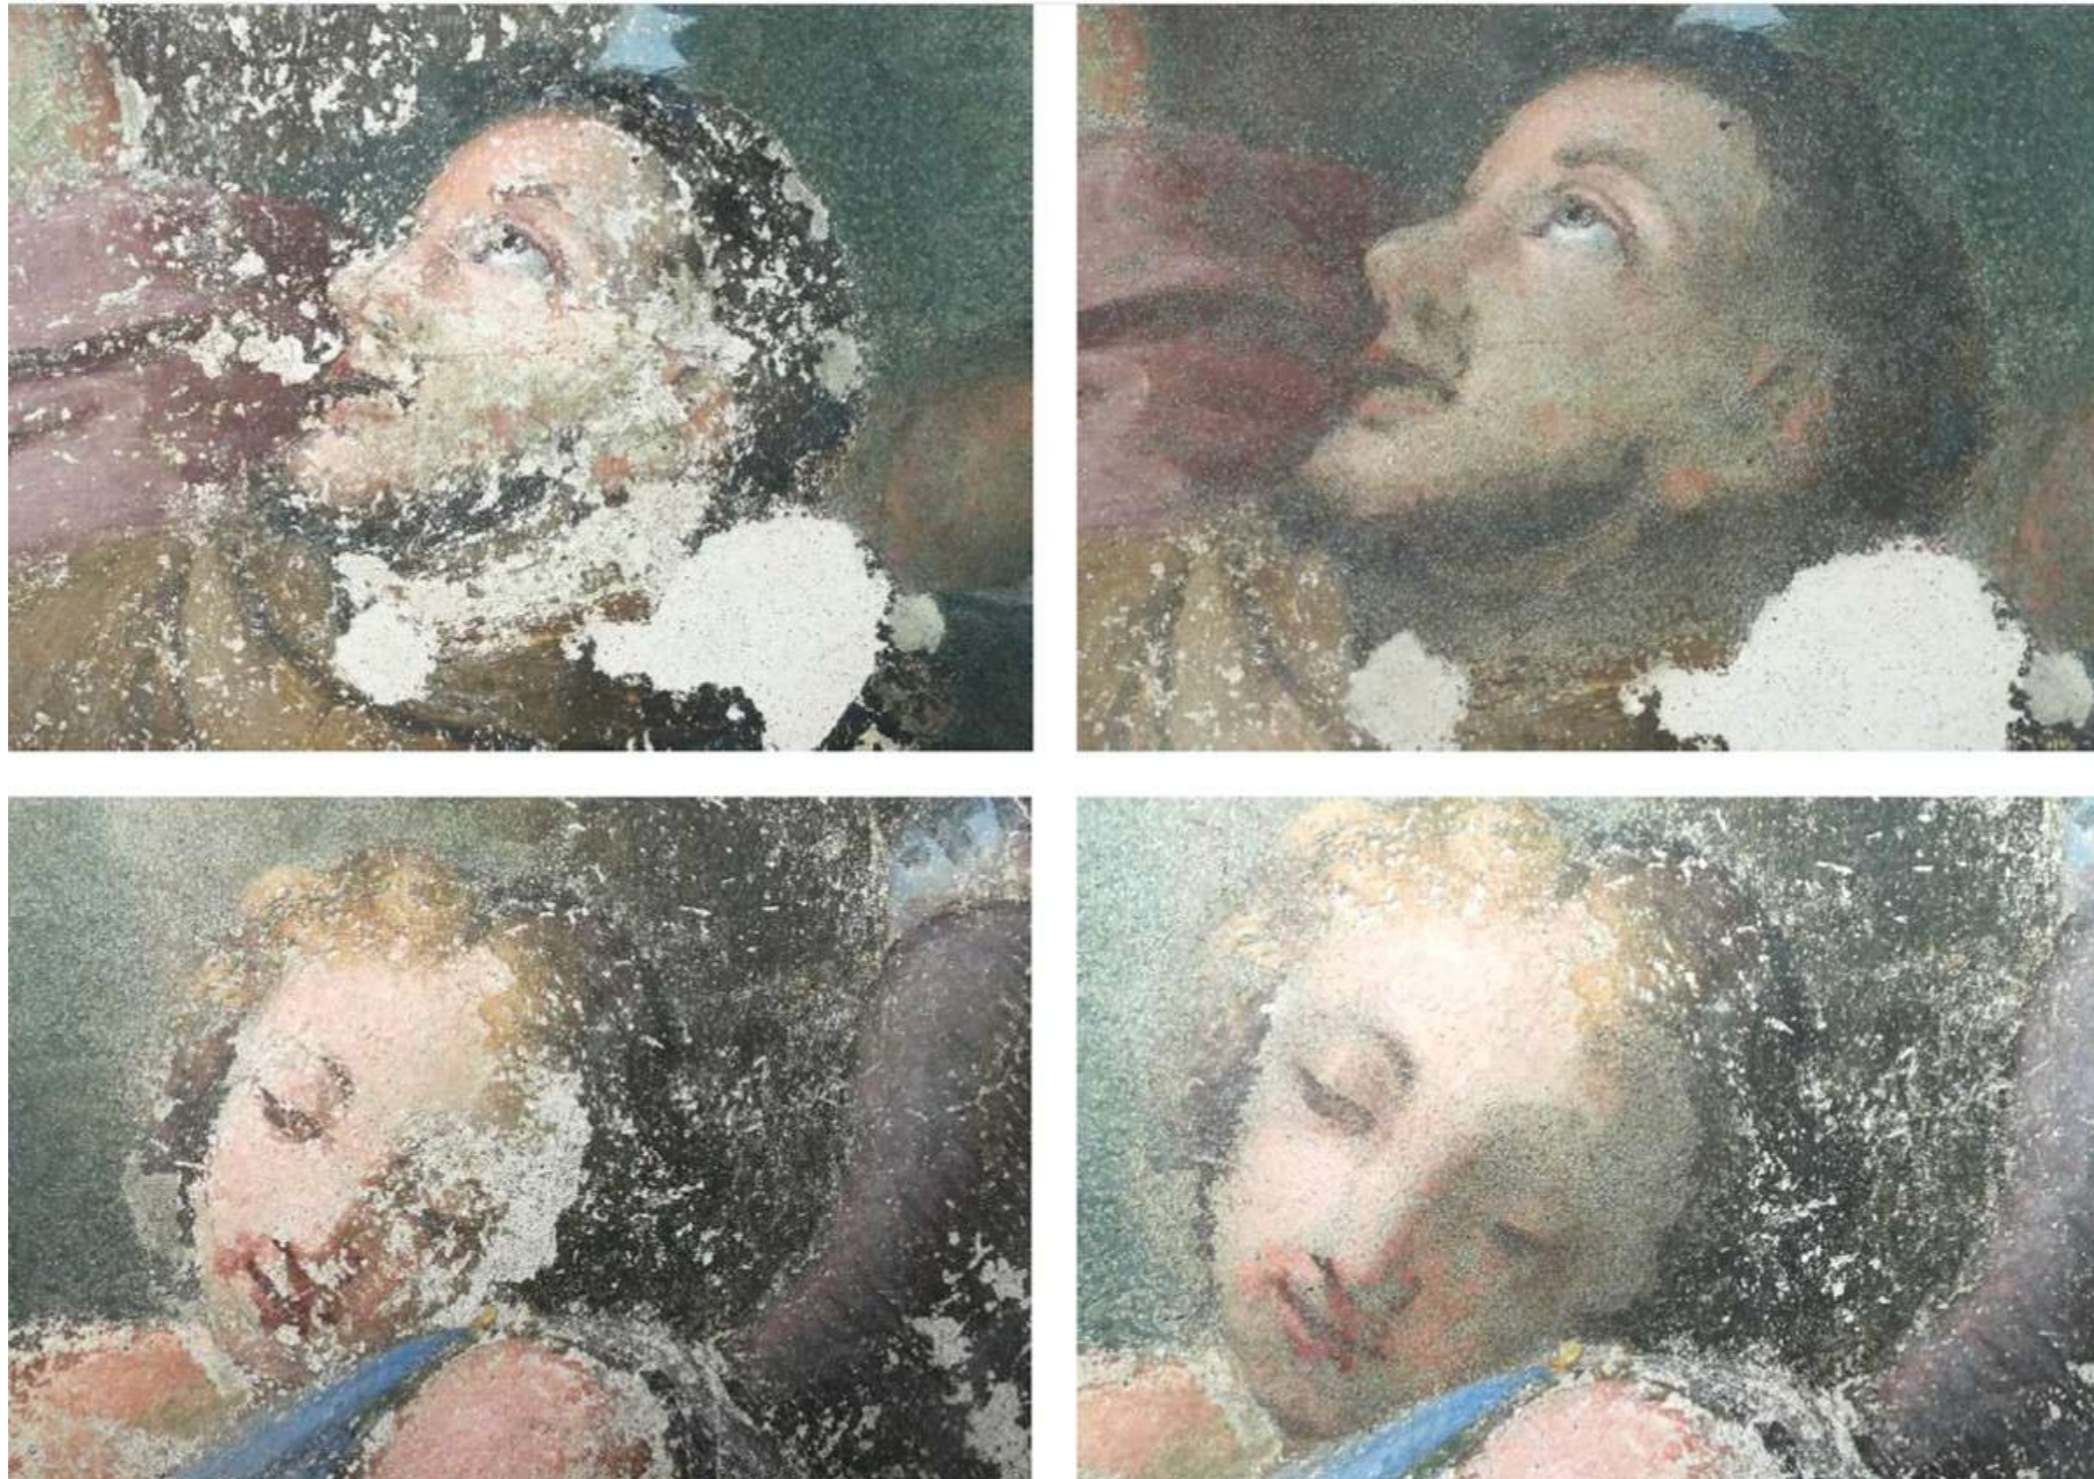
Fig.17: Restoration phases of discovered fresco paintings; details before and after interventions. ©University of Palermo, Technical Area

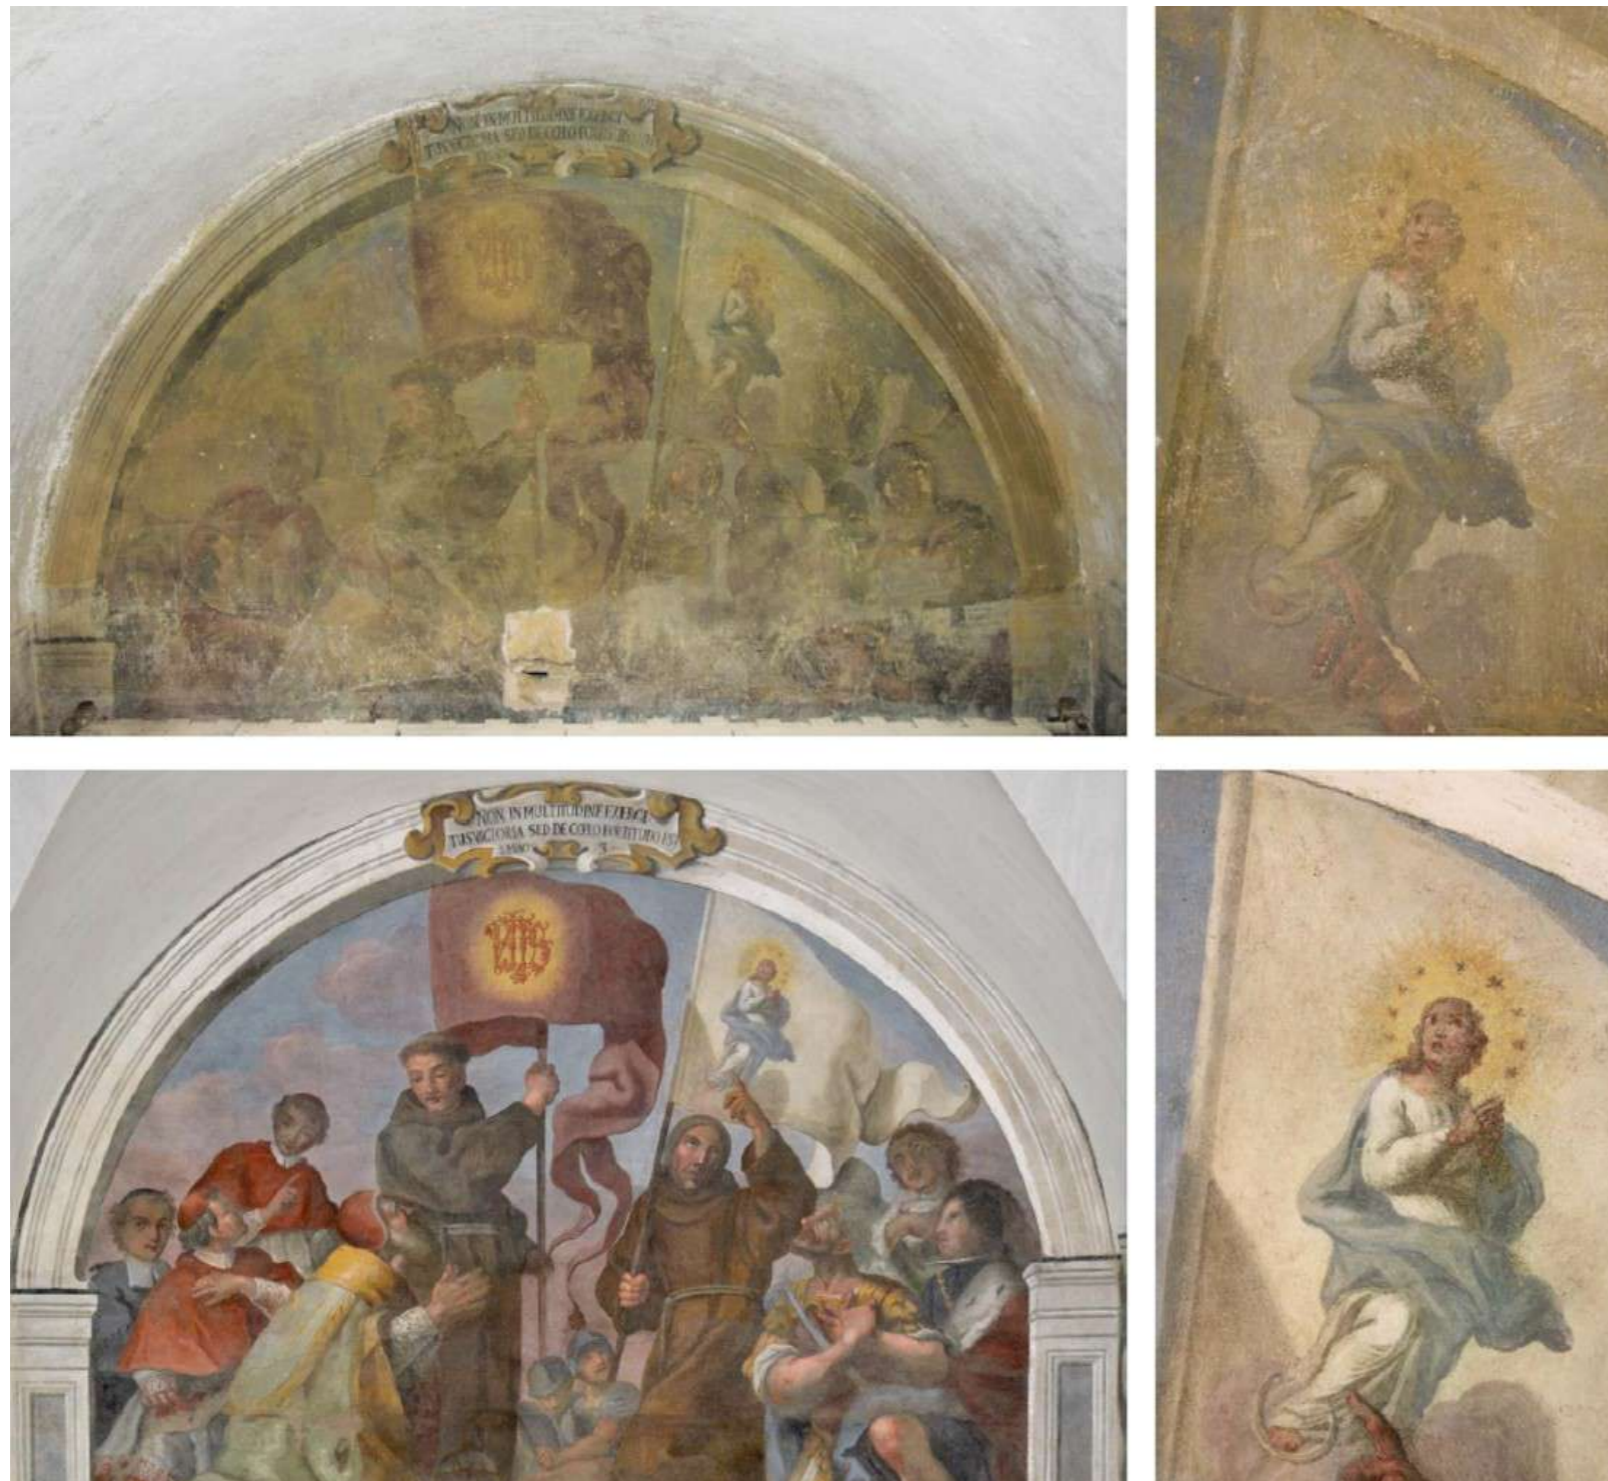
Fig.18: Restoration phases of discovered fresco paintings; details before and after interventions. ©University of Palermo, Technical Area
