Rehabilitation of a colonial building.

Institutional use for a British period building.

Site Omirou Street 38, Nicosia, Cyprus

Date Project Development 2019,
Works 2019

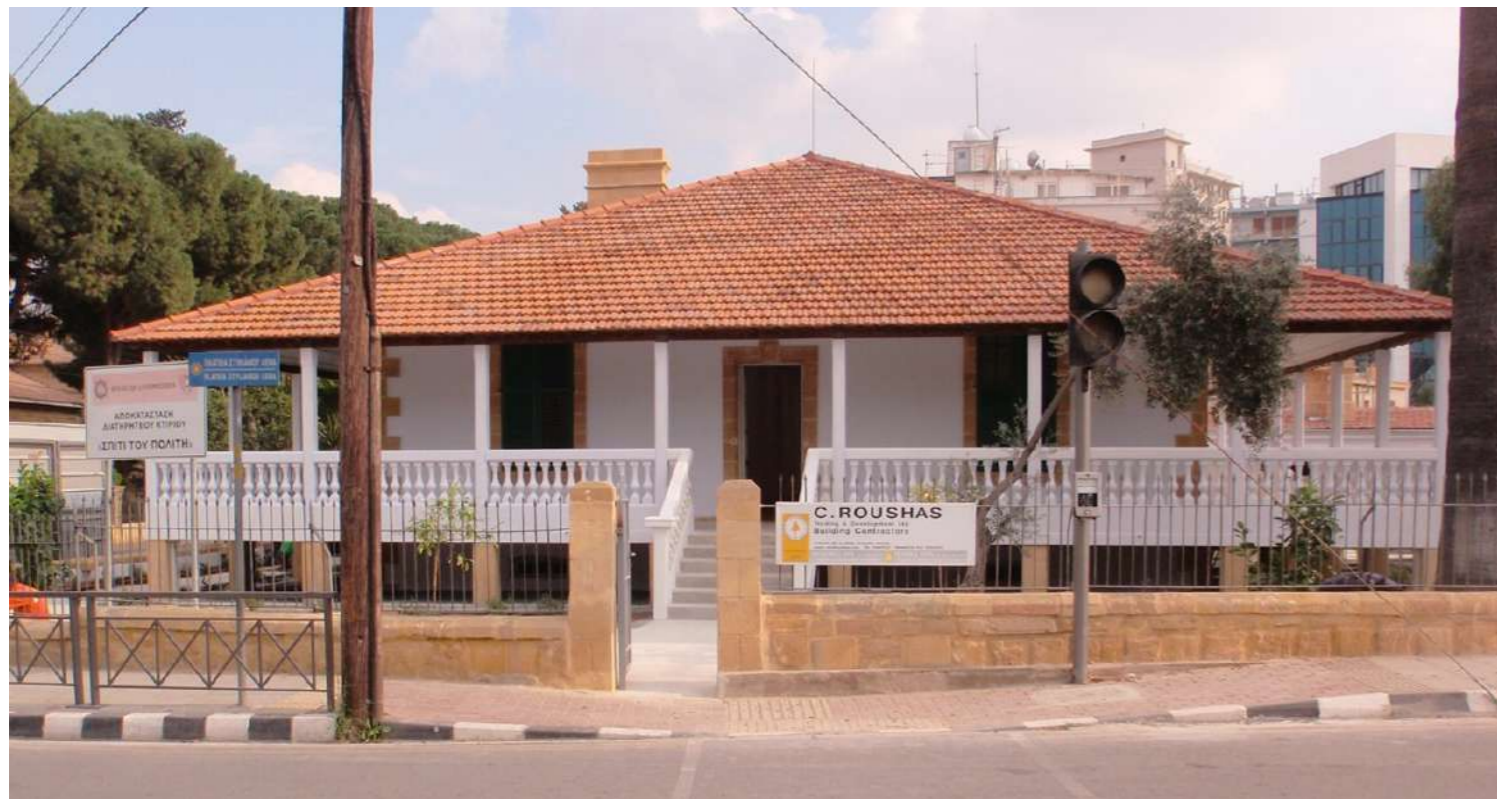
Fig.5: General view of the side of the building. © C. Marathovouniotis

The building was in a very bad condition. Part of the surrounding balcony has collapsed. The roof of the building had major problems. The wooden floor of the ground floor was damaged. Some of the masonry walls of the semi-basement floor were rotted as a result of trapped moisture. The doors and the windows were damaged, as well. As for the auxiliary buildings, part of the roof and the walls have collapsed.

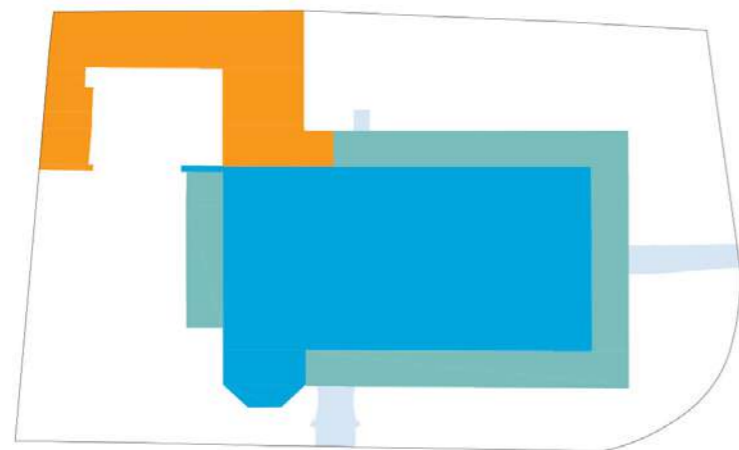
First changes to the building
 Remodeled around 1930

- Remodeling of the existing building
- Replacement of the existing wooden balcony with a new one made of reinforced concrete
- Construction of auxiliary buildings
