EcoLiving 1802.

Site EcoLiving 1802, Carrer de la Riereta 35, Barcelona, Catalonia, Spain.

Designer Juli Pérez-Catalá Arquitectura

Date 2021

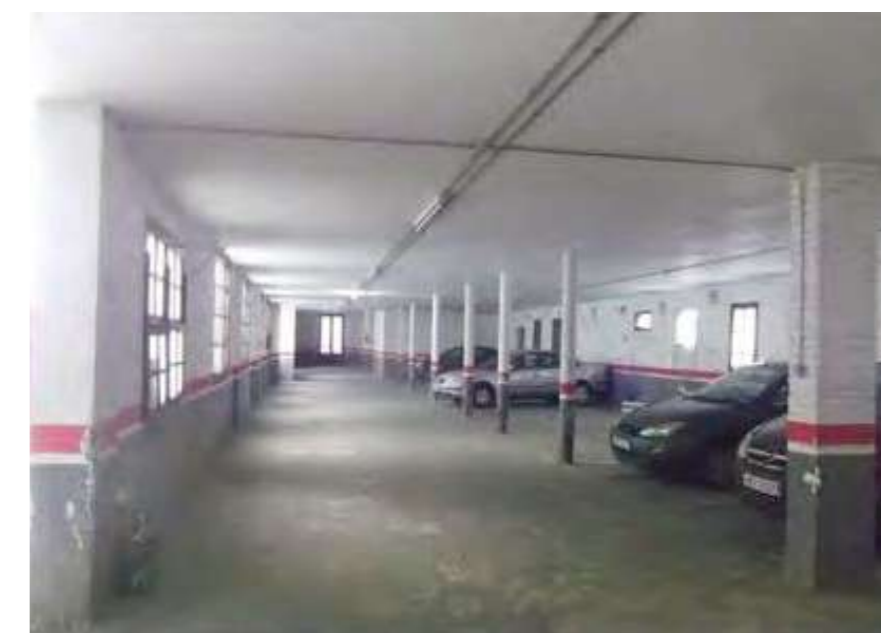
The ground floor occupies the entire surface of the plot. There are finishes and fittings typical of a standard car parking garage. It can be considered to be a free floor, with access for vehicular traffic and the start of a ramp for vehicles that connects with the first floor located on the side of property no. 33. This ramp is exterior, in an open courtyard. In the central area there is a vestibule with independent access from the street and which contains the stairwell. The start of the staircase is located 8 metres from the façade while the ramp is 20 metres away.

Fig.3: View of the existing parking garage. © Juli Pérez-Catalá Arquitectura

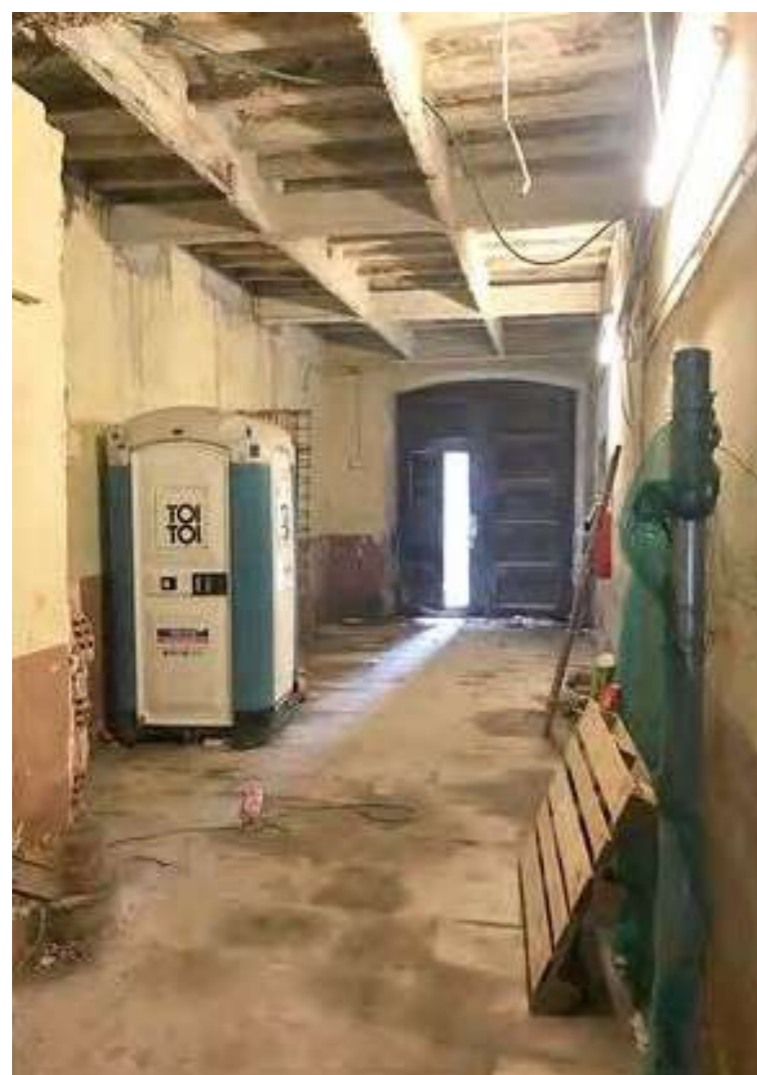
This lobby and access core have the dimensions and finishes of a staircase in a multi-family building, which indicates that the building was formerly used as a dwelling.

Fig.4: View of the existing entrance hall. © Juli Pérez-Catalá Arquitectura
