Functional and energetic rehabilitation in Kapedes.

Appreciation of vernacular architecture.

Site Vernacular dwelling, 1st of April 12, Kapedes, Nicosia, Cyprus

Date 2010-2011

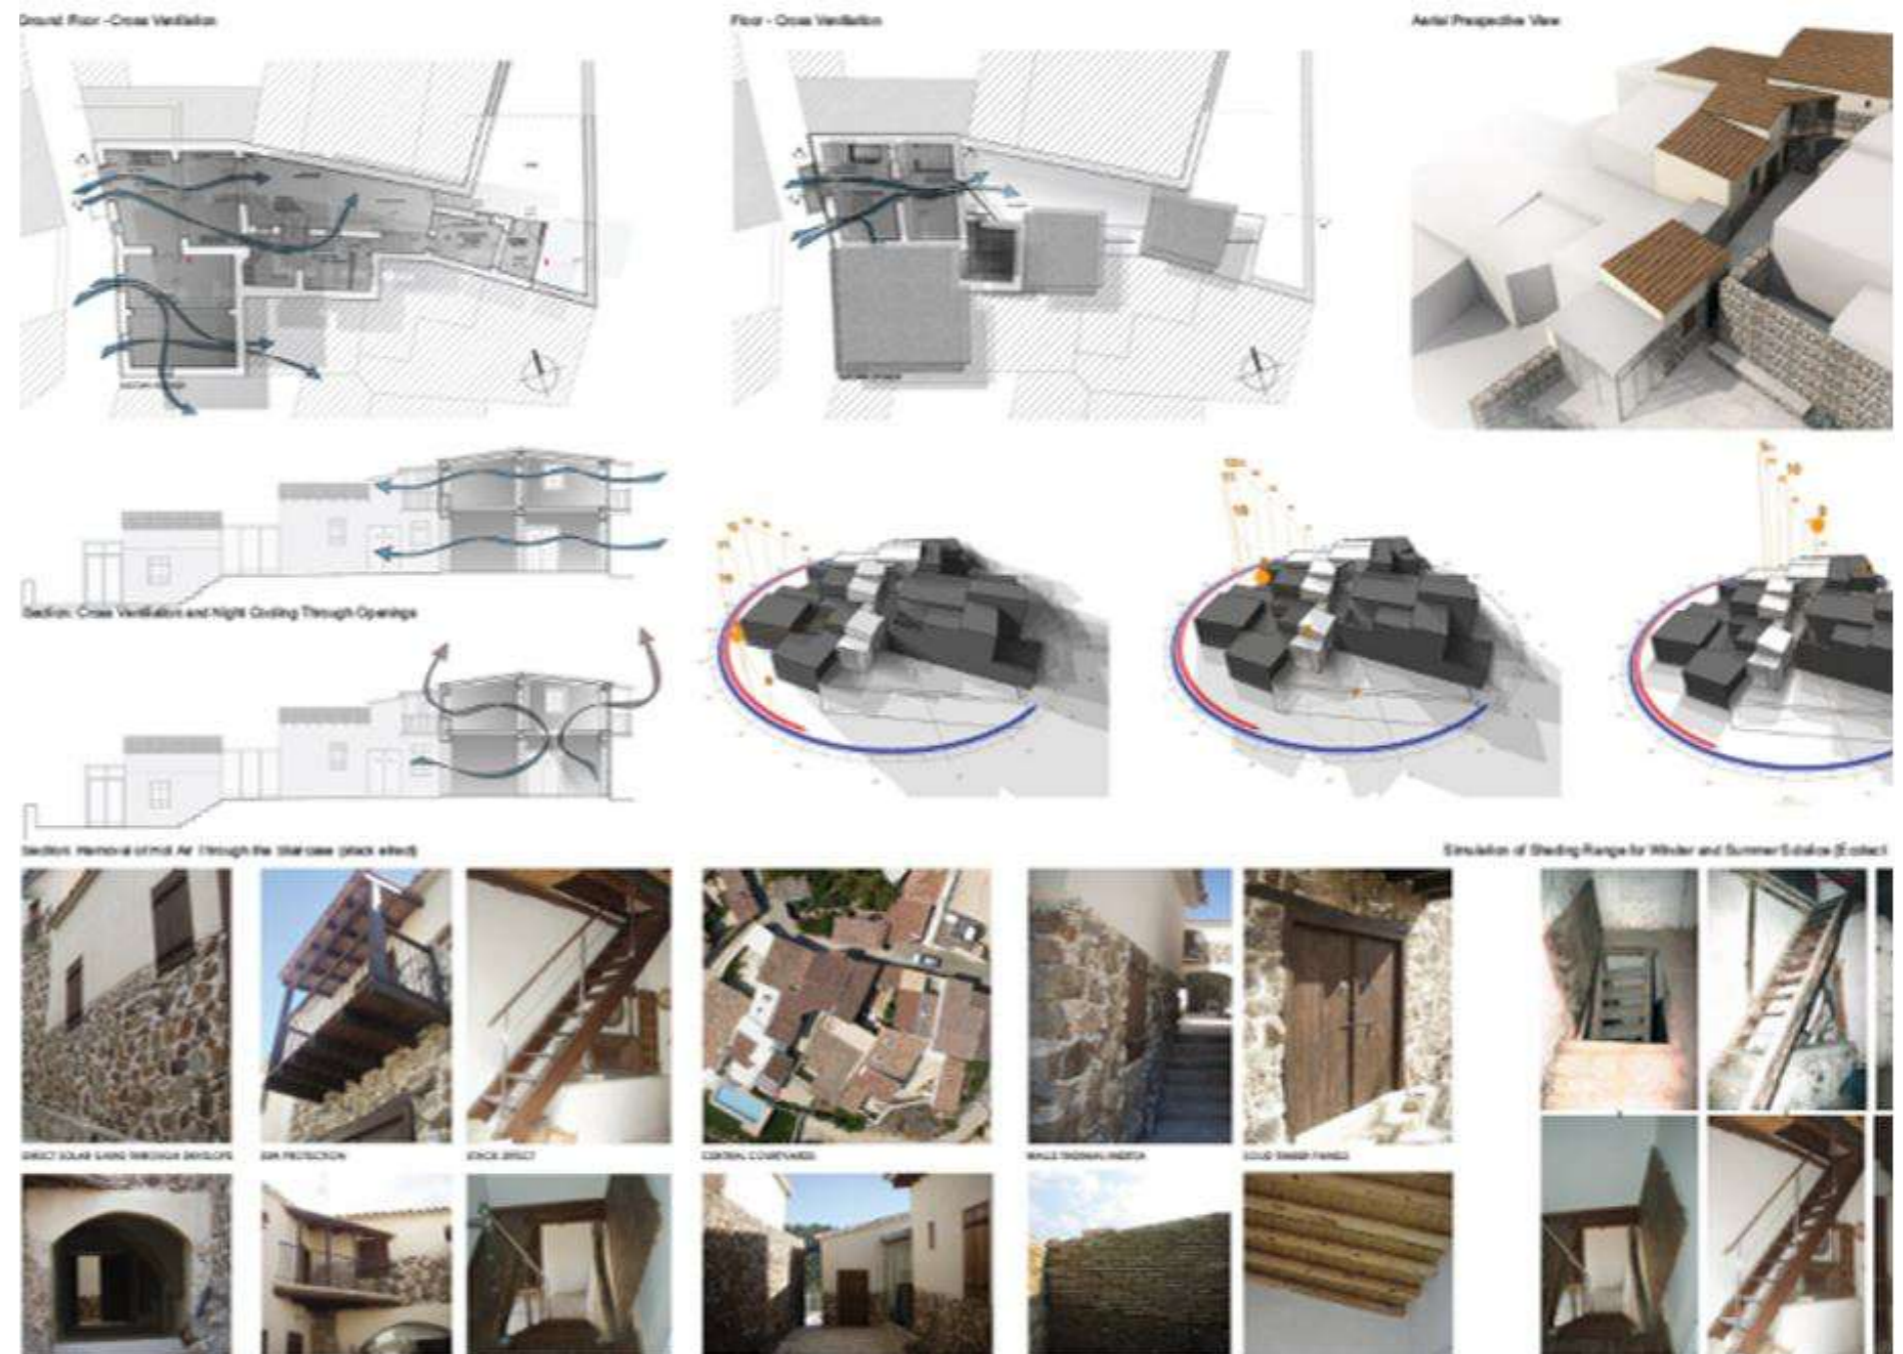
Fig.36: Passive environmental strategies incorporated in the dwelling. © M. Philokyprou

The restoration works helped towards the maintenance of the passive environmental strategies incorporated in the dwelling (cross ventilation, high thermal mass of the structure etc).
