La Mina, an extreme neighborhood in Barcelona.

Improving the accessibility, installations, equipment, and the building envelope.

Site Barrio La Mina, Sant Adrià del Besós, Catalunya, Spain

Date 2003-2005

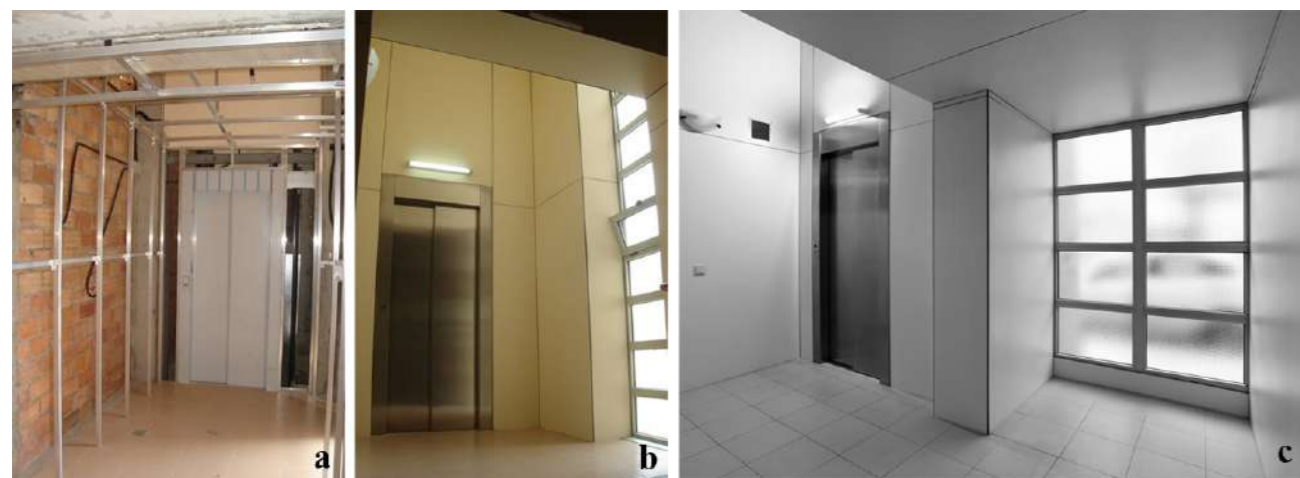
Fig.13: Interior of the elevator modules.

Meanwhile, in order to solve the problem of accessibility, most of the buildings in the Mina Vieja did not have elevators. In all of them, elevators are added from the outside, with new volumes that give access to the original stairwell of the buildings. This exterior structure was built in 3 construction

phases, the first phase with a structure of in-situ concrete frames and phases 2 and 3 with metal profiles. The enclosures are made of prefabricated concrete panels bolted together.

Although there are several phases, it is intended that the image of the new elevators be uniform, in addition to modernizing the general image of the neighborhood.

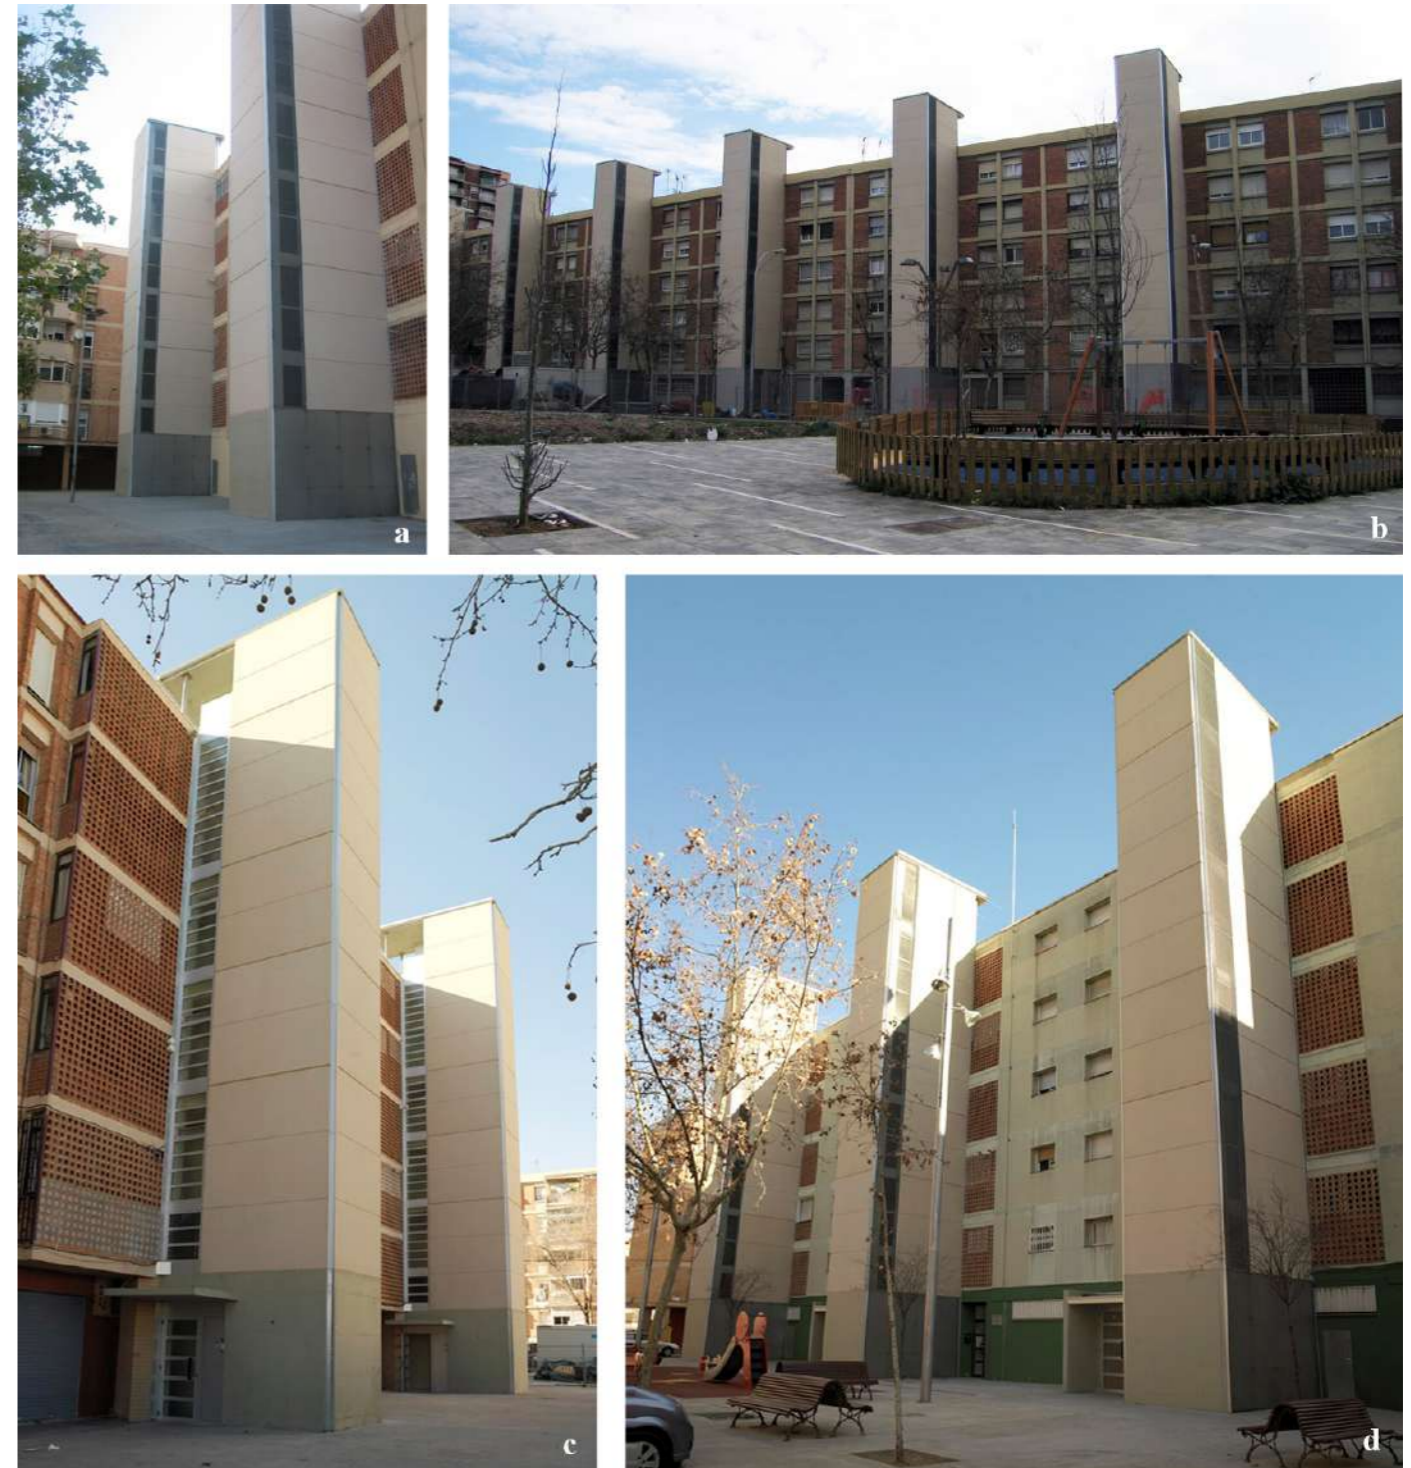
Fig.14: Exterior image of the elevator modules.
