Addressing structural issues on a 20th century office building.

Rehabilitation of floor slabs, stuccoes and decorative elements on a historic office building in Barcelona's Via Laietana.

Site Office building, Via Laietana 4, Barcelona, Catalunya, Spain

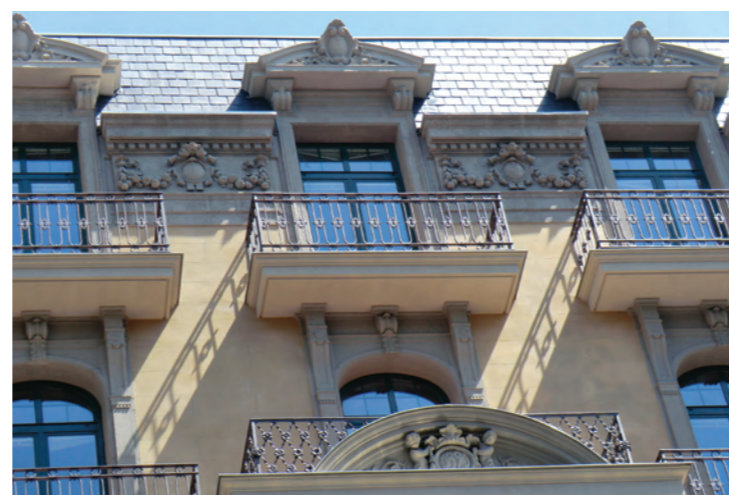
Fig.1: Detail of mansard windows and Agullers Street's façade.

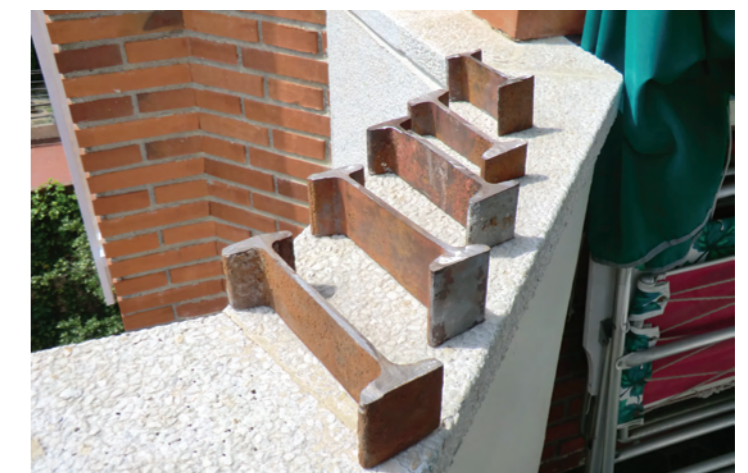
- The cause was due to the fact that lime mortar, contrary to what was considered years ago, does not protect the steel as is the case with Portland cement mortar, in which the lime hydroxide adheres to the steel and waterproofs its surface. In fact, lime carbonate does not waterproof the steel, and allows interstitial water transfer, whereby the alternation air/water leads to oxidation of the metal. The steel beams of the first-floor ceiling, made of large composite edge profiles, with a brick masonry core, were also affected and by the same issue.

Fig.3-4: Rusted and swollen profiles; Fig.5: Narrow-wing profiles used in the building.

The profiles that were almost completely damaged had to be replaced by new ones and the entire floor slab had to be rebuilt: mixed slabs of corrugated metal sheeting and concrete were chosen. This basically affected the basement ceiling slab, which was completely rebuilt.

The damaged profiles, when their heads had lost effective section for their function, were shored up and cut at a distance of approximately 50 cm from the vertical face. The attached images show the design and construction details, as well as their implementation.

Damaged profiles, but still with sufficient cross-section, were suitably sanded and primed with epoxy to better guarantee their durability.
