Rehabilitation of an old paper mill to give it a new life as an interpretation center.

Rehabilitation of Cal Xerta Mill

Objectives Rehabilitation of Cal Xerta Mill as an interpretation center on the traditional paper industry.

Date Master Plan: 2013; Phase I: 2016; Phase II: 2017;
Phase III: 2019.

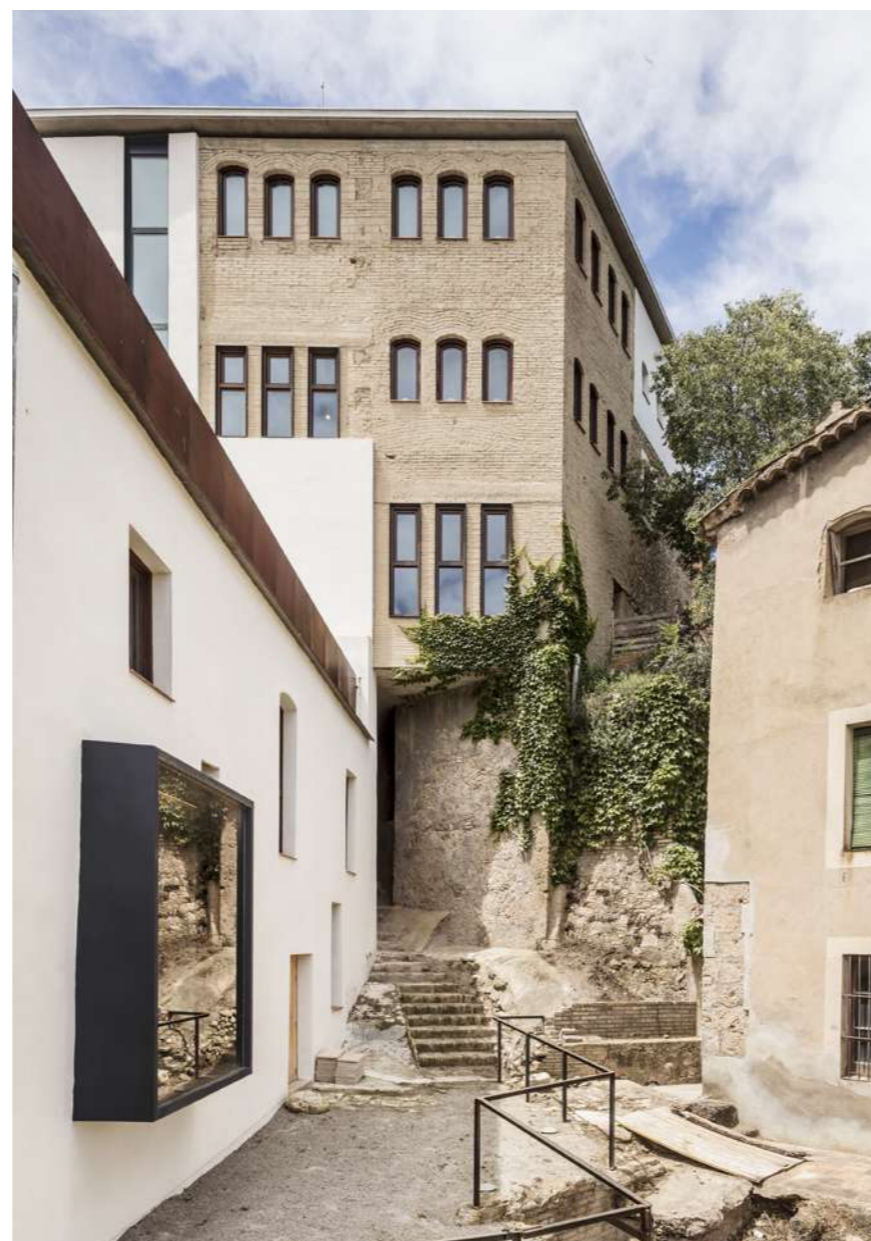
Fig.1: View of the rehabilitated complex.

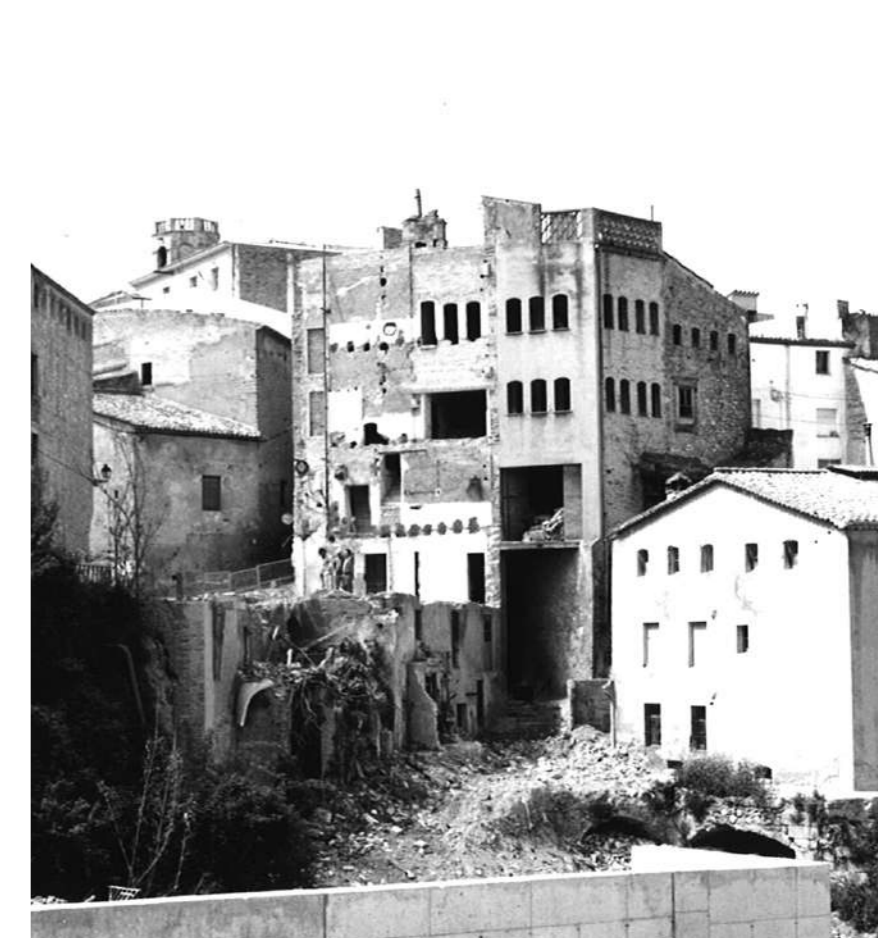
Fig.2: View of the existing conditions prior to the intervention.

Previous to the interventions, the upper floors, dating from the contemporary period, were demolished. With the demolition, a reinforced concrete slab was created to allow the passage over it and to generate a viewpoint over the river. Below the street level, in the area of the riverbed, old installations were still preserved, where the remains of a small wooden wheel can be seen, as well as other elements, although the specific state was unknown, as access was not possible due to the large amount of demolition debris and the dangerous general state of the site, in that moment. A high part of the building was preserved, once the passage of the Baix road towards the center of the Vila is passed. Three floors were preserved in this sector.

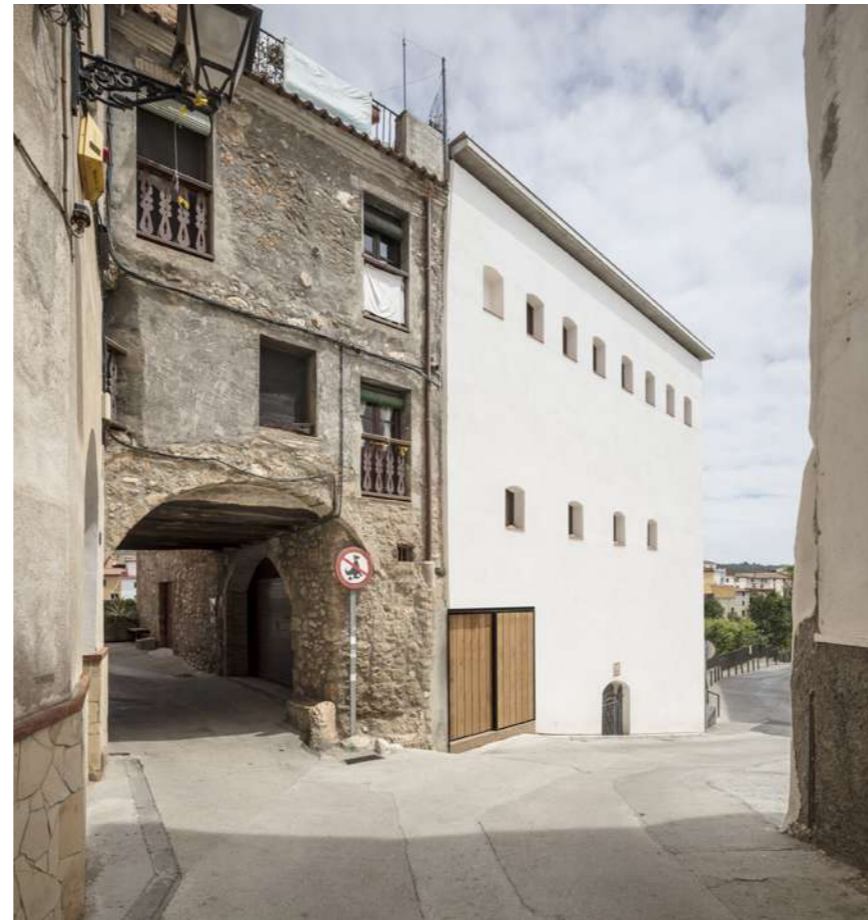
Fig.4: View of one of the side façades, and neighboring buildings.

Outside, the different treatment of the façades explains the growth of the building throughout its history. The oldest part of the mill is covered on the outside with an ecological coating based on lime and cork, which allows the interior walls to be exposed. On the other hand, the most recent part of the building, dating from the mid-20th century, is left bare on the outside to be insulated on the inside. A new unitary roof, which is free-standing, connects all the different periods. The existing openings, with new joinery, are combined with the new openings, which are adapted to the existing openings, resulting from the demolition of part of the complex. Thus, in the workshop area, a new showcase recognizes a gap in the stone wall and allows the old machinery to be shown.

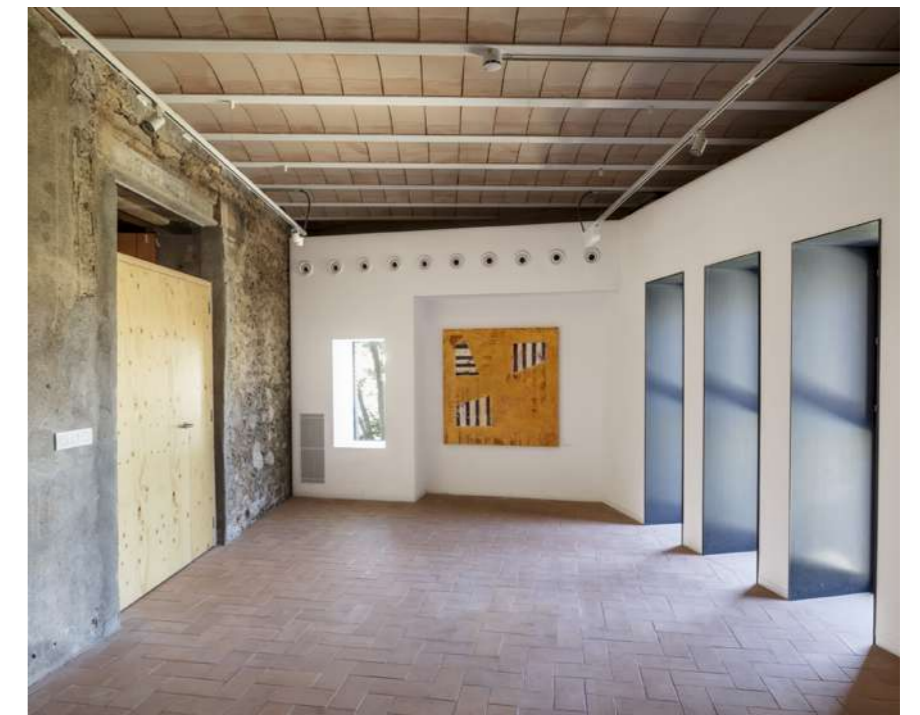
Fig.5: View of a room in the renovated interiors.

Inside, the duality expressed on the exterior of the building is strengthened. The spaces of the newer body are resolved with joist and vault ceilings that replace the old ones, damaged by aluminosis, while in the old part of the building the wooden beams are preserved. The new slab sections that solve the need to level the floors are expressed with solid concrete slabs. The technical ceilings, the new elevator core, the staircases, the wooden service cores... hybridize with the historical spaces and the patina of time as superimposed objects that respect the traditional configuration of the building and dialogue from a new contemporary language with the existing traces and wounds.

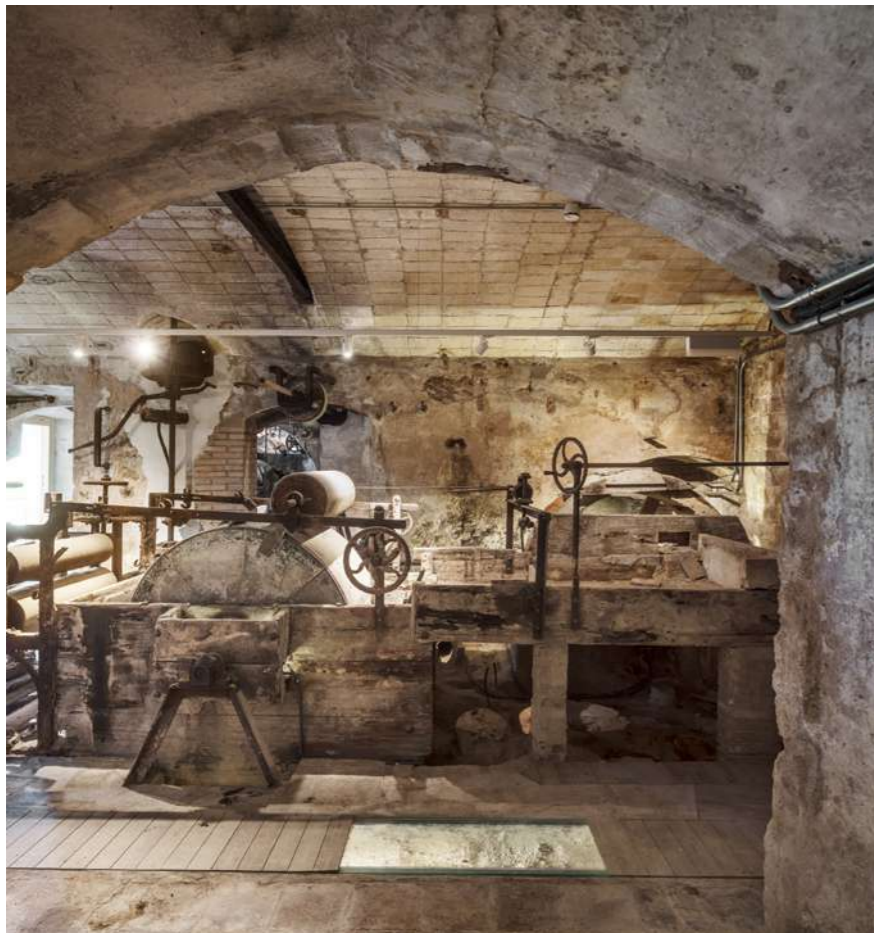
Fig.6: View of the restored machinery rooms.

In the workshops area the interventions are more punctual and specific: a minimal railing, a new ramp to overcome an isolated step, new lighting ... and seek to ensure the safety of the visit without damaging the expression of the memory of the place. The facings are consolidated as they are, without

polishing or scratching, showing the passage of time and the transformations throughout the history of the factory building. The machinery is preserved just as it was found, elements that are already an inseparable part of the very definition of the architectural space.

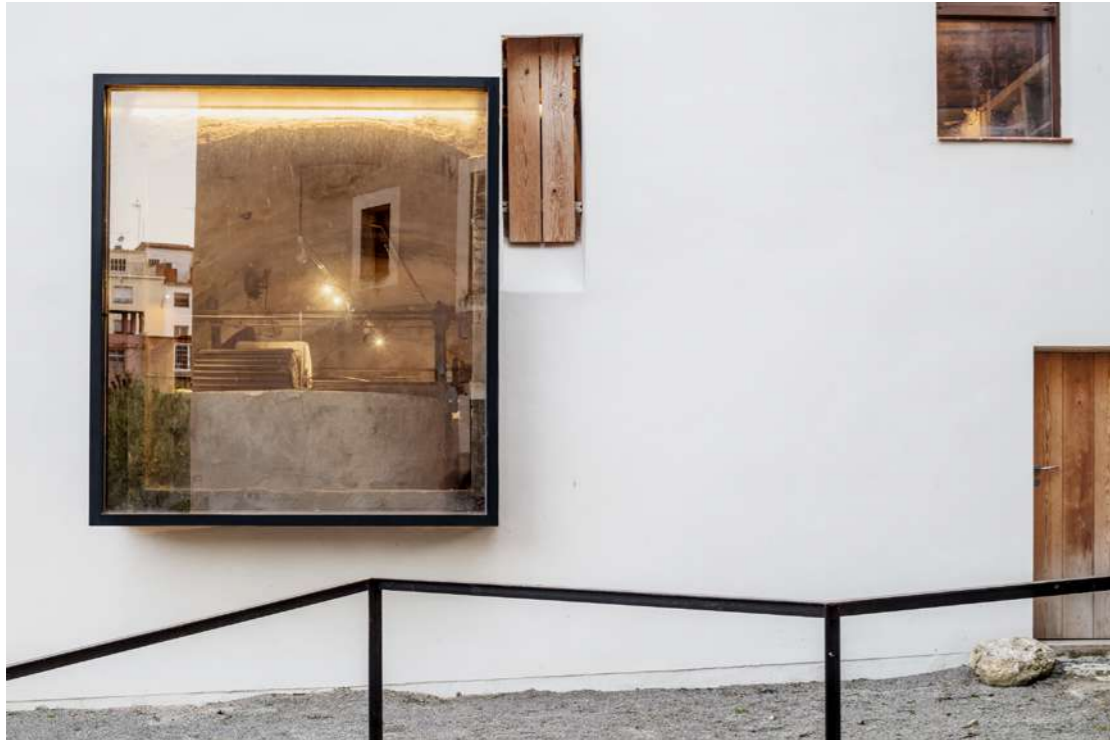
Fig.11: Detail of a mirrored window on the outside façade of the building.

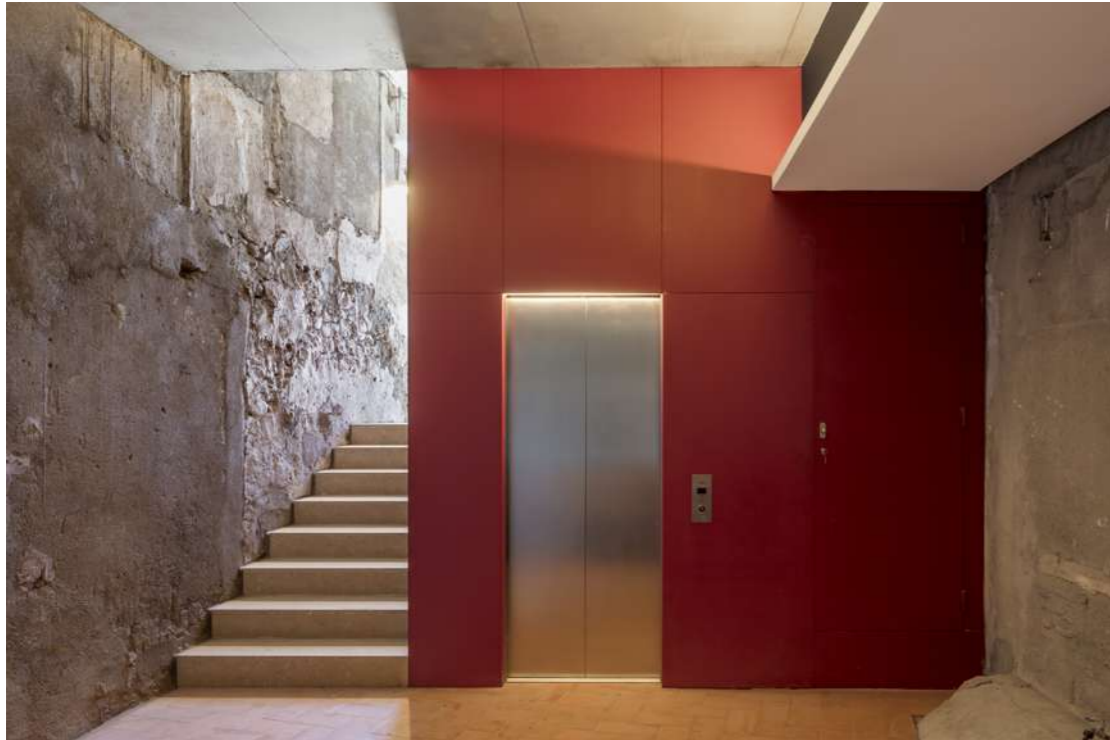
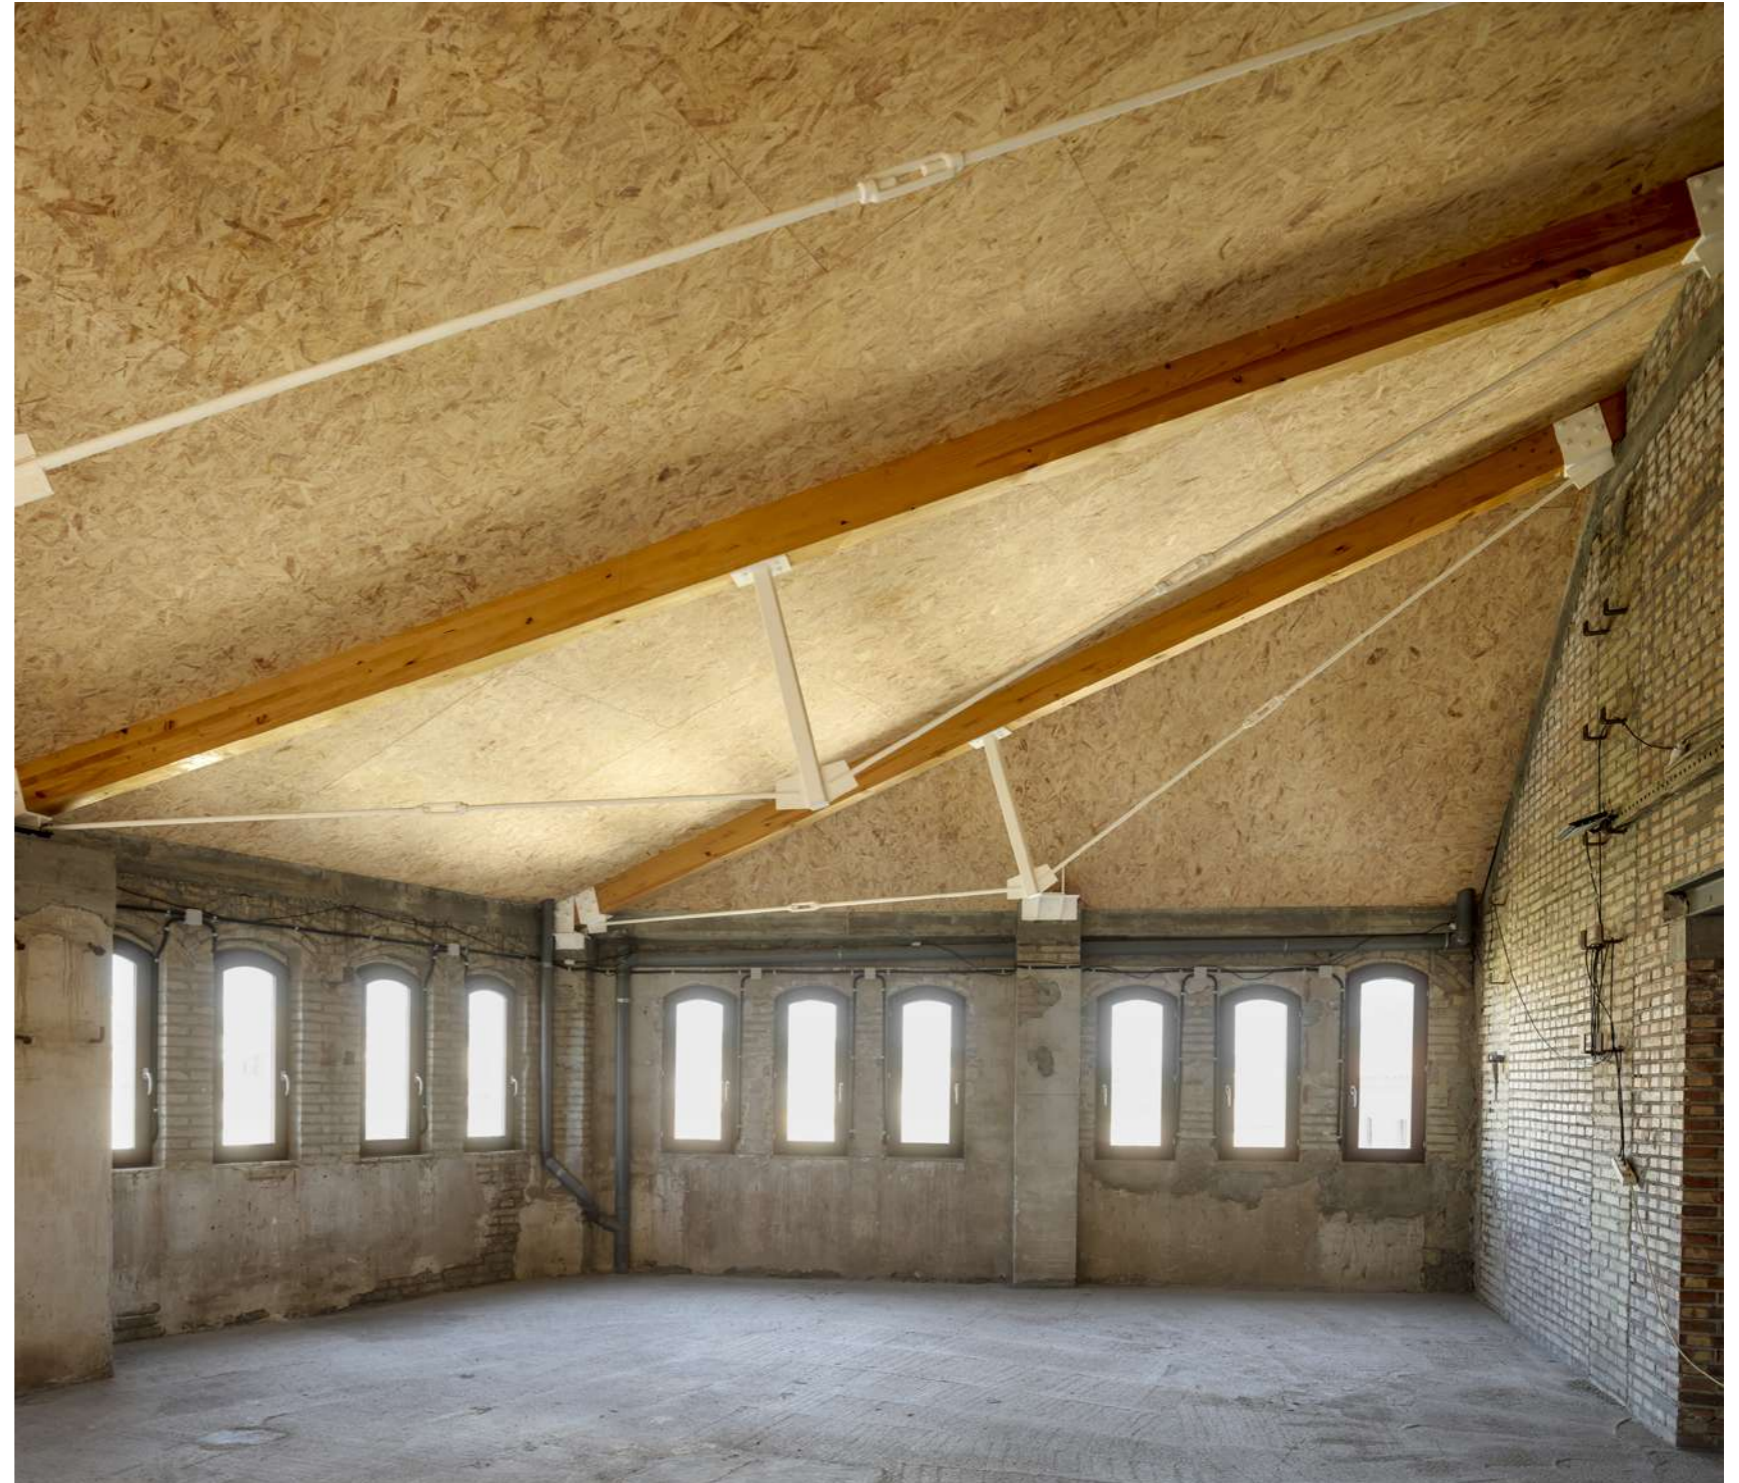
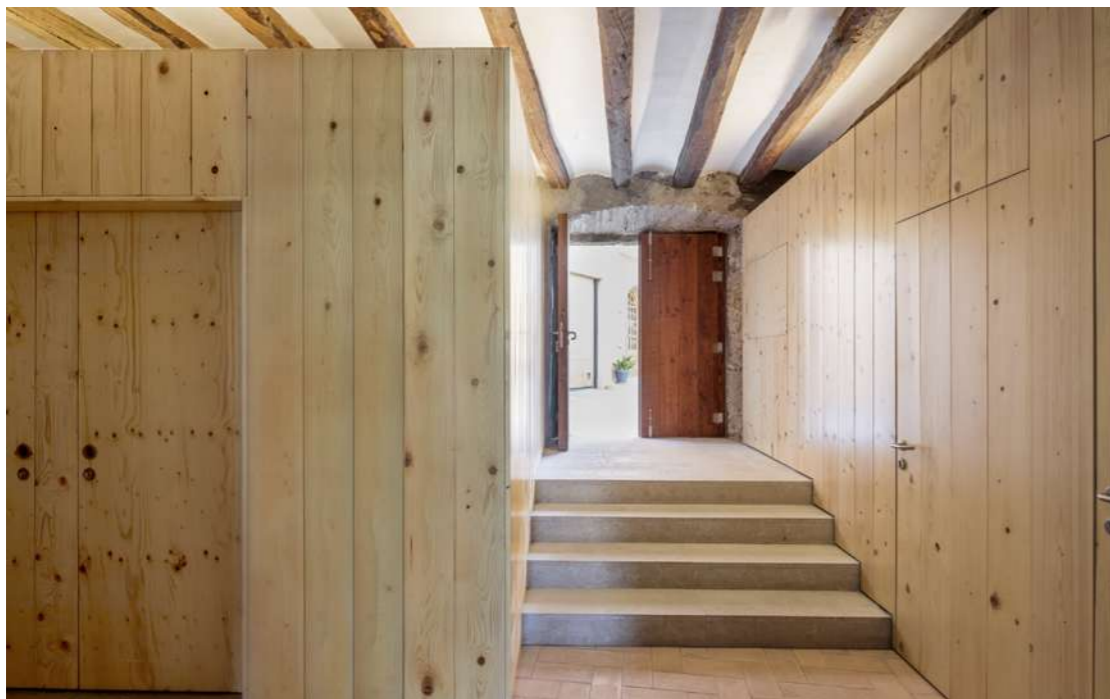
Fig.14-16: Views of various renovated interior spaces of the Cal Xerta Complex, and the dialogue of new and old material.

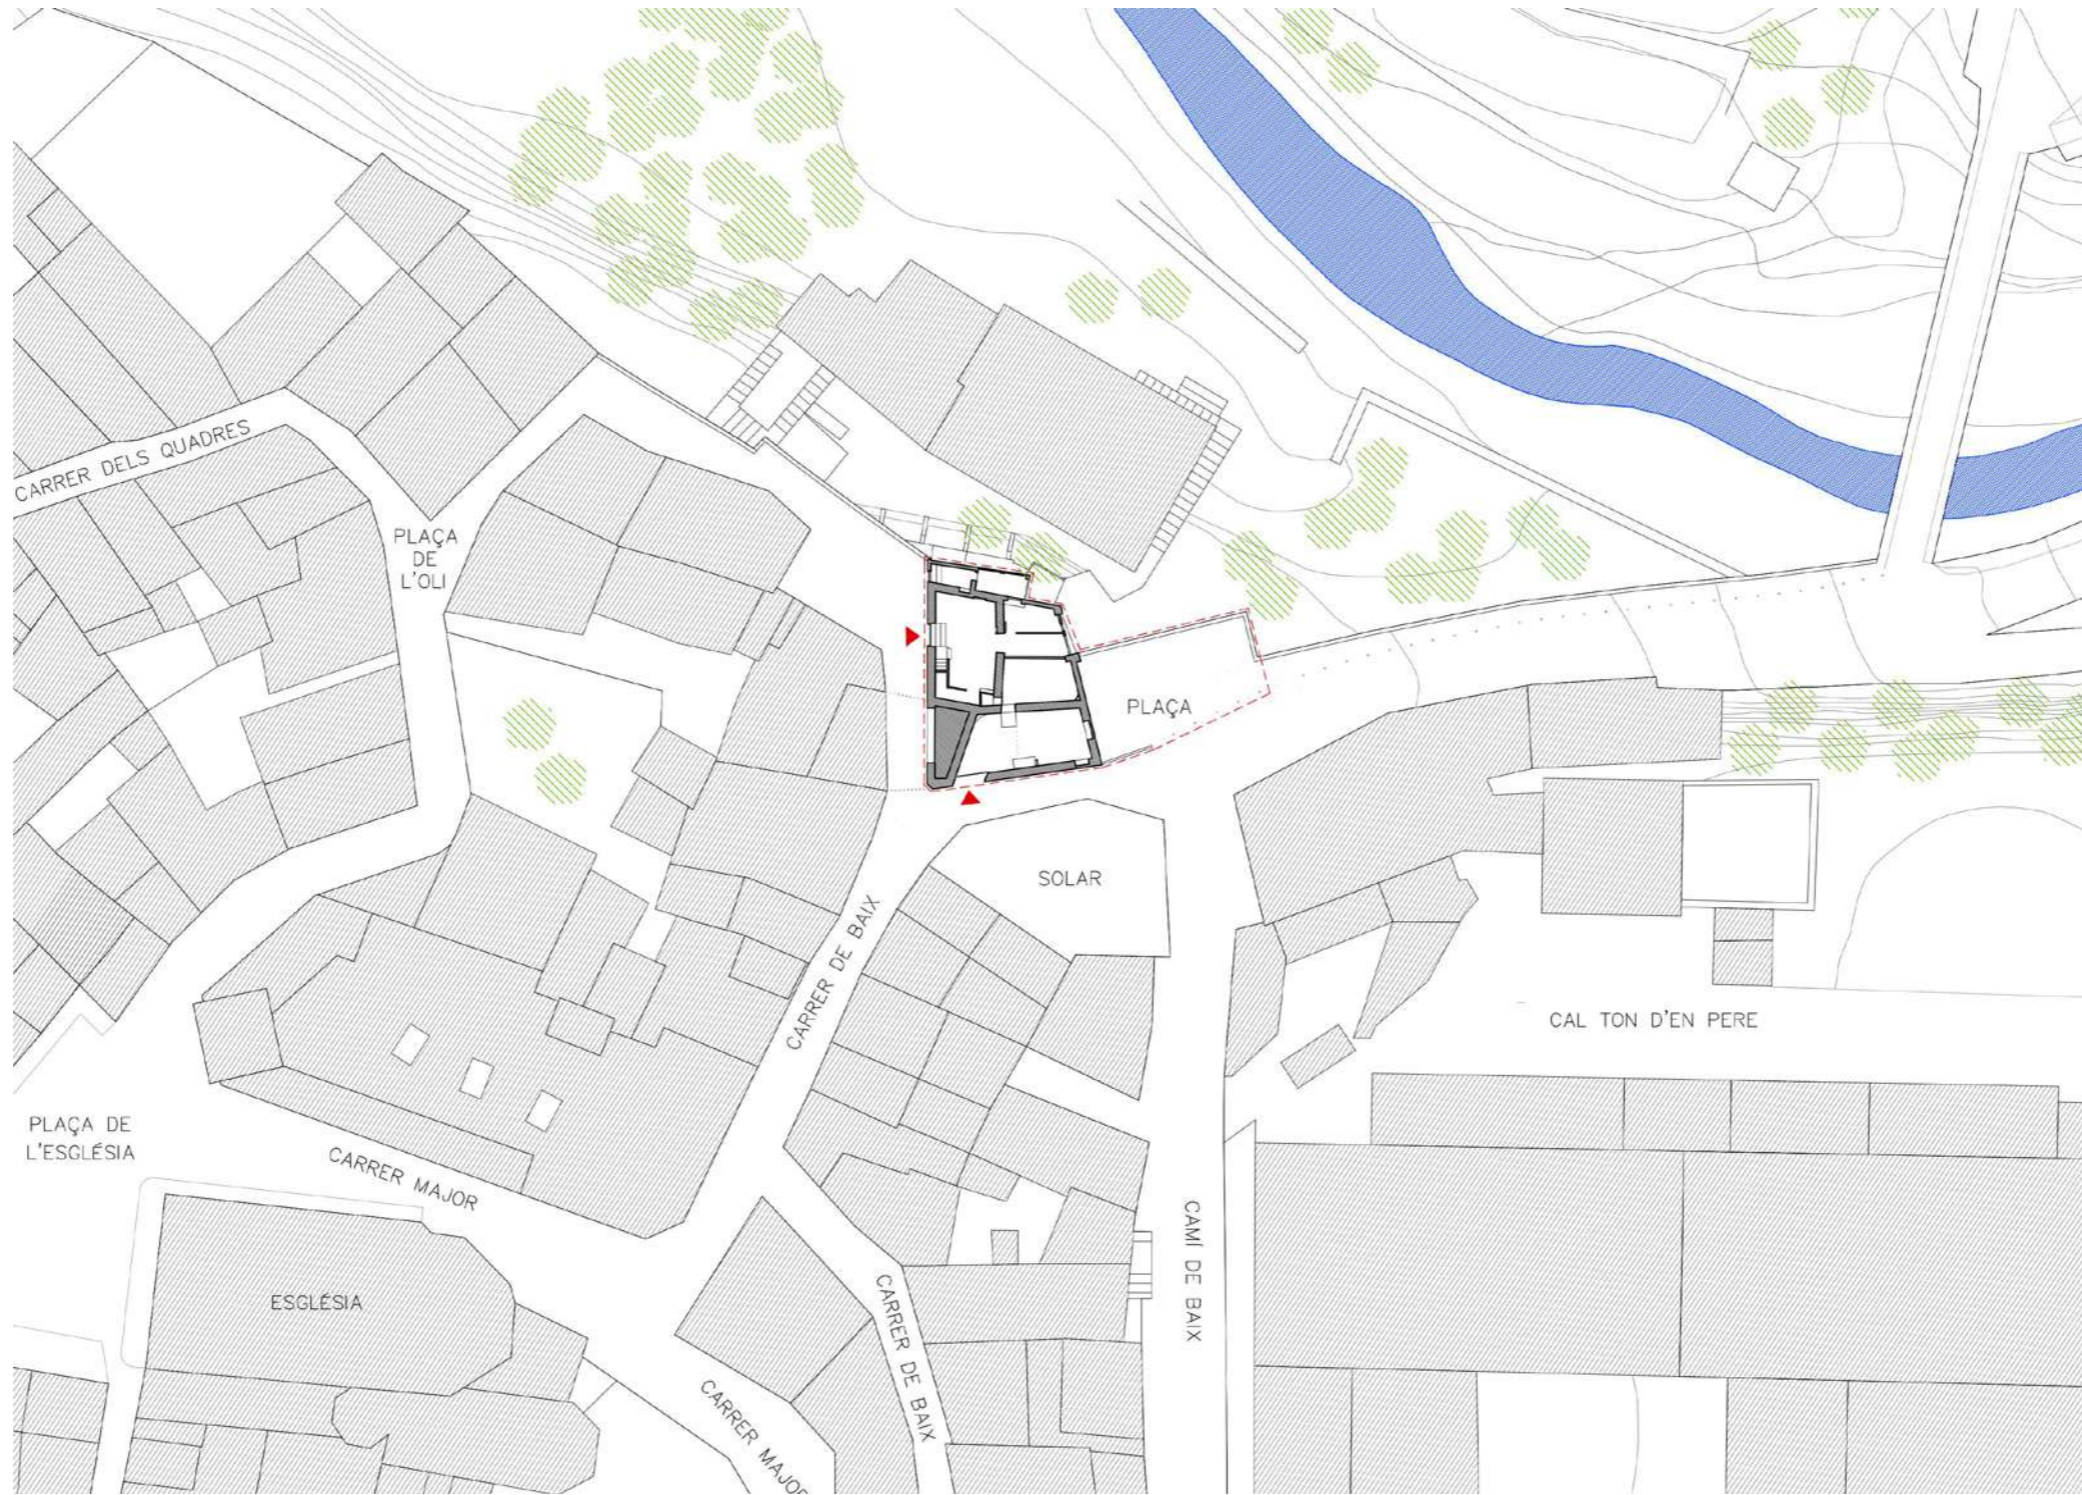
Fig.23: Site plan.

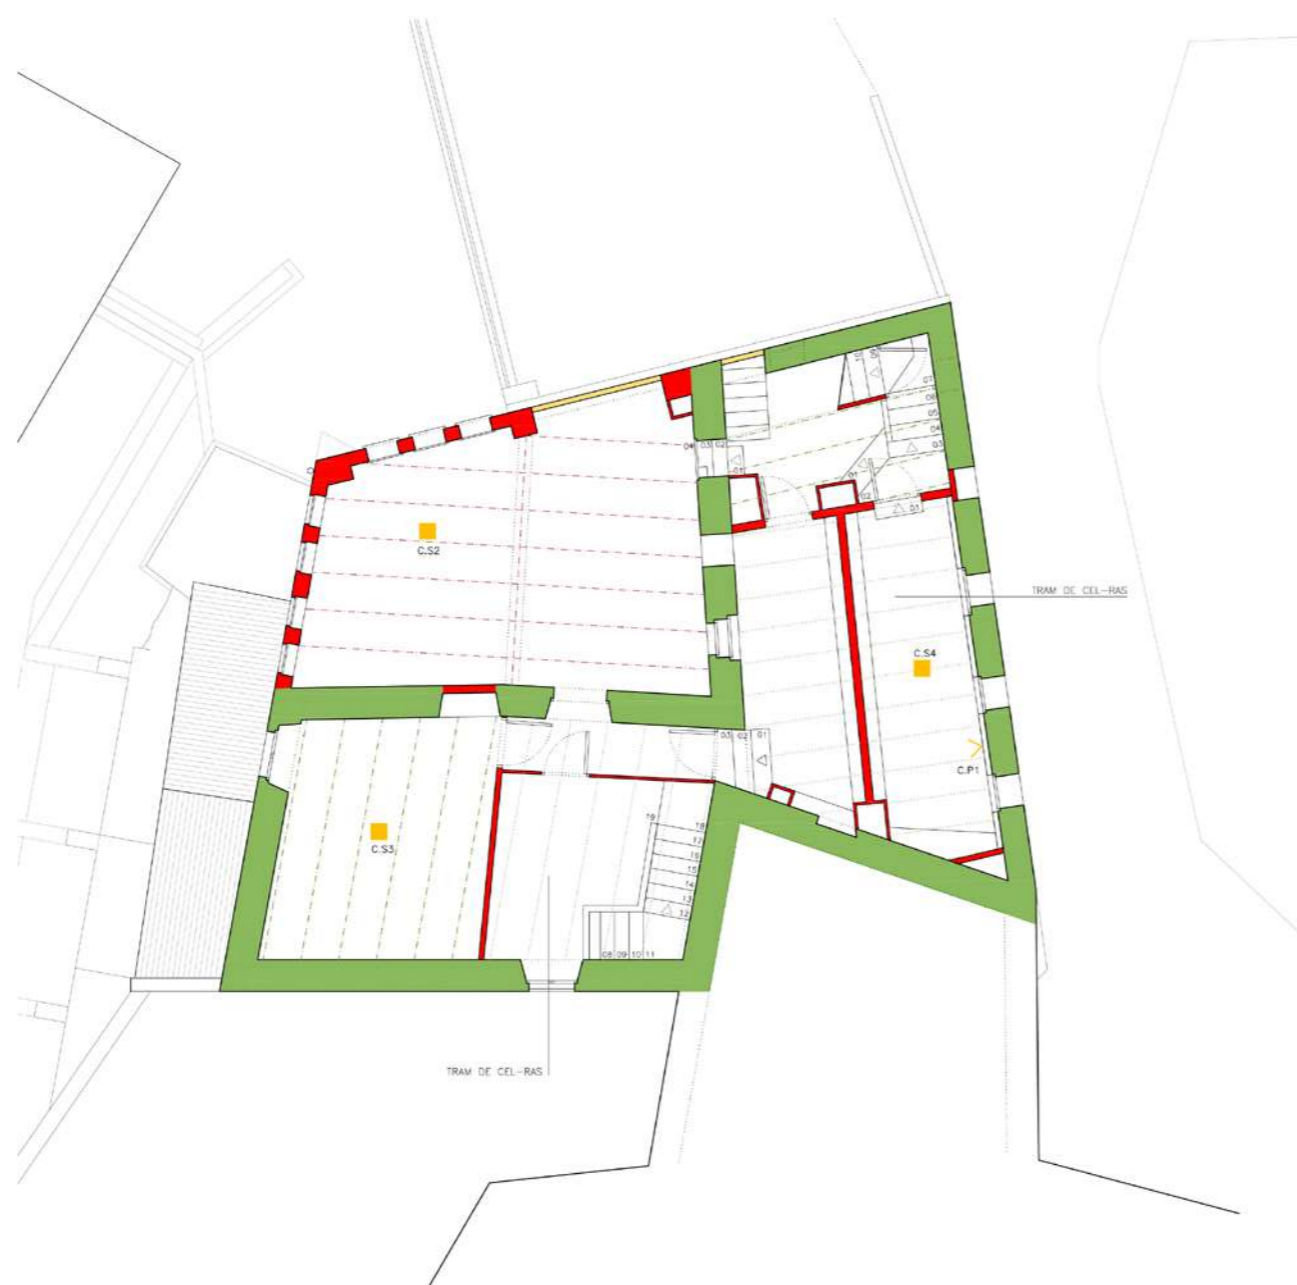
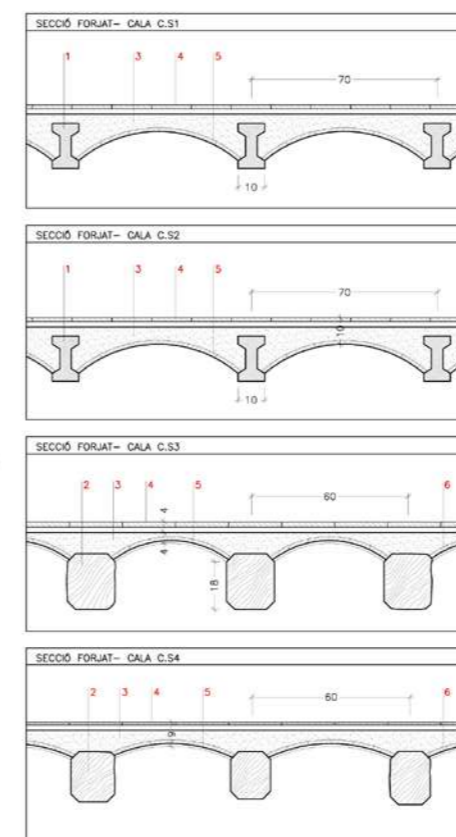
ANALISI CONSTRUCTIU P1

SOSTRES (EMBIGATS)	
---	BIGUES DE FORMIGÓ
---	BIGUES METAL·LIQUES
---	BIGUES DE FUSTA
ELEMENTS VERTICALS	
■	PARETS DE MAÇONERIA PEDRA IRREGULAR
■	PARETS CERÀMIQUES TOTXANA O CERO
■	PARETS CERÀMIQUES MAÓ MASSIS
■	PARETS MIXTES (CONCREMAT DE PEDRA I CALÇ)
■	ELEMENTS DE FORMIGÓ ARMAT
CALES REALITZADES	
■	CALES EN PARAMENTS
■	CALES EN FORJATS (TRAVERSANT TOT EL GRUIX, INCLÒS CEL-RAS)
■	CALES EN FONAMENTS (FINS A BASE DE L'ELEMENT RESISTENT)
NOTA: LA DENOMINACIÓ DE LES CALES ES CORRESPON AMB LA DE LES FOTOGRAFIES

1. BIGUETA DE FORMIGÓ
2. BIGA DE FUSTA
3. MATERIAL DE REOMPLERT
4. PAVIMENT DE RASILLA CERÀMICA
5. REVOLTÓ CERÀMIC

Títol del plànol
ANTECEDENTS I PREEXISTÈNCIES
ESTRUCTURA
PLANTA I SOSTRE PLANTA PRIMERA

Fig.24: First-floor existing Conditions, floor and ceiling structural plan.

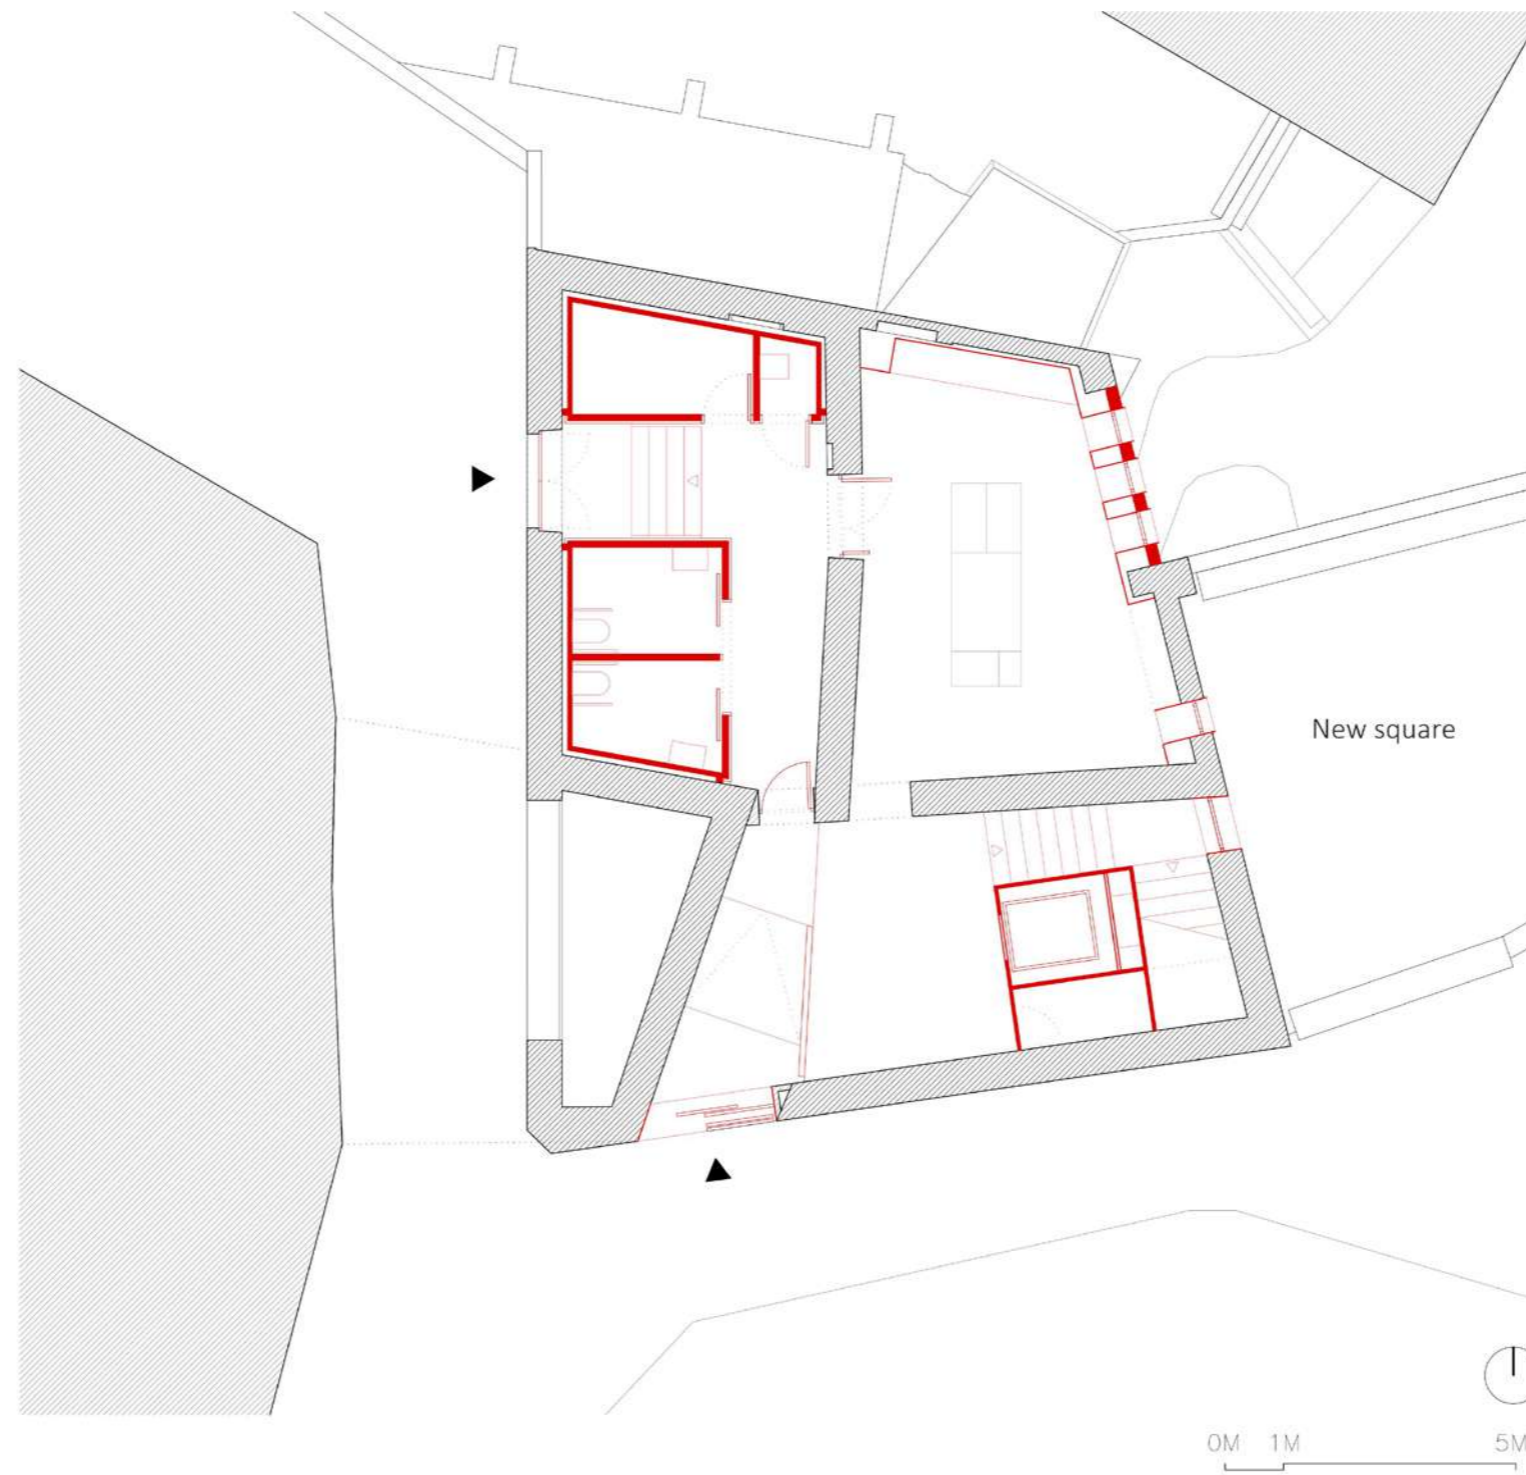
Fig.25: Ground-floor plan.

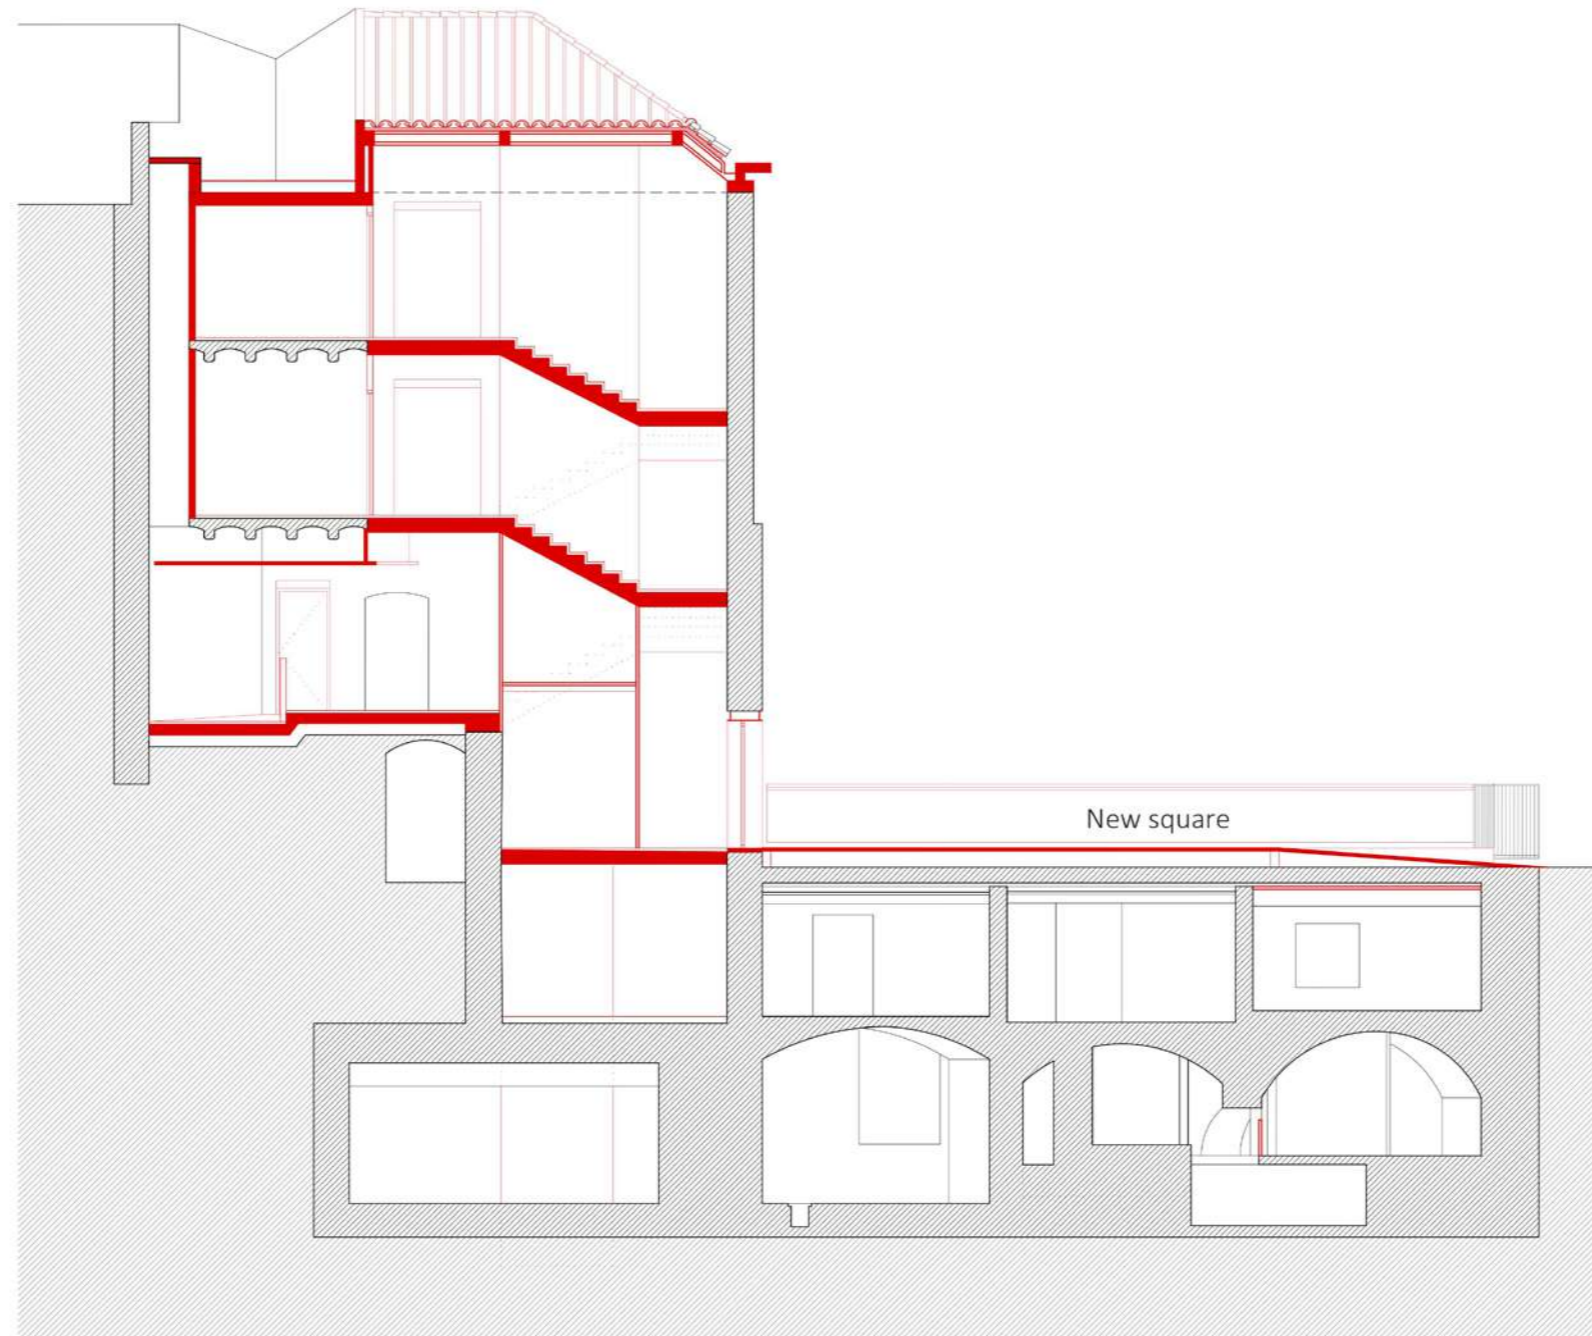
Fig.27: Section plan showing the new set of stairs and square.

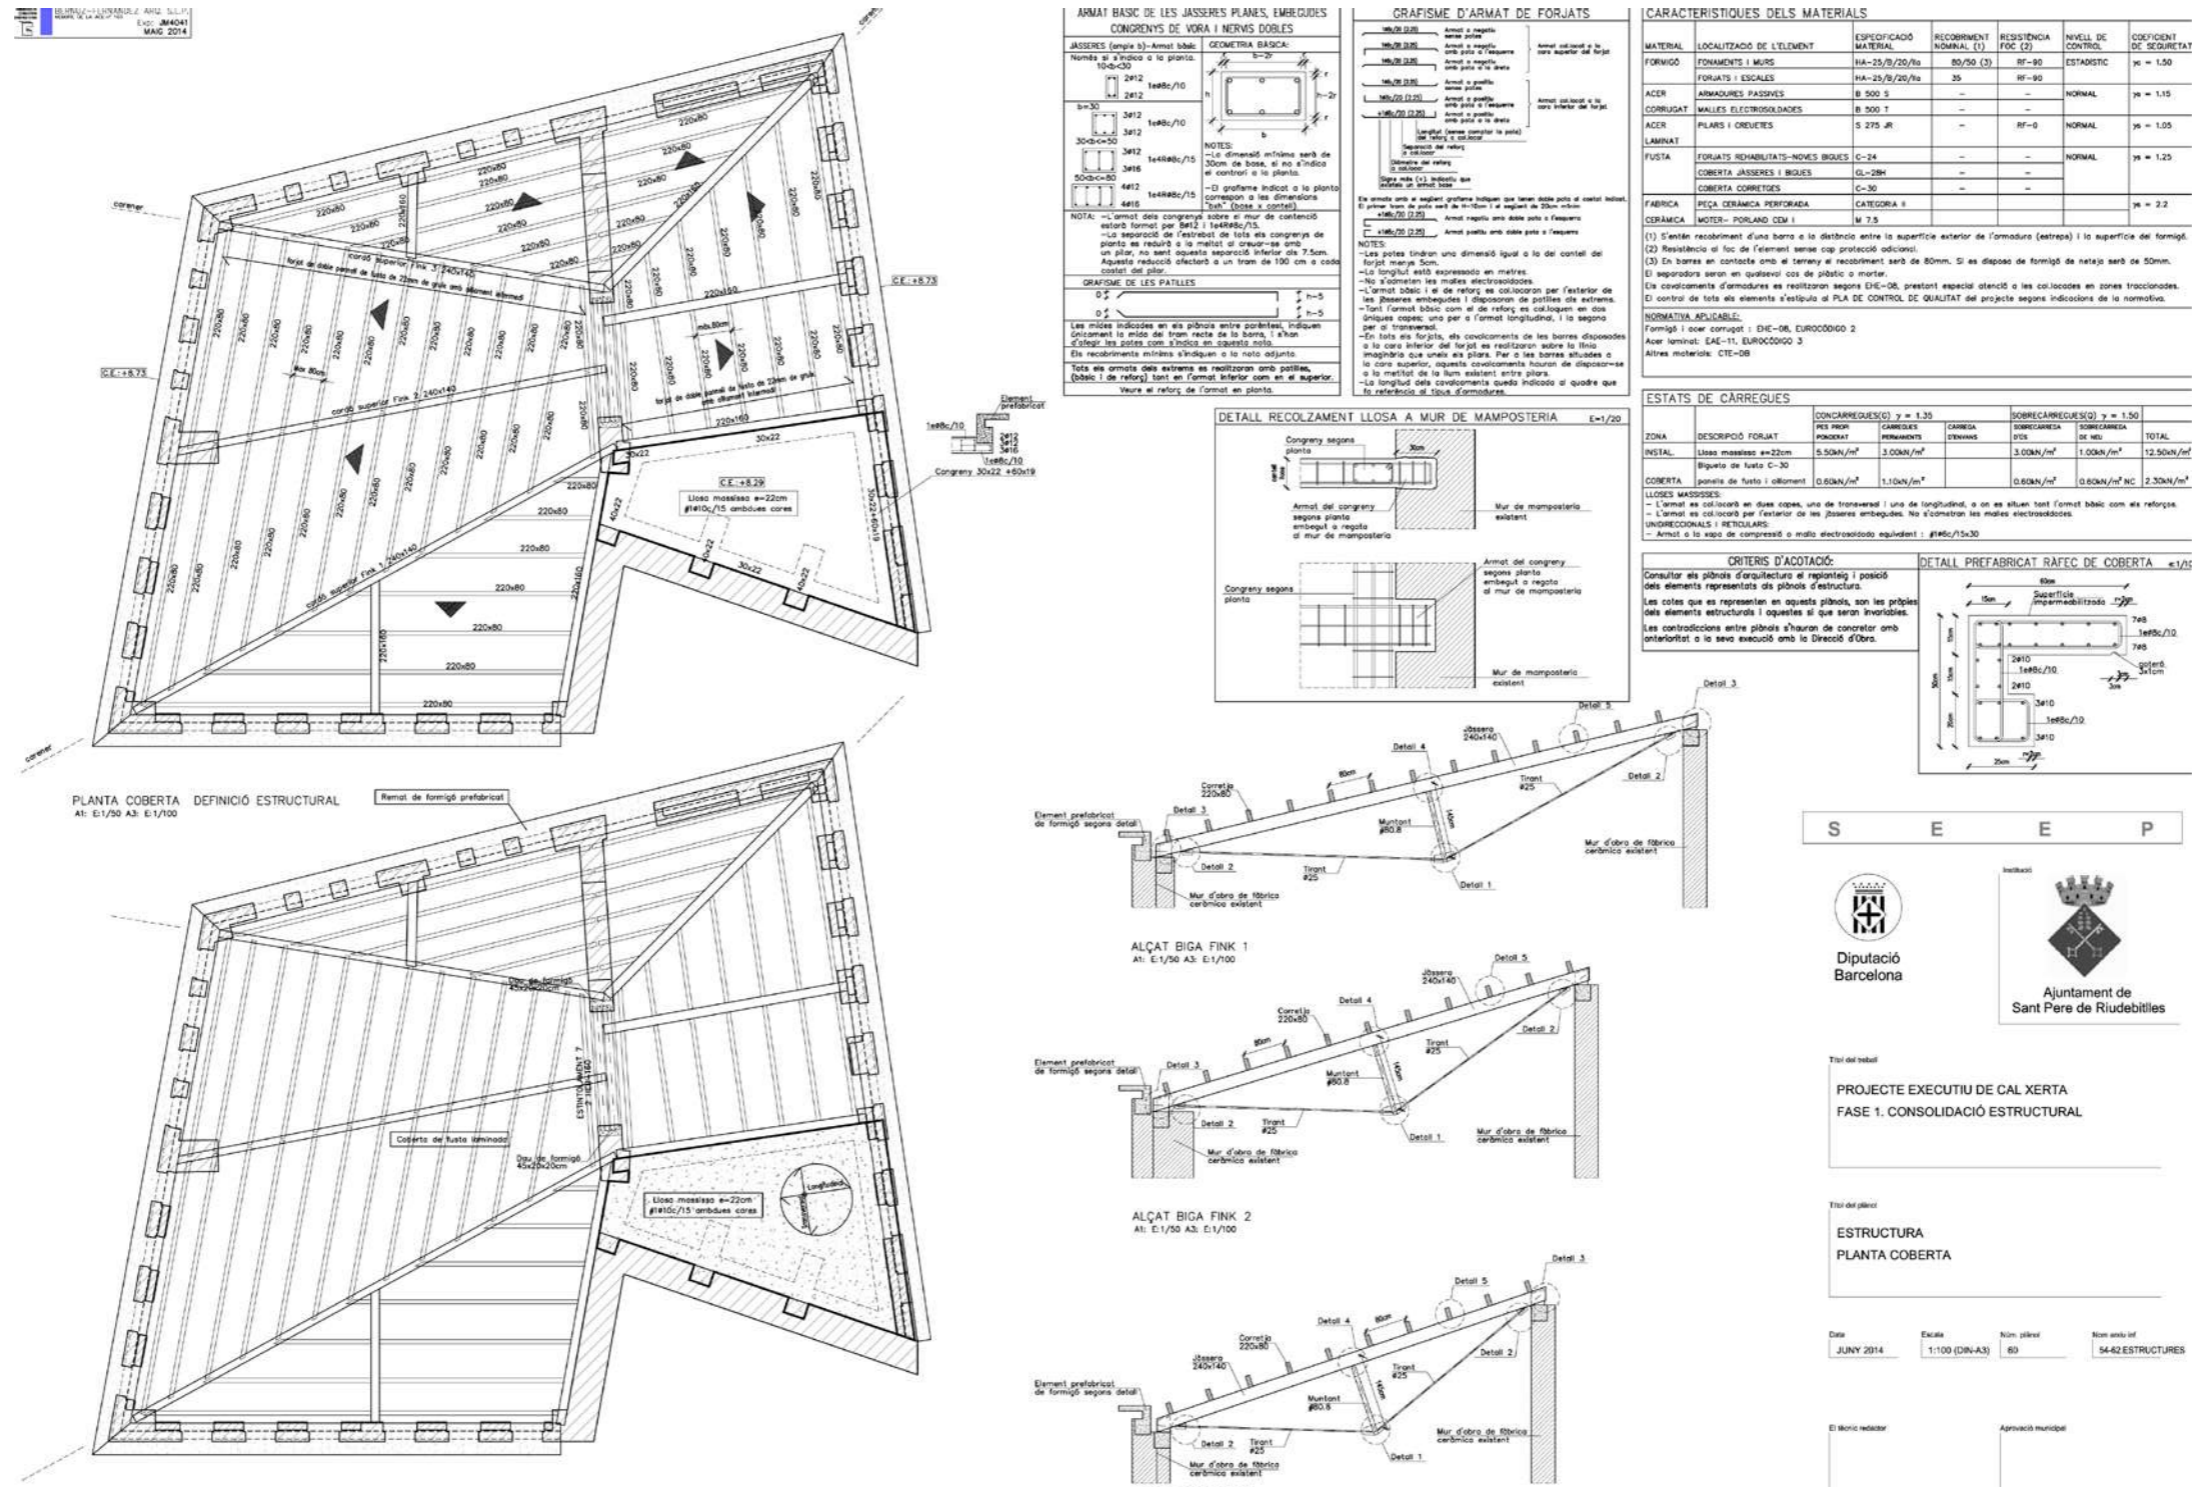
Fig.28: Structural roof plans and details.
