Rehabilitation of an old paper mill to give it a new life as an interpretation center.

Rehabilitation of Cal Xerta Mill

Objectives Rehabilitation of Cal Xerta Mill as an interpretation center on the traditional paper industry.

Date Master Plan: 2013; Phase I: 2016; Phase II: 2017;
Phase III: 2019.

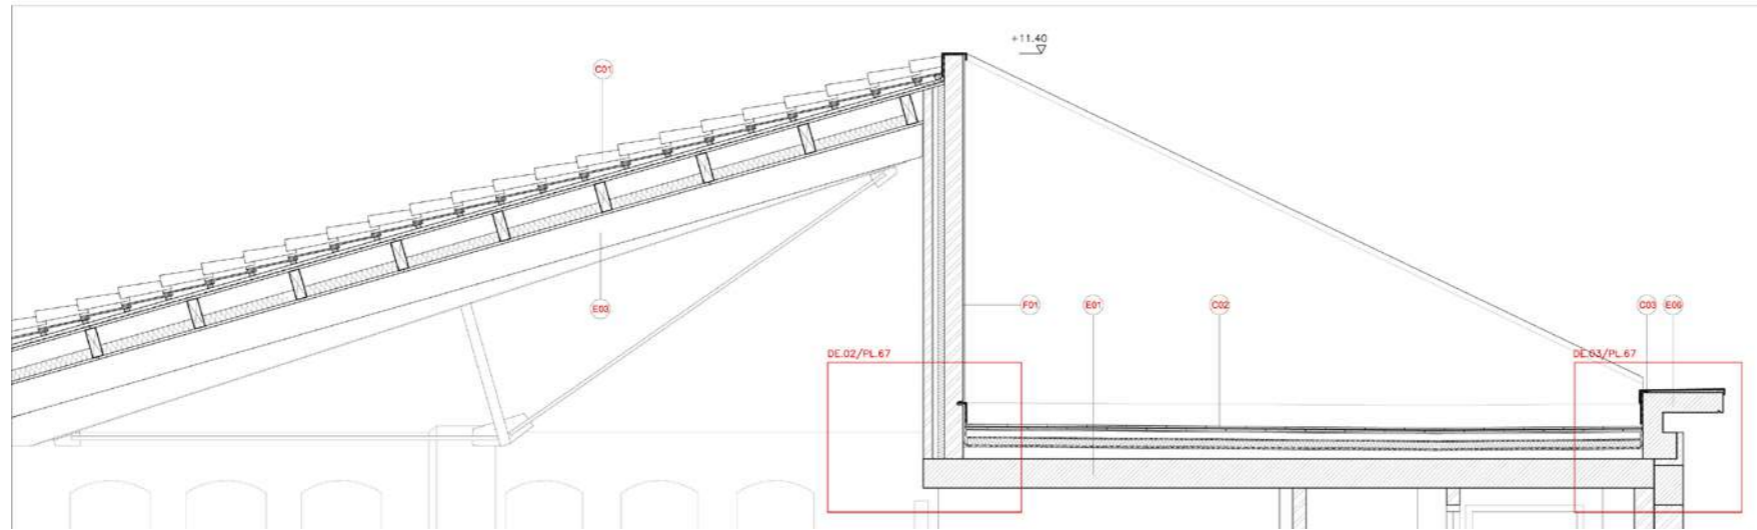
SC.1/ SECCIÓ CONSTRUCTIVA TIPUS

- E01 LLOSA DE FORMIGÓ ARMAT HA-25 DE 22CM DE GRUIX SUBSTITUÏNT TRAM DE FORJAT DE BIGUES DE FUSTA I REVOLTONS, ENCOFRADA PER ANAR VISTA AMB TAUERS FENOLICS (PRIMER OS)
- E02 FORJAT NOU DE BIGUES METAL·LIQUES (PE-220 I REVOLTONS CERÀMICS CONUS DECATS VISTOS AMB CAPA DE COMPRESSIÓ)
- E03 ENCAVALLADA MIXTA TRUS FINK DE FUSTA LAMINADA GL-28H I ELEMENTS METÀL·LICS D'ACER
- E04 MUR EXISTENT DE MAÓ MASSIS DE 30CM DE GRUIX
- E05 NOVA LLINDA METÀL·LICA (ESTINTOLAMENT 7) FORMAT PER DUES HEB-160 PER A FORMAR PAS DE PORTA
- E06 ELEMENT PREFABRICAT PER A FORMAR CÈRCOL I RAPEC VOLAT DE FORMIGÓ ARMAT AMB ACABAT LLIS
- E07 MASSISSAT DE PART CENTRAL AMB MAÓ MASSIS AMB CÈRCOL SUPERIOR DE FORMIGÓ ARMAT PER A RECOLZAMENT BIGUES

- C01 COBERTA INCLINADA TIPUS C1 FORMADA PER DOBLE TAUER DE FUSTA 22MM (AGLOMERAT I OSB) CARGOLAT SOBRE ESTRUCTURA AMB BOMM D'ALLAMENT I LÀMINA IMPERMEABLE AMB SOLUCIÓ DE TEULES ARABS SOBRE RASTRELLS (VENTILADA)
- C02 COBERTA PLANA TIPUS C2 DEL TIPUS INVERTIT AMB ACABAT DE DOBLE CAPA DE RASILLA CERÀMICA
- C03 CORONAMENTS DE XAPA DE ZINC PREPATINAT DE 0.8MM PLECADA
- C04 CANAL RECTANGULAR DE ZINC AMB DOBLE CAPA I ALLAMENT INTERMIG DE LLANA DE ROCA

- F01 MUR DE FAÇANA TIPUS F1 DE DOBLE FULLA CERÀMICA DE 30CM. GERO EXTERIOR I TOTXANA INTERIOR. ALLAMENT DE LLANA DE ROCA (SOMM DE GRUIX). ACABAT ARREBOSSAT A L'EXTERIOR

Títol del plànol
SISTEMA D'ENVOLVENT
SECCIONS CONSTRUCTIVES

Fig.30: Constructive sections of the building envelope system.

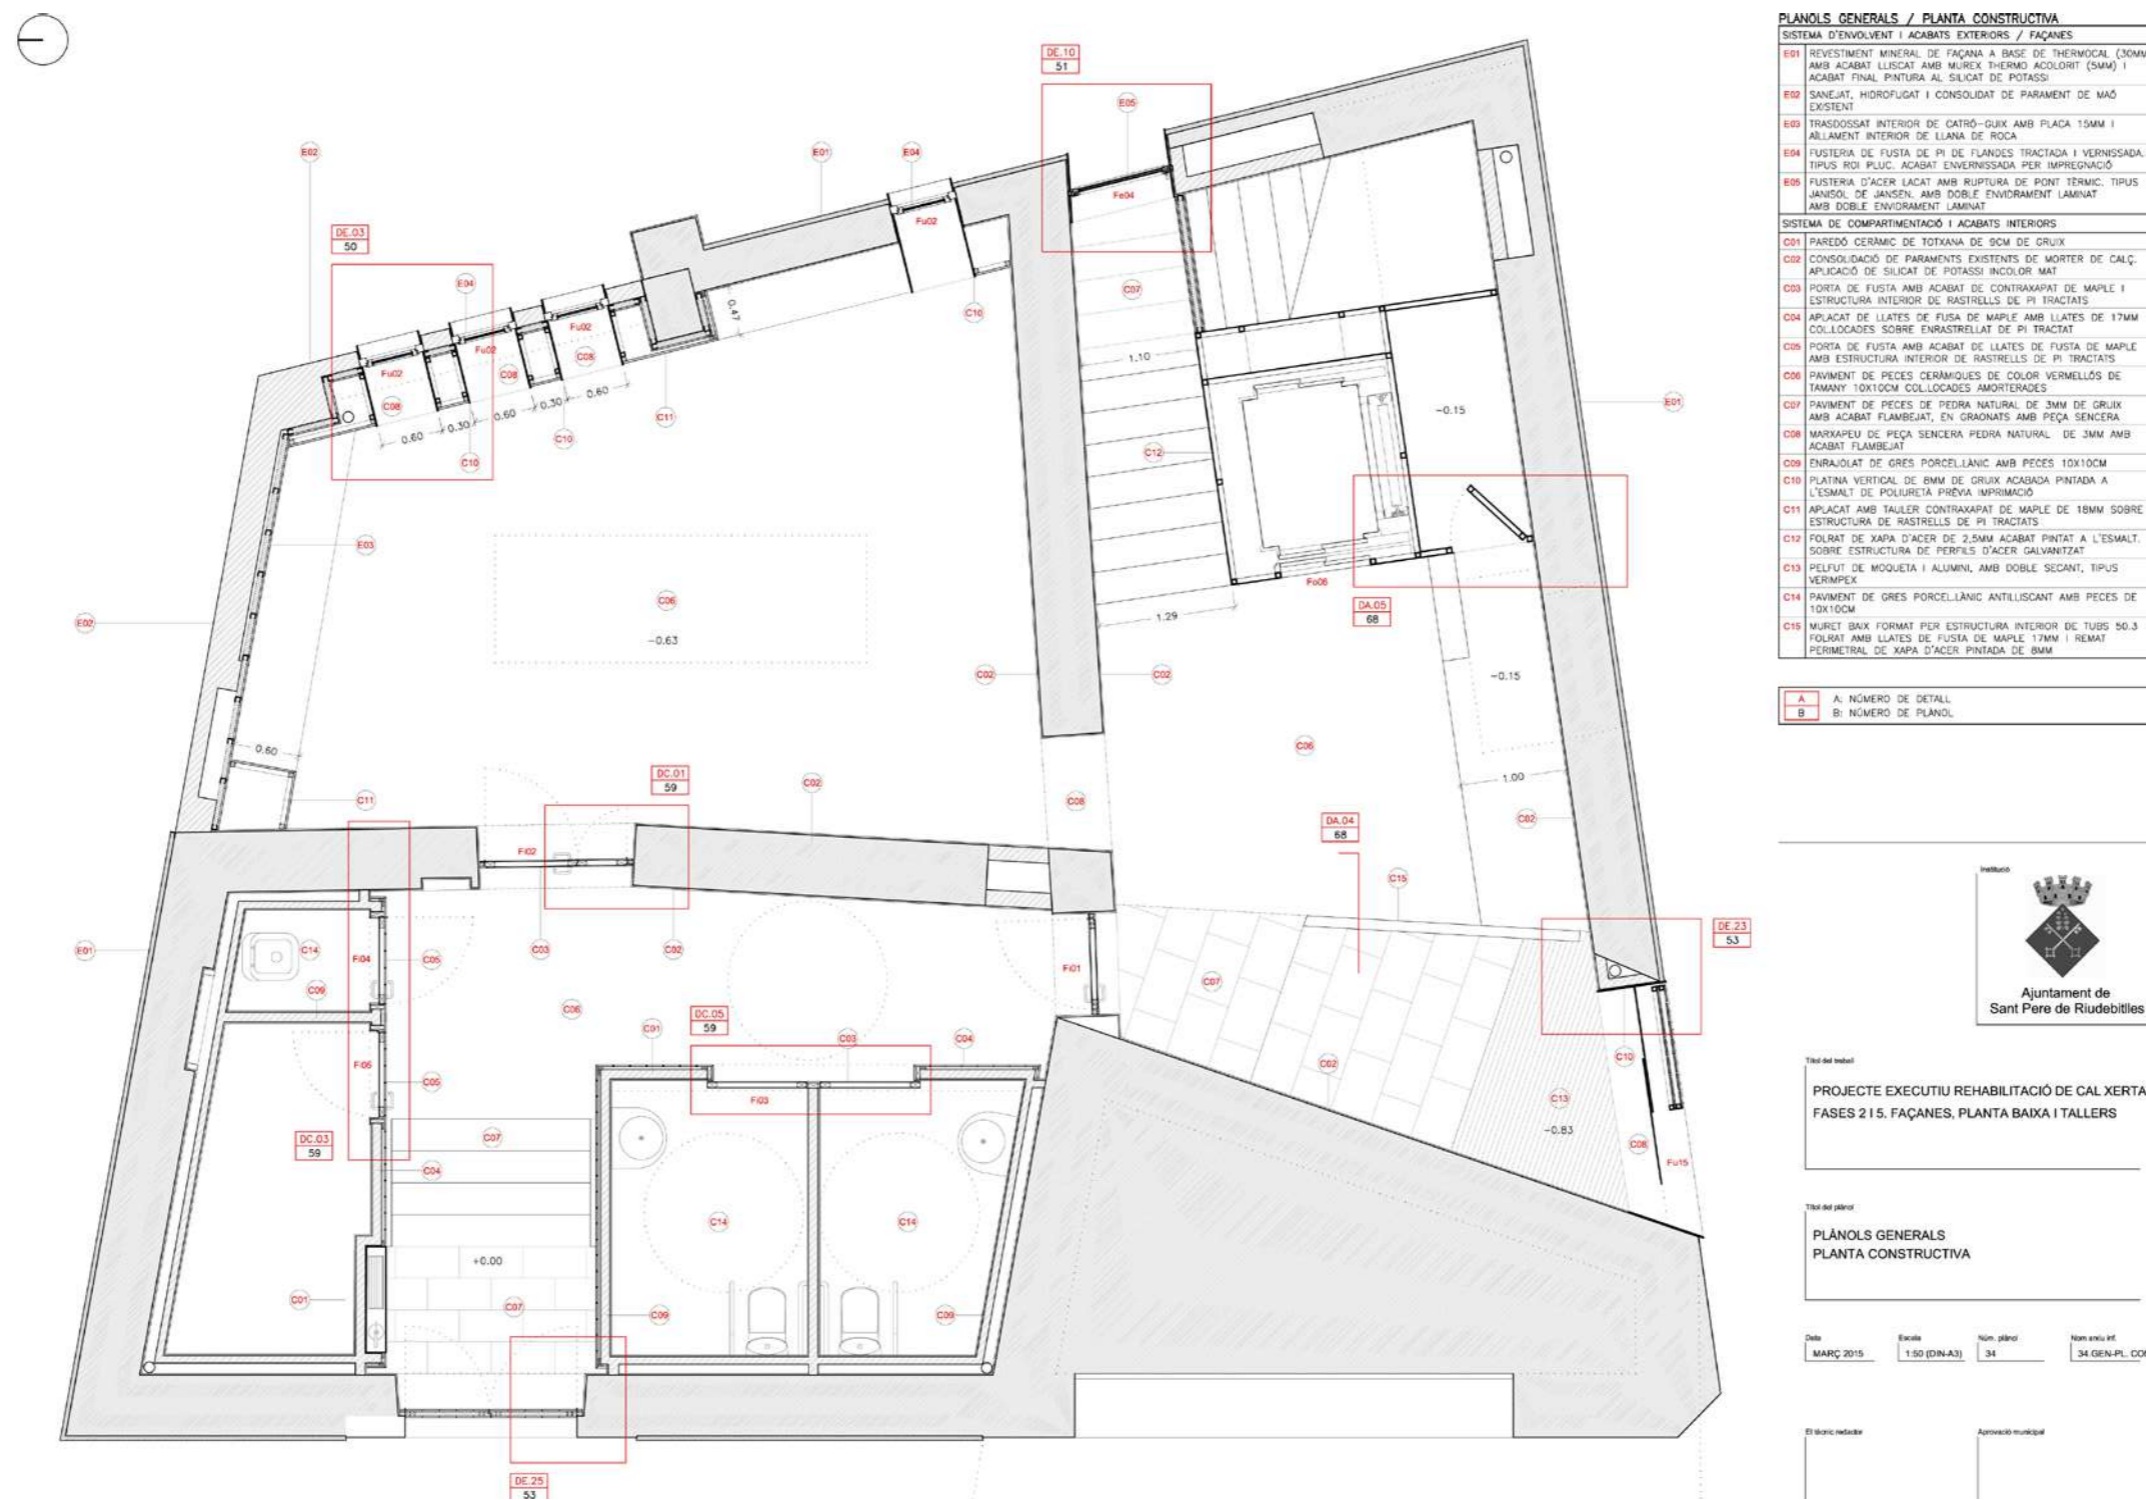
Fig.31: Construction floorplan.
